Condition Assessment and Recapitalization Plan

Job No. F01-25-01-23
Joseph Howe Building
Hollis Street, Halifax, NS

Final Report

October 31, 2007

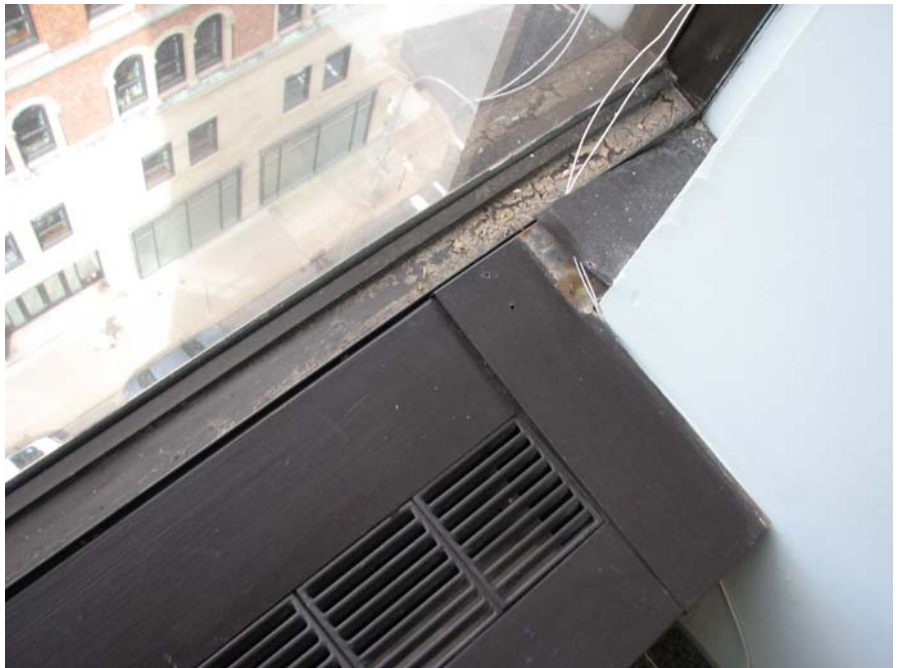
Figure A-7

The aluminium curtain wall framing on the majority of the building appears to be in fair condition with some erosion of the anodizing on the framing the members, particularly on the Hollis Street façade (refer to Figure A-7, Appendix A) and some minor damage to flashing, at the bottom of the vertical mullions. The single glazing is causing problems: such as heat loss and gain, increased energy consumption required for heating and cooling, reducing comfort levels within the office spaces, condensation on interior of glass and aluminum framing. In an effort to reduce the effects of solar gain through the single glazing, a tinted vinyl film has been applied to the interior face of the glass panels. Discussion with building staff indicated that this has reduced the effects of solar gain/heat loss, but is still not wholly satisfactory (refer to Figure A-8, Appendix A).

The entire curtain wall and insulated panel wall system would be replaced in the new capitalization program, with a modern curtain wall system with a higher thermal performance. The single glazed window system on the Granville Street level would also be replaced as would all the exterior man doors.

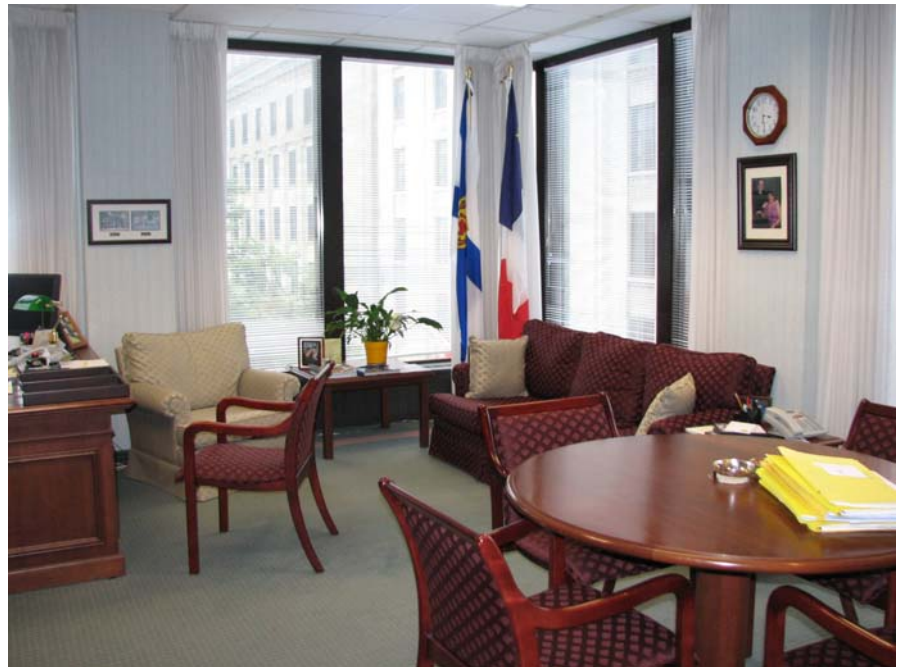
Figure A-23

In general, the interior finishes observed on all floors of this building are typical for similar type office buildings (Figure A-23, Appendix A). Some individual offices have a higher level of finish in keeping with the occupant's status (Figure A-24, Appendix A).

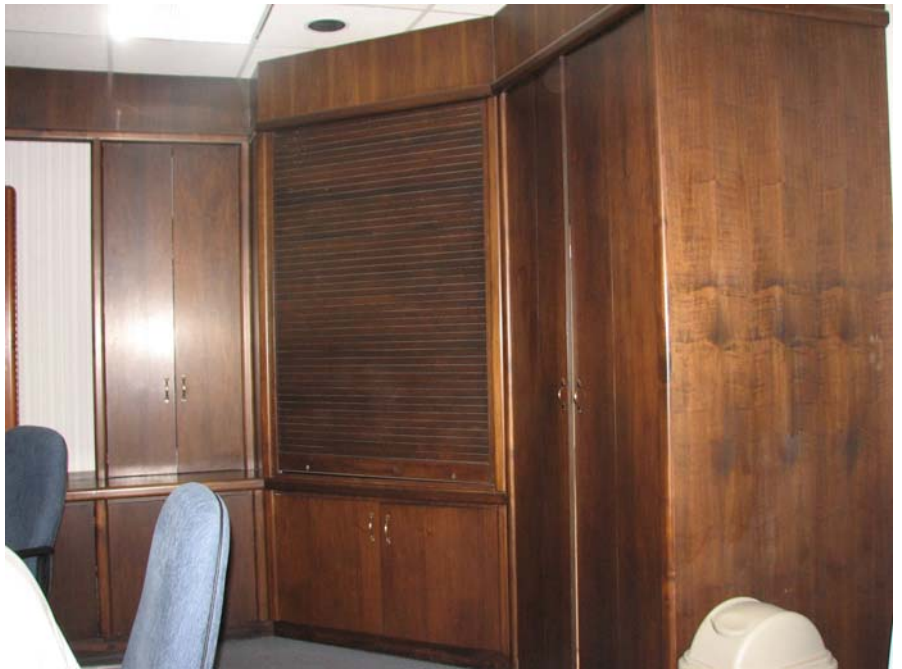
Figure A-25

Most built-in cabinets are of an inexpensive nature, again with some other of a slightly higher quality observed (Figure A-25 and A-26, Appendix A).

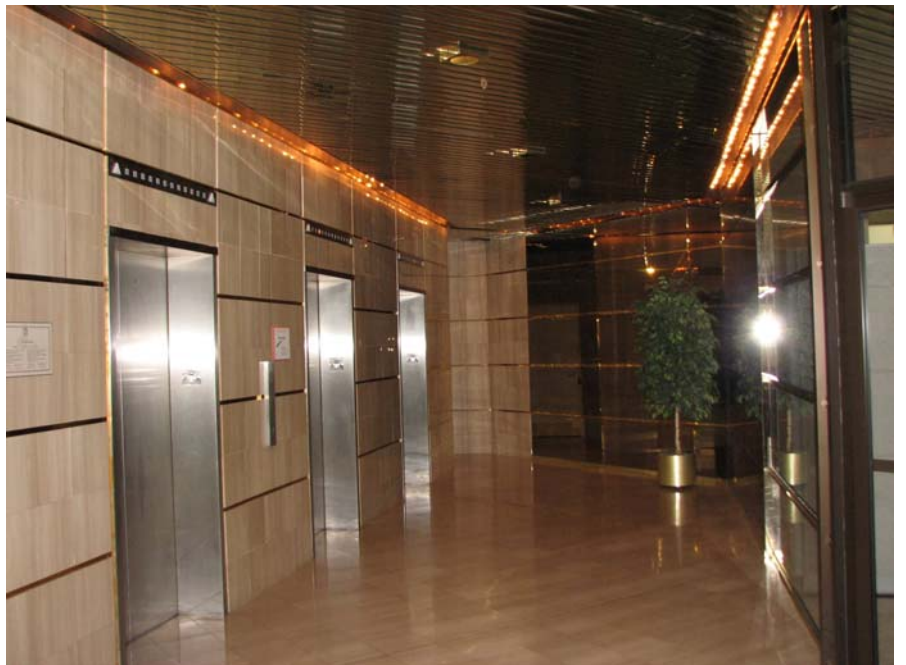
Figure A-27

The majority of ceiling finishes are 2'-0" x 2'-0" acoustic ceiling tile and suspension grid, with various patterns of ceiling tile observed (Figure A-27, Appendix A). Some small areas of painted gypsum board ceiling were also observed. On the Hollis and Granville Street levels, metal linear type ceilings are used in the public spaces, extending into adjacent office spaces

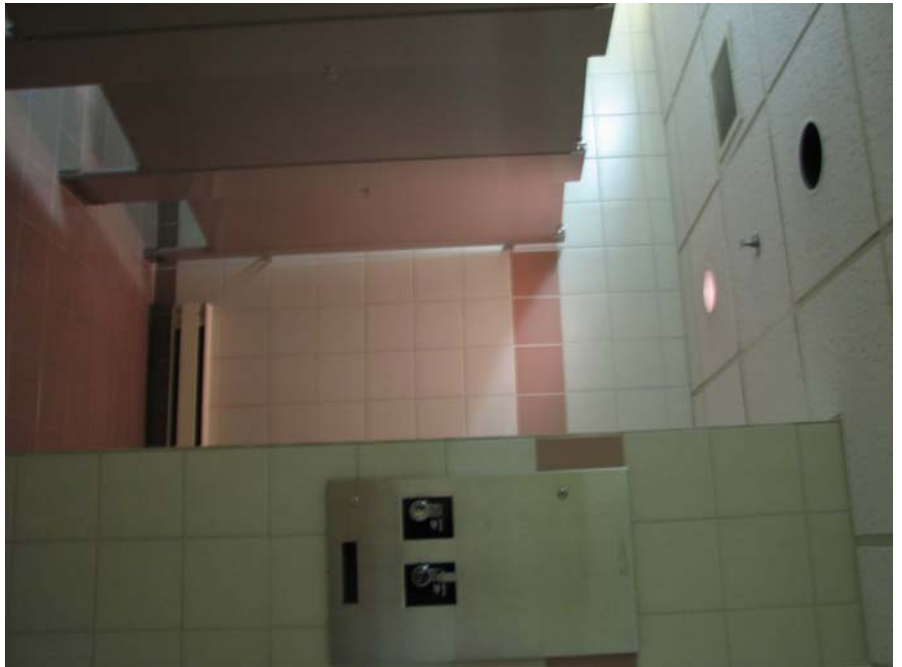
Figure A-29

Areas of gypsum board with sprayed on acoustic plastic were observed on Levels 11 and 12. (Figure A-29, Appendix A).

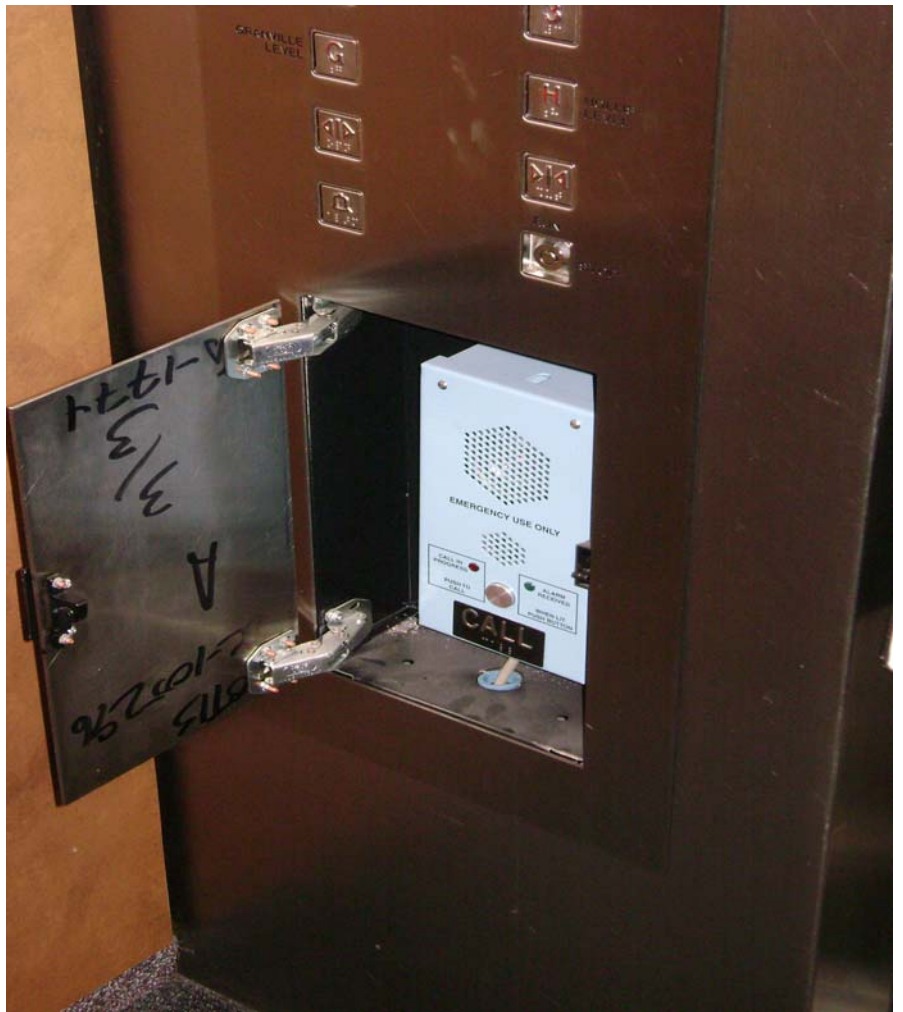
Figure A-39

The elevator cabs are finished with carpet floors, plastic laminate panels on three sides and stainless steel panels on one side. The ceiling is a metal type “egg crate” suspended ceiling with fluorescent back lighting. The eastern most cab has a higher ceiling than the other two. The “in cab” floor pushbuttons are located on both sides of each cab and each cab has an emergency phone device (Figures A-39 and A-40, Appendix A).

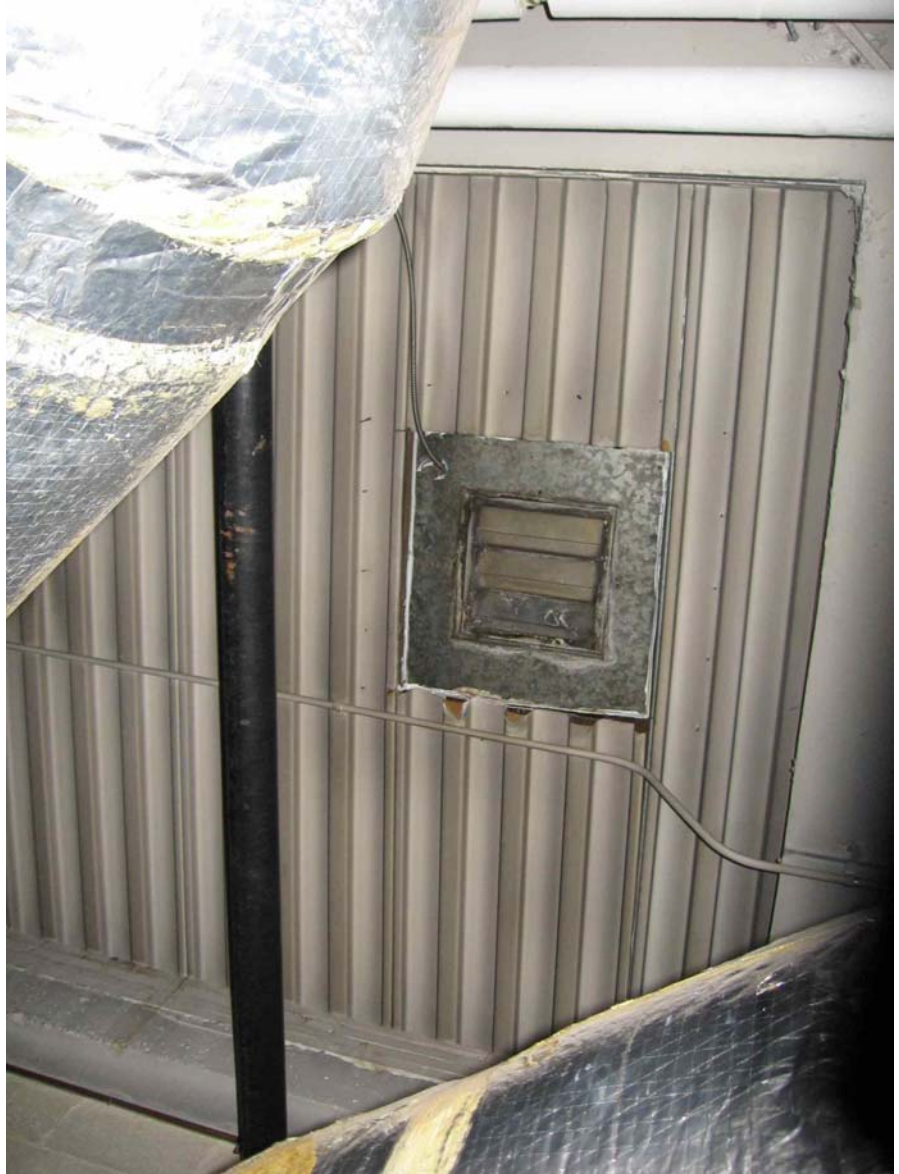
Figure S1: Existing un-reinforced opening in steel roof deck

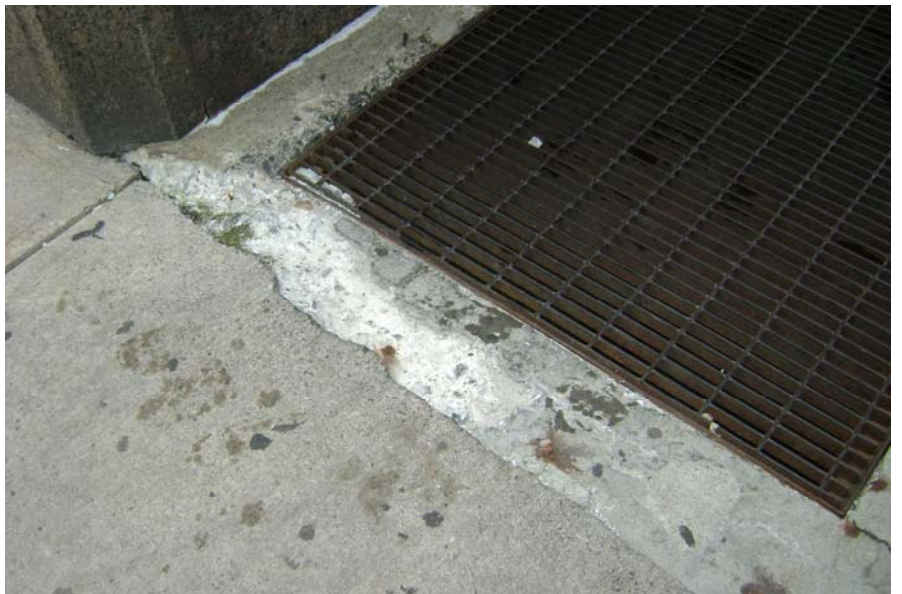
Figure S3: Spalled concrete at transformer grating in Granville Street ramp slab.

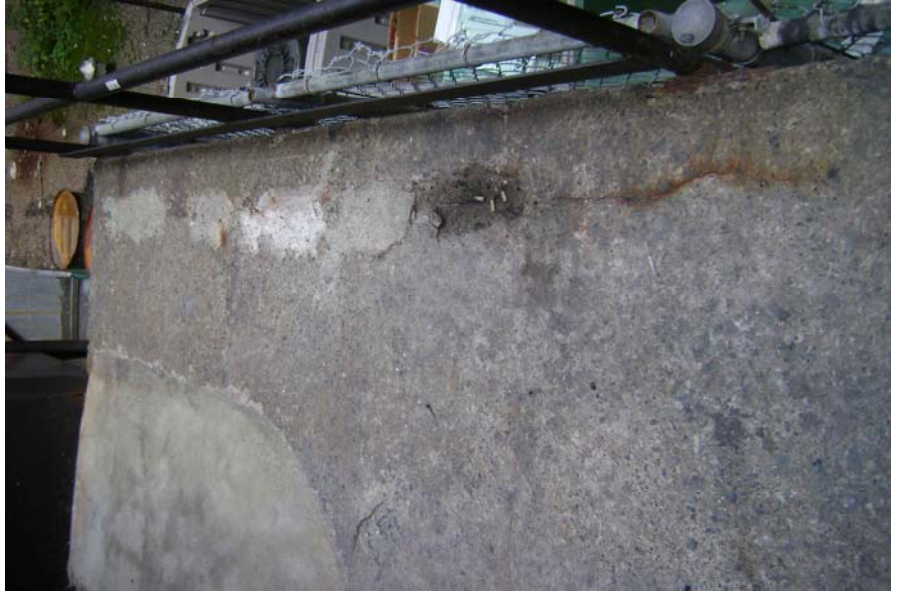
Figure S4: Spalled concrete at the Granville Street cantilevered slab.

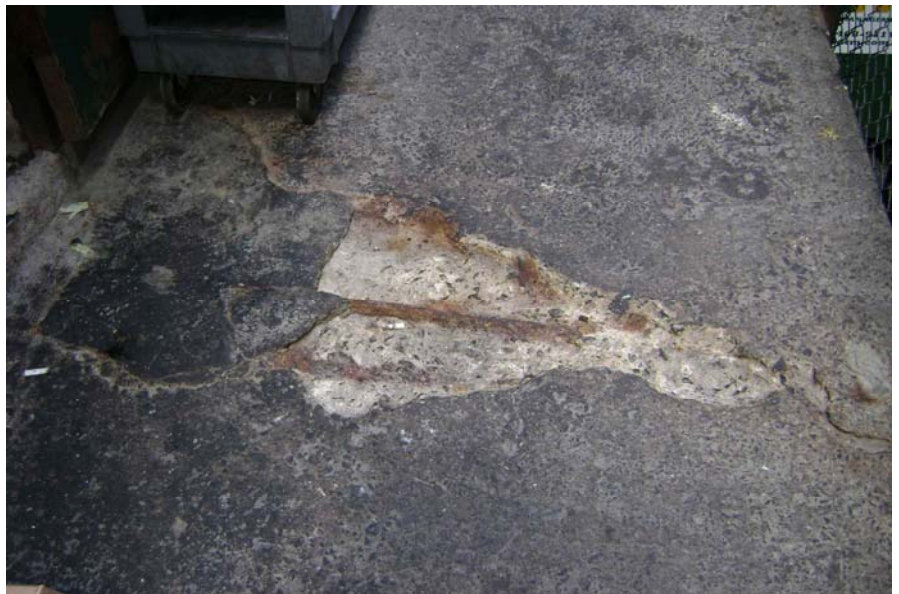
Figure S5: Spalled concrete and corroded reinforcing steel at the Granville Street cantilevered slab.

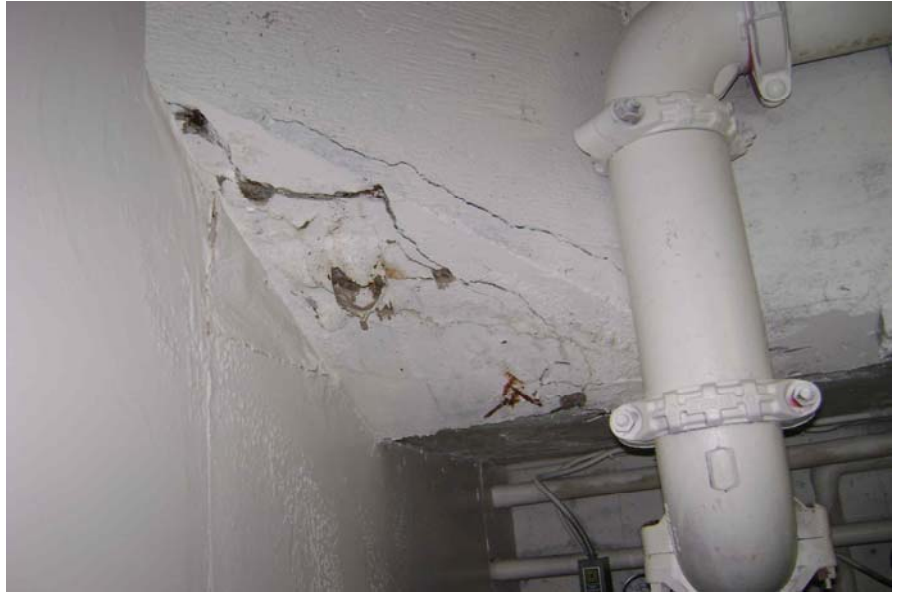
Figure S6: Cracked, spalled concrete at the soffit of the main entrance stair slab, Hollis Street level.

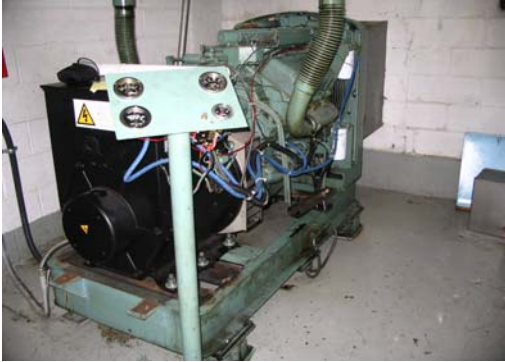
Photo 1.1; Genset

Overall, the emergency power system appears to have been well maintained and in satisfactory condition: however, the engine of the genset is beyond its anticipated life expectancy. It was also observed that there is no emergency lighting installed in the elevator lobbies on all floors. This does not allow safe egress to the stairwells during a loss of normal utility power.

Due to the over loading of the emergency power system and the concerns with the reliability of maintaining the life safety equipment, we are recommending that the system be updated. We have explored several options including keeping the existing genset and removing all non life safety equipment from it and transferring this load to a new genset. Due to the age of the existing genset and it did not meet the C282 performance test we do not recommend this option. Therefore, we are recommending the complete replacement of the genset.

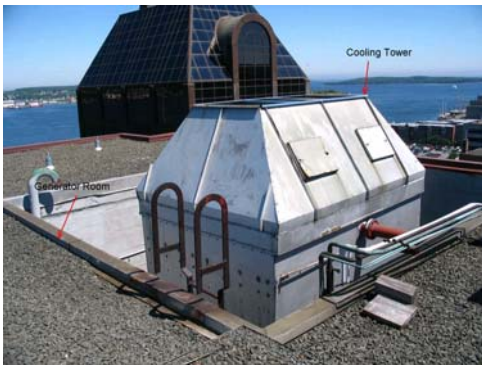
Photo 1.4; Shows the generator room location and cooling tower

The generator room location is on the 12th floor with one wall exposed to the exterior of the building. Outside this exterior wall, sits a large cooling tower. Refer to *photo 1.4* for details. This has basically "trapped" the genset within the building with no simple means to remove it for maintenance or replacement.

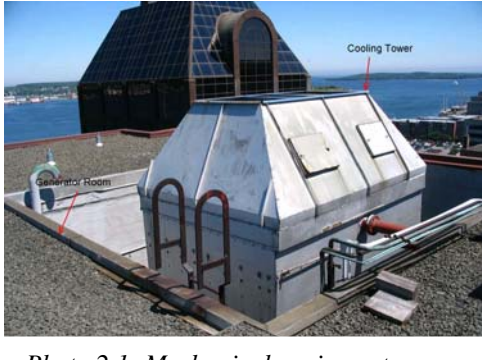
Photo 2.1; Mechanical equipment located outside of generator room

1. Getting a genset into this room would require temporary removal of the mechanical cooling equipment to allow a crane to lift the old generator out and to install a new generator in its place (Refer to *Photo 2.1*). This would require shut down of the building air conditioning.
2. The exterior wall of the generator room would require removal to allow the genset to be removed.
3. The existing emergency power system will require complete removal to install the new system, therefore leaving the building with no emergency power for a significant amount of time (estimated shut down of emergency system is 3 weeks) .
4. The existing room will require an extension to allow for the new generator and ductwork.
