FIELD BULLETIN

January 3, 2023

Equipment: 2:1 Roped counterweight

Subject: Counterweight assemblies with 2:1 roping.

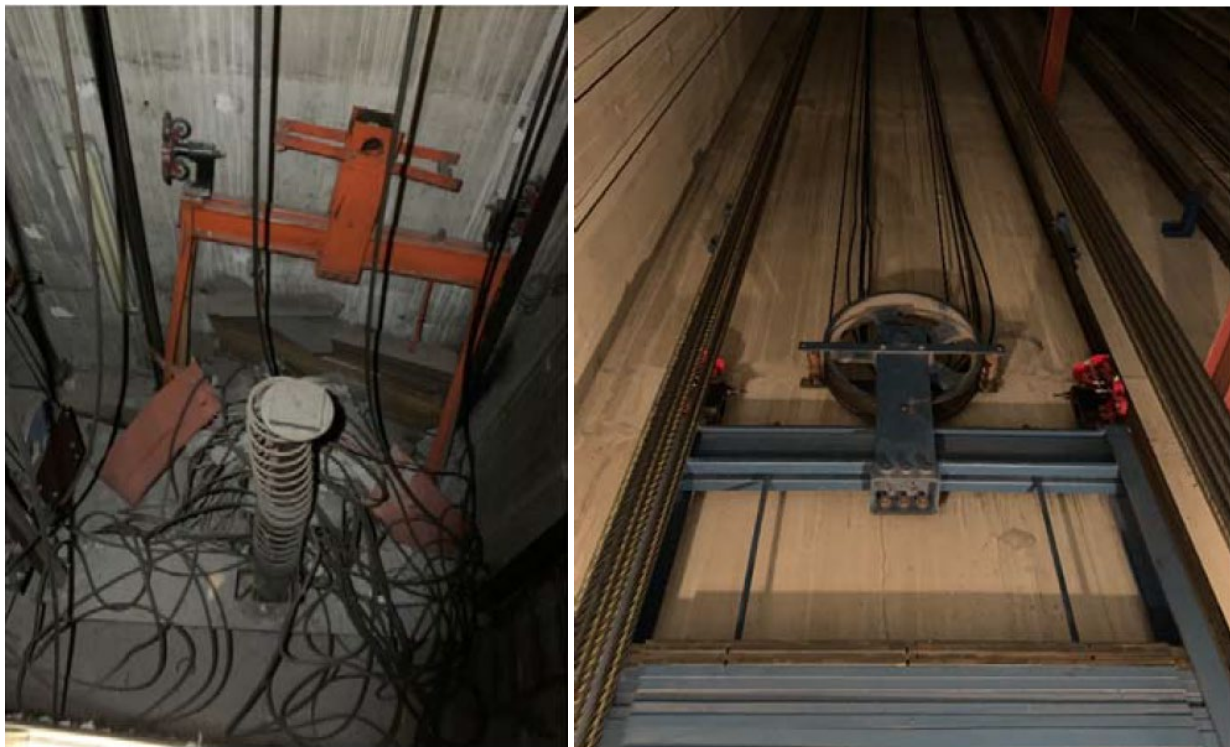
FIG 1 – Failure examples

In both cases above the bearings failed on a unit manufactured by Turnbull – Dover, with 2:1 roping, where the sheave fixing arrangement failed which should have kept the pulley shaft in position even in case of bearing fracture.

1. Identify all Turnbull – Dover 2:1 Counterweight installations.
2. Notify regional AHJ's and industry of need to prioritize bearing inspections.
3. Include scheduled inspections of sheave shaft bearings in MCP documentation.
4. Mandatory inspection of bearings after CAT 5 tests are performed.
5. Bearing inspections will not be confined to Turnbull installations.
6. Replace suspect bearings and promote retrofit kits with redesigned shafts.

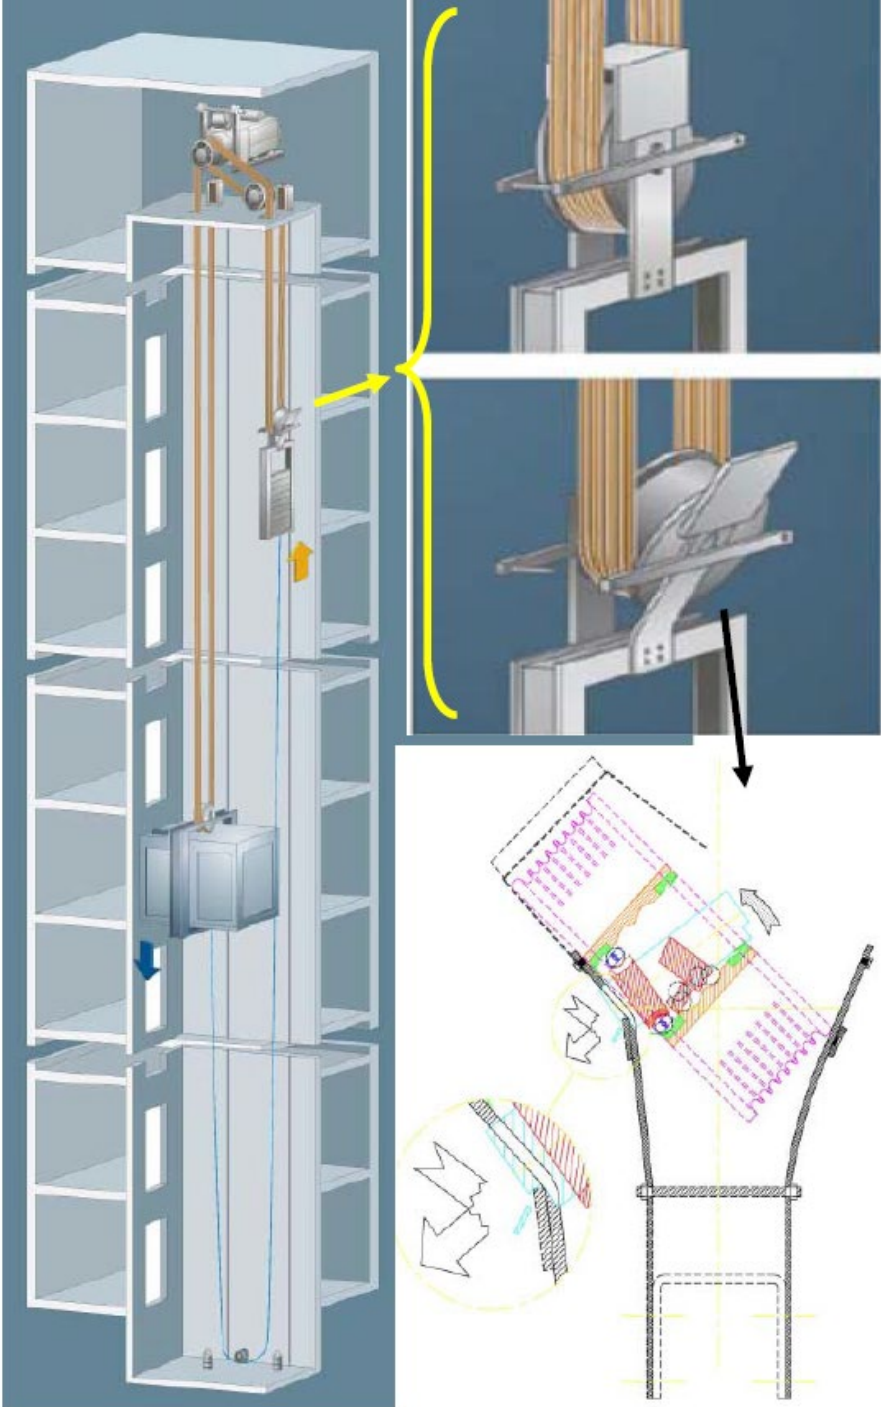
Figure 1: Illustration of bearing failure

The counterweight sheave shaft bearing can fail due to excessive service life, overload stress or lack of lubrication. The counterweight sheave would then jam on the counterweight shaft. The counterweight sheave is then on an angle placing pressure on the cheek plates which connect the counterweight to the counterweight sheave. This pressure can cause the shaft retaining means to fail and the sheave to separate from the counterweight, possibly resulting in the car being in a free fall condition activating the car safety gear in its most severe operating condition.

In the noted incident the bearings which failed were SKF-6218 sealed bearings which cannot be lubricated and were used on some Dover-Turnbull counterweights. Engineering calculations, based upon SKF data indicate the bearing service life should not exceed 27,000 hours. The life will vary depending on the duty cycle of the installation.

TKE have also designed a retrofit kit to replace the sheave shaft and bearings. The retrofit kit also includes additional rope retainers to mimic the seismic requirements which prevent the hoist ropes from jumping off the sheave. This is now more relevant now that full speed, full load buffer and safety tests are mandatory which apply further stresses to the system.

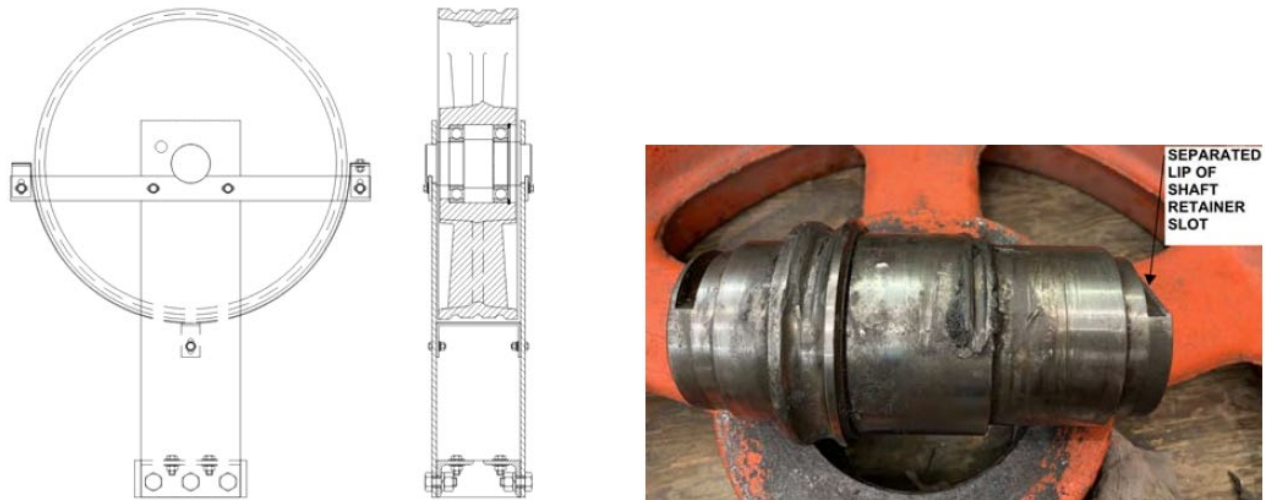
During normal elevator operation the counterweight (CWT) idler sheave separated off the CWT frame. CWT frame fell into the pit. CWT idler sheave fell on the car roof, penetrated through it and landed on cab floor. Car safeties applied stopping the car from a free fall.

The root cause of an incident is the failure of CWT idler sheave bearings. One of inner bearing rings got worn faster than the other allowing the outer ring with roller cage to relocate towards the center of the sheave shaft. Subsequent shaft wear allowed the sheave to skew out of plumb. Sheave started applying horizontal force on side retainer plates and on the lip of shaft retainer slot. The lip of shaft retainer slot snapped off and one side of the shaft dislodged from retainer plate making the sheave to separate off the CWT frame.

Method of preventing such accidents is periodic checks and replacement of sheave bearings. Note that bearings in this sheave design are sealed, lubricated for life, and cannot be lubricated. Bearing life span depends on use. Signs of bearing failure are vibration and noise.
