Brenton Suites Crane Collapse Report

Department of
Labour and Advanced Education

© Crown copyright, Province of Nova Scotia, 2021
Brenton Street Crane Collapse Report
Department of Labour and Advanced Education
April 2021
ISBN: 978-1-77448-192-9

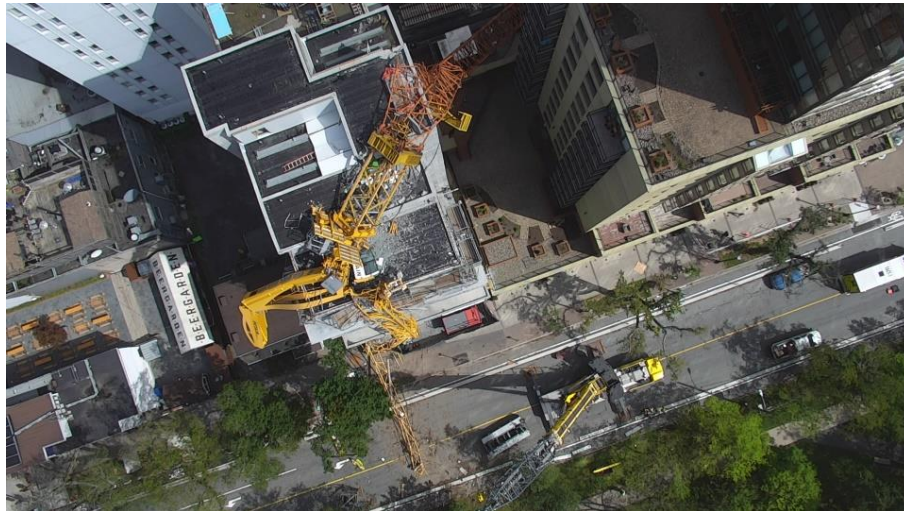
Photo 1: Aerial View of 1400 block of South Park Street Halifax after the collapse. Credit: Halifax Regional Fire & Emergency

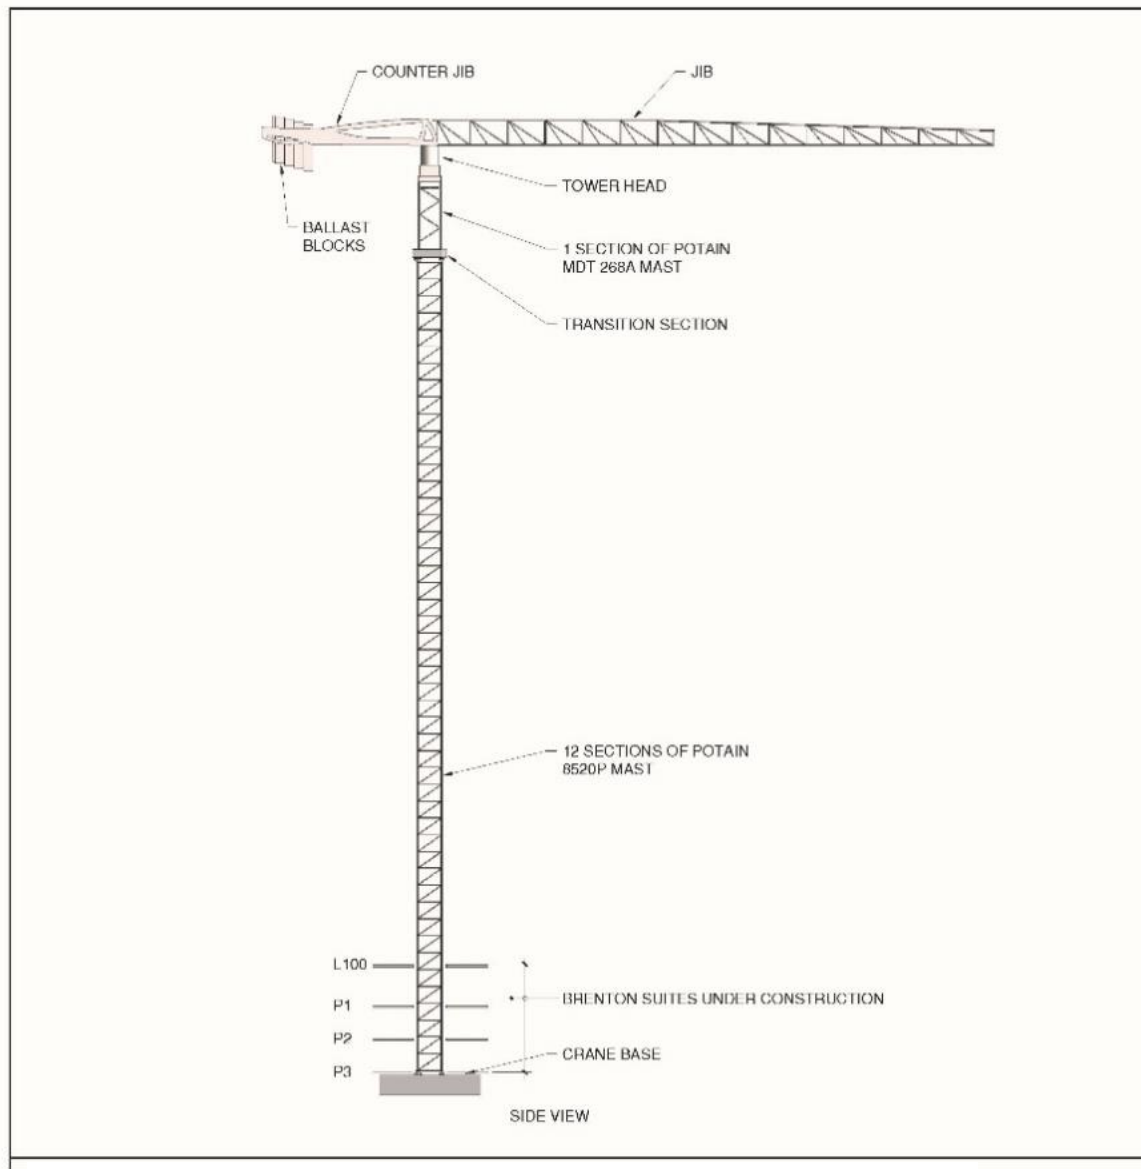
Figure 1: Crane sections.

On June 17, 2019, a new transition section (Figure 1) was installed on top of the previously erected Potain 8520P tower section (which had been manufactured in approximately 1974) to allow for proper weather-vaning. At the same time, a newer Potain MDT 268A model turntable, cabin, and jib (manufactured in 2015) were installed on the older tower section. Additionally, on this date, all the required test and certification documentation was provided to the Safety Branch, including:

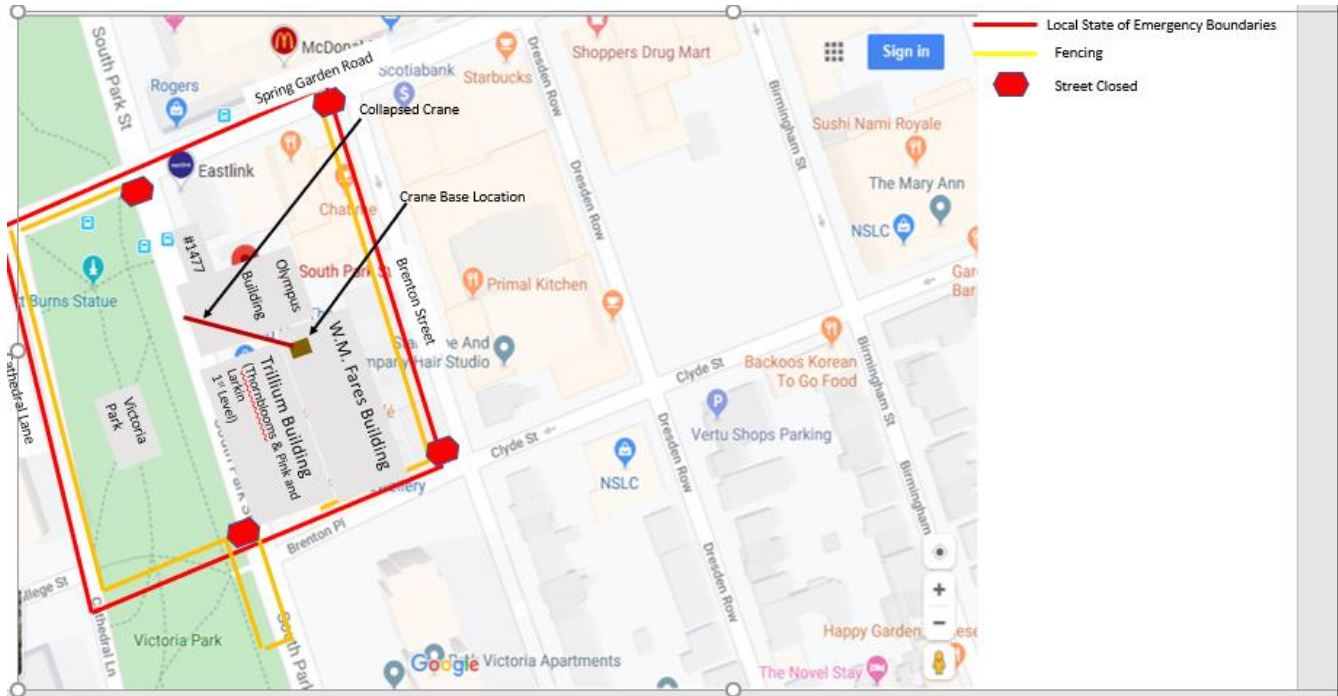
Figure 2: Crane collapse location

During the storm on September 7, 2019, at approximately 4:00 PM, the tower crane collapsed toward the north-west and struck the top corner and a balcony deck on the northeast corner of The Trillium Building located at 1445 South Park Street, causing damage to that building (Figure 2). The crane came to rest on the Olympus Building, an adjacent 13 storey building under construction in the 1400 block of South Park Street. The top three levels of the Olympus Building were significantly damaged. Counterweights from the tower crane fell to the ground, landing on the east side of South Park Street, causing significant damage to the sidewalk and street. This resulted in several businesses and residents being evacuated from the area under an order issued by Halifax Regional Fire and Emergency Services. Those evacuated returned only after it was determined safe to do so.

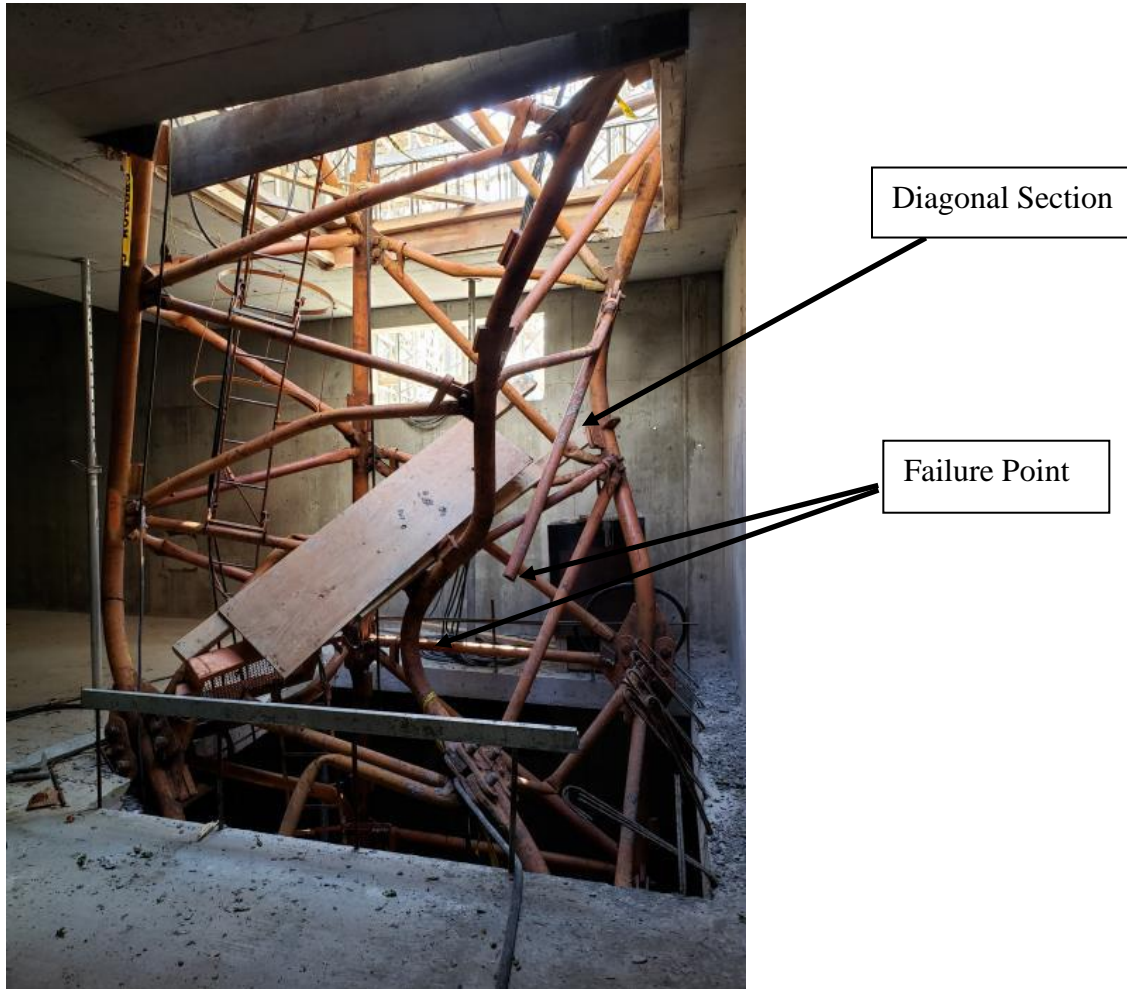
A possible failure point was initially identified in a lower mast section at the northwest corner of the crane tower (later referred to as Section 2) where a hollow diagonal tube had become separated from a solid vertical post at a point where it had previously been welded together (Photo 2).

Photo 2: Crane section after collapse. Highlighting the diagonal section and failure point. Credit: NS Department of Labour and Advanced Education

On August 7, 2020, the metallurgical testing report for the diagonal section, node and weld was received, indicating there was a lack fusion, corrosion, pores, and a crack, which propagated from the inside diameter to the outside diameter of the area of the weld. The report also mentioned other welding defects on other welded connections.

1. The Department of Labour and Advanced Education will meet with tower crane owners and operators to review the findings of this investigation and require structurally critical welds in the masts and booms of all tower cranes in Nova Scotia immediately undergo a thorough cleaning for visual inspection of welds, non-destructive testing on any welds as found to be necessary, and any deficiencies repaired by a person as specified in the regulations or standards.

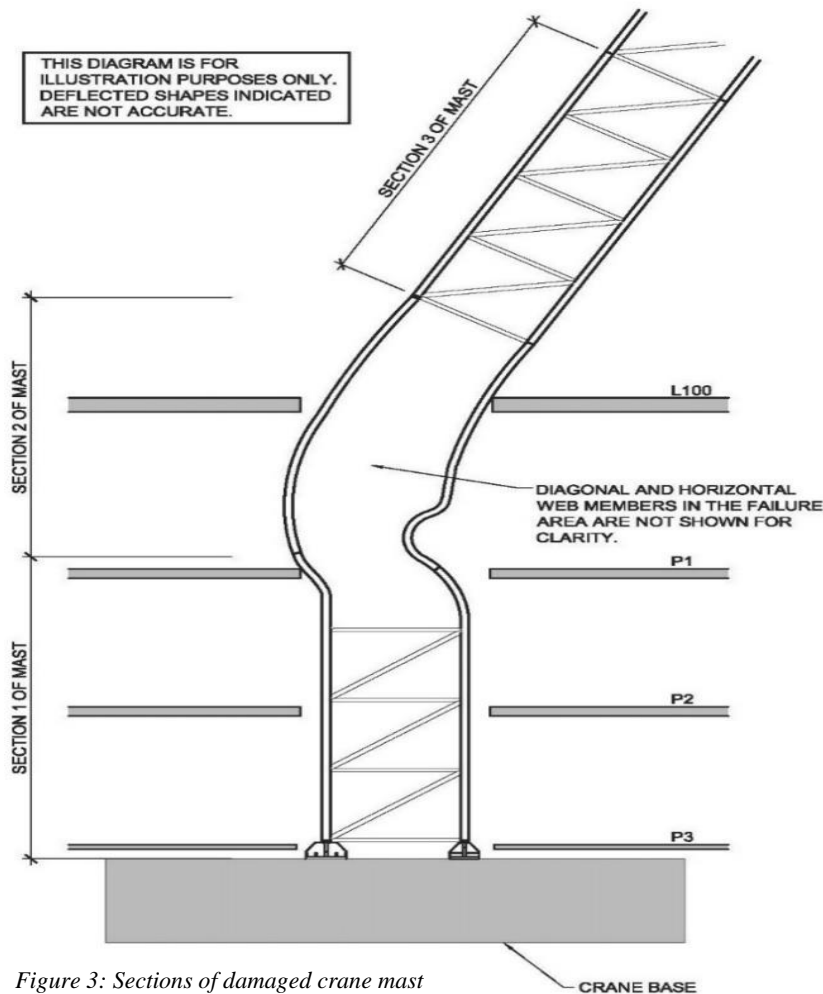
Figure 3: Sections of damaged crane mast
 Credit: BMR Structural Engineering for NS
 Department of Labour and Advanced Education

- The engineer's report concluded that the crane collapse was the result of the failure in the second section of the mast approximately 6 to 9 meters above the base (initially identified by inspectors in Figure 3).

The investigation by the LAE Safety Branch determined that the tower crane collapsed during the high winds of Post Tropical Storm Dorian on September 7, 2019, as a result of the failure of a weld where a diagonal tube had been connected to a vertical member of the crane mast between 6 and 9 meters from the base. The weld failure caused the diagonal tube to separate from the vertical member of the mast, transferring the weight supported by the mast's 4 vertical posts to only 3 of its posts, causing the tower section to rotate and fail, which resulted in the total collapse of the crane.
