Factors Affecting Coastal Armour Stability along the Amherst Shore, Northern Nova Scotia

P. W. Finck

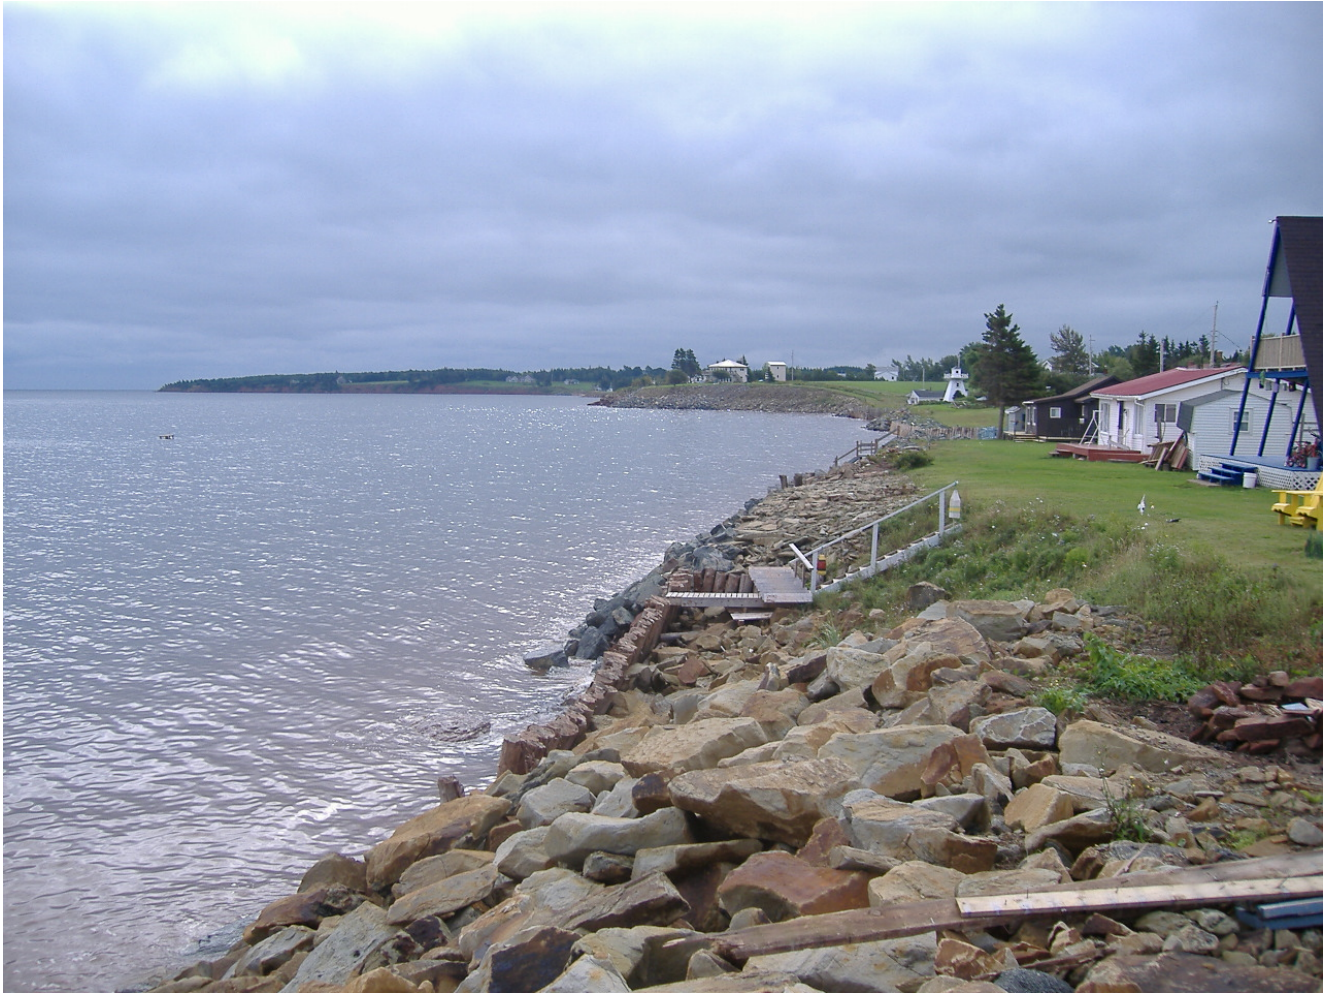
Figure 2. Extensive armouring along the coastline.

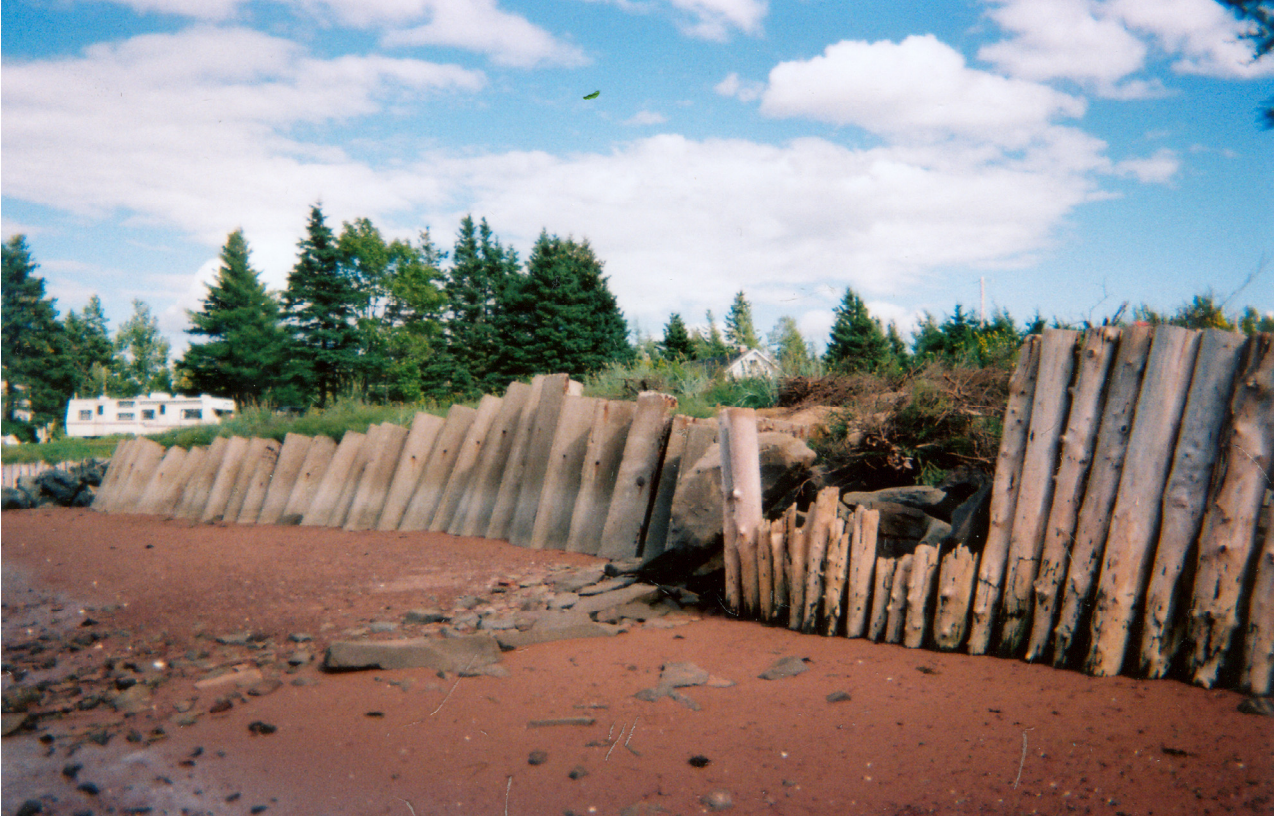
Figure 3. Retaining wall constructed from concrete 'L shaped' forms located west of the Ship Rail Provincial Park.

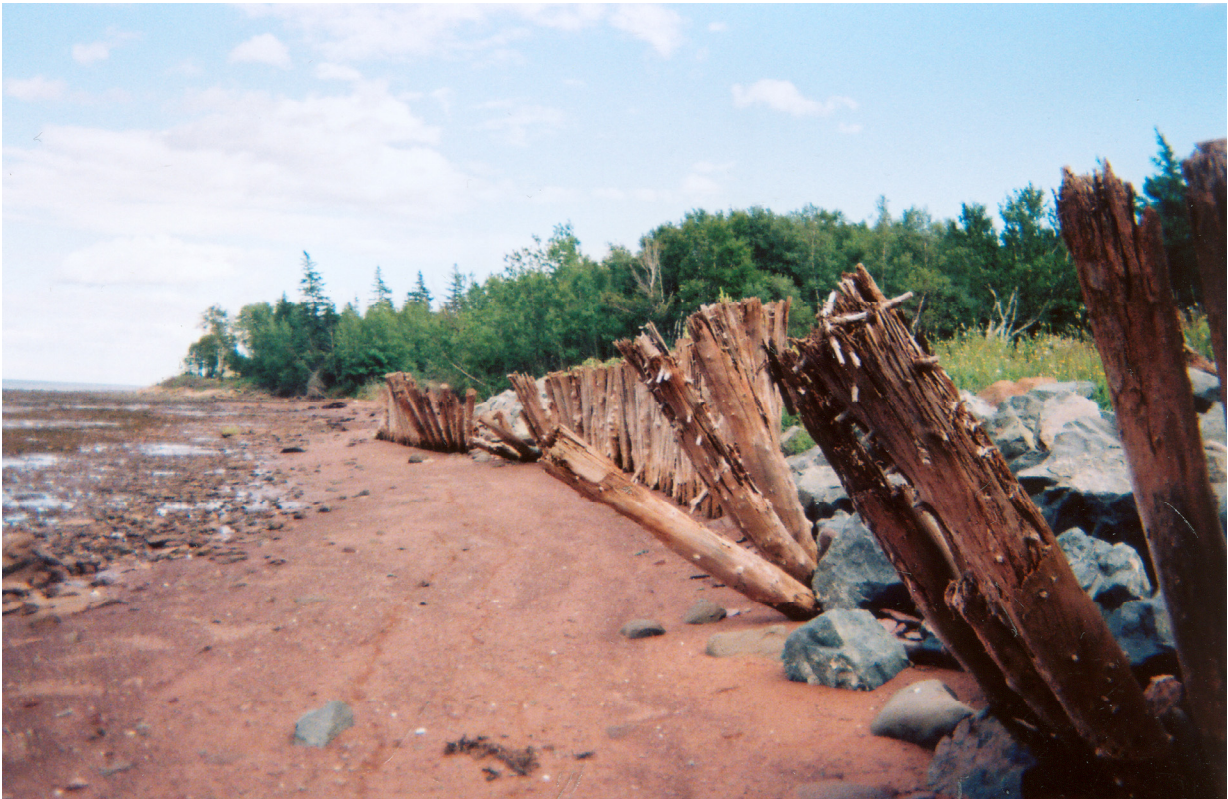
Figure 6. View of a failed wood retaining wall later partially backfilled with armour stone. Note the lack of horizontal bracing.

Wood retaining walls in the study area exist in various states of decay. The newest wall was roughly 3 years old, but there are 10 to 20 year old walls that appear to have had stone replaced between the bank and the wall, and 20 or more year old walls that have failed and been breached by tide and waves (Fig. 6). In general the wood walls are remarkably resilient and durable. Obvious causes of failure are rot and rusting of spikes and bolts. In general the posts seem to have been driven deep enough into the substrate to prevent tipping and wash out by vertical lift. As shown in Figure 6, however, the wood walls tip both toward and away from the bank. Note that when they are completely decoupled from the bank they still do not lift and float away. This suggests that a major source of failure is washout behind the walls and horizontal failure due to inadequate bracing and inadequate backfilling. Once a log is broken or otherwise breached, unless the stone backfill at the inner wall face is larger than the opening between the logs, waves will quickly eat away the stone (or soil) behind the wall. In addition, waves may flank the wall at either end. When waves pile up against the shore face the water will take a path of least resistance, this being in part a flow parallel to the shore. Thus, a channel or opening behind the wall will act much like a sluiceway and quickly erode the sediment behind the wall. Failure of wood walls is prevented by reducing or eliminating penetration of sea water behind the wall. Adequate horizontal bracing, properly sized backfill, and adequate end protection to prevent flanking are necessary to optimize the service life of the wall. In addition, construction of small platforms across the horizontal bracing with associated overlying rock ballast would provide increased horizontal and vertical stability. It would also limit flow of water behind the wall in the case of erosional flanking by sea water.

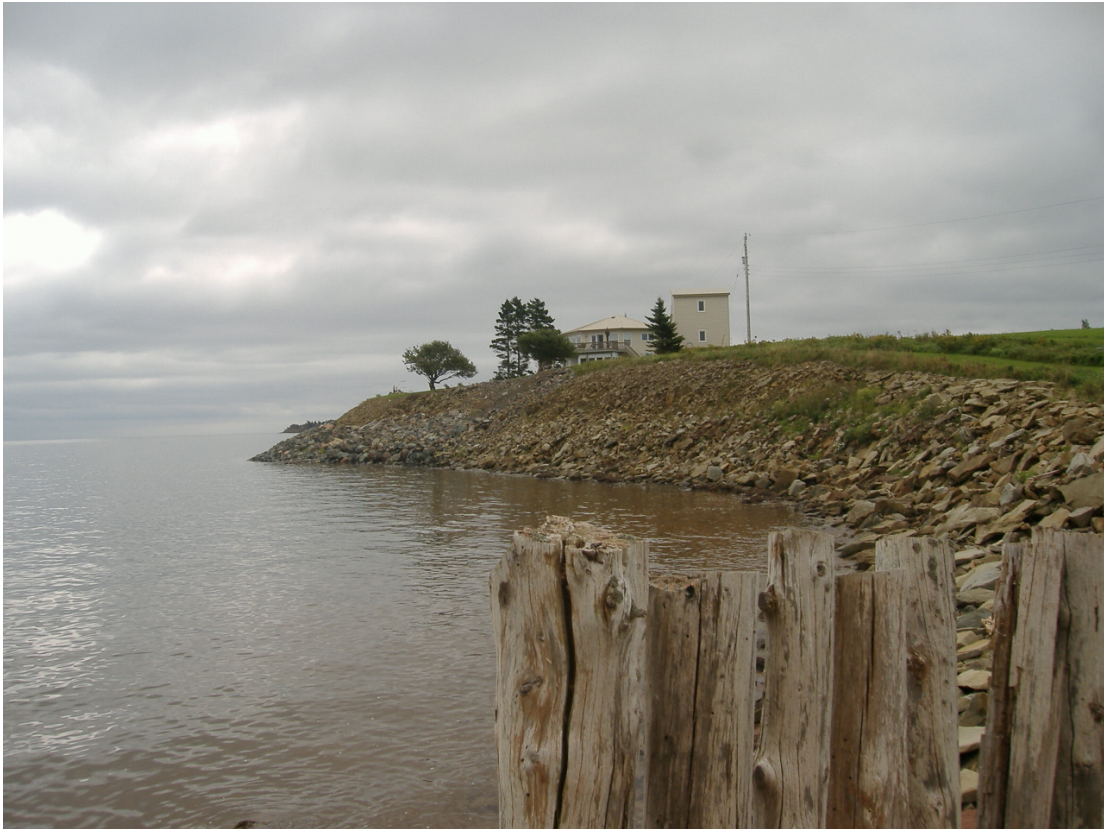
(1) Truck loads of heterogeneously sized stone are dumped over and down the shore face with the overall result being a veneer of stone covering the slope (Fig. 7).

Figure 7. Retaining wall constructed by simply dumping stone over the bank.

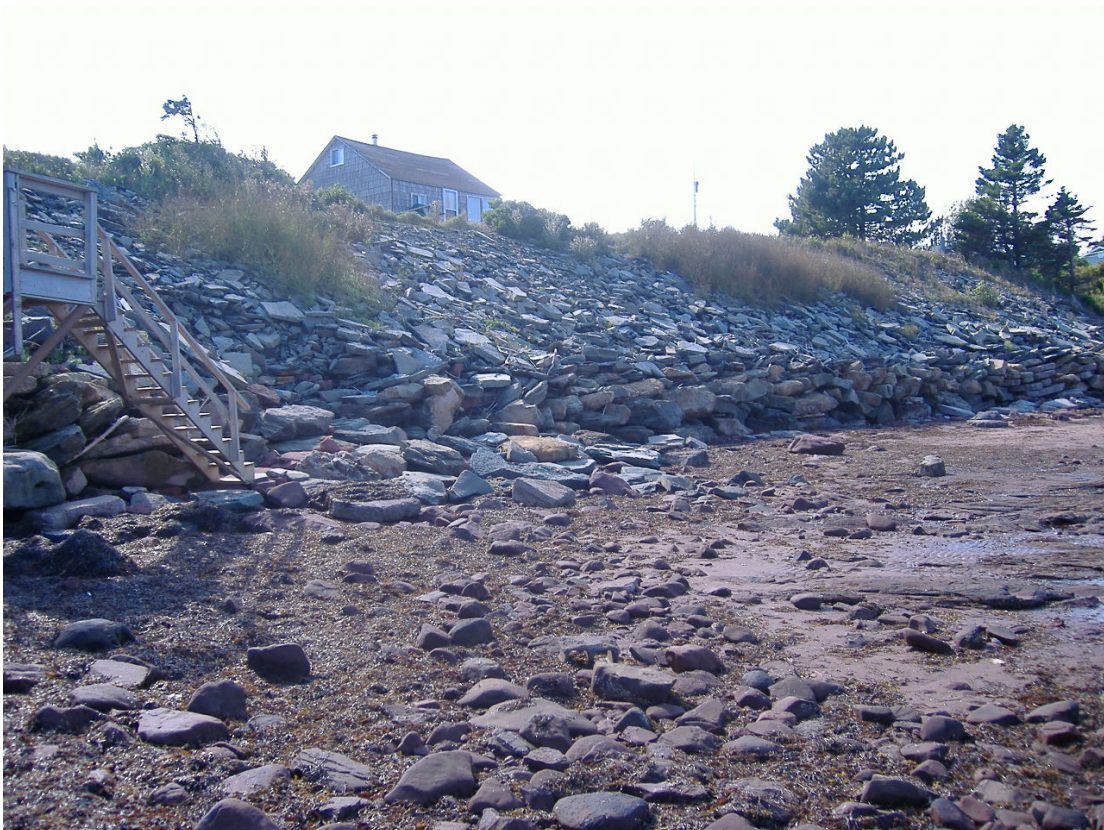
(2) A row of large boulders is placed on top of, or dug down into the top of the beach. A landward-sloping layer of variously sized rock and boulders is dumped down the cliff face with some moving and placing of stone. Varying amounts of infilling between the lower stone and the unconsolidated bank was observed (Fig. 8).

Figure 8. Retaining wall illustrating stone placement at base with dumping of stone along upper bank.

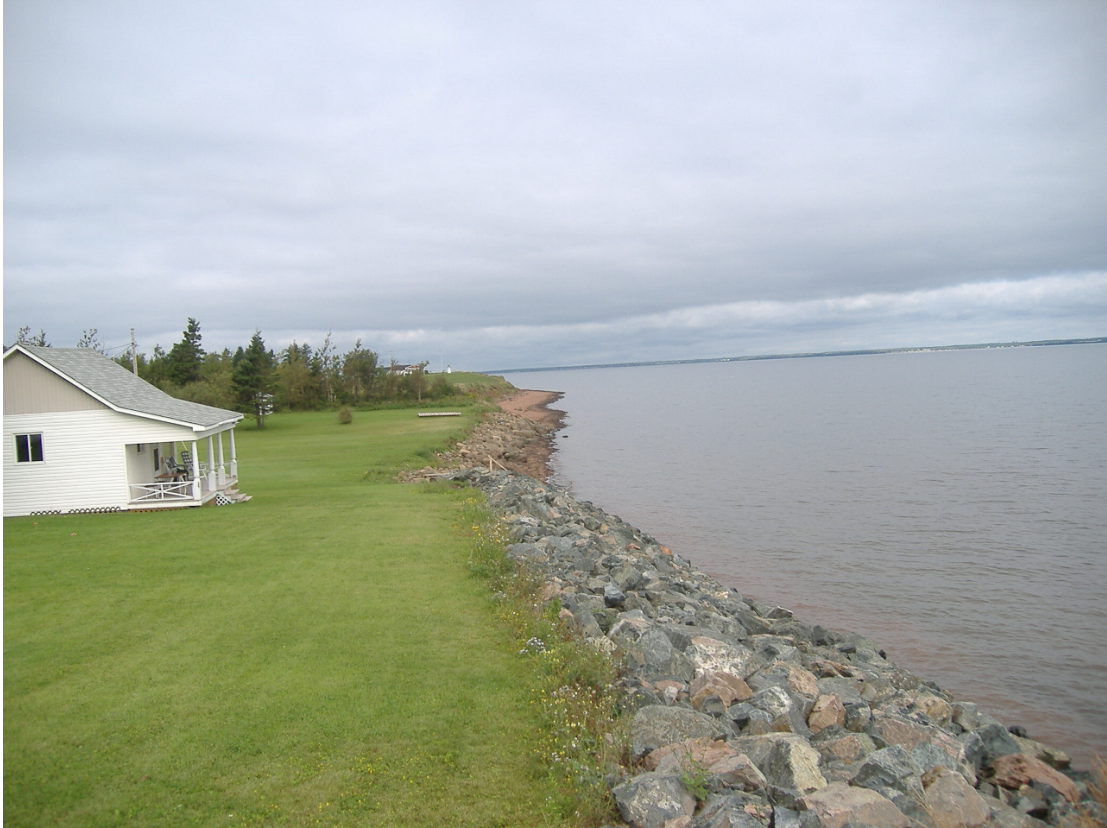
(3) A wall of variously sized boulders, typically large stone at the base, is placed on or dug down into the top of the beach to cover the shore face to the top of the slope. This type of wall tends to be more than one boulder thick at the base and is typically backfilled with stone of varying sizes between the lower stone and the unconsolidated bank (Fig. 9).

Figure 9. A retaining wall with reasonably placed armour stone.

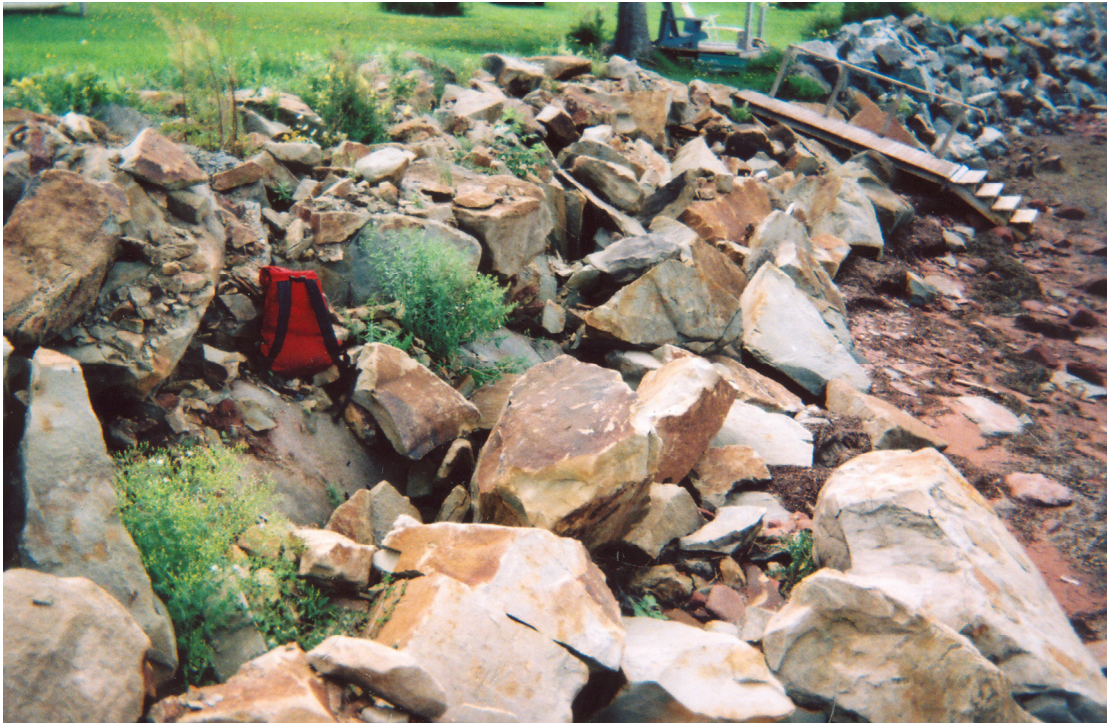
Figure 10. Collapsed retaining wall showing fragmented boulders, substandard sandstone armour stone, improper placement of stone on an eroding till substrate, failure to anchor the toe of the wall below the actively eroding shoreface, and improper use of geotextile.

several smaller rocks that will collapse and wash away (Fig. 10).

The author questions the value of the use of geotextile in these applications, or more specifically the inappropriate use of the material. Figure 10 illustrates the use of geotextile in a retaining wall where: (1) the stone is disintegrating because of poor quality, (2) the stone is poorly placed, (3) stone size is highly variable, (4) width of the stone wall at the base is insufficient to support the overlying material, (5) the stone is placed directly on till, (6) the toe of the wall is not dug down or anchored in the till, and (7) there is no backfill between the geotextile and the large stone. This retaining wall represents almost a complete list of 'what not to do' in constructing a retaining wall.

The geotextile in the above example is ripping because when it isn't supported it lacks sufficient strength to support the bank material. In addition, it

is being cut by the large sharp boulders. Geotextile should only be used between the bank material and a properly placed wall where stone fill is of sufficient quantity and grain size to properly support the geotextile. In this case the question arises as to the necessity of the geotextile. If proper backfill is used it should be coarse toward the front and finer toward the bank face. The face of the wall and the backfill should absorb and reflect sufficient wave energy so that virtually no energy reaches the bank - fill interface. At this interface properly sized backfill should be sufficient to prevent washout of the bank through the retaining wall by either surface runoff, groundwater or saltwater egress. In addition, the bank material will penetrate the stone fill to a degree producing a strong interface. The presence of a geotextile at this interface, however, will prevent the washout of bank sediment (if it doesn't fail due to other factors) but of concern is its potential to present a plane of weakness or slip face along which slumping and wall failure can occur.

The metamorphic/volcanic armour stone is hard, competent even after blasting, and will not weather. Despite additional transportation costs, this stone should be used for all large armour stone and at the very minimum used for any stone exposed in the face of the retaining walls. Green massive sandstone may be arguably used as backfill, though the author does not recommend this practice.

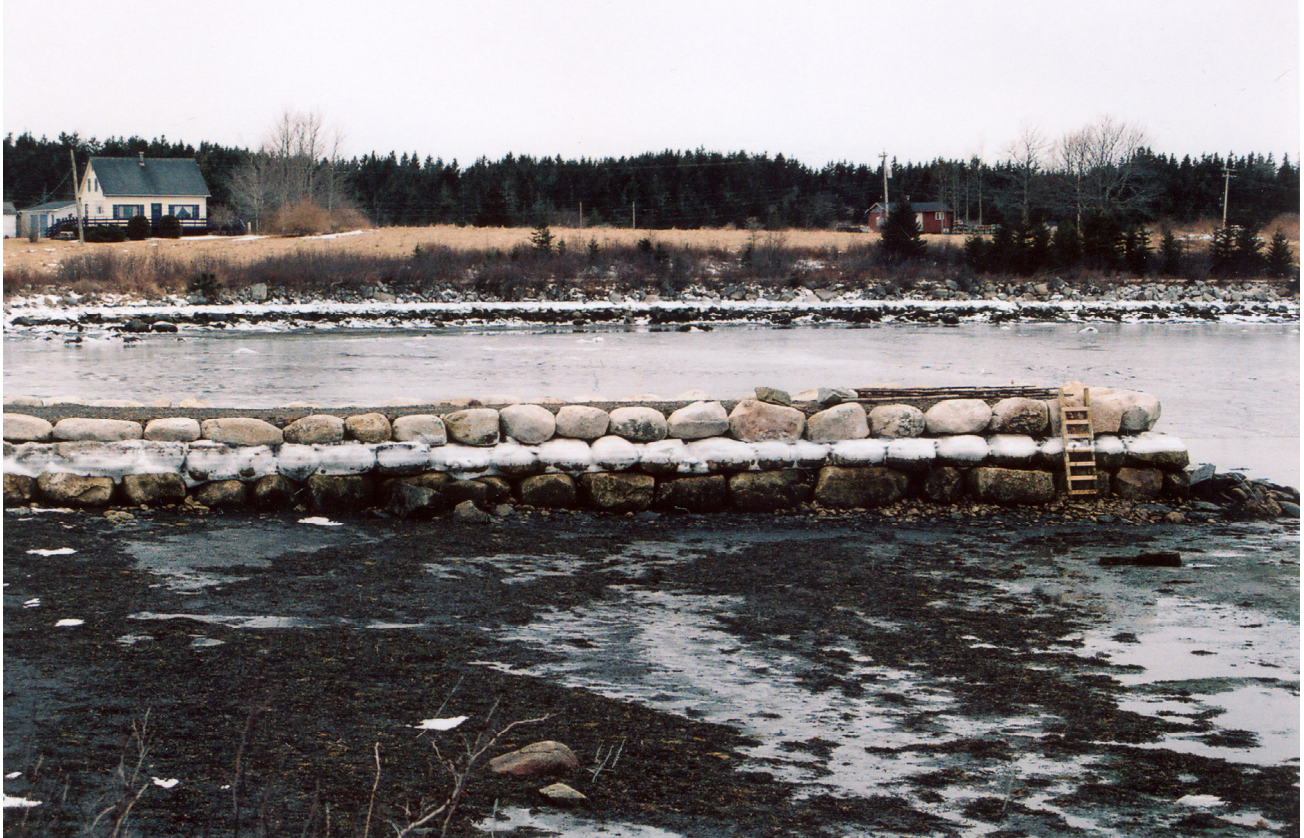
The rule is to use the largest boulders at the base and they may decrease in size as wall height exceeds the height of effective wave action. A mix of large and small boulders on the face should be avoided unless the small stones are securely anchored and cannot be washed out leaving holes in the face of the wall where water can enter and erode the fill behind the face. Boulder rows should be staggered so that they interlock. Boulders stacked one on top of another will shift dramatically in response to any loss of stone. A properly placed retaining wall constructed of oval shaped rocks can be very stable (Fig. 15). It will be more stable than a wall containing poorly placed and undersized angular stone.

Figure 15. A well constructed and durable stone pier built using oval shaped granite boulders, Blandford, Mahone Bay. Note the row over row staggered placement of stone.
