An Assessment of Coastal Erosion at the Malagawatch Graveyard Archeological Site

P. W. Finck

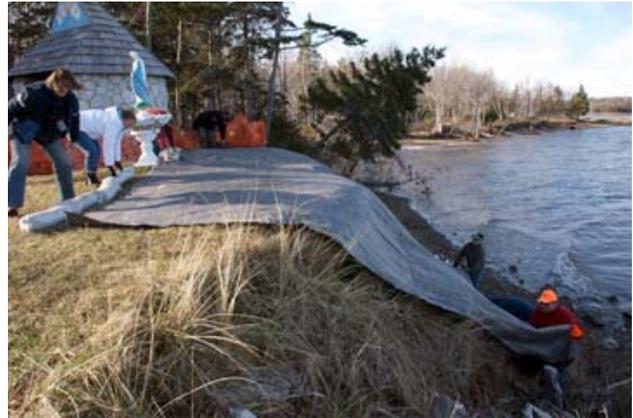
It is the role of the division to provide independent expertise to other government departments with respect to coastal processes and how they will affect social and economic development in the province. On September 24, 2009, the Geological Services Division received a request from Harold Carroll (DNR's Director of Parks and Recreation) for any insights on the surficial and the subsurface geology in the area of a Mi'kmaq burial site at Malagawatch, Cape Breton Island. The area is subject to shore-face erosion that is compromising the integrity of the burial site (Fig. 1).

Figure 1. Mi'kmaq burial site at Malagawatch, Inverness County.

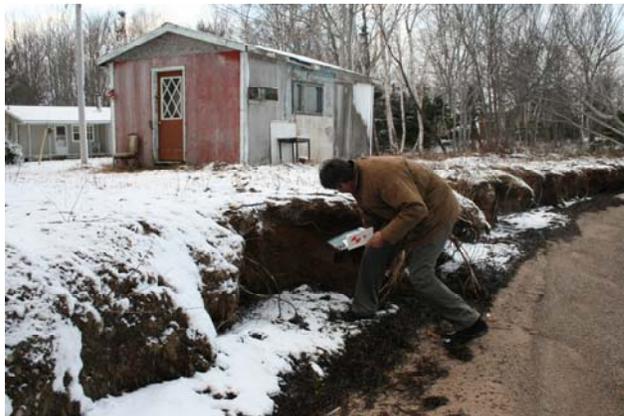
The elevation of the north end of the island graveyard site on the east-northeast facing side is very low, only in the order of 1 m – 1.2 m above the common high tide line. Erosion is occurring above the high tide level by bank undercutting and collapse of the overlying sod (Fig. 2).

Figure 2. This low bank is being eroded by undercutting.

the beginning of the main spit is also eroding (Fig. 2). This area may be of less concern to the various aboriginal communities. Regardless, it is strongly recommended that this section of shoreline also be stabilized to prevent flanking erosion of the graveyard site. In addition, it is recommended that the coastal armouring should attempt to replicate the geometric shapes observed along the front of the sand spit (Fig. 6) to ensure maximum stability and to decrease any undesired effects on coastal areas down current of the armouring (i.e. to the north).

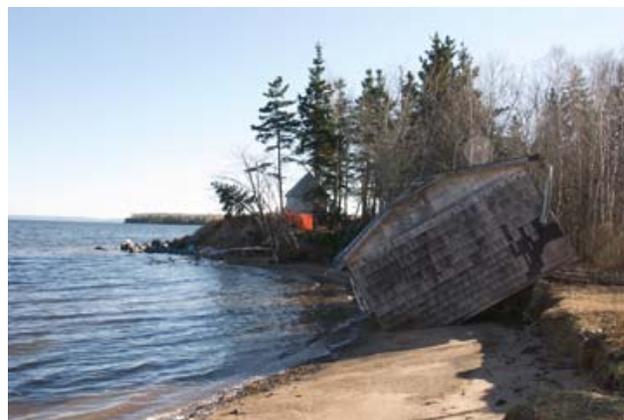
Figure 3. A small bungalow that had to be removed due to undercutting erosion.

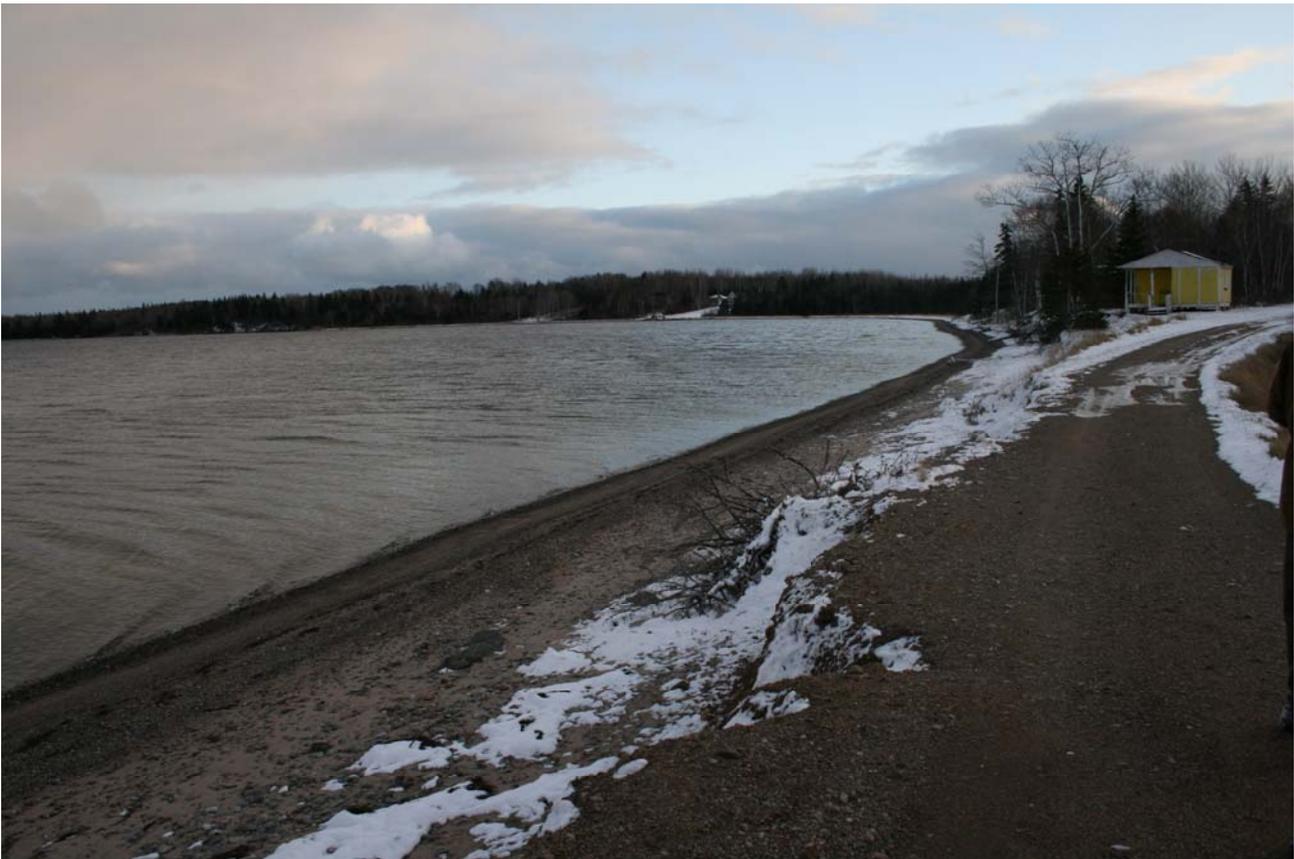
The access road to the island across a former sand bar is clearly subject to continuing erosion. It is worth noting that the general high tide is lower than the base of the gravel road. The road base is also above the present eel grass strand line on the beach (Fig. 4).

Figure 4. Access road to the island; view to the south.

Similar but smaller scale armouring along the road and northern part of the island is also required. The road could be moved landward (westward on the existing bar) using existing material. This should reduce wave attack but is not a long-term solution. In addition, some armouring would still be required. This is a cost/benefit question, given that protection would still be required. This option is not recommended as it has the potential to create unnecessary sediment runoff. This is particularly the case as there is no information about the composition of the road material at depth.

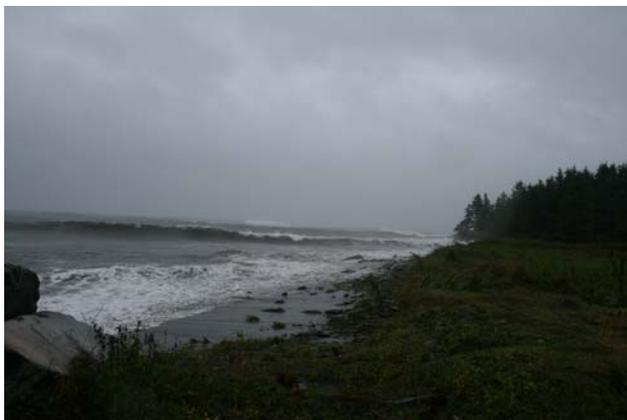
storm surges and tidal ranges are much higher. This location also lacks exposure to deep water swells typical of exposed Atlantic shorelines (Fig. 5). Ice build-up and ice jamming were identified as potential problems when armouring a shoreline (Baird and Associates, 2009). This is correct and should not be discounted. It should be noted, however, that ice hasn't dislocated boulders in the remaining portion of the armour stone that was dumped over the cliff during the 1970s (Johnson and Denny, personal communication, 2009). Ice also doesn't appear to have affected the northern end of the island. In summary, it appears that ice, wind, wave, tide and surge hazards are much less severe than would be the case if this site was located on an ocean coastline.

Figure 5. Plunging breakers approach the front, sheltered side of East Ironbound Island, Lunenburg County, during Hurricane Bill.

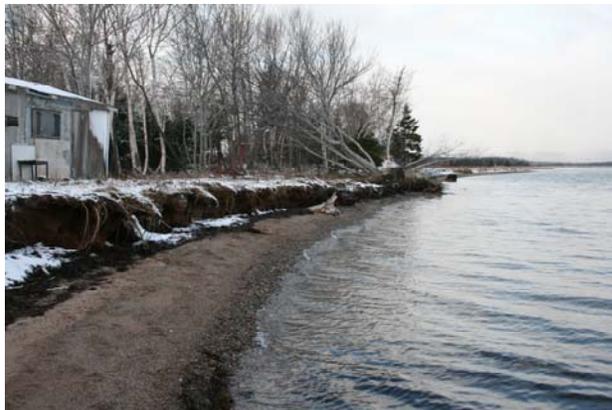
The east side of the spit forms a series of concave shore segments that are considered to reflect a state of maximum geomorphological stability under the present conditions in the area.

Figure 6. Note the repeating concave shape of the shoreline at Malagawatch.

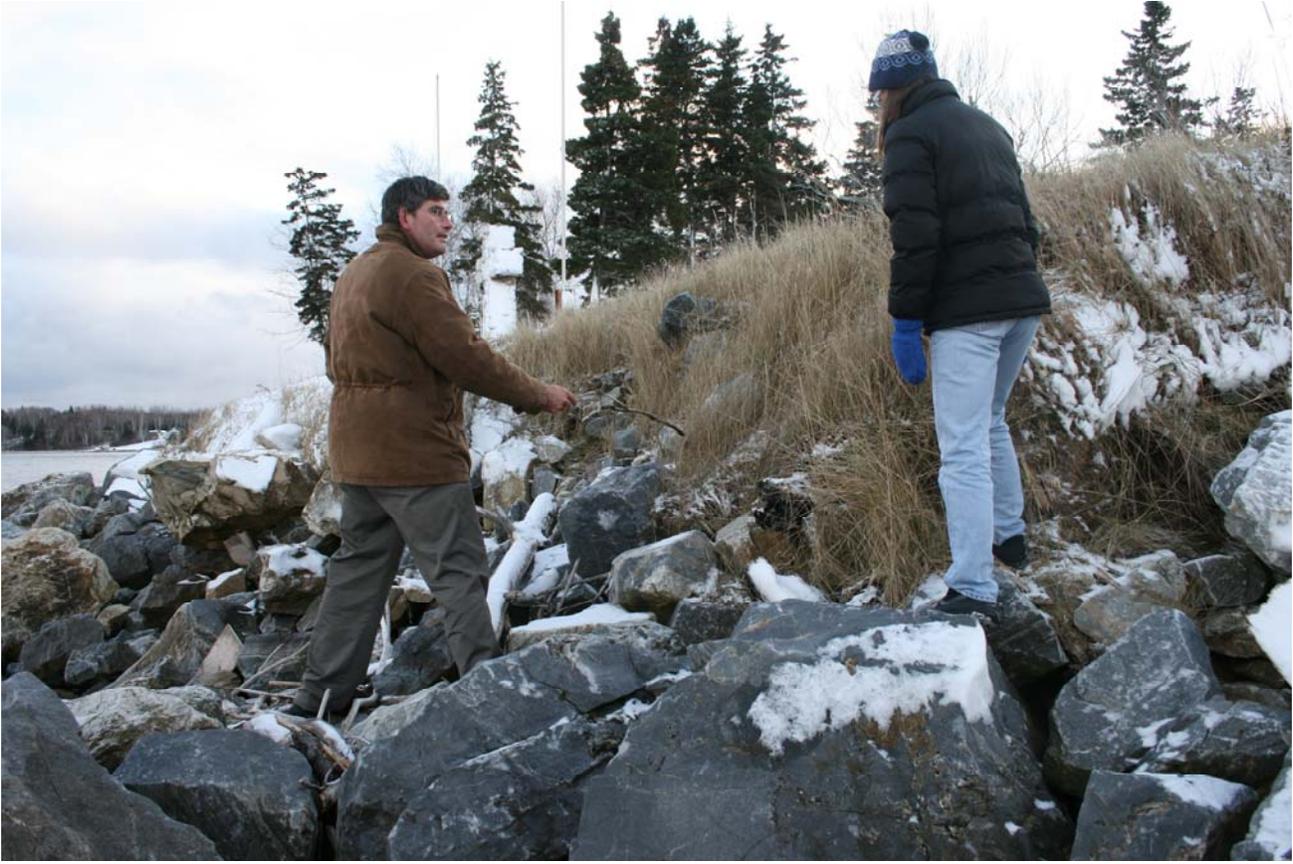
A significant section of the previously placed armour stone is still standing and appears to have been highly effective in preventing any further erosion of the grave yard site behind the armour for 30 – 35 years. Johnson and Denny (personal communication, 2009) were not aware of any maintenance to this original armouring. This is important to consider as it has survived beyond the 25-year design life for the structure described in the Baird and Associates (2009) report. The present elevation of this armour has also been sufficient to prevent erosion overtopping. Near the top of the armour stone, driftwood was observed (Fig. 7). In addition, at the south end of the armour the landward extent and height of beach gravel is easily observed (Fig. 8). It is clear that the elevation of the gravel is well below the height of the existing armouring.

Figure 7. Armour stone is still successfully protecting the site after more than 30 years. Note the lack of overtopping or erosion above the armour stone.

It is recommend that minor ‘touch ups’ to the existing armour be done to ensure long-term stability. Given the vertical nature of the failed shore face at either end of the present armouring at the grave yard site, it is recommended that the armour be stepped out from the face toward the

former armour location. This will allow for filling with clean material and the associated sloping and vegetation as described in Baird and Associates (2009).

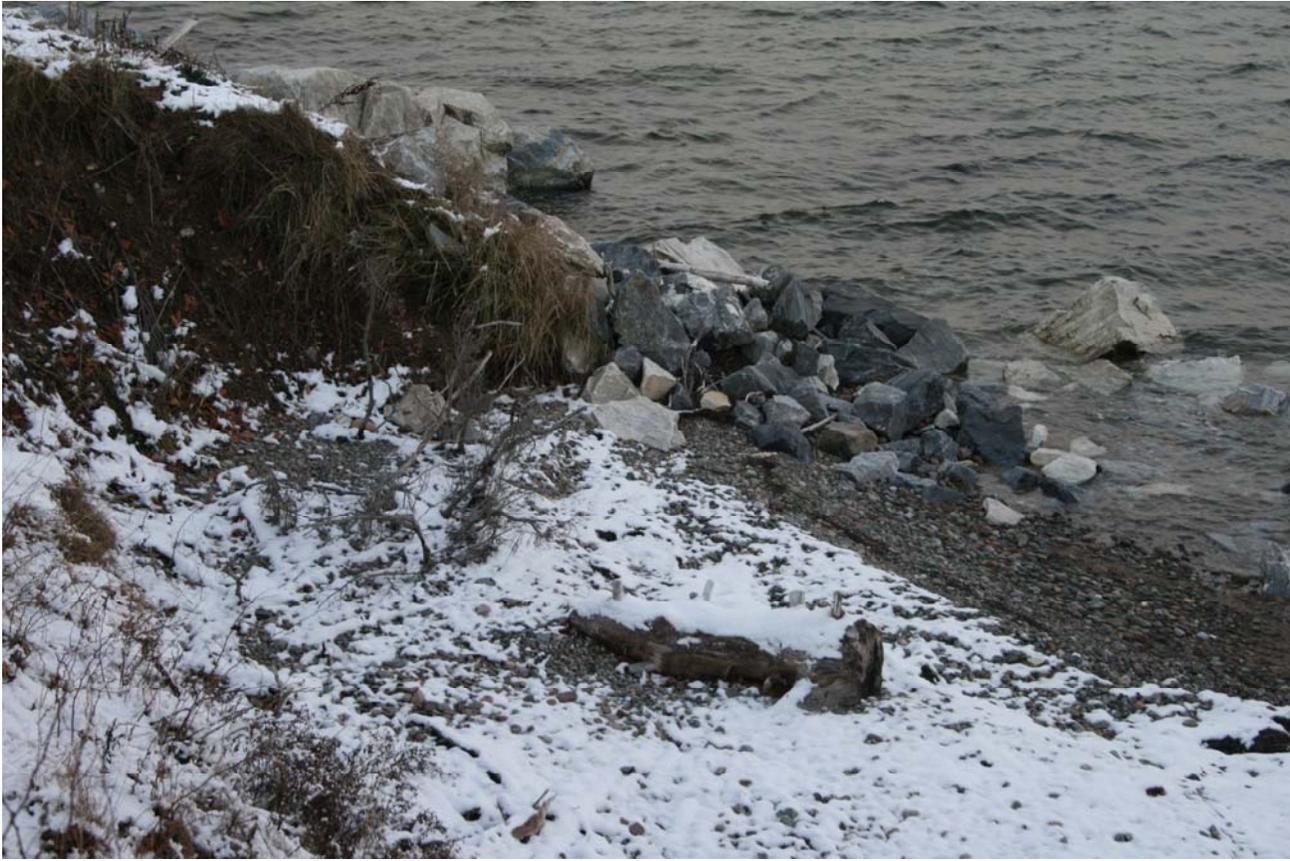
Figure 8. Gravel strandline against the eroding cliff face on the south side of the remaining armour stone.

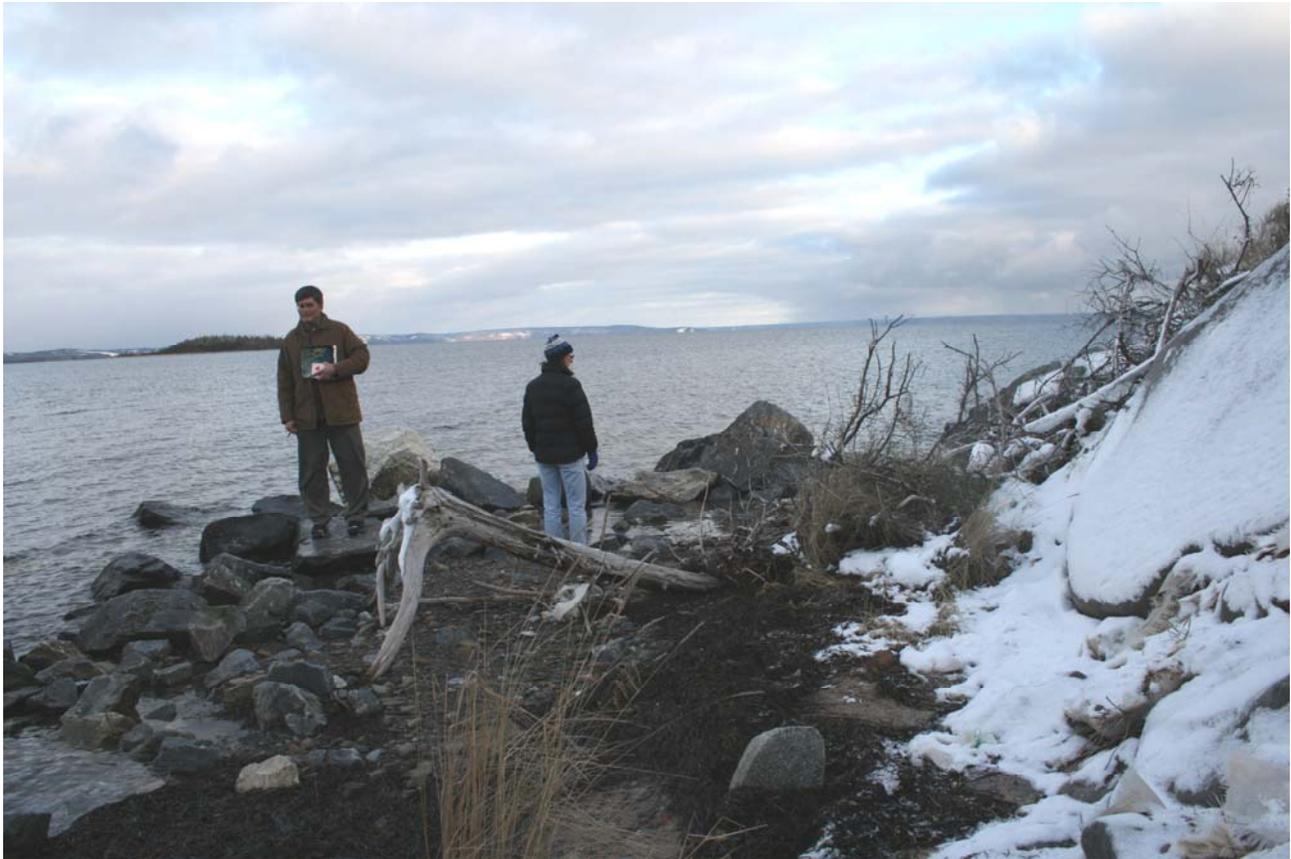
Denny, personal communication, 2009). The presence and distribution of larger boulders at the base of the failed sections is suspect. It should be noted that there are only a small number of boulders in the failed armour observed on the beach (Fig. 9). It is suspected that this is why the northern end of the armouring failed.

Figure 9. Remnants of failed armour stone. Note the lack of large boulders required for stability.

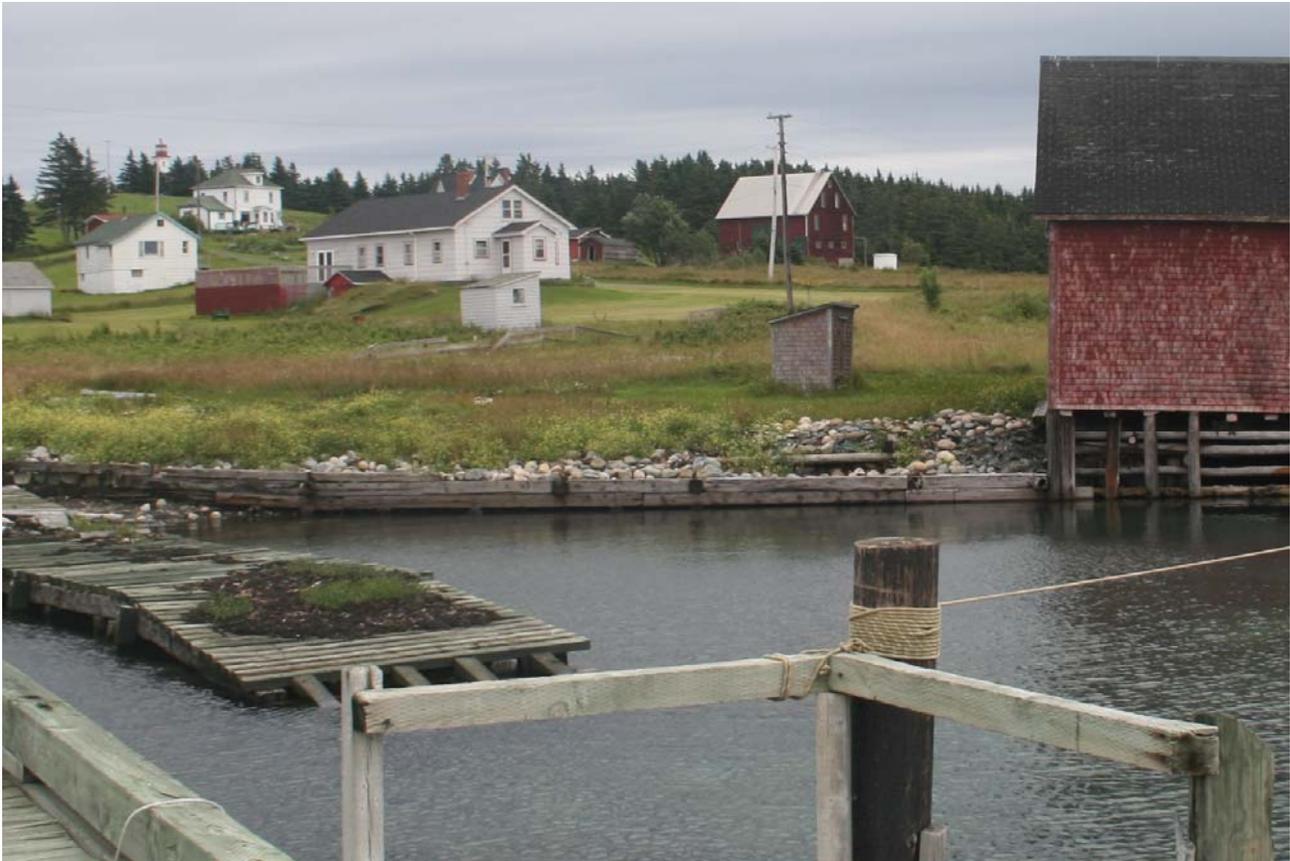
The crib in Figure 10 is over 40 years old and has withstood heavy drift ice and numerous hurricanes.

There has been little or no maintenance, yet it exceeded the 25-year design life of the large scale armouring suggested by Baird and Associates (2009). Cribbing does not need to be solid as long as the fronting rocks are larger than any gaps between the cribbing.

Figure 10. A horizontal rock-filled crib (centre left, extending to the corner of the red building on the right) located on East Ironbound Island.

Protecting the access road and the low area of exposed shore face north of the main graveyard site shouldn't be difficult or necessarily costly. Given budget concerns, the author enquired whether or not the local native communities have volunteers who have the expertise and experience necessary to safely undertake all or part of the required work. It appears that the band has access to logging trucks with associated boom capability. In mapping coastlines in various areas of the province, it is observed that many forms of shore-face stabilization are used. One such method (Fig. 10) uses large logs or beams to build low cribs filled with stone along the shore.

These cribs, if properly constructed, can be highly effective in preventing shore-face erosion and may also be resistant to ice impact. Such structures may be built of marine-grade treated wood or a combination of treated and native trees (e.g. one lift of treated wood at the base). As a biologist, Shelley Denny is able to identify the most appropriate native species available having the greatest natural resistance to rot. Worm attack is not an issue as the crib would be above high tide. It is recommend, for at least the low shoreline and road, that the Unama'ki Institute of Natural Resources investigate the possibility of using qualified volunteers as a low cost alternative to undertake and/or supervise crib construction.
