# Coastal Hazard Assessment Along the Blue Beach Fossil Cliffs, Kings County

*P. W. Finck and D. J. Utting*

## Background and Scope of Report

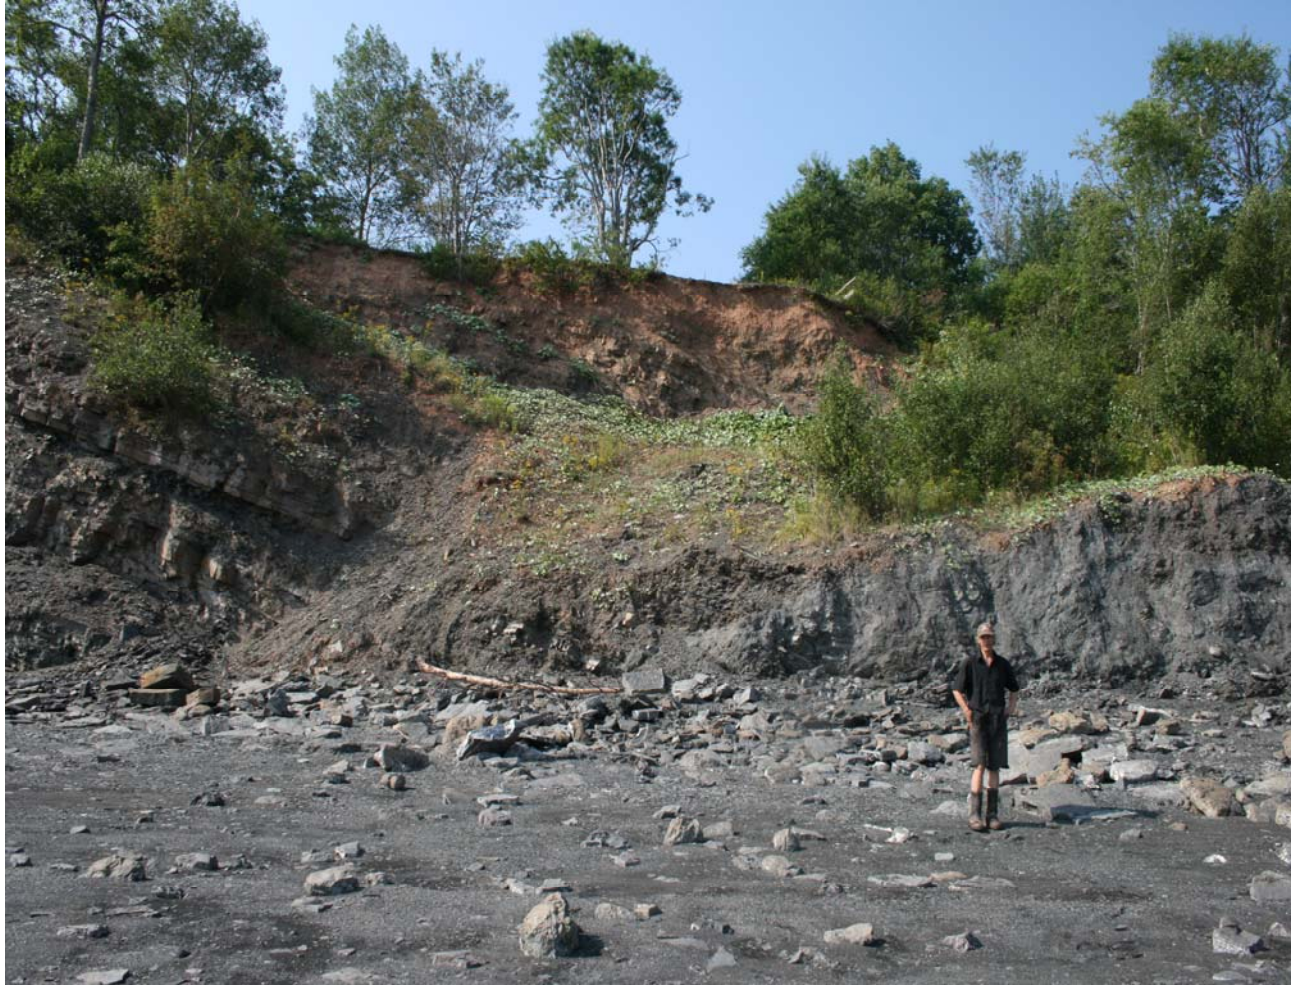
At Blue Beach the interface between the slump and non-slumped material is visible approximately 75 m north of Site 3 (Fig. 2). The slumping involved not just the stony till, but also the underlying bedrock (Fig. 3, top). At the base of the slump, siltstone bedrock is highly deformed, with the appearance of a silt-clay mass where internal structure is almost completely destroyed. It is likely that the triggering mechanism for this slump was failure of the incompetent siltstone between the more competent sandstone beds.

Rotational slumps along the shoreface likely fail along main internal plains of weakness in the bedrock, or at the overburden - weakened rock interface, producing a main scarp (Fig. 4), and in some areas multiple secondary slumps internal to the main rotational slump. The result is a series of systematic ridges, tilted landward and decreasing in elevation toward the shoreface. At Blue Beach observed slumps are in excess of 10 m in width, though significant amounts of material were previously eroded and washed away. Thus 10 m is

**Figure 3.** Rotational slump involving till and bedrock located 75 m north of Site 3, Figure 2.

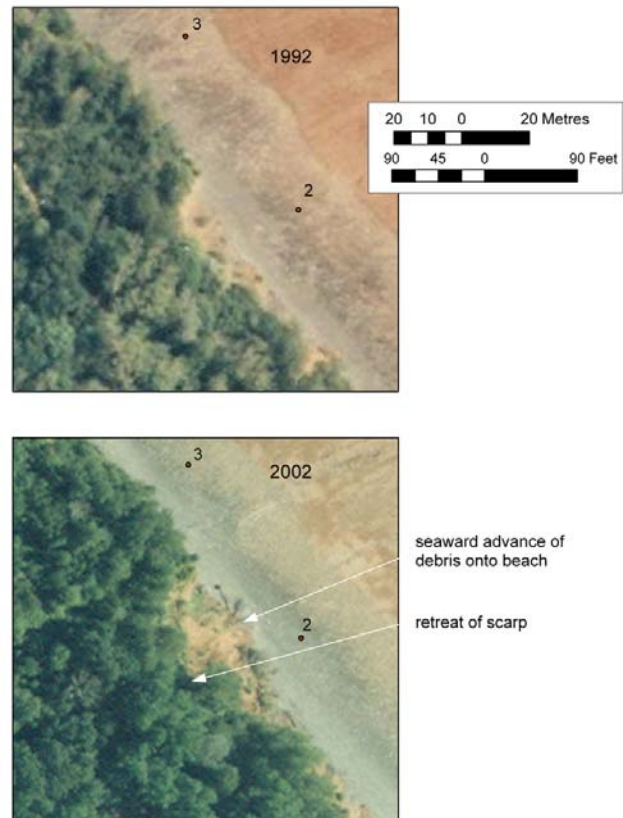
**Figure 5 (above).** Location is at Site 2 on Figure 2. A comparison of aerial photographs from 1992 and 2002 at a scale of 1: 1000 shows evidence of recent earth flows and slumps.

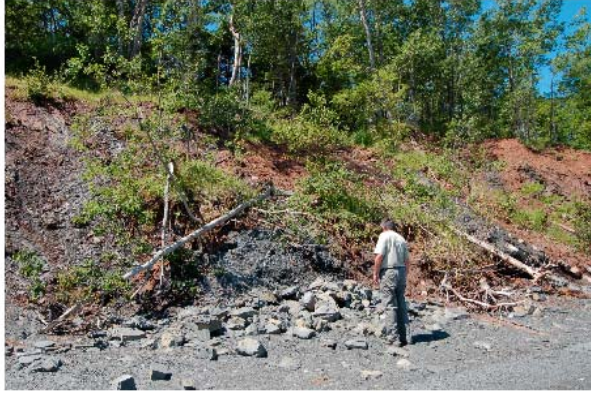
**Figure 6.** Example of a recent earth flow of till and rock fall (foreground) at Site 1, Figure 2.

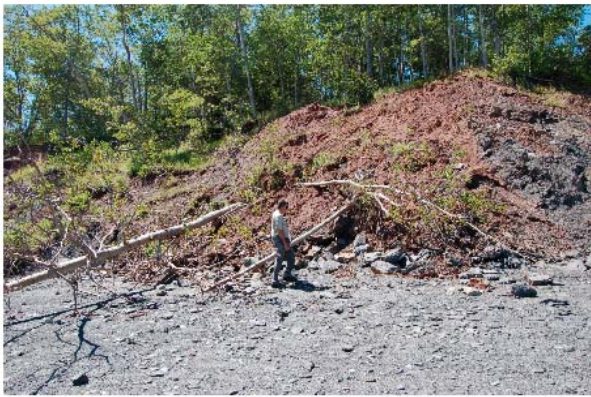
**Figure 7.** Another view of a recent earth flow of till and rock fall (foreground) at Site 1, Figure 2.

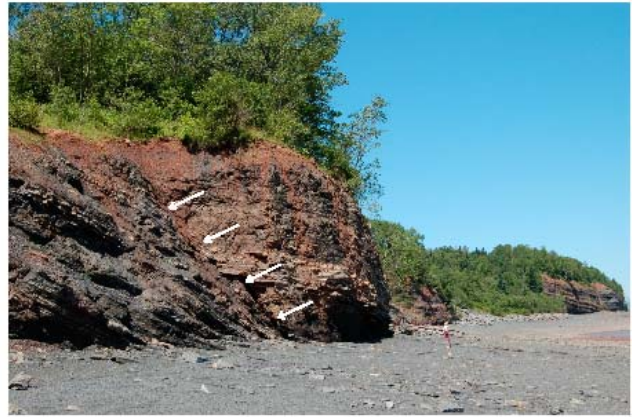
**Figure 8.** Fracturing and faulting in the cliff face contribute to slope instability. Arrows indicate the fault line. Location is at Site 3, Figure 5.

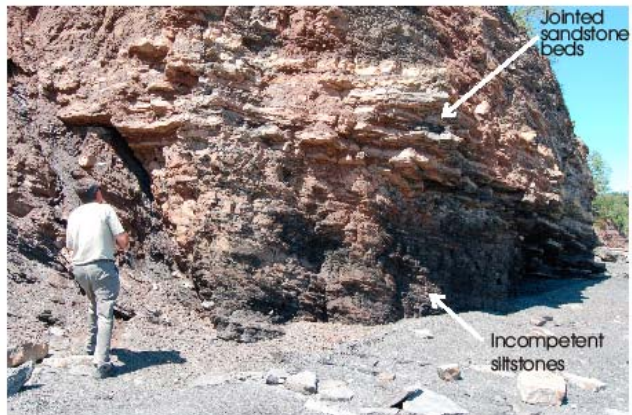
**Figure 9.** Close-up view of the fault in the cliff face shown in Figure 8.

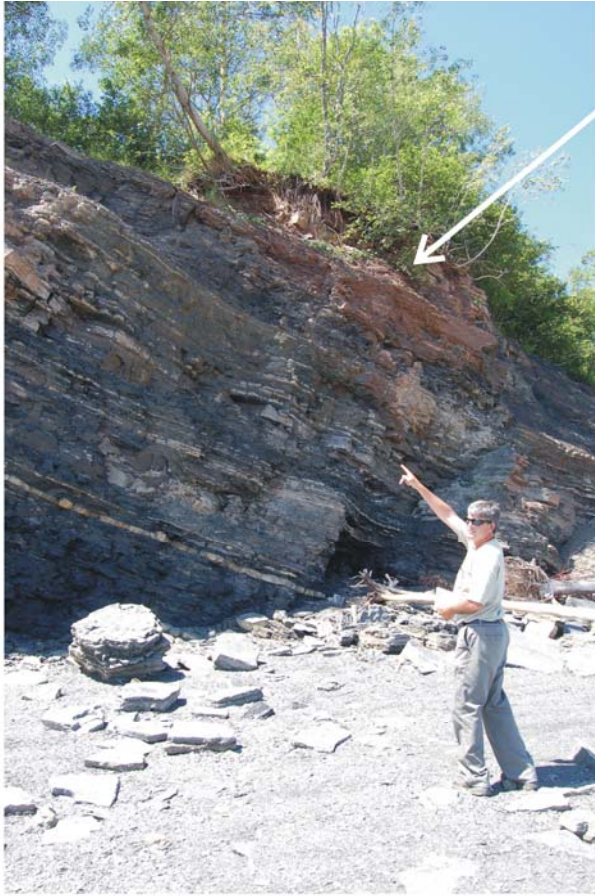
**Figure 10.** A rock block fall and earth flow in the top right of the photograph. Note the trees still standing in the debris sliding over the underlying sandstone bed.

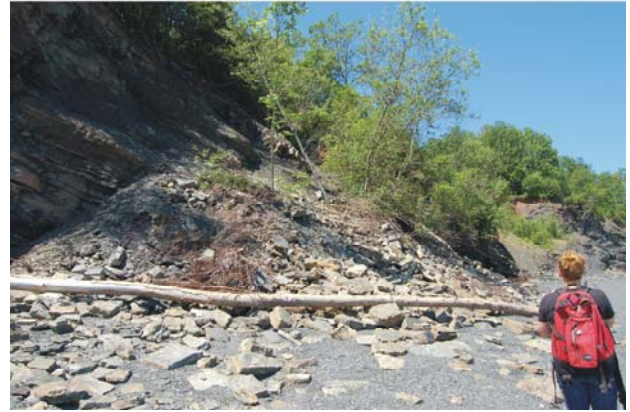
**Figure 11.** Camera panned to the right of Figure 10.. Photograph shows a typical rock fall near the proposed development site.

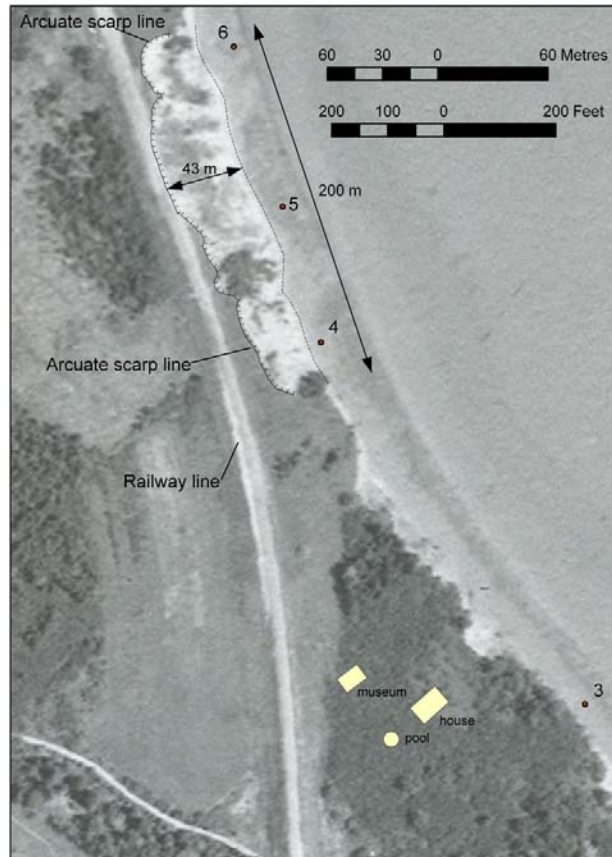
The Rail Line Slide is a large-scale debris slide that impacted the former rail line. It is approximately 200 m long (measured parallel to the shoreline) and approximately 43 m wide, measured perpendicular to the shoreline (Fig. 12).

The Rail Line Slide is clearly visible on 1945 air photographs (Fig. 12), where damage to the rail line can be observed. In addition, it is apparent that both the main part of the slide and its upper edge show little vegetation. This lack of vegetation indicates that the slide occurred, or that major sliding was re-initiated, within the previous 5 to 10 years (1935 – 1940) or less. The slide was stabilized by placement of creosote crib work filled with armour stone at the base of the slide (Figs. 14 and 15), clearly visible on the 1955 image. The age of the Rail Line Slide places it within time frames that must be addressed in hazard or slope stability assessments.

**Figure 12.** Air photograph of the Rail Line Slide. Numbers with dots are site locations with corresponding photographs referred to in this report.

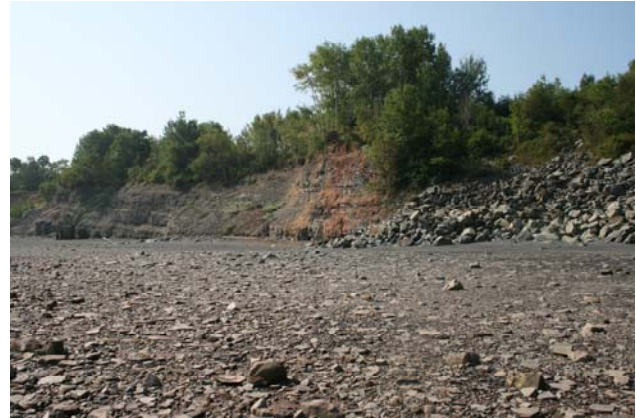
**Figure 13.** Location at Site 4 on Figure 12. Note (a) the near flat-lying beds at the outcrop – armour stone interface and (b) the level nature of the top of the cliff face on the right side of the picture, continuing left to the depression remaining from the Rail Line Slide.

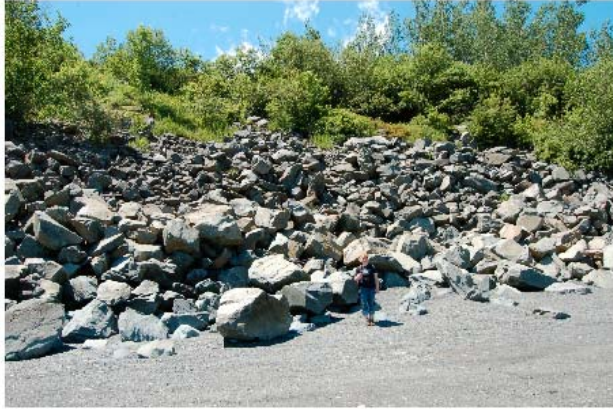
**Figure 14.** Armouring at base of the Rail Line Slide. Photo location is at Site 5 on Figure 12.

A variety of mitigation efforts could reduce the risk of mass movement along the cliff face of the fossil cliffs. The most obvious is armouring at the base of the cliff face, similar to what is observed at the base of the Rail Line Slide. This would require regulatory approval and may have unanticipated effects on either end of the armoured sections, such as increased cliff face erosion. It is also very costly.

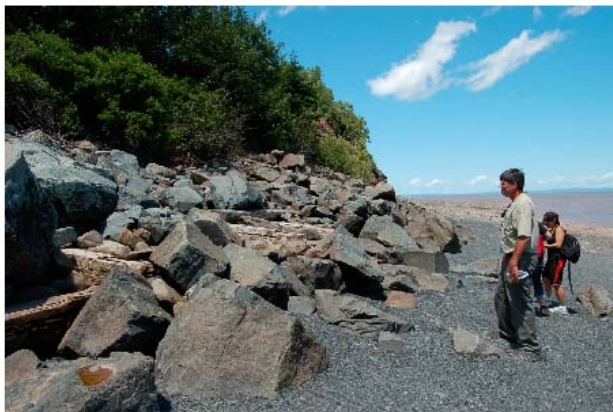
**Figure 15.** Armour stone and wood crib work at the base of the Rail Line Slide. Location is just north of Site 4 shown on Figure 12.
