Flooding at Tank Pond, Cape Breton County, Nova Scotia: Coastal Hazard Assessment and Recommendations for Remedial Action

P. W. Finck

Open File Report ME 2013-001

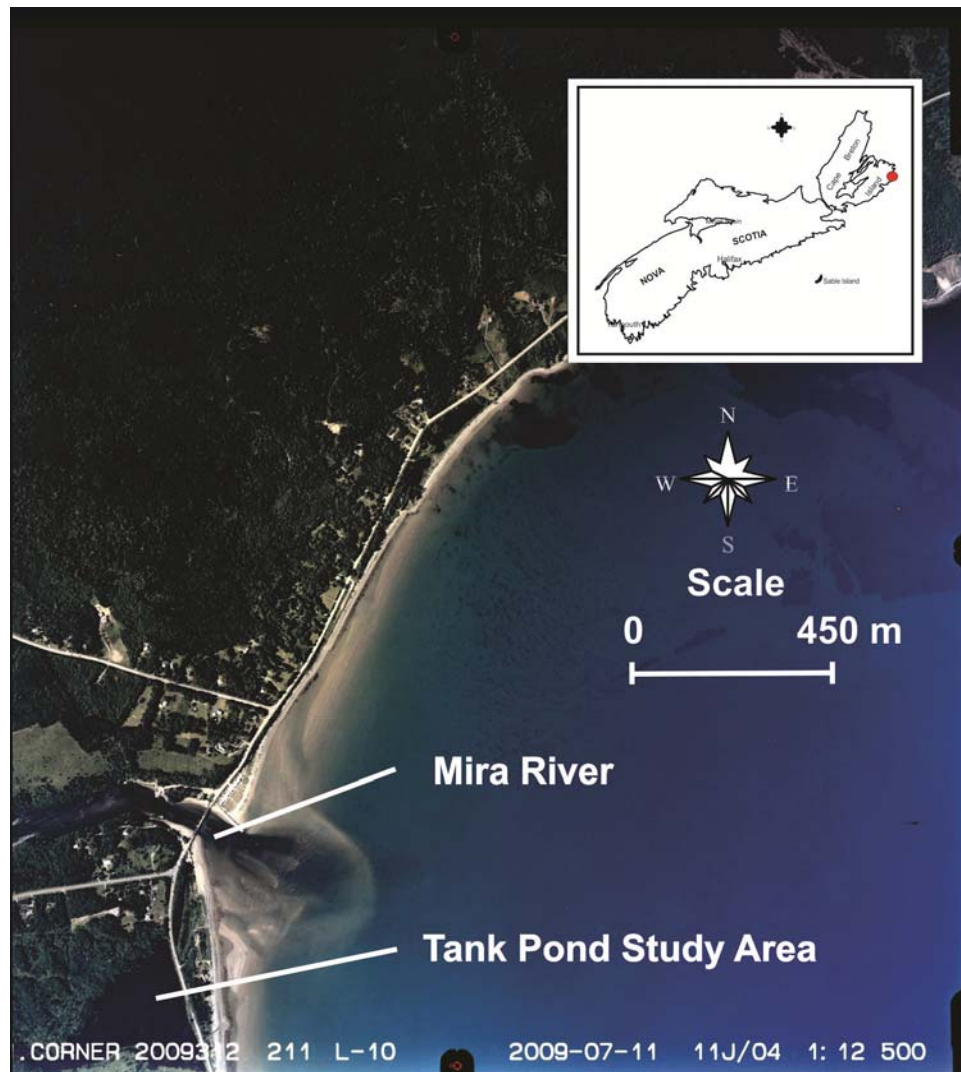
Figure 1. Aerial photograph of the Tank Pond study area.

of two clearly defined groins on the shoreline of the properties under study. It can be seen that the two groins trapped large amounts of sediment on their southern sides, preventing coastal erosion in front of associated buildings on the shoreline. In 1969 imagery (not shown), the groins are no longer visible, and the shore line appears to have eroded substantially. By 2009 the spit was eroded and narrowed such that all of the structures seaward of the old Mira Road and the road itself were gone (Fig. 1).

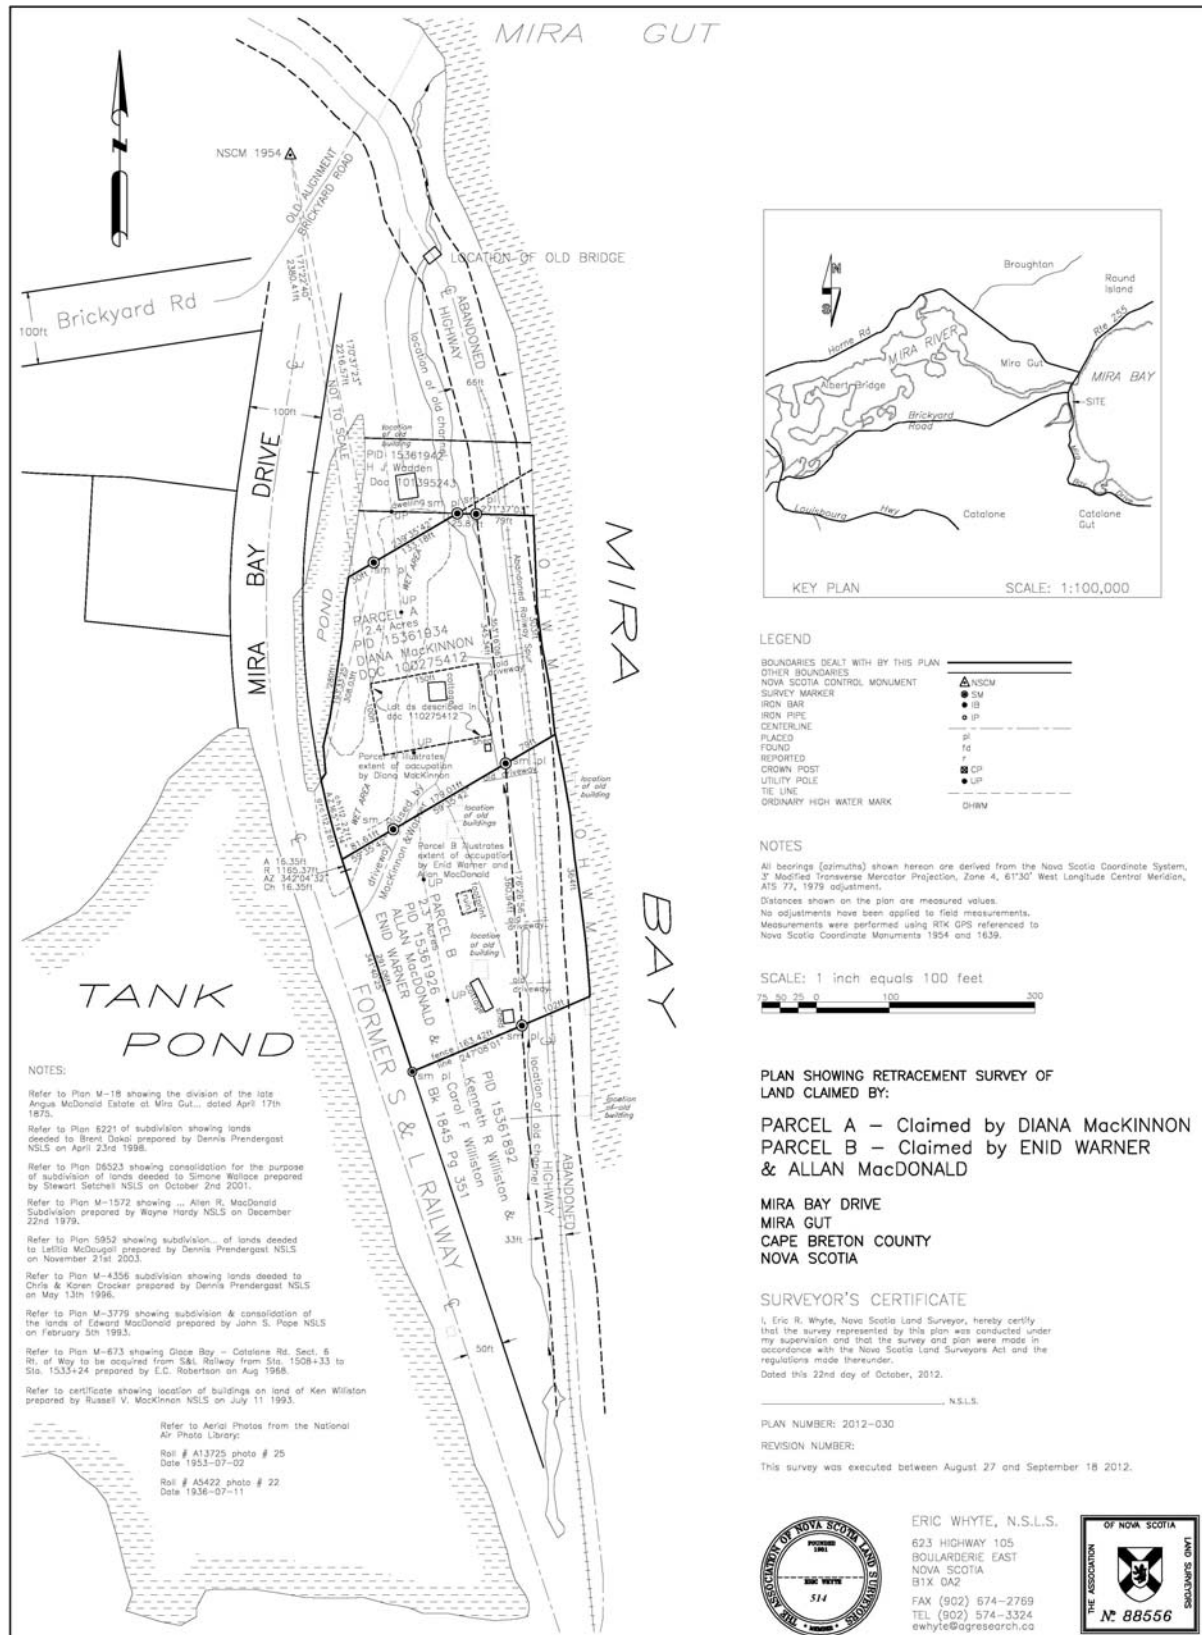
The tracing of the 1875 map shows the locations of several properties that still appear in similar locations. It also shows properties that have since been destroyed by coastal erosion or removed by property owners. These properties were located east of the old Mira Road, which also no longer exists. Figure 2 indicates the former locations of two buildings of these now nonexistent properties east of the present ordinary high-water mark.

In 1875, drainage is shown from the south end of Tank Pond running north along the back of the former Mira Road and discharging into the mouth of the Mira River (unpublished survey tracing, 1957). This is identified on Figure 2 as “location of old channel.” Additional separate drainage is shown on the 1875

map (unpublished survey tracing, 1957) flowing from the north end of Tank Pond and discharging likewise into the mouth of the Mira River. On the 1875 map (not shown in this report) there is no indication of the pond at the north end of Tank Pond that now exists on the present survey map (Fig. 2).

On the 1957 tracing of the 1875 map, the drainage channel flowing from the south end of Tank Pond is shown as flowing along the back of what would have been at that time over-wash sediments. The storm ridge would have been seaward of the former buildings east of the old Mira Road (Fig. 2), and approximately 0.3 m or more lower than the present 2012 storm ridge.

There is a small body of water at the extreme south end of the properties (Fig. 2). At present it drains very poorly southwards to the channel into which the culvert from the south end of Tank Pond empties. In the past, however, this body of water drained northwards into the old channel along the back of the spit, as indicated in Figure 2. The old channel is no longer an effective drainage channel for this small body of water. It is in-filled along much of its length by what appears to be a combination of landward movement of the storm ridge due to centuries of slow progressive sea-level rise, re-vegetation and infill by some residents. In 1875 the old channel drained not only the small body of water, but also water from the south end of Tank Pond (unpublished survey tracing, 1957).

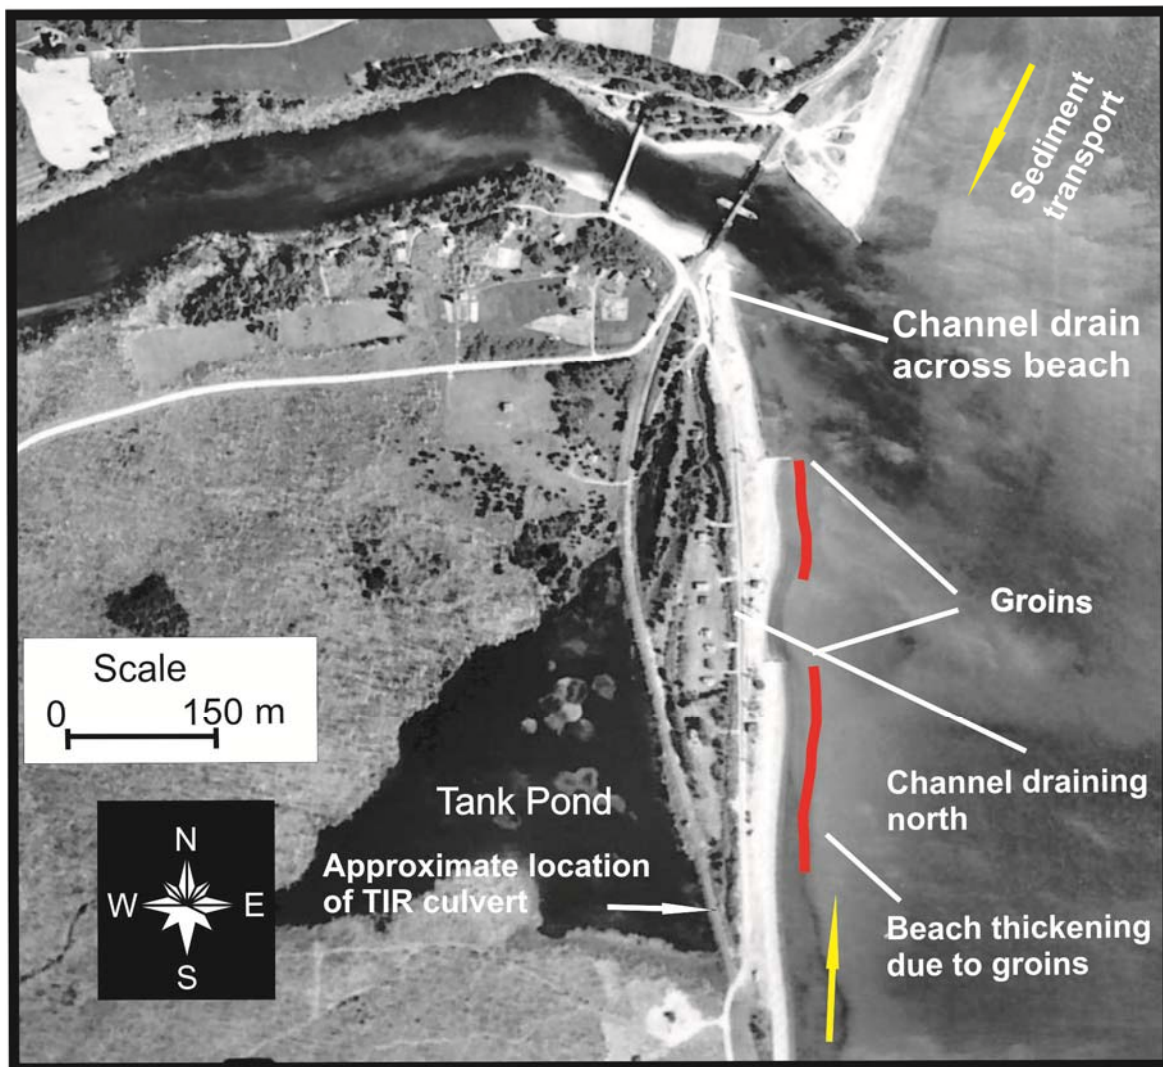
The 1953 air photograph of the study area (Fig. 3) shows a large breakwater on the north side of the mouth of the Mira River, which produced channelization on the south side of the breakwater and deposition of a large fillet beach on the north side. It appears that there is a current flowing from north to south on the north side of the Mira River mouth; this observation is consistent with results from Strait Engineering Limited and W. F. Baird & Associates (2009). The northern fillet beach would not have existed without the presence of the breakwater. However, of far more relevance is the existence

Figure 3. Air photograph of the Tank Pond study area taken in 1953 showing presence of groins.

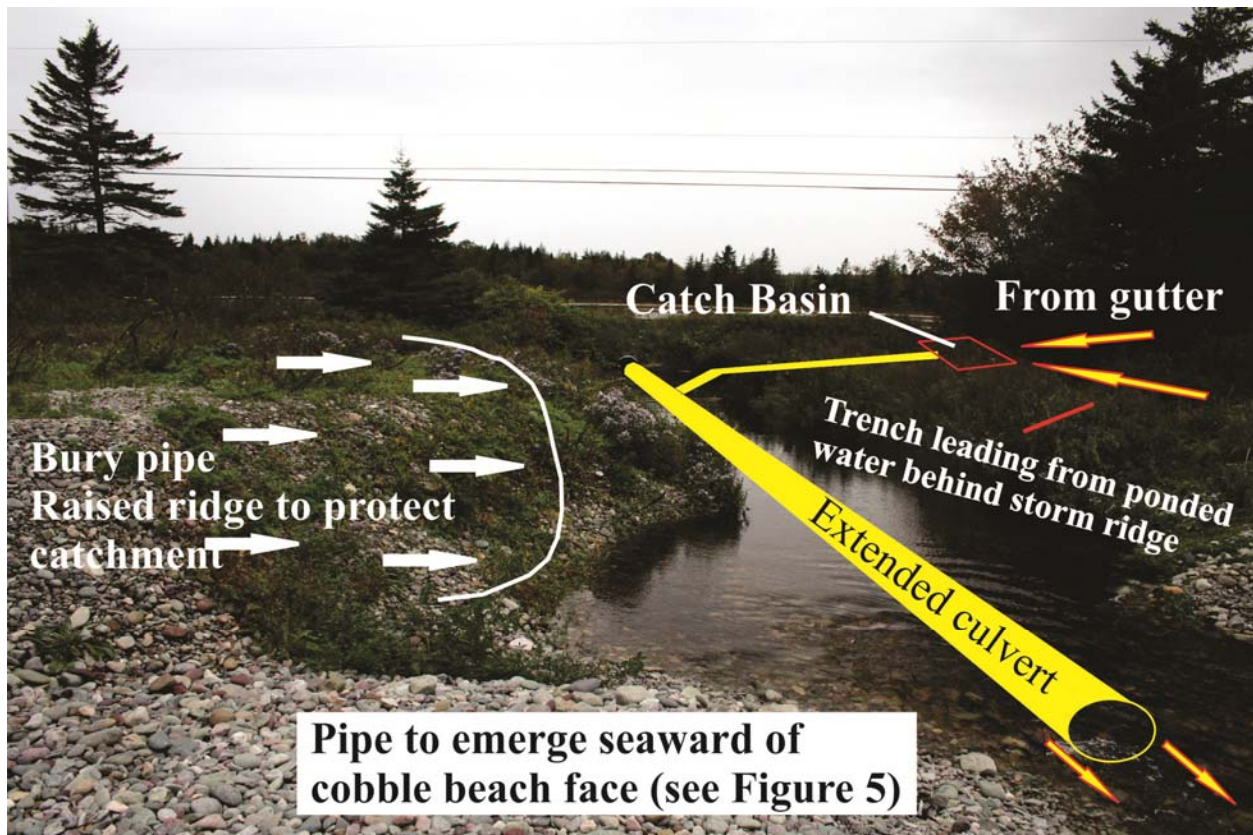
Figure 4. Illustration of extension of existing Tank Pond culvert and associated drainage modifications.

Figure 4 shows a proposed extension of the culvert from Tank Pond. The culvert would be covered and pass underneath the storm ridge, which would no longer have to be repeatedly excavated to keep the drainage channel open. The figure also shows a proposed catchment that would collect water from a gutter that drains water ponded behind the south end of the storm ridge. It would also collect water from a drainage system along Mira Bay Drive as previously described. The catchment would be connected to the extended culvert from Tank Pond.

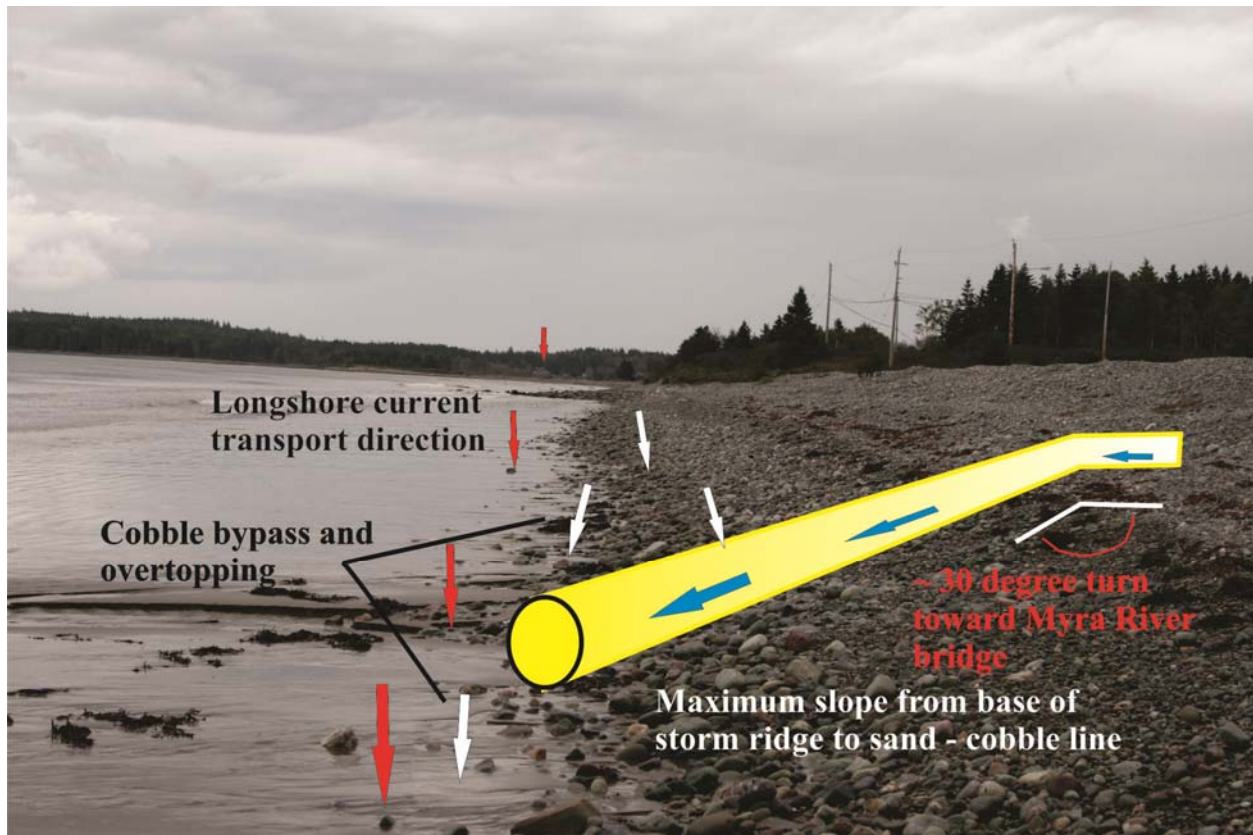
Figure 5. Placement of the extended culvert across the intertidal zone under the storm ridge.

Figure 5 shows the extension and orientation of the culvert with its termination at the base of the cobble beach. Figure 6 shows one method of anchoring and protecting the culvert. The culvert could alternatively be buried by armour stone, though crushing of the culvert would need to be avoided. The author has also observed similar systems where the culvert was made from concrete with a

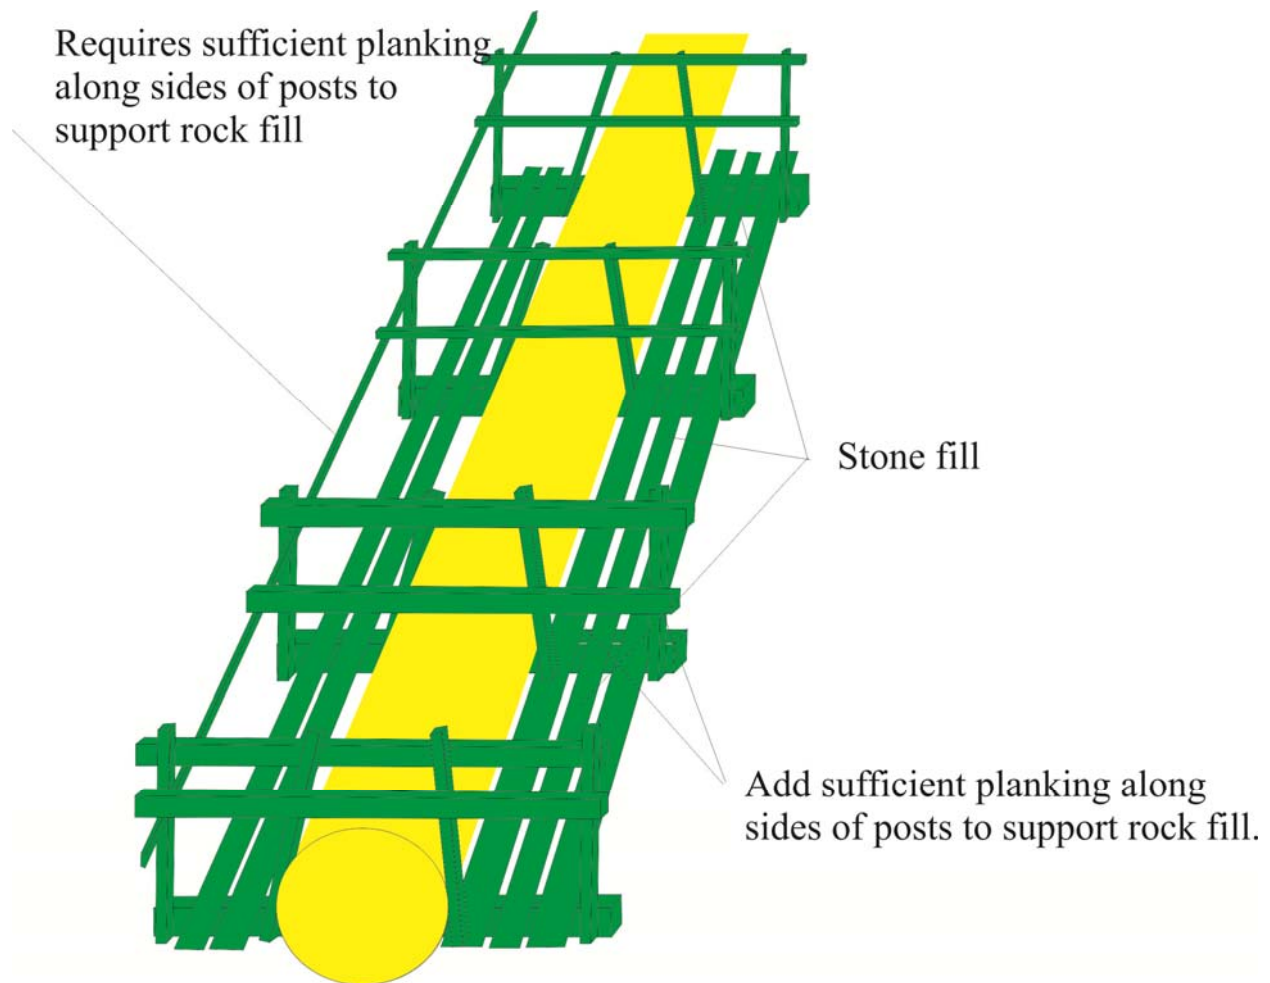
Figure 6. Illustration of a stone-filled crib anchoring the culvert in the intertidal zone on the beach.

rectangular cross-section. It would be advisable that a section of the top of the culvert, nearest the beach, be removable in case the need to clean out the culvert arose.
