Coastal Process, Geohazard, Erosion and Infrastructure Sustainability Studies at Cabots Landing Provincial Park, Port Shoreham Beach Provincial Park, and the Proposed Replacement for Plaster Provincial Park, Nova Scotia

P. W. Finck

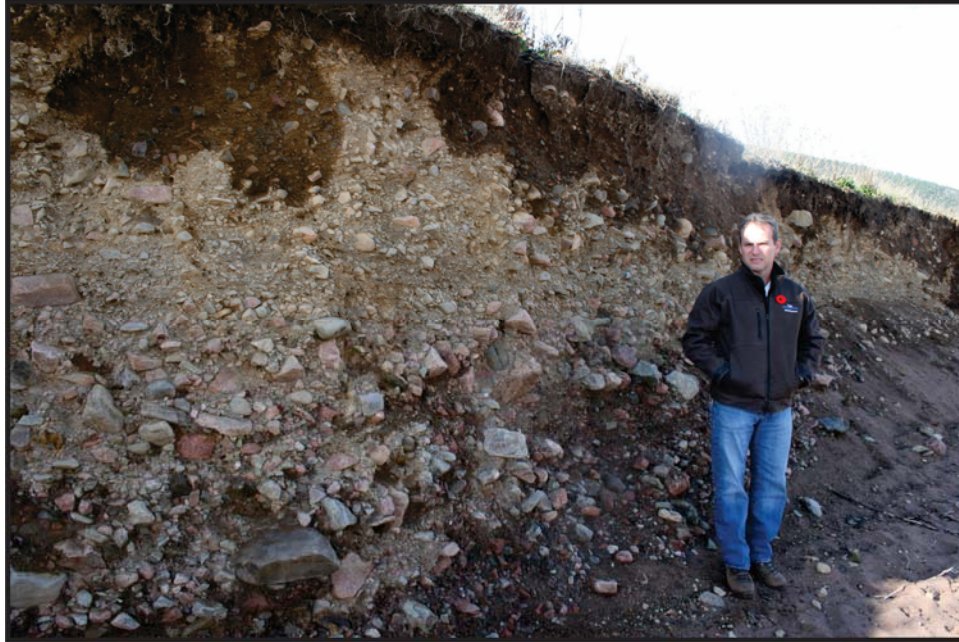
The scarp is generally vertical and varies from approximately 2 m in height at the north end of the park to approximately 4 m at the south end of the park at Wilkie Brook (Fig. 2). The height of the scarp, measured from the top of the beach sand, depends on the amount of beach sand piled up against the base of the scarp (Fig. 3).

Figure 2. Eroded shoreface at Cabots Landing Provincial Park composed of outwash deposited by water derived from melting glacier ice.

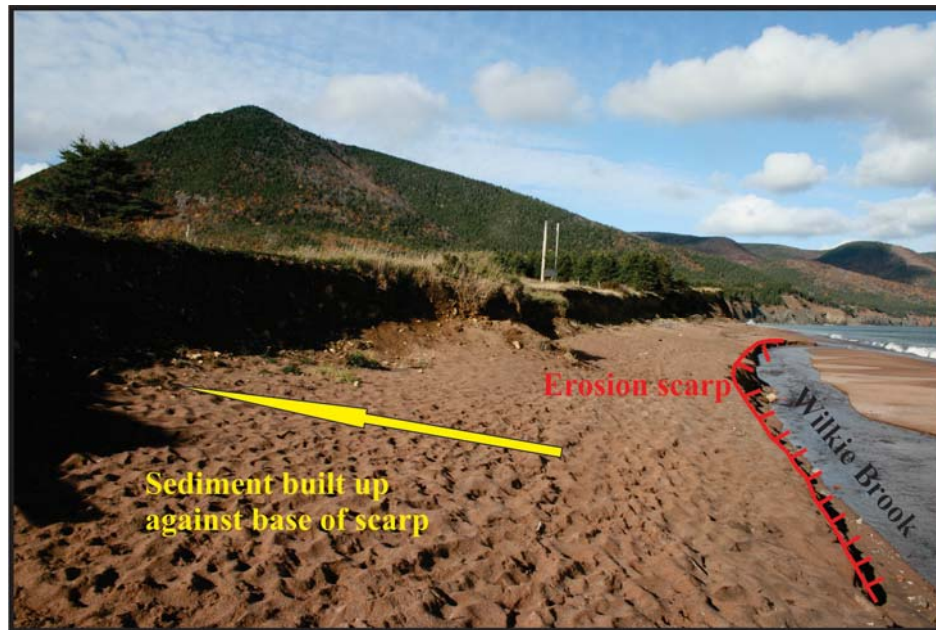
Figure 3. This image from Cabots Landing Provincial Park shows sand piled up against the erosion scarp and Wilkie Brook flowing north along the face of the scarp.

As discussed previously, migration of Wilkie Brook is believed to have increased the rate of erosion along the southern extent of the park shoreline. Whether this has had the effect of increasing the overall rate of erosion is unknown. It is possible that an increase in the rate of northward transport of sediment in the general study area has had the effect of blocking the outflow of Wilkie Brook, forcing it to flow northward along the face

of the erosion scarp. This would be a situation where increased sediment supply, rather than decreasing coastal erosion, has actually increased coastal erosion by forcing a change in the outflow of Wilkie Brook.

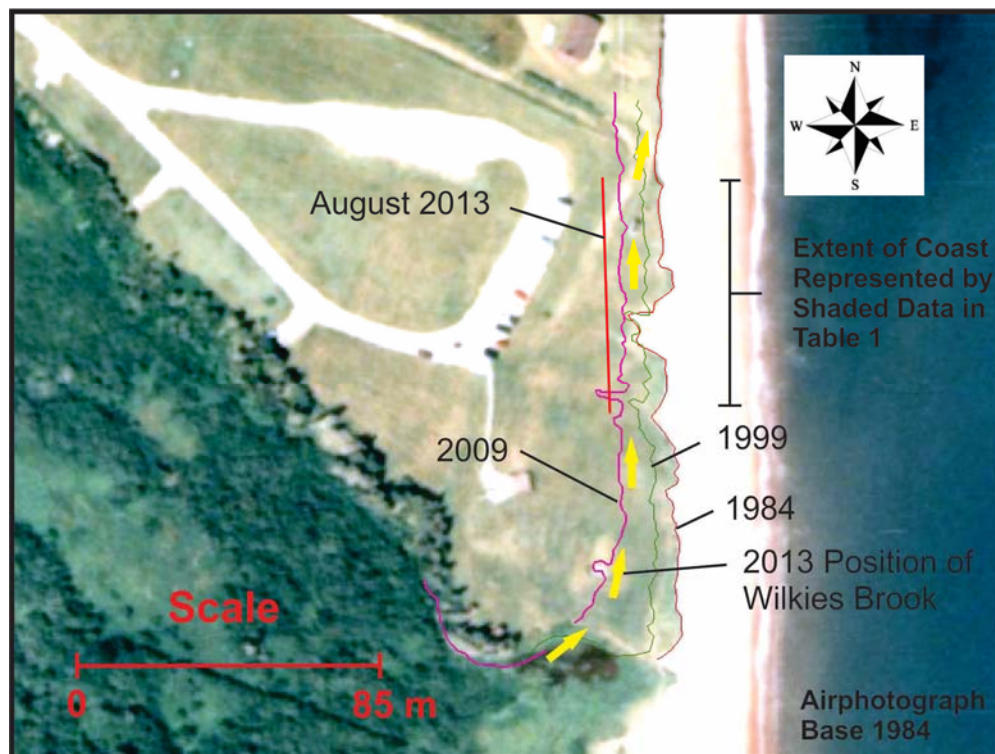
In order to compensate for the effect of differential erosion, I recalculated the rates of erosion for the area directly seaward, or east, of the main parking area (Fig. 4; shaded values in Table 1). This was done so that the position of the 2013 scarp could be compared to the previous scarp positions along the same length of shore line; the position of the 2013 scarp was not measured along the south end of the park toward Wilkie Brook. However, this did not appreciatively change the average yearly rates of erosion of 0.33 m/a (1984–1999), 0.71 m/a (1999–2009) and 0.96 m/a (2009–2013), especially when one accounts for the considerable error in the methods used to determine scarp positions between successive aerial photographs. Although there are significant errors associated with this method, there aren't any better alternatives available for this site. Nonetheless, it appears that the overall rate of erosion of the shoreface at Cabots Landing has increased significantly over the last 30 years. Other important considerations, in addition to the rates themselves, are the mechanisms and physical

Figure 4. Approximate positions of the top of the beach erosion scarp at Cabots Landing in 1984, 1999, 2009

I believe that a fixed ramp at Cabots Landing will not be sustainable for more than three to five years without modifications if present rates of erosion continue. The location of the ramp will not affect the sustainability of the structure as the rate of erosion is uniform across the main eastern face of the park and is even higher at the southern end of the park. Other, non-beach access infrastructure, such as roads, should be constructed with a 0.7 to 1 m/a rate of erosion in mind.

The Parks Division may wish to consider a moveable access ramp. As a general concept, this would be a ramp (with or without rails) that has sufficient structural integrity to be pulled up onto the flat grass in the fall and pulled back down in late spring. The ramp would be placed in a trench cut across the scarp at the appropriate slope. Truck access to the ramp area is readily accomplished so

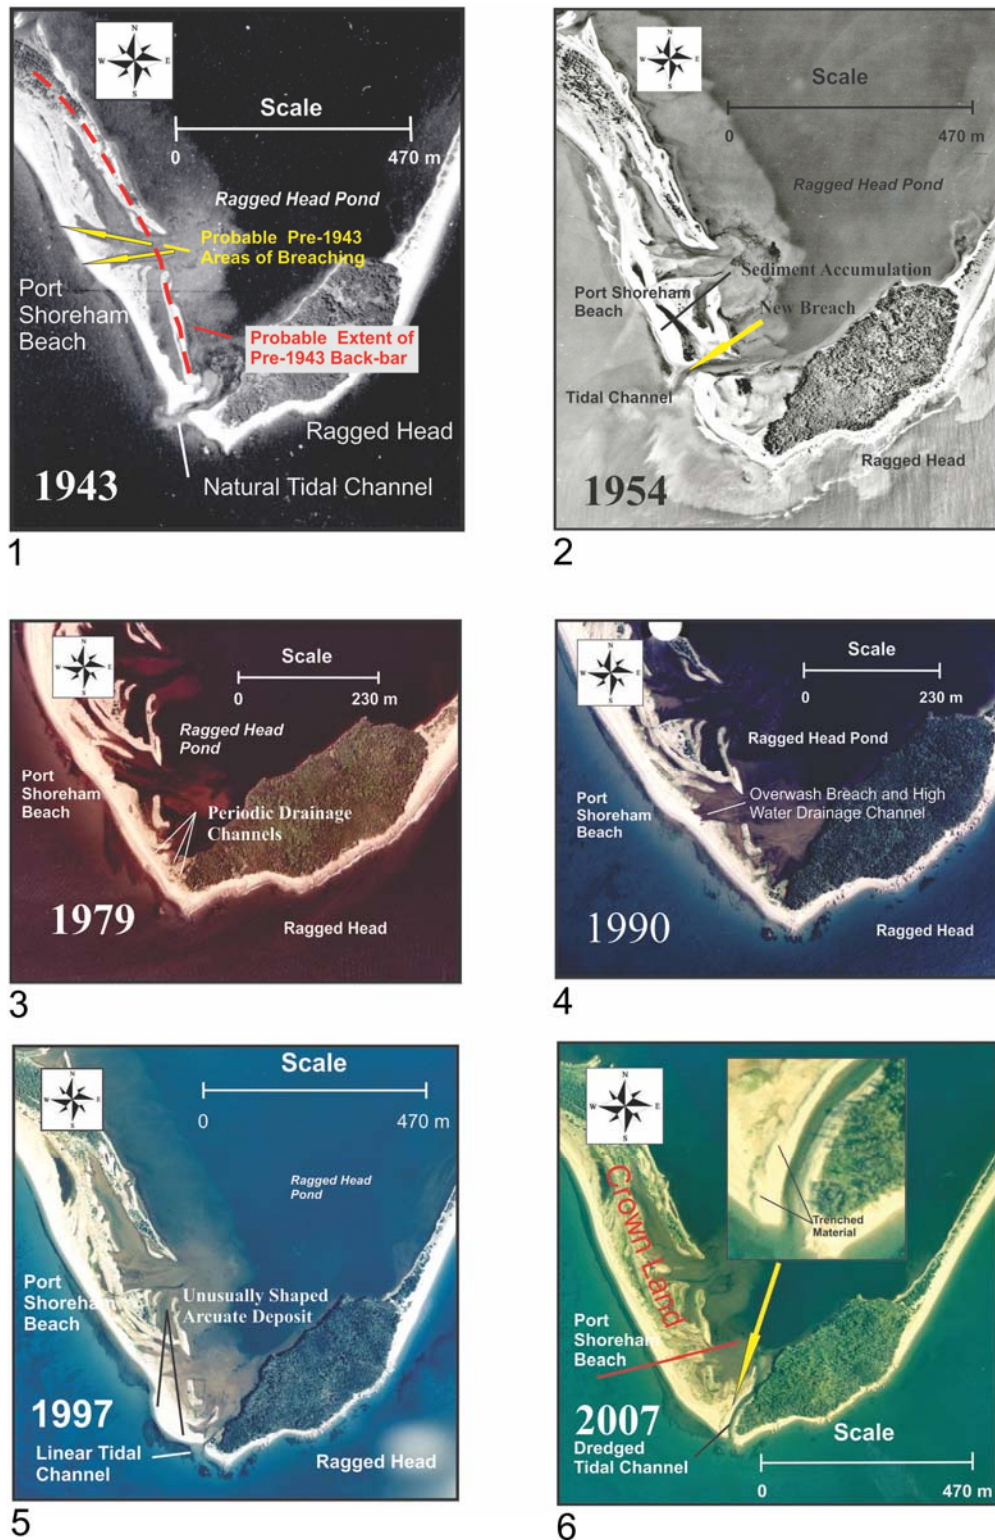
The breach immediately west of Ragged Head was blocked at some time after 1943, and by 1954 a new, large breach developed farther to the west (Fig. 8.2). There also appears to have been further spit development (beach buildup) or sediment accumulation on the seaward side of the beach immediately northwest of the breach on the 1954 air photo. The breach shown in the 1954 photo (Fig. 8.2) is sinuous with ebb and flood tide channel bars and is therefore interpreted as being

By 1979 (Fig. 8.3), the large breaches had closed, leaving what appears to be two or three smaller channels allowing water to drain out of Ragged Head Pond when the pond water-levels were high. Between 1979 and 1990 (Fig. 8.4), there do not appear to have been any major breaches on the scale of the pre-1954 channels. In Figure 8.4, there is a possible lake drainage channel formed by an overwash event in a similar location to a pre-1943 breach. How this channel evolved between 1979 and 1990 is unknown; possibly it was a repeating cycle of growing bigger followed by infilling.

and Clam Harbour Bay. On April 16, 1991, the channel visible on the 1997 air photo (Fig. 8.5) was dredged open. From that point onward, the channel was periodically opened by private parties under the authority of permits issued by the Department of Natural Resources. The channel continued to be dredged from this point onward except for a few short interruptions while permits were waiting to be approved. The channel was last dredged in mid 2013. In the 1997 and 2007 air photos (Figs. 8.5, 8.6), material from the dredging is clearly visible.

Figure 8. Composite of air photograph views of the Port Shoreham study area, 1943 to 2007.

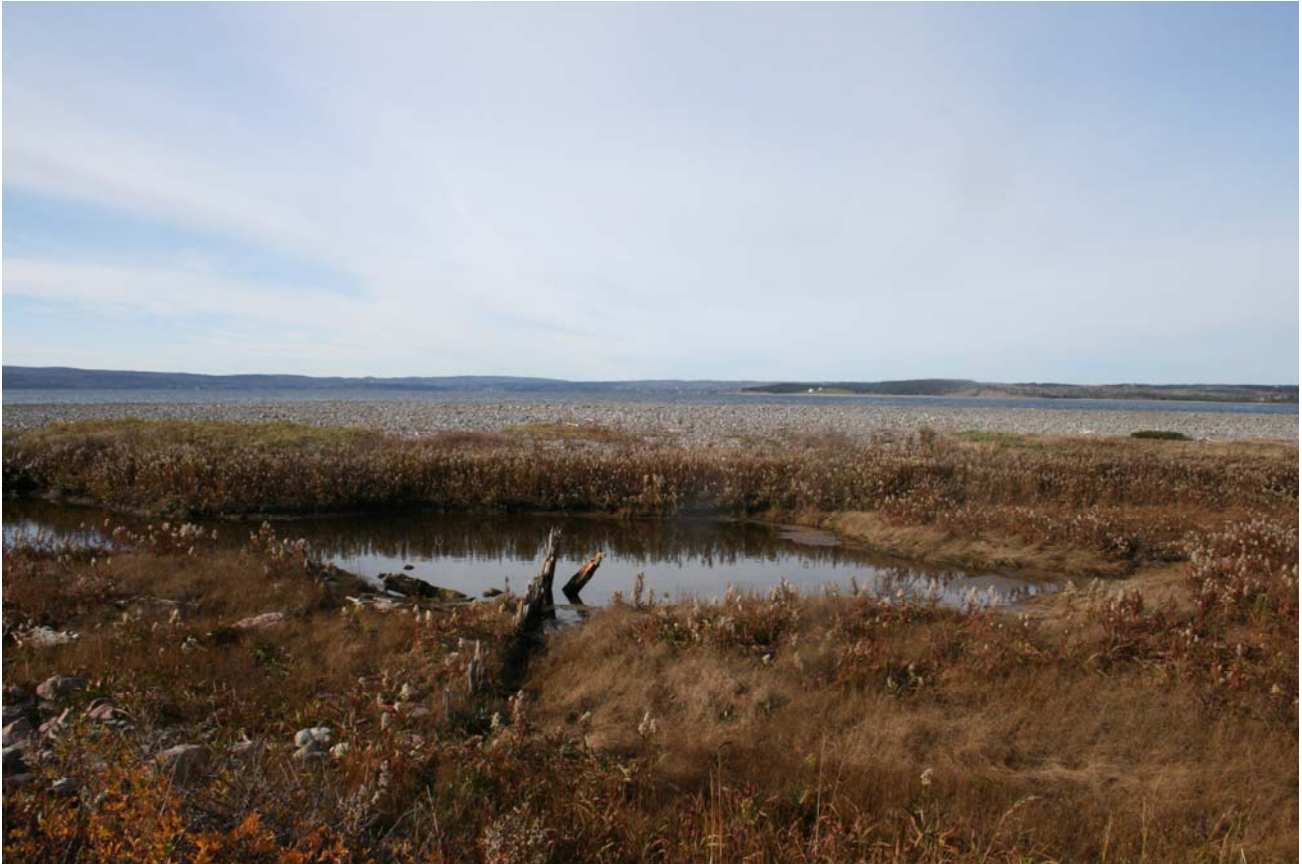
natural. However, cribbing may have been installed in an attempt to keep the channel open. This is based on the observation of vertical poles forming what is interpreted to be a retaining wall; these poles can be seen in Figure 9 leading from the edge of the water-filled depression landward toward Ragged Head Pond.

Figure 9. Remnants of a wood retaining wall constructed in the mid-1900s on Port Shoreham Beach.

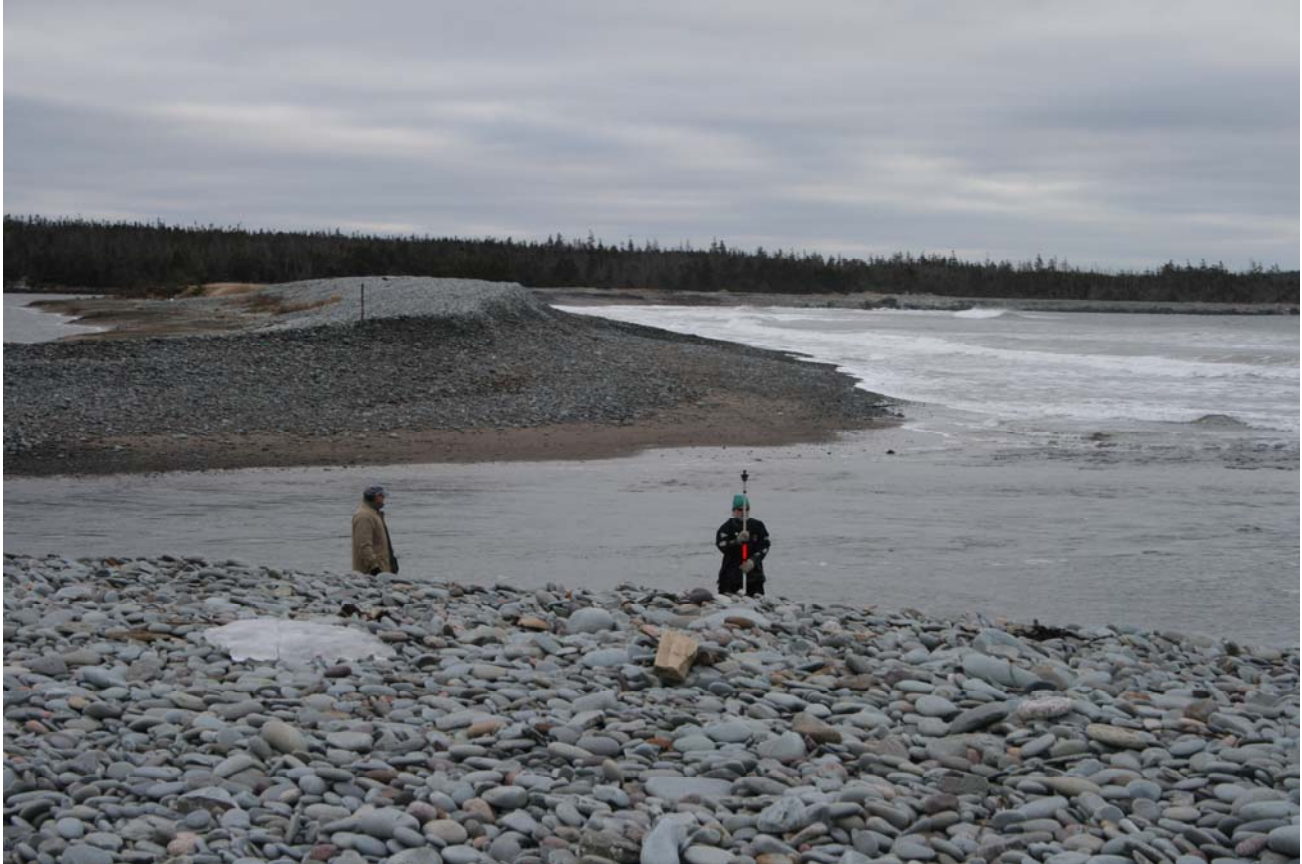
Figure 10. A major breach in a cobble barrier beach east of Halifax, photographed on January 8, 2010.

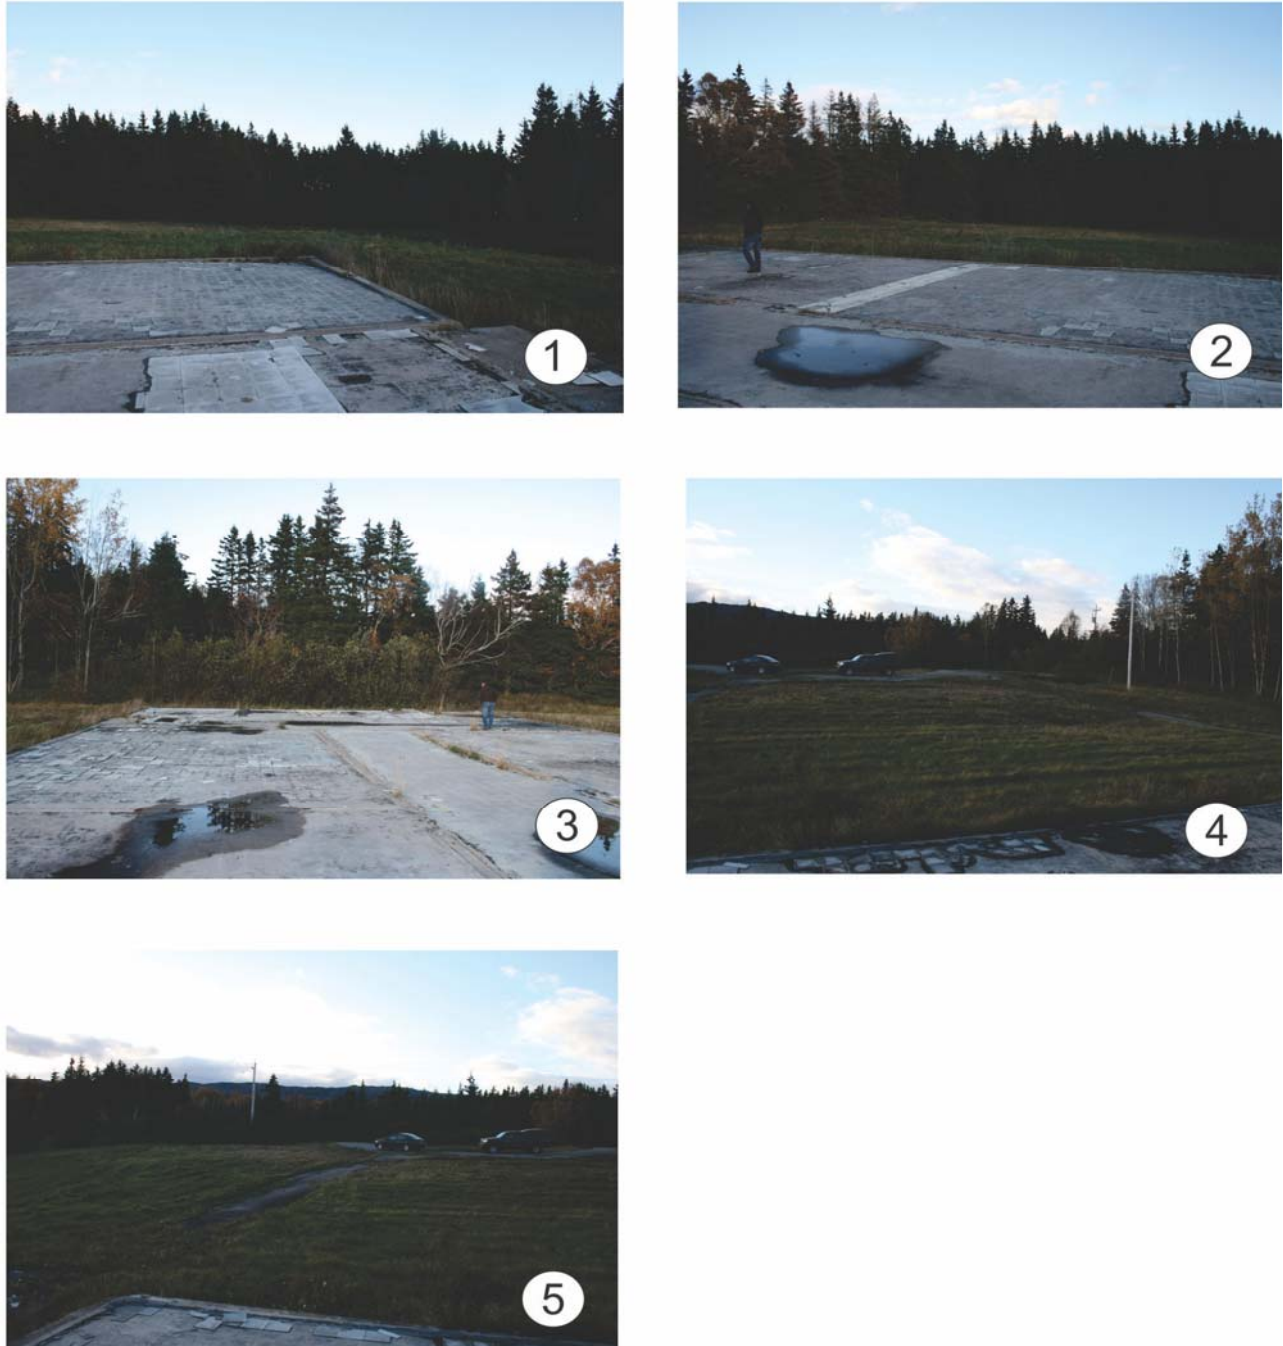
Access to the property from the main road (Cabot Trail) is excellent via a U-shaped, dual entrance driveway that is in reasonable condition considering it has been abandoned for some time (Figs. 12.4, 12.5). The former school has been demolished, and only the concrete slab of the foundation remains (Figs. 12.1-12.5). The slab appears to be mostly solid, except for the rear, left corner (Fig. 12.3), which appears to have a cavity under the cement.

Figure 12. A 360 degree view of the former school site (open field): (1) looking east toward the coast and back, right corner; (2) looking east toward the coast and the back, left hand corner; (3) looking north; (4) looking west toward the road, left side; and (5) looking west toward the road, right side. All of the pictures are taken from a vantage point standing on the concrete slab of the former school.

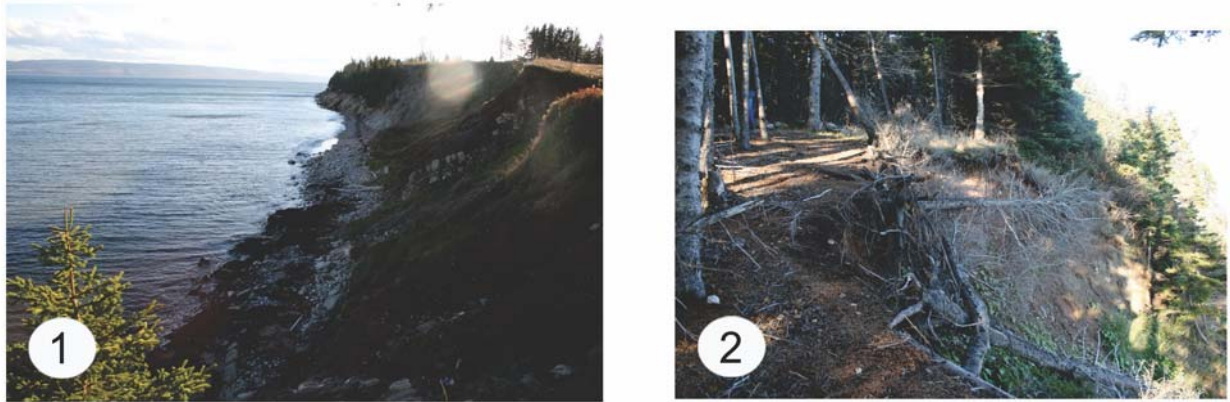
There is obvious erosion occurring along the shoreface of this property. Figure 13.1 shows the shoreline along the shoreface of the adjoining property to the south. The erosion is obvious, particularly in the immediate foreground where bedrock outcrop is low and sporadic. In the

background, outcrop is more extensive and extends higher above the high-tide mark; consequently, erosion is somewhat reduced. Note that there are no trees along the top of the scarp on the adjoining property (Fig. 13.1). On the former school property the top of the coastal cliff is heavily treed. This coastal section is also undergoing erosion as can be seen by the dead trees collapsed over the top edge of the shoreface. The scarp is also eroding at its base causing rotational slumps. These slumps contain large amounts of material, and most translocate trees and vegetation down the slope in, or approximately in, their original growth positions. Such a slump is visible in Figure 13.2 on the far-right side of the photograph. These slumps are relatively competent and take some time to erode. No quantitative rate

of erosion was calculated. From a qualitative perspective, I would rate erosion in this area as moderate.

I do not feel that coastal erosion at this site is a major issue. The parcel of land is quite long, and there is ample area for development that would

consider erosion in design and placement of infrastructure and recreational opportunities. I would be surprised to see multi-decadal erosion rates exceed 0.3 to 0.5 m/a (1 to 1.5 ft./yr.).

Figure 13. Erosion on the shoreface: (1) property immediately south of the school property and (2) along the shoreface of the school property.

Moderate coastal erosion is apparent, but in my opinion will not impact the overall viability of the park. It will impact construction of beach access if this becomes part of a future development plan. This can be mitigated by proper siting and design elements. I do not consider the erosion at the top of the slope to be particularly hazardous. However, undergrowth should be cleared back from the edge so that visitors have a clear view of the upper edge of the cliff. This is not a situation where there are 30-metre drops over vertical cliff edges. Appropriate signs should be erected warning of the steep, unstable slope and the potential for undercutting at the top of the slope.

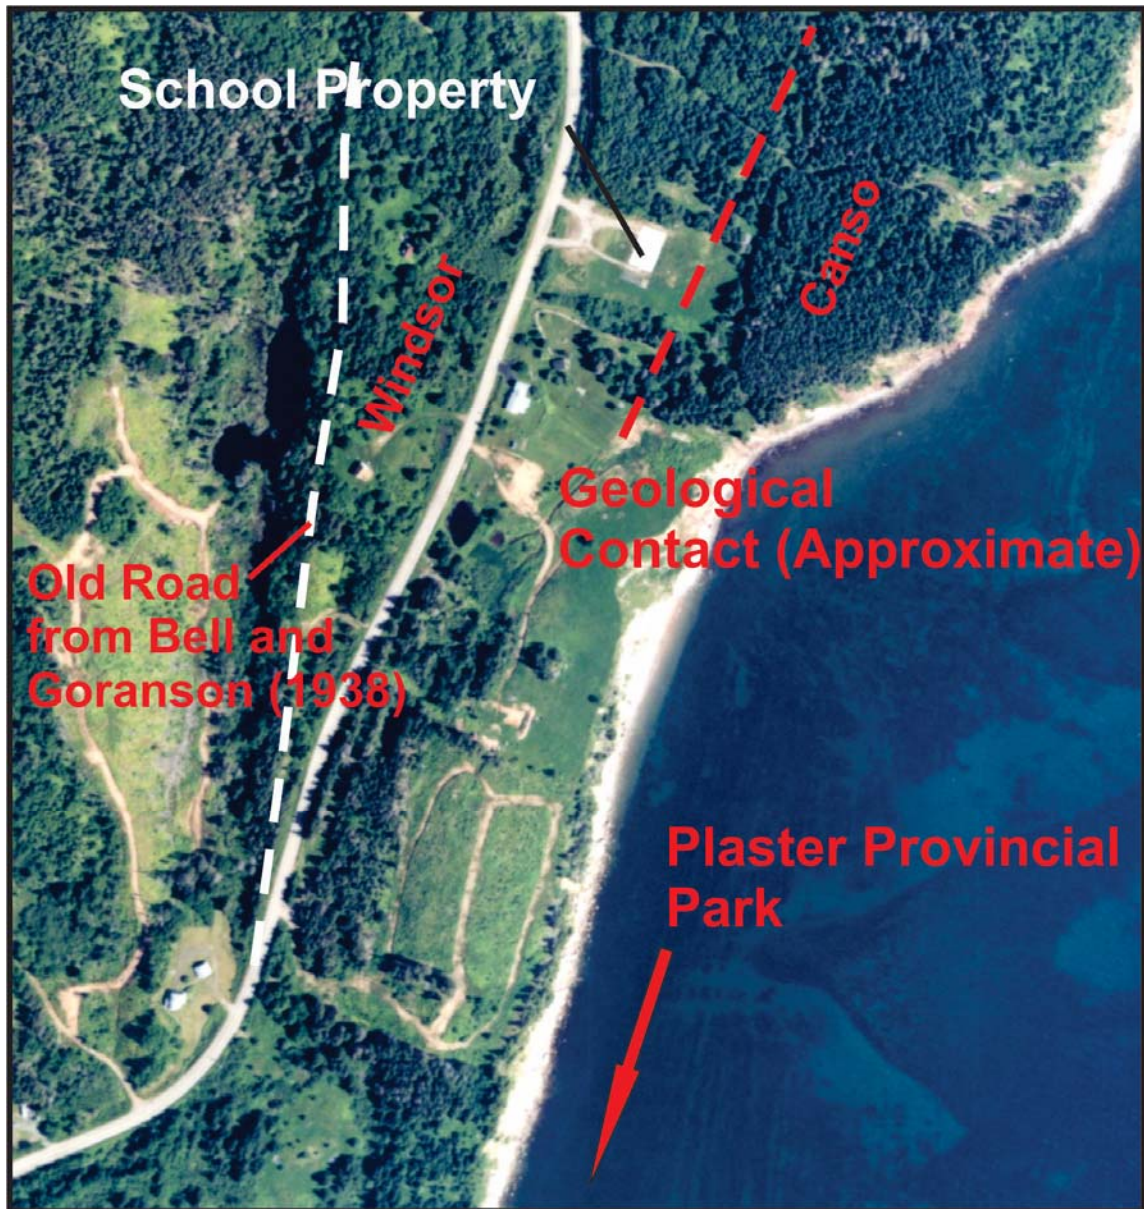
Locating the bedrock contact between Windsor Series and Canso Series inland on the site of the former school is problematic (Fig. 14). The base for Figure 14 is at a scale of 1:10 000 while the Bell and Goranson (1938) map is at a scale of 1:63 360. In addition, the present road is farther to the east than the location of the road on the Bell and Goranson map. Thus, the location of the bedrock contact indicated in Figure 14, which is extrapolated from Bell and Goranson (1938), can only be considered as approximate. Nonetheless, these data suggest that the school property is underlain largely by Canso Series.

Figure 14. Bedrock geology in the vicinity of the former school property (from Bell and Goranson, 1938).

Based on the available bedrock geology data and my observations, I believe that the school property is underlain by Canso Series bedrock. Even if there is some Windsor Series bedrock on the site, given that the school was present on this site for many years, and considerable construction activity would have taken place when the school was demolished, it is unlikely that any work on the site now would result in sinkhole development.

There are no specific geohazard risks associated with development of this former school property as a provincial park. If the site is redeveloped as a day park, care should be taken not to change natural drainage patterns. In particular, culverts or channels should not be constructed that would direct drainage onto the property. If Windsor Series bedrock is present, this can rapidly initiate karst development on time frames of only a few days or weeks.
