## **APPENDIX E**

### **PHOTOGRAPHS - No. 2 SHAFT**

PROJECT NO. 10903

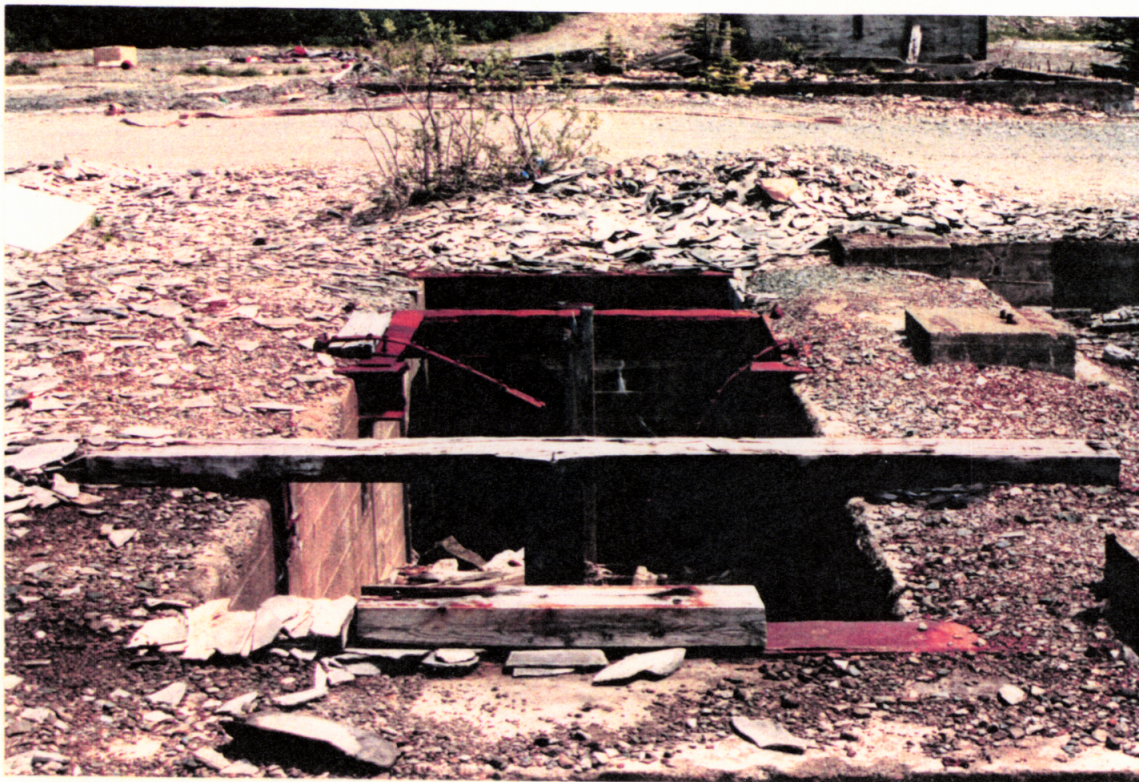
PHOTO E-1: No. 2 Shaft collar prior to removal of timber and debris.

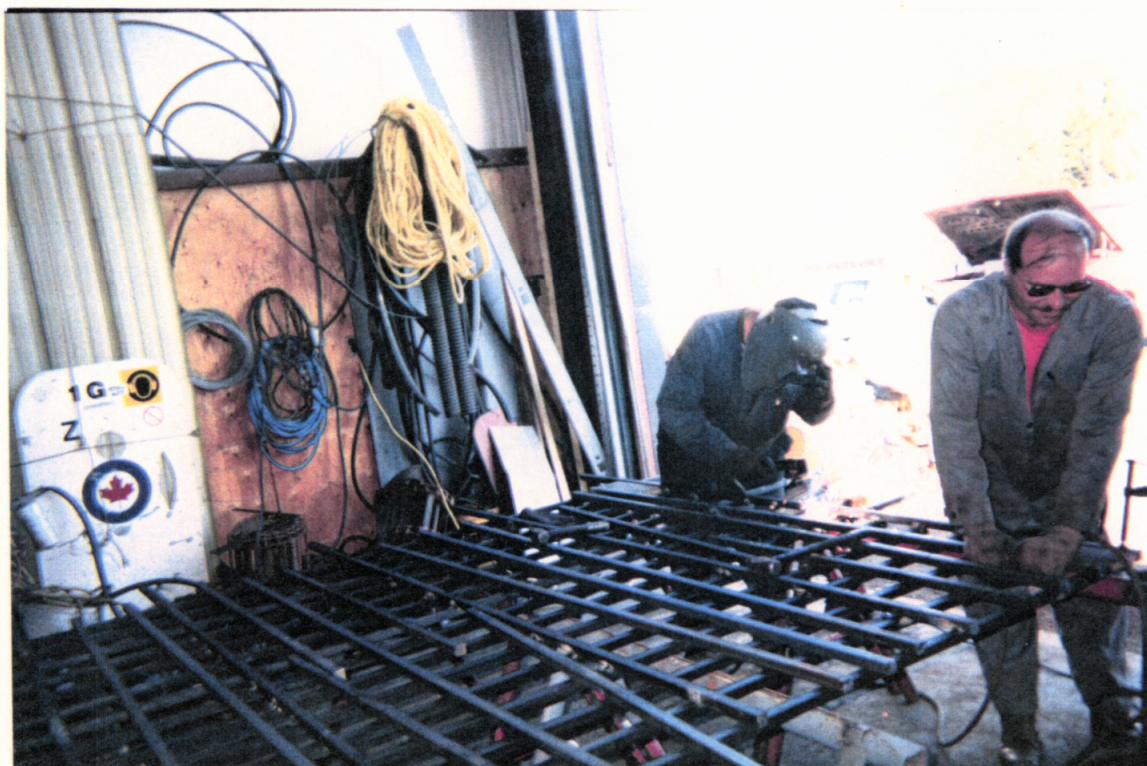
PHOTO E-2: Shop fabrication of steel grate for No. 2 Shaft closure.

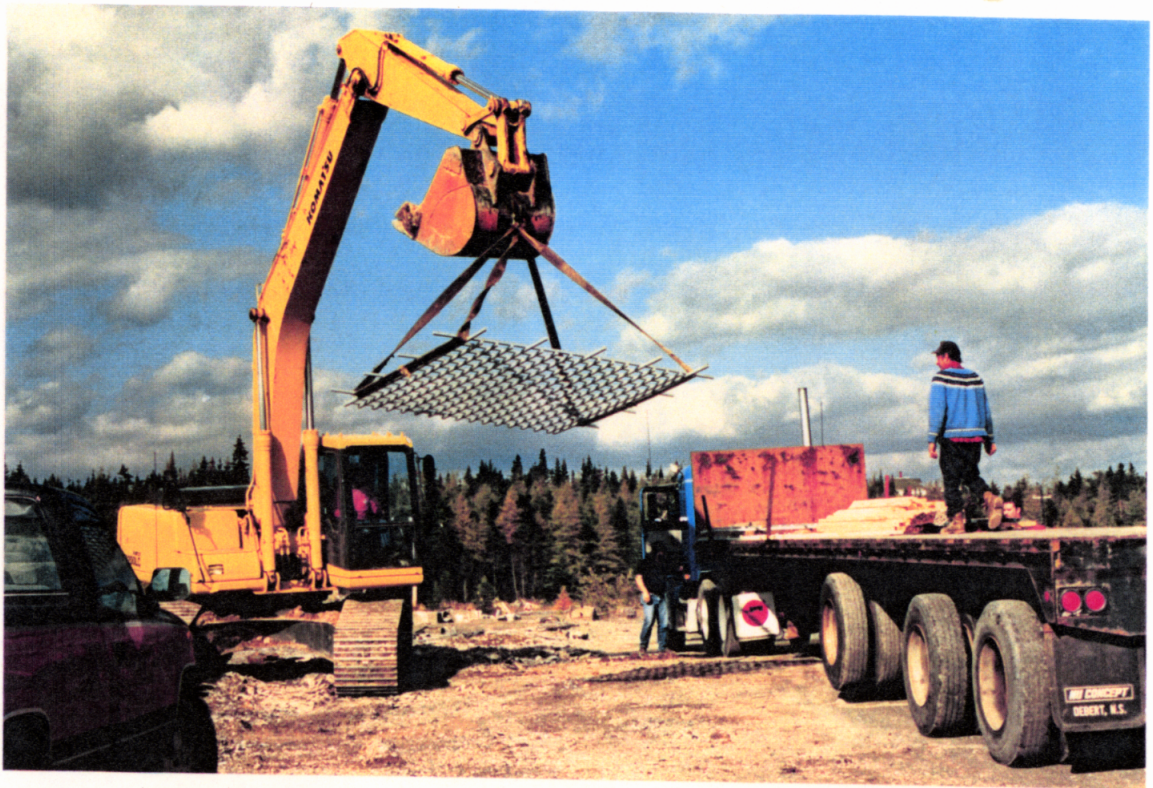
PHOTO NO. E-3: Unloading steel grating from flatbed.

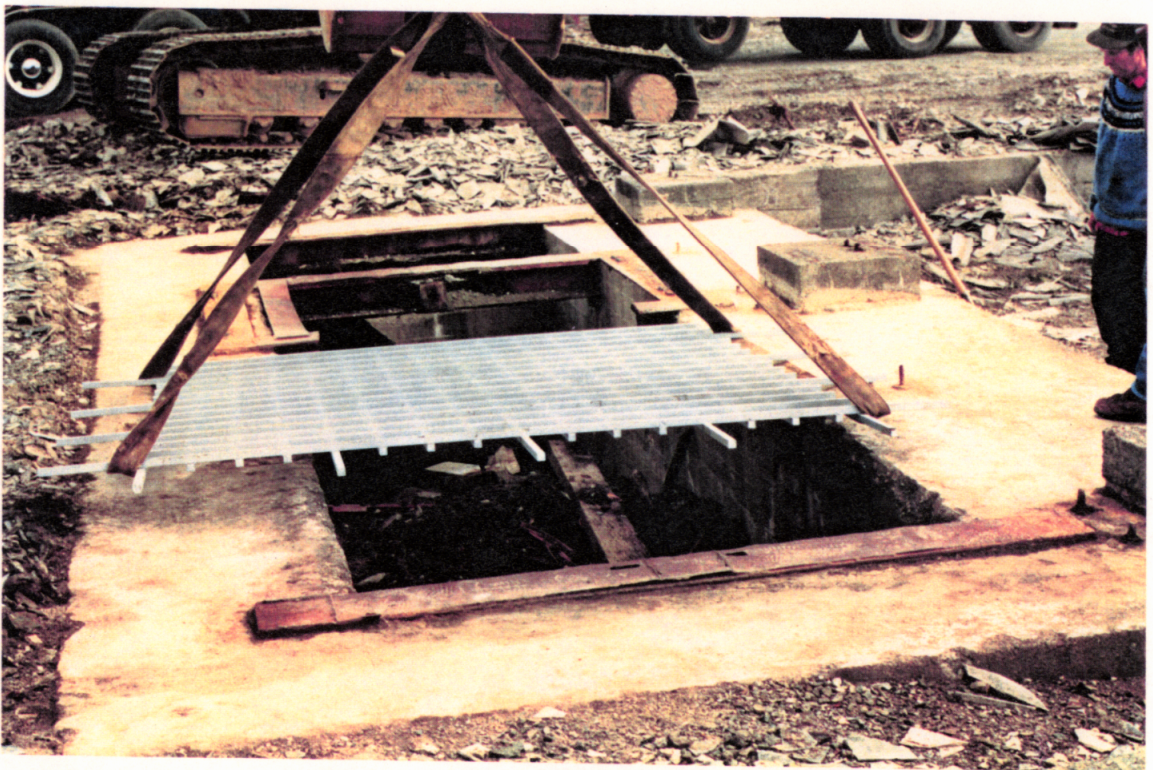
PHOTO NO. E-4: Positioning steel grating on No. 2 Shaft collar.

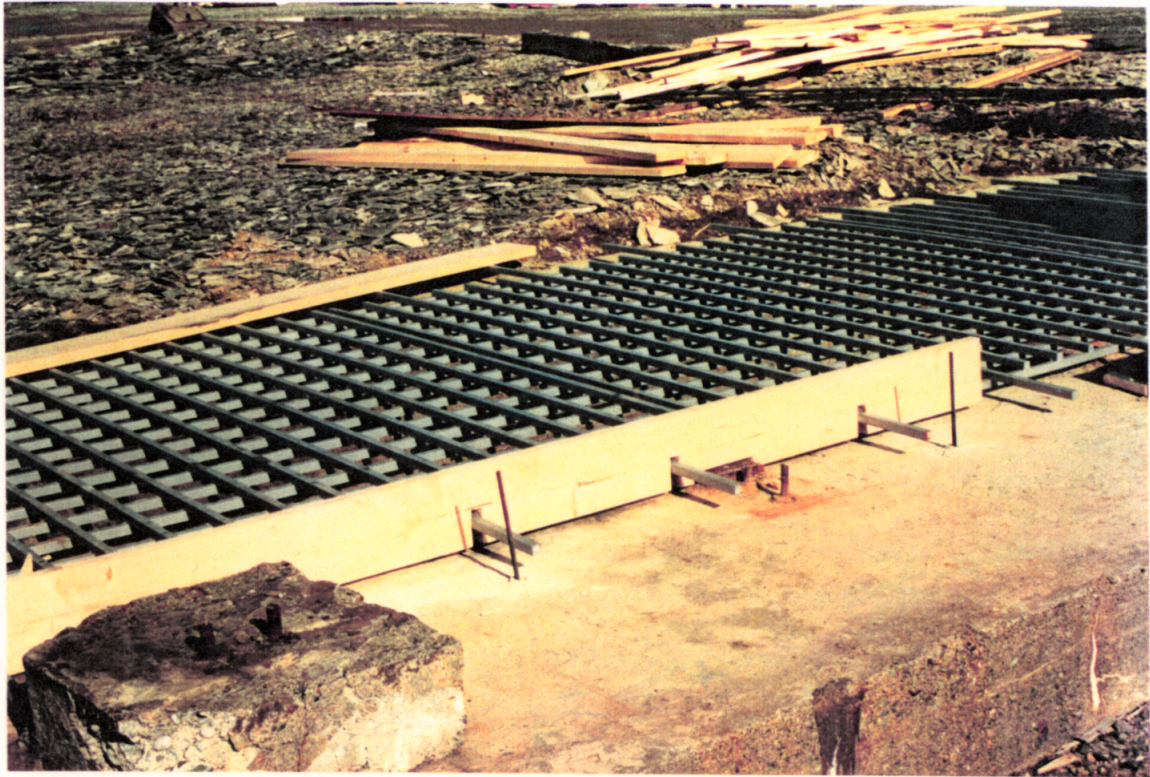
PHOTO NO. E-5: Initial construction of forms showing grate anchoring bars and rebar dowels.

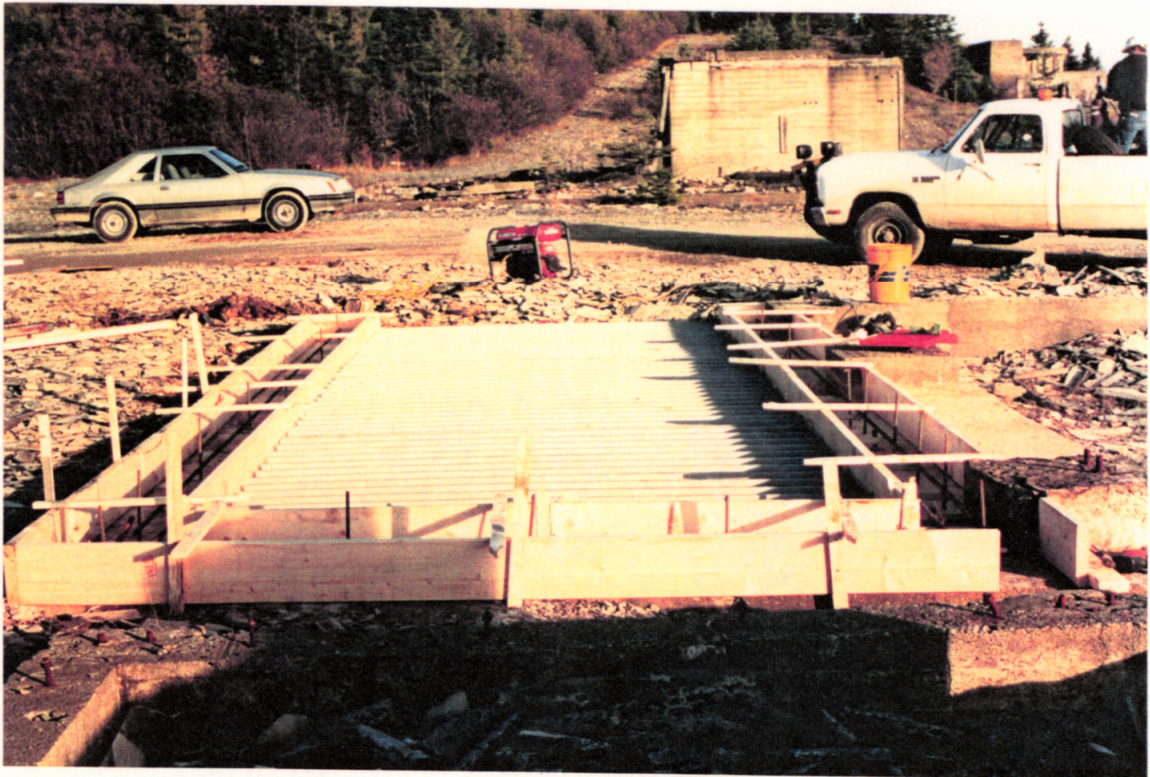
PHOTO NO. E-6: View of formwork for concrete collar.

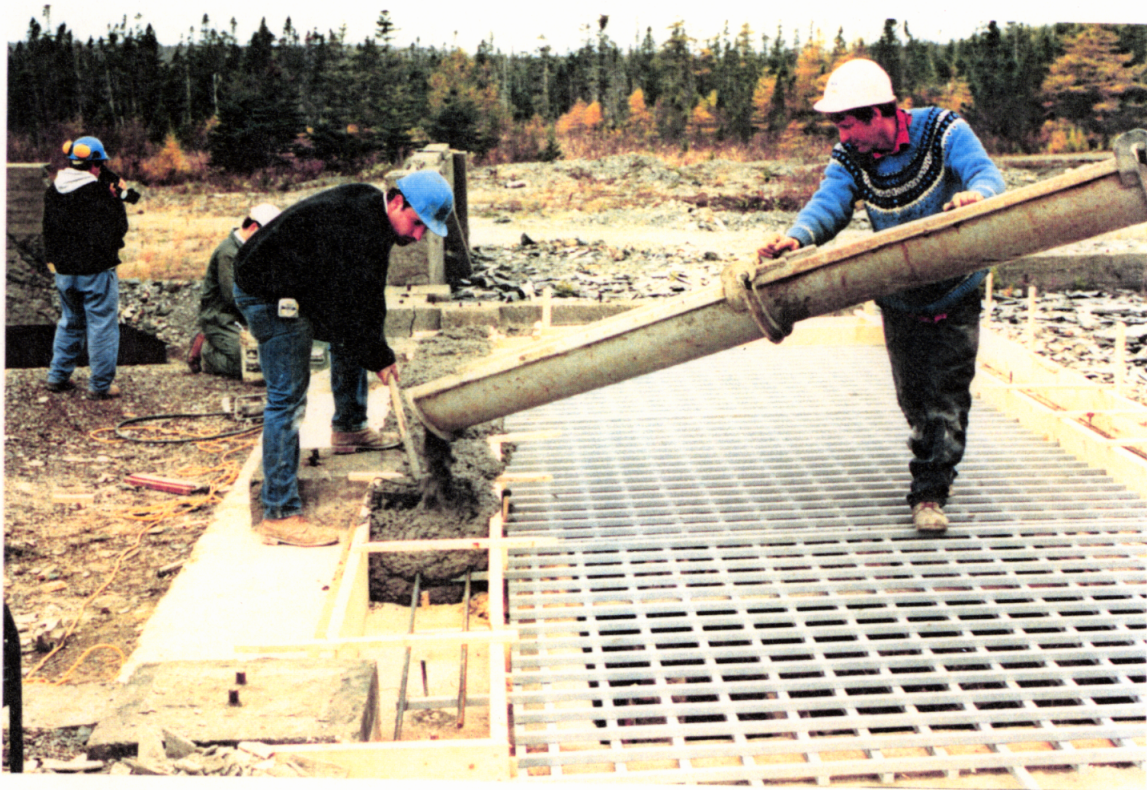
PHOTO NO. E-7: Casting concrete into collar forms showing rebar reinforcement.

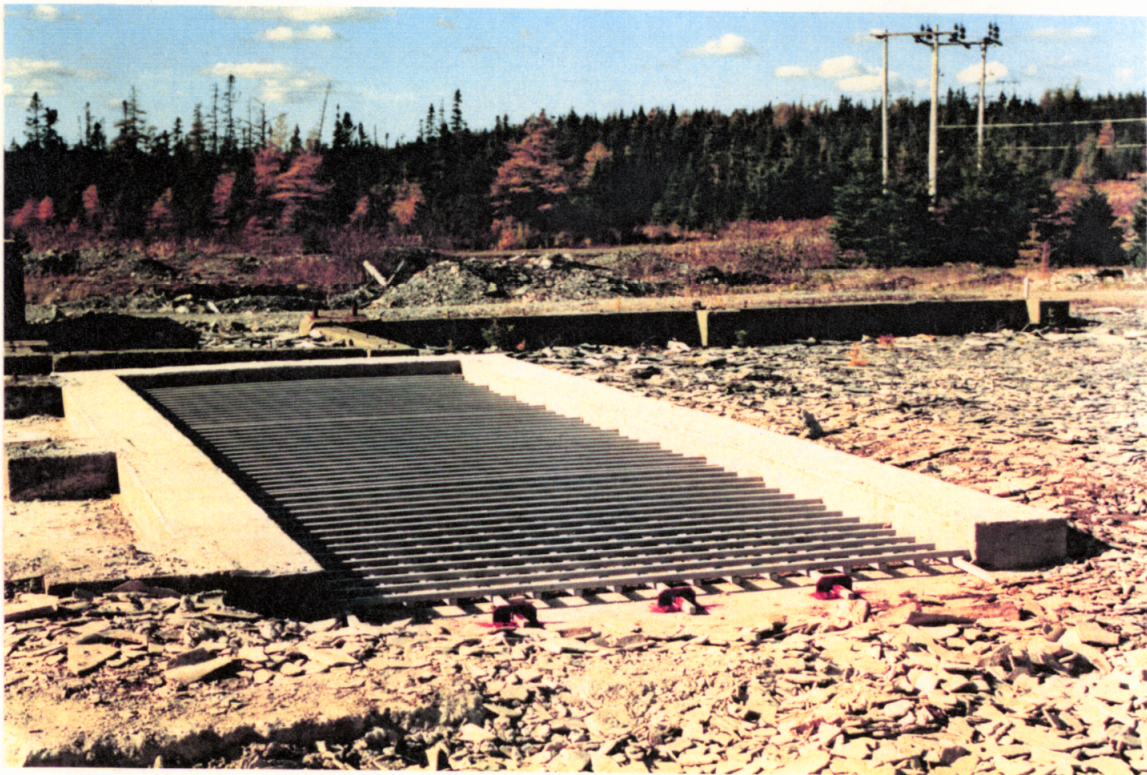
PHOTO NO. E-8: Completed concrete collar and steel grate over No. 2 Shaft showing steel anchor brackets.

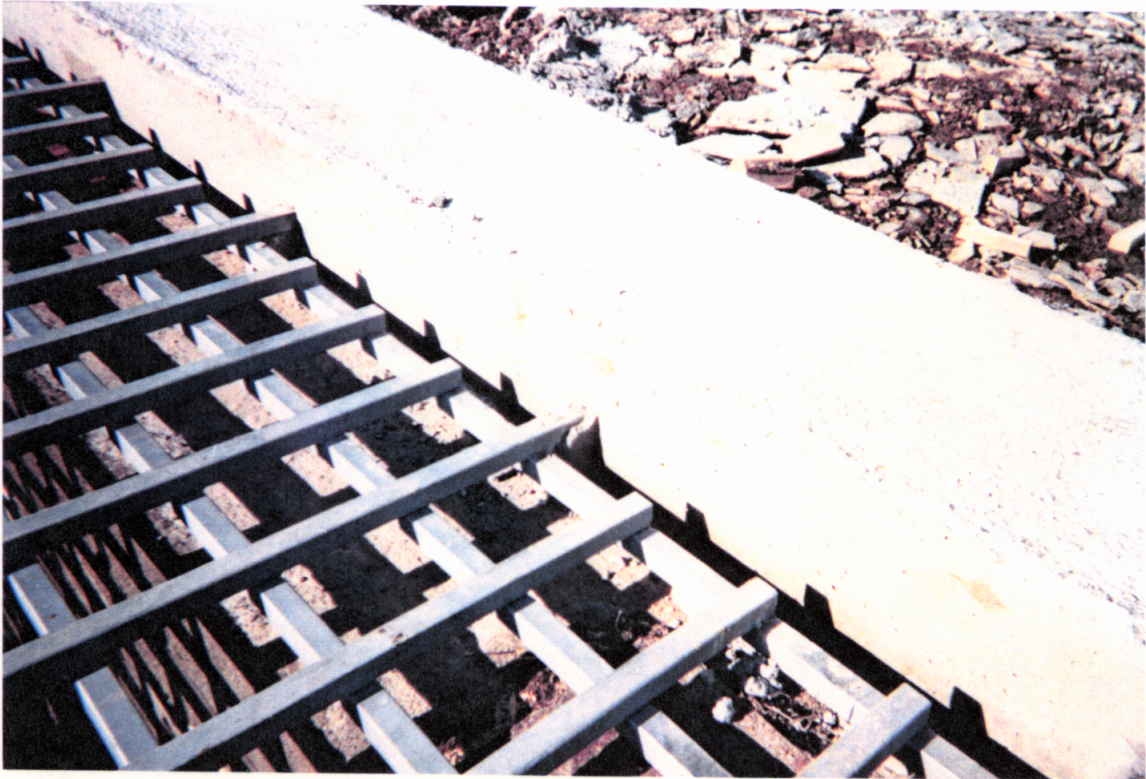
PHOTO NO. E-9: Close-up of concrete collar showing bars extending into concrete.

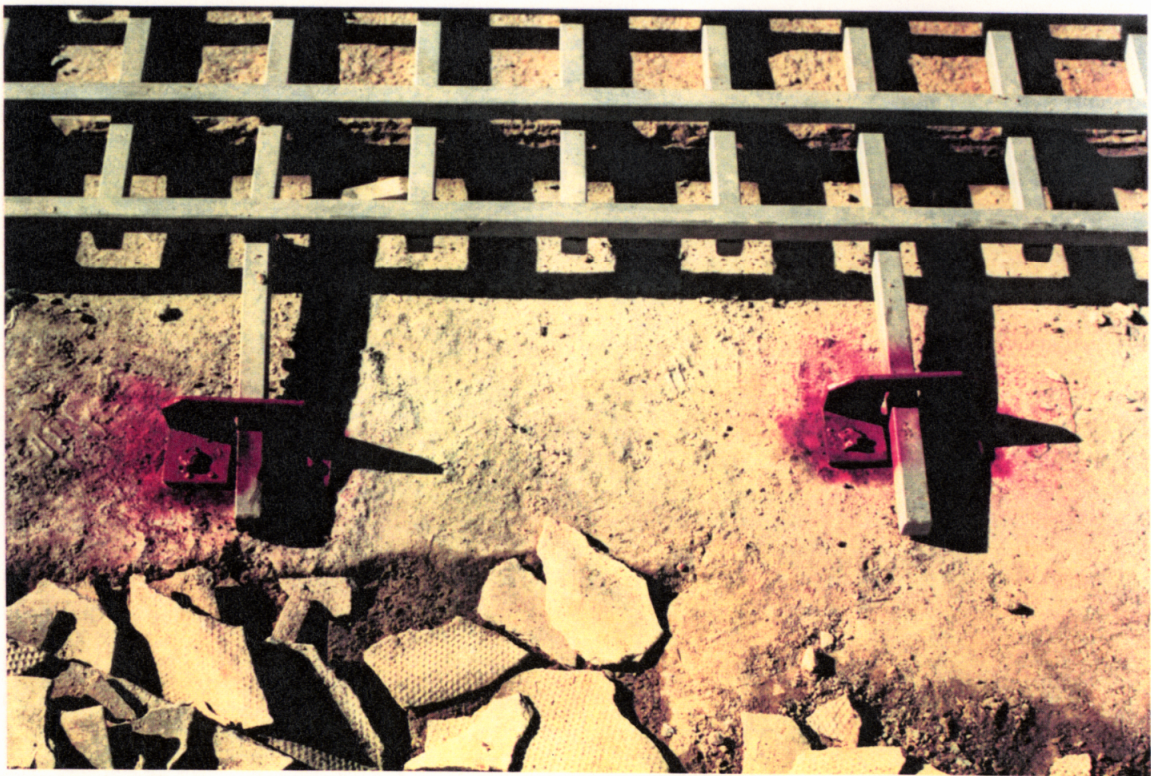
PHOTO No. E-10: Close-up of steel anchor brackets.
