Open File Report ME 1996-016

**Spillway Design/Construction Report
Stirling Mine Site
Richmond County, Nova Scotia**

File No. 24-3594-008-1

March 1996

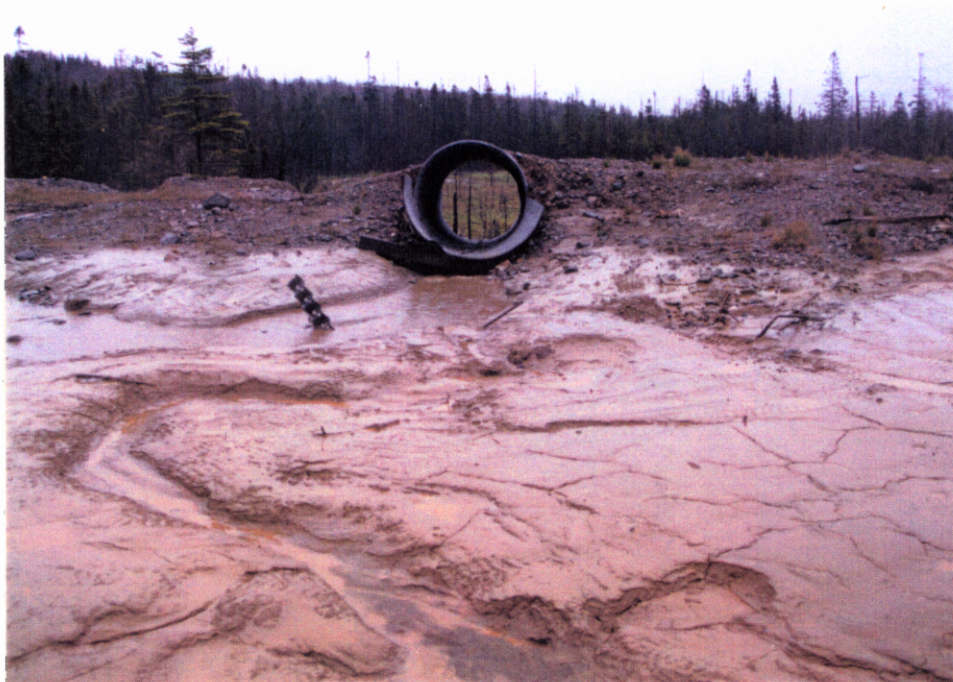
The pre-construction conditions at the spillway site and shown on photographs No. 1 and No. 2 provided in Appendix B. The existing galvanized culvert was removed by the contractor. The culvert installation included a large concrete counterweight which was buried in the embankment slope. The occurrence of the counterweight was not expected and considerable effort was required to excavate this concrete block and backfill the void. Locally obtained borrow was used to backfill the excavation. The backfill was placed in lifts and compacted with a vibratory plate.

Photo #1: Discharge Structure Intake prior to upgrade. Note runoff water flowing under culvert.

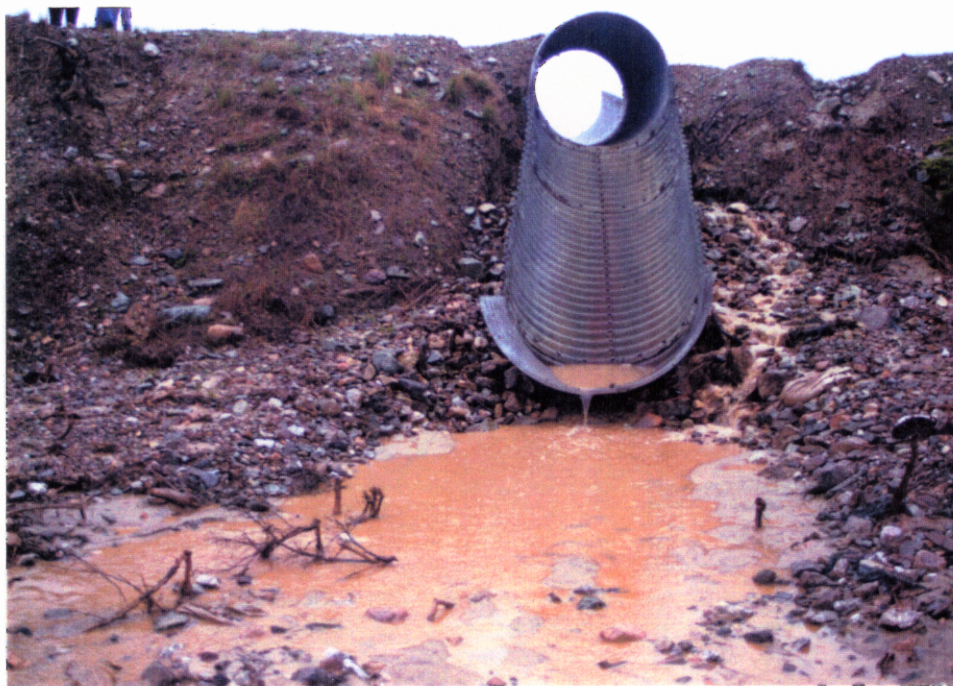
Photo #2: Discharge Outlet prior to upgrade. Note erosion and seepage to right of pipe. Sediment evident in discharge flow.

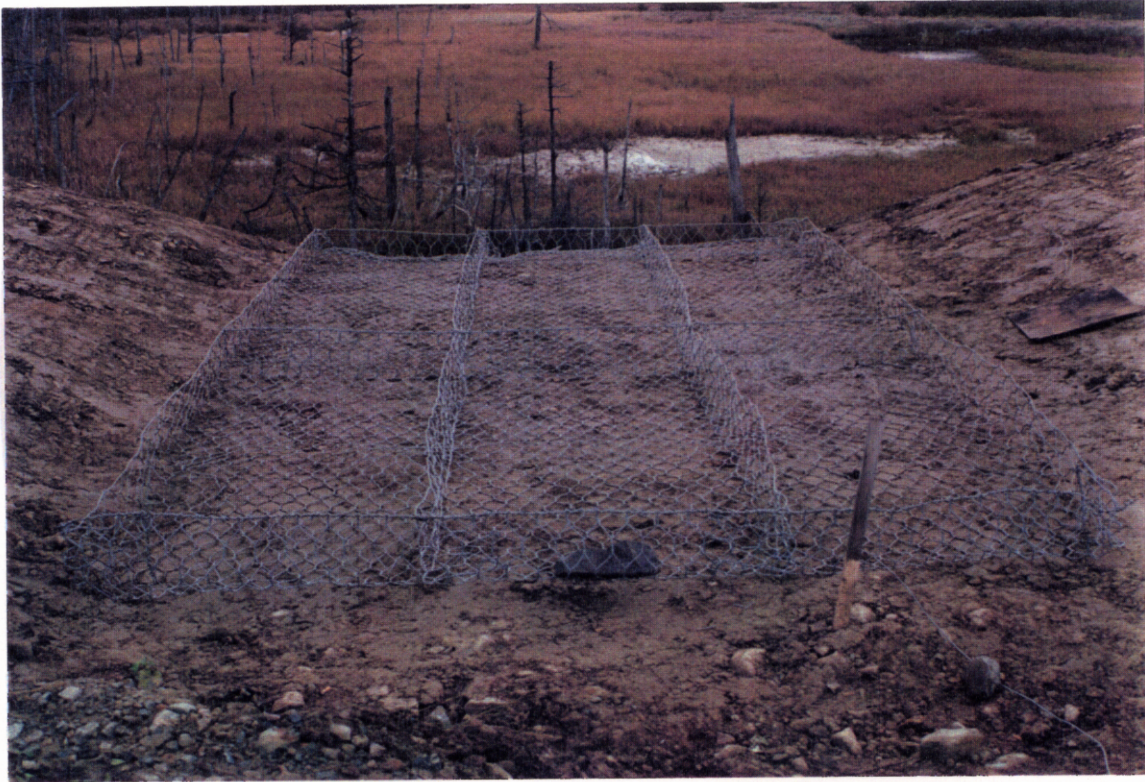
The "prepared" surface for the spillway is shown in photograph No. 3. The surface was heavily compacted and considered to be not easily erodible. Initially we had considered using a geotextile to separate the embankment soil and the gabion mattresses. However, based on case histories and the manufacturer's recommendation, we deleted the geotextile to reduce the potential for sliding of the mattresses. Instead, sand was sluiced into the rockfill to create a filter and enhance "contact" between the soil and the gabions. A geotextile was placed around the gabion baskets at the intake to reduce the potential for fine material in the tailings basin to migrate through the coarse rockfill. This is shown in photograph No. 4.

Photo #3: Gabion Mattresses placed on heavily compacted glacial till berm. Sand placed latter to provide cushion/filter with rockfill.

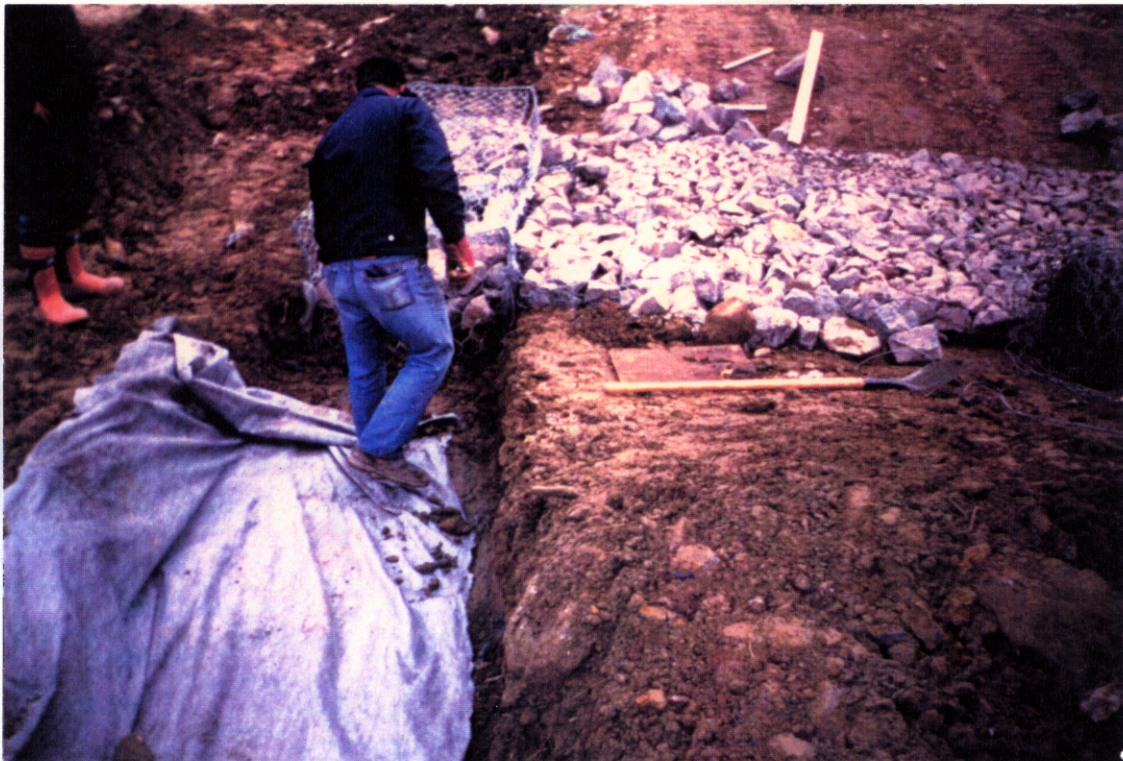
Photo #4: Construction of Spillway Intake. Gabion Baskets countersunk into existing glacial till embankment.

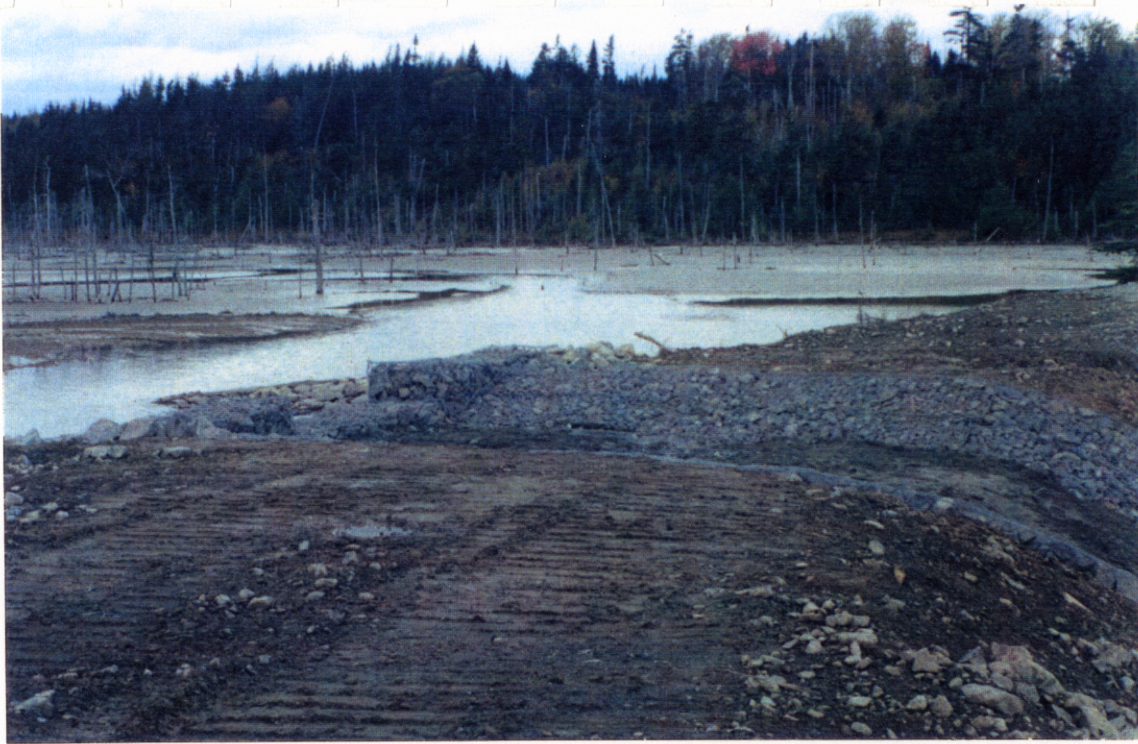
The completed spillway structure is shown in figures 5 and 6. The photographs show the rip rap material that was placed at the intake structure and the discharge outlet to prevent scour.

Photo #5 (above): Completed Spillway. Note ponding of water in tailings basin.

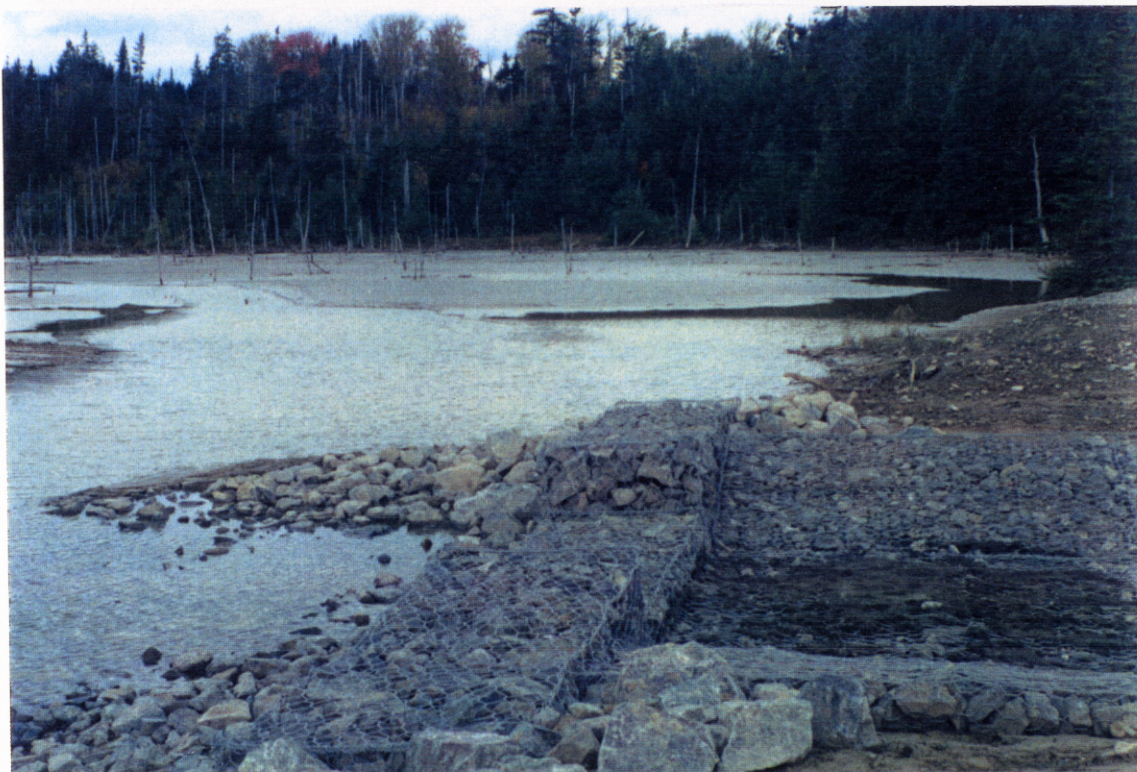
Photo #6 (right): Close-up of Completed Spillway Intake. Rip Rap placed at abutments for scour protection.

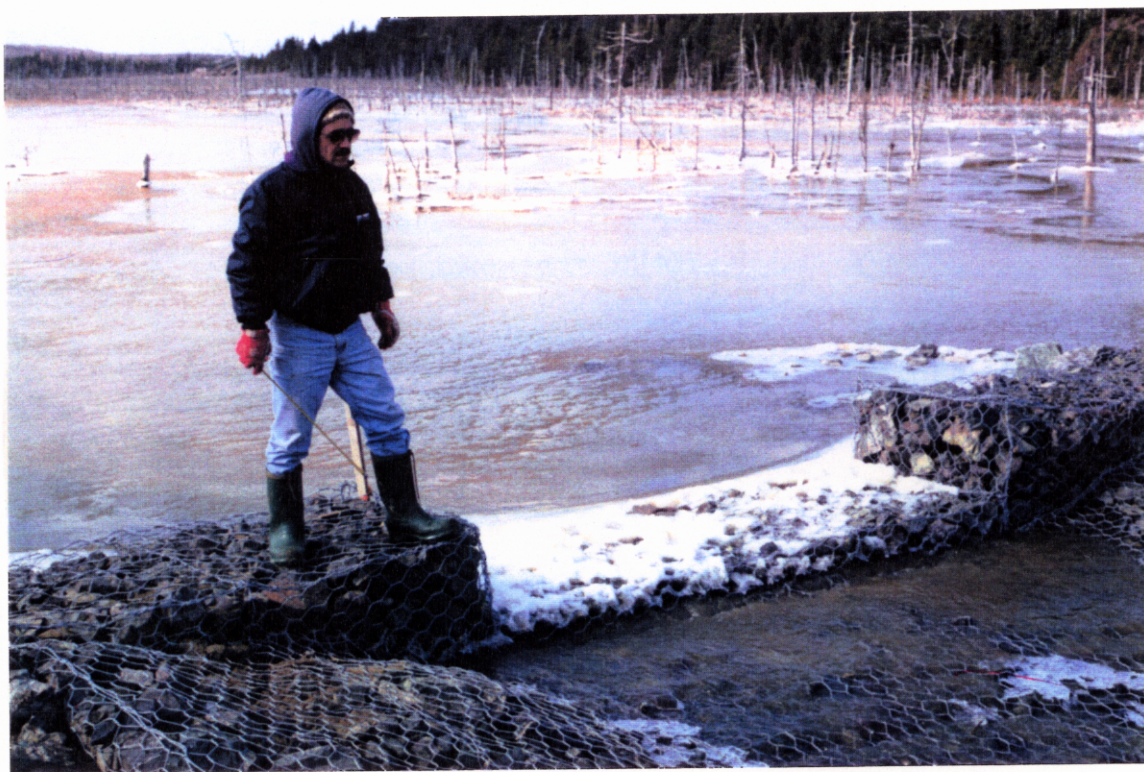
The inspection on February 18, 1996 showed that the structure was performing satisfactorily. Photographs No. 7 and 8 show the runoff discharge on that date. The water in the tailings basin ponded to a depth of approximately .3 to .4 metres near the discharge and tapered to 0 at approximately 100 to 150 metres into the basin. The discharge was relatively free of suspended sediment. There was no evidence of scour along the structure. As previously noted, the flow tends to travel in the upper level of the gabion mattresses and slightly above.

Photo #7: Spillway Intake approximately 12 hours after 60 mm rainfall event on February 17, 1996.

In conclusion, the rockfill gabion spillway is performing satisfactorily. It is recommended that the department make annual inspections of the structure. The buildup of sediment in the area near the discharge should be observed to determine if periodic dredging is required.

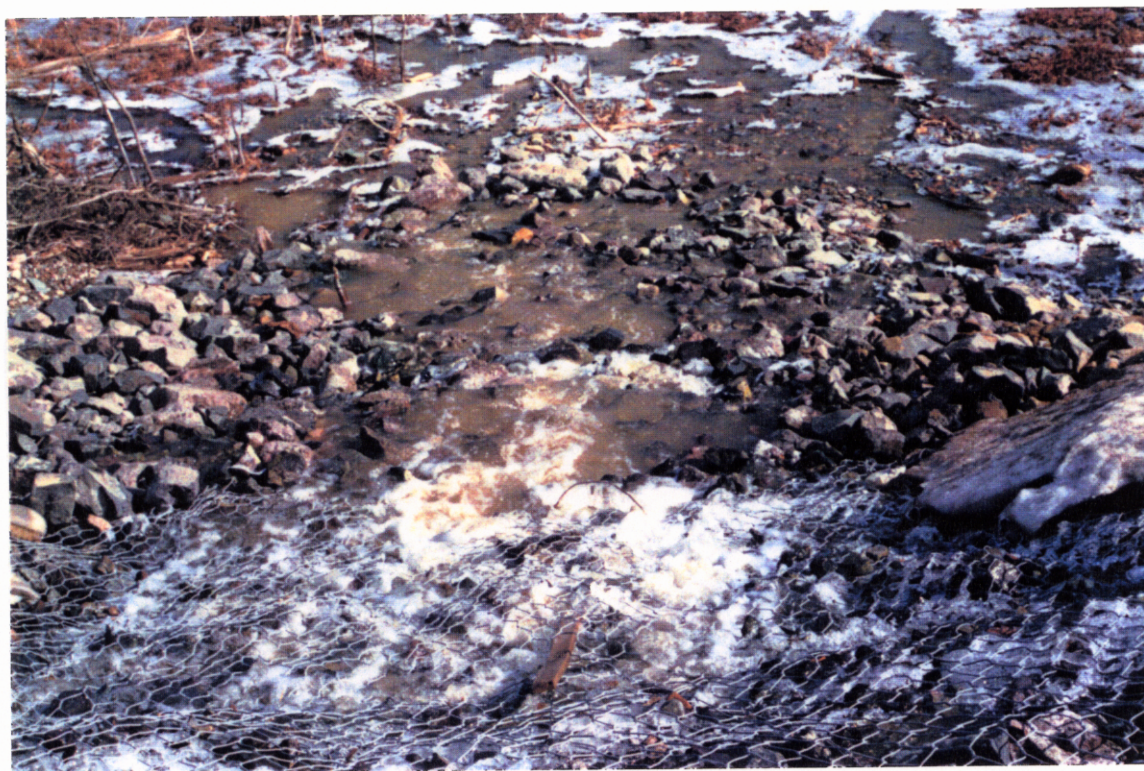
Photo #8: Spillway Discharge on February 17, 1996. Discharge dissipated at outlet. Sediment loading in discharge water appears to be diminished from pre-construction flow.
