## Northern Pulp – Effluent Pipeline Issues

**SJC Materials Engineering Ltd.  
Report Date: Sept 30<sup>th</sup> 2020**

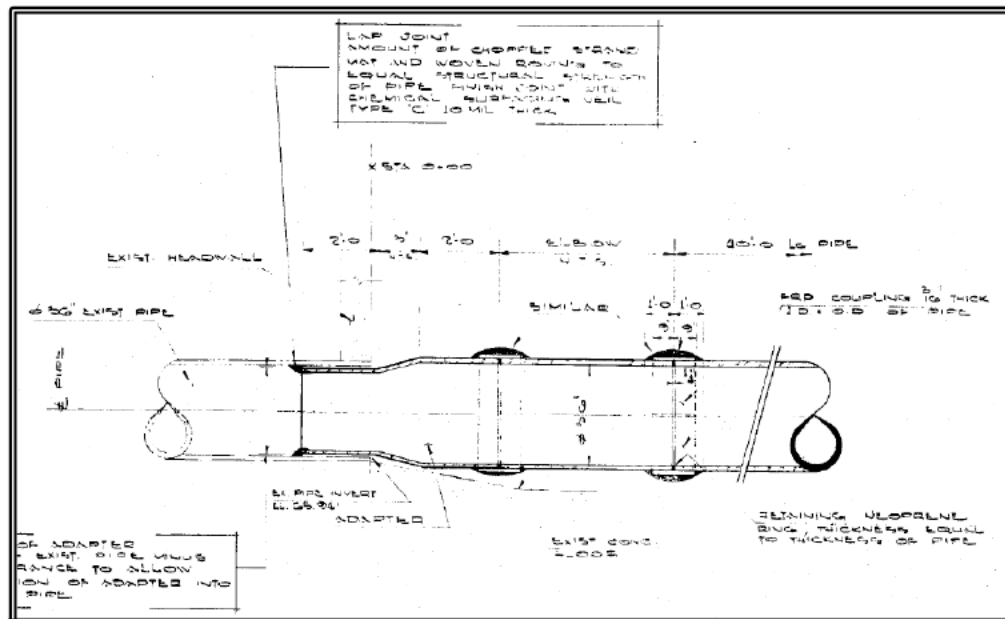
The extract below is taken from BEAK drawing 3828-2B-1 (01-060830-0007.pdf) dated 14th Feb 1972. The drawing of the pipe joints seem to show that there is a neoprene insert in the gap between the pipe ends and what seems to be a collar that fits over outside of the pipe ends such that the pipes are then slid into it (see excerpt in Figure 1) which shows *“FRP Coupling 3/16” thick ID=OD of Pipe” is then over-wrapped with “7 layers of chopped strand mat + 6 layers of woven roving 12” wide impregnated with bisphenol fumarate resin and painted with resin containing air-dry additive”*.

It is not clear if the coupling is bonded to the pipe with resin or not. If it is not, then the butt and strap overwrap on the outside of the pipe is not fully bonded to the pipe but to the coupling and is only bonded to the pipe past the edge of the coupling. This is not a common approach. Normally the bare ends of the pipe that are being joined together are put as close together as practical. The outsides of the two pipe ends is ground to a 6:1 taper and the exposed joint is wrapped with structural FRP laminate sequence and a resin rich layer (corrosion barrier) is then applied on the exterior. If there is access to the inside of the pipe, the remaining gap in the inside of the pipe is then filled with a “putty” mixture of resin and milled fiber and a corrosion liner is applied to the inside over the joint to prevent wicking of the pipe contents into the putty plug and the structural laminate on the outside of the pipe.

From the drawings 01-060830-0007.pdf it is not clear if the dry coupling and neoprene gasket method is how the entire pipeline is made or if it just refers to the 1972 modifications. If the entire pipe was made like that, it goes some way to explaining why there were problems with the joints. If this is how the pipe was joined together, inspection of the leak-free path (the bond between the external FRP wrap and the pipe) even from the outside would be extremely difficult. Once

the effluent in the pipe was able to breach the corrosion liner on the inside and passed the neoprene insert (which may or may not form an effective seal) attack of the external over-wrap could easily result. This would not be obvious to the designers if they assumed that the neoprene “insert” was acting as a “seal” and would not be at all apparent to the pulp mill owners of the pipe if they were not aware that the pipe had been constructed by this non-standard means when the system was owned by the Province.

**Figure 1. Excerpt from the BEAK drawing of 1972. This shows an unusual jointing detail.**

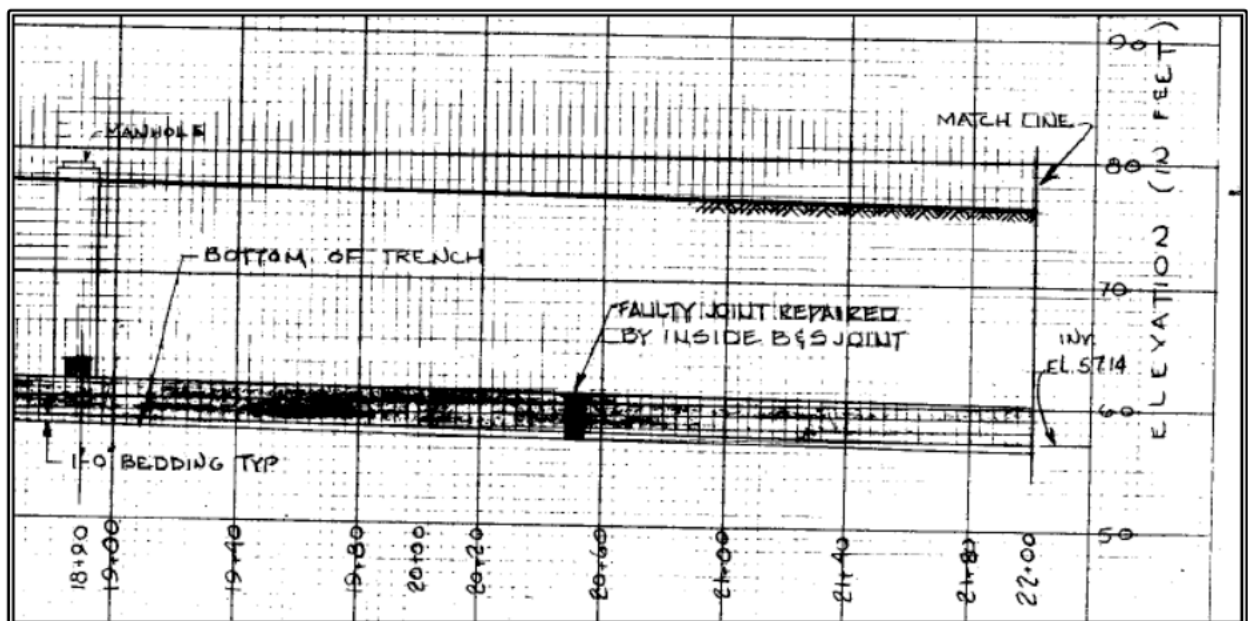
Work was done in 1976 (Montreal Engineering Co. Ltd. Drwg. F63506 (01-060830-0018.pdf) to repair “*Faulty Joint by inside butt and strap joint*” (Figure 2), which means there was no replacement or modification of the joint on the outside of the pipe. This is a practical approach given the difficulty (and therefore the cost) of finding the exact location, excavating around and under the pipe then cleaning it and providing safe access and egress for the workers. When excavating buried pipe there is also a risk of damaging the pipe and this is particularly true for non-metallic pipe which are more at risk of mechanical damage than steel or concrete pipe. Application of an “inside butt and strap” implies that a significant strength layer was added on the inside, which should be at least as strong as the joints described in 1972. It is also assumed that by 1976, repairs would be made with vinyl ester resin, which would have improved chemical resistance to the bisphenol-A fumarate that the original pipe was made from.

**Figure 2. Excerpt from 1976 Montreal Engineering Drawing F63506 (01-060830-0018.pdf) that shows a “Faulty Joint” was repaired.**
