# Highway 101 Digby to Weymouth North Road Safety Review

April 2015

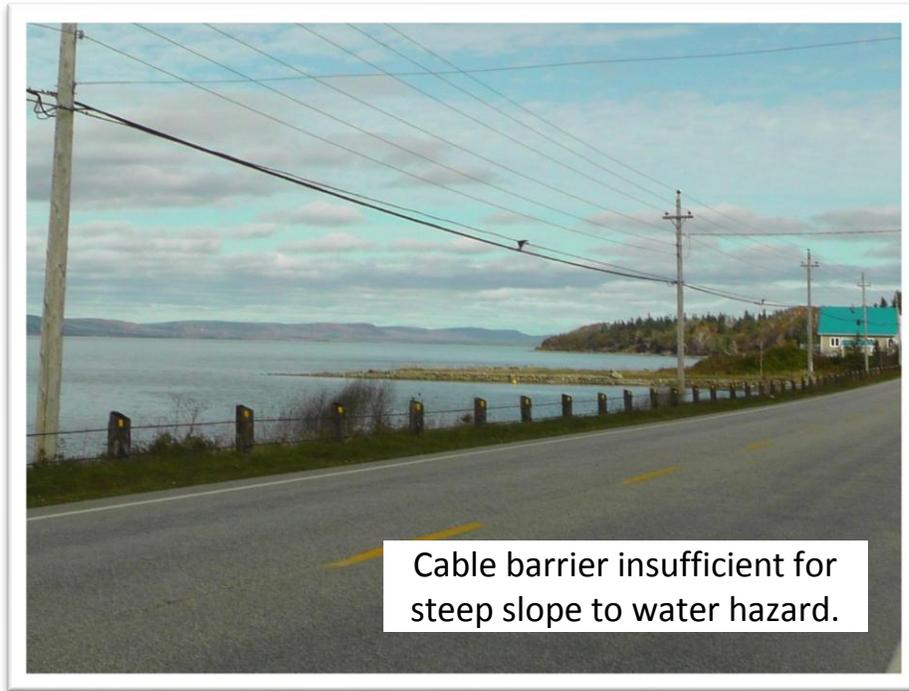
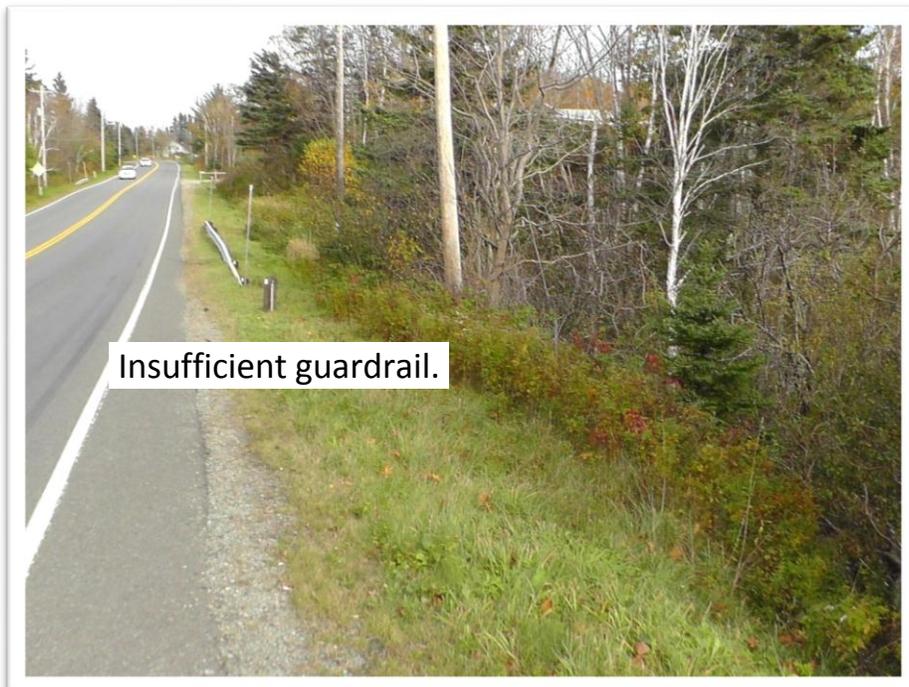
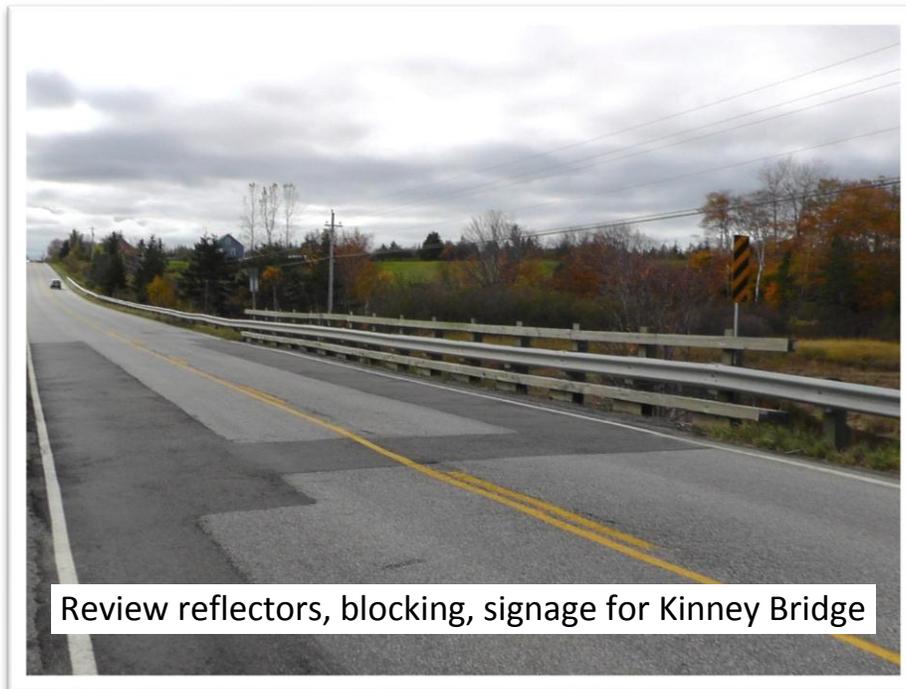
There are numerous locations throughout the study area where 6 x 6 wooden posts serve as roadside or intersection delineators. These posts present a hazard to off tracking vehicles and should be replaced with flexible guide posts in areas where additional road-edge delineation is found to be required or with guardrail where it is warranted. There are several low-tension cable barrier installations along the corridor as well. At these locations, cable barrier deflection distance extends to or beyond the hazard it is meant to protect and does not properly shield the driver from the hazard. Some roadside hazards located in the area do not appear to be protected by barriers.

### Examples of Barrier Deficiencies

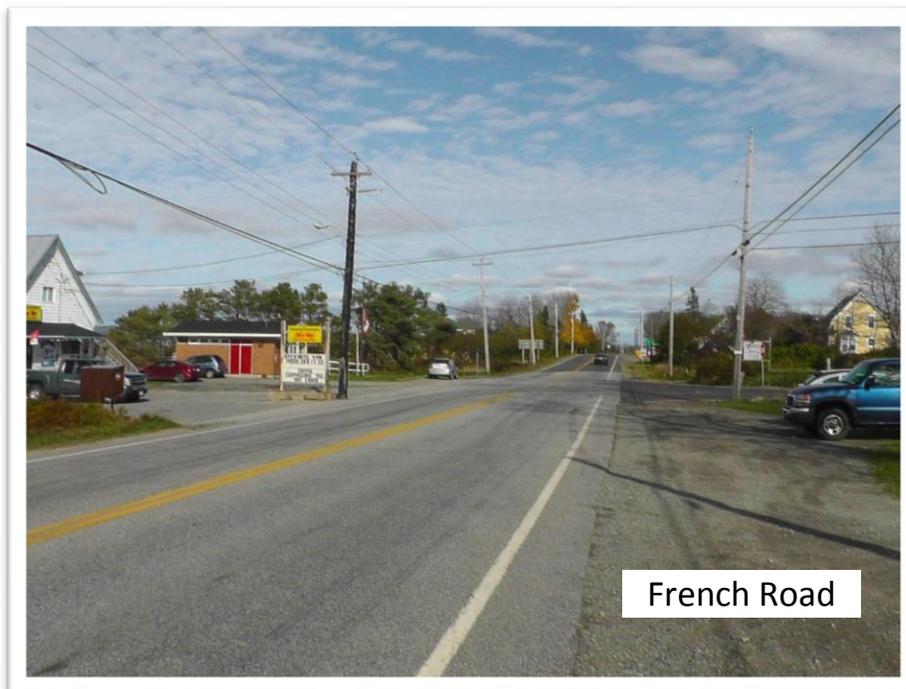
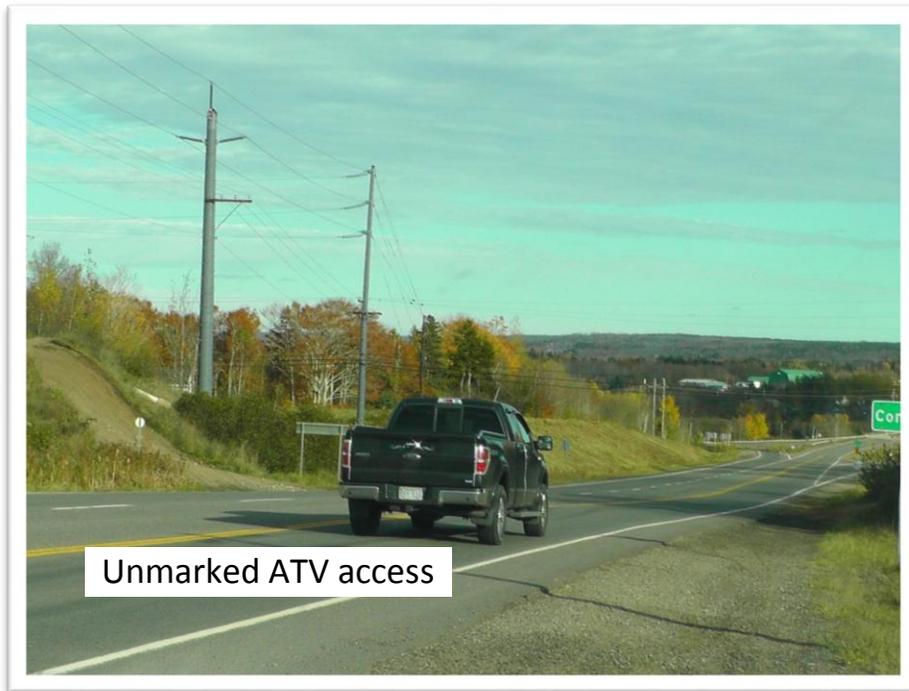
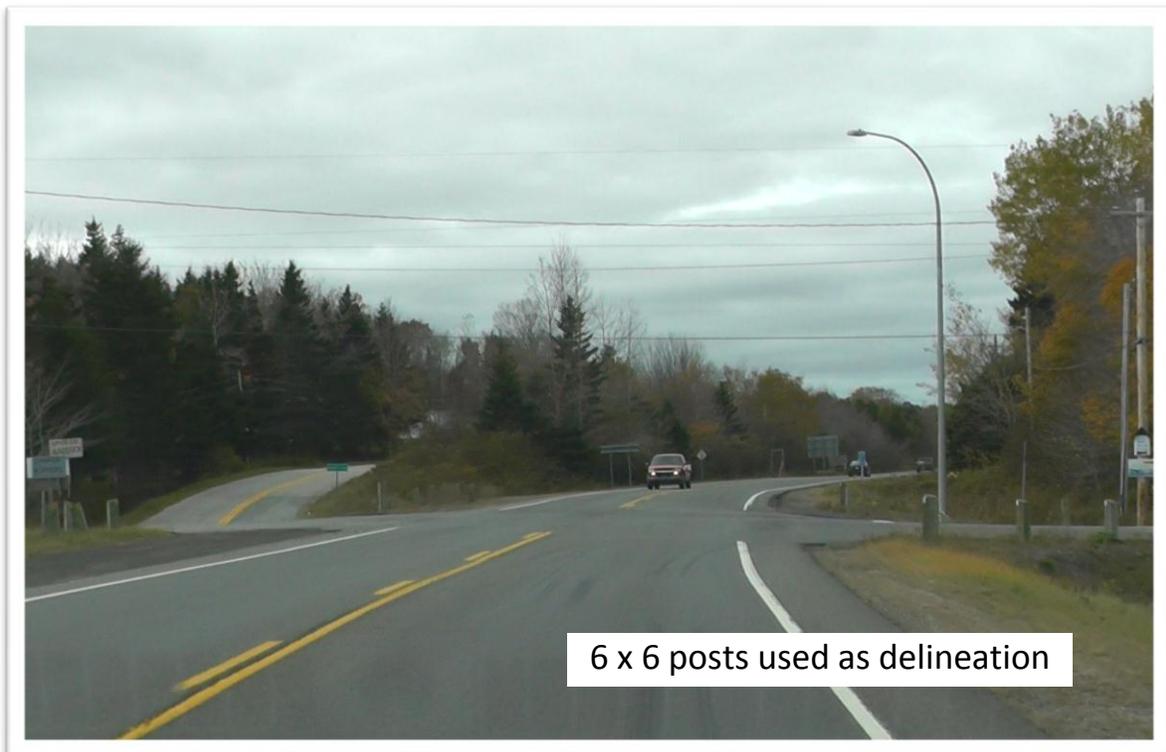
There are several intersections in the study area that lack advance signage. Some intersections lack delineation to indicate to the driver that a road intersects the highway. Some sections of the corridor have insufficient lighting and where lighting does exist several lights were not working. Proper illumination provides the driver with guidance regarding the alignment of the roadway. Regulatory and warning signs are inconsistent throughout the corridor. Guide signing at Exit 27, Weymouth North will be renewed in 2015 as part of a paving project. There were no observed deficiencies in pavement markings throughout the corridor.

Examples of Lack of Access Delineation

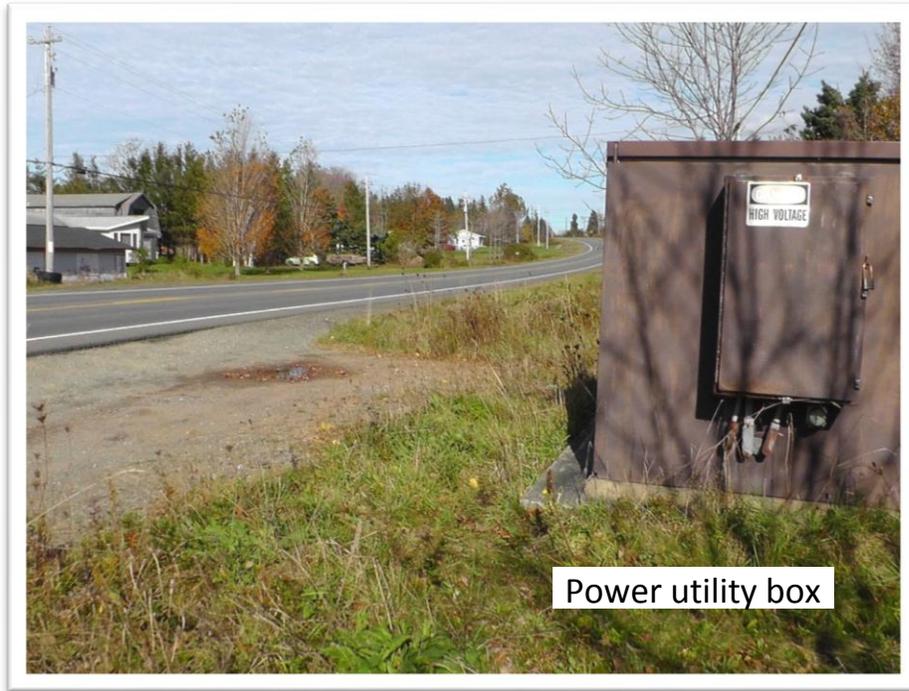
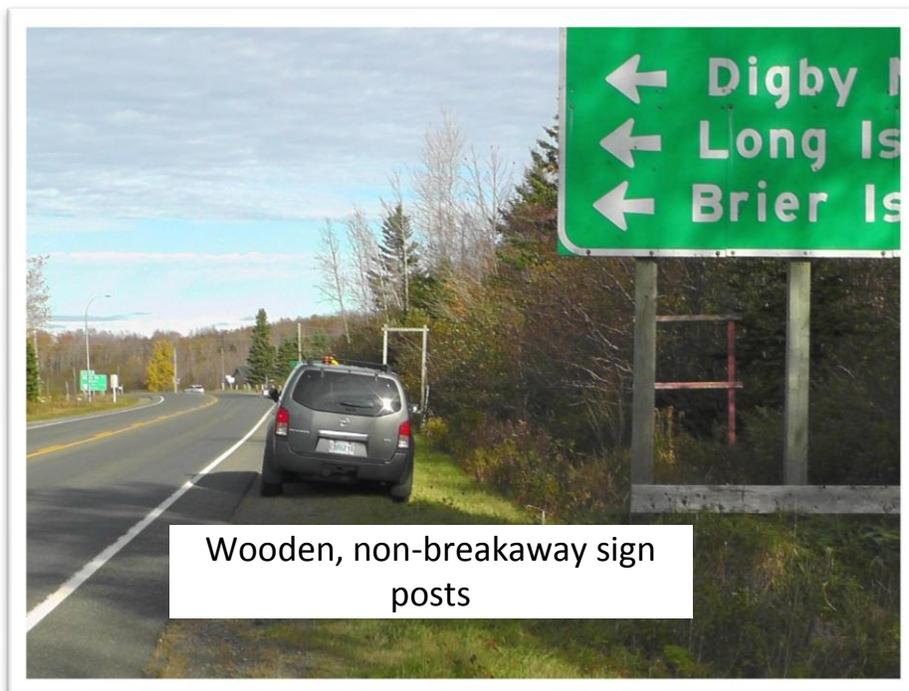
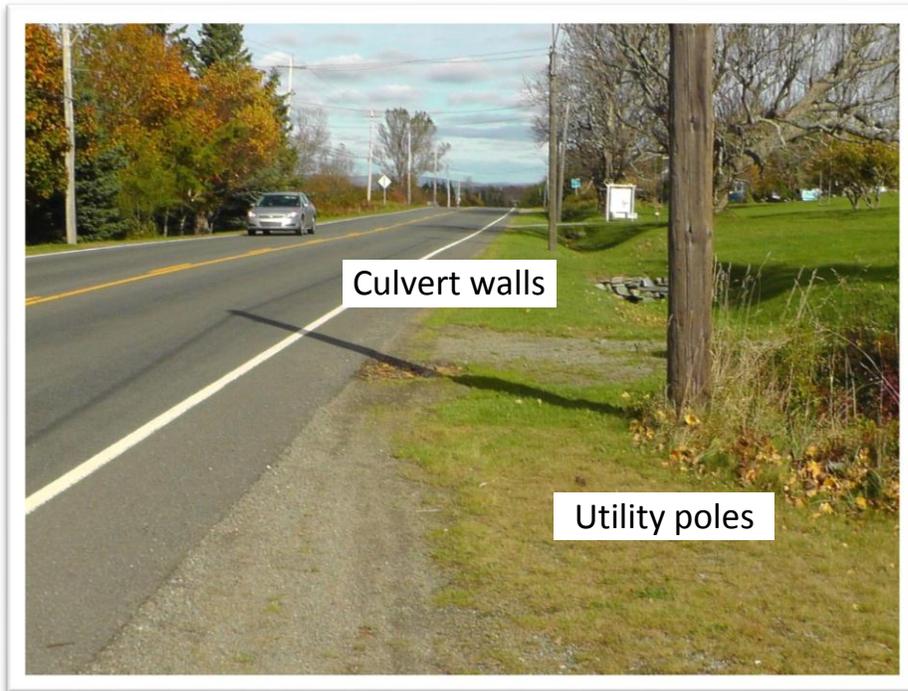
Of particular note is the unforgiving nature of the roadside in the study area with critical side slopes and hazards including utility poles, large trees, numerous other fixed objects and driveway culverts (steeper than 3:1) within the clear zone that could present a hazard if struck by a vehicle.

### Examples of Roadside Hazards in Clear Zone

Culvert walls

Utility poles

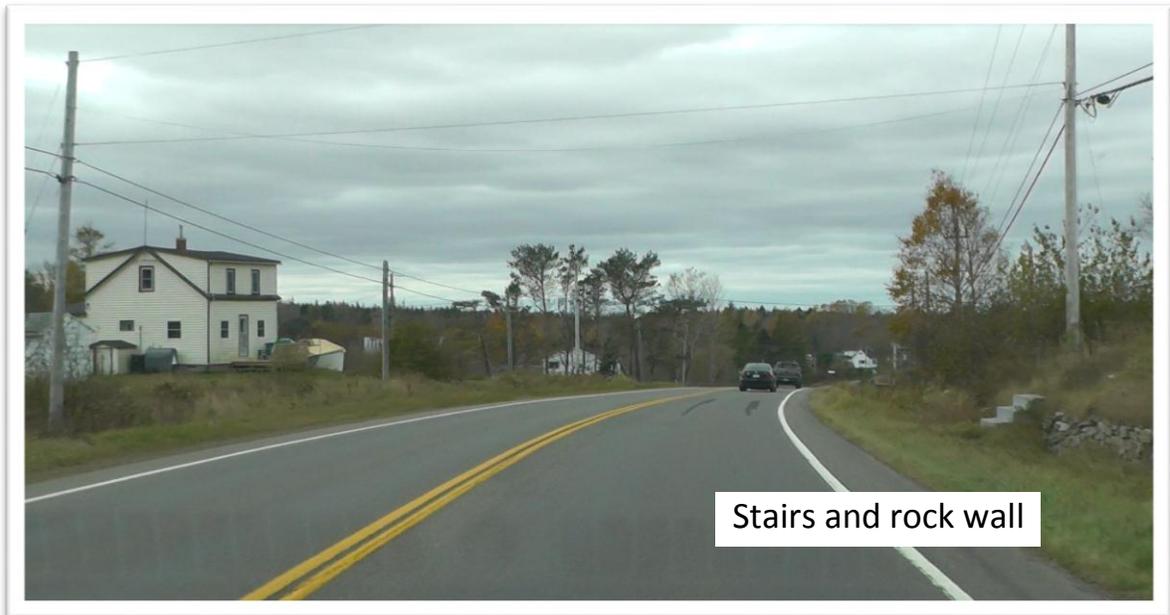
Stairs and rock wall

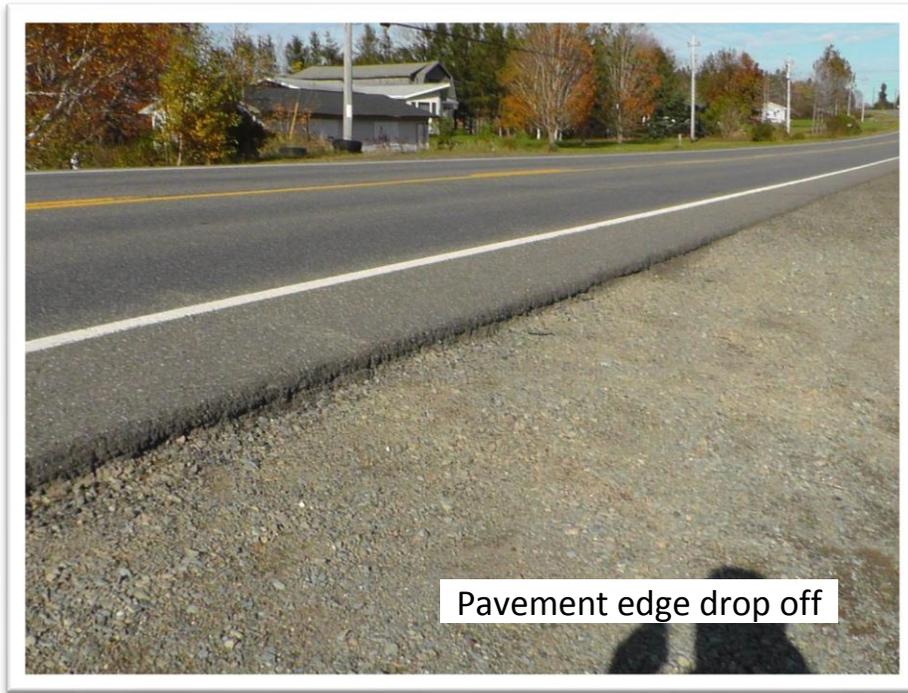
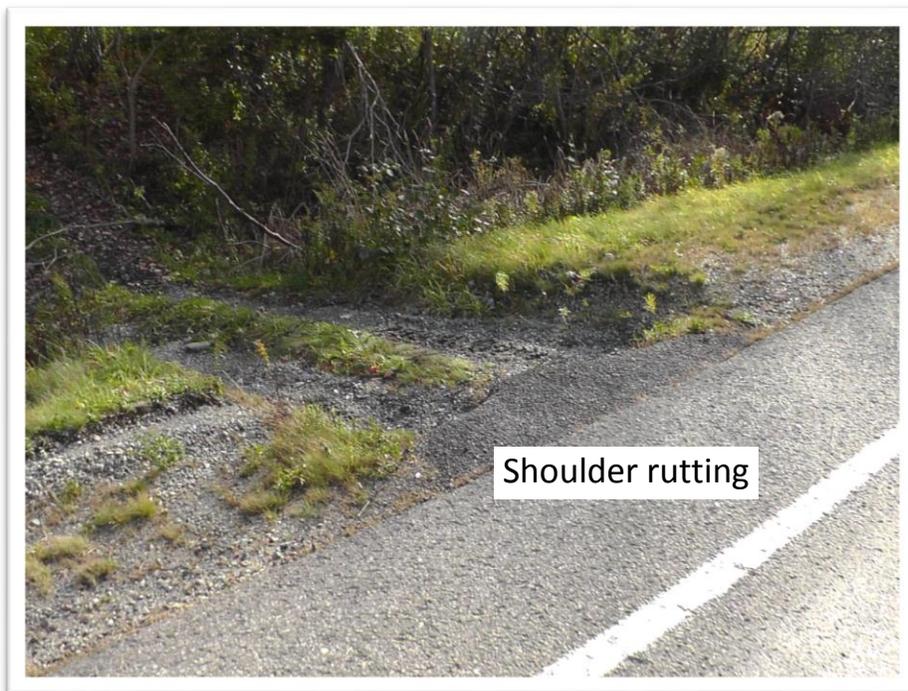
While it was observed that the pavement along this corridor was in good condition without any observable wheel rutting, polished surfaces, transverse cracks across the lanes or alligator cracking, there are many locations where the condition of the shoulder is an issue. Throughout the corridor there are gravel shoulders with pavement edge drop-offs, troughs that would hold water and furrows around barriers that don't allow water to run off the shoulder which present a significant hazard. In some locations along this corridor there isn't a full 2.0 meter shoulder width. If not properly and regularly maintained, gravel shoulders have a tendency to rut, slump or erode as was observed along this section of roadway.

### Examples of Shoulder Deterioration

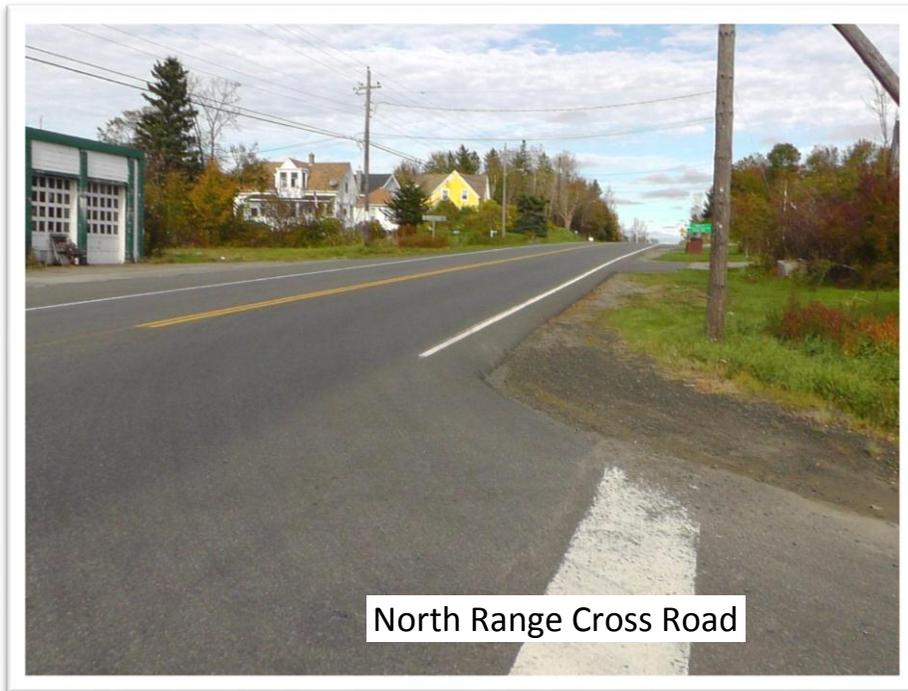
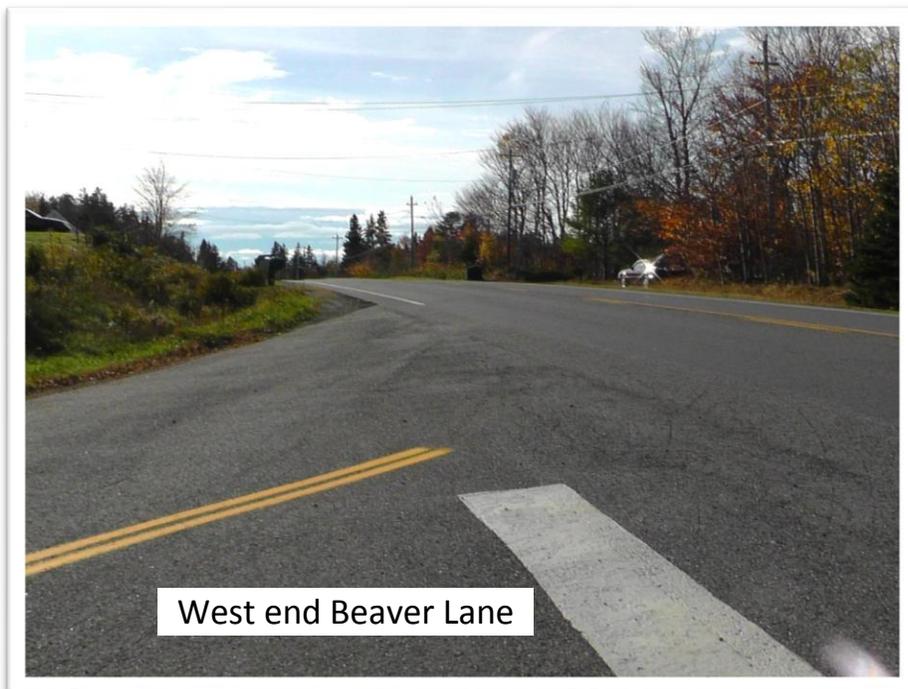
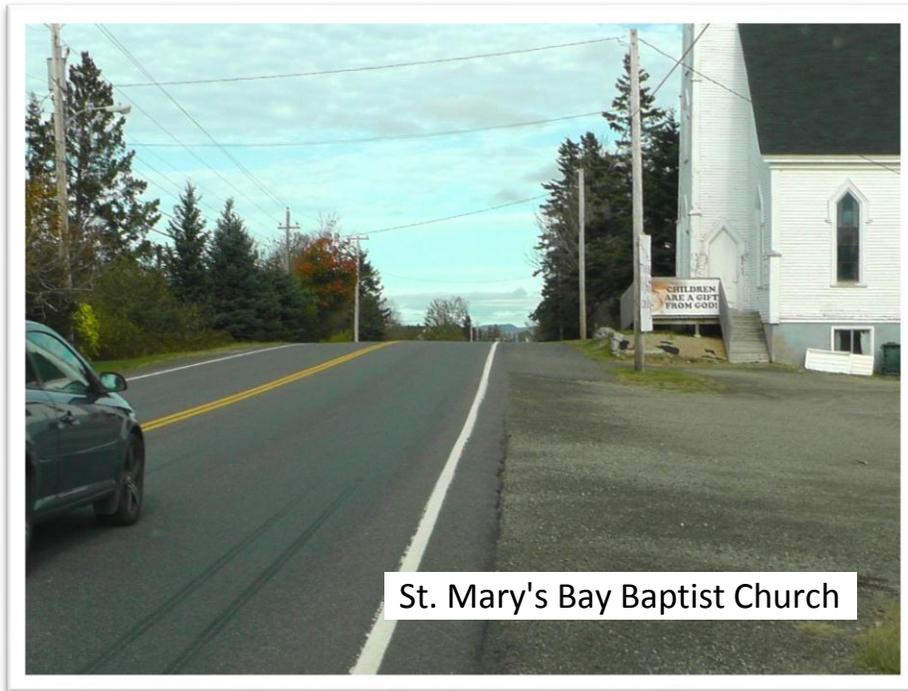
In several locations along the Digby to Weymouth North corridor stopping sight distances appear to be insufficient. Some of these locations are on horizontal curves, on crests, on sites with poor sight distance and are in close proximity to intersections. Parking on the roadside near accesses was observed at the scrap yard just west of Exit 26, the Barton and Plympton Post Offices as well as on both sides of the roadway at the convenience store opposite French Road. Sight lines are also restricted by roadside vegetation in some areas. There are several skew intersections along the corridor. Skew intersections may present a hazard to vehicles turning onto Highway 101.

### Examples of Insufficient Sightlines

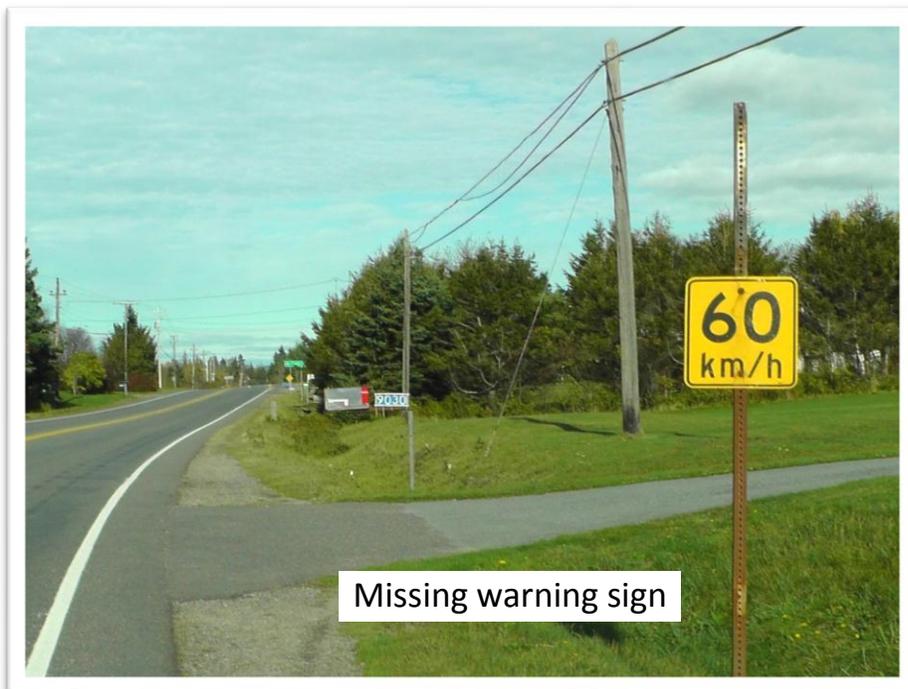
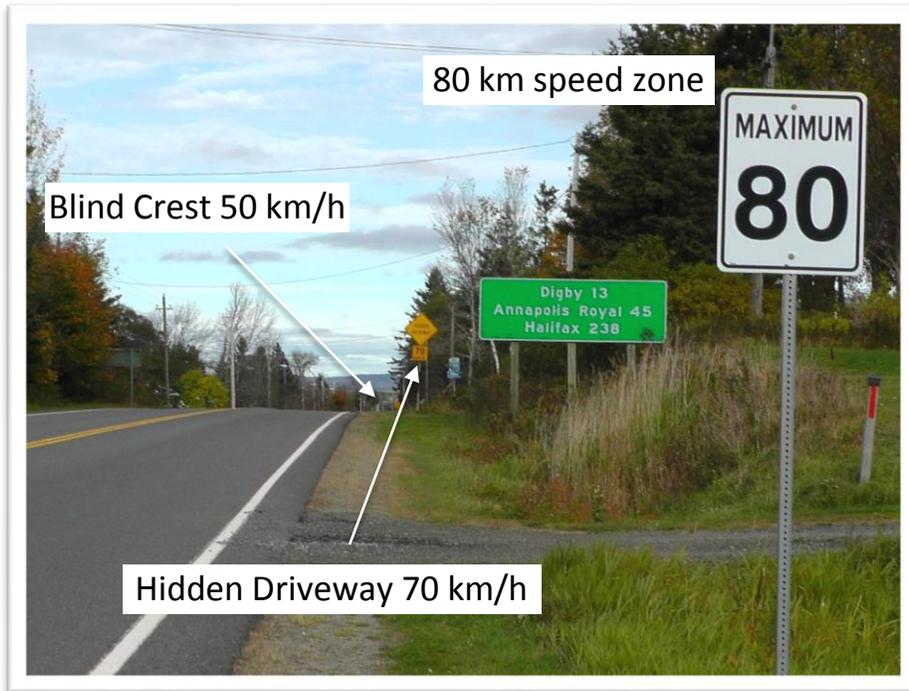
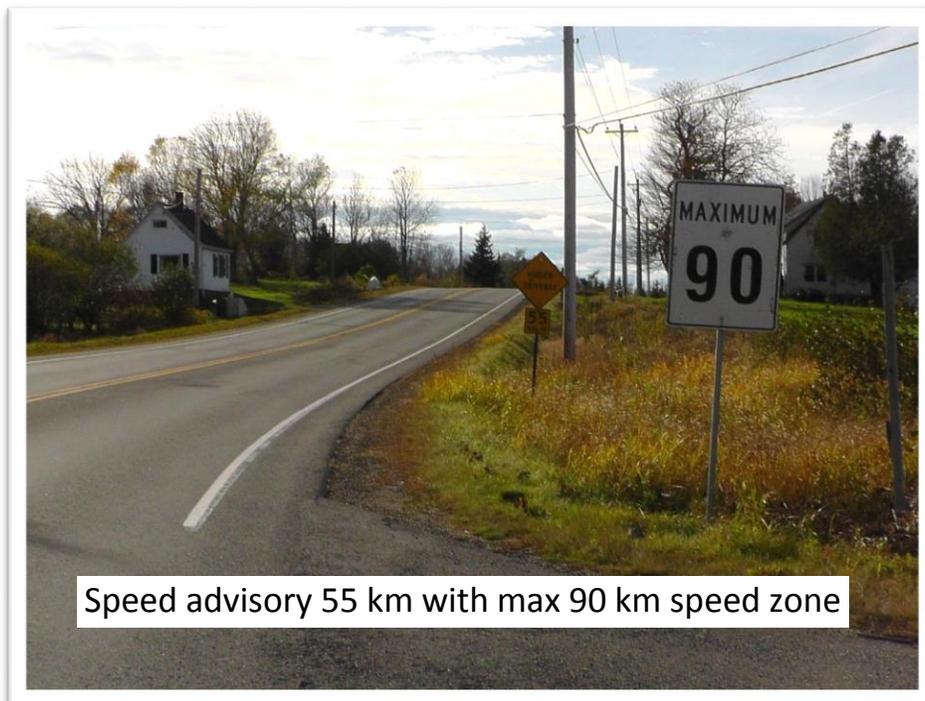
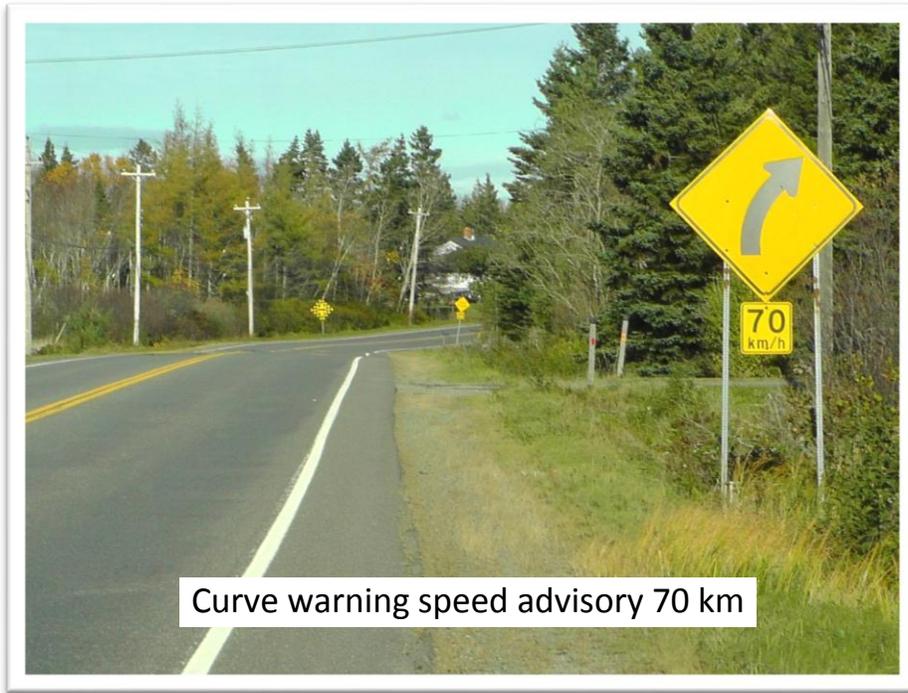
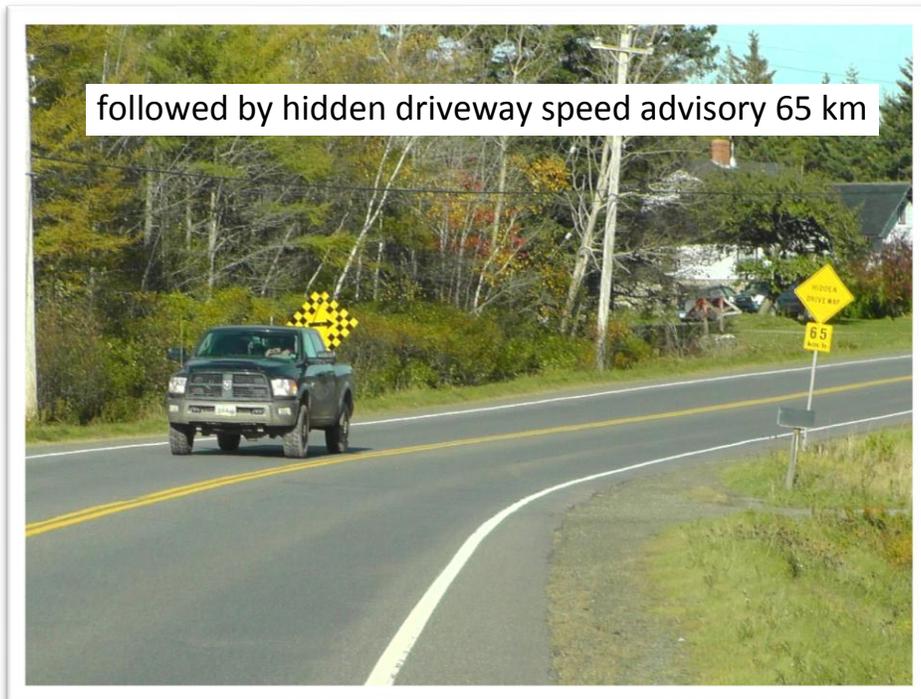
Examples of speed advisory sign issues
