Highway 105 Port Hastings to South Haven Road Safety Review

December 2016

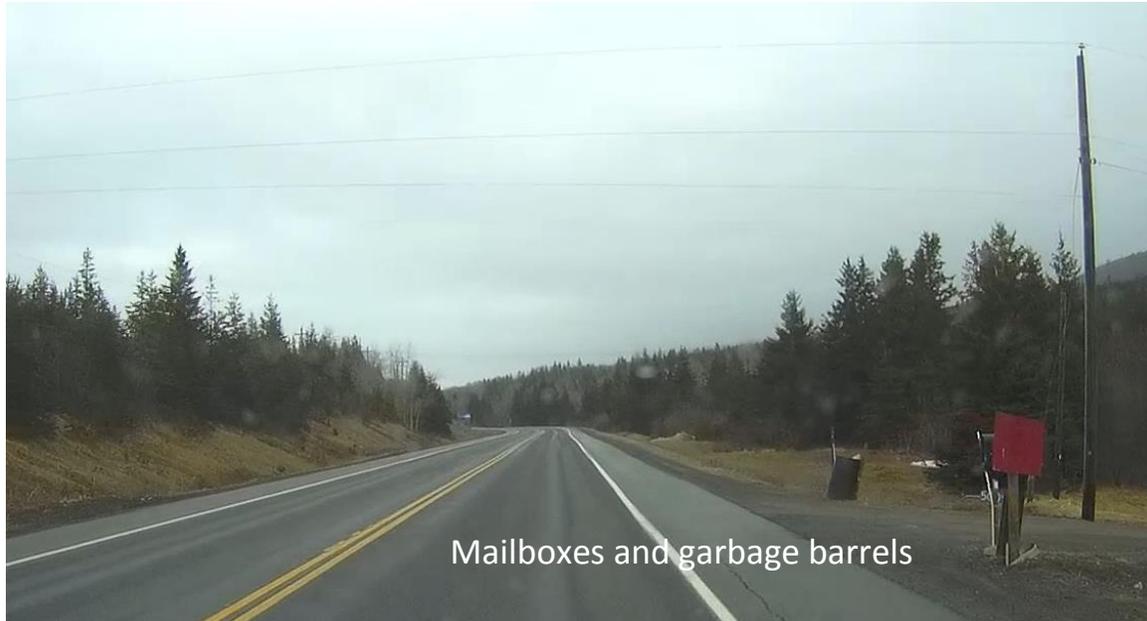
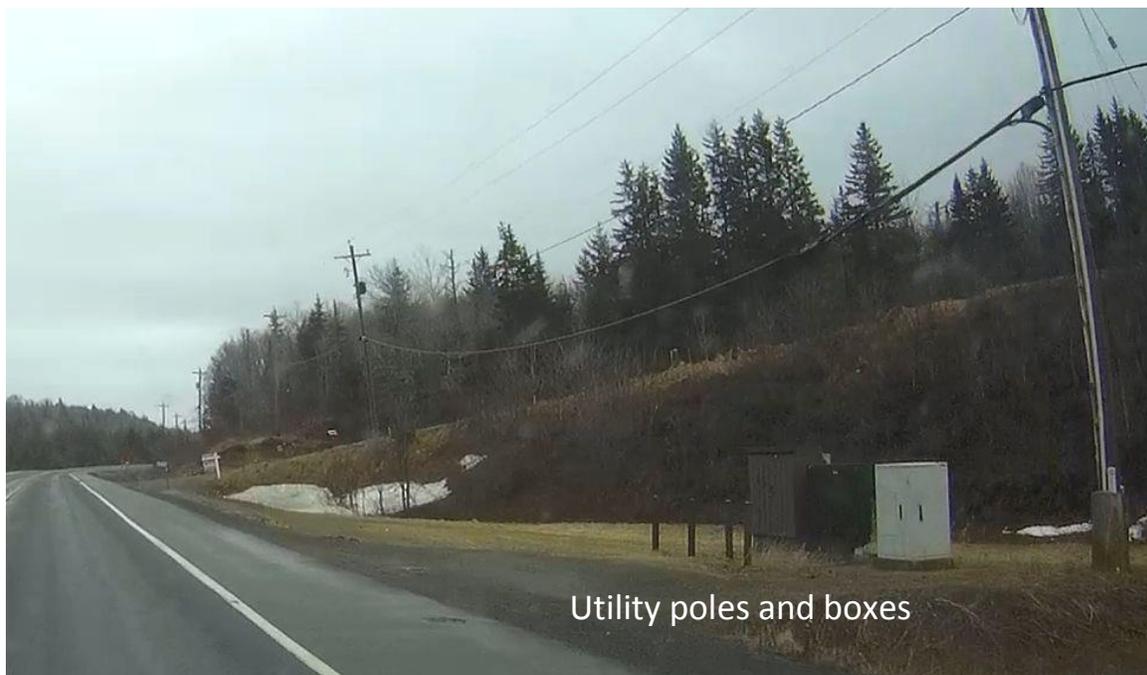
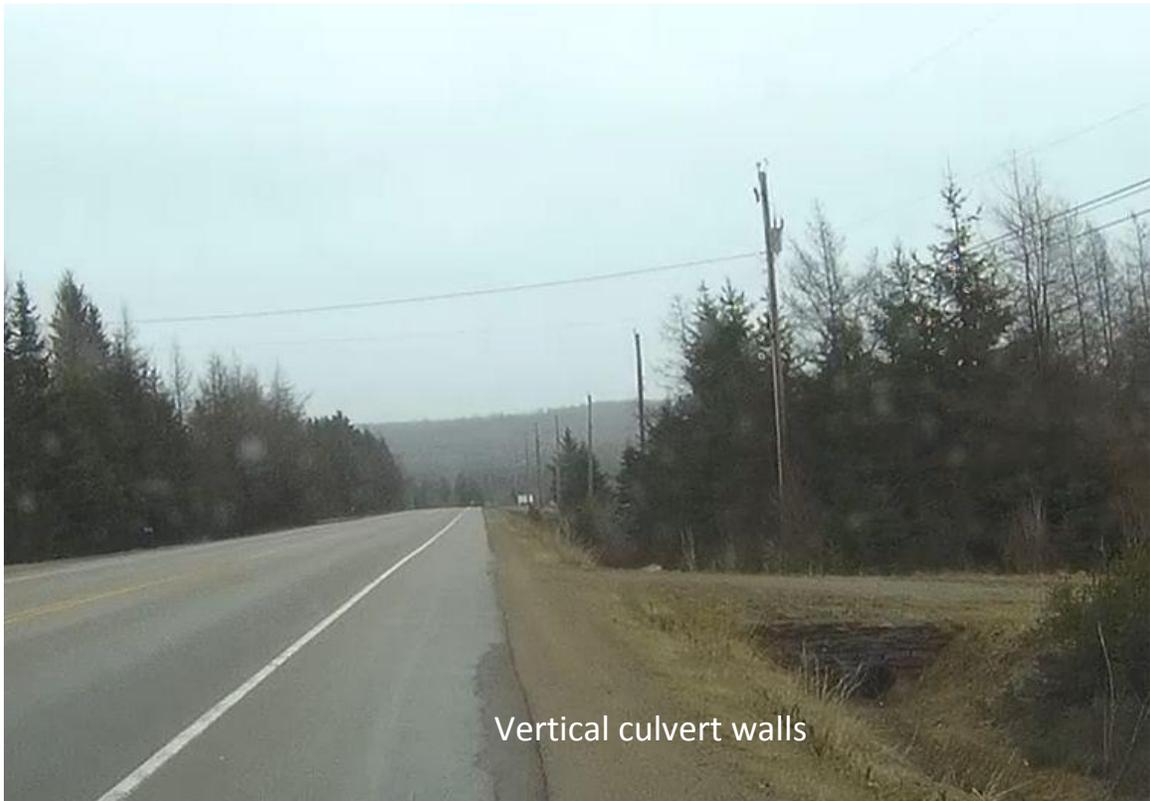
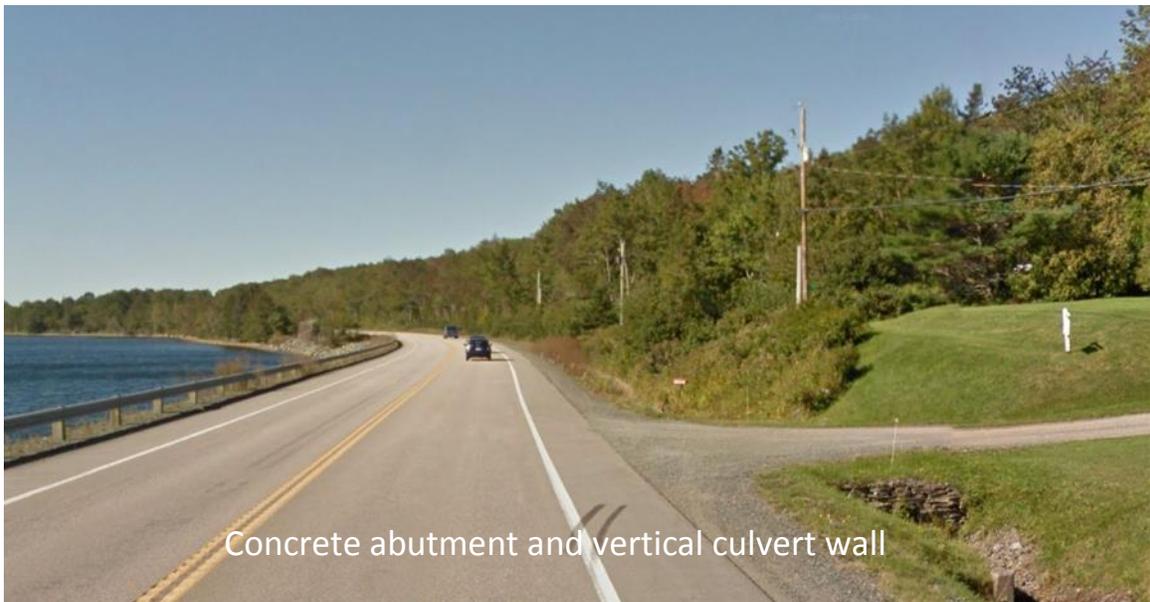
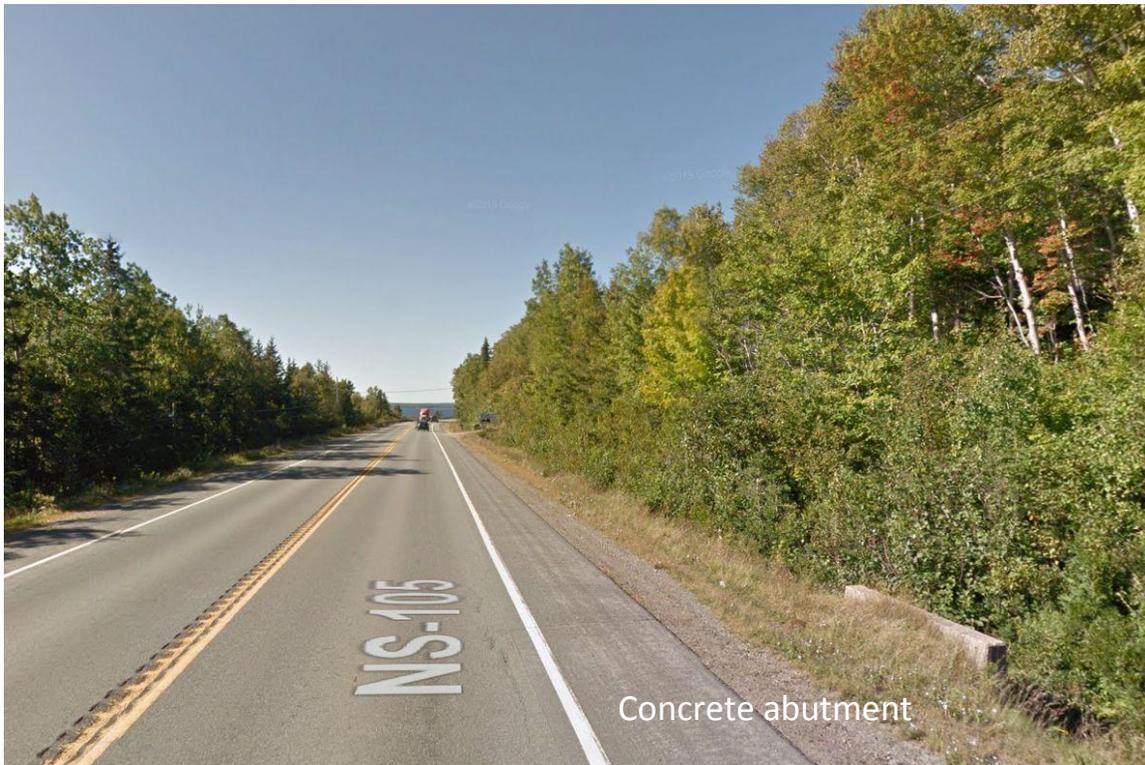
Examples of Objects in Clear Zone

There are utility boxes and poles, large trees, numerous other fixed objects and driveway culverts within the clear zone that could present a hazard if struck by a vehicle. (see Photos 1 -5)

Concrete abutment

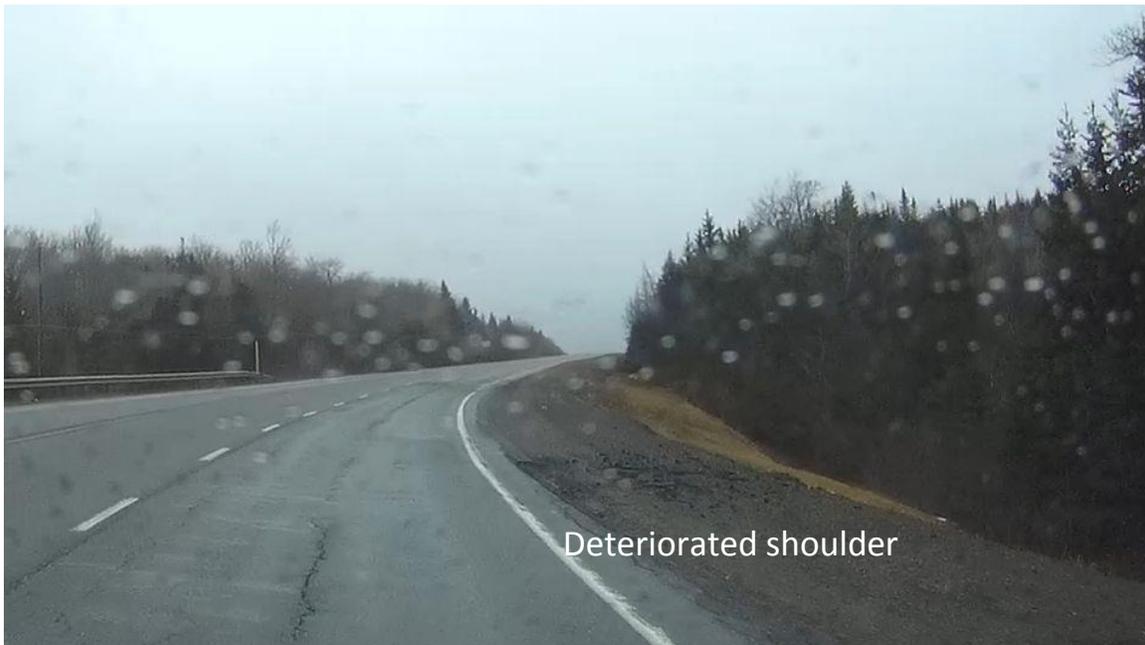
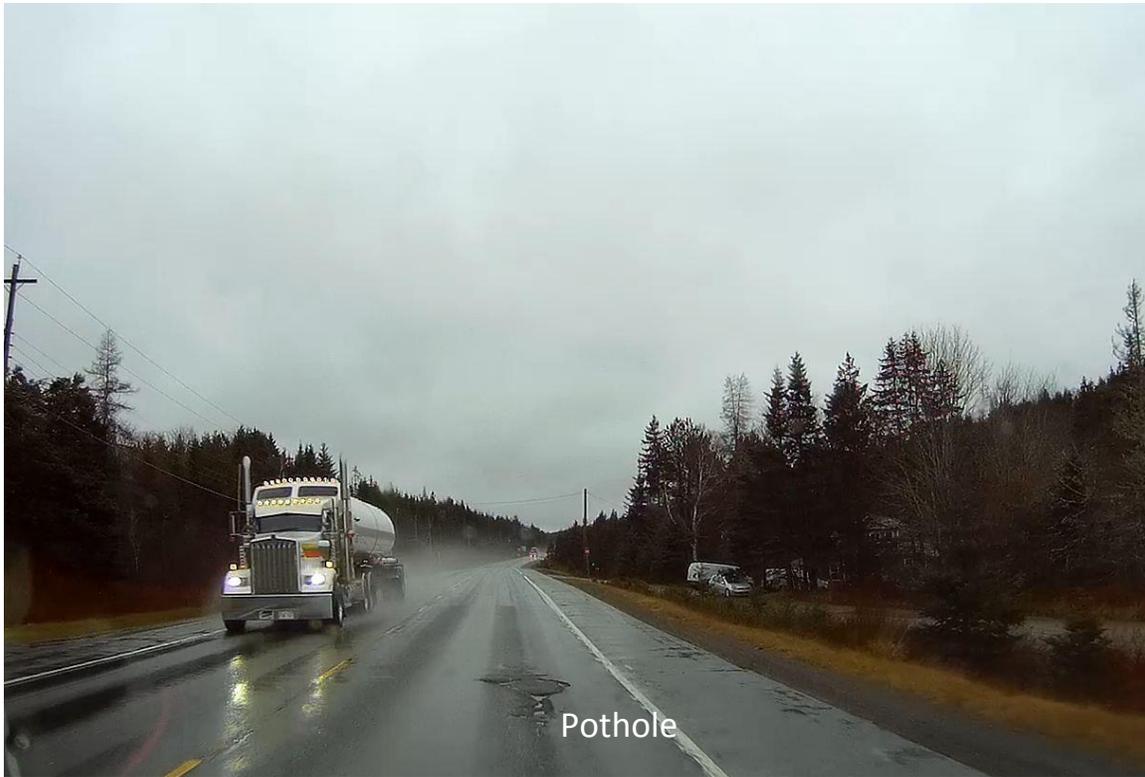
While it was observed that the pavement along this corridor was in good condition without any observable wheel rutting, polished surfaces, transverse cracks across the lanes or alligator cracking, there are a number of locations where large potholes were observed. (see photos 6 &

7) Bumps significant enough to warrant warning signs are also present and some asphalt overlays are worn out. Paved shoulder widths, which should be 2 metres wide to accommodate edge line rumble strips, are not consistently wide enough. Throughout the corridor there are shoulders with significant pavement edge drop-offs which present a hazard. In some locations there is deterioration of adjacent pavement, which may indicate poorly drained subgrade. (see Photo 8)

Deteriorated shoulder

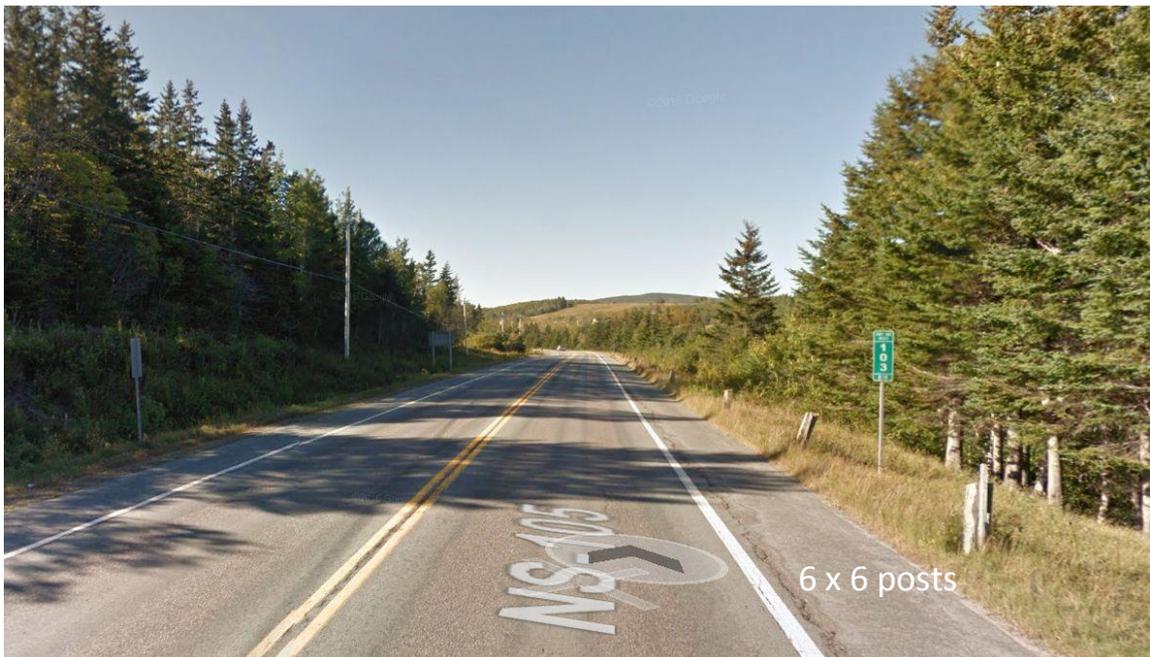
Photo 10

There are locations throughout the study area where 6 x 6 wooden posts serve as roadside or intersection delineators. (see Photo 10) These posts present a hazard to off tracking vehicles and should be replaced with flexible guide posts in areas where additional road-edge delineation is found to be required or with guard rail where it is warranted. There are a number of locations where barrier installations are not consistent with NSTIR's new draft 100 Series Highway Roadside Barrier Policy. At some locations, barrier meant to protect does not appear to properly shield the vehicle from the hazard. Some roadside hazards located in the area are not protected by barriers. Where adequate guard rail does exist, proper end treatments are not in place. Only proprietary Energy-Absorbing Guard Rail Terminal (EAGRT) systems are acceptable on high speed sections. Buried or blunt guard rail ends should be replaced. (see Photo 9) Reflectors on most of the existing guard rails are missing. Brush along the roadway makes it difficult to see the existing reflectors as well as the guard rails in some places.

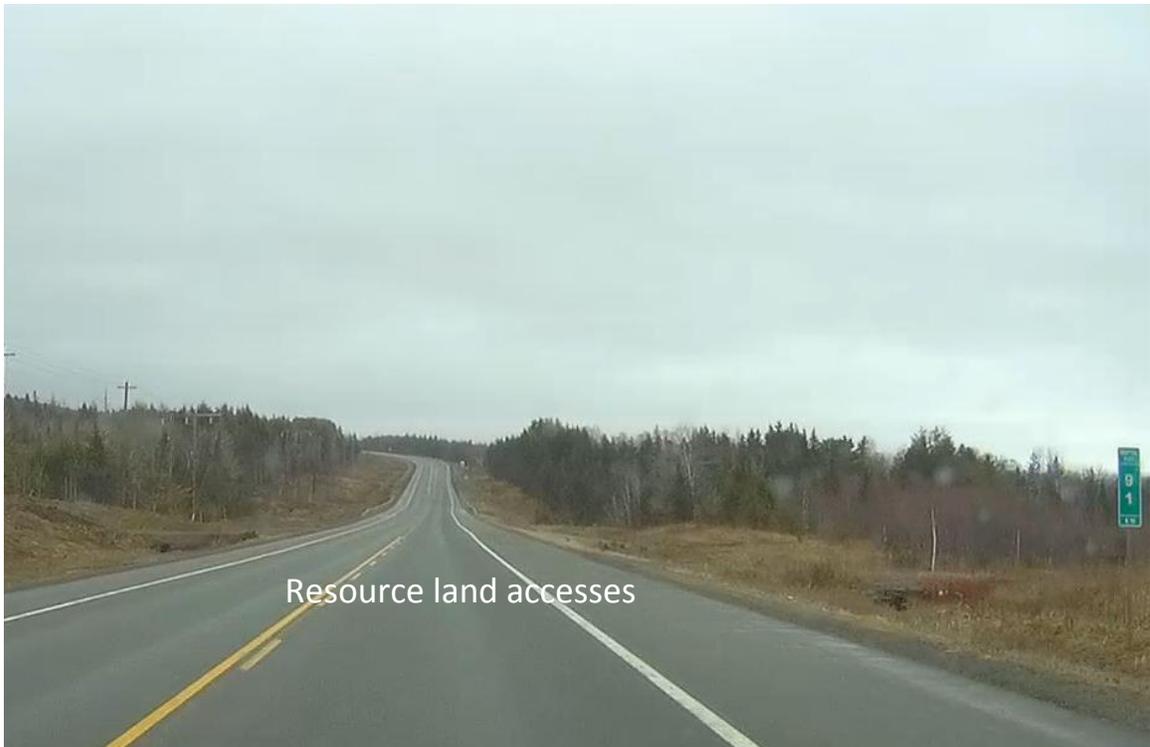
Photo 12

Resource land accesses

There are a multitude of driveway locations along the controlled access portion of Hwy 105 that service resource land, and they appear to range greatly in use (free of vegetation due to regular travel, to overgrown from the absence of use). I recommend as many of these as possible get closed. Western District have initiated a project with this goal in mind. Enhanced definition and improvement of driveway widths should be explored throughout the corridor.

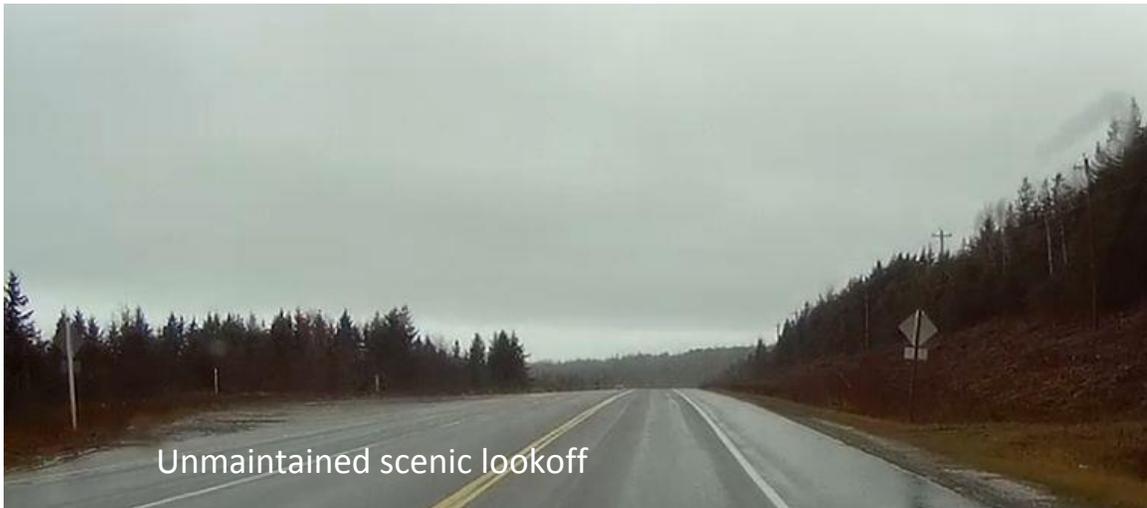
Photo 17

unmaintained scenic lookoff where vehicles can stop adjacent to the climbing lane near the 90 kilometer marker. (see Photo 17) The pavement at this location is crumbling and roadside trees have not been cut in decades and are blocking the view. It has been reported that truck operators use this location as a rest area. NSTIR should review the need for suitable rest area locations along the corridor and should contact Tourism Nova Scotia to discuss future plans for use of this lookoff and consider closing it off, either by regrading the ditch/sideslope or with guard rail. A detailed list of access issues is provided at the end of this report in Appendix B.

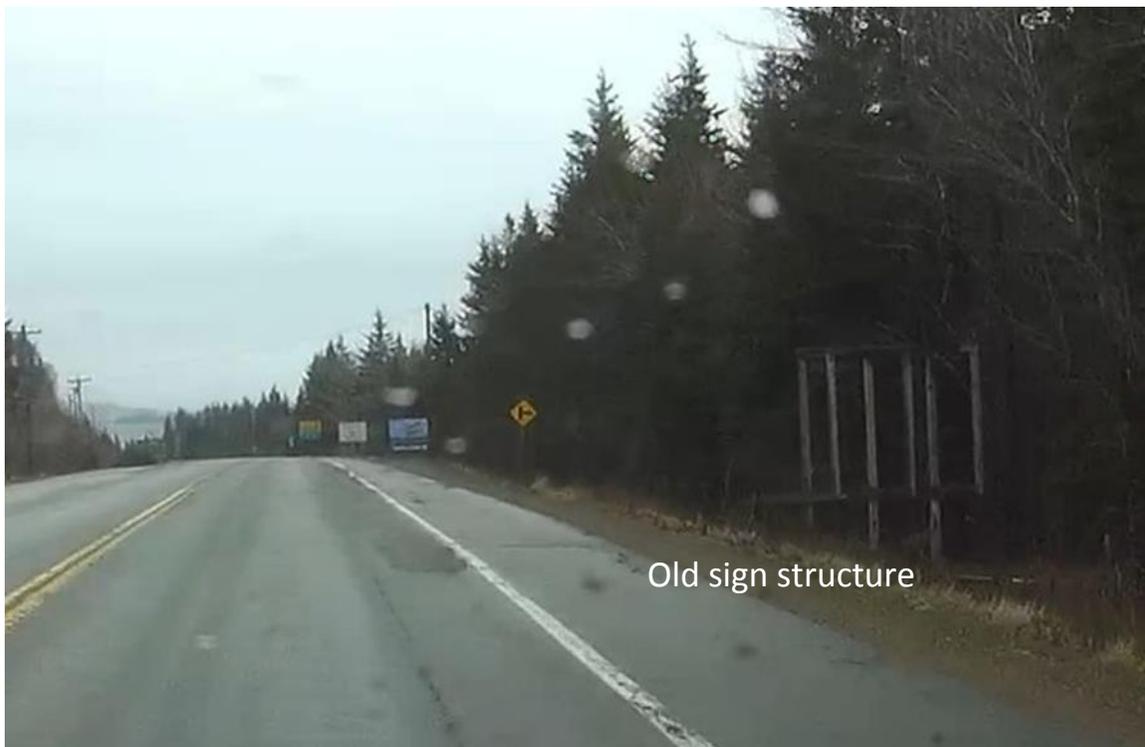
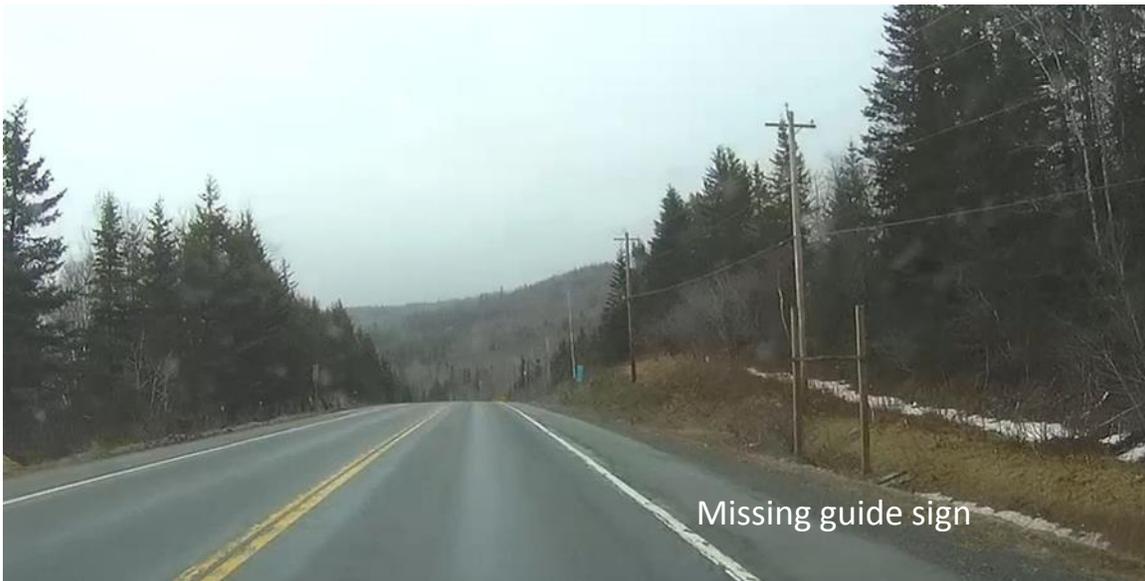
There are several roads that intersect Highway 105 in the study area that lack advance road name signage i.e. the east end of Main Street in Whycomagh. Although there were no observed deficiencies in pavement markings on the main roadway throughout the corridor, some intersections lack pavement markings and delineation to indicate to the driver that a road intersects TCH 105. Regulatory and warning signs are in poor condition and need upgrading throughout the corridor. Missing guide signs should be replaced. Existing lighting appears to meet Department standards. (see Photos 18-20)

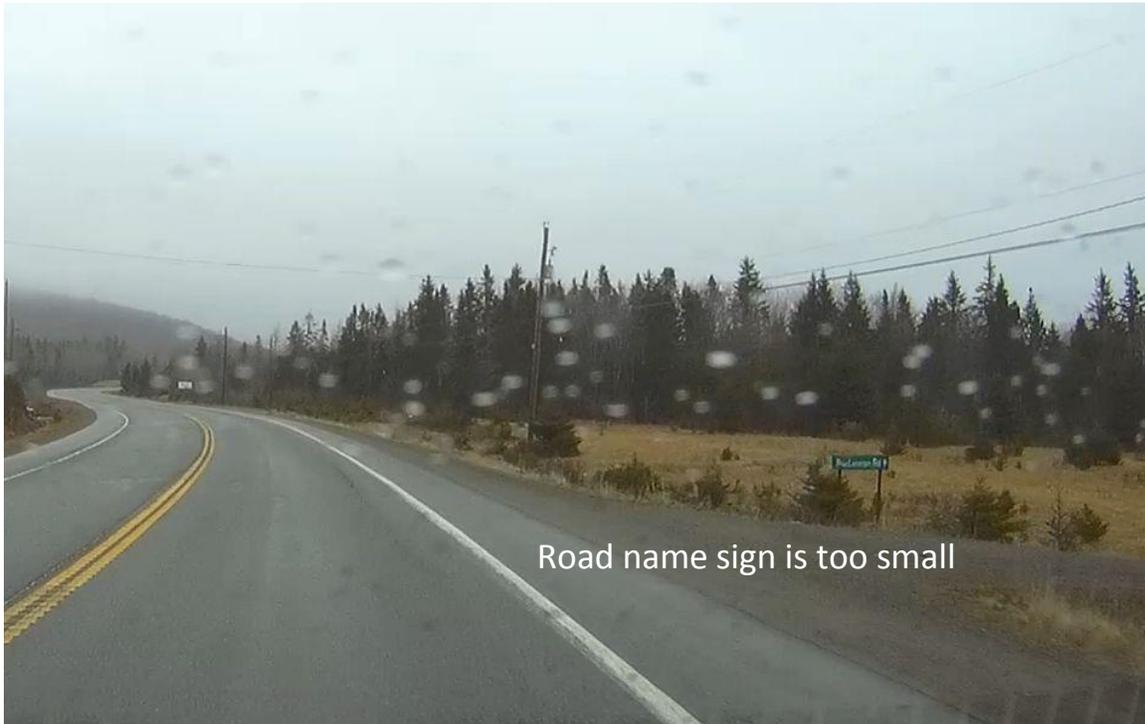
Photo 19

Road name signs are too small. (see Photo 19) Analysis of collisions data has revealed a majority of collisions along the study area sections of TCH 105 involve drivers 45 years of age and older.
