Evaluation CBNS Sydney Subdivision

**Preliminary REVIEW of OPERATING, COSTS,
GEOTECHNICAL and INFRASTRUCTURE IMPROVEMENTS
RAIL LINE – Subsidized Portion of Sydney subdivision
MP 20.0 to 113.8 Nova Scotia**

CANARAIL Consultants Inc.

Date : August 31, 2015

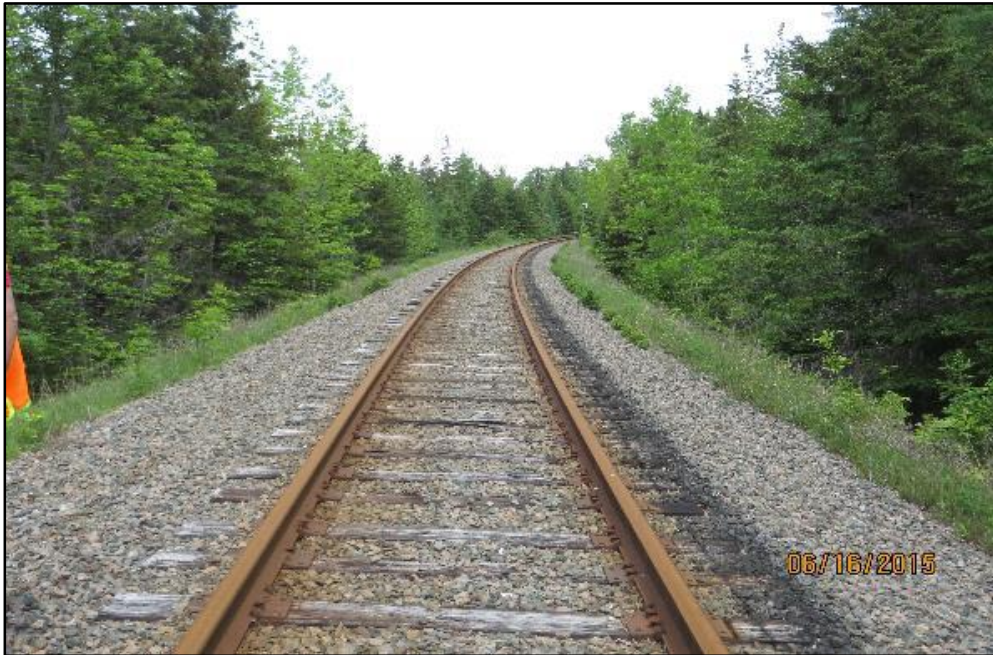
PHOTO M.P. 25.46 – Track alignment – R.H. Curve
Good ballast cross-section and solid ties

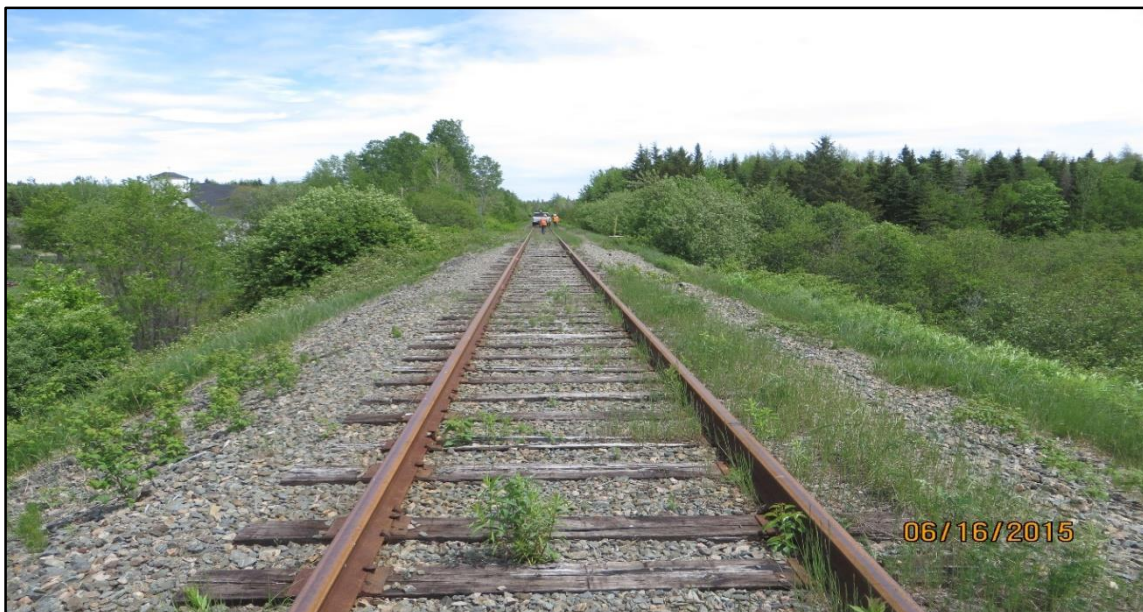
M.P. 33.37 – Tangent Track
Vegetation in roadbed – Defect ratio for ties at 45% - 55%

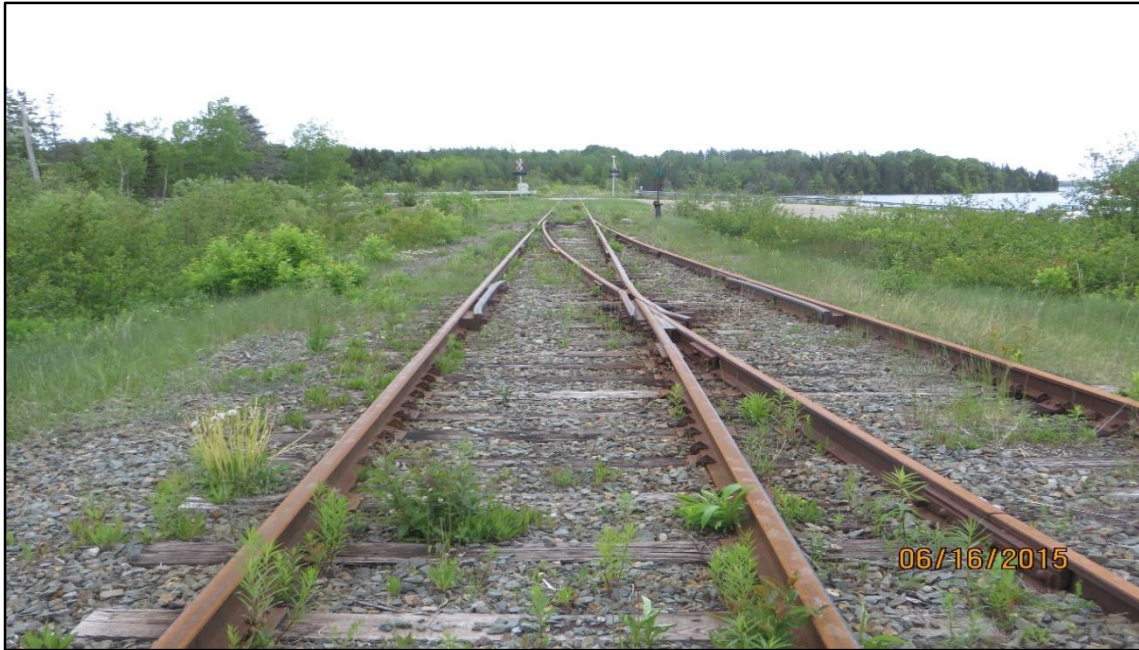
M.P. 41.3 – East Turnout - ORANGEDALE
No. 10 Turnout with Spring Frog

In general, the rail components of the turnouts are in good condition. Some maintenance is required to adjust the fitting of the horn and hold down housing for the spring frogs.

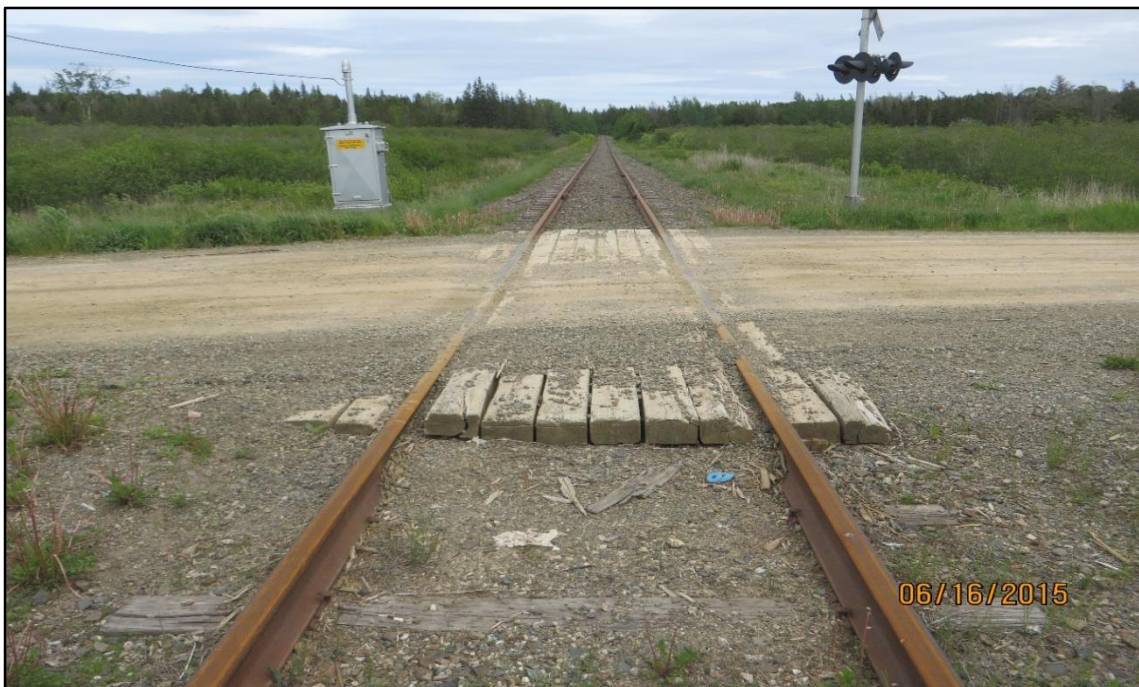
M.P. 52.08 - ROAD CROSSING – FLASHING LIGHTS
Gravel roadway approaches and wood planks

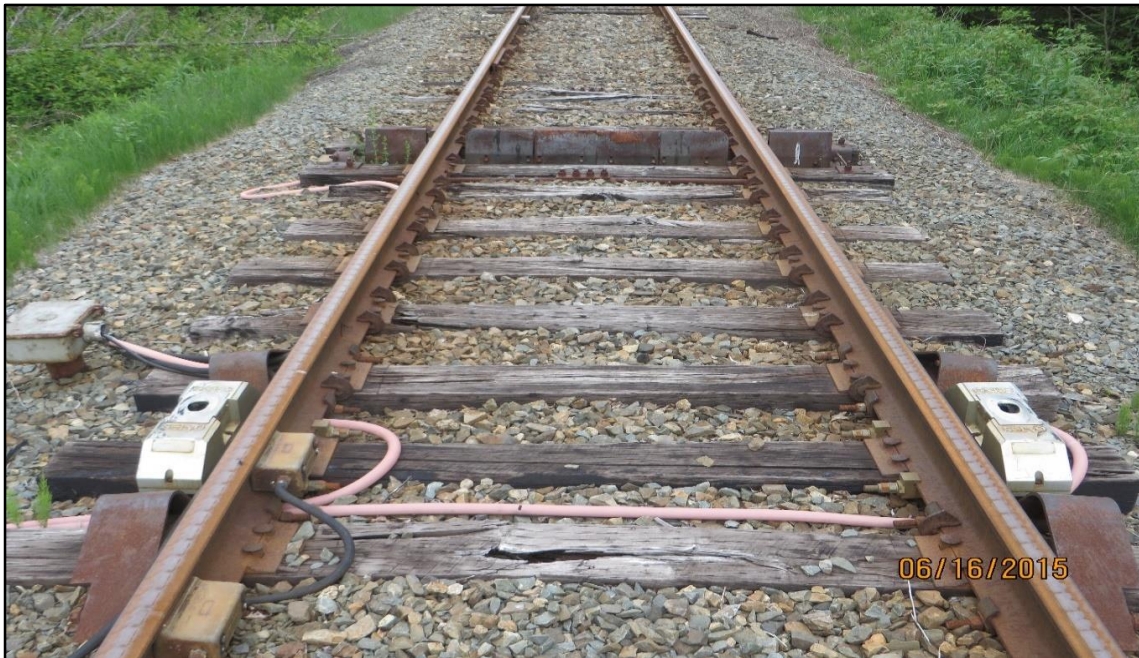
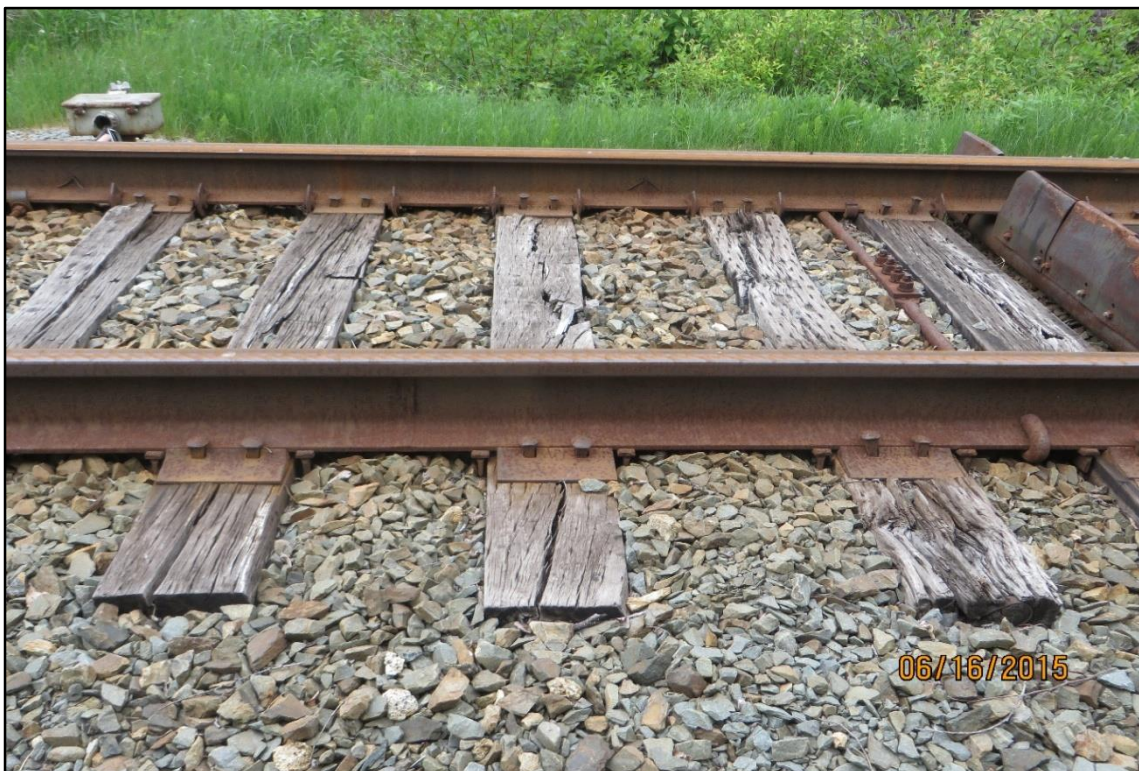
As per date of inspection, the detectors were in working order. The condition of the wood ties at the approaches to the detectors requires attention. Several defective ties at each location and gauge-rods used to help hold track gauge.

M.P. 42.8 - HOT BOX AND DRAGGING EQUIPMENT DETECTOR
New wood ties required to hold track gauge across the detector

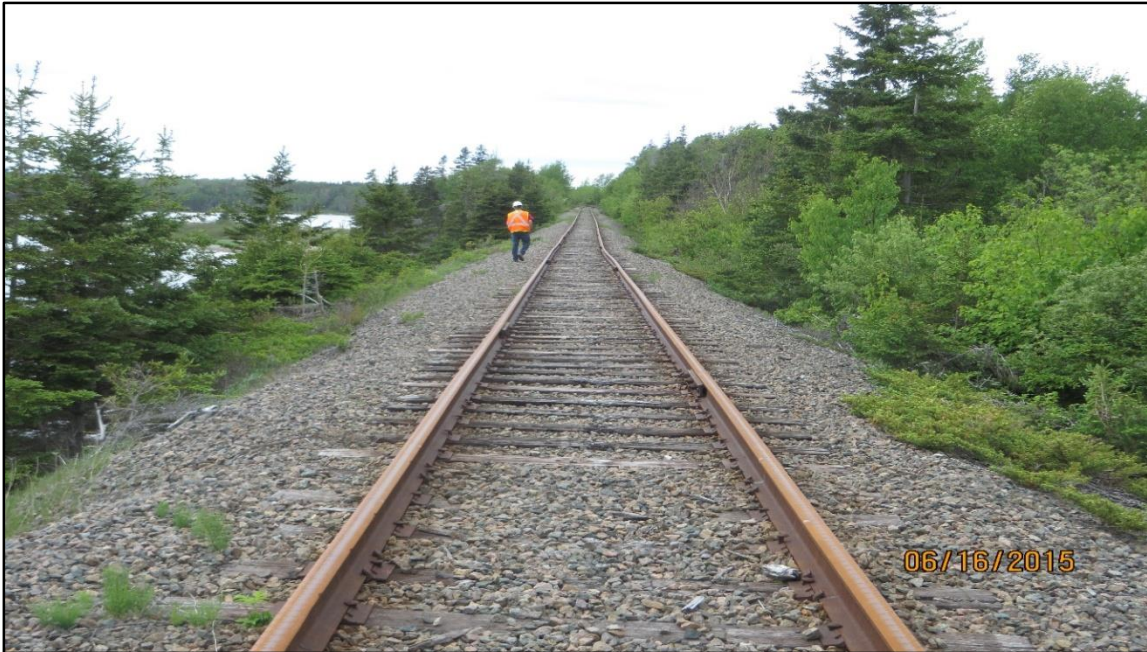
M.P. 53.7 – TRACK ALIGNMENT – MacKinnon Harbour
This area identified by Stantec Consulting Ltd

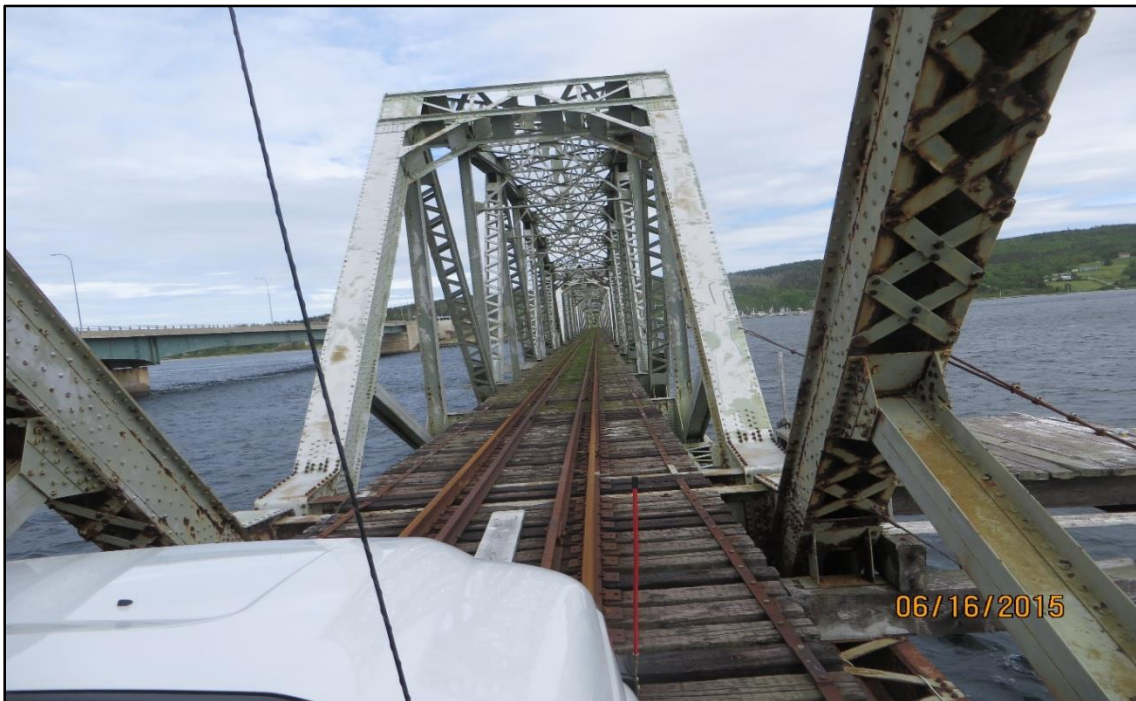
M.P. 57.7 – BRIDGE - GRAND NARROWS
Swing Span at east end of bridge
Manual interlocking between M.P. 57.4 and M.P. 57.9

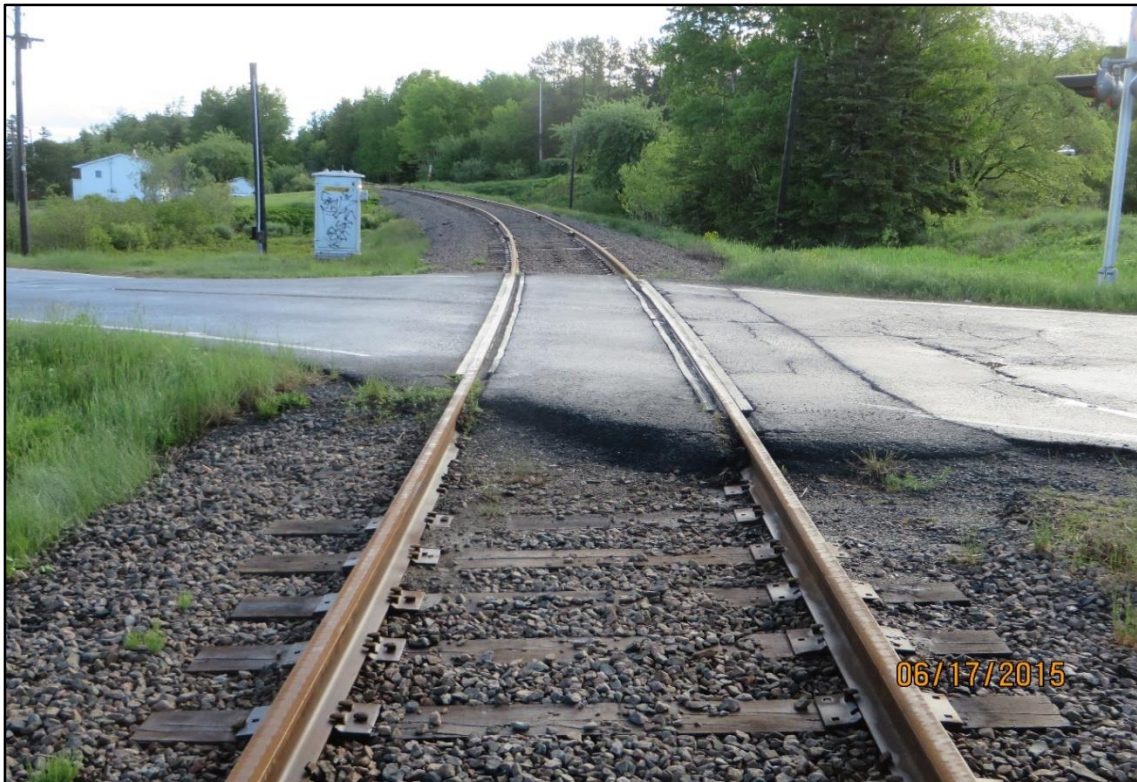
M.P. 104.86 – LEVEL ROAD CROSSING

A total of 15 road crossing between M.P. 104.8 to M.P. 113.9

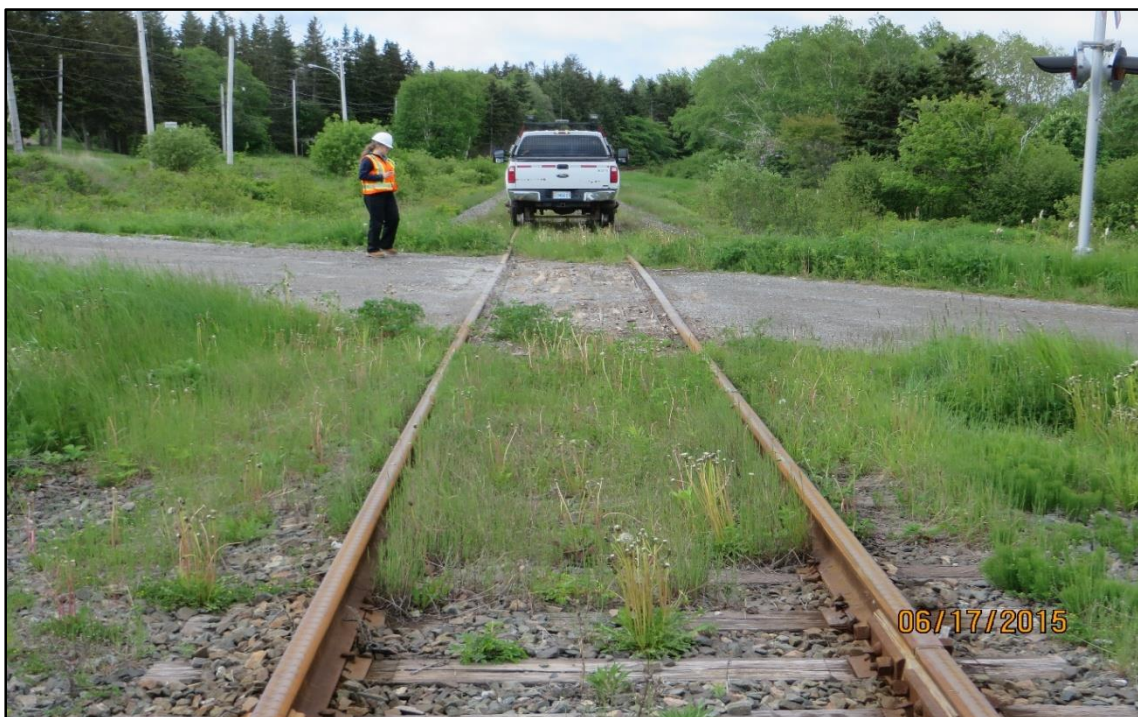
M.P. 90.56 – ROAD CROSSING

This crossing leads into a Camp Grounds and Mobile Trailer Park

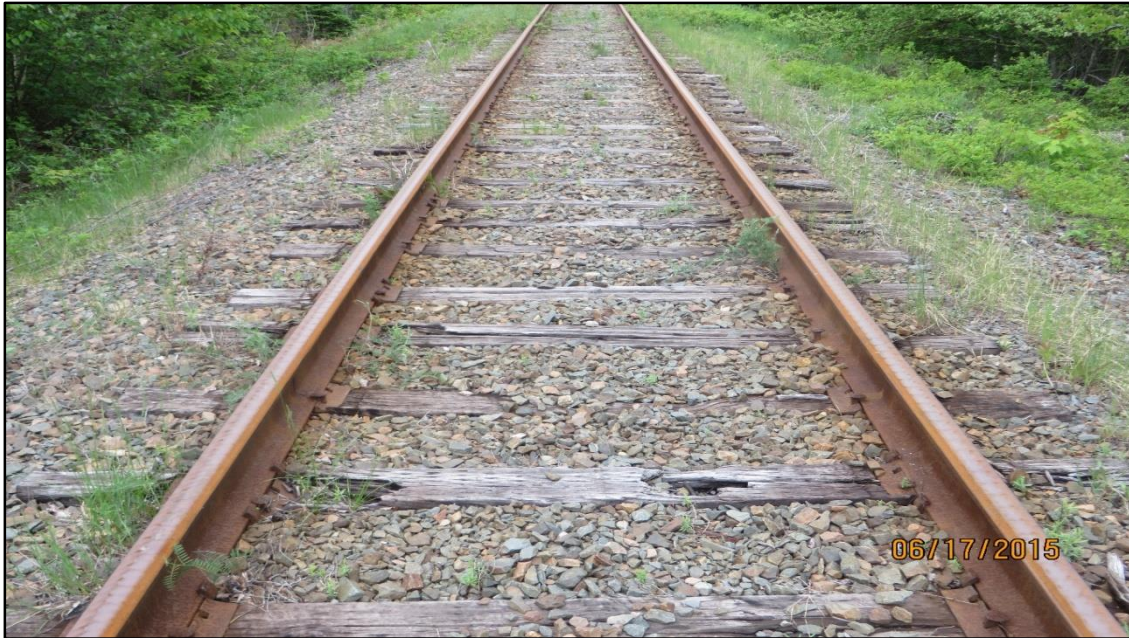
M.P. 85.85 – TANGENT TRACK
Tie Defect Ratio at 50% - 55%

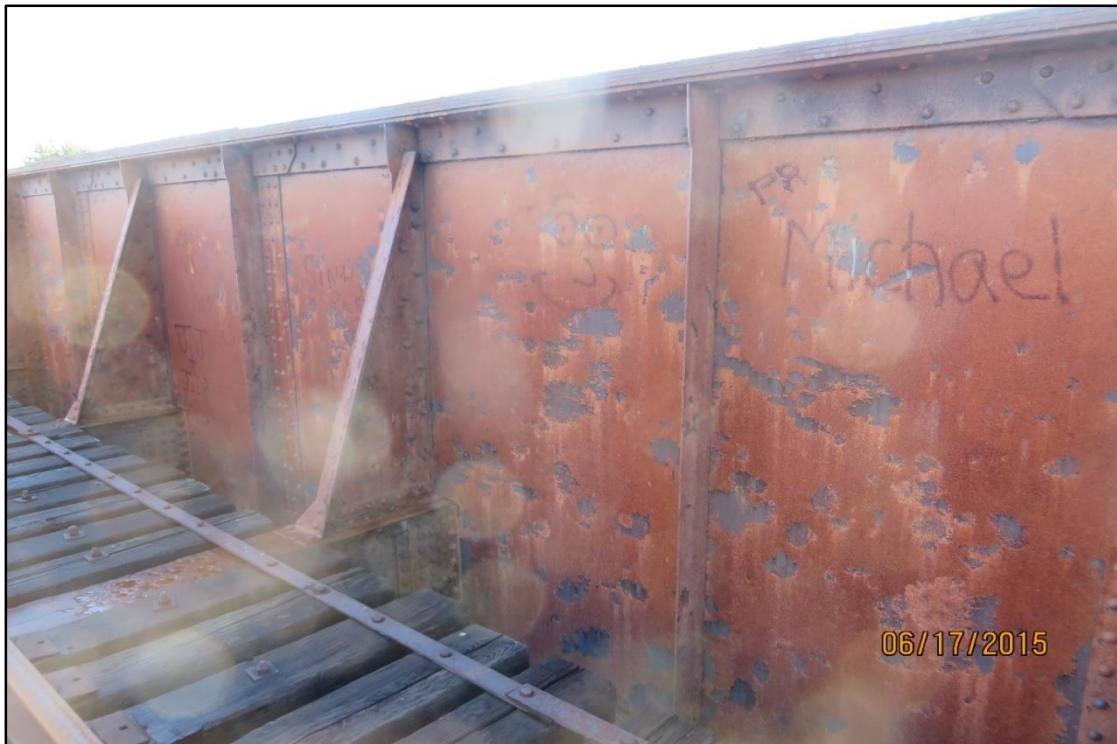
M.P. 103.3 – BRIDGE PLATE
Heavy rust

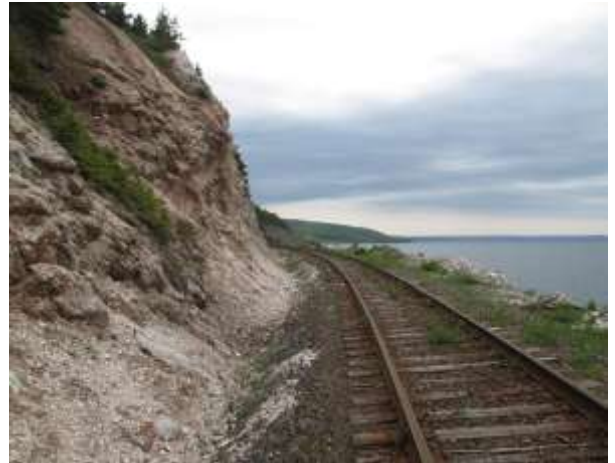
**Photo 26 – Mile 54.6: Subsidized Line
South Side of Line**
June 8, 2014

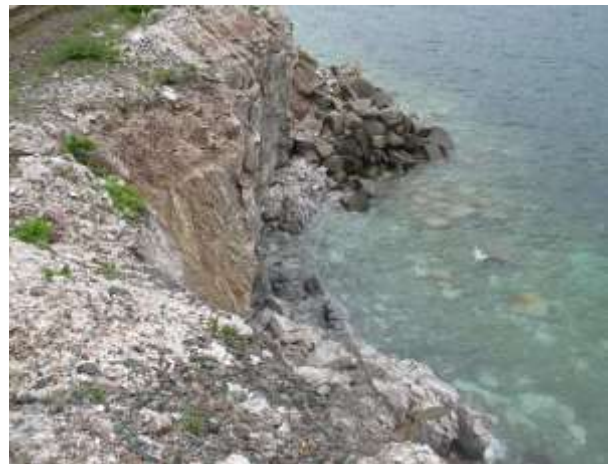
**Photo 28 – Mile 54.6: Subsidized Line
Local Sloughing Near Crest of Cliff**
June 18, 2014

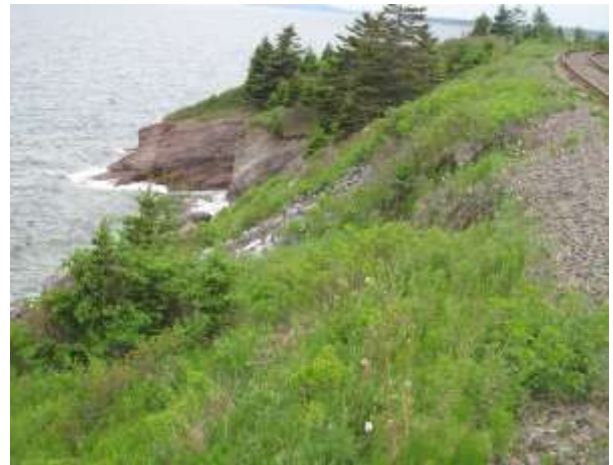
**Photo 32 – Mile 55.1: Subsidized Line
Sloughing Near West End of Slope**

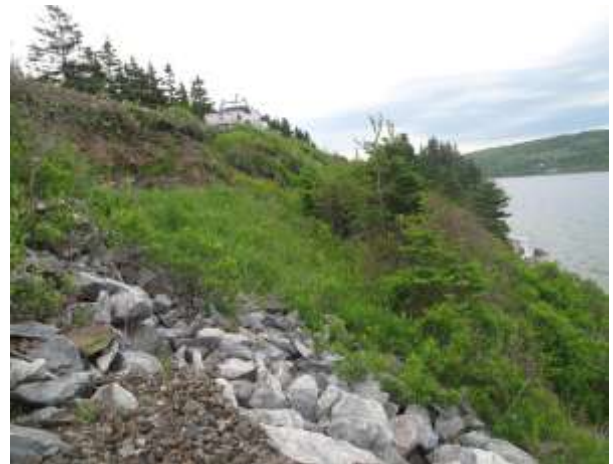
**Photo 34 – Mile 55.1: Subsidized Line
Vertical Displacement at Crest of Slope**

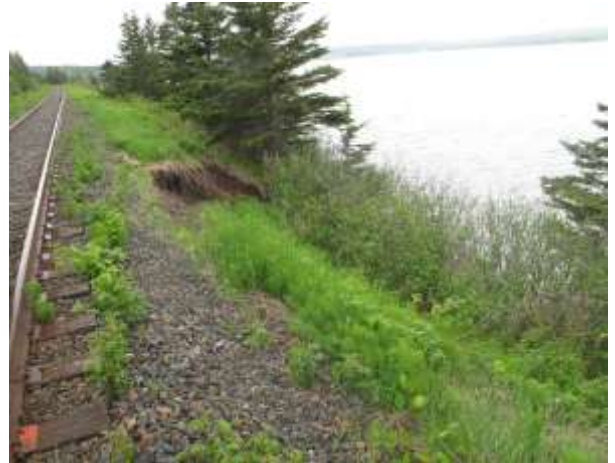
**Photo 38 – Mile 60.1: Subsidized Line
Vertical Displacement at Crest of Slope**
June 18, 2014

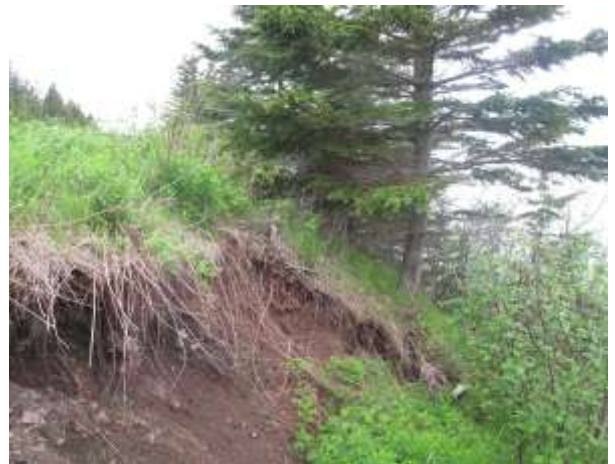
**Photo 40 – Mile 60.1: Subsidized Line
Close Up of Sloughing Near Crest of Slope**
June 18, 2014

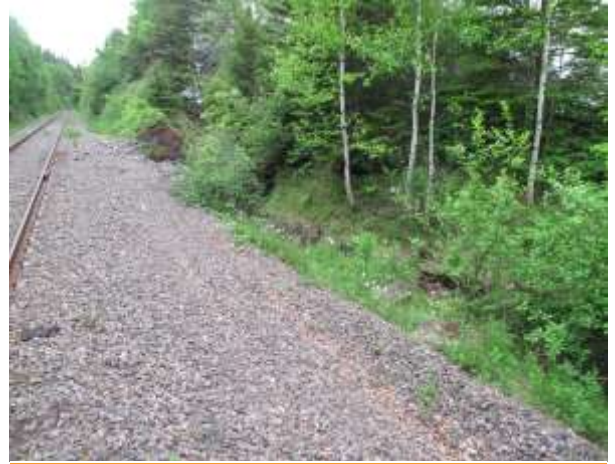
**Photo 42 – Mile 68.3: Subsidized Line
Significant Slope Movement**

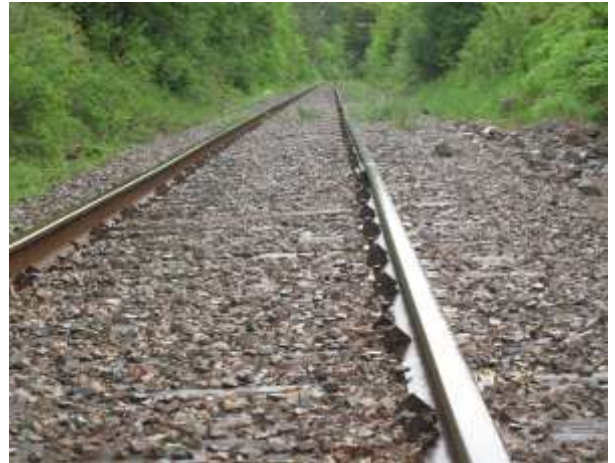
**Photo 44 – Mile 68.3: Subsidized Line
Easterly Looking Westerly: Close Up of Line**

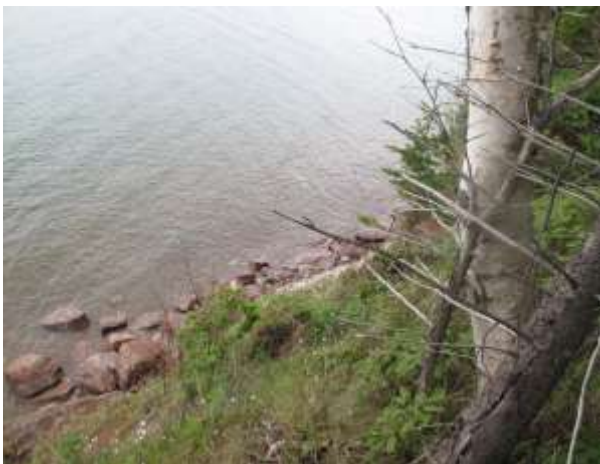
**Photo 45 – Mile 68.3: Subsidized Line
Conditions at Toe of Slope**

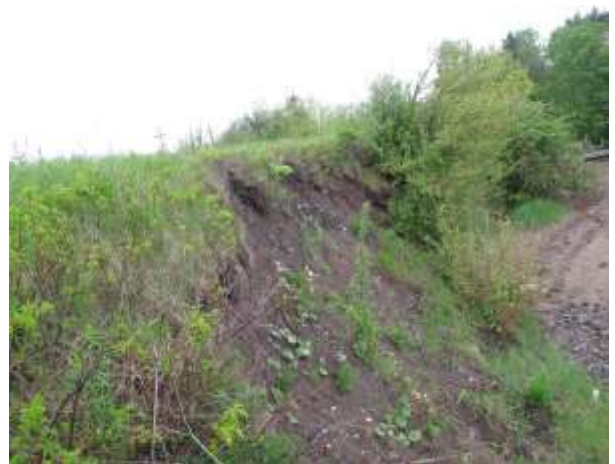
**Photo 52 – Mile 103.3: Subsidized Line
Close Up of Soughing at Crest of Slope**
June 18, 2014

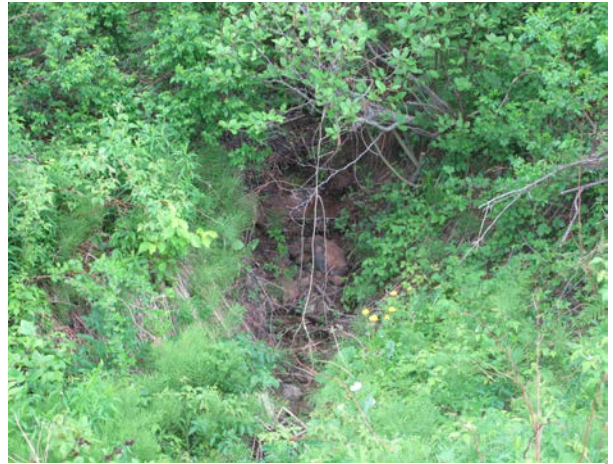
Photo #60 - Mile 57.0: Subsidized Line Surficial Sloughing

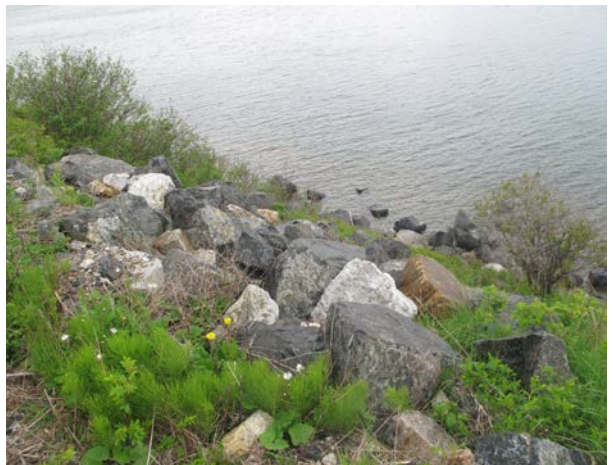
Photo #62 - Mile 58.8: Subsidized Line Location Remediated East of Subject Slope
