Reclamation of the Irish Cove Limestone Quarry (NTS 11F/15), Richmond County

D. B. Hopper and F. J. Bonner

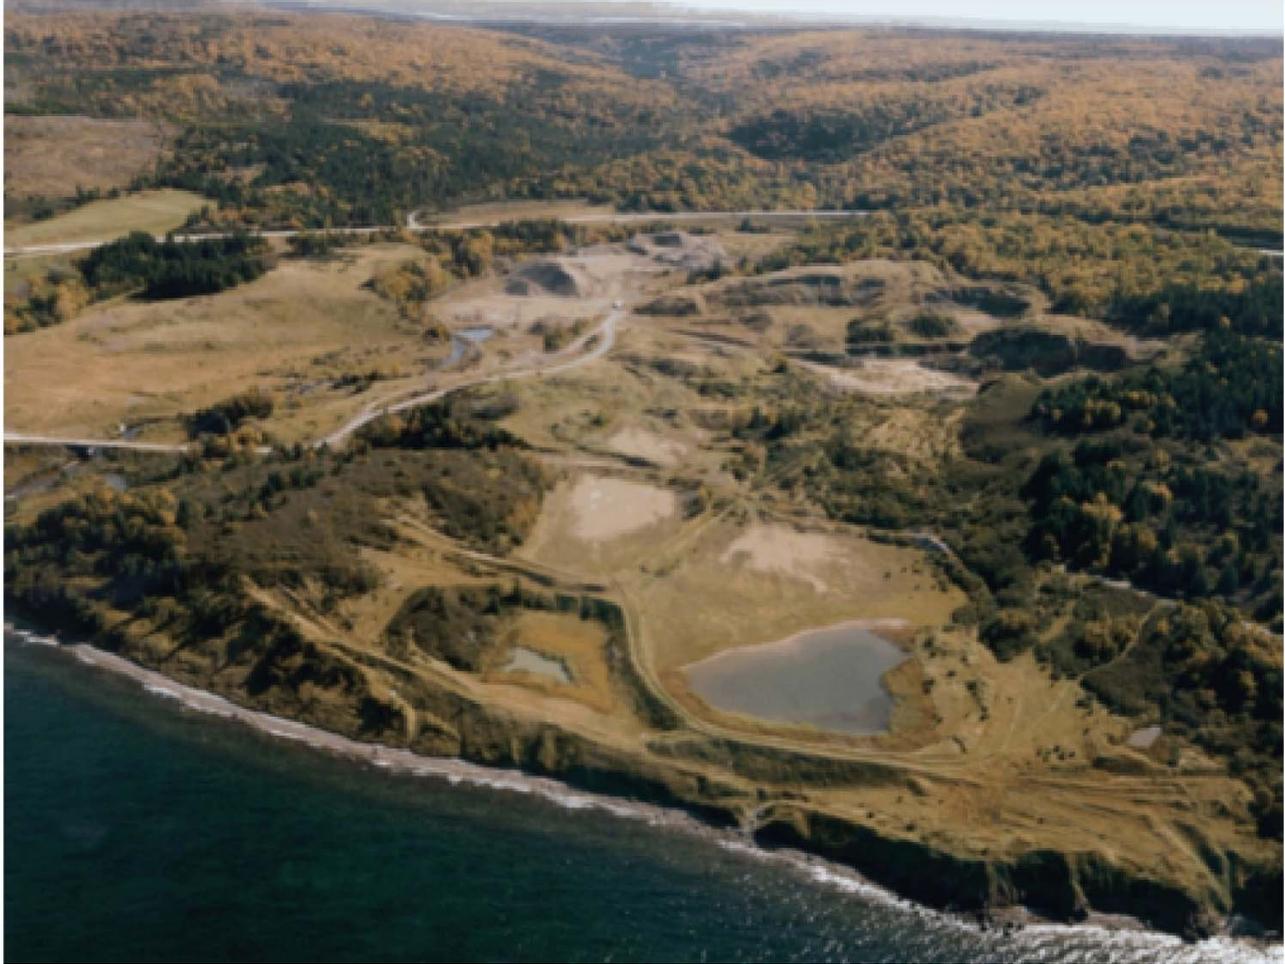
Figure 2. Photo of the Irish Cove Quarry (looking south) circa 1992.

The quarried area contains debris, stockpiles of limestone, exposed cliffs, and steep overburden mounds which all provide hazards to public safety. The most disturbed portion of the site occurs in the area containing the steep quarry walls (Fig. 2, middle ground, right of centre) and the stockpile area lying adjacent to Irish Cove Brook (Fig. 2, middle ground left of centre). The brook and riparian area has been impacted by the former operation and continues to be stressed from the crushed limestone stockpiles along the west bank, which erode into the stream. The occupation of the stockpiles on the riparian zone continues to inhibit revegetation.

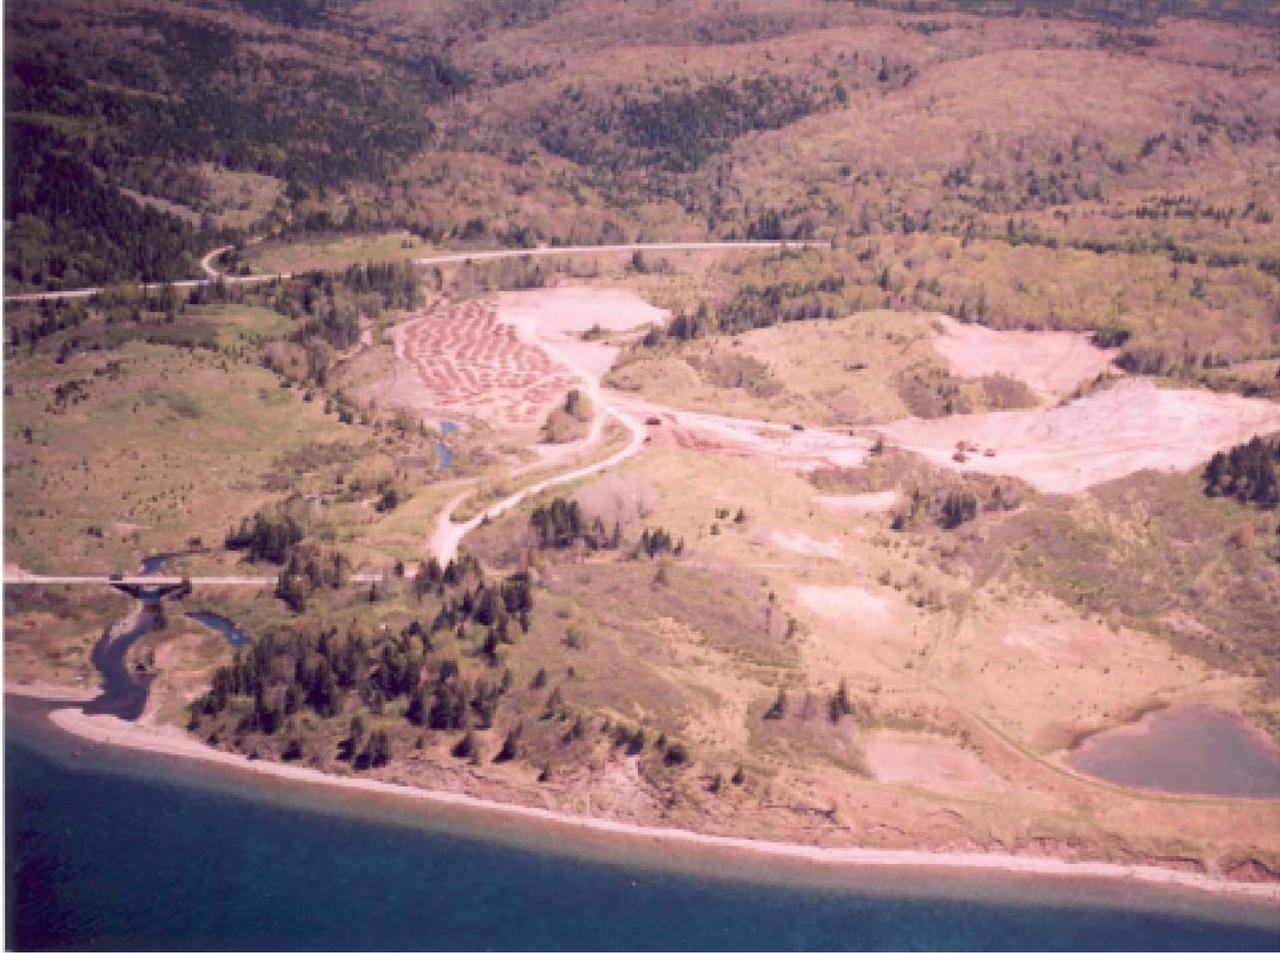
Figure 4. Photo of the Irish Cove Quarry reclamation project (June 2004).

Son. Ltd., of Mira Gut. The preliminary work and site preparation included permitting, cleaning up the site and establishing sediment and erosion control structures (Fig. 4). Debris was removed such as truck parts, wooden structures, metal and plastic pipe, cable, tires, fuel drums, power lines, etc. Non-essential power poles and lines were disconnected and removed. The power poles were donated to the local community after residents expressed interest in acquiring them for holding lamps along a nearby cross-country ski trail. A drilled water well was inspected by Nova Scotia Department of Environment and Labour staff and later decommissioned.

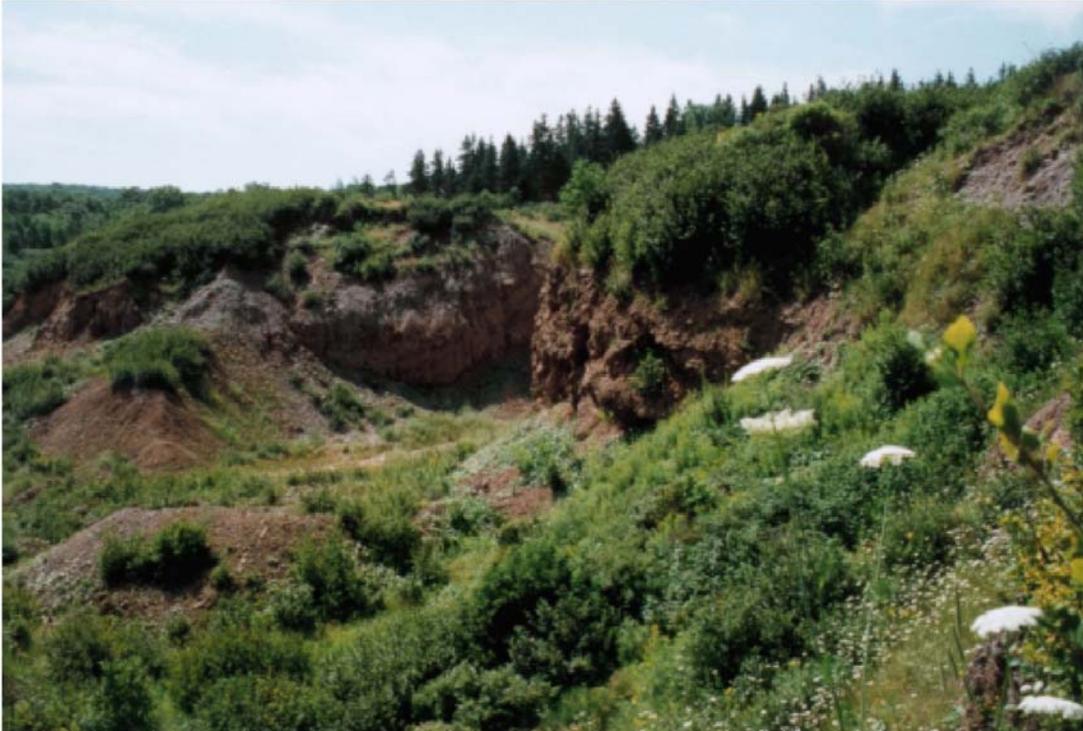
Figure 5. Photo of the Irish Cove Quarry highwalls before reclamation.

The quarry walls and steep overburden (areas 1, 2, 3 and 5 as shown on Fig. 3) lying above the crests of the walls were public safety hazards. The quarry walls located in Areas 1 and 2 were, by far, the

greatest danger to public safety with steep faces exceeding 10 m in some places (Fig. 5). Therefore, these areas were the top priority areas to be backfilled. The stockpiled limestone was moved back into the quarry as fill and ramped up against the walls to slopes of approximately 1:3 (Fig. 6). The northern and southern flanks of Area 4 (former quarry faces) also required limestone fill material to achieve the required 1:3 slope ratio.

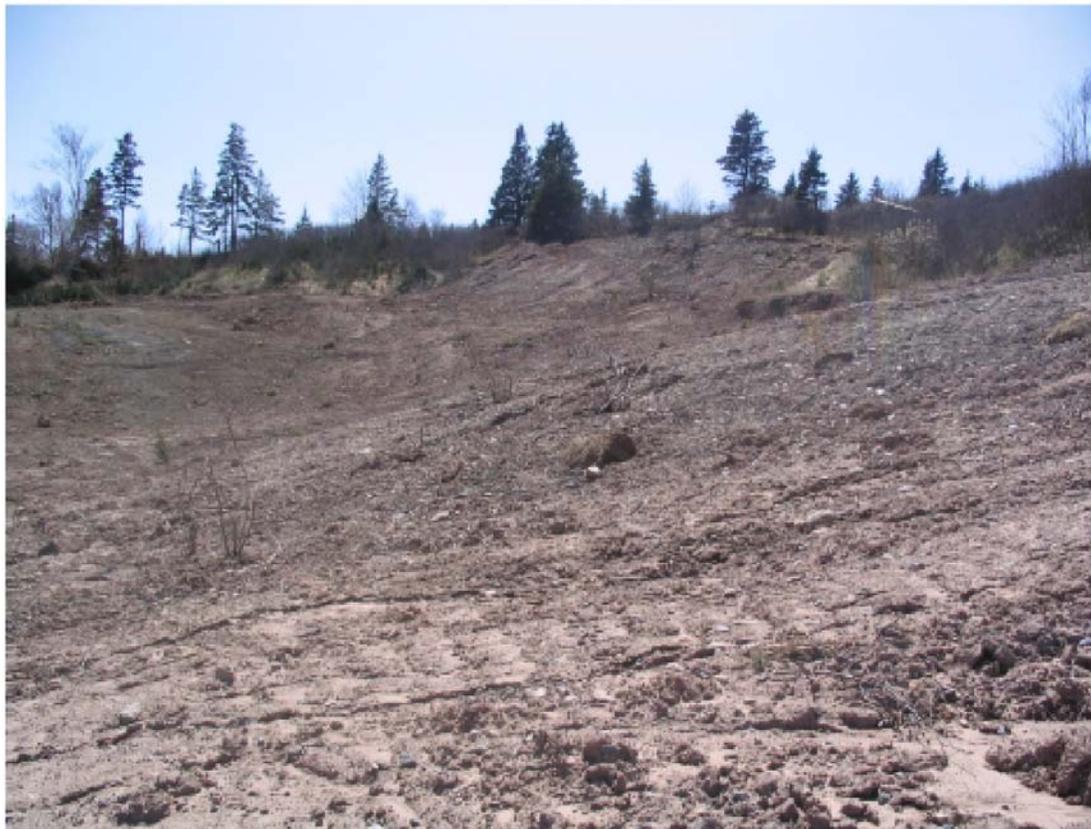
Figure 6. Quarry walls after reclamation and recontouring.

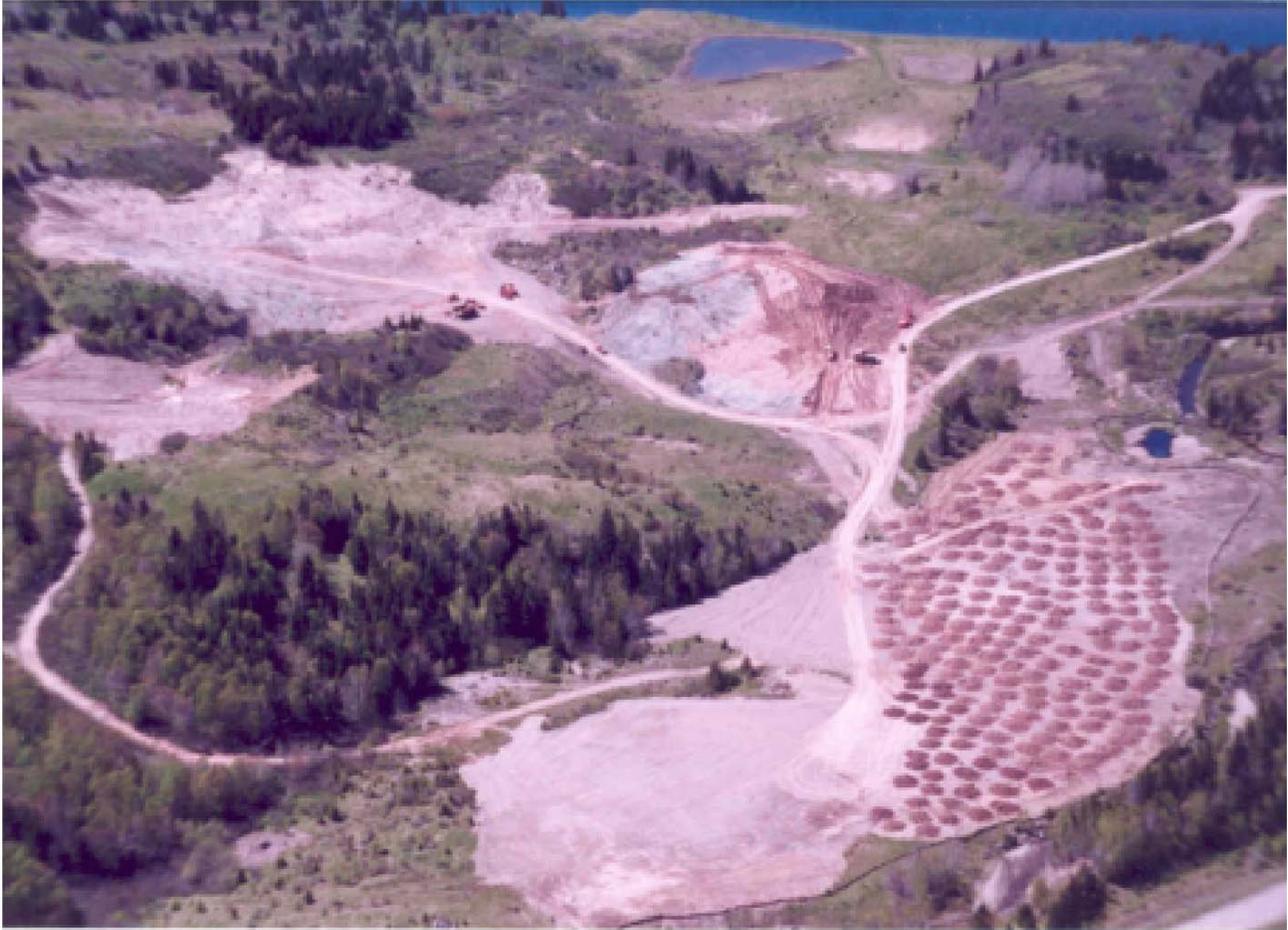
Figure 7. Photo of the reclamation project circa June 2004. Areas 2, 3 and 4 (background) are complete and seeded. Area 1 (middle ground) is used as a source of cover material for Areas 9 and 11 (former stock pile in foreground).

Once the ground conditions were suitable in the late spring of 2004, the revegetation process began (Fig. 7). This included the replantation of 185 small
