# APPENDIX B

## Fish Habitat Assessment Fact Sheets

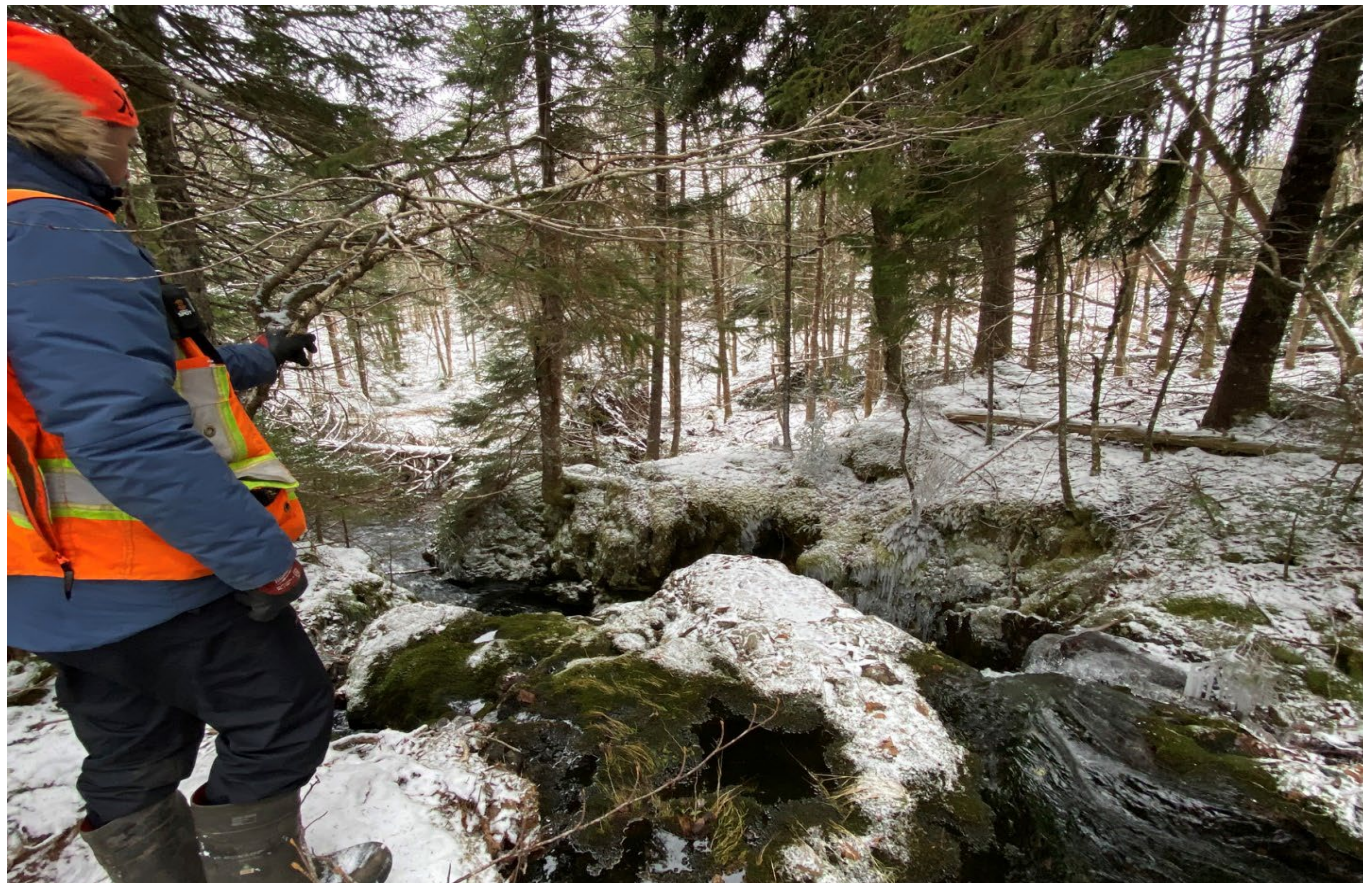
Waterfall/cascade (6-8 m high by 20 - 30 m long, with 1 to 1.5 m drops) at 150 m downstream of centreline.

**Photo 3: Feature 1 (Waterfall ~80 m upstream from crossing)**

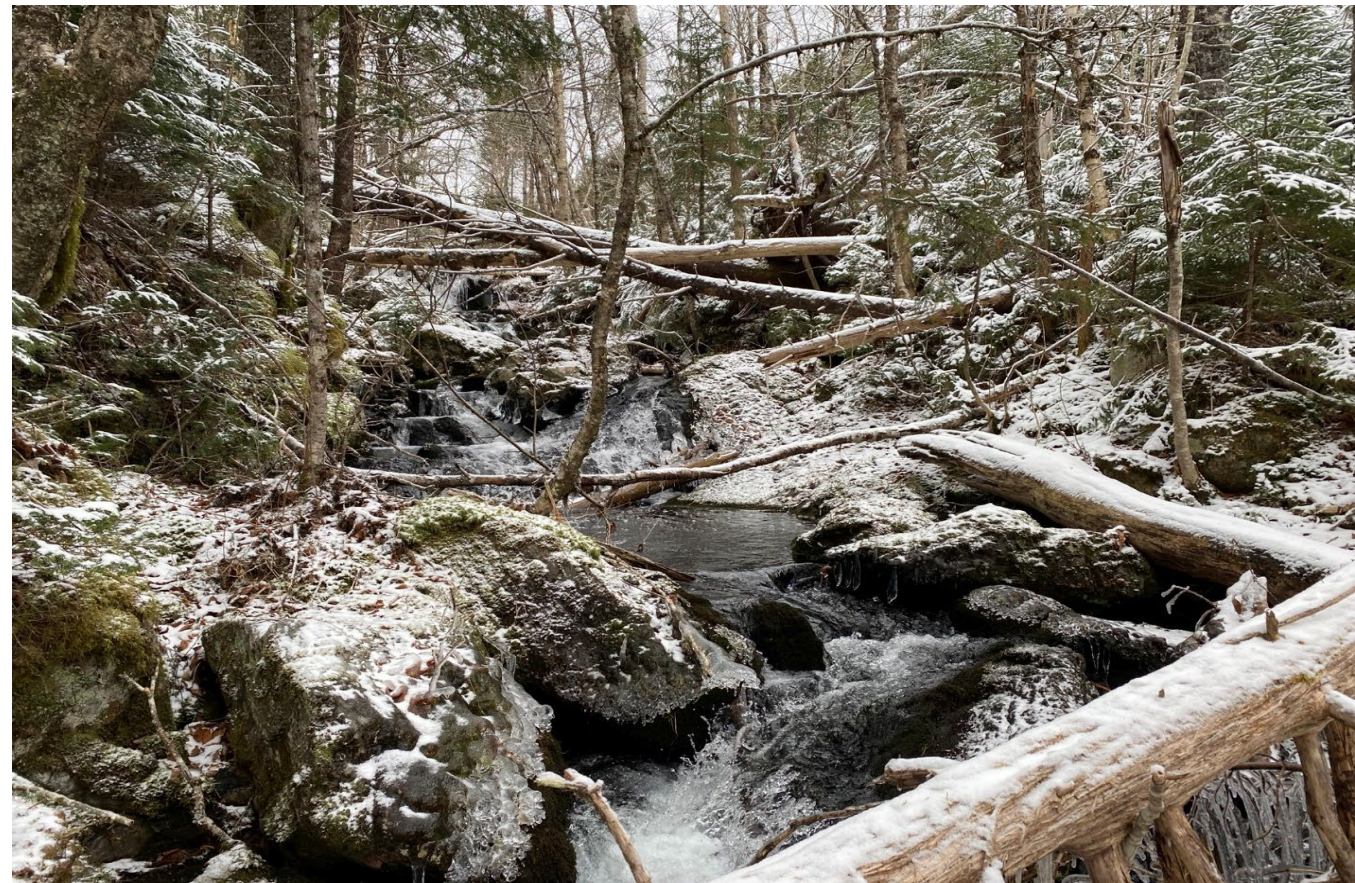
**Photo 4: Feature 2 (Cascade 200 m downstream of crossing)**

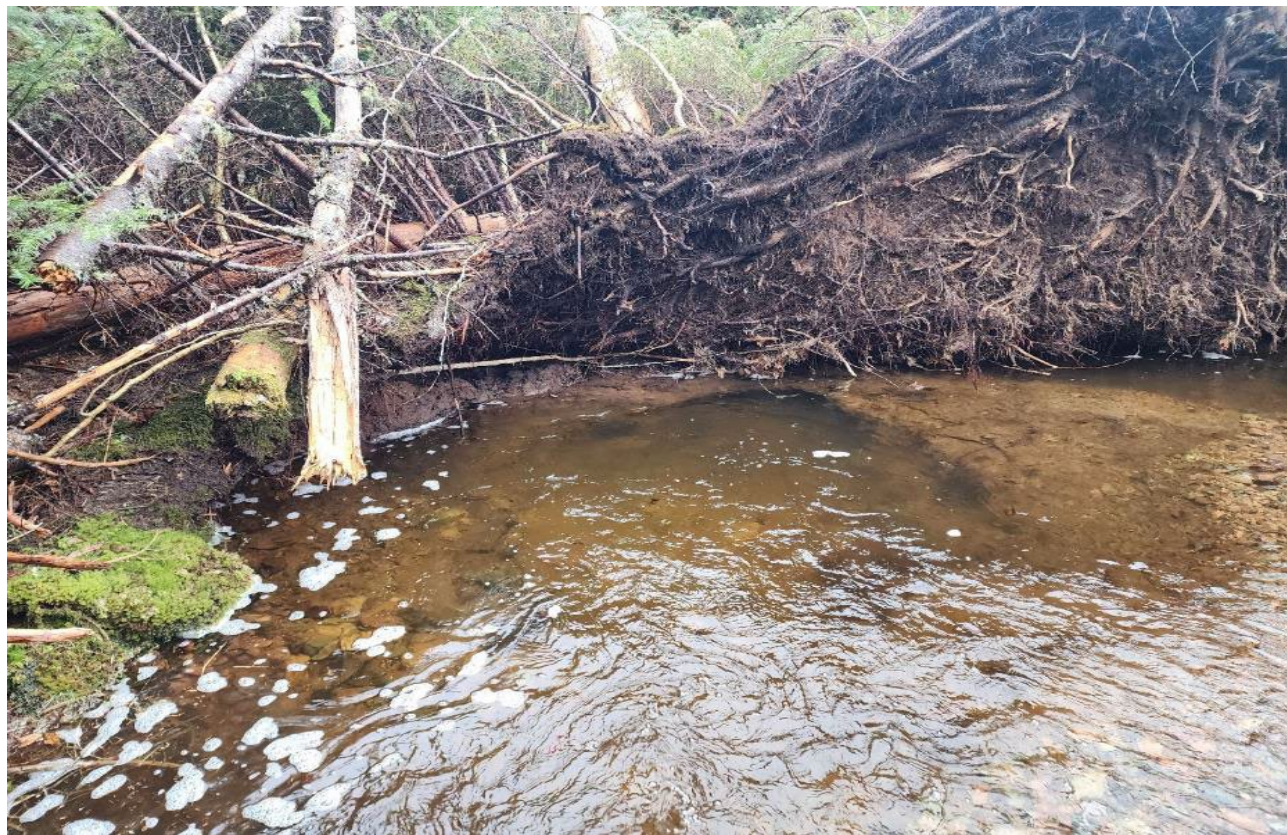
**Photo 3: Feature 1 (Upriver tree in stream, downstream of crossing)**

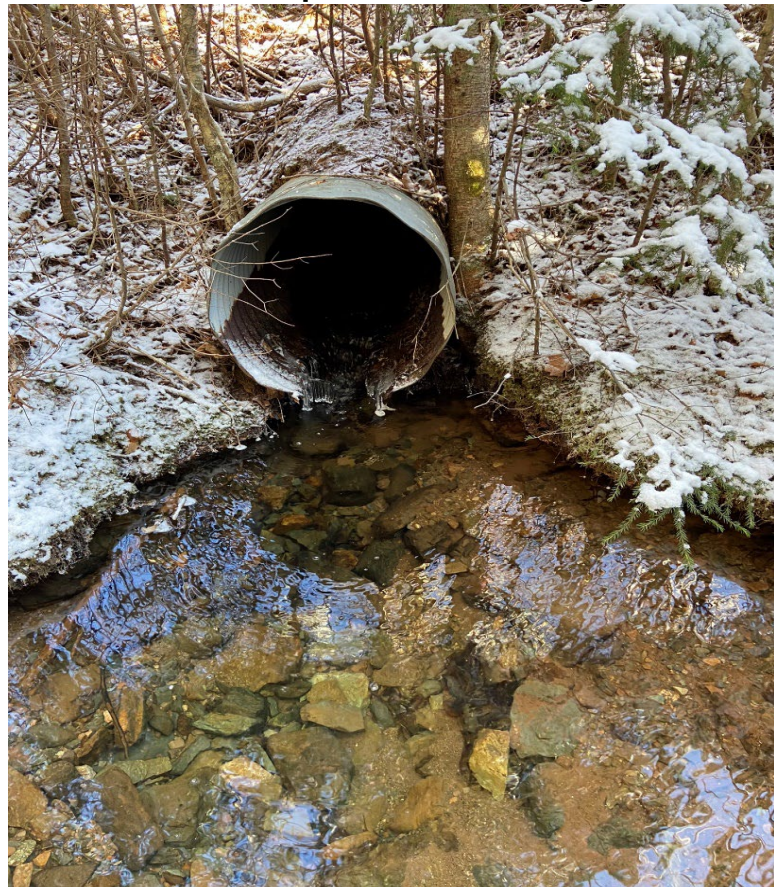
**Photo 3: Feature 1 (Culvert at crossing with angular cobble)**

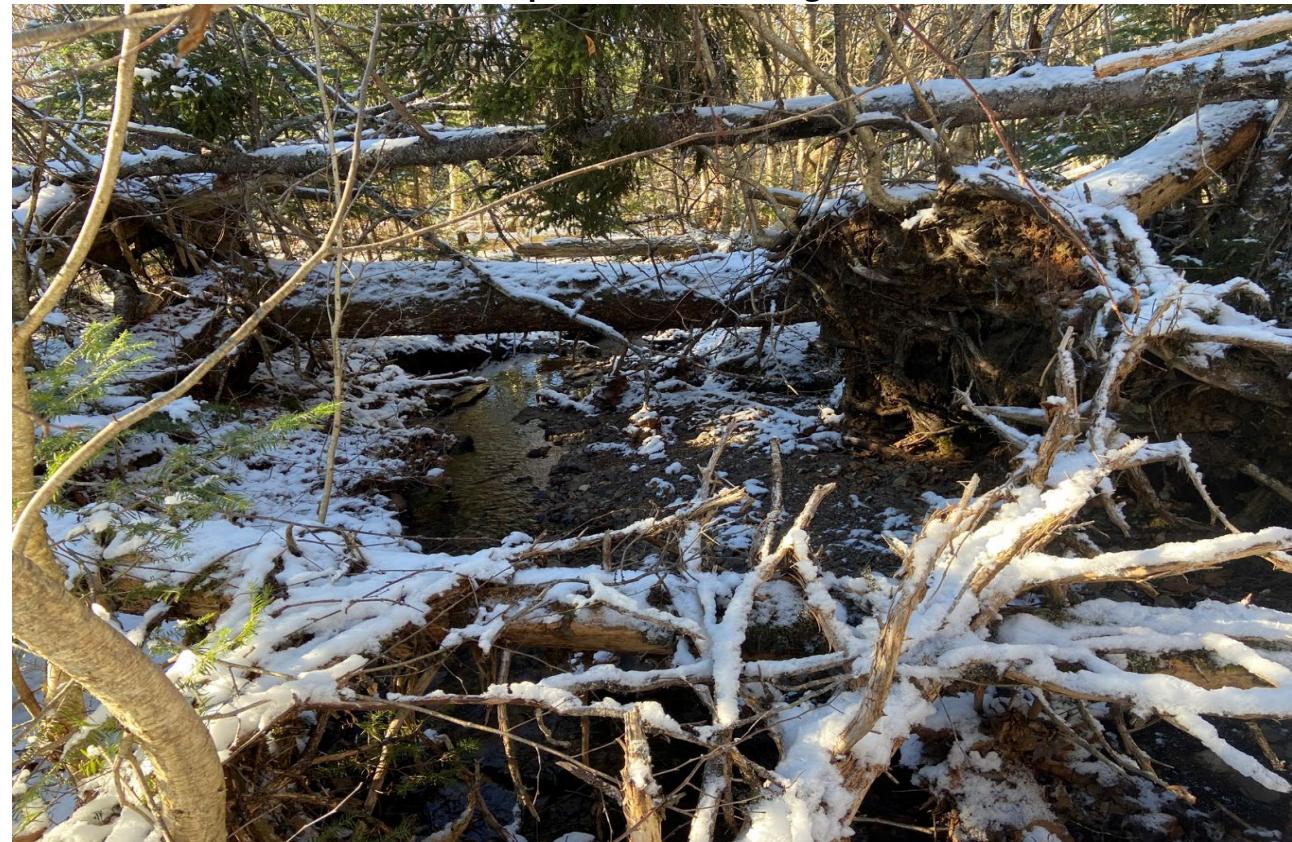
**Photo 4: Feature 2 (100 m downstream of crossing with downed woody debris)**

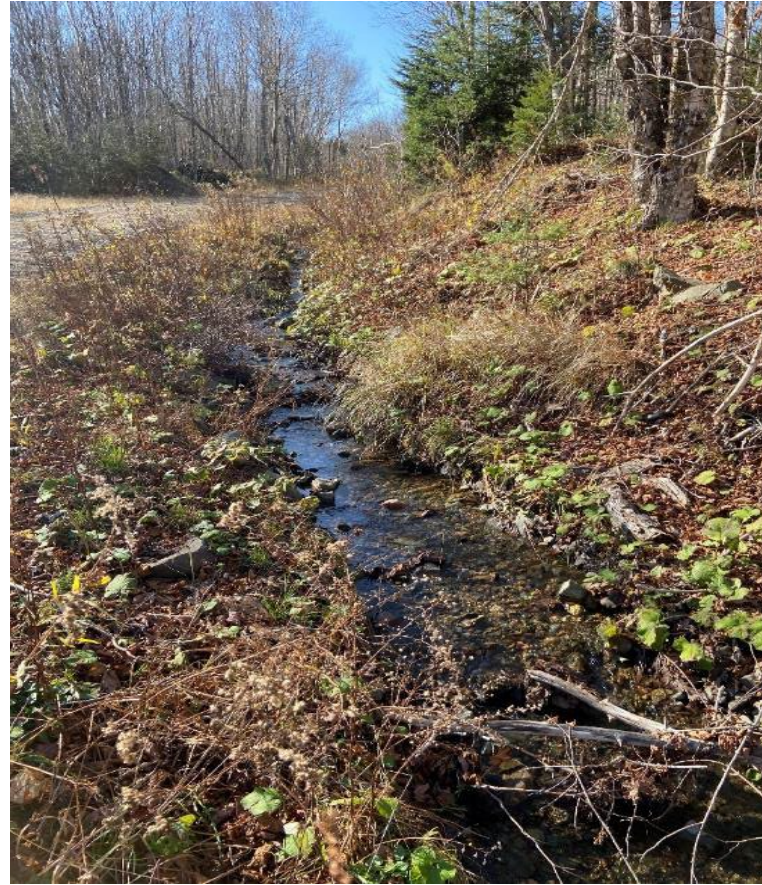
**Photo 2: Feature 1 (Road side ditch connected to watercourse)**

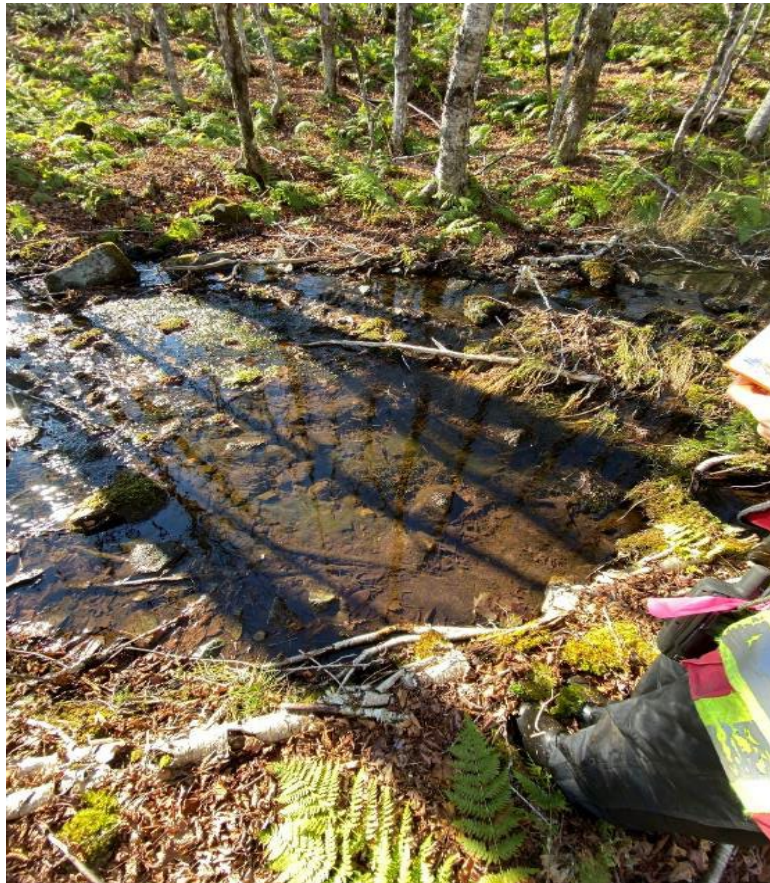
**Photo 3: Feature 2 (Shallow ponding area wher fish was observed)**

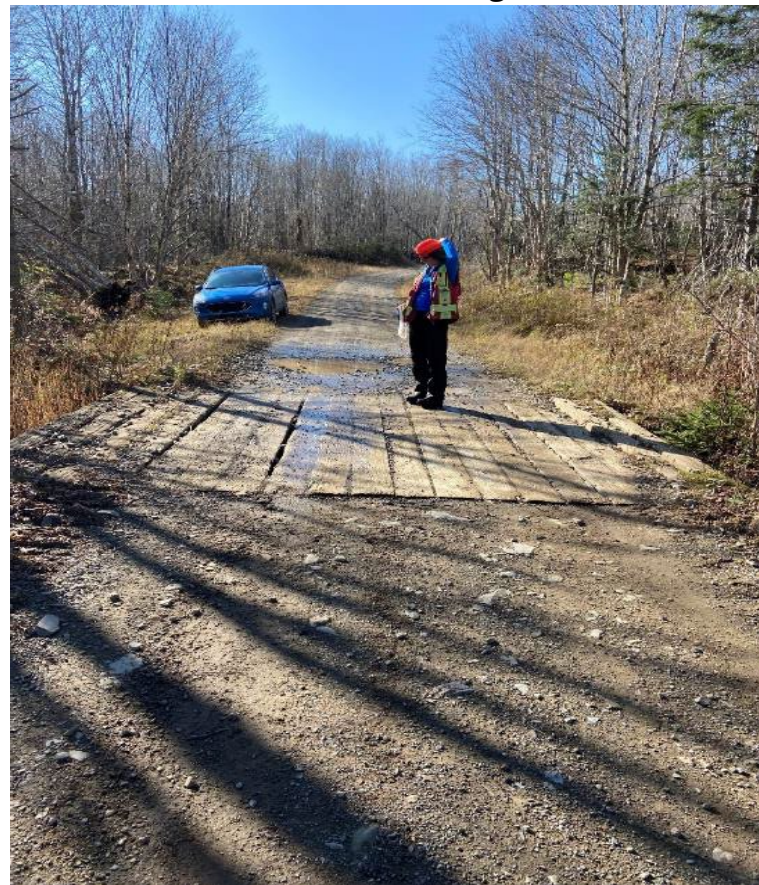
**Photo 4: Feature 2 (bridge/crossing over watercourse)**
