Watercourse Fact Sheet: Fish Habitat - Page 1

WATERCOURSE INFORMATION	
Watercourse ID:	Nuttby Watercourse NR- WC-122d101
General Site Location:	Nuttby
Watercourse Name	ib to West Branch North Riv
Field Assessor(s)	CJ, LG
Field Assessment Date:	03-Nov-22
UTM Coordinates:	WP 1877
Datum:	UTM
HABITAT QUALITY (AT CENTRELINE)	
Overall Habitat Quality	Moderate
Spawning	Poor
Rearing	Moderate
Foraging	Moderate
Migration	Poor
Overwintering	None
POTENTIAL FOR FISH PRESENCE	
Overall Fish Potential	Moderate
FISH OBSERVED	
Yes, Salmonid	
WATER QUALITY AND VELOCITY	
Temperature (Deg. C)	7.8
pH	6.11
Dissolved Oxygen (mg/l)	10.39
Dissolved Oxygen (%)	89.1
Conductivity (µs/cm)	30.4
Salinity (mg/L)	0.02
Total Dissolved Solids (g/L)	
Turbidity (NTU)	
Average Velocity (m/sec)	0.27
Velocity Location	Crossing

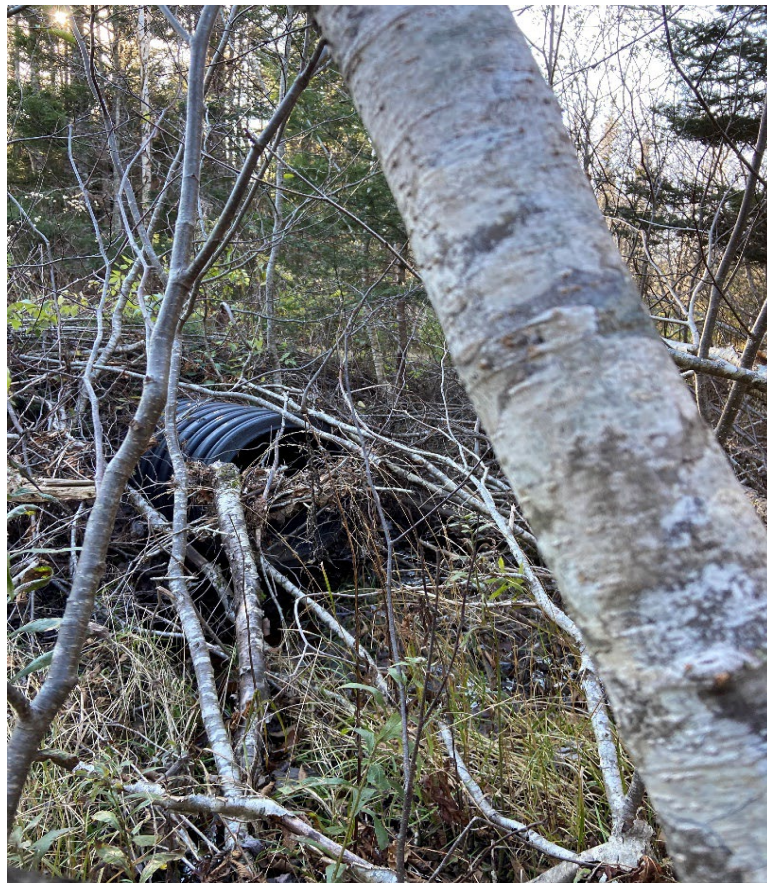
Photo 3: Feature 1 (Perched, partially blocked culvert, upstream of crossing)

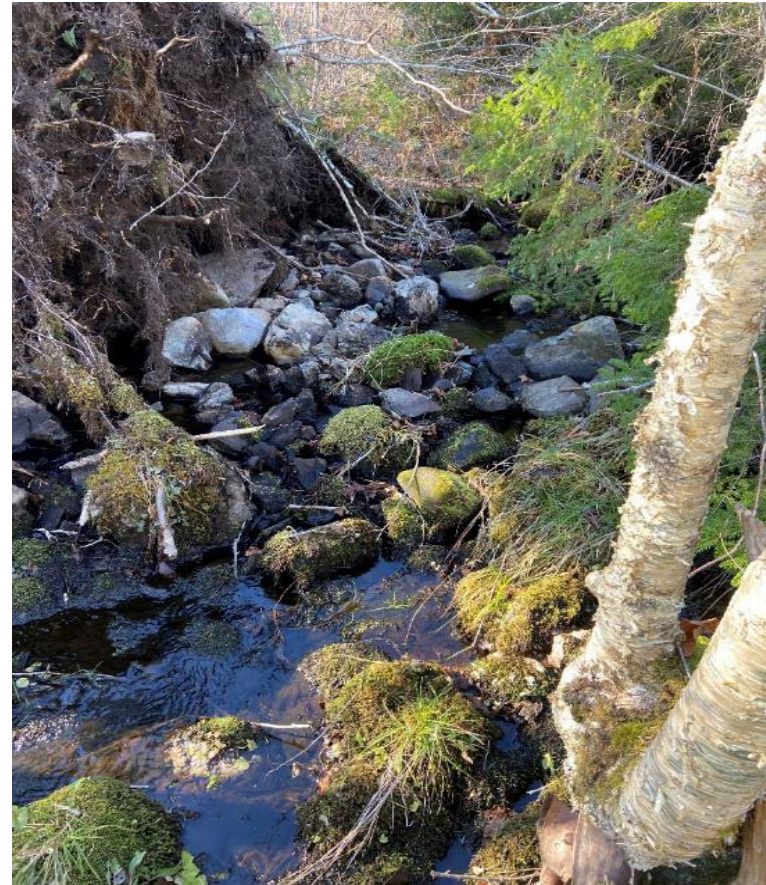
Photo 4: Feature 2 (Downstream riffle, upturned tree root)

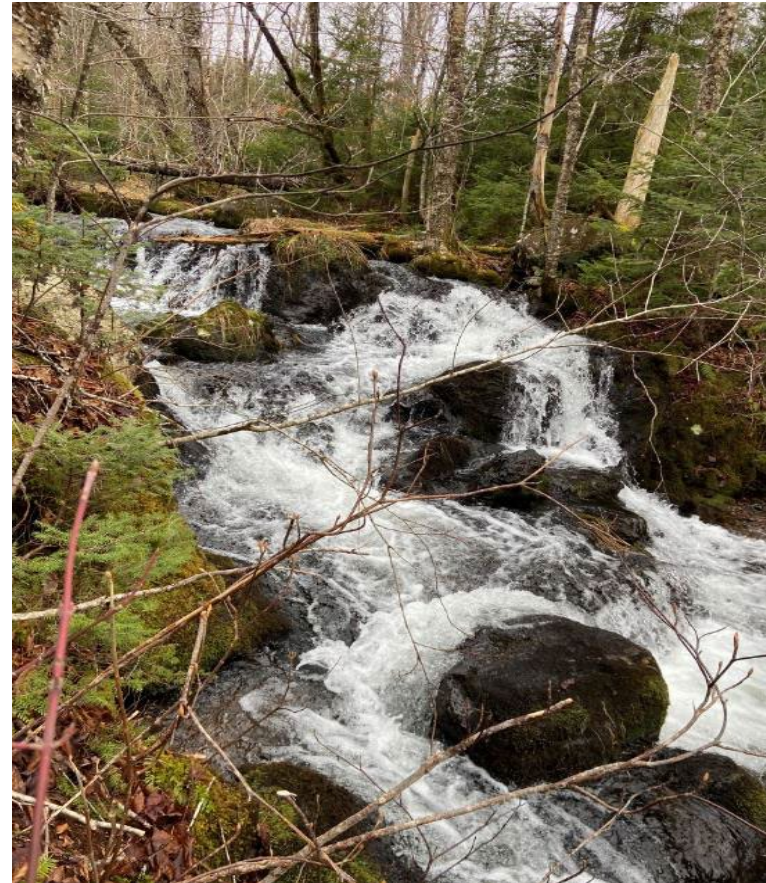
Photo 4: Feature 2 (Cascade)

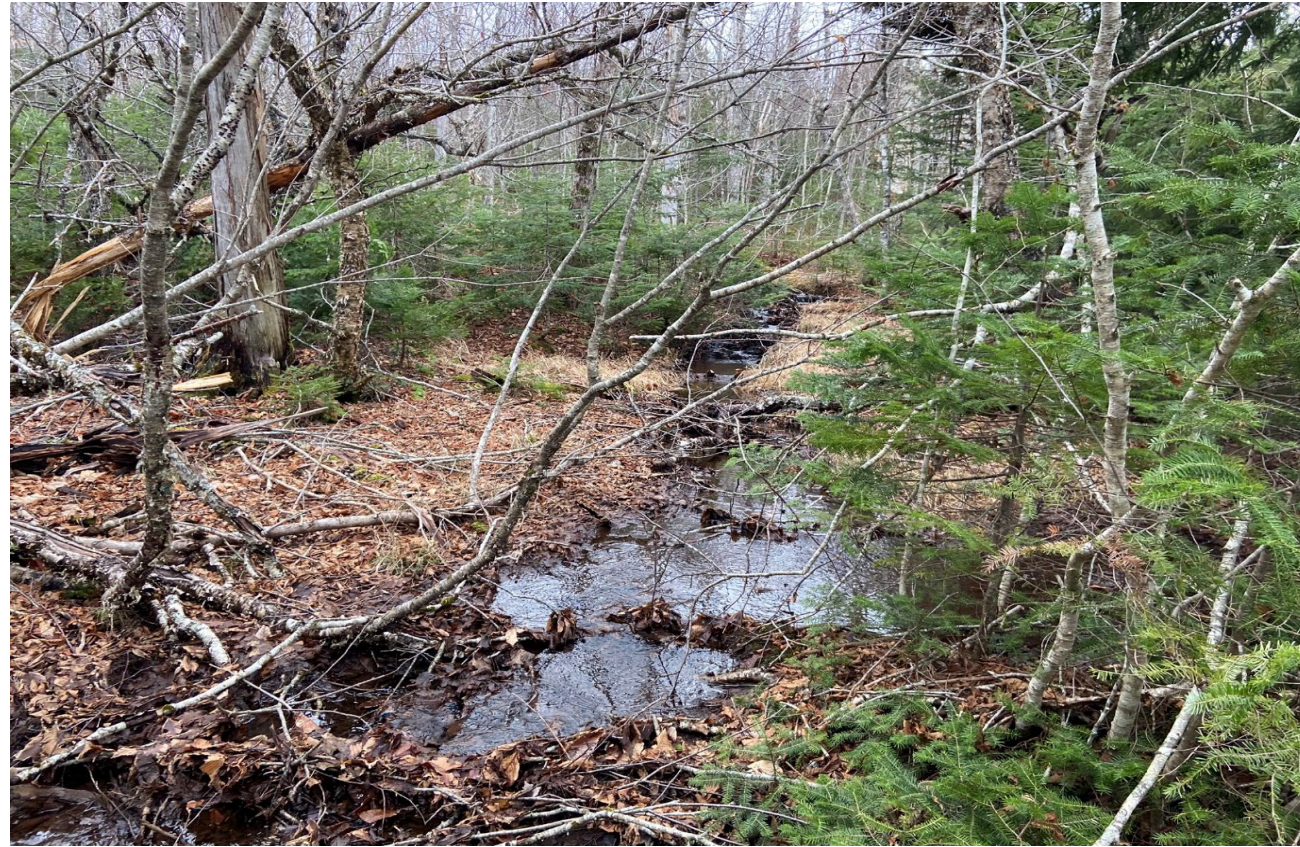
Photo 4: Feature 2 (Section with abundance SWD)

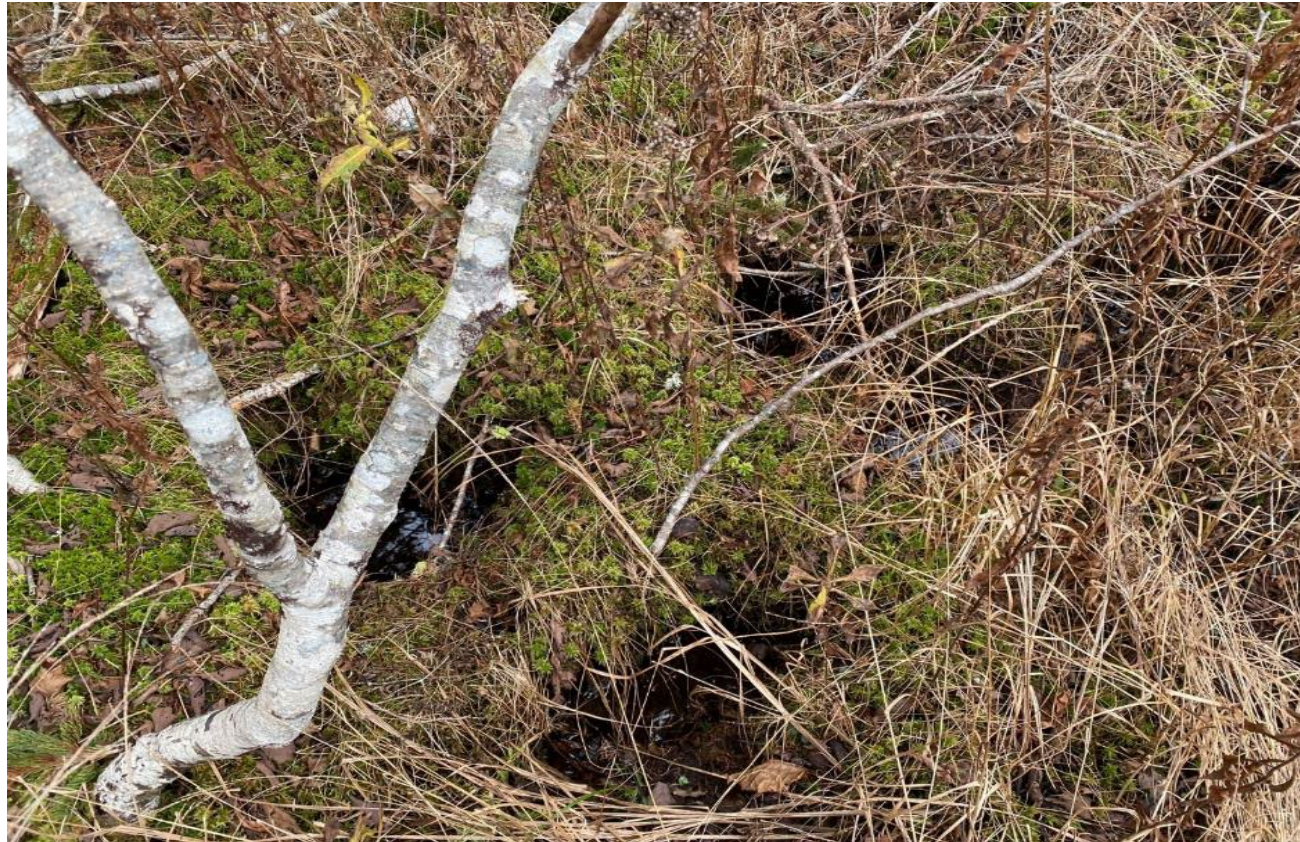
Photo 4: Feature 2 (Underground Section, etc.)

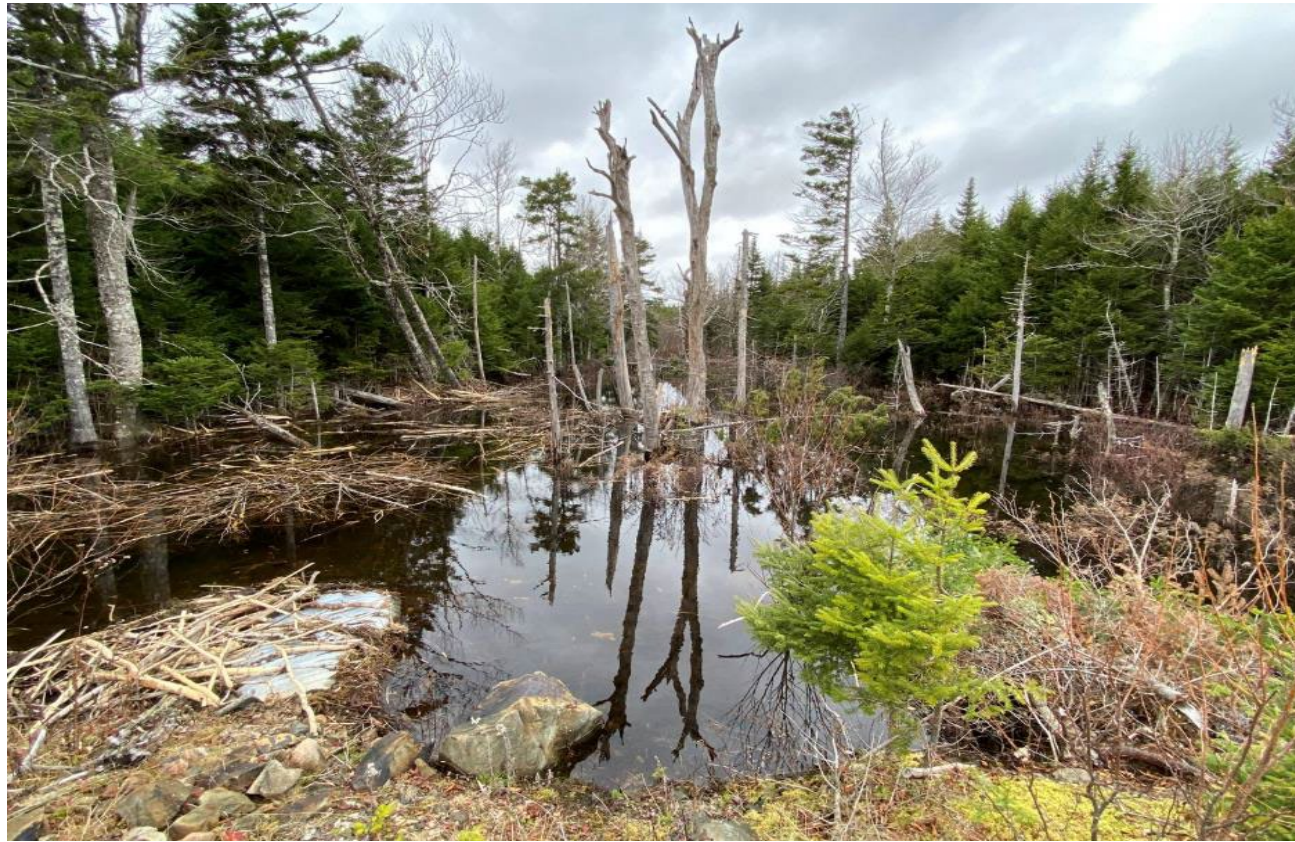
Photo 1: Upstream at Crossing Location (beaver impacted area)

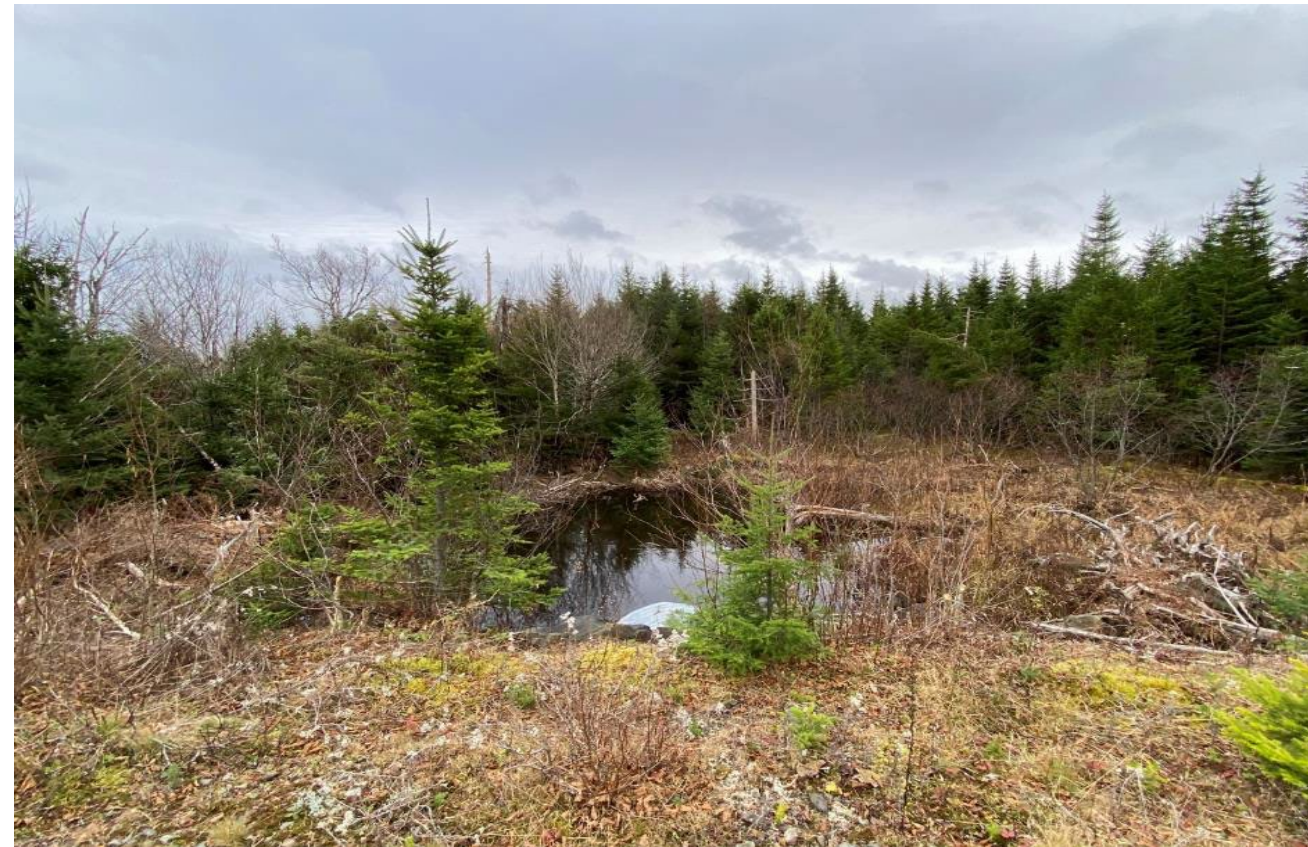
RIPARIAN VEGETATION SPECIES		
#	Common Name	Scientific Name
1		#N/A
2		#N/A
3		#N/A
4		#N/A
5		#N/A
6		#N/A
7		#N/A
8		#N/A
9		#N/A
10		#N/A
RIPARIAN INFORMATION		
Crown Closure %	1-25%	
Bank Texture	Organics	
Bank Shape	Shallow Slope (<100% / 45 deg.)	
Bank Stability	Fair 50-80% Stable	
Vegetation Stage	Mature Forest	
IMPORTANT FEATURES OBSERVED		
Spawning Area / REDD	<input type="checkbox"/>	
Beaver Dam	<input checked="" type="checkbox"/>	
Beaver Pond	<input type="checkbox"/>	
Underground Sections	<input type="checkbox"/>	
Waterfall or Cascade	<input type="checkbox"/>	
No Defined Channel	<input type="checkbox"/>	
Hanging Culvert	<input type="checkbox"/>	
Blocked or Damaged Culvert	<input checked="" type="checkbox"/>	
Bridge	<input type="checkbox"/>	
ADDITIONAL NOTES		
Beaverdam on watercourse at 300 m downstream of Centreline and 50 m upstream. Deep pool above beaver dam. Culvert on road at centreline, plugged.

Photo 2: Downstream at Crossing Location (downstream of culvert)

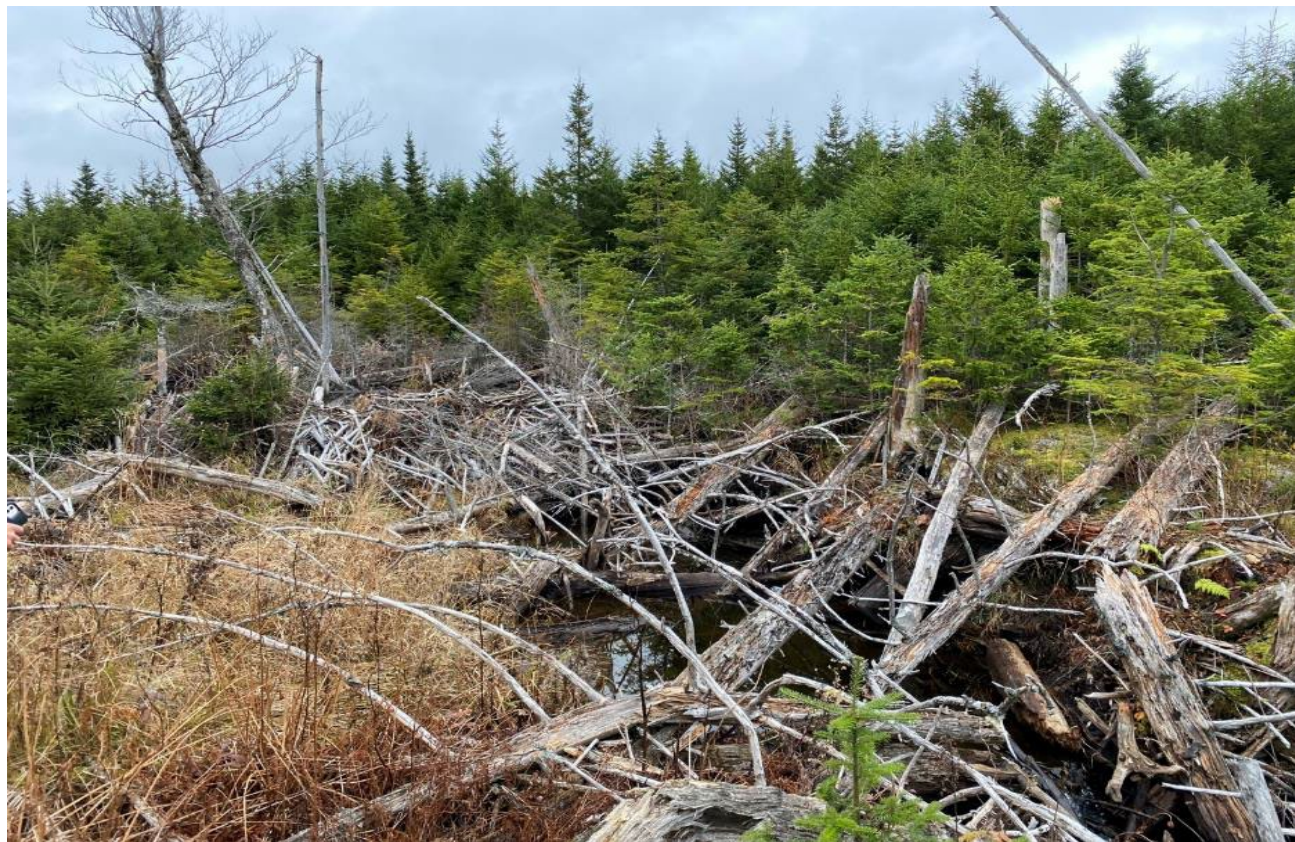
Photo 3: Feature 1 (Beaver Dam at 300 m downstream)

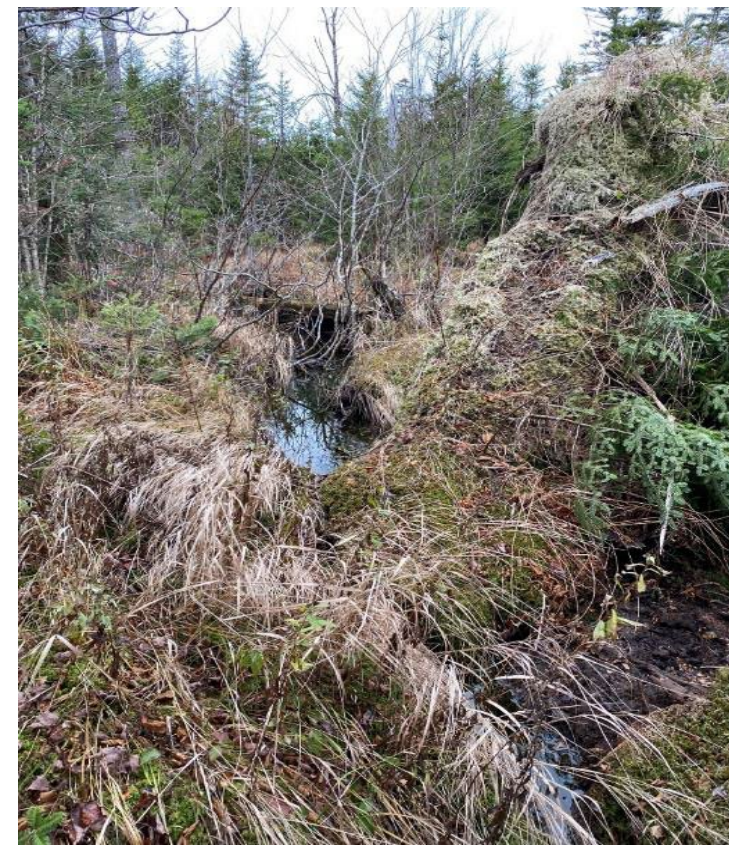
Photo 4: Feature 2 (small channel above upstream beaver dam (@ 100 m upstream))

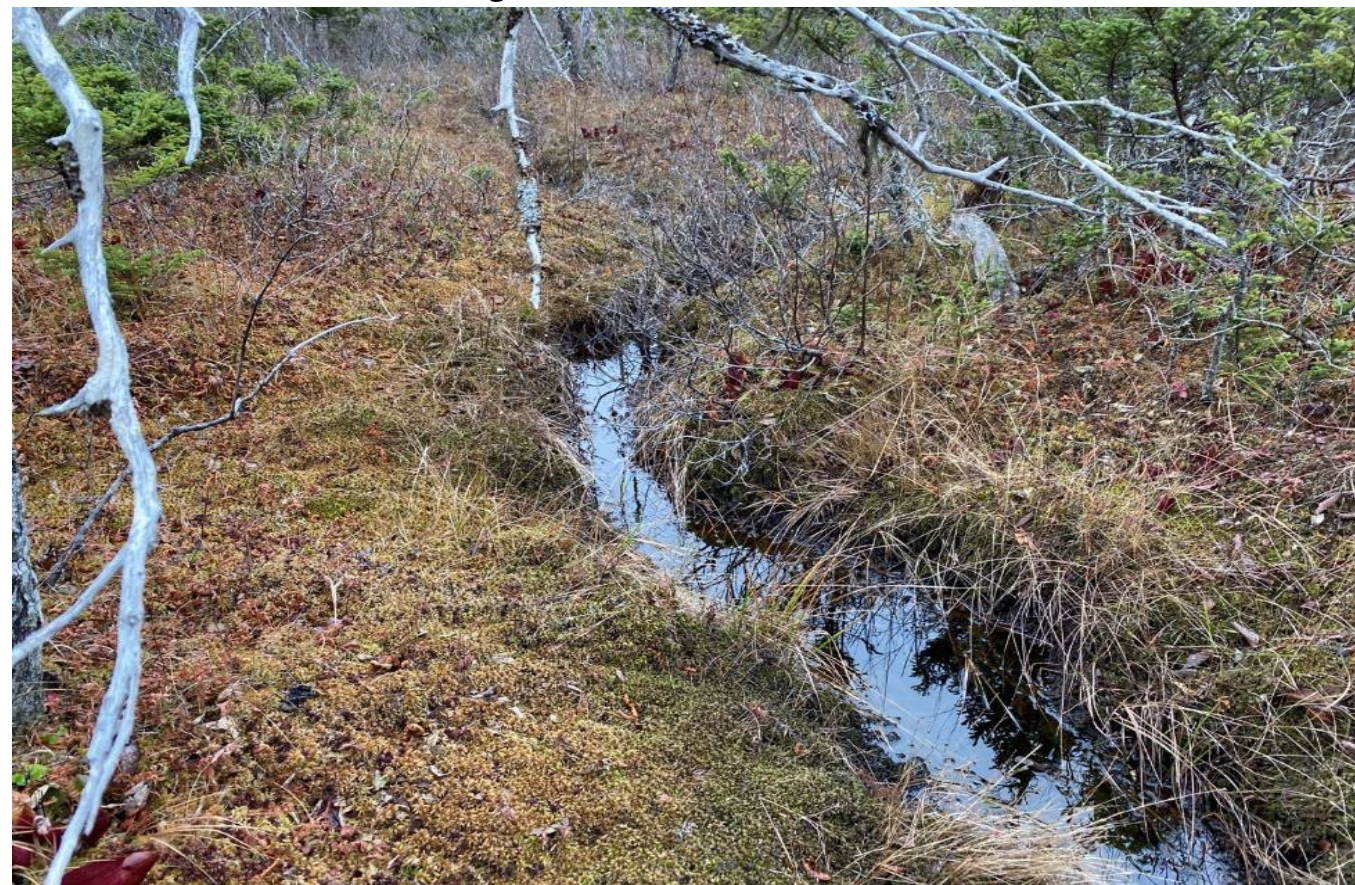
Photo 4: Feature 2 (small insized channel upstream)
