OVERVIEW OF BEDROCK AGGREGATE POTENTIAL IN THE HALIFAX-DARTMOUTH METROPOLITAN AREA, NOVA SCOTIA

Economic Geology Series ME 2001-1
G. Prime

Halifax, Nova Scotia
2001

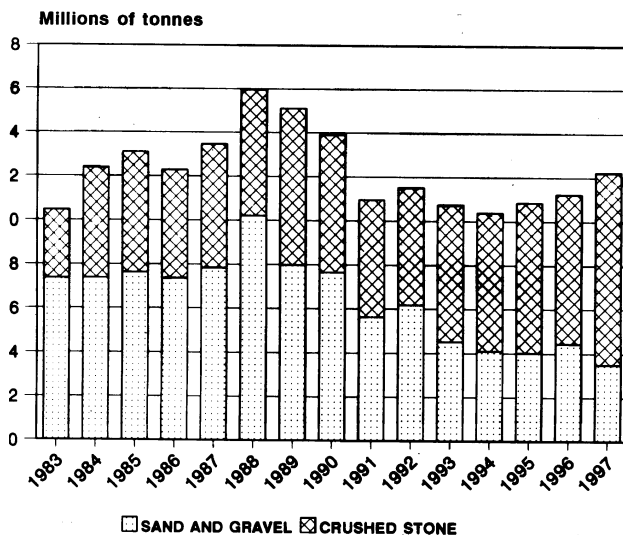
Figure 1. Nova Scotia aggregate production, 1983-1997 (data from Registry of Mineral and Petroleum Titles).

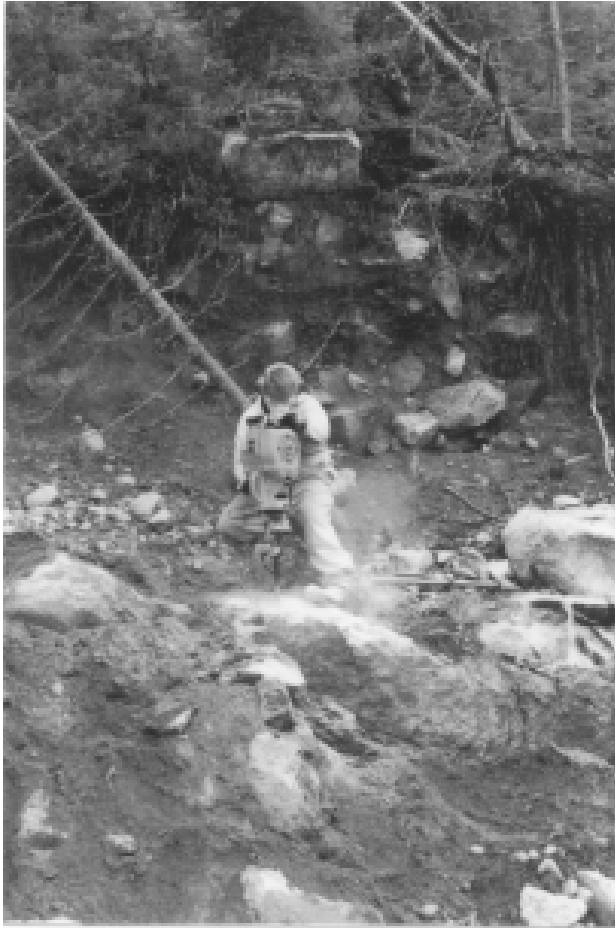
Figure 5. The primary method for collecting fresh samples involved use of a small gasoline-powered drill, wedges and feathers.

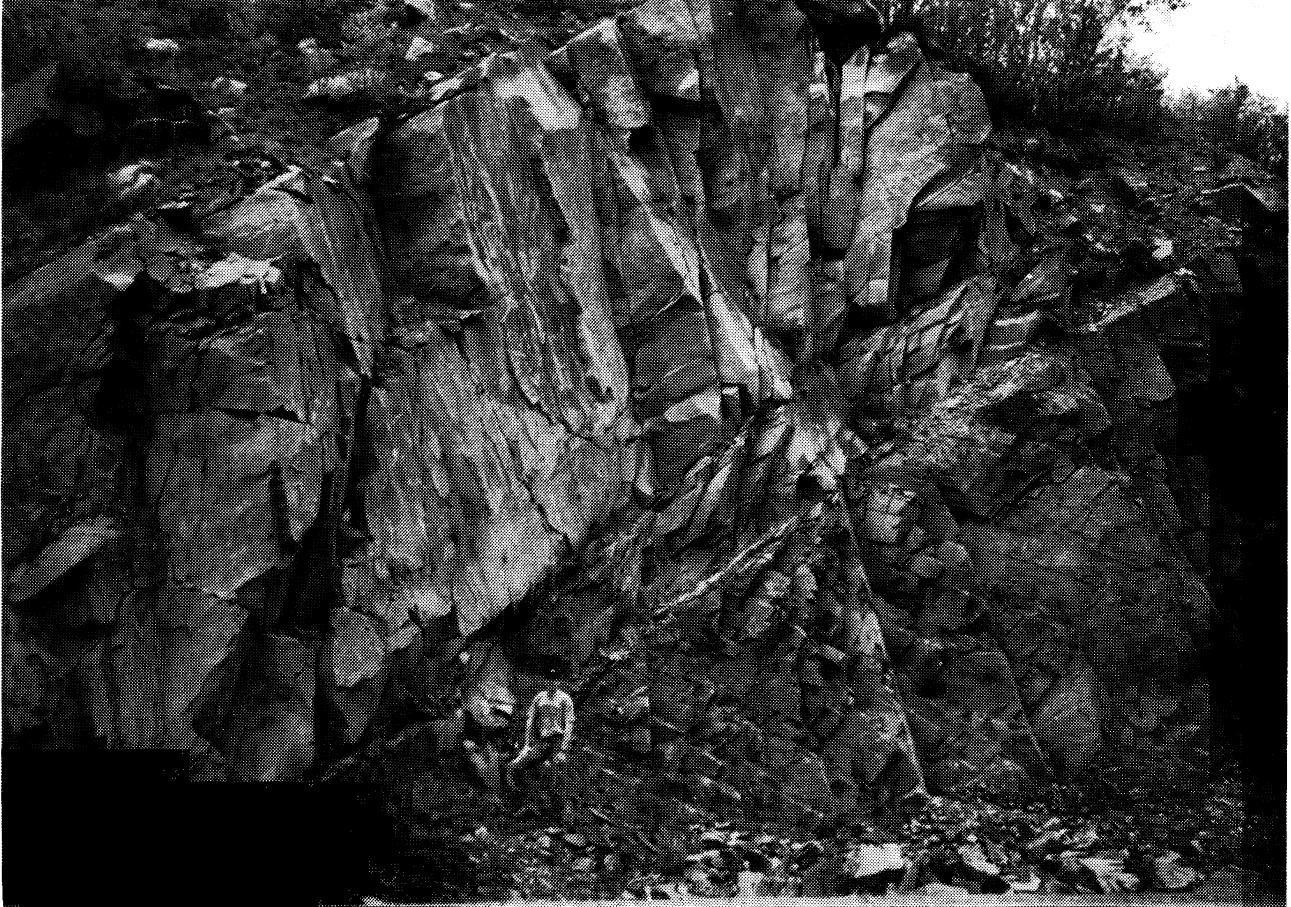
Figure 8. Exposure of Goldenville Formation quartzite in a road cut on Route 102 near Bedford (location #1, Fig. 7). The combined thickness of these units (dipping diagonally to the left) is approximately 12 m. Quartzite at this site is uninterrupted for several tens of metres.

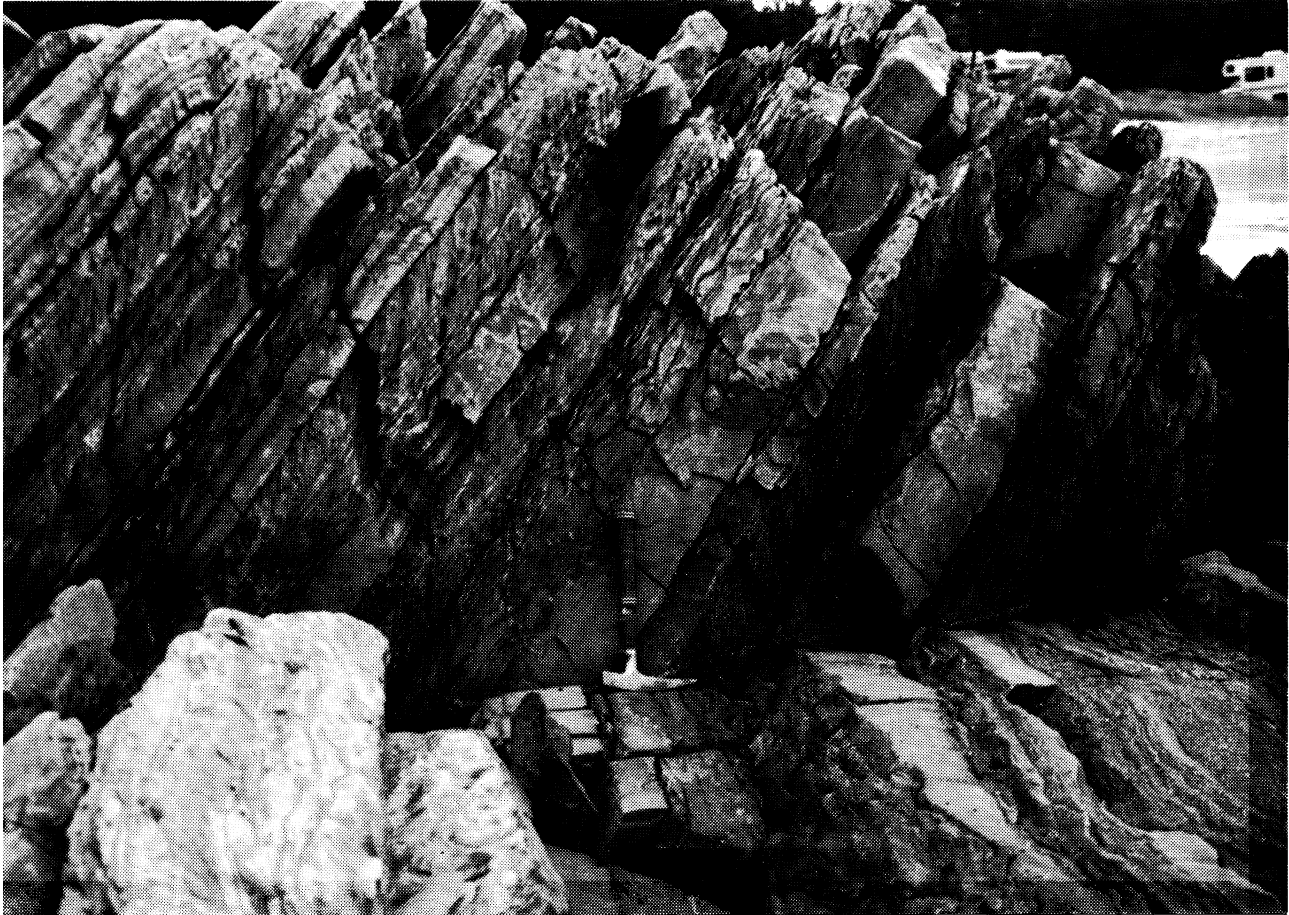
Figure 10. Example of interbedded quartzite (pale and blotchy) and slate (darker beds) in the Goldenville Formation (location 2, Fig. 7). The tabular nature of this layered bedrock presents opportunities for dimension stone products (see Fig. 11).

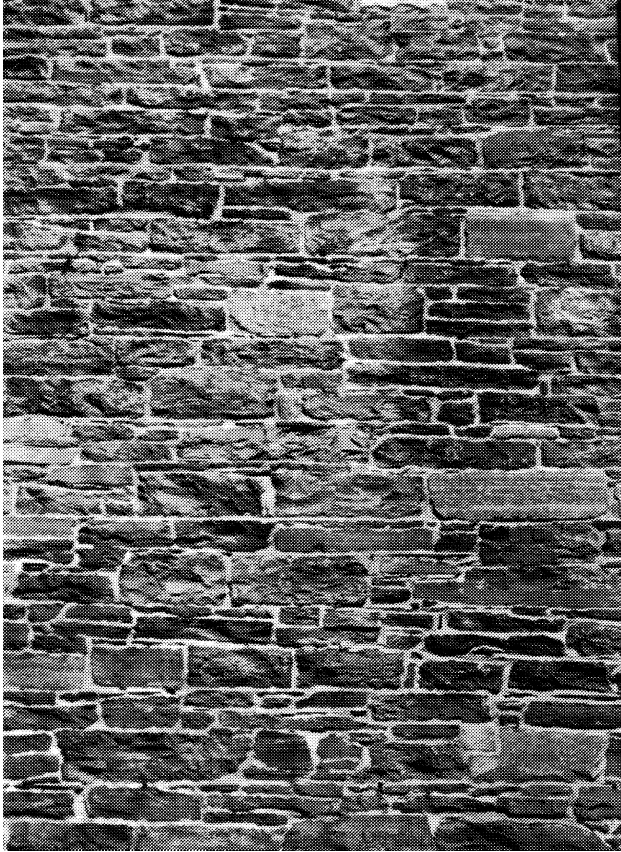
Figure 11. Wall at Historic Properties in Halifax (location 3, Fig. 7) constructed from blocks of Meguma Group slate and quartzite. The source of the material is probably similar to bedrock observed in Figure 10.

Because fine-grained quartzite and siltstone interbeds are commonly found in most exposures of the Goldenville Formation, Factor 3 and Factor 6 stone can also be expected in the quarry. These rocks typically have platy minerals and cleavage planes, which reduce the mechanical strength of the aggregate particles and their hardness in the scratch test. This would cause the acceptable quartzite/slate ratio to be even higher. However, most quartzite quarries can be selectively mined to extract the better materials for high-end uses, permitting a greater amount of slate and siltstone in the deposit, provided they can be cost-effectively worked around. The presence of some thinly interbedded slate/quartzite units (Fig. 10) can also be a benefit because they result in tabular or brick-shaped pieces of stone which can be used for dimension stone, such as the construction of walls (Fig. 11).

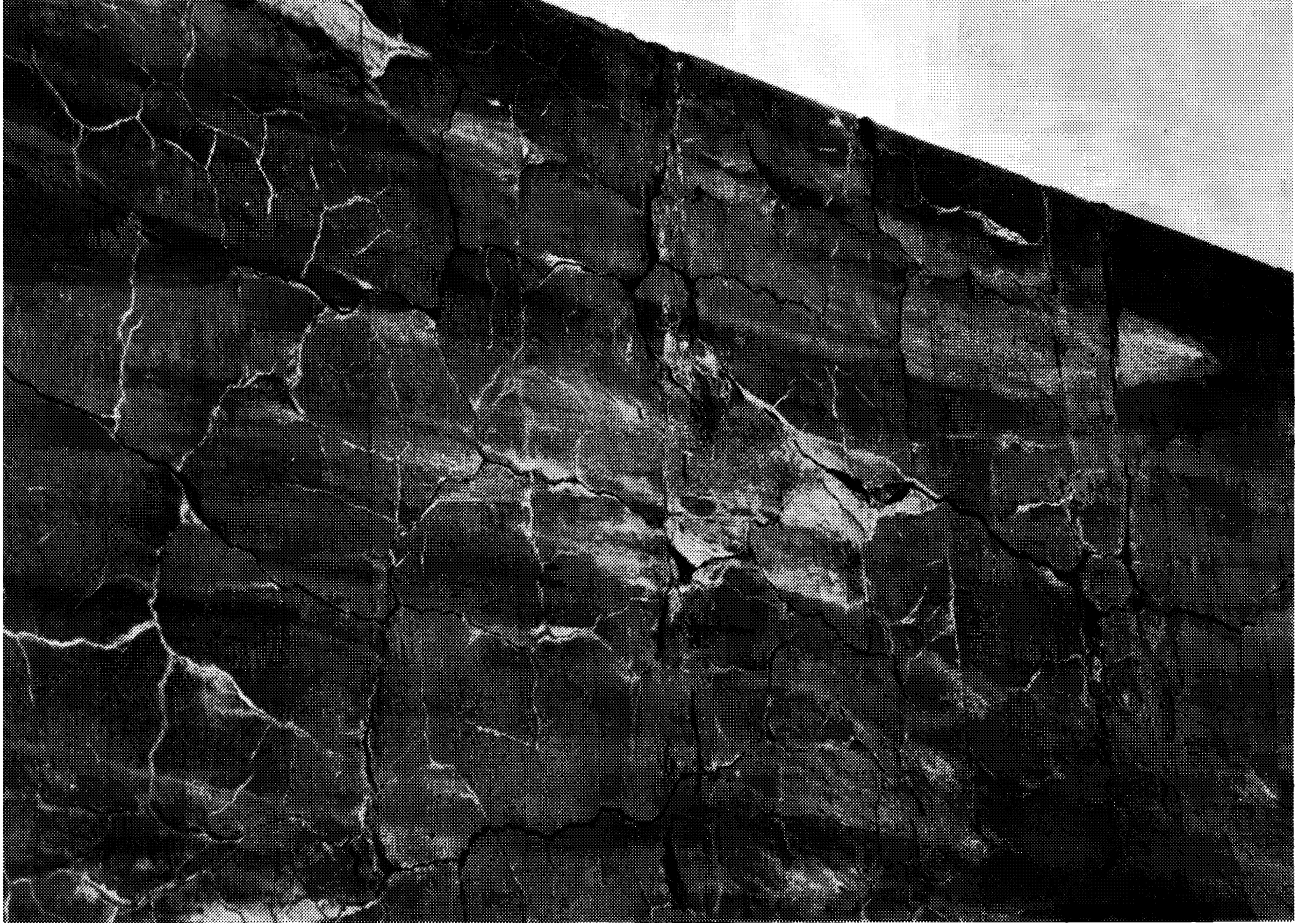
Figure 13. Example of a concrete structure in the advanced stages of alkali-aggregate reactivity. Once the reaction has begun, deterioration of the structure is accelerated by freeze-thaw cycles.

The research of the last 30 years has concluded that alkali reactivity in Nova Scotia is common and occurs as an alkali-silica reaction. When alkalis from the cement are exposed to certain silicate minerals (e.g. microcrystalline to cryptocrystalline quartz) in some aggregates in the presence of water, a reaction occurs at the surface of the aggregate particle to produce a silica gel reaction rim. The affinity of silica gel for water causes the rim to grow and cracking to occur (Fig. 13). For a detailed description of the reaction refer to Dolar-Mantuani (1983).

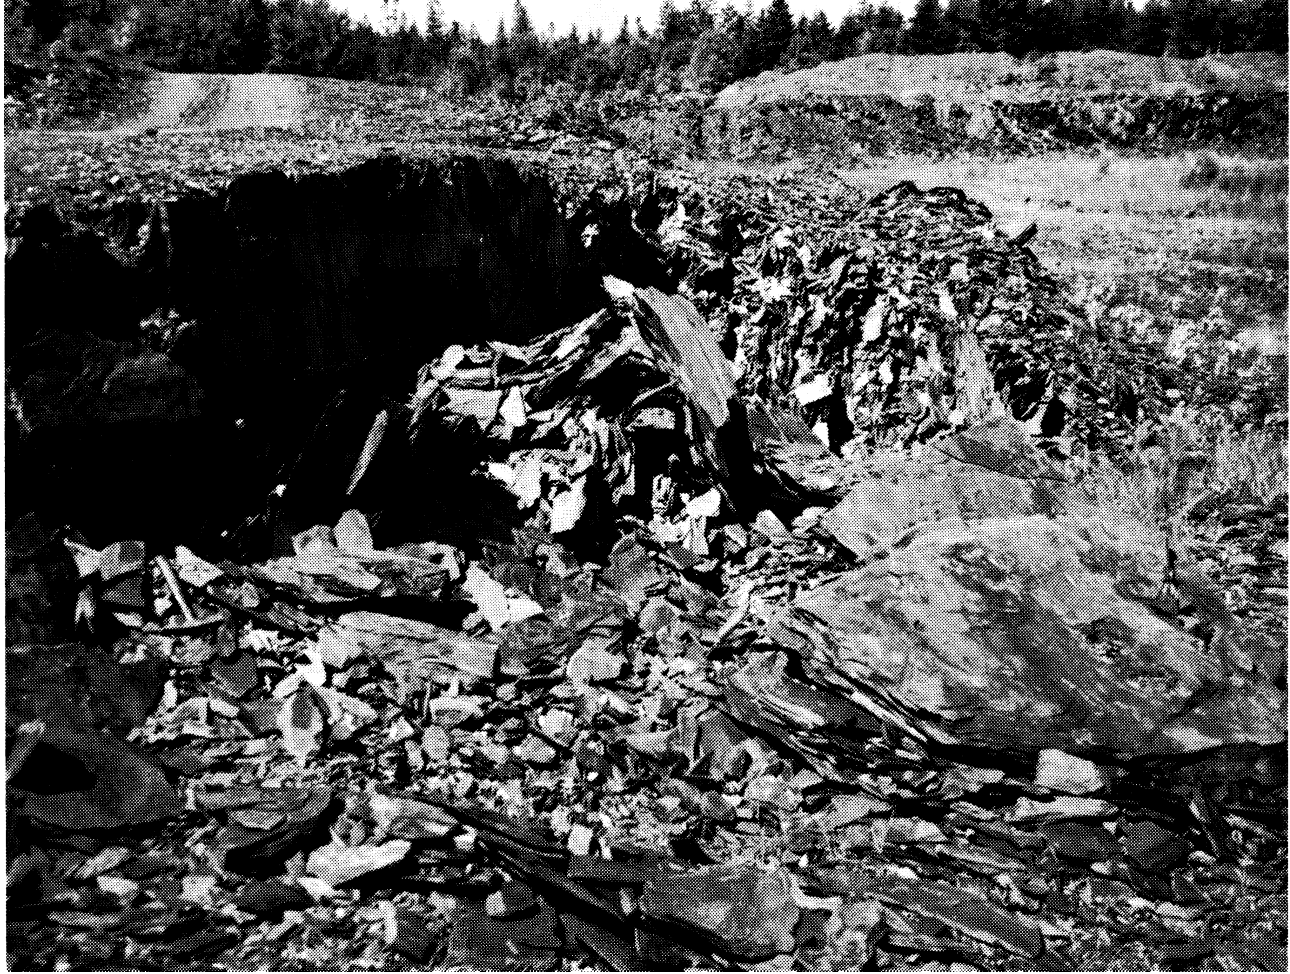
Figure 14. Slate quarries such as this one near Wykes Corner, Halifax County (location 4, Fig. 7), have been a primary source of aggregate in some parts of the province.

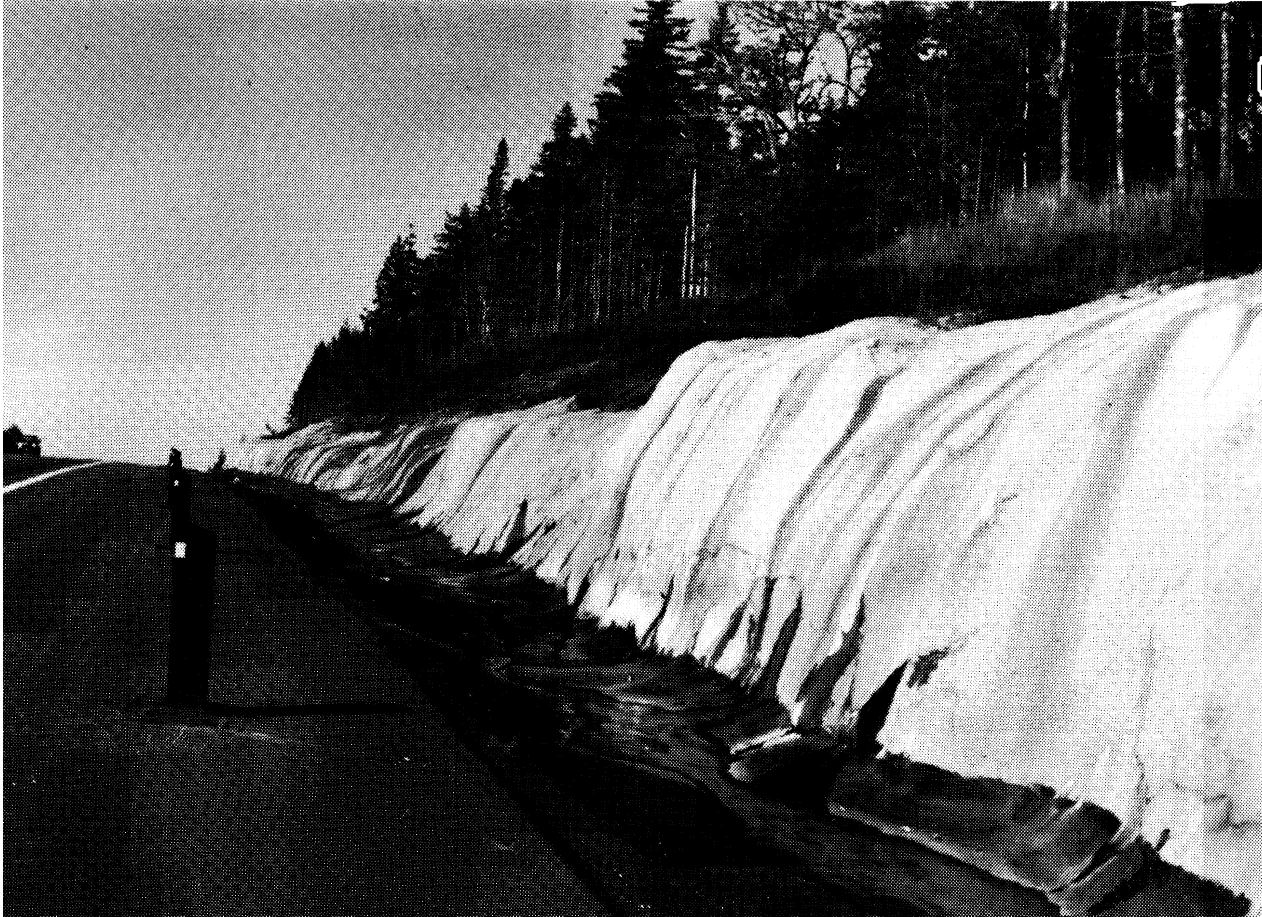
Figure 16. Attempts to seal acid-generating slates exposed during construction of Route 107 near Petpeswick Lake (location 5, Fig. 7) have not eliminated the problem. Rusty, iron stains (they look like shadows in the photo above) on the shotcrete and in the drainage ditch are a telltale sign of acid-generating slate. A containment pond at the base of this hill is used to buffer the low pH runoff before it enters the local lake system.

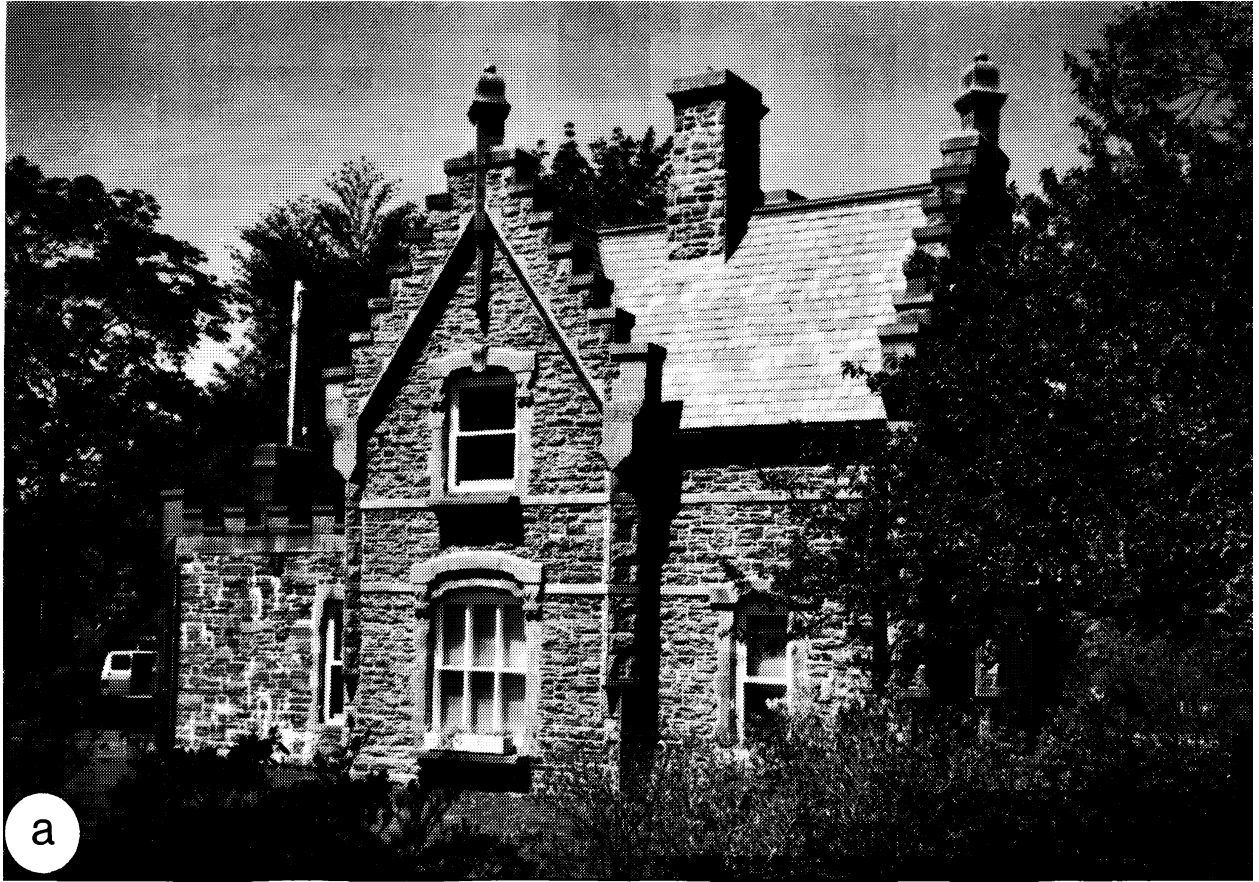
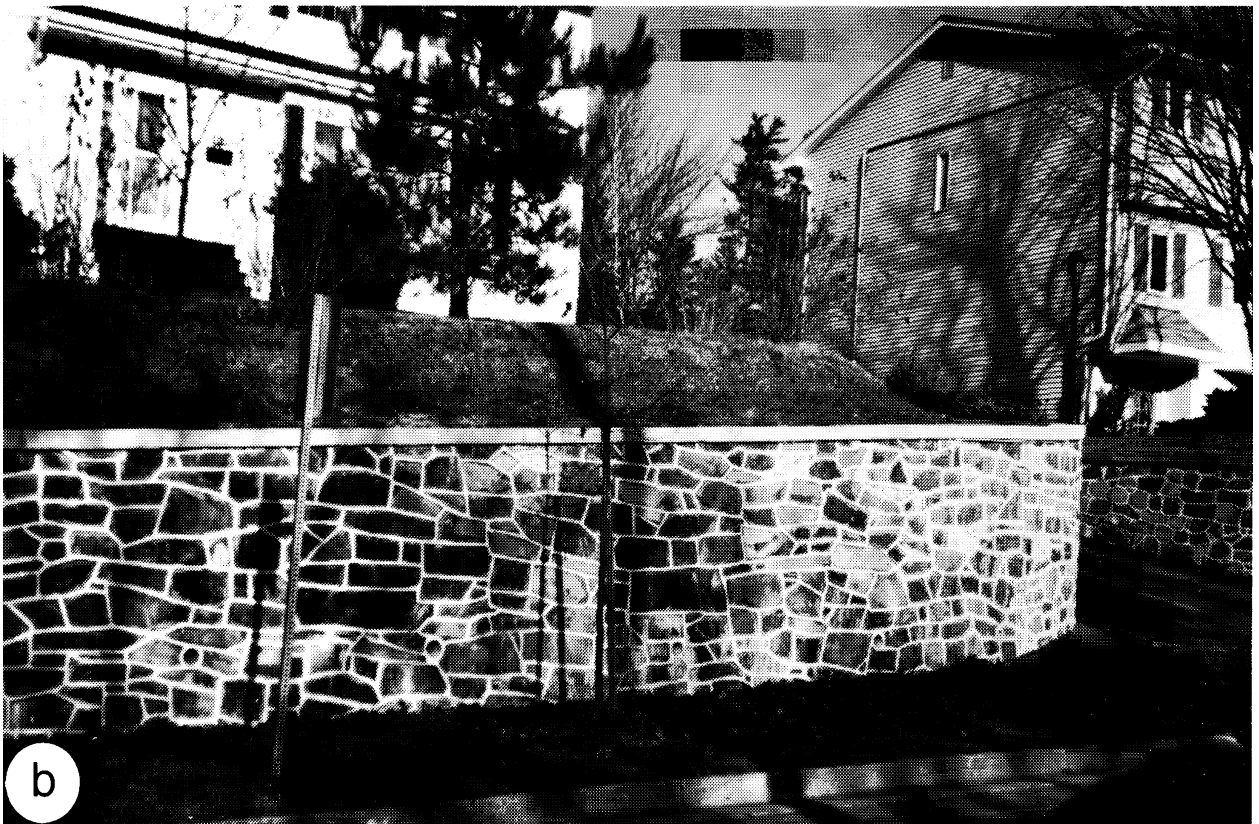
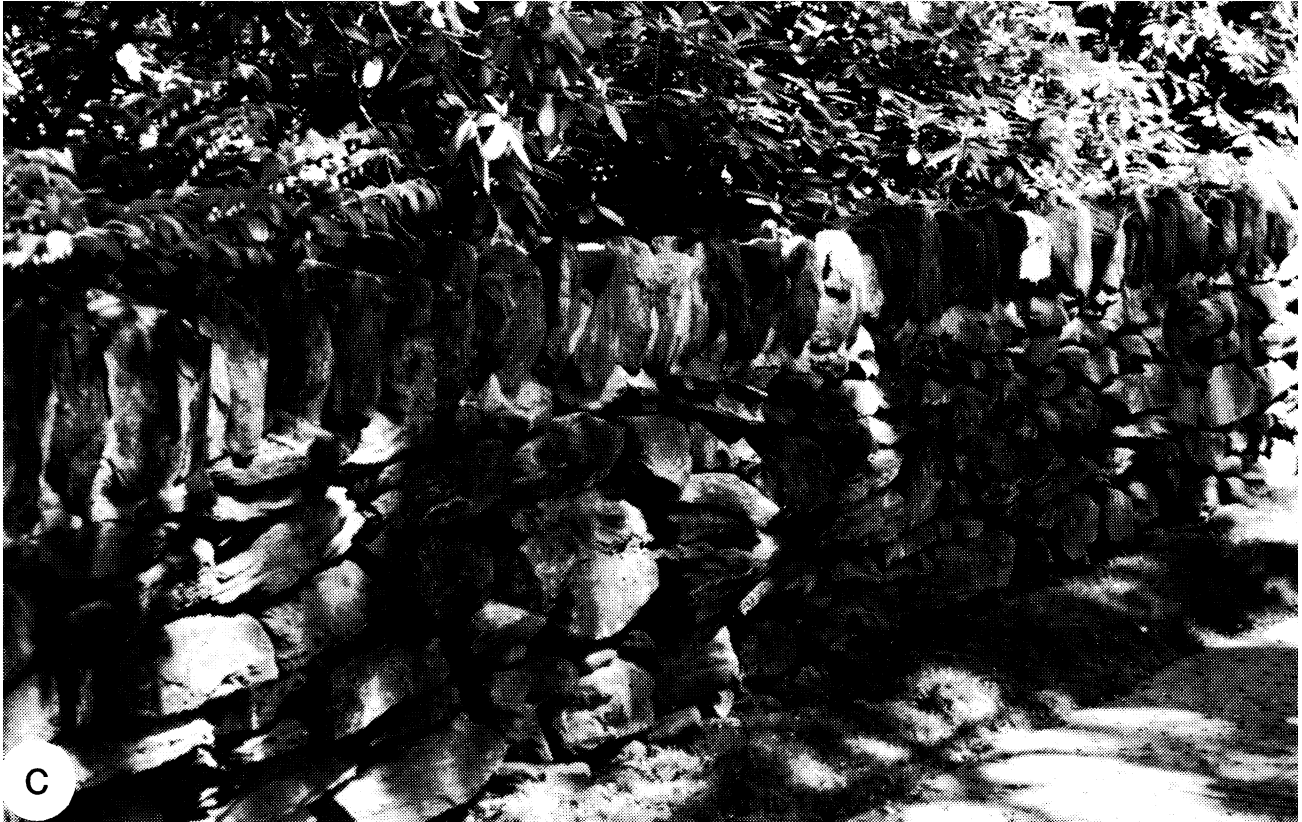
Figure 17. Examples of quartzite and slate dimension stone in the Metro area. (a) This stone building in Point Pleasant Park (location 6, Fig. 7) is a testimony to the lasting architectural appeal of quartzite as a building stone. (b) Retaining walls constructed of quartzite are a common site in Metro. The mortared wall shown here is in Rockingham (location 7, Fig. 7). (c) Fence rows of slate are a focal point in the south end of Halifax (location 8, Fig. 7).

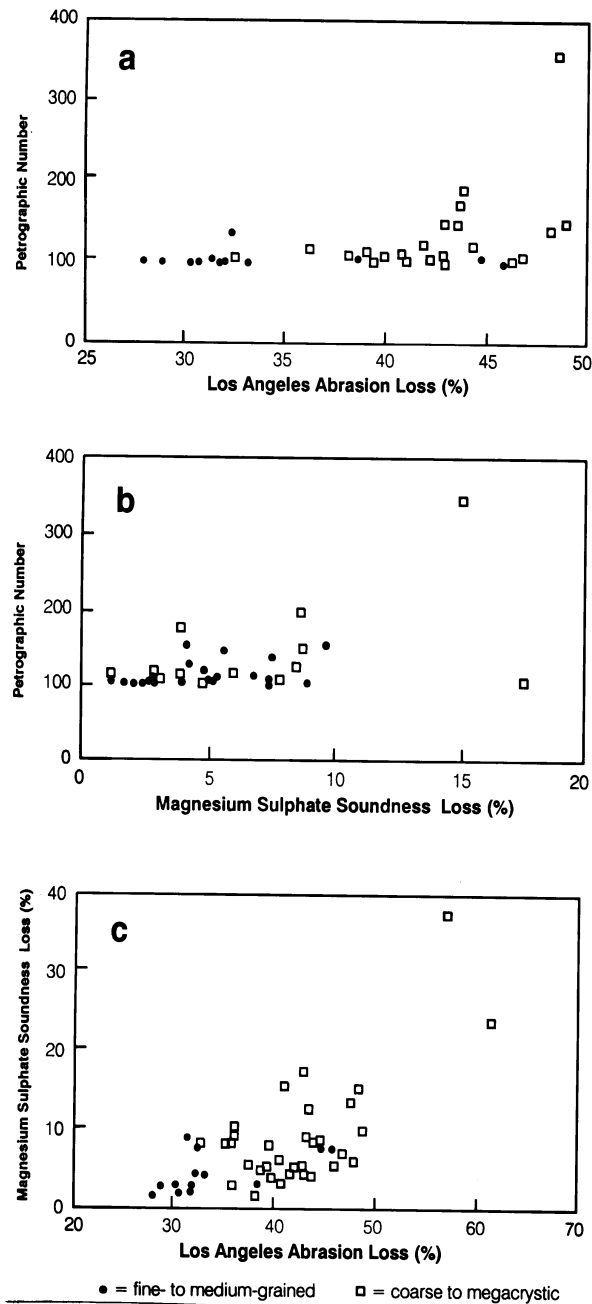
Figure 20. Graphs of aggregate test results in granites based on grain size differences

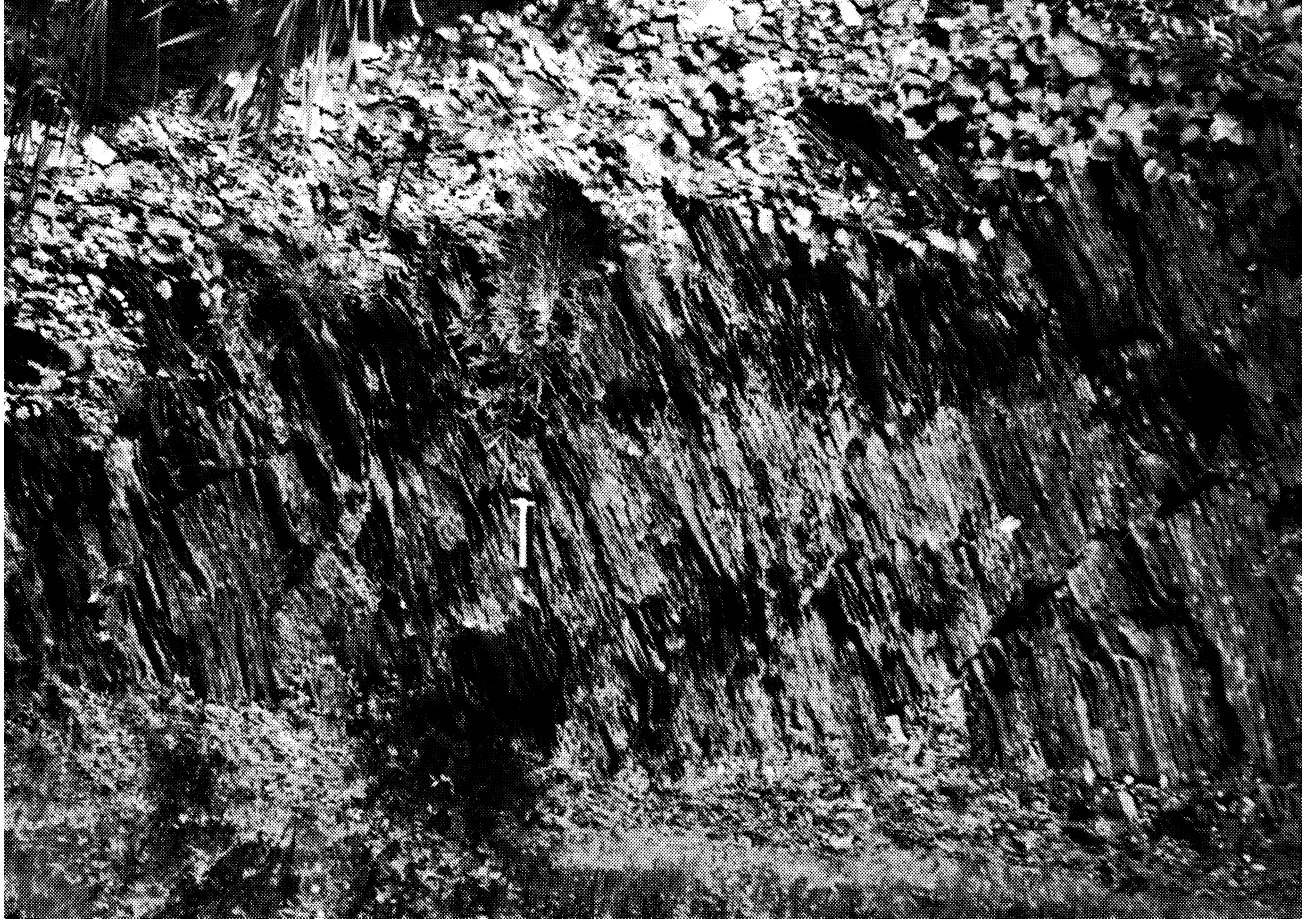
Figure 24. This recently exposed slate road cut at Waldeck, Annapolis County (location 9, Fig. 7b), demonstrates how quickly weathering can take place. Rubble at the base of this outcrop is the result of weathering.

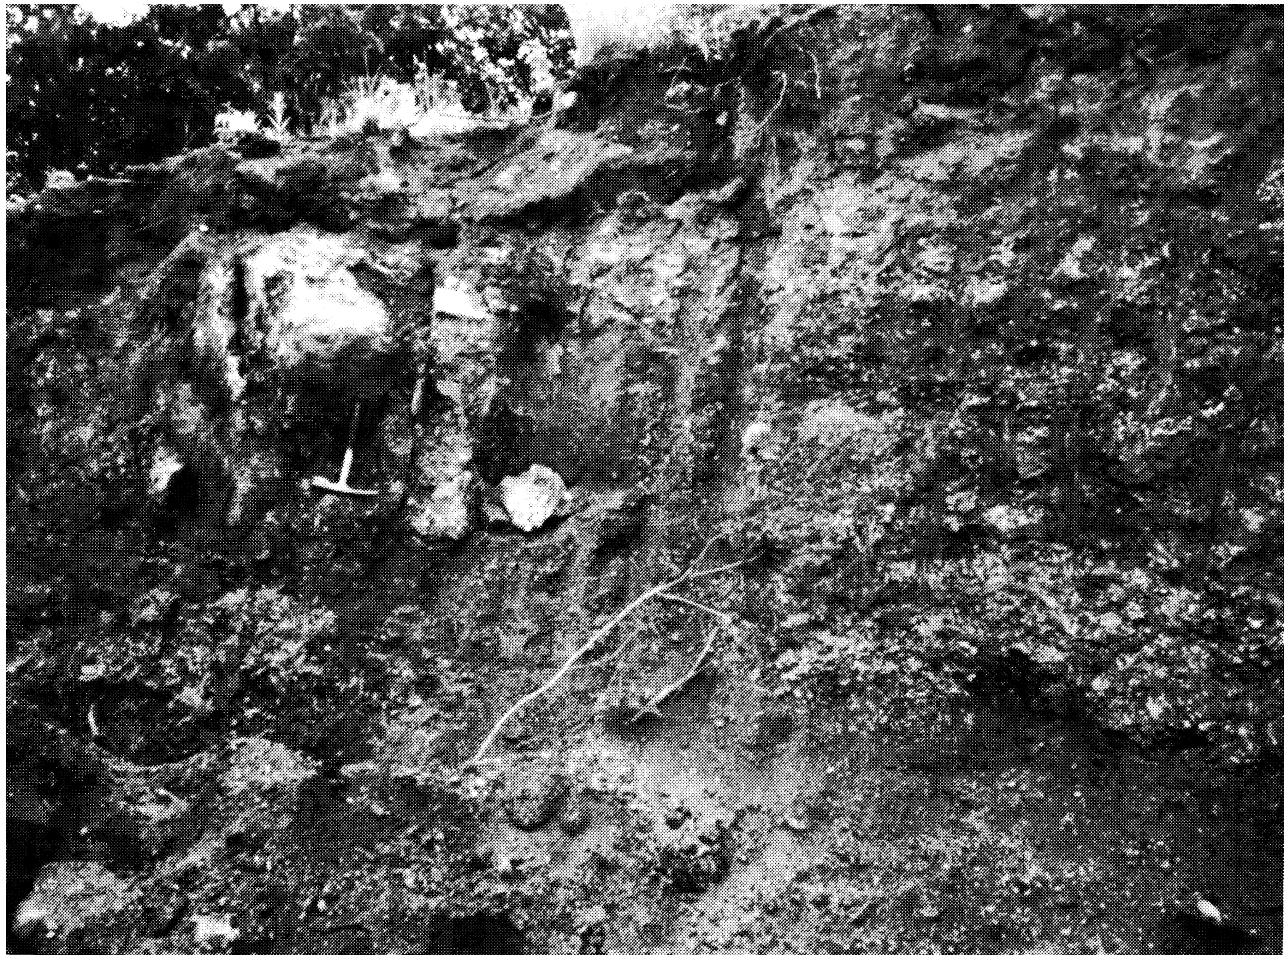
Figure 27. Weathered granite or grus in a borrow pit near Milford, Annapolis County (location 12, Fig. 7b). Note corestone (above hammer) within the surrounding disaggregated material. Although rare in the study area, the presence of grus at any location makes it unsuitable for quarrying.
