**CEAA Screening-Level
Environmental Assessment
Report for Highway 103
Twinning**

Twinning of Highway 103 from
Upper Tantallon to Hubbards,
Nova Scotia

FINAL REPORT

Report Prepared for:
Nova Scotia Transportation and
Infrastructure Renewal

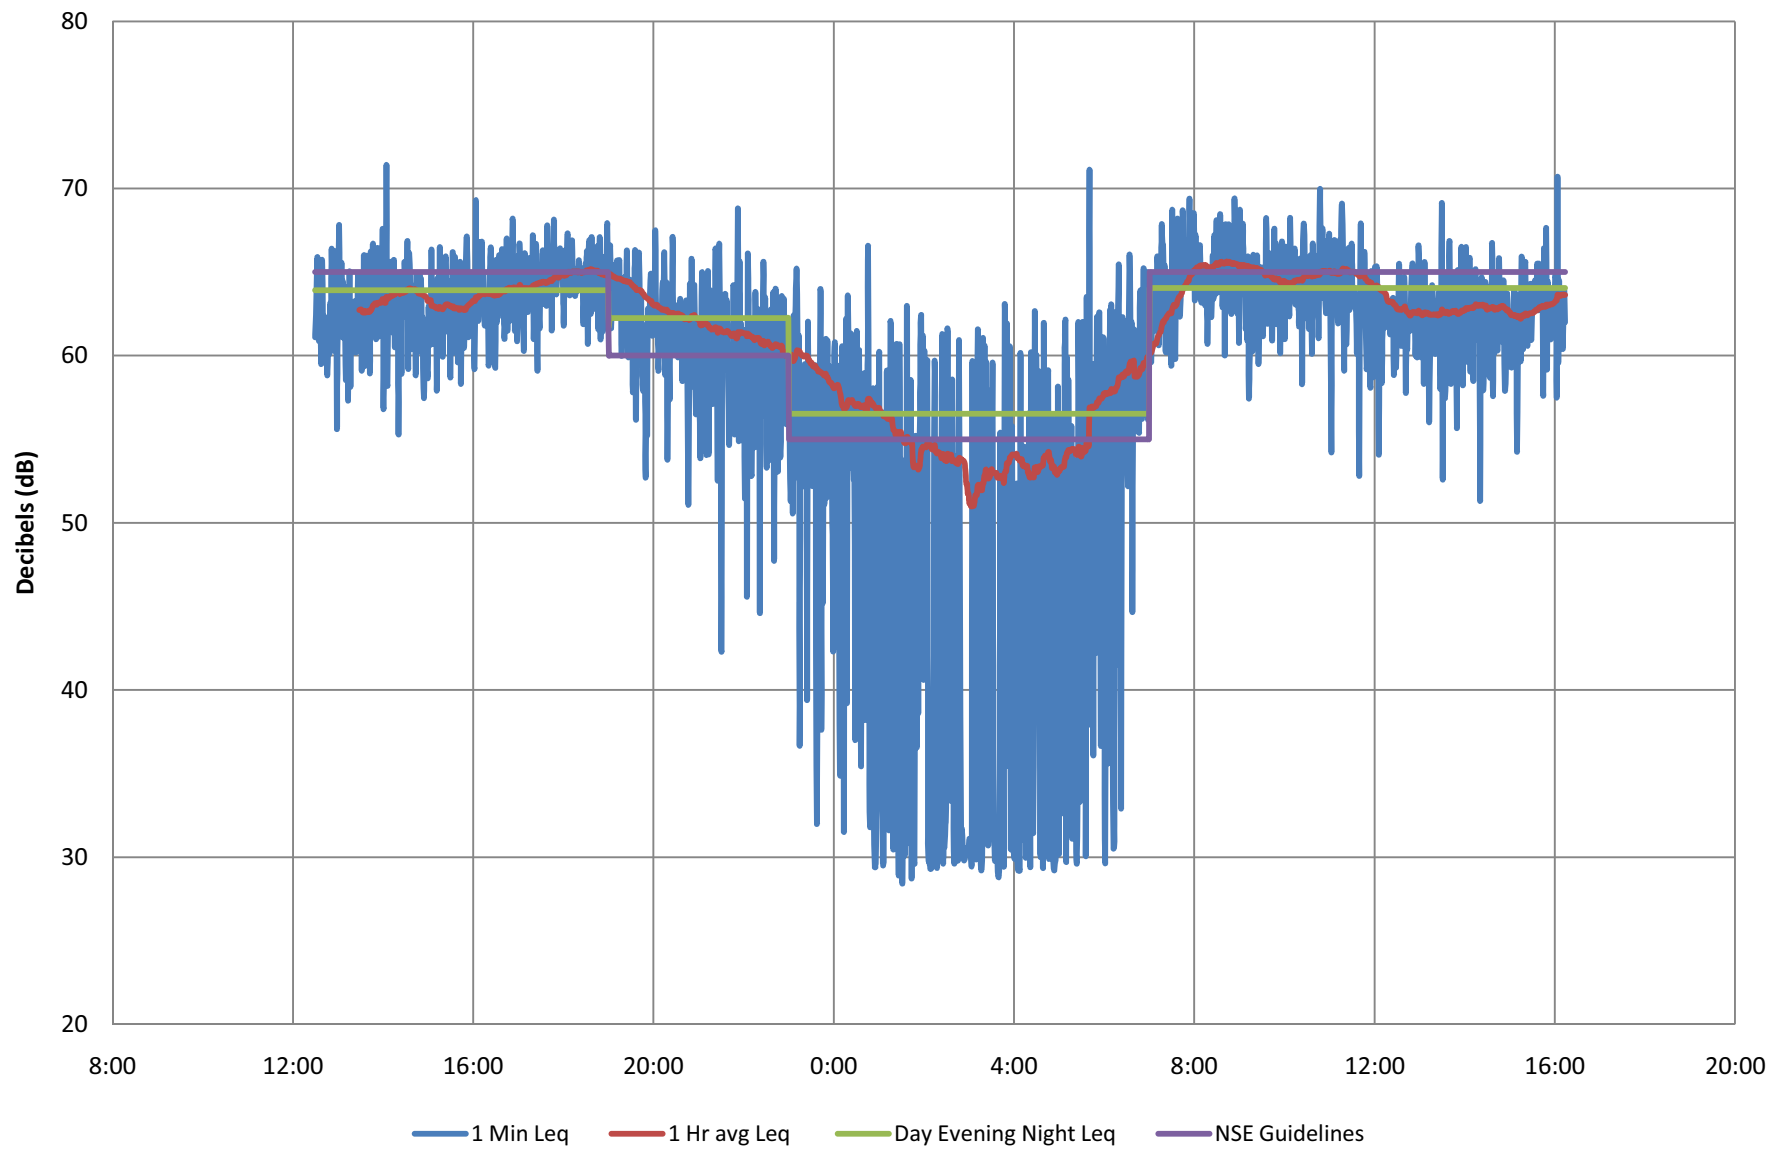
**Figure 7 24 - Hour Sound Pressure Level Monitoring - Baseline Noise
Monitoring Site 7 - November 9-10, 2009**
