**Stantec**

February 3, 2010  
File: 9299

**Reference: Biological, and Supporting Water Quality Studies, Woodens River Watershed, 2009**

This letter provides the results of an investigation of littoral (near-shore) benthic invertebrate communities present in selected lakes in the Woodens River watershed, and the findings from a fall brook trout spawning survey.

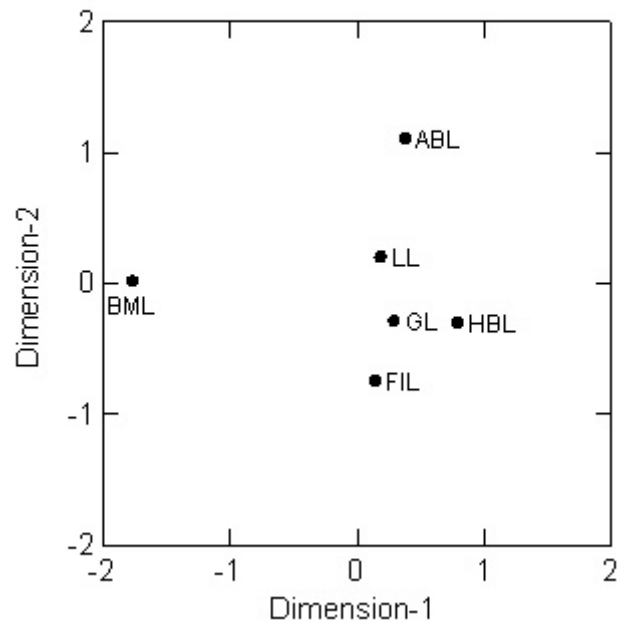
Figure 2. Ordination Plot for Benthic Invertebrate Community Survey. Lakes Include Albert Bridge Lake (ABL); Ben Miller Lake (BML); Five Island Lake (FIL); Gates Lake (GL); Hubley Big Lake (HBL); and Long Lake (LL).

Firstly, the benthic invertebrate abundance data (based on presence or absence, with values of 0 to 5) were compared using a Spearman (nonparametric) correlation matrix to measure the overall likeness between the assemblages captured in each sample. The resulting correlation matrix was then submitted to NMDS with results visualized in a two-dimensional plot. This approach was chosen as it allows the representation of the overall relationships of a complex data set, such as benthic invertebrate community survey data, with minimal loss of information. The NMDS ordination plot for the Woodens River watershed benthic invertebrate data is shown in Figure 2. Based on this figure, it is apparent that the benthic invertebrate assemblage of Ben Miller Lake is distinct from the assemblages in all other lakes (as visualized by the distance between lake pairs in NMDS Dimension 1), and that the remaining five lakes display a similar gradient between Five Island Lake and Albert Bridge Lake on NMDS Dimension 2.

Three of the four taxa that correlated positively with Dimension 1 scores were found predominantly in Albert Bridge and Hubley Big lakes. Four of the five taxa that correlated negatively with Dimension 1 scores were predominantly found in Ben Miller Lake. Additionally, all three taxa that correlated positively with Dimension 2 scores were found predominantly in Albert Bridge Lake and Long Lake, whereas those that correlated negatively were found in Five Island Lake and Hubley Big Lake. These observations corroborate the ordination plot (Figure 2) and the benthic community structure of these lakes.

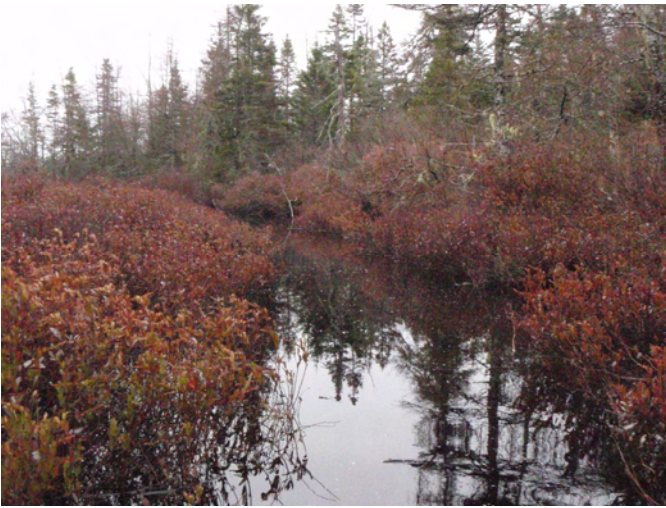
Photo 1: Fleck Brook - downstream reach

At the time of the survey, the downstream reach of Fleck Brook was a flat run surrounded by wetland with stream banks that were minimally entrenched, stable and covered with sphagnum moss and overhanging woody vegetation (Photo 1, Attachment 4). The stream was widest and deepest in this downstream area, with the brook varying from 3 m to 5 m in width and supporting mean depths of 0.75 m to 1.0 m. The low velocity through this section of brook allowed settling of organic material and fines that covered 50% of the rocky substrate composed of equal parts boulder, gravel and sand. This organic material provided substrate for the growth of submerged aquatic plants (*i.e.*, macrophytes), while the boulders provided an appropriate surface for aquatic algae growth. The wetland tannins stained the water brown, and made the streambed difficult to see in the larger, deeper stillwaters. One redd was observed within this section and a sample for water quality analysis was taken at the location of the redd (Photo 2, Attachment 4; Figure 4). The redd was characterized by cleared gravel in an area suspected of receiving ground water input (Photo 3, Attachment 4).

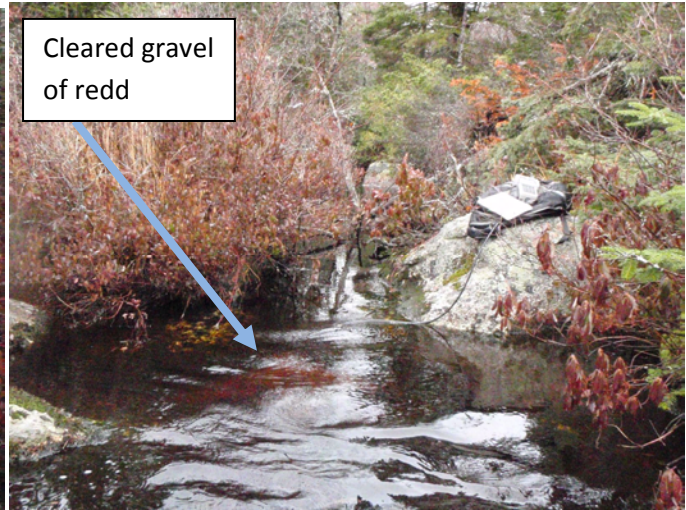
Photo 2: Fleck Brook observed redd (water quality site)

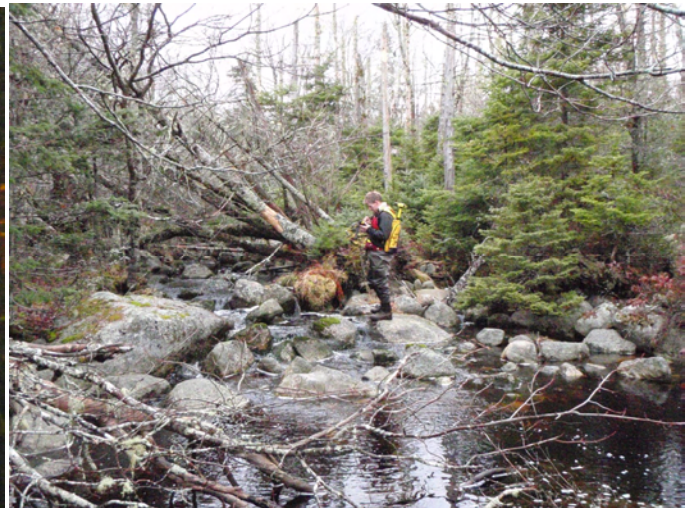
Photo 4: Fleck Brook - second (midstream) surveyed reach

The second surveyed reach (the midsection of Fleck Brook) was located north of the heavy wetland coverage and provided different fish habitat. The brook narrowed through this area and slope increased (Photo 4, Attachment 4), except in one wetland area where the brook widened into a slow-moving flat. The substrate of the 1.5 m wide brook in the second surveyed reach was dominated by boulders. With the stronger velocity resulting from the increased slope and decreased width, coverage by fines was reduced to approximately 30% of the substrate within this section. A forest canopy developed in this survey section and lead to increased shading and riparian vegetation dominated by deciduous forest species and minimal overhanging vegetation. Algae remained present on the large substrate and submergent macrophytes were noted as well. Three redds and a few areas of potential spawning habitat were observed within this section, including within the slower moving flat (Photo 5, Attachment 4).

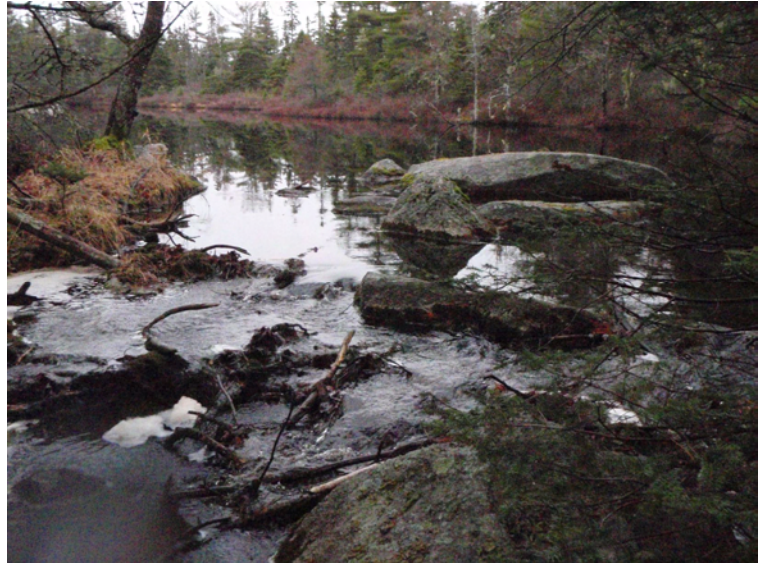
Photo 6: Fleck Brook – upstream reach at Birch Hill Lake

The third and most upstream section of the surveyed portion of Fleck Brook was shorter in length than the two previous sections and included the riffle immediately below Birch Hill Lake (Photo 6, Attachment 4). Bounded by deciduous forest on stable banks, the canopy cover over the brook remained low due to the width of the watercourse. At nearly 4 m wide, the depths varied from 0.15 m to 0.4 m. This area supported increased water velocities and larger substrate, but had fewer areas of potential spawning habitat than the remainder of the brook.

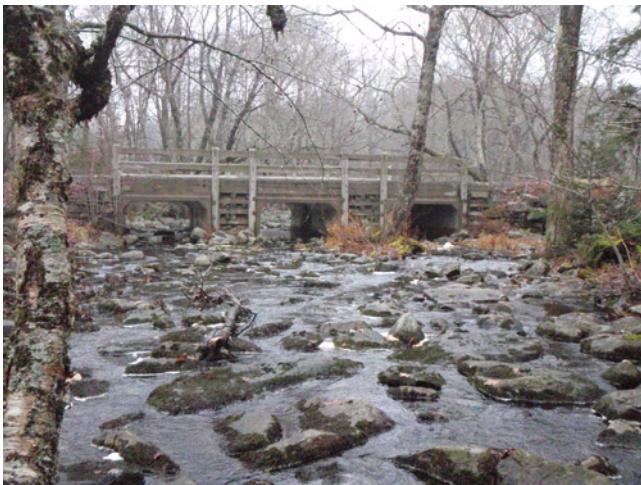
Photo 7: Five Island Lake Run – downstream reach

At the time of the survey, the downstream extent of Five Island Lake Run was dominated by riffles running over rock and boulder substrate (Photo 7, Attachment 4). The watercourse was surrounded by deciduous forest and the stream banks were stable and covered with overhanging woody-stemmed vegetation. Minimal undercutting was observed and was limited to bends within the run. A road crosses the run at its widest section approximately 80m upstream of Hubley Big Lake. Wet widths in this area of the survey varied between 15 m and 20 m, and the average depth was 0.2 m. The shallow water depth allowed the boulder and rock substrate to be exposed above water throughout much of the lower reach of Five Island Run. Submerged vegetation and algae were present along this section. There was no spawning habitat observed within the area downstream or immediately upstream of the road.

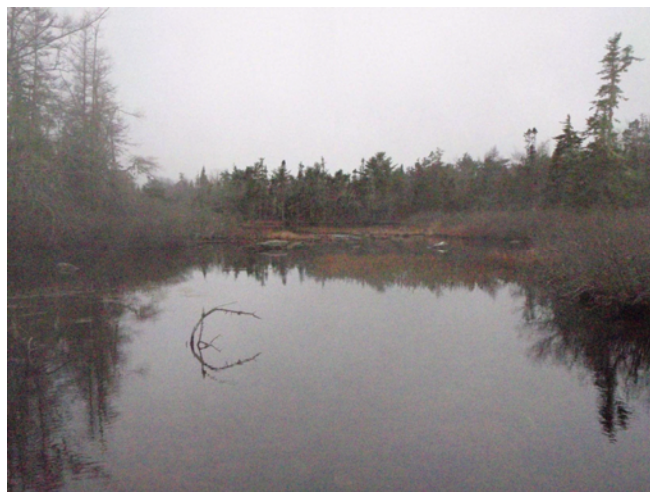
Photo 8: Five Island Lake Run – second (midstream) surveyed reach (stillwater ponds)

The second surveyed reach of Five Island Lake Run (the midsection) encompassed the stillwater pond area (Photo 8, Attachment 4). While the ponds themselves were not assessed due to poor substrate visibility (heavily stained, deep water), the runs between the ponds were included in the survey. A redd was observed within one of these short runs (Photo 9, Attachment 4). The runs connecting the ponds varied in width: the area in which the redd was observed was 10 m wide and 0.4 m deep. The substrate consisted of boulders, rock, rubble and patches of gravel and sand. The larger substrate was 35% to 50% embedded with gravel and sand. Stream banks were stable although moderately undercut. A deciduous forest canopy provided partial shade to the run while the riparian community of grasses and woody vegetation added to the 30% stream cover. Submerged vegetation and algae remained present within the runs and were anticipated to be plentiful within the ponds during the growing season. A water sample was taken for chemical analysis at the location of the observed redd (see Figure 4).

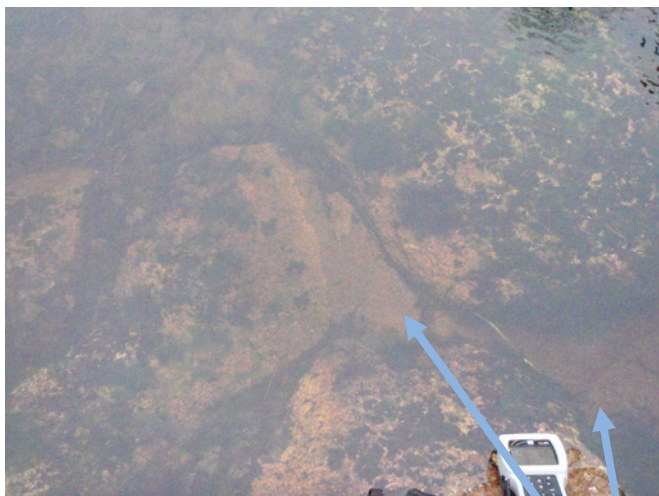
Photo 9: Five Island Lake Run – observed redd  
(water quality site)

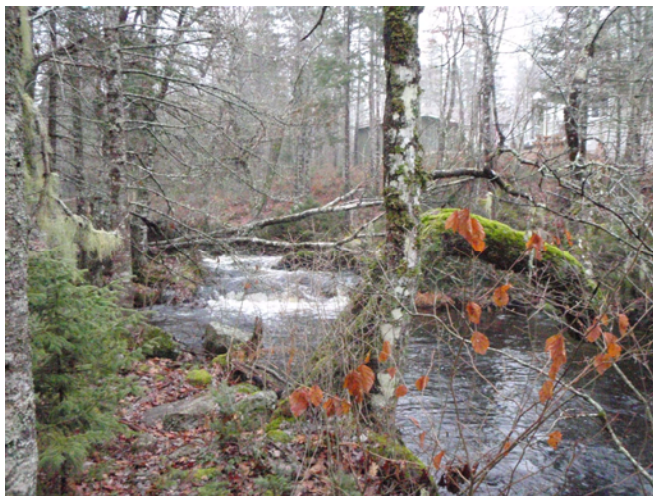
Photo 10: Five Island Lake Run – upstream reach

The third (upstream) section of the surveyed portion of Five Island Lake Run differed significantly from the previous two segments. The run narrowed to 6 m, contained smaller substrate in areas, became more entrenched, and exhibited flow characteristics that alternated between runs, riffles and pools leading to the outlet of Five Island Lake (Photos 10 and 11, Attachment 4). The primary substrate was rock measuring 18 cm to 46 cm, followed in dominance by a mixture of boulder and rubble which was surrounded by gravel that embedded the larger substrate (embeddedness was less than 20%). Riparian vegetation was composed of an equal mix of grasses, shrubs and deciduous trees on a stable stream bank with moderate undercutting. An area of wetland was observed adjacent to the stream approximately 100 m downstream of Five Island Lake; potential spawning habitat was recorded in this area and at the head of a pool 50 m downstream from the wetland. The 0.75 m deep pool was observed to have multiple areas of clear gravel, but could not be confirmed as a redd at the time of the survey. A large open-bottomed culvert is present upstream of the wetland, approximately 75 m downstream of Five Island Lake. Above the culvert the stream gradient steepens, the run narrows, velocities increase and no additional spawning habitat was observed.

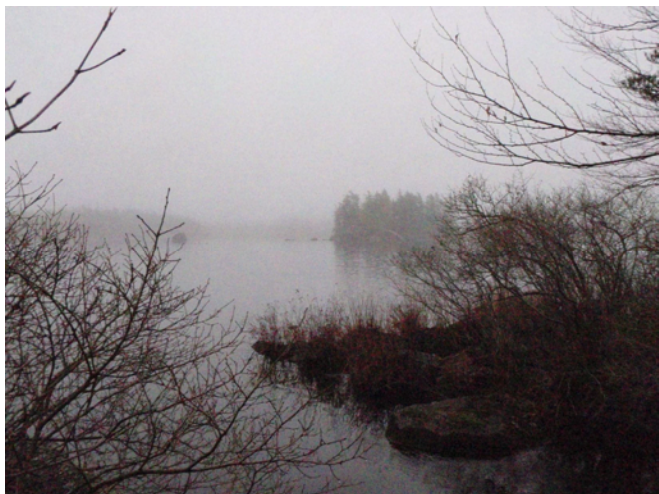
Photo 11: Five Island Lake Run – upstream reach at Five Island Lake
