Fuel Safety Bulletin

Bulletin Number: FS17-02

SUBJECT: Rego filler valve L7579

L7579 1-3/4" X 1-1/4" MNPT Filler Valve **Date Codes 8B16 to 1C17**

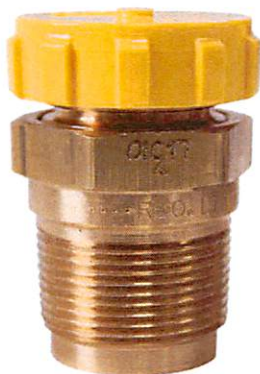
Date Code Identification

The dates of manufacture of the valves covered by this field advisory are August second week 2016 (8B16) to January third week 2017 (1C17).

1. We advise that you use a 3179 Filler Valve Adapter whenever you fill through an affected L7579 fill valve with date codes of 8B16 to 1C17, which is consistent with best industry practices for safety during every fill operation. If for some reason you did not use a 3179B fill adapter and have an issue disconnecting from any fill operation, please exercise extreme caution and follow your company procedures to prevent an accident.

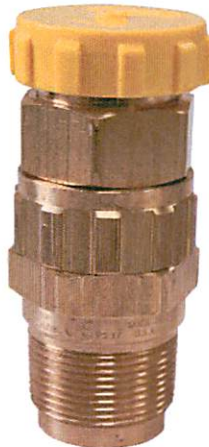
**L7579 with 3179B
adapter installed.**

It is a best practice to use filler hose adapters like the 3179B when conducting any filling operation into a 1-3/4" ACME filler valve. When a filler hose adapter is attached to the hose end valve connection during the filling process and there is a problem disconnecting due to leakage through the upper check, the 3179B or other type filler hose adapters can remain on the subject filler valve. This will allow the delivery person to safely disconnect the hose end valve from the filler hose adapter which will remain connected to the subject filler valve leak free.
