Monitoring Coastal Erosion Using Remotely Piloted Aircraft

P. Horne

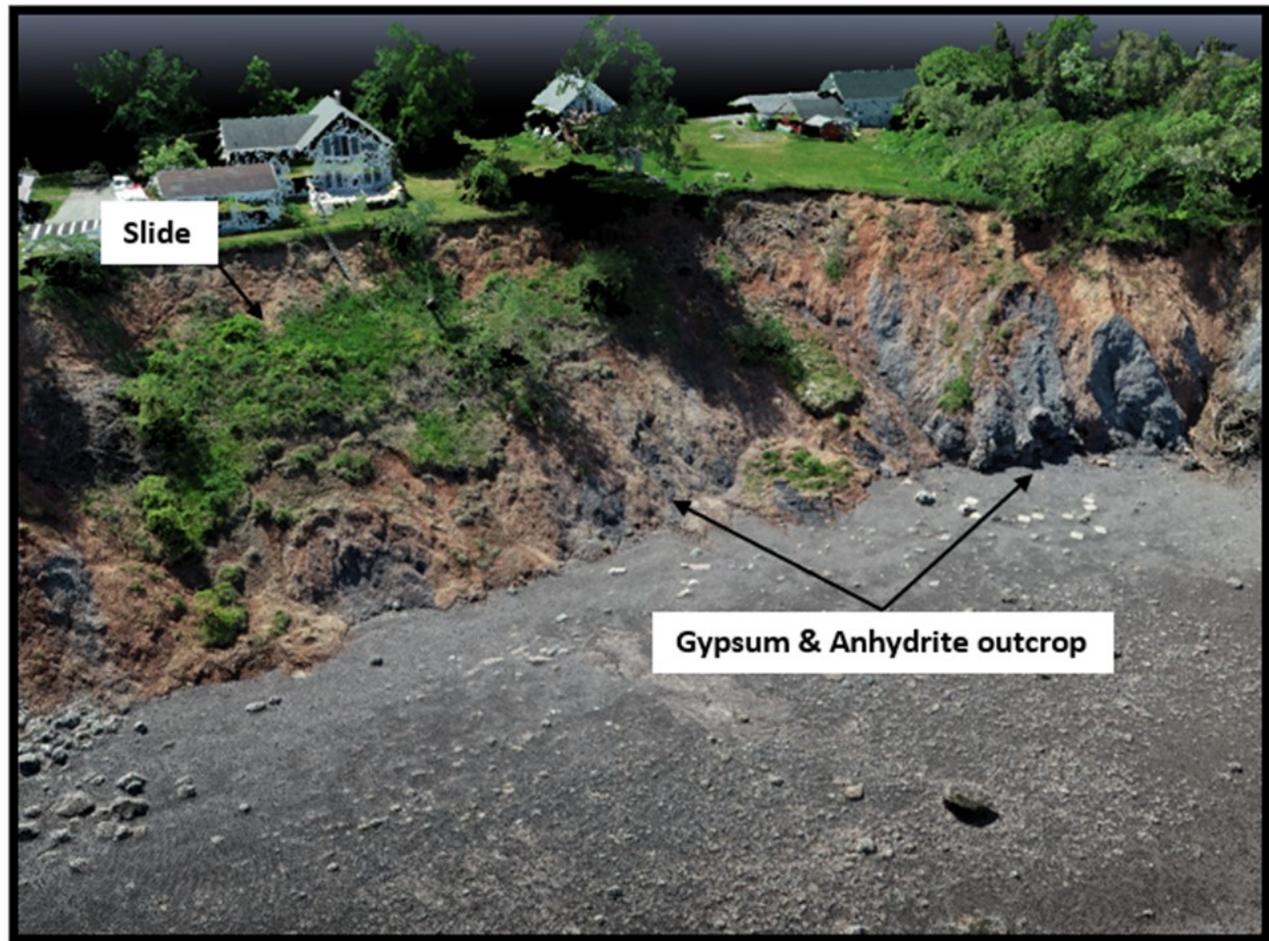
Figure 1. High density 3D point cloud of Cheverie, Nova Scotia, showing an active erosion site with gypsum and anhydrite outcrop at the base of the slope.

With the development of Remotely Piloted Aircraft Systems (RAPS), more commonly known as drone technology, high resolution (1 to 2 cm) aerial photography can be captured and, using photogrammetry software such as Pix4D, high resolution point clouds can be produced. Photogrammetry utilizes the geometrical relationship that exists between the spatial position of points within the two-dimension image to their corresponding position in three-dimensional space (Hanslow et al., 1997). An example of the three-dimensional point cloud from Cheverie along the Bay of Fundy is shown in Figure 1.

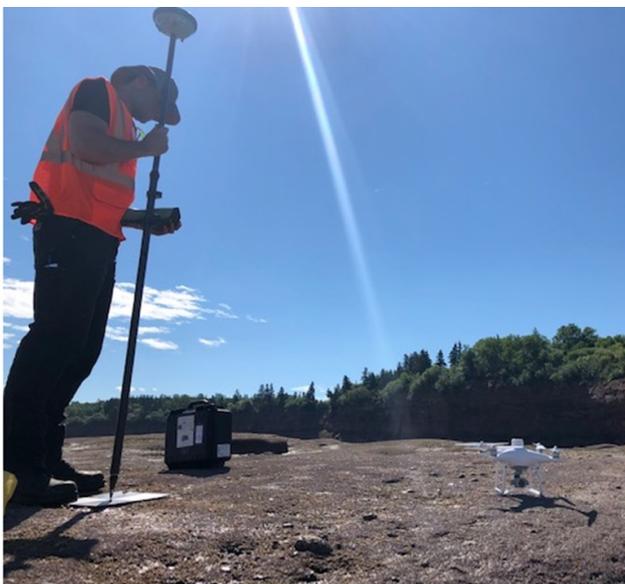
Figure 3. Geological field assistant Justin Tupper conducts a GPS survey in 2019 of aerial photo targets for an RTK Phantom 4 drone, shown in bottom right of photo.

The monitoring sites are surveyed using a survey-grade Real-time Kinematic (RTK) GPS system and RTK RPAS. The GPS system is used to survey in-photo targets throughout the monitoring site. The photo targets help to align the RPAS photos

and tie them to the local coordinate system being used (Fig. 3).

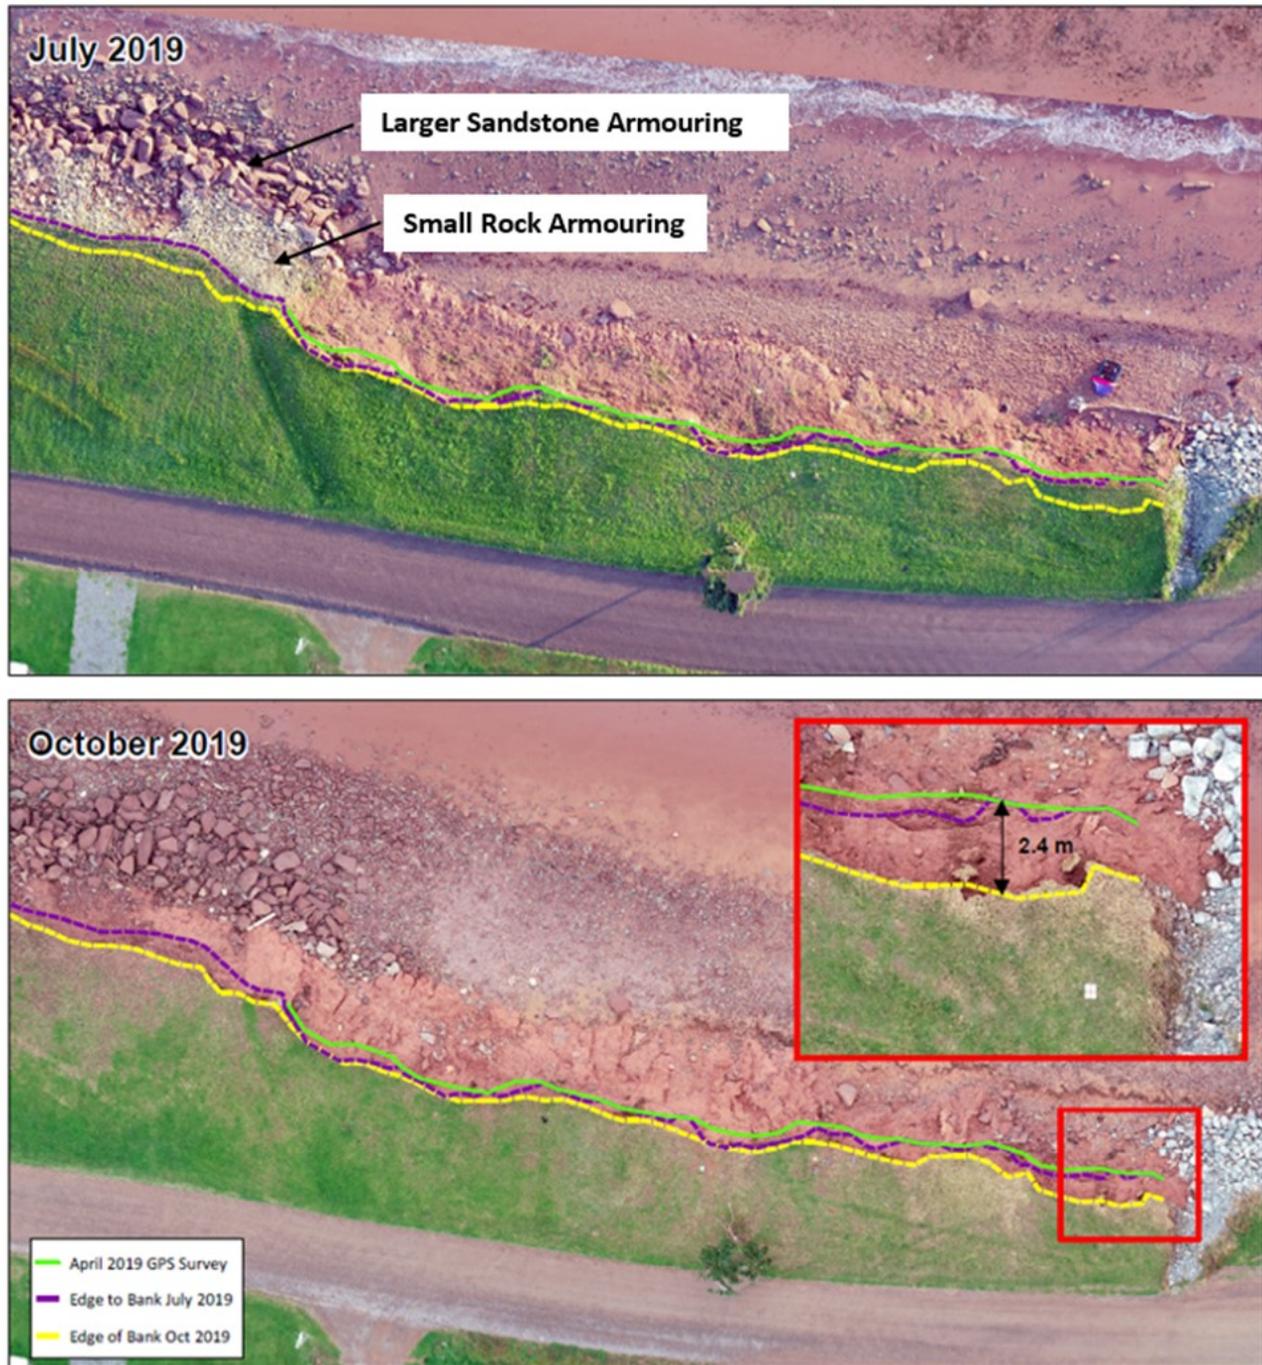
Figure 4. Heather Beach, Nova Scotia. The small rock armouring along the left side was removed between July 2019 and October 2019.

to 3 year interval. To date, 60 of the planned 100 sites have been surveyed and there have only been repeat surveys conducted along the North Shore to capture damage from Post-tropical Storm Dorian. The repeat surveys along the North Shore allowed for erosion rates to be captured, showing the effects of the storm. At Heather Beach on the North Shore, the edge of the bank retreated up to 2.4 m from April 2019 to October 2019. Heather Beach has a relatively low shoreline with a 2 m high till bank. There was no bedrock outcrop observed, but there are sandstone boulders imbedded up to 1.5 m in the bank (Fig. 4). The lack of outcrop leaves the till bank exposed to wave action. Armouring has been attempted at each end of the monitoring site at Heather Beach. The smaller stones, which were placed on the western side of the site just above the sandstone armouring, were washed away. The armour appears to have migrated seaward, causing the till to slide and the edge of the bank to retreat.
