A Preliminary Volumetric Analysis of Water Draw-Down in Active Karst Terrain, Slade Lake, Cumberland County, 2020

A. Tizzard and P. Horne

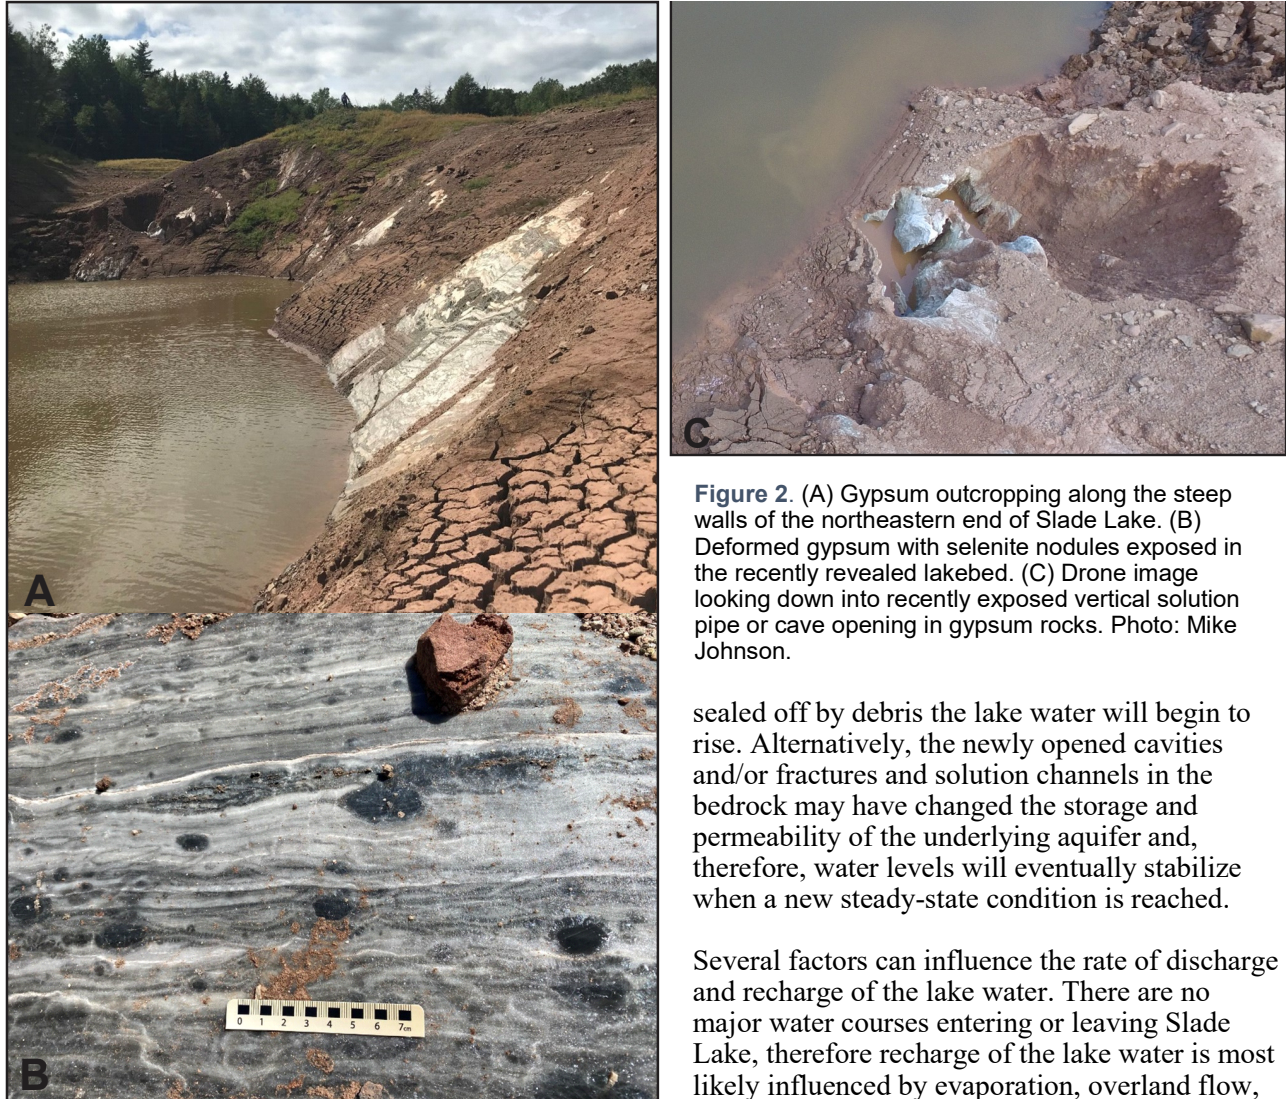
Figure 2. (A) Gypsum outcropping along the steep walls of the northeastern end of Slade Lake. (B) Deformed gypsum with selenite nodules exposed in the recently revealed lakebed. (C) Drone image looking down into recently exposed vertical solution pipe or cave opening in gypsum rocks. Photo: Mike Johnson.

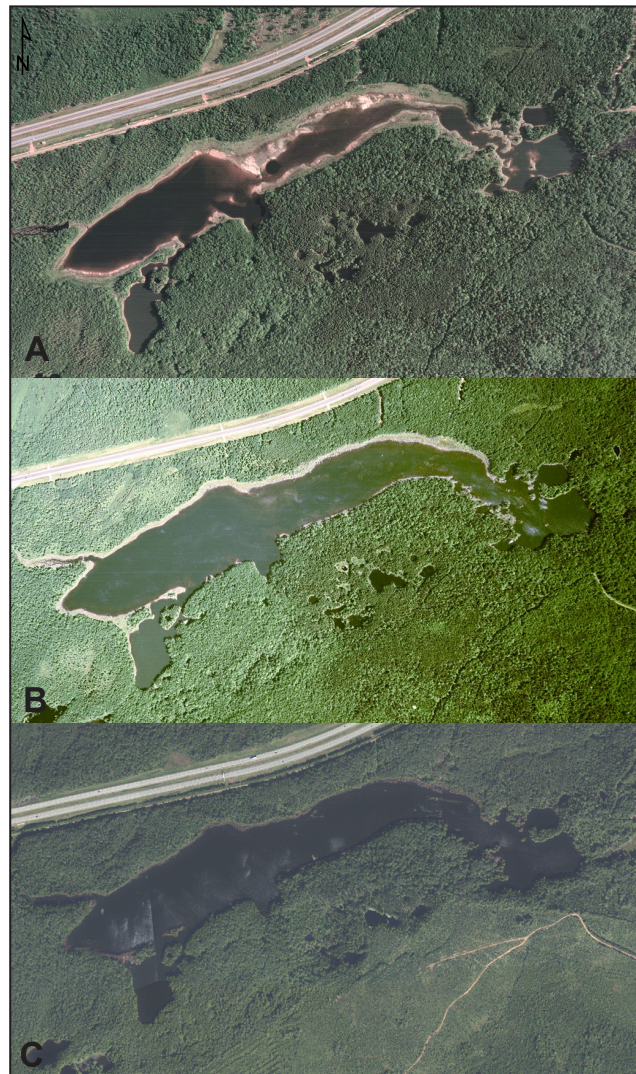
Figure 4. Examples of (A) low (1995); (B) moderate (1985); and (C) high lake water levels (2013).

The water level of Slade Lake has been known to historically fluctuate and, accordingly, is locally referred to as “Dry Lake.” A review of historical aerial photography and satellite imagery demonstrates the fluctuating nature of the water levels. Table 1 summarizes a review of available imagery where water levels have been categorized into three classes: high (lake levels close to the tree line); moderate (some emerged beach and/or islands); or low (extensive beach and/or islands visible). Examples of high, moderate, and low lake water levels are shown in Figure 4.

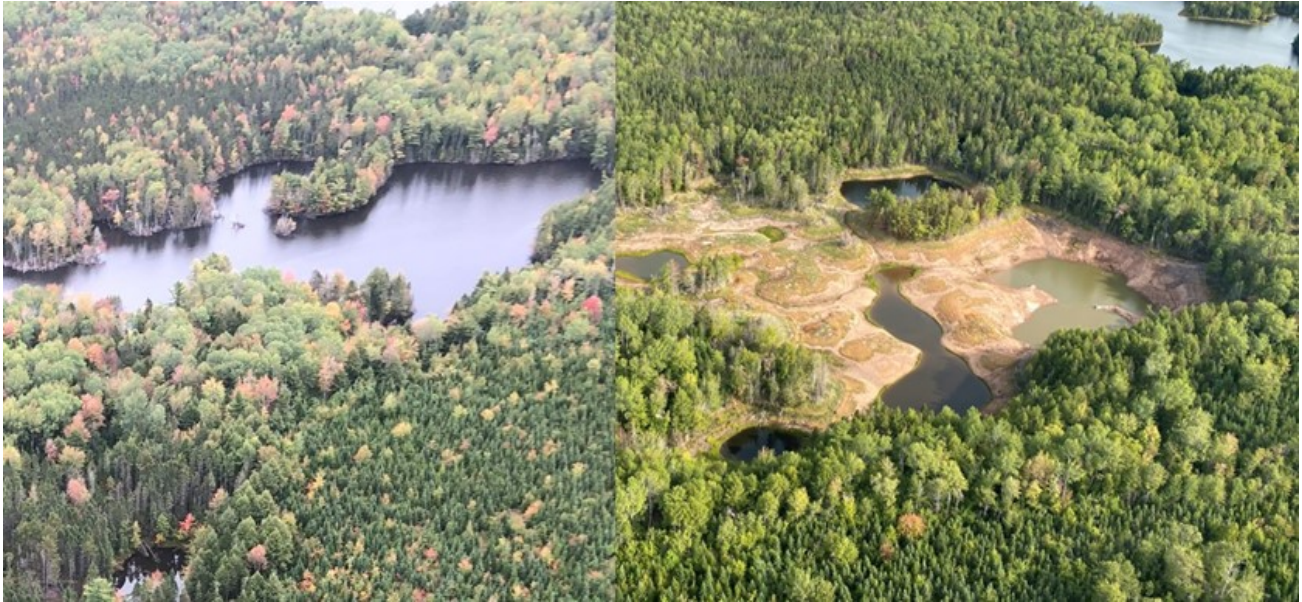
Figure 5. Northeastern end of Slade Lake, September 2019 (left) and September 2020 (right).

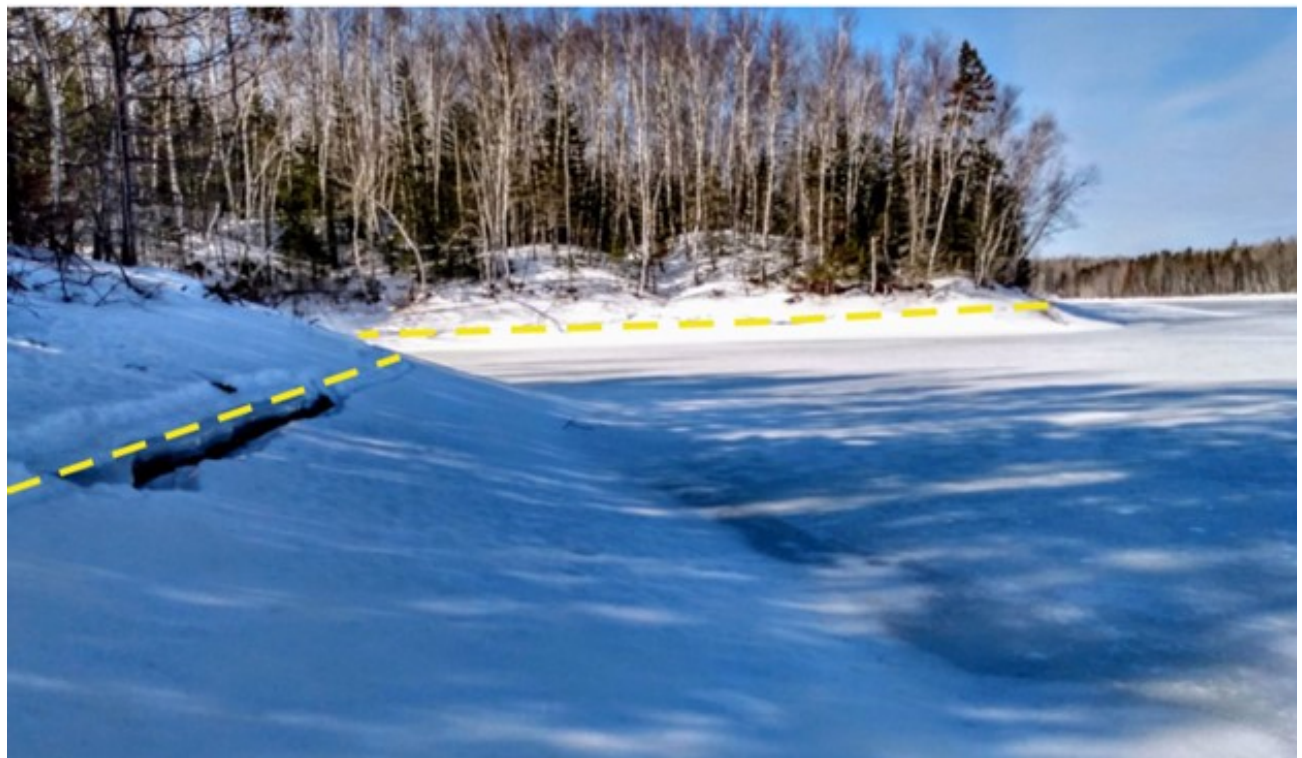
Figure 6. Ice shelf in Slade Lake in early March, 2020. Photo: Dana Rector.

Aerial photos of Slade Lake were collected in September 2019 showing high water levels (Fig. 4). The timing of the main draw-down event is therefore constrained to within an 8-month period between September 2019 and April 2020. Additional photographs of Slade Lake from early March 2020 show a broken ice shelf around the margin of the lake (Fig. 5). The subsidence of the

ice surface suggests that the draw-down began after the lake surface froze, therefore further constraining the timing to within a four-month period from January to April 2020.
