Geological Observations Relating to Coastal Erosion along the Tidnish - Amherst Shore Area of Nova Scotia

P. W. Finck

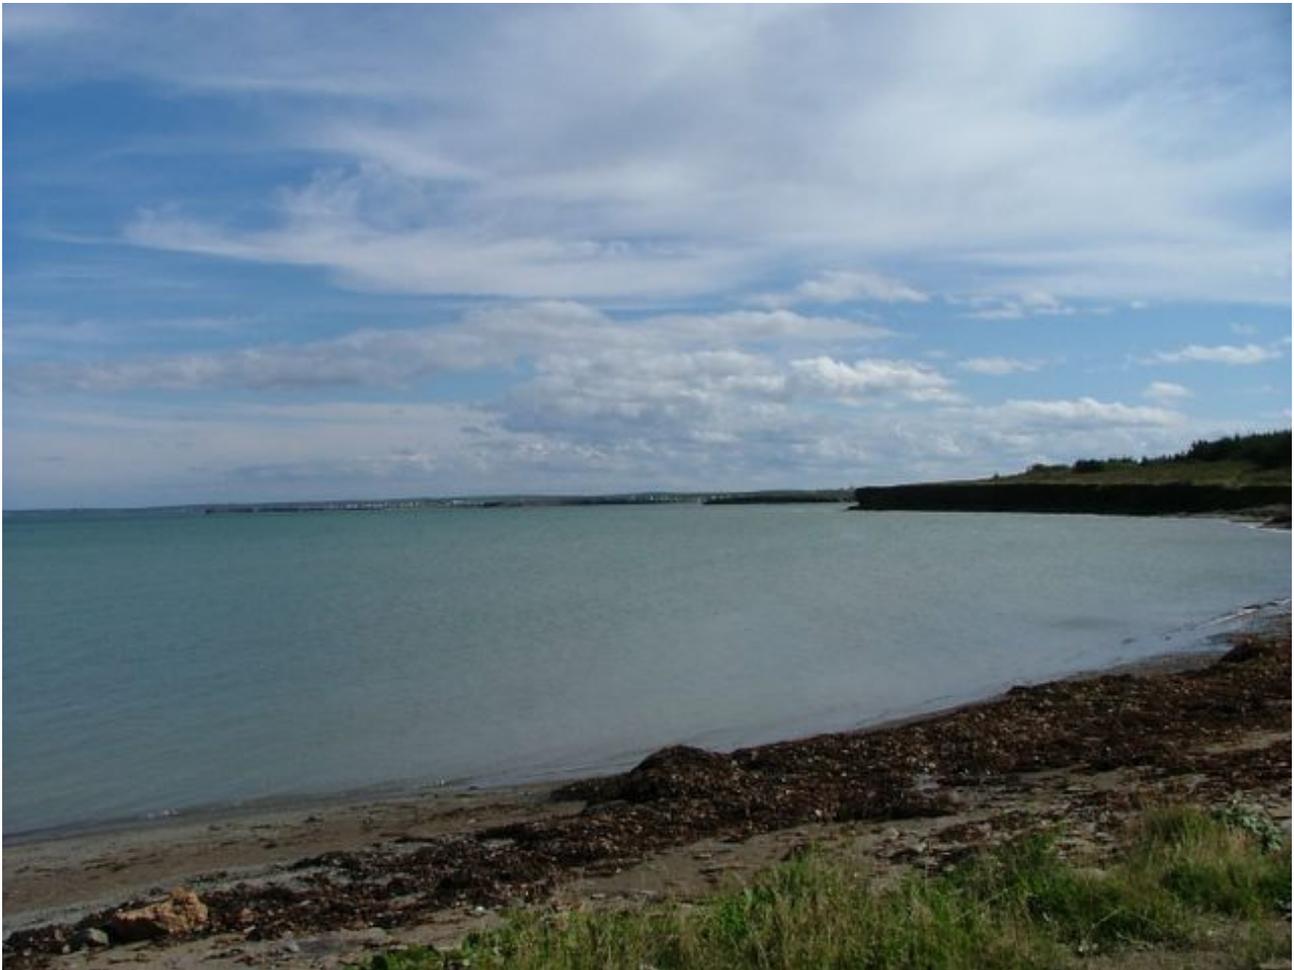
Figure 1. Exposure of a wave cut bench on Cape Breton Island.

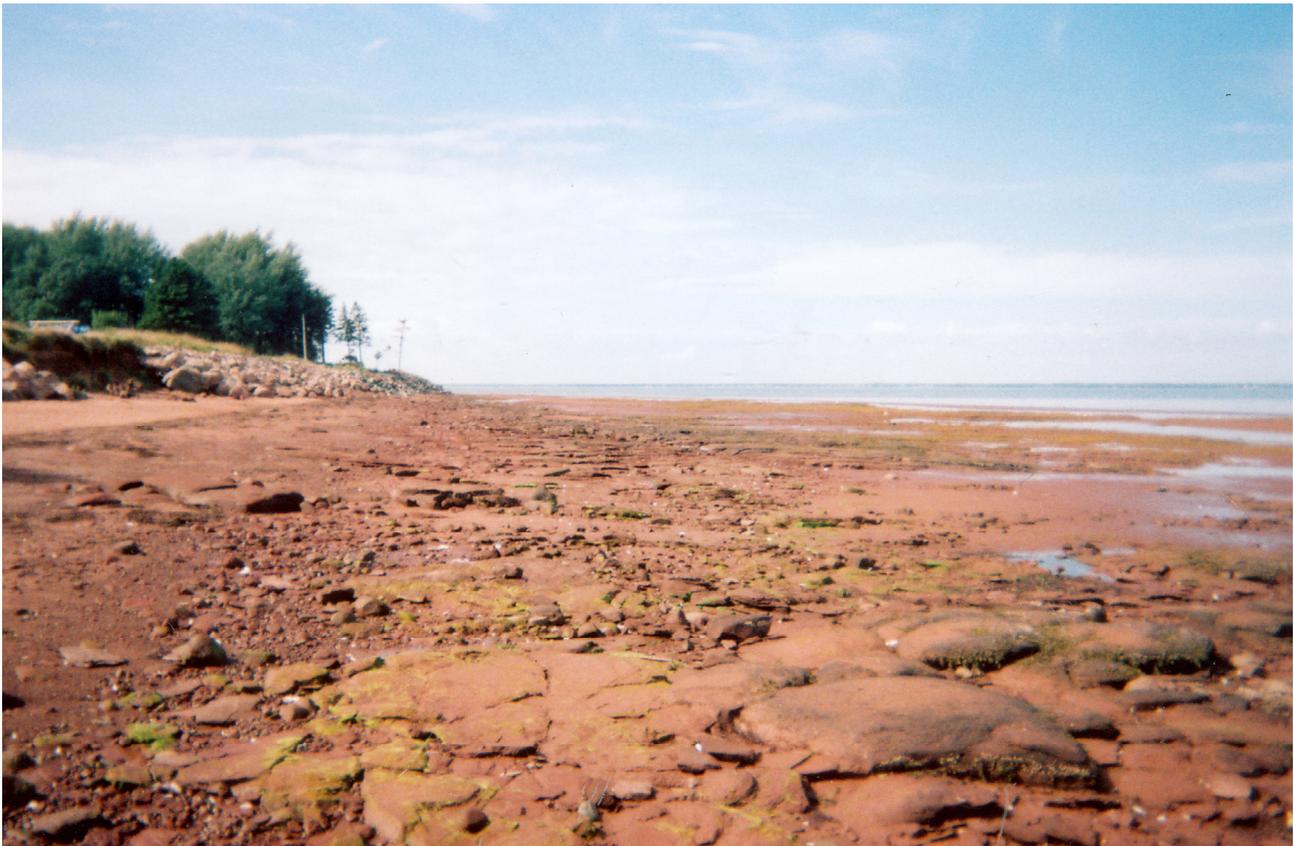
Figure 3. Soft sandstone outcropping across the upper and mid-foreshore.

The author refers to Ryan and Boehner (1994) for the following summary of bedrock geology in the study area. Rocks in the study area are mapped as the Balfroun and Tatamagouche formations, forming part of the Pictou Group. From Tidnish Head to the east end of Amherst Shore Beach (approximately 500 m west of Boss Point) the author observed red-brown sandstone of the Balfroun Formation outcropping at mid- to low-tide. The outcrops form a gently seaward-sloping bench that appears to be transitional to a wave cut platform below lowest low water within the surf zone (Fig. 3). The sandstone does not appear to outcrop in the cliff face. Sandstone outcrops across the intertidal bench are soft and the rock erodes as layers (on a cm

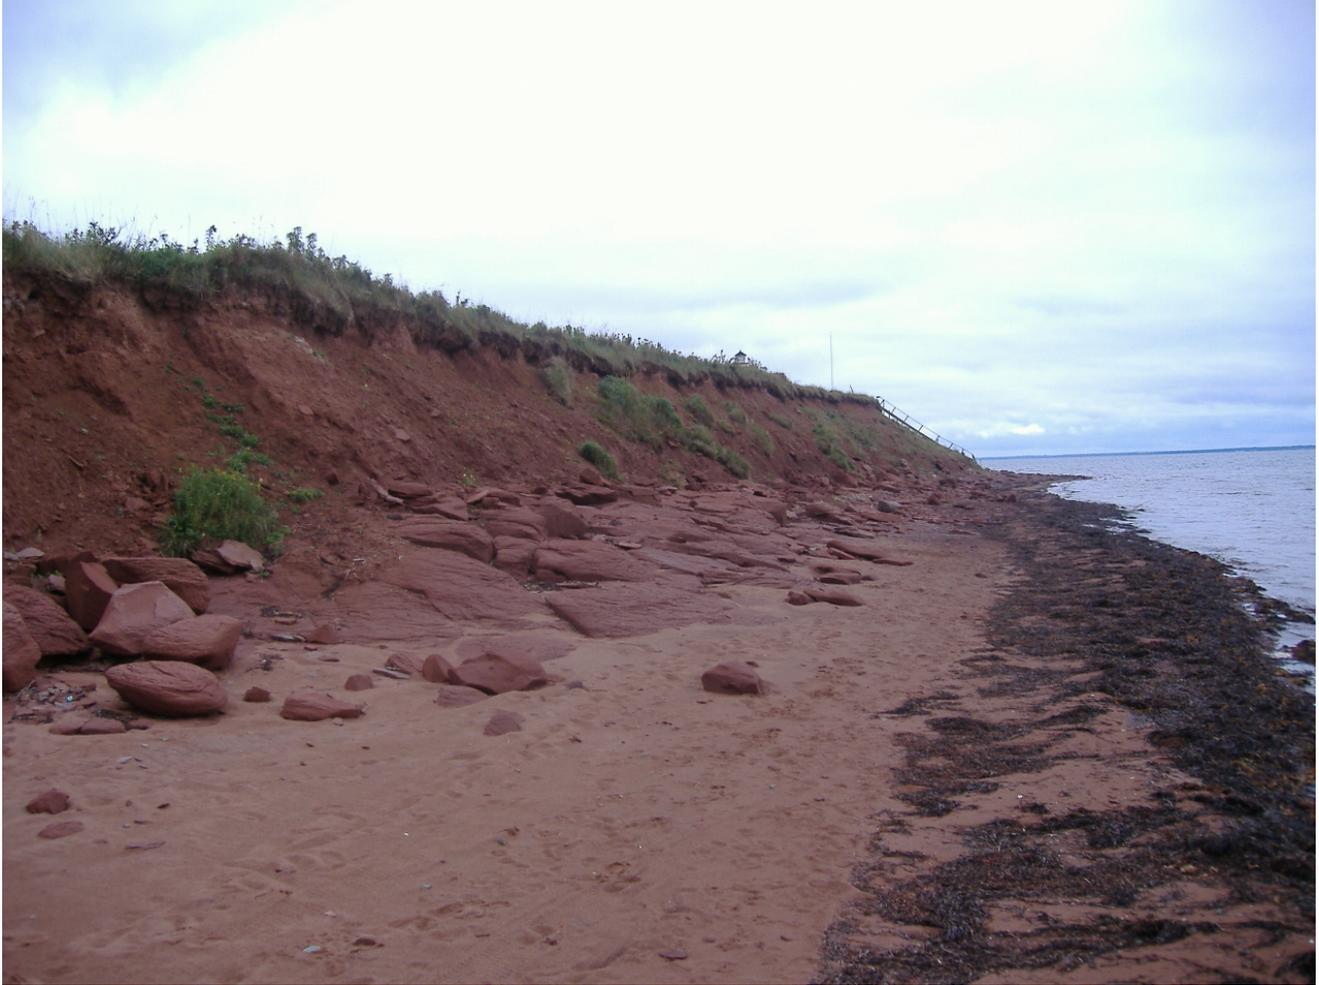
Figure 4. Sandstone outcrop along the base of a cliff, overlain by glacial sediments (till).

scale), controlled by what appears to be trough crossbedding consistent with northward-trending trough axis-intersection directions mapped by Ryan *et al.* (1990). At the east end of Amherst Shore Beach steep cliffs were observed (vertical in some areas) composed of what is believed to be red-brown mudrock and mud-chip conglomerate of the Tatamagouche Formation. The bedrock grades upward into a weathered, shattered, and unconsolidated version of the underlying rock. This, in turn, is overlain by muddy till. Farther to the east sandstone forms the base of the shore face (Fig. 4). It is eroded, rounded and undercut along bedding planes. The upper beach face on the north side of the Boss Point bluff is armoured by slabs of hard sandstone eroded out of the glacial till immediately above the beach (Fig. 5). These rock slabs or erratics were ripped from underlying bedrock by glaciers during the Wisconsin glacialiation. The northeast-facing side of the headland is a low, almost vertical sandstone cliff

overlain by a silty sand till. The sandstones in both cases are believed to be channel deposits (R. J. Ryan, personal communication, 2006).

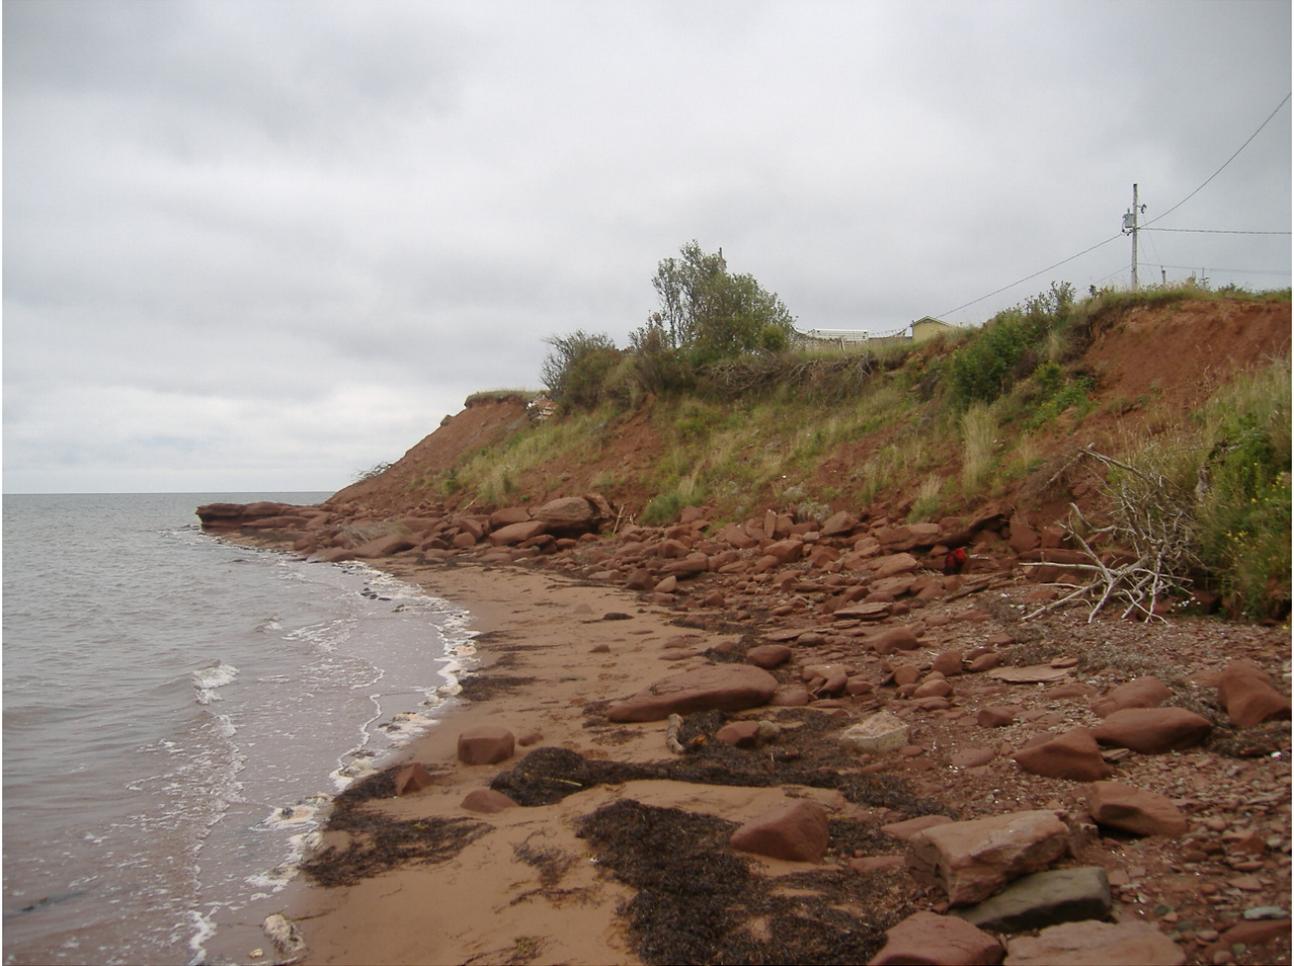
Figure 5. Glacial erratics and collapsed slabs of bedrock armour the face of the beach. This may not reduce erosion rates significantly but may help to preserve the beach sediment.

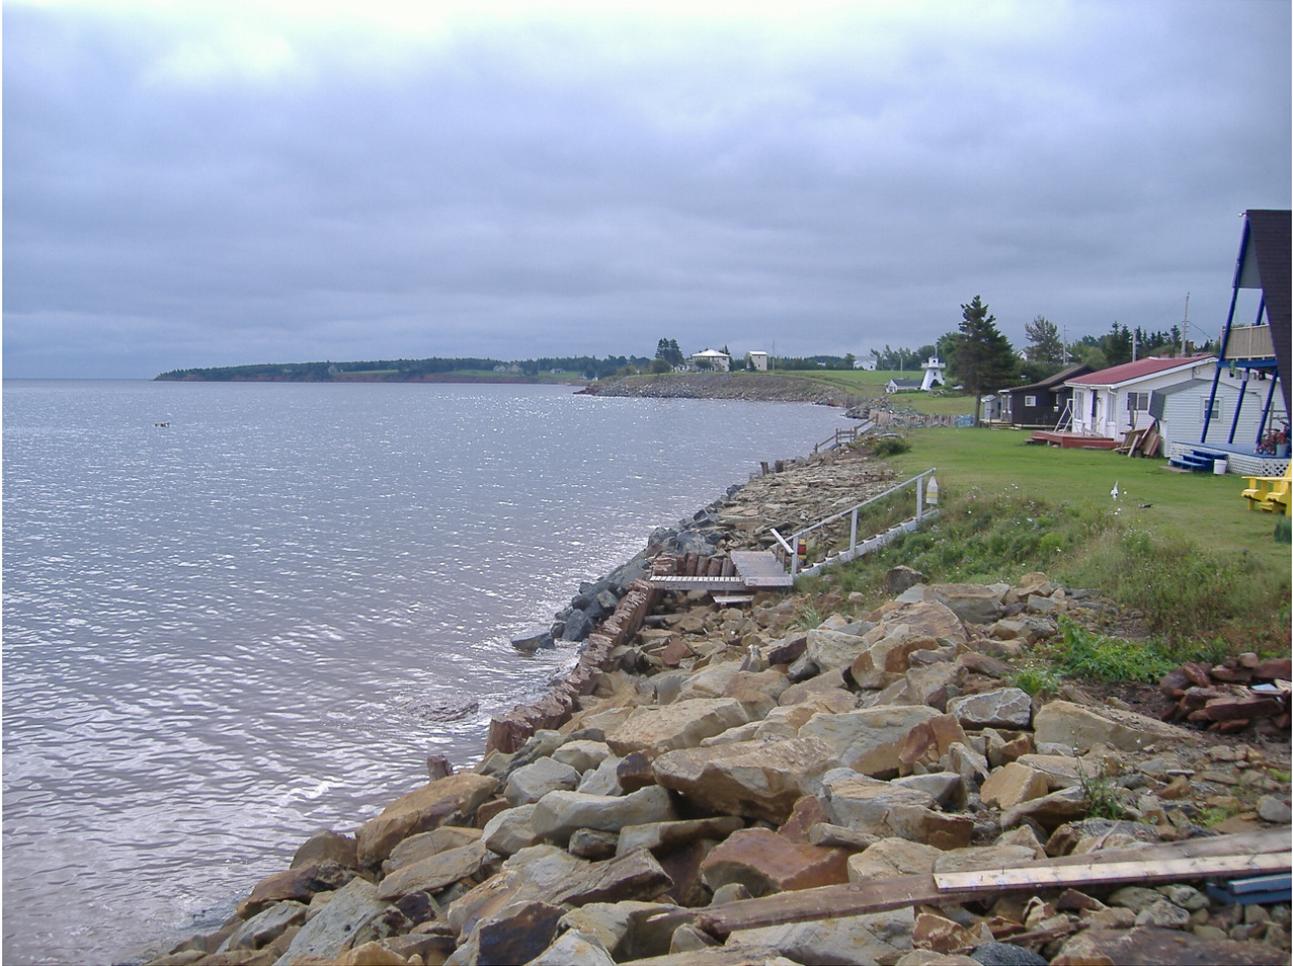
Figure 6. The shore face has been widely hardened in the study area using a combination of wood retaining walls and more recent armour stone.

Selective prevention of natural coastal erosion is a complicating factor when attempting to examine or measure these rates. You can’t map erosion if it doesn’t occur. Equally problematic is that coastal hardening (a term used in this paper to refer to any form of protection against coastal erosion) results in an artificial reduction in sediment supply to the littoral cells along the coast. This reduction in sediment supply not only results in beach deflation but would also likely increase rates of erosion on adjacent properties located ‘down shore’ in the direction of the seasonally predominant longshore current.

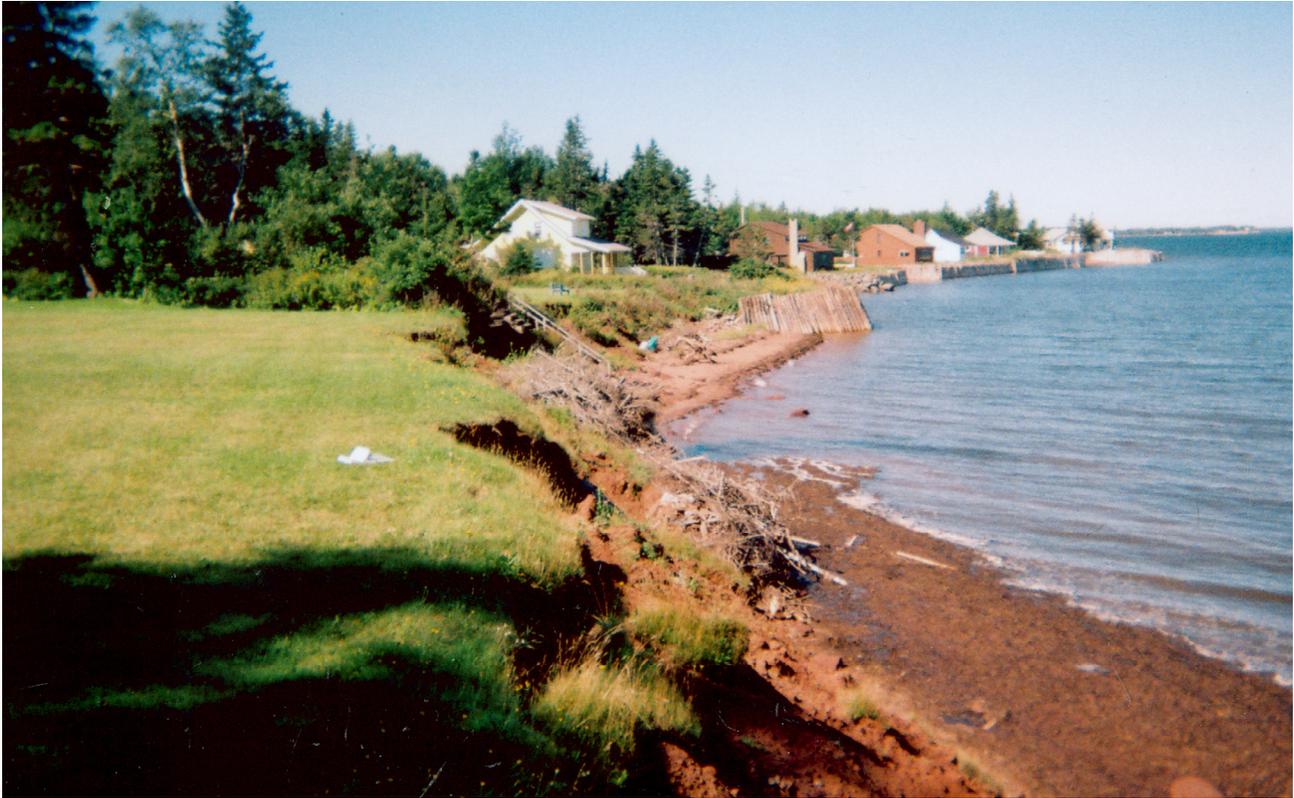
Figure 8. Extensive erosion of Eatonville Till along the bank of a shore front property. The owner has chosen not to armour the shore face; his cottage is located well inland from the bank edge. Note the armouring in the background and the lack of exposed beach at near high tide.

any numerical conclusions with respect to lawn- vs. tree-fronted erosion rates. Looking at Figures 8 and 9, both areas appear to be slumping and the trees (shallow-rooted evergreens) are simply toppling seaward. Qualitatively, it is doubtful that the presence of softwood trees on this shoreline would make any difference in long-term erosion rates.

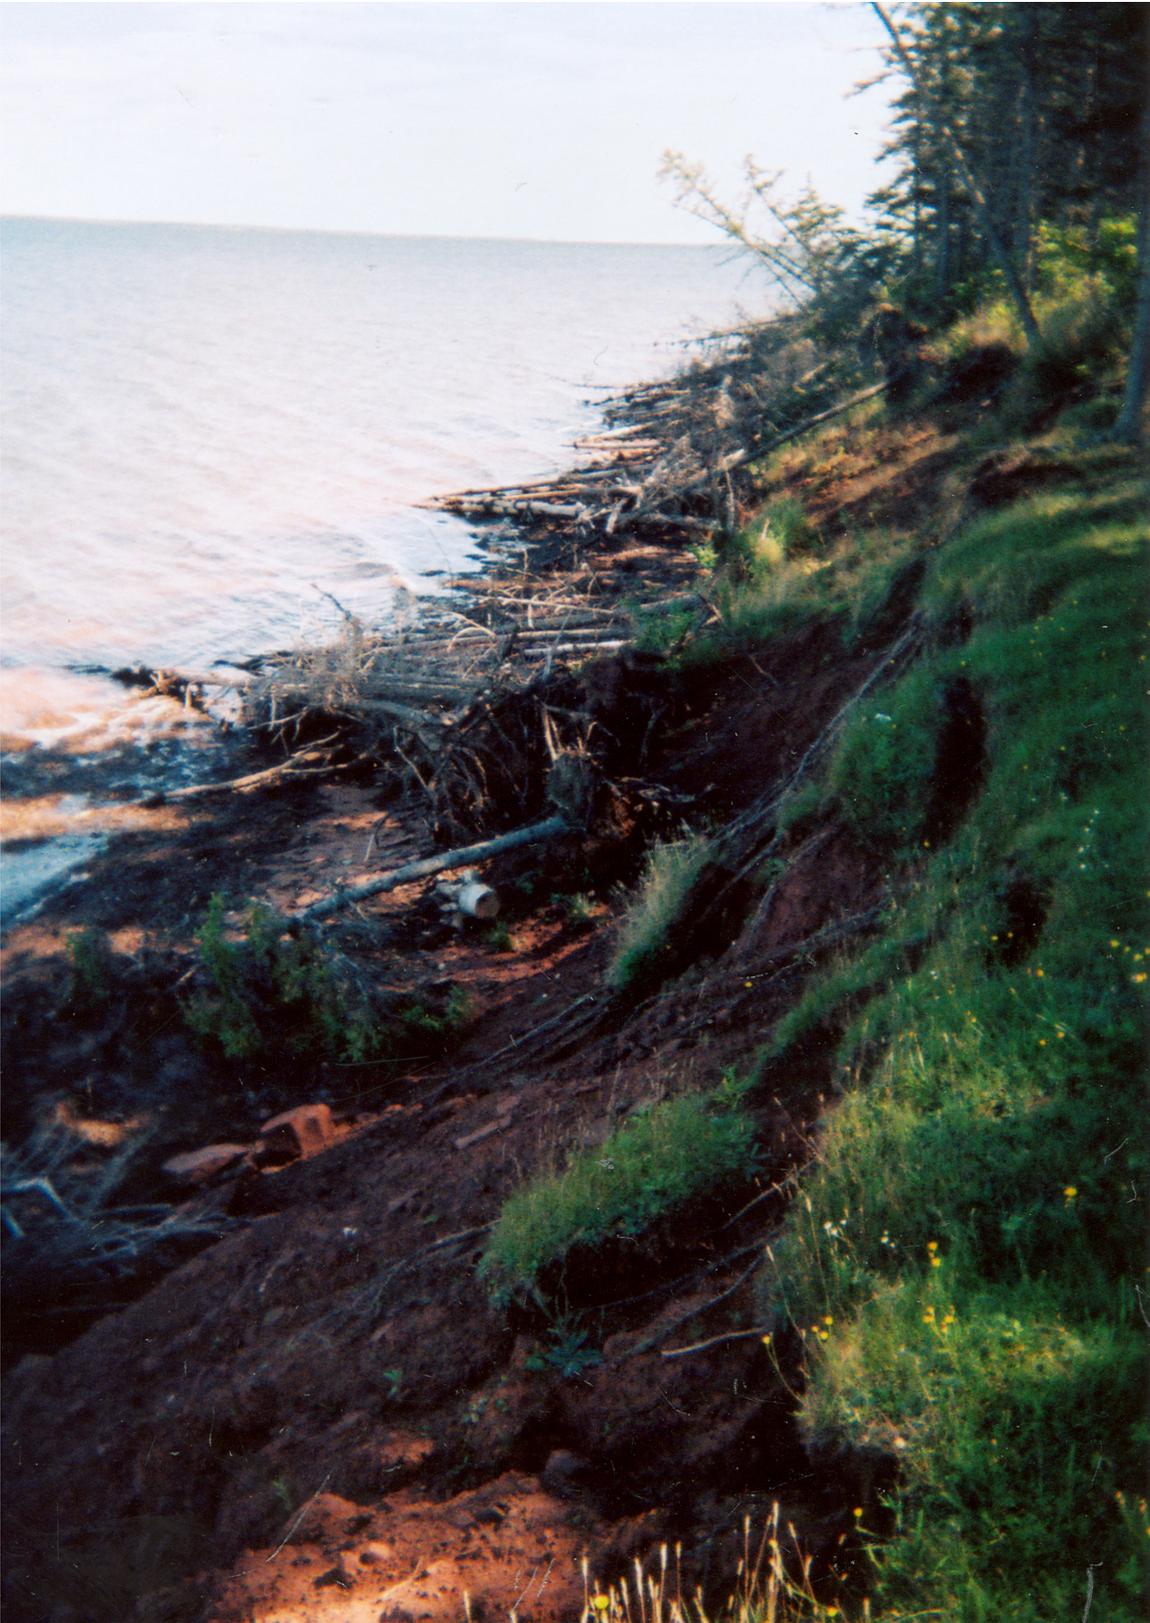
Figure 9. Erosion of Eatonville Till along the bank of a heavily wooded shorefront property. Trees are undercut and collapse outward onto the beach, suggesting that the shallow spreading root systems of the softwoods are having little effect in reducing the rate of erosion.
