Surficial Geology Mapping + Geohazard Identification + Coastal Zone Mapping = Better Land-use Planning in Central Antigonish County

G. J. DeMont, D. J. Utting, P. W. Finck and T. Broughm

12 Mineral Resources Branch

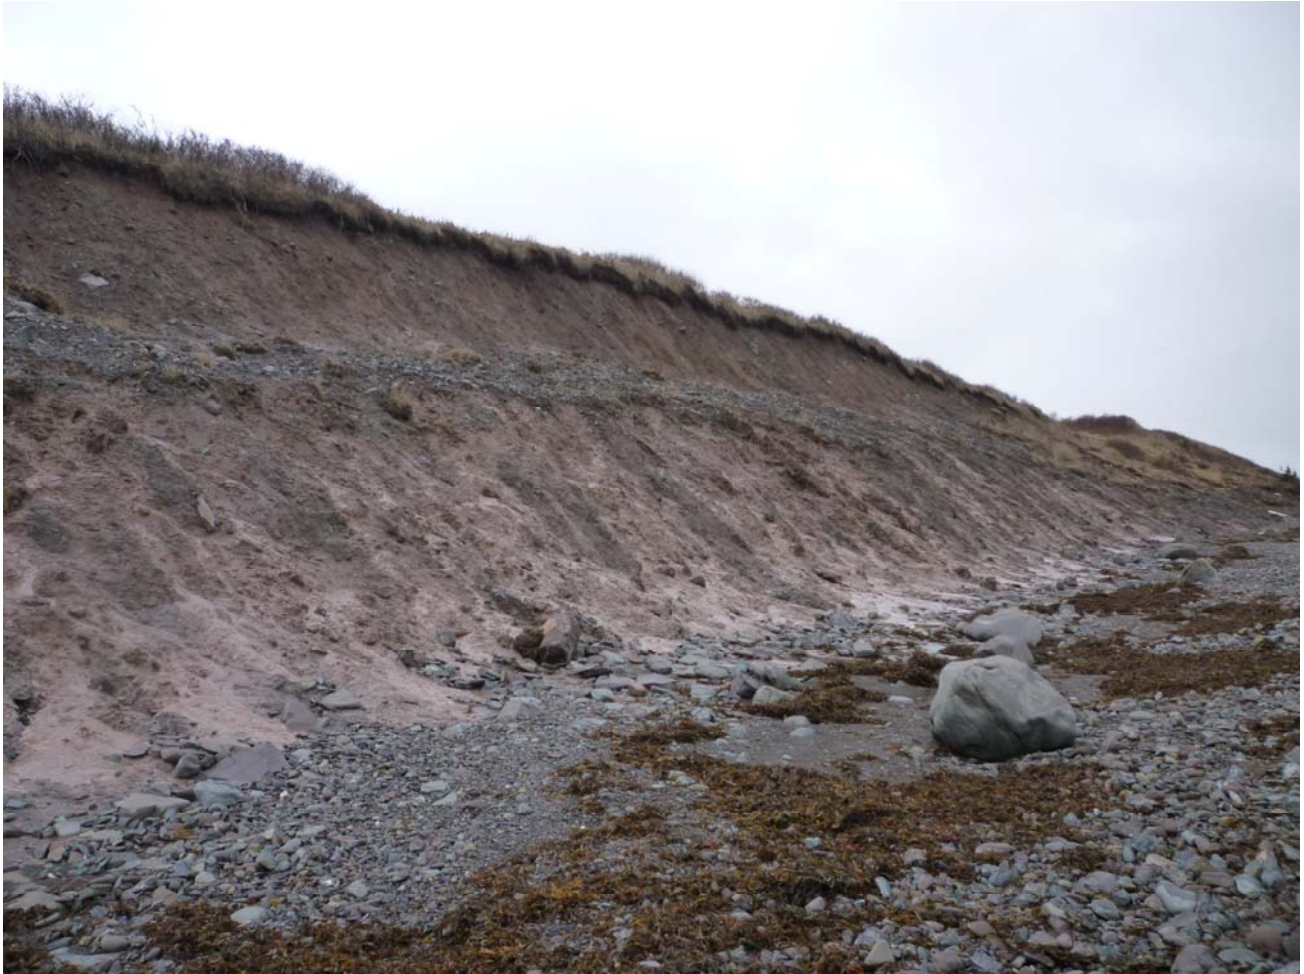
Figure 1. A series of earth flows are seen along the drumlin cliff face at Havre Boucher.

A January 2009 site visit to assess damage to the coastline after a major storm identified numerous active earth flows on drumlin bluffs (Figs. 1 and 2), delivering sediment to the beach that would be washed away by wave action. Evidence of earth flows were observed during the 2008 summer field work (Utting and Gallagher, 2009), but at that time the sediment was hardened and little movement was evident. After observing the January 2009 conditions of the drumlin faces we suggest that much of the erosion of drumlins occurs during the winter, while the sediment is water saturated.

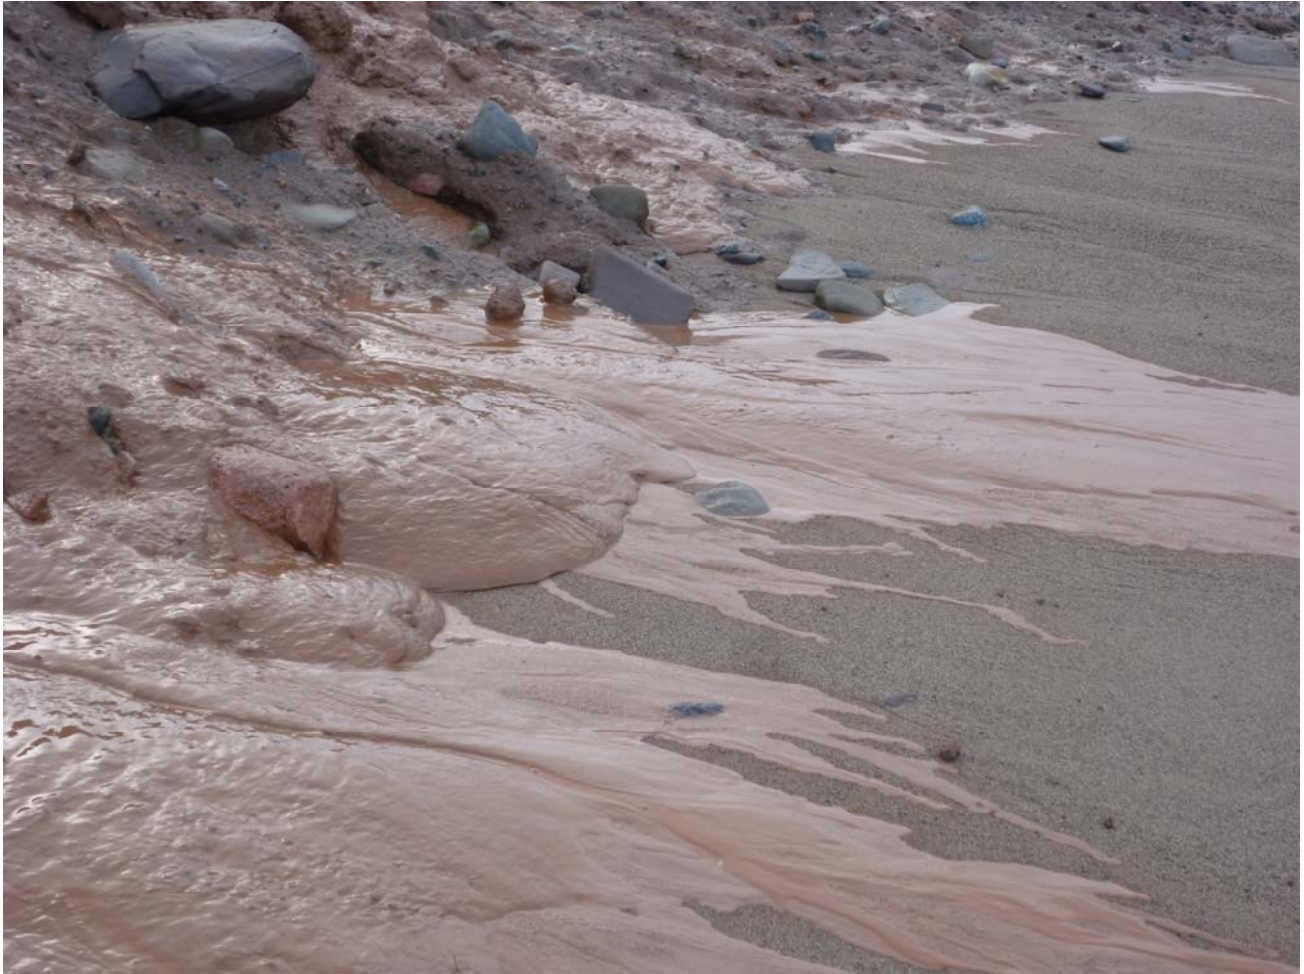
Figure 2. Enlarged view of an earth flow taken at Dunns Beach.

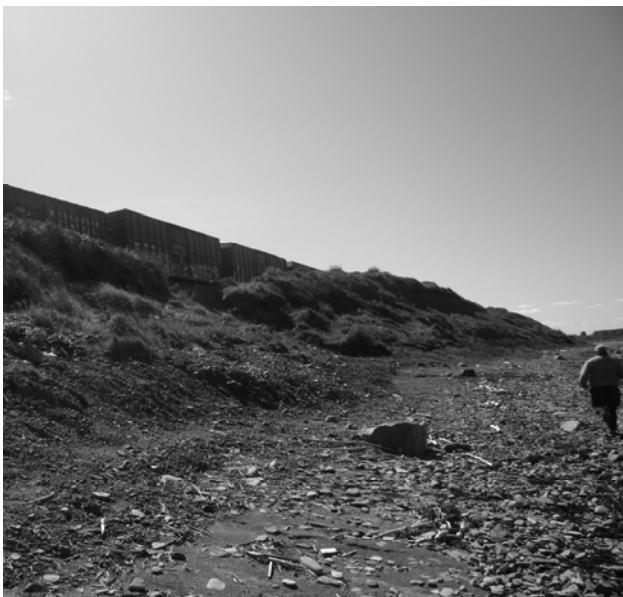
Figure 3. The rail line sits on eroding drumlins east of the central Antigonish County study area.

The airborne LiDAR survey coverage extends east, beyond the central Antigonish County boundary line so reconnaissance coastal mapping traverses were completed in this extended coverage area. The railway corridor, which follows the coastline east of Pomquet Harbour, sits on eroding drumlins (Fig. 3). In some areas the track is located precariously close to the cliff edge. Further mapping studies are required to assess the degree of risk associated with erosion and collapse of the till banks underlying the rail line because this is an important provincial transportation corridor.
