# A Coastal Hazard Assessment of the Gabarus Seawall, Cape Breton County, Nova Scotia

Open File Report ME 2012-002

## 1.0 Introduction

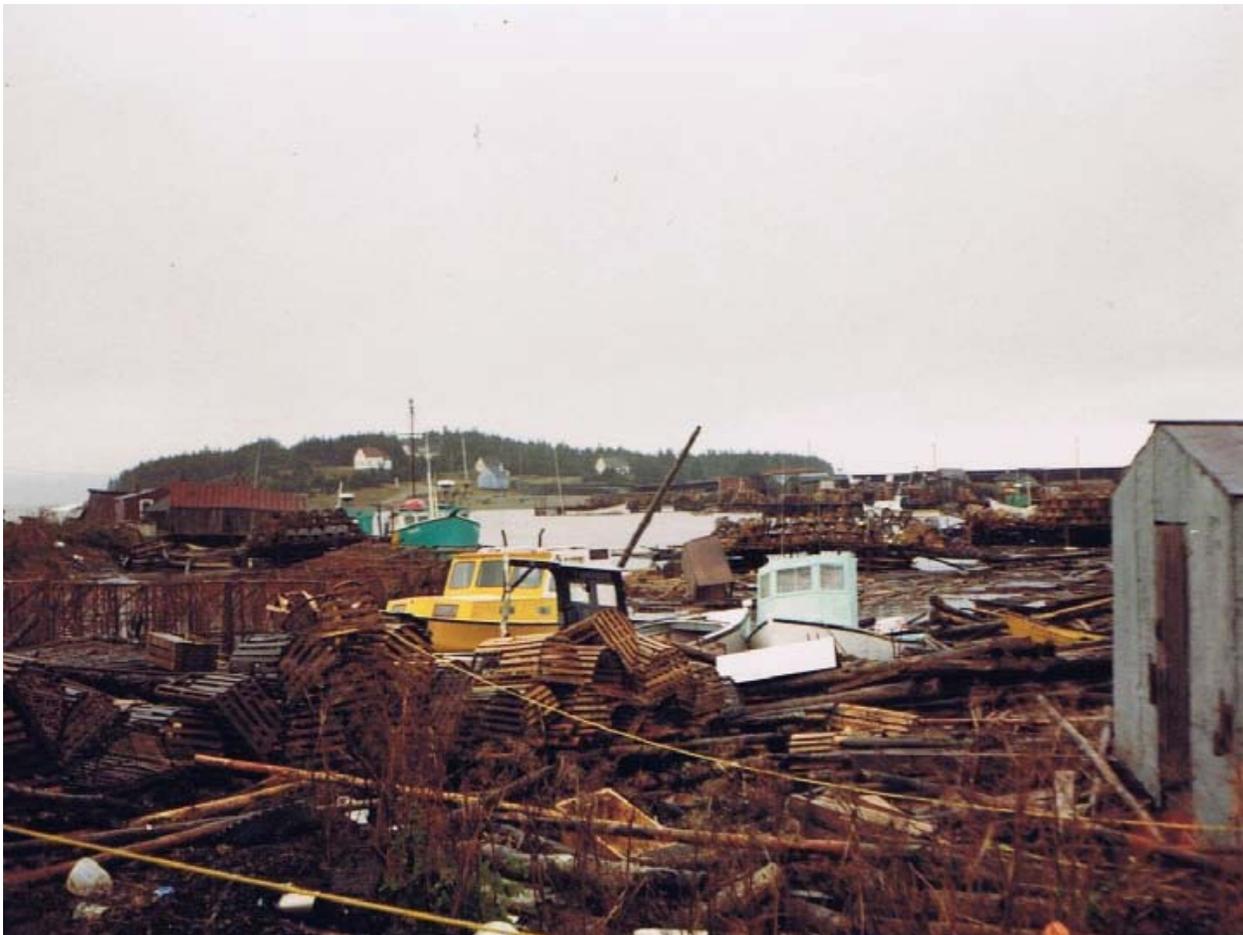
*Figure 2. Photograph of damage caused when the seawall failed during a late October storm, 1983. Photograph courtesy of Dr. Bob Taylor, GSC Atlantic.*

In the 1983 breach large amounts of floating debris were generated by the failure of fishermen's wharfs. **Figure 2** shows the extent of the damage and debris in the 1983 breach.

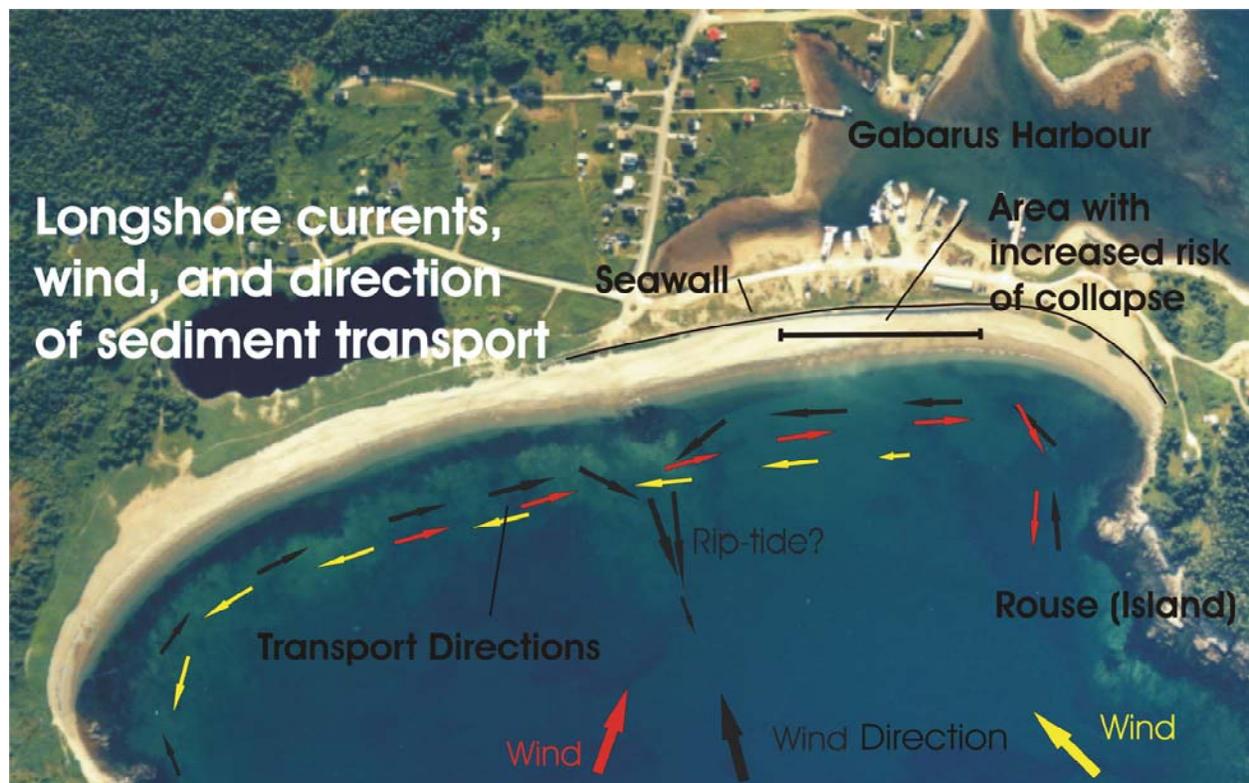
**Figure 3** illustrates the transport of sediment under varying wind conditions along the eastward facing, main bar. The north end of the beach (backed by the sea wall) protects Gabarus Harbour from easterly winds and surges generated by storms and tropical (post-tropical) cyclones. Examination of **Figure 3** reveals a ‘double arc’ in the longshore profile of the bar. The two arcs correspond closely to the protected – unprotected parts of the bar, with the central apex located near the south end of the seawall. This also corresponds to the location of a possible rip-tide effect.

**Figure 3.** Illustration of general sediment transport in front of the Gabarus Seawall, including the area of the seawall at increased risk of collapse.

Relevance. The seawall at Gabarus is aligned roughly north – south along the top of the bar (**Fig. 3**) and is directly exposed to the east. There are two headlands at either end of the bar that offer only limited protection to the north and south ends of the bar from northeast and southeast winds respectively. With respect to tropical cyclones the highest winds are encountered along the north and east sides of the cyclone's headwall. Thus, a hurricane making landfall west of Gabarus would likely be a worse-case scenario for the village and protecting seawall. However, hurricanes that pass just offshore of Nova Scotia may produce very large storm surges with accompanying large ocean swells. An example is Hurricane Bill that passed south of Nova Scotia on August 23, 2009. Such a hurricane, passing south of Nova Scotia, could be particularly damaging to the seawall if the surge and accompanying ocean swells struck during high tide.

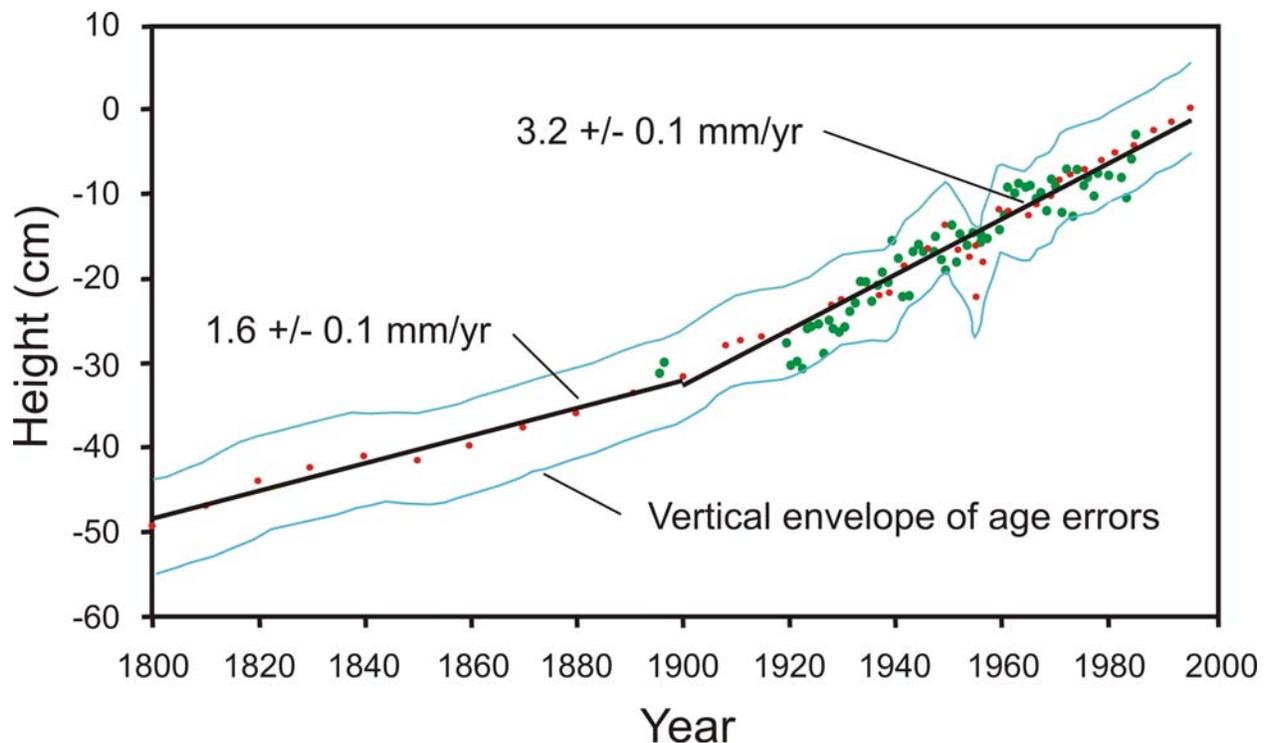
The best estimate of changing rates of sea-level rise along the Atlantic coast of Nova Scotia is from a paper published by Gehrels (2005) and shown in **Figure 4**. Note that during the period 1800 – 1910(20) the rate of sea-level rise was 1.6 mm/yr (16 cm/100 yr). In the 1910 to 1920 time interval, the rate of sea-level rise accelerated to 32 cm/100 years, and it has remained constant since that time. This acceleration is a global phenomenon occurring at different times in different regions, but generally occurring between the mid- to late-1800s and 1930.

**Figure 4.** Historical reconstruction of the rate and observed amount of sea-level rise along the eastern shore of mainland Nova Scotia. Green dots indicate tide gauge data from Halifax. Modified from Gehrels et al., 2005.

Based on an examination of the peer reviewed literature, the author concludes that sea-level rise at Gabarus will remain at approximately 30 cm/100 years for the foreseeable future (**Figs. 4, 5 and 6**). Thus, with appropriate repairs, the community of Gabarus, the seawall, and the harbour infrastructure will be sustainable in the future with respect to the low risk associated with the issue of sea-level rise in this area.

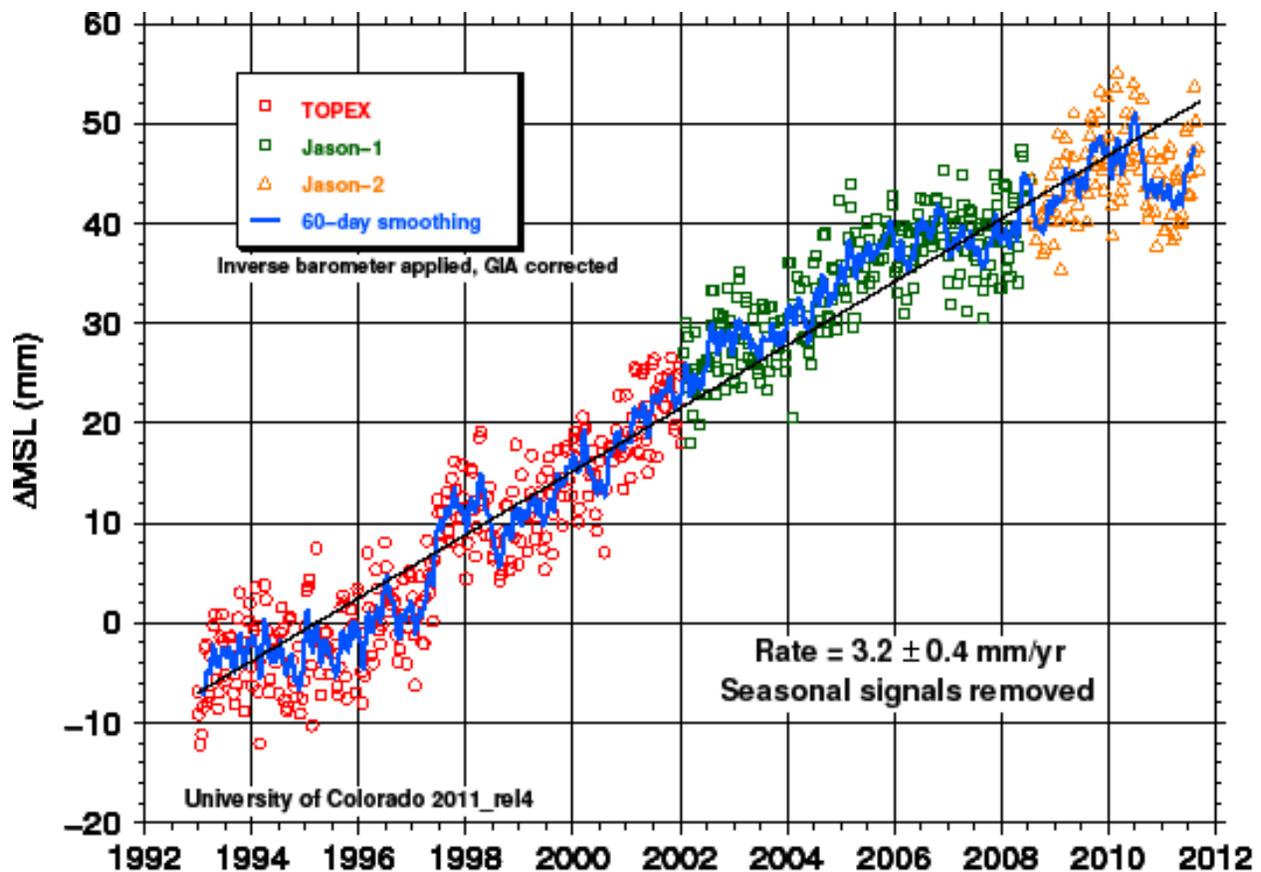
**Figure 5** shows the rate of global sea-level rise between 1993 and late 2011, based on satellite altimetry (used with permission from the University of Colorado). The average rate based on an assumption of a continuous linear rate of rise is approximately 32 cm/100 years. Examination of a GRACE gravity measurement plot of regional sea-level rise near Cape Breton indicates that the regional rate is only one-

**Figure 5.** Average global sea-level rise between 1993 and late 2011, as measured by satellite. Figure reproduced with permission from the University of Colorado.

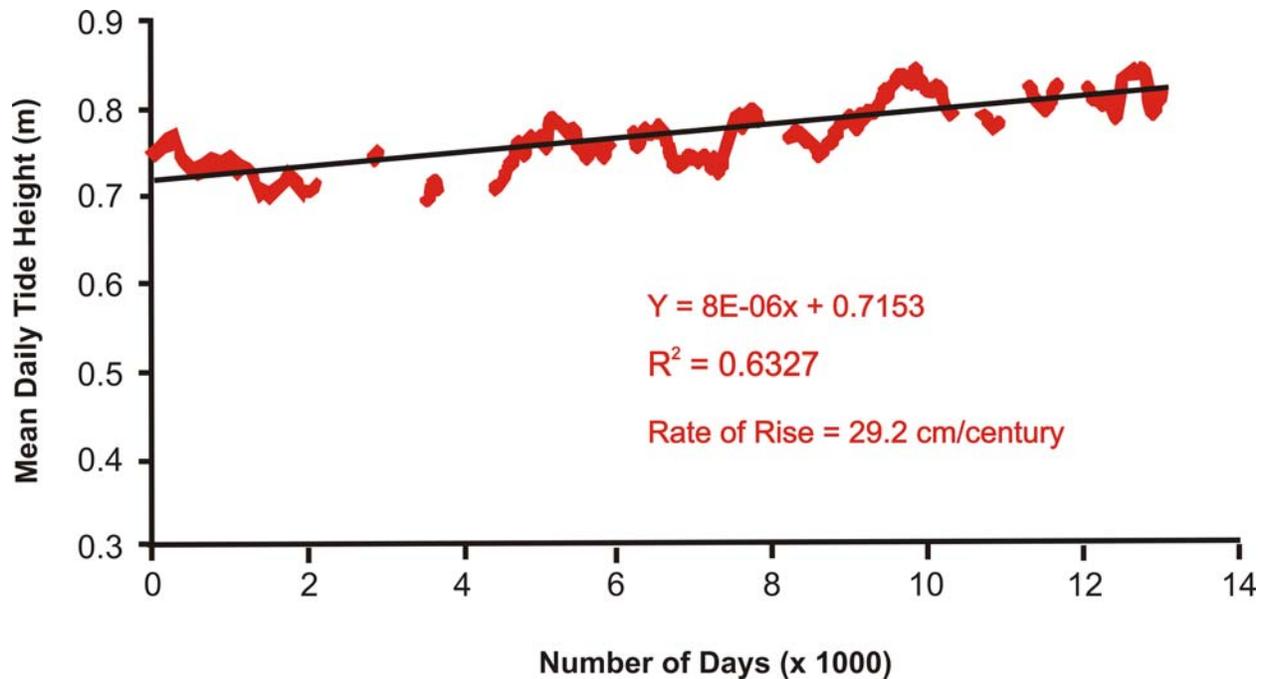
The average rate of sea-level rise at North Sydney is 29 cm/100 years. This is entirely consistent with global rates of sea-level rise, work by Gehrels (2005), the Halifax tide gauge data, and measured crustal

**Figure 6.** Tide gauge data from North Sydney between the mid-1970s and 2011. Lunar and seasonal yearly variations were removed using a box smoothing technique. Data are from the Canadian Hydrographic Survey.

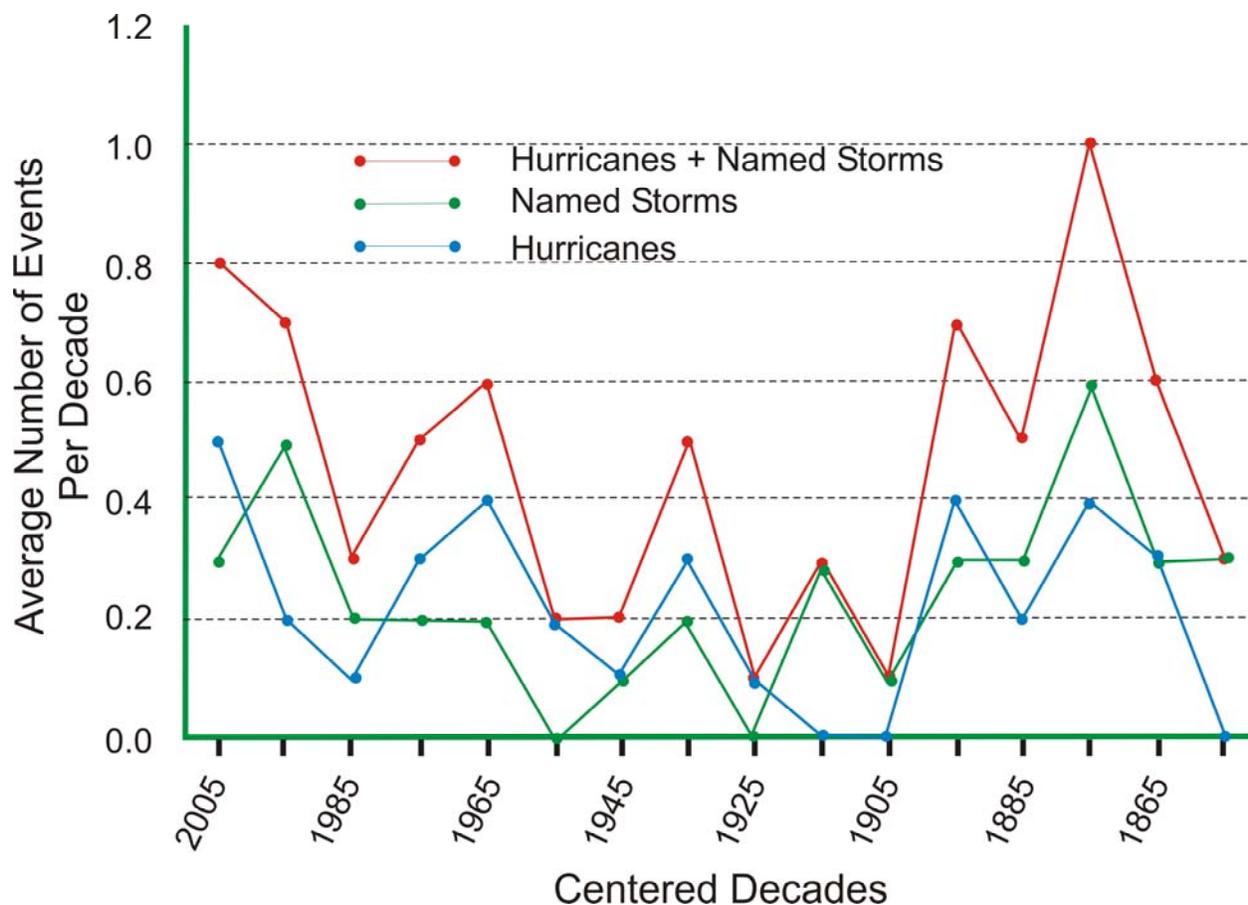
**Figure 7.** Frequency of named storms and hurricanes making landfall in the Atlantic Provinces between 1951 and 2010, inclusive. Raw data from the National Oceans and Atmospheric Administration (NOAA) hurricane database, 1951 – 2012.

**Relevance.** With respect to the village of Gabarus, Gabarus Harbour, and the seawall, there is no evidence to suggest that infrastructure maintenance costs or long term risk will increase over time with respect to named storms, tropical and post-tropical cyclones. Such claims in similar situations are based on conclusions from erroneous literature. There is low risk.

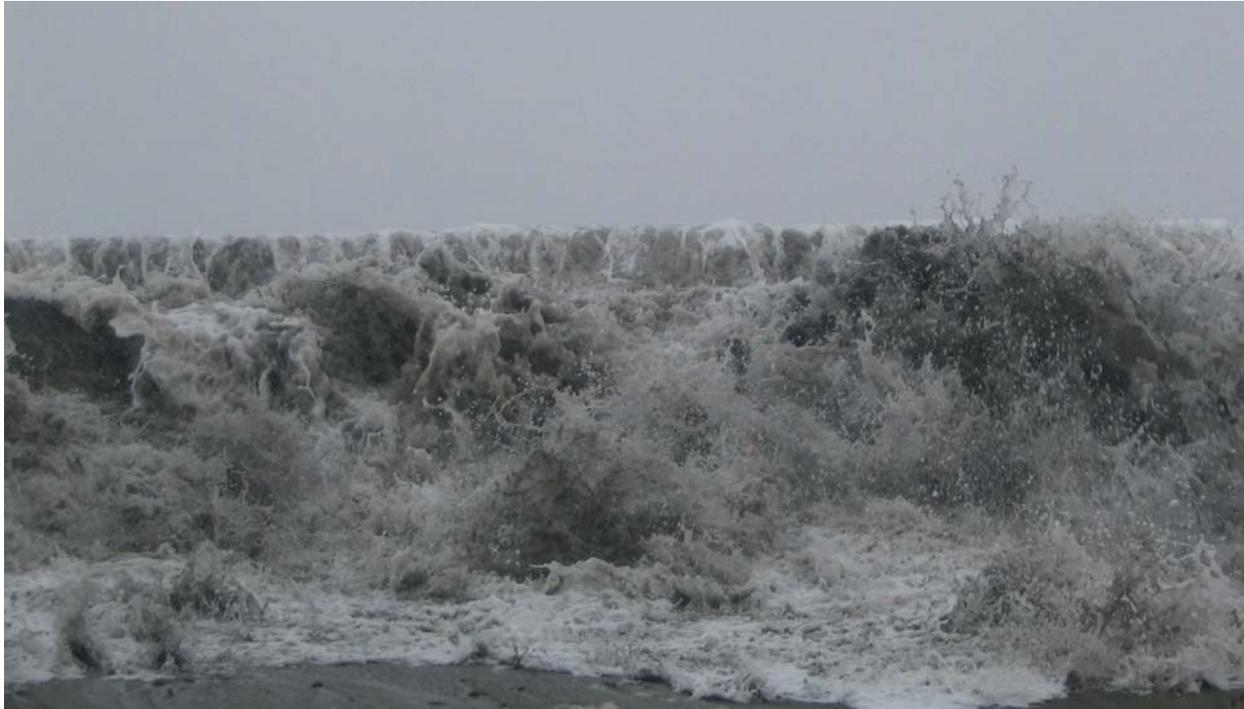
*Figure 8. Water overtopping the Gabarus seawall due to wave run-up.*

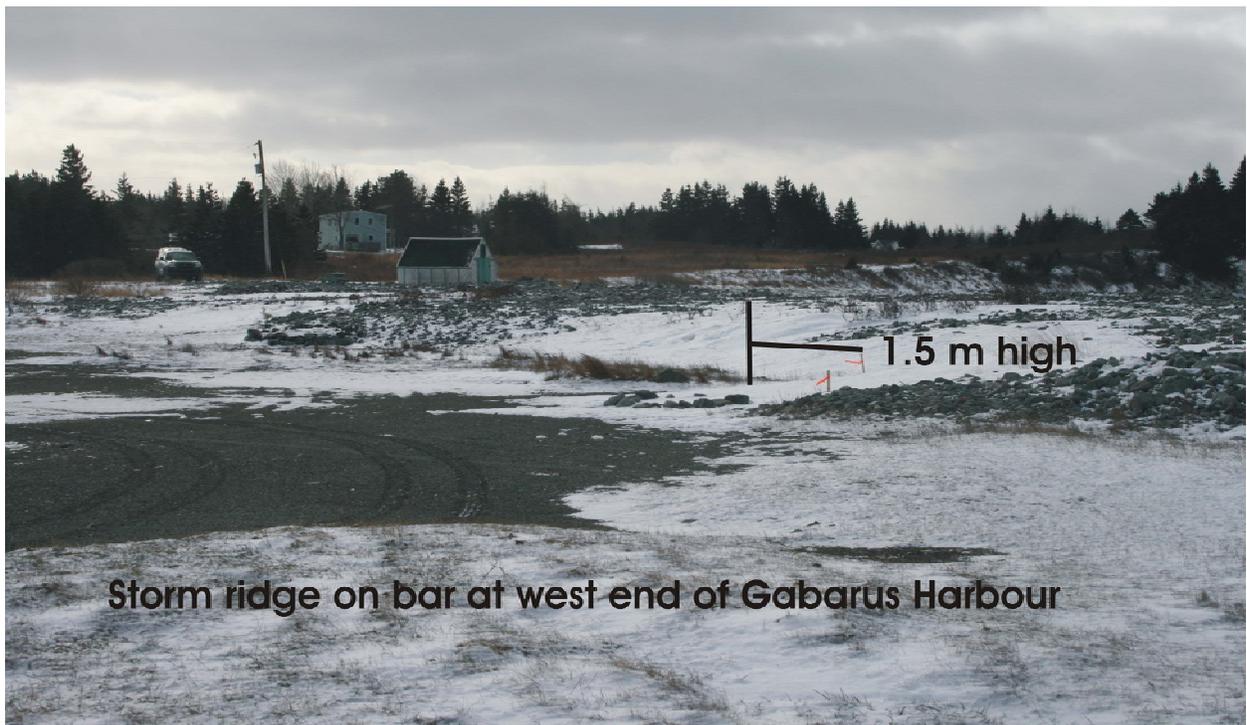
*Figure 9. A 1.5 m high cobble, gravel and sand storm ridge on the west side of Gabarus Harbour.*

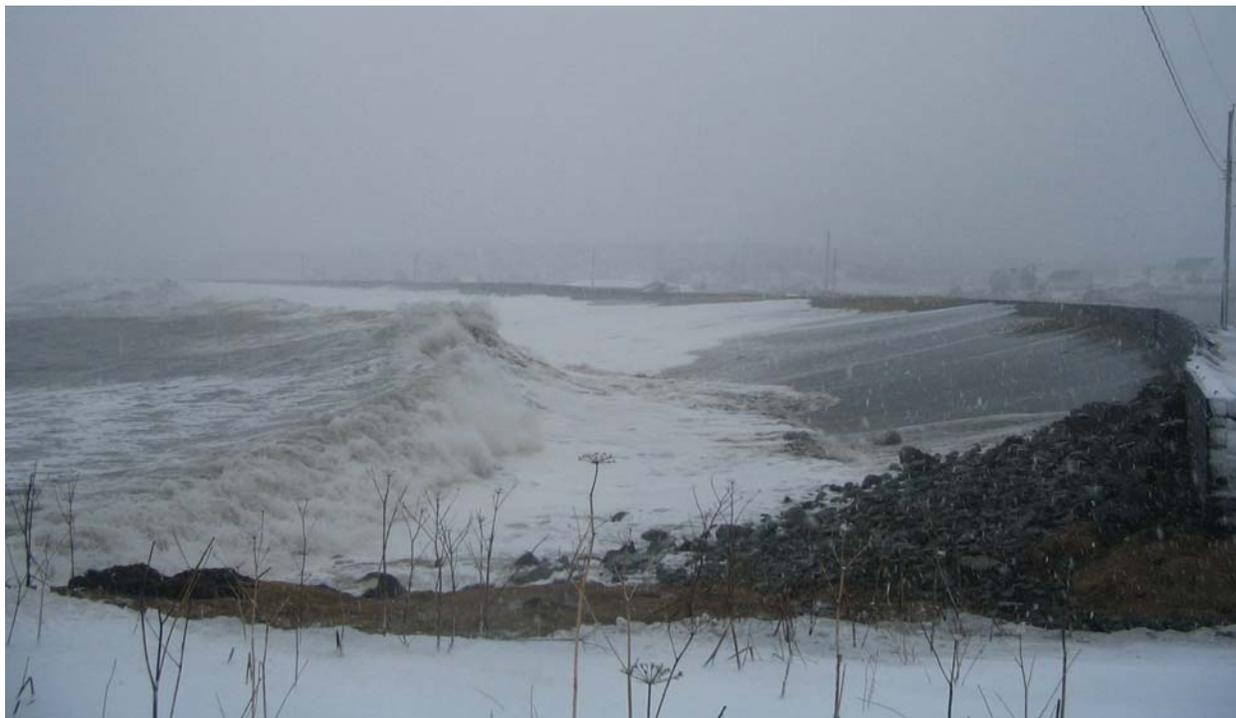
**Figure 10.** Breaking waves dissipating energy before striking the Gabarus seawall.

The breaking of a wave seaward of the seawall is an important factor influencing the relatively long-term stability of the seawall. The maximum theoretical height of a wave hitting a vertical structure, if the maximum depth of water is known, can be calculated. So too can the actual 'overtopping' height of the structure (the height required to prevent the wave from overtopping the structure). However, of more importance at Gabarus is the build up of the wedge shaped sand and gravel deposits against and immediately seaward side of the seawall (**Fig. 12**). Even though the waves break seaward of the seawall, the intruding water rushes landward up the ramp of sediment and overtops the seawall. This action is referred to as wave run-up. This is a significant issue that enhances the risk of flooding behind the seawall in the main harbour (refer to section 5.3).

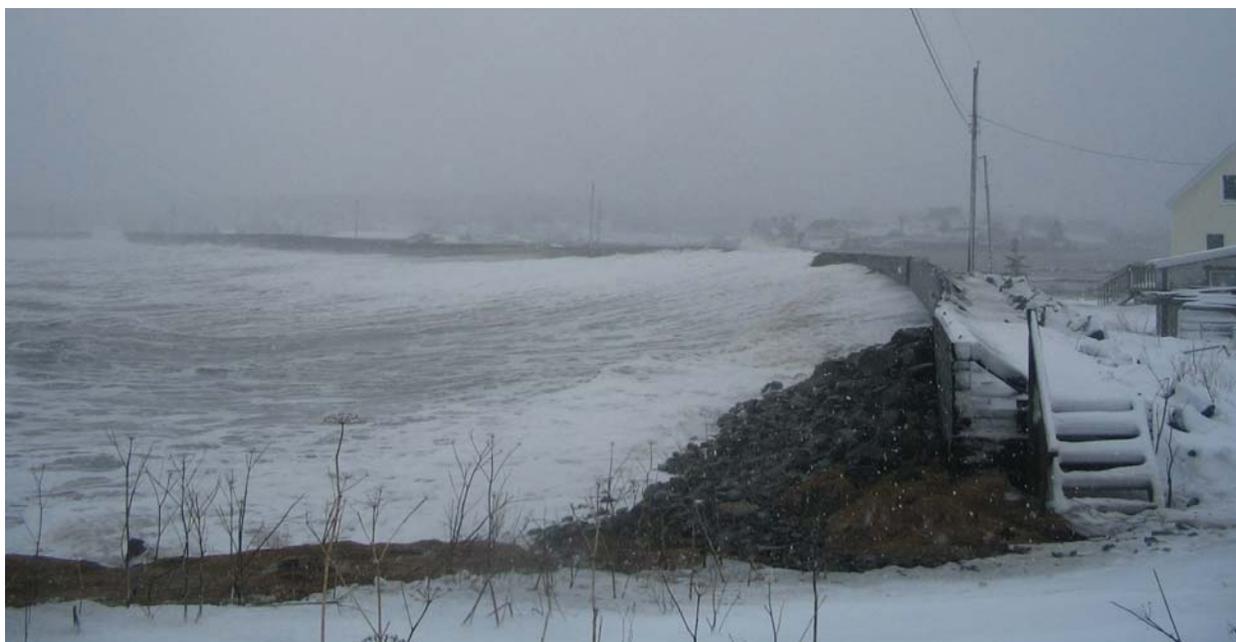
**Relevance.** The foreshore seaward of the seawall at Gabarus is relatively shallow. Because of this, even if it is high tide and there was to be a 1.5 metre storm surge, there is a limiting of the height of waves impacting the shoreline. This is because the waves break and lose energy before they reach the seawall (**Fig. 10**) and continue landward and over the seawall due to wave run-up (**Fig. 11**).

**Figure 11.** Wave run-up on the sediment buildup at the north end of the Gabarus seawall, with resulting overtopping and flooding behind the seawall.

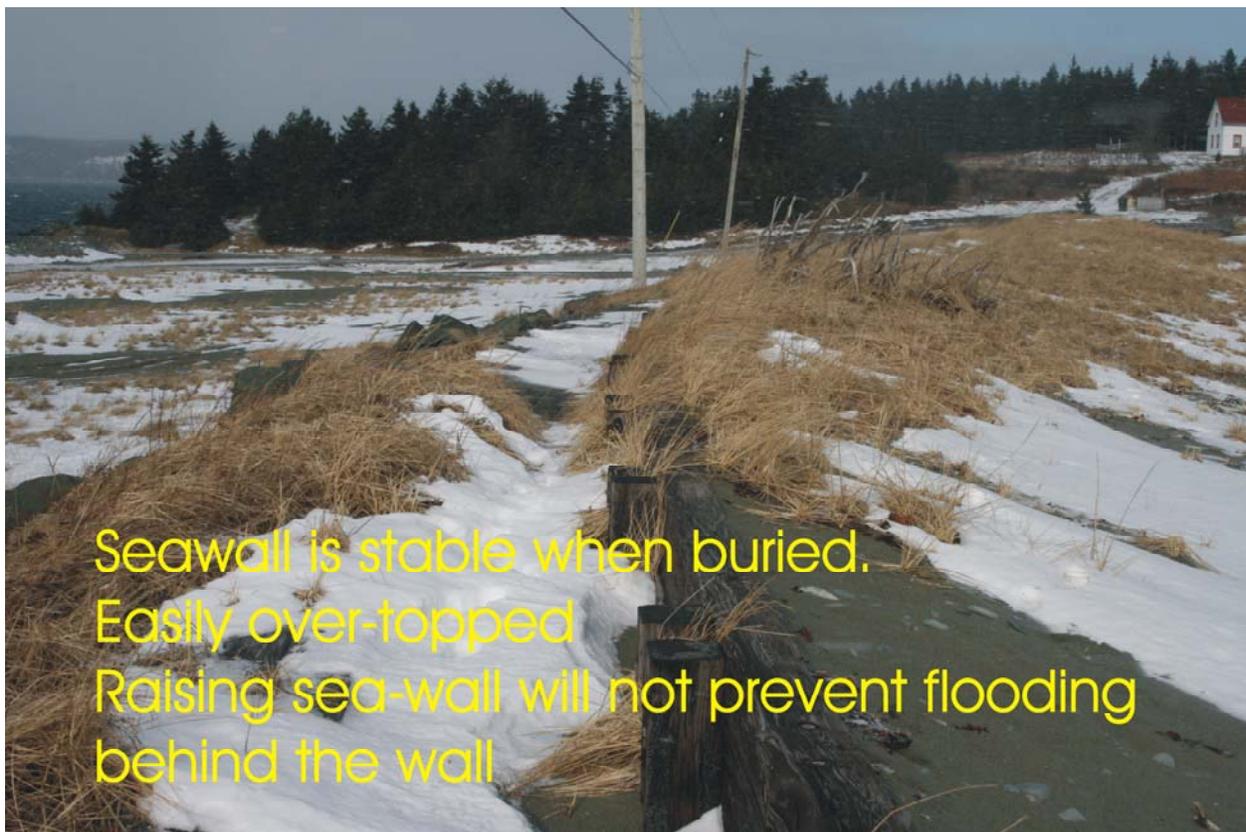
**Figure 12.** Sediment build up against and over the north end of the Gabarus seawall.

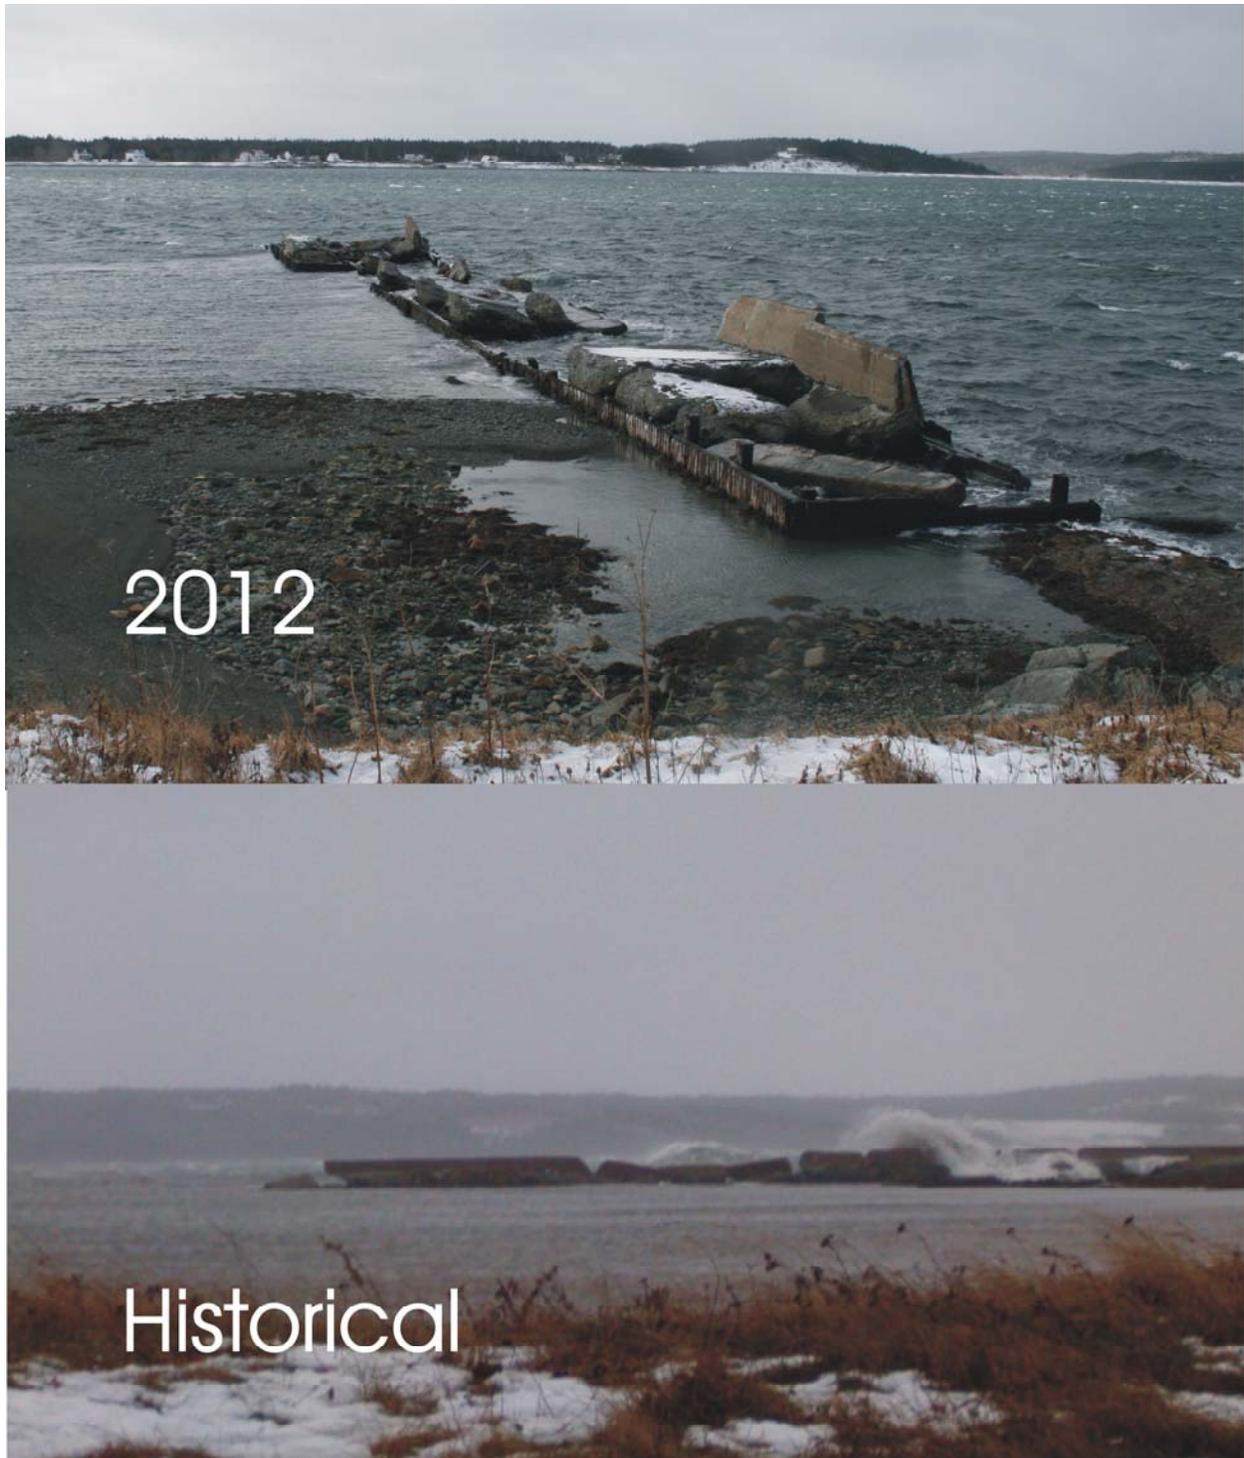
On a point of land northwest of the harbour there was a former government constructed concrete and creosote breakwater (**Fig. 13 top**). This breakwater has deteriorated (**Fig. 13 bottom**) and no longer offers shelter to the area of the western storm ridge. This likely allows increased overtopping of the bar in this area, thus exacerbating flooding of the harbour during storm events.

**Figure 13.** Historical concrete breakwater showing deterioration (bottom) with present day enhanced deterioration (top).

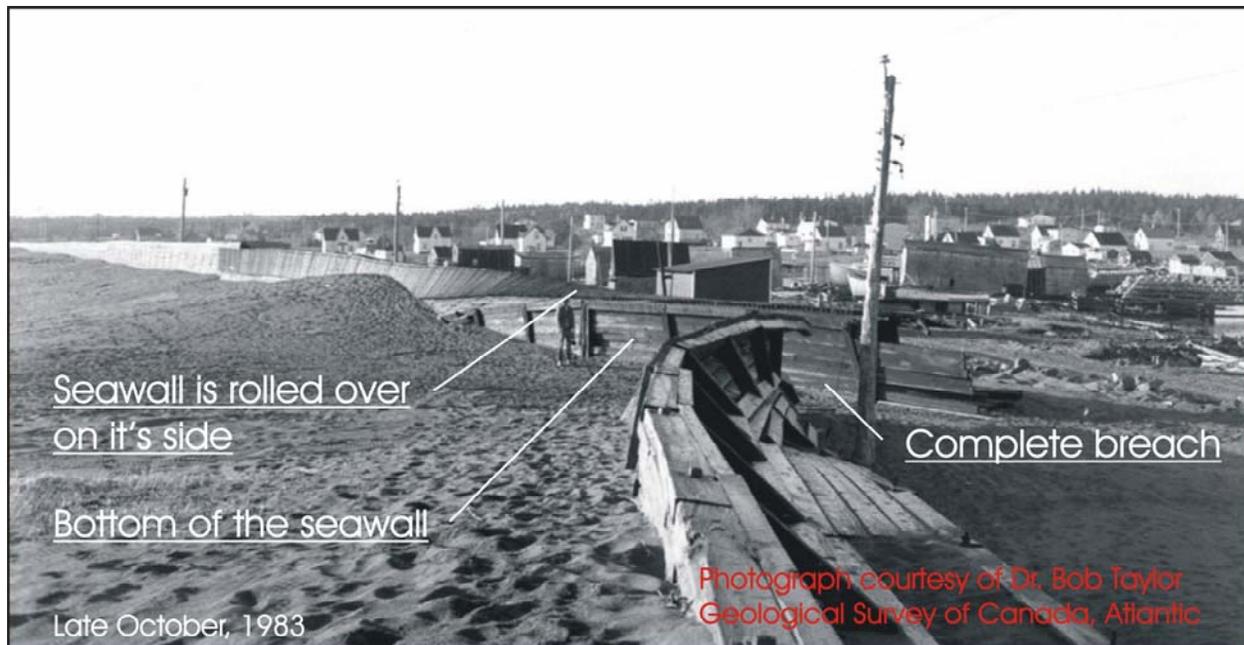
**Figure 14**, showing the damage to the seawall in 1983, provides a cross-section view of the seawall. It was constructed out of creosote timber with a rectangular cross section, with a raised wall on the

**Figure 14.** 1983 photograph of damage to the seawall at Gabarus. Photo by Bob Taylor, GSC Atlantic.

seaward side. It was ballasted with stone. It appears that it was simply placed on top of what was then the top of the beach (probably on wash over). In **Figure 14** it appears that the seawall was pushed landward, likely by the force of breaking wave impacts. The seawall ruptured, at which point the southern end rolled over on the back side exposing the base of the structure.

The photograph shows that the structure was not undercut in the front. It simply wasn't heavy enough to remain stationary, and once it started to move the structure was not strong enough perpendicular to the length of the seawall to prevent it from rupturing. An alternative failure mechanism may have been vertical lift from wave impact and a concomitant twisting or rolling of the structure. If this occurred the wall simply twisted and broke apart with the concomitant landward movement of the seawall. In either case the force of the waves exceeded the mass of the seawall.

Armour stone has subsequently been placed against the back side (landward) of the seawall to prevent it from moving landward. This appears to have been successful. However, over the last several years, where sediment is not piled against the front of the seawall, the seawall has tipped and bulged outward toward the water (**Figs. 15 and 16**). The back of the seawall has separated from its position against the backing armour stone. In **Figure 16** a small amount of armour stone is visible, presumably placed in front of the seawall in an attempt to keep the north end of the wall from collapsing.

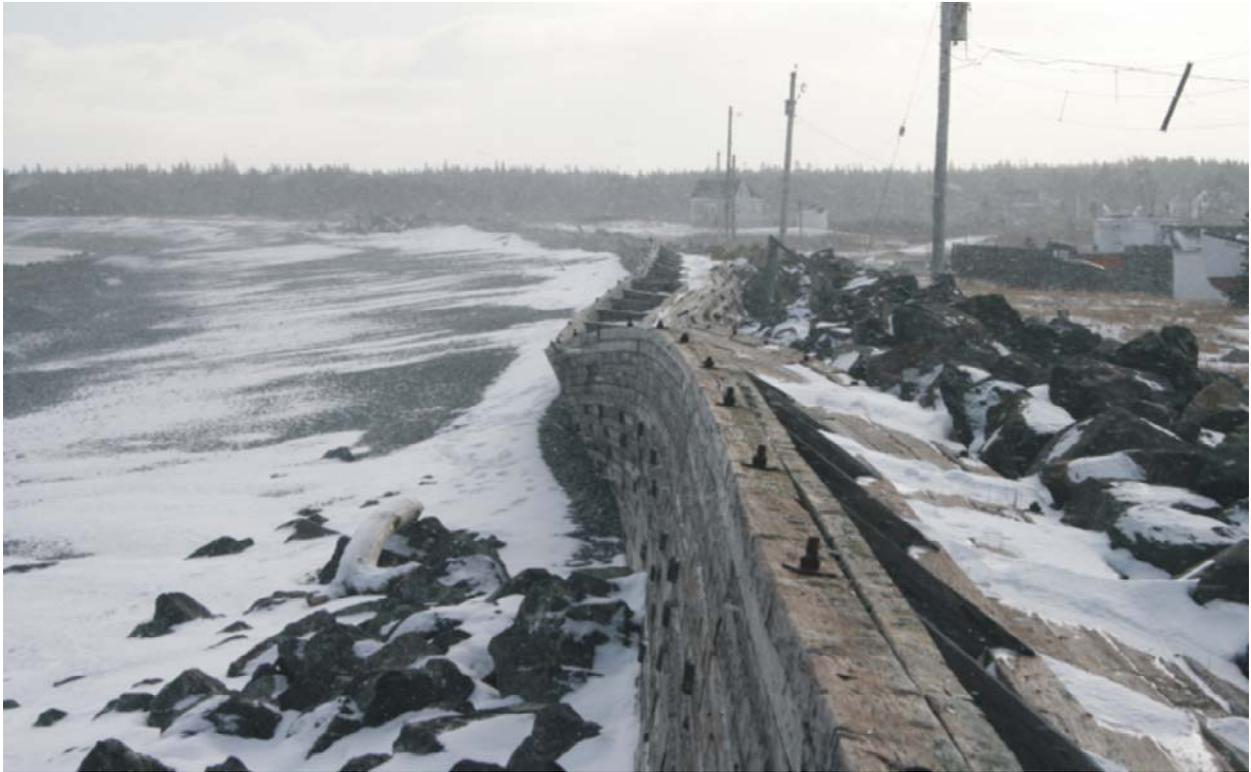
*Figure 15. Severe deterioration of the Gabarus seawall.*

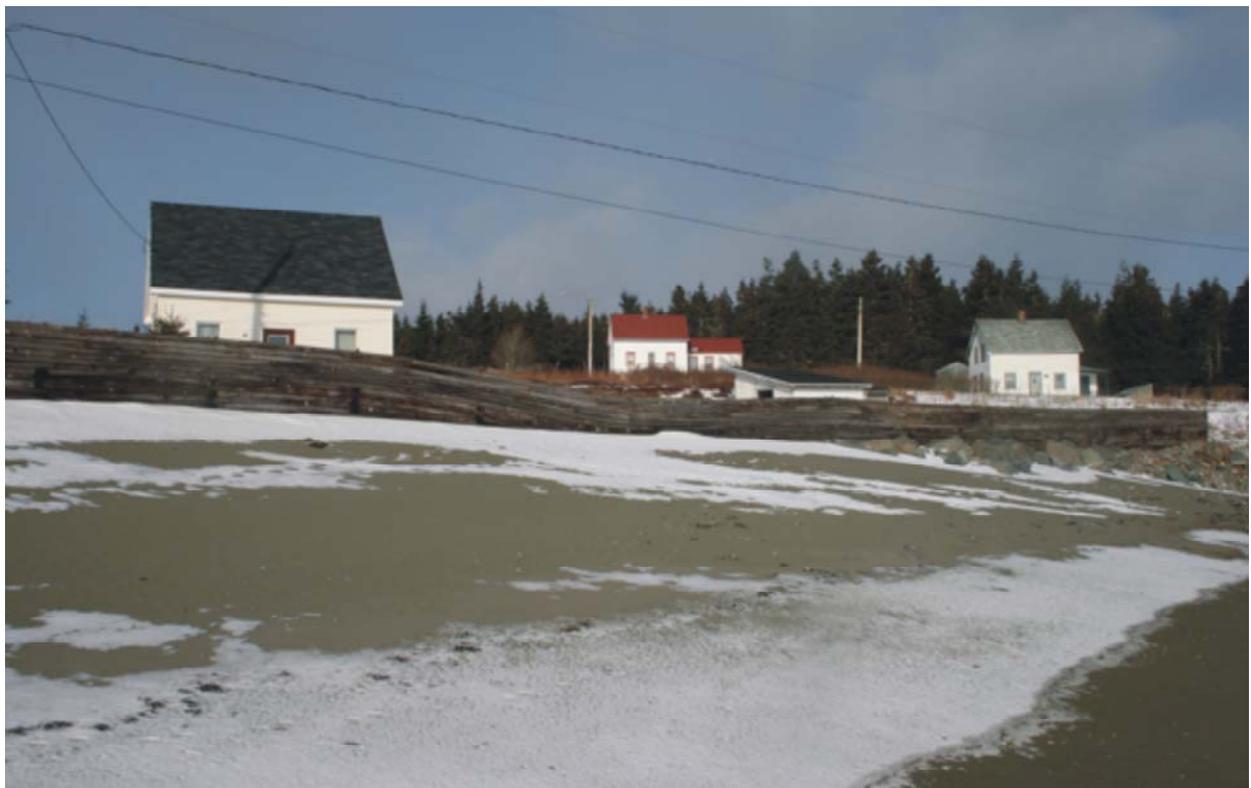
*Figure 16. Outward collapse of the seawall, with armour stone placed to prevent further tipping (?) and/or erosion behind the north end of the structure.*

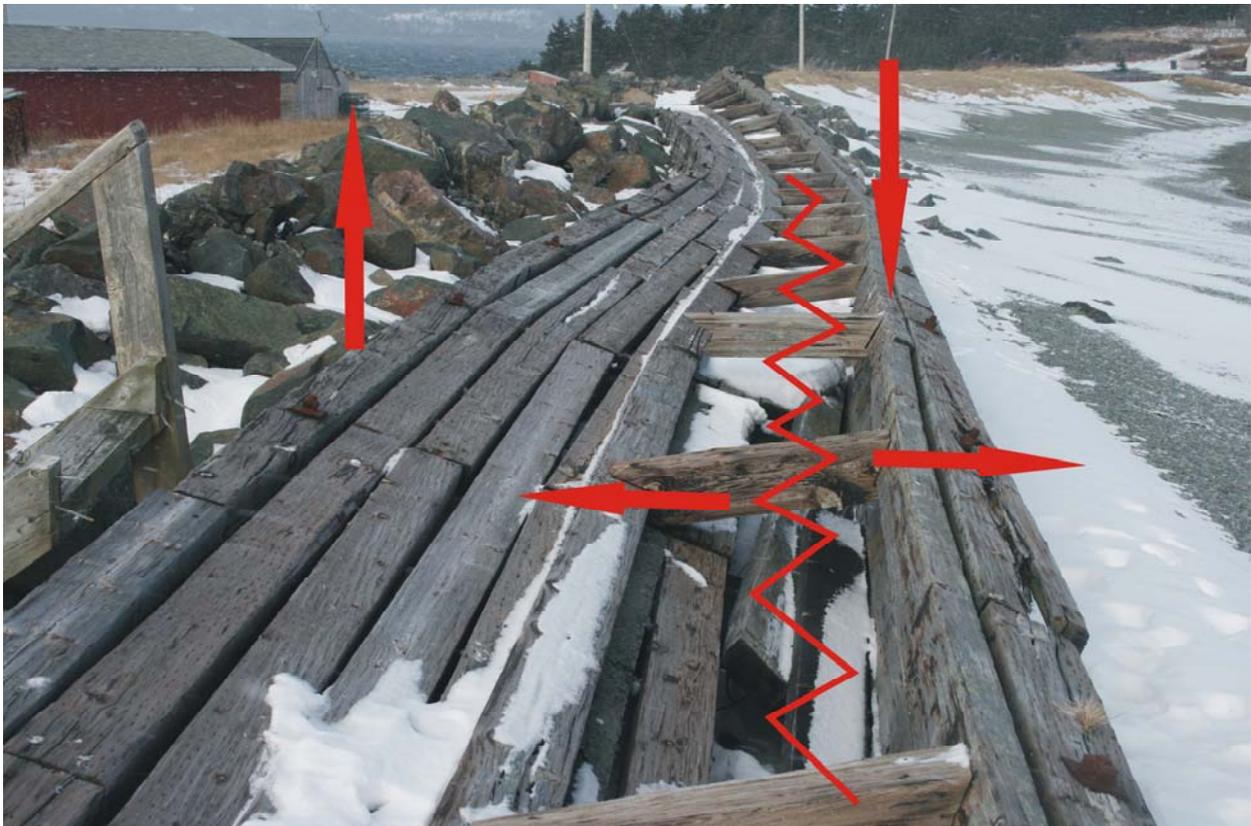
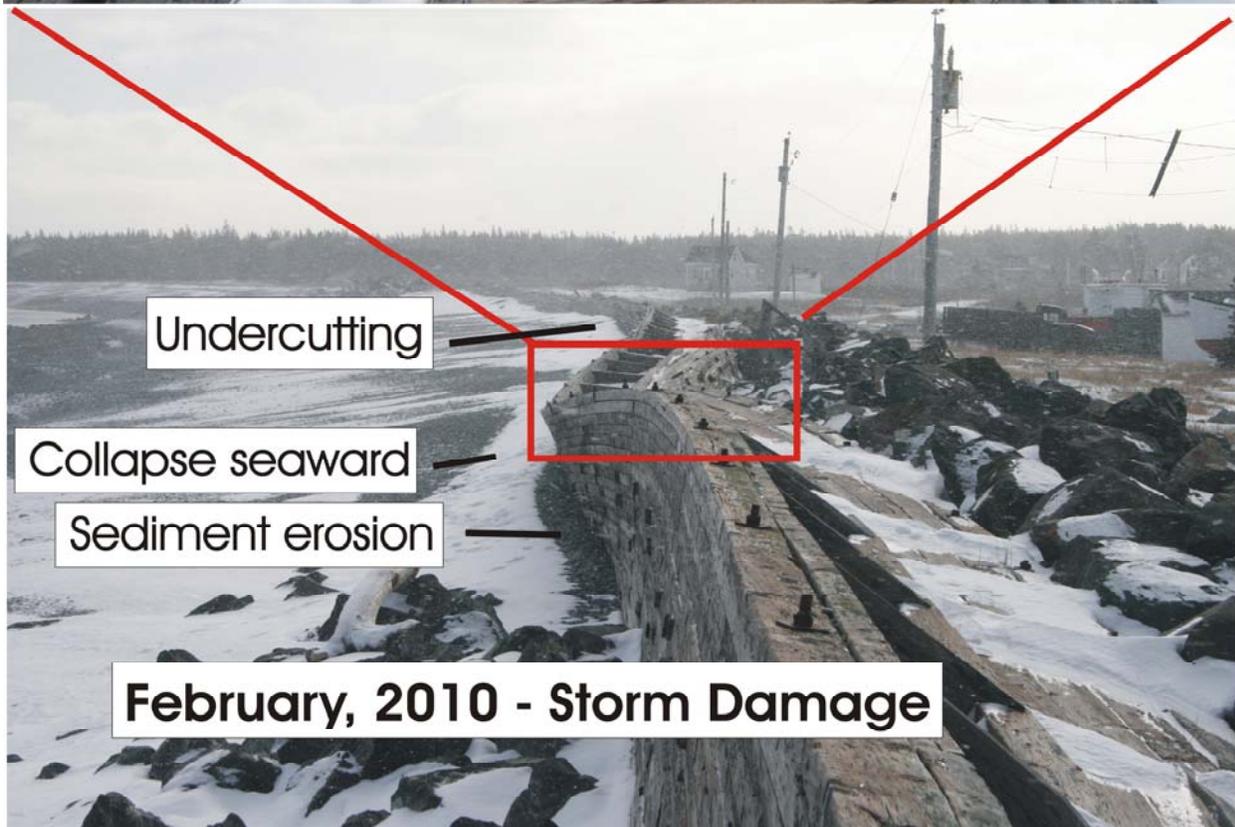
It is critical to note that where the seawall has tipped and bulged outward, it has in fact twisted and rolled (**Fig. 14**). As was discussed in relation to the 1983 failure, this is the same failure mechanism that occurred in 1983, only this time the movement is seaward rather than landward.

It is also apparent that the movement is more damaging than previously discussed in this report. Looking at **Figure 17** one sees that the entire front of the seawall over a distance of 75+ meters has separated from the top, back and bottom of the seawall. This indicates that not only may the seawall rupture, but in the process (unlike in 1983) it is twisting itself apart, and this dramatically increases the hazard due to the potential for floating debris (see Section 5.3 above).

Figure 17. Rolling and twisting of the seawall is causing severe damage.

Undercutting has caused the seaward side of the seawall to twist, drop down and forward (seaward). A 75 m to 100 m section is severely compromised as the front of the seawall has split from the top, back, and bottom of the structure.
