Analysis of Spit-Beach Migration and Armour Stone Placement, and Recommendations for System Sustainability at Dominion Beach Provincial Park, Cape Breton County, Nova Scotia

Open File Report ME 2012-003

November 2012

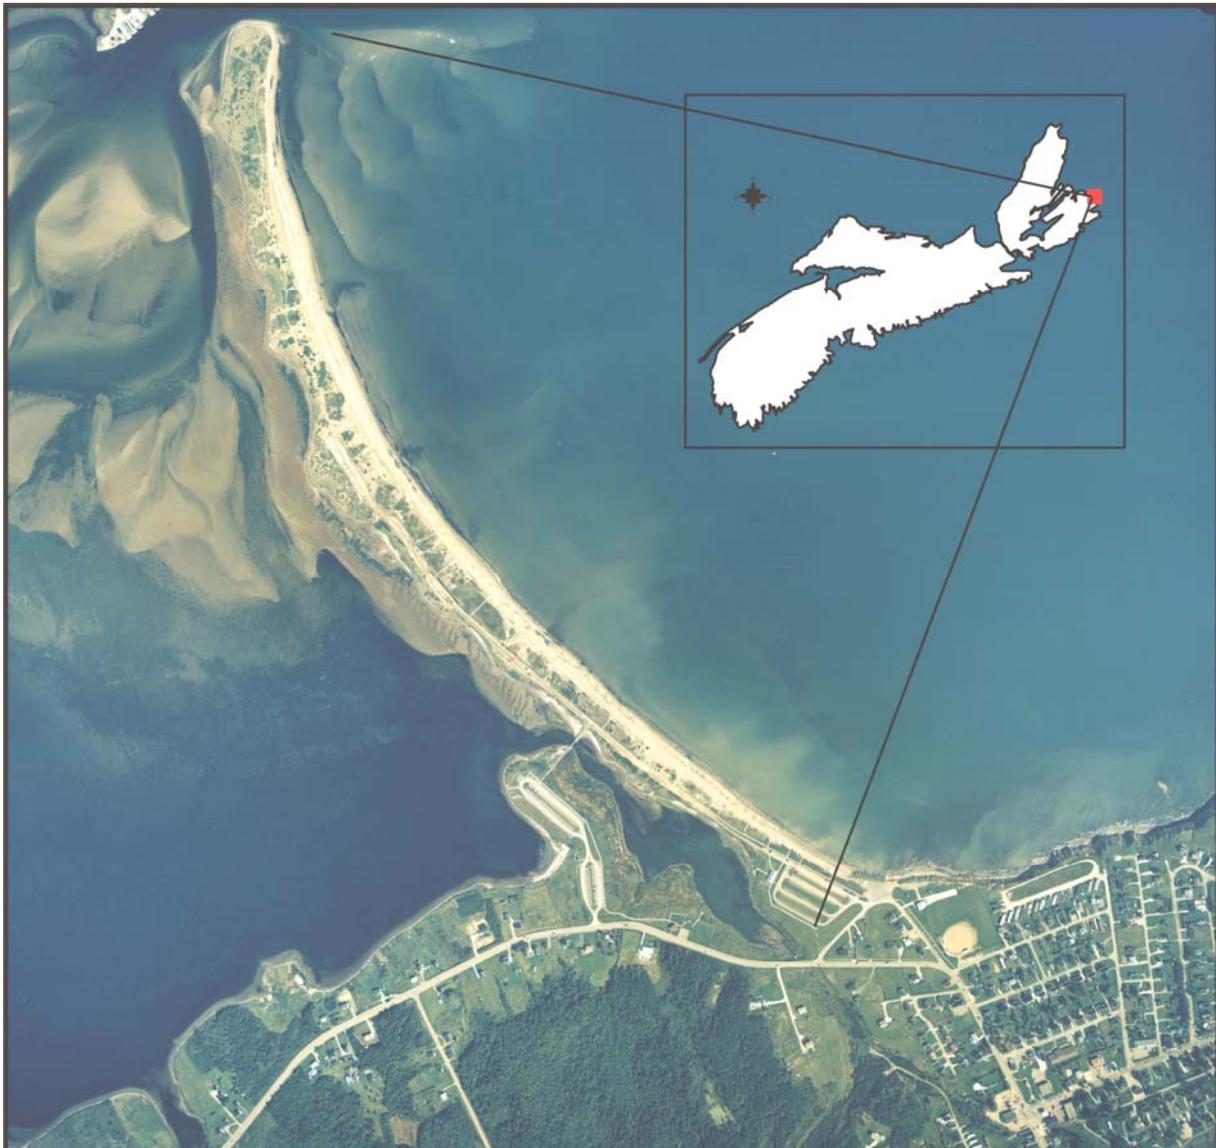
Figure 1. Map and air photograph showing the location of Dominion Beach.

Dominion Beach is located approximately 15 km northeast of downtown Sydney, at the westernmost edge of the town of Dominion (**Fig. 1**). The beach proper is the seaward-facing side of a 2 km long,

arcuate spit (**Fig. 1**). The spit is oriented approximately northwest-southeast. The spit is anchored to the shore at its southeast end, indicating that the major direction of sediment transport is to the northwest. The sediment is derived from actively eroding rocks of the Late Carboniferous Sydney Mines Formation (Boehner and Giles, 1986). The rocks are mainly well-bedded mudstones, shale, siltstone, sandstone and major economic coal seams (Boehner and Giles, 2008). The beds are jointed and fractured. Due to the broken and soft nature of the individual beds, erosion by pounding surf, freeze-thaw cycles and precipitation events creates actively eroding, vertical to sub-vertical cliffs.

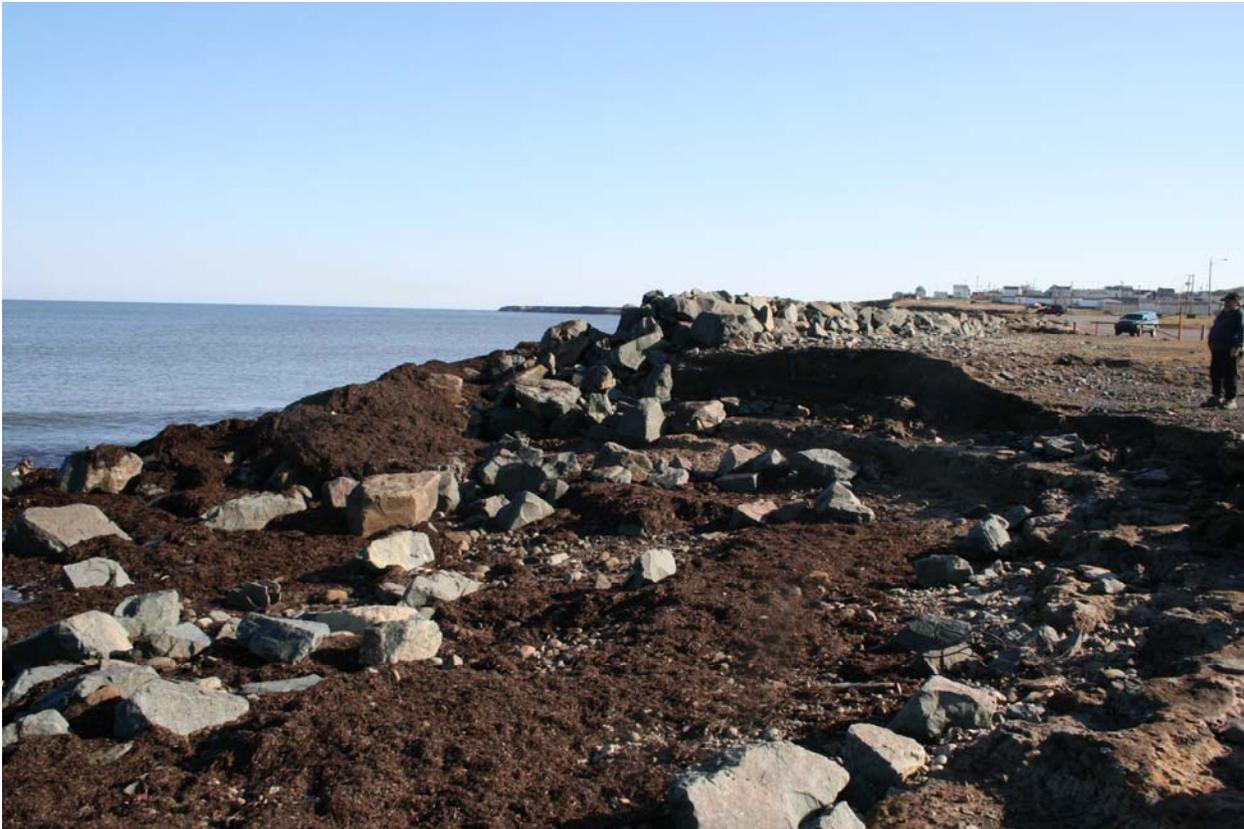
Figure 6. Boulders strewn near the low-tide level of the beach is evidence of erosion of the north end of the abutment at Dominion Beach.

The northern end of the abutment is eroding, and boulders are strewn northward (down current) of the abutment along the mid-tide to low-tide mark (**Fig. 6; Illustration 2**). Severe erosion is occurring immediately northward (down current) of the abutment and even behind the end of the abutment. This is caused by the seaward displacement of sediment discussed above, and also by turbulence caused by the end of the abutment. With the current configuration of the abutment, the erosion will continue. As the erosion continues, the back side of the abutment will eventually collapse. Over an extended period of time the abutment will likely become detached from the shoreline at high tide.

Simply extending the existing armouring northward will result in the same situation of flanking erosion as is presently occurring (**Fig. 6**). In an attempt to prevent this, it is recommended that the revetment be gradually curved landward so that it wraps around the northern side of the change house. Thus, the northern part of the revetment would actually be constructed in an excavated trench that turns inland rather than along the beach face. The revetment would be of sufficient height to prevent overwashing of future park infrastructure in the area of the existing parking lot.

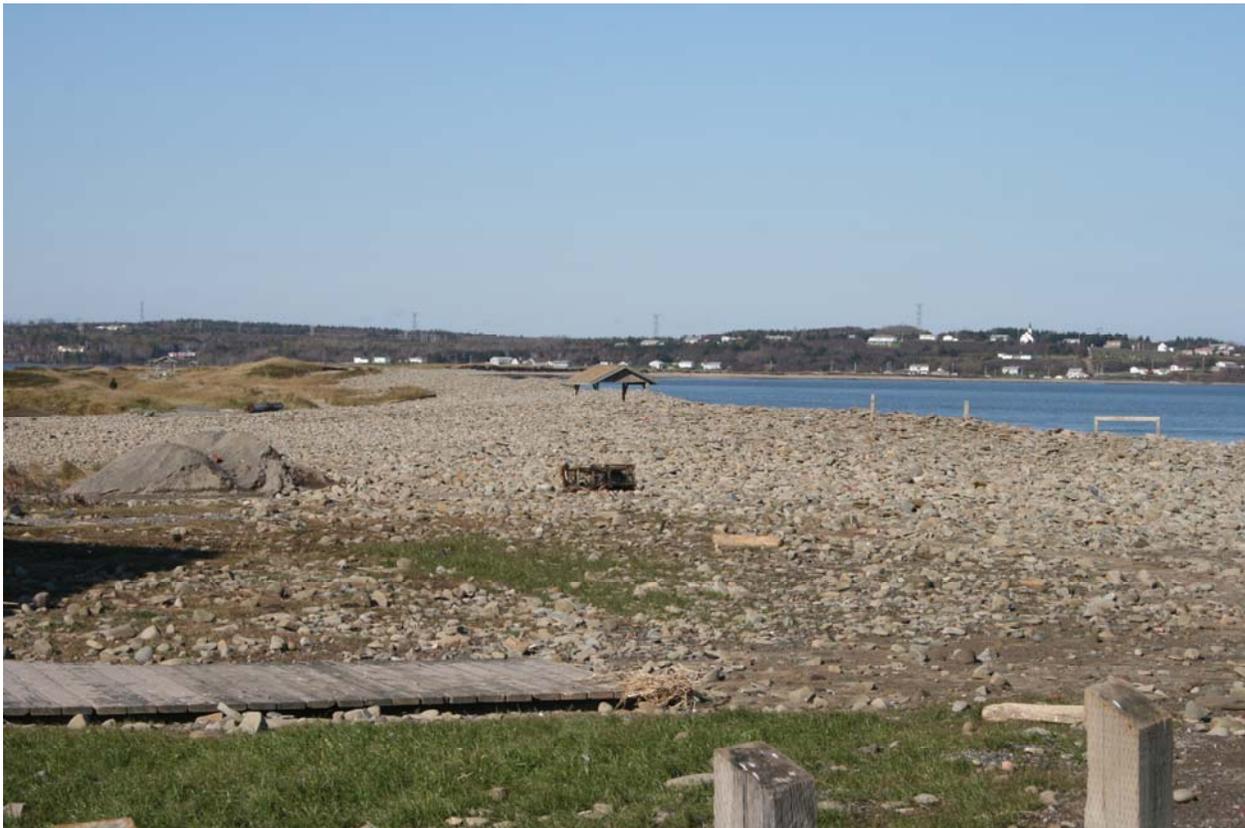
Figure 7. Landward migration of the Dominion Beach spit is illustrated by the progressive burial of park infrastructure.

In the area of cobble overwash, the beach is migrating landward, as can be seen by the burial of the roofed sitting area (**Fig. 7**). Seaward of the structure, an obvious cobble storm ridge is developed. It is recommended that the natural process of beach stabilization be enhanced. By doing so, the potential for successfully stabilizing the beach is increased while limiting potential damage to the beach system that would occur as described above by using intrusive methods.

It is recommended that stabilization of the beach be accomplished by imbedding a rubble mound within the existing beach but behind the cobble storm ridge (**Fig. 7**). The base of the rubble mound would be set down (buried) in the beach to a depth at which it would be unaffected by severe storms or extensive scouring. The top of the rubble mound would be slightly higher than the existing storm ridge. The concept is that the rubble mound would act as a brace to the existing storm ridge while at the same time reducing overwash and allowing the storm ridge to build higher. In areas where the storm ridge is less well developed more of the rubble mound would initially be exposed above the existing cobble beach. Over time it is likely that it would be progressively buried as cobbles build up seaward of the rubble mound.
