High Water Levels and Associated Flooding on the Margins of Catalone Lake, Cape Breton County, Nova Scotia: Coastal Hazard Assessment and Options for Remedial Action

Open File Report ME 2013-002

January 2014

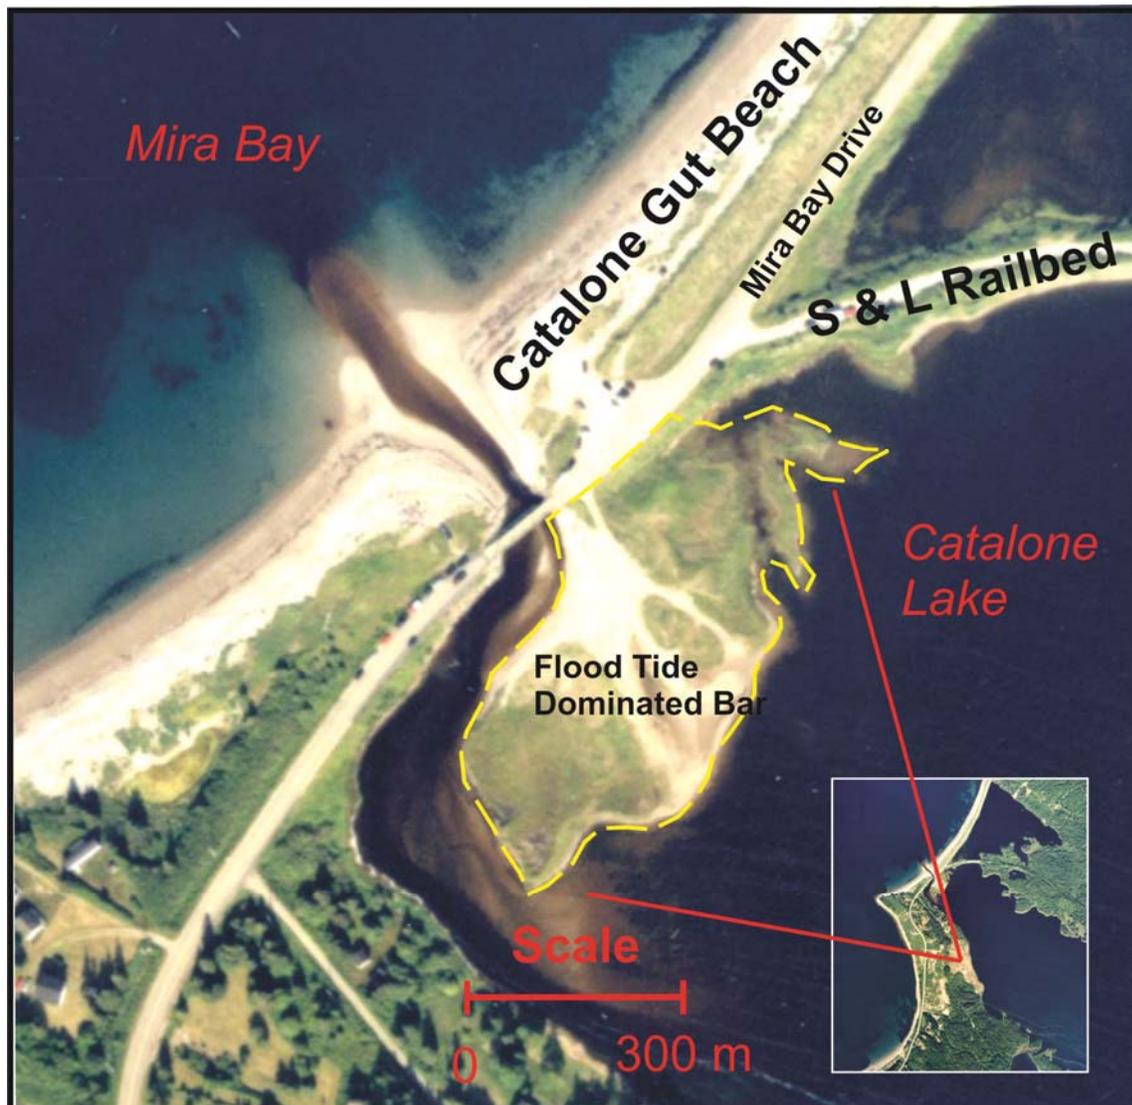
Figure 1. Air photo of Catalone Gut Beach and Catalone Lake, Cape Breton County. Photograph is from 2009.

The properties affected by flooding and drainage problems are located along the margins of Catalone Lake. Catalone Gut barrier beach separates Mira Bay from Catalone Lake (Fig. 1). The beach is composed of sand in the lower shoreface and sub-tidal zone, and by sand, coarse gravel and cobbles in the upper shoreface and storm ridge (Fig. 2). The shoreface and storm ridge sediment is highly mobile due to a strong west- to northwest-flowing longshore drift current.

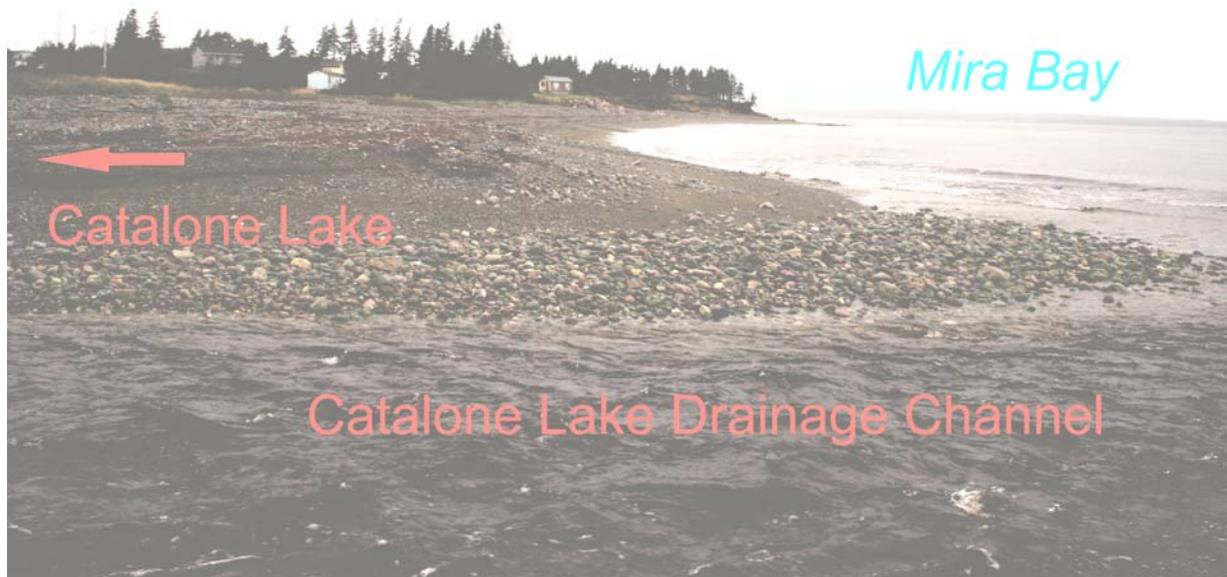
Figure 2. Photograph showing sediment composition of the foreshore and beach ridge.

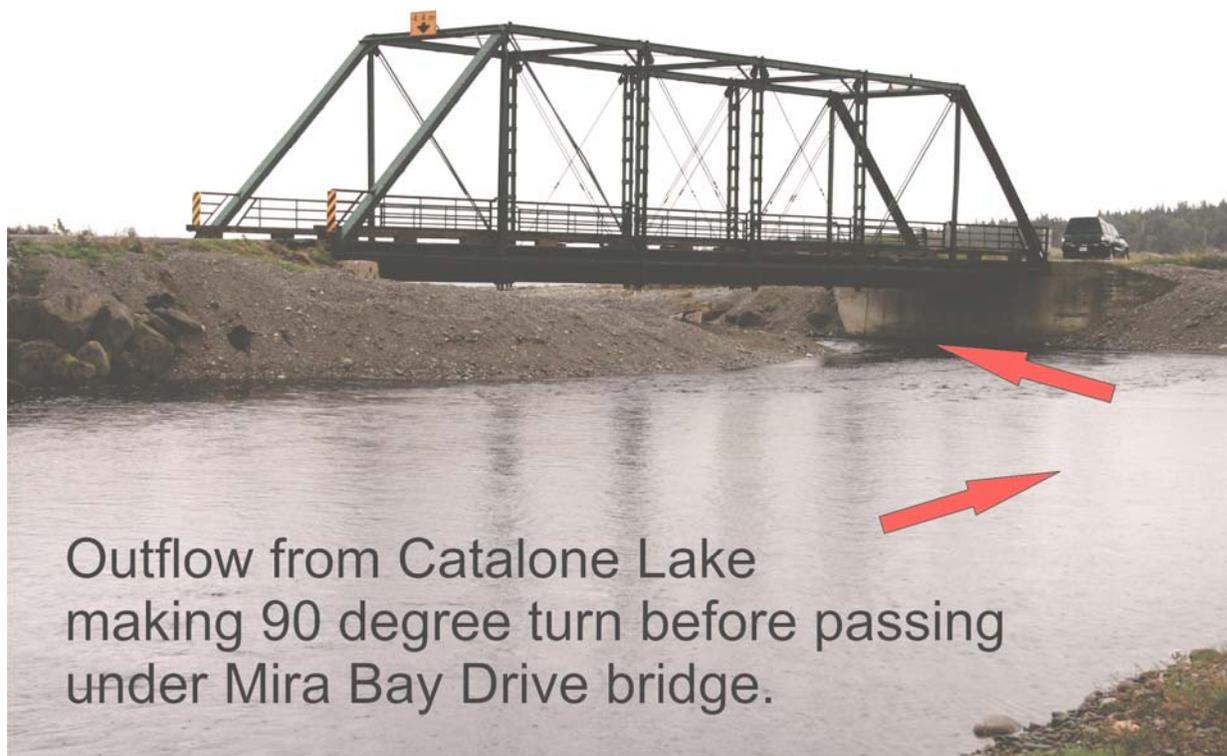
Figure 7. Photograph illustrating the wide, shallow, meandering nature of the drainage channel on the landward side of Mira Bay Drive Bridge.
