# Highlights of the Community Engagement Program in 2015

## Coastal Erosion and Mapping Program: Community Engagement Activities

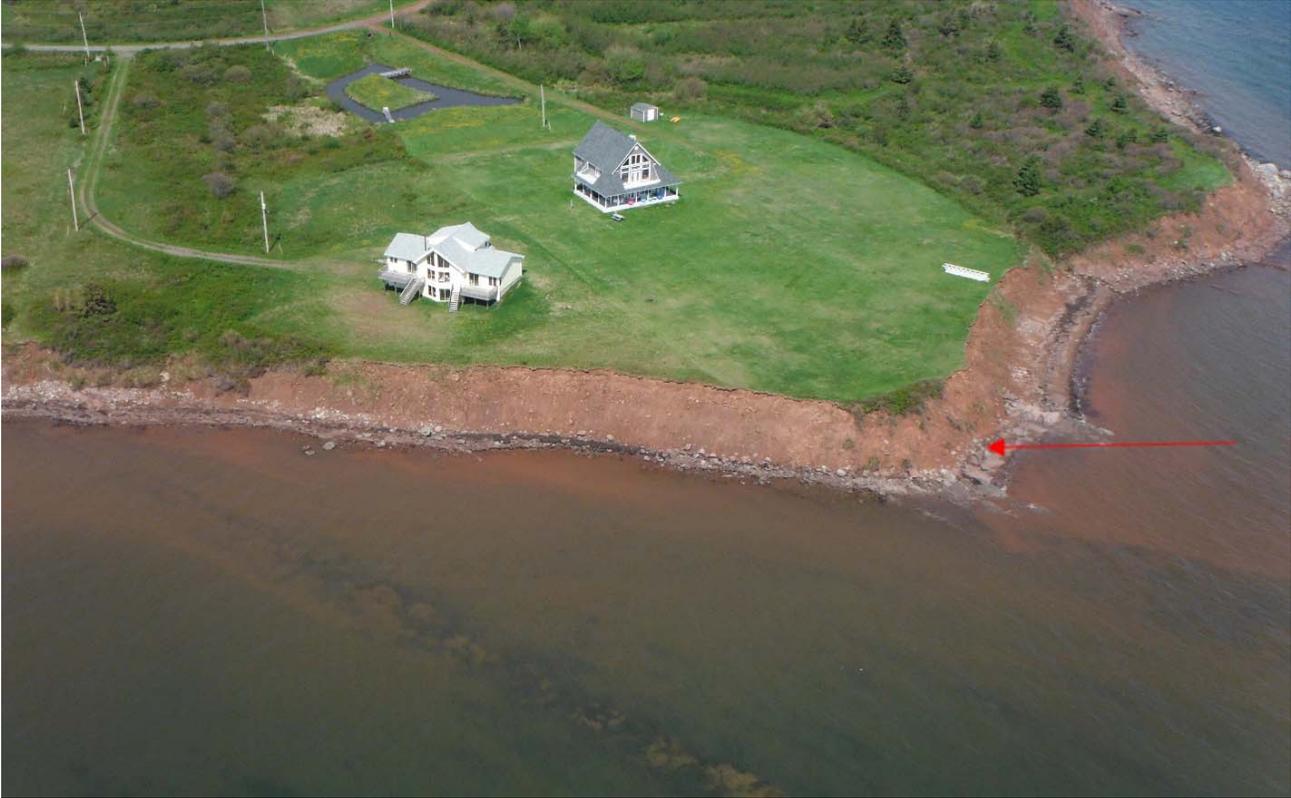
**Figure 1.** High-resolution coastal image taken from a DNR helicopter along the shoreline at Malagash Point. The red arrow shows the location of the photograph shown in Figure 2.

As part of the Cumberland County Coastal Project the entire Northumberland Strait shoreline of Cumberland County and a portion of Colchester County was flown with a DNR Air Services Branch helicopter to capture high-resolution, oblique-angle photographs of the coastline. One of the images is shown in Figure 1.

characterizations. Linear sandstone bedrock ridges are seen in the aerial image. While it appears in this image that a brown till-bedrock contact is located in the cliff, slightly above the water level, much of the reddish-brown material is actually bedrock. The red arrow seen in Figure 1 marks the location of the image seen in Figure 2, which was taken during a shoreline traverse. Sedimentary bedrock bedding is more evident in Figure 2. Only the upper metre or so of the cliff is glacial till.

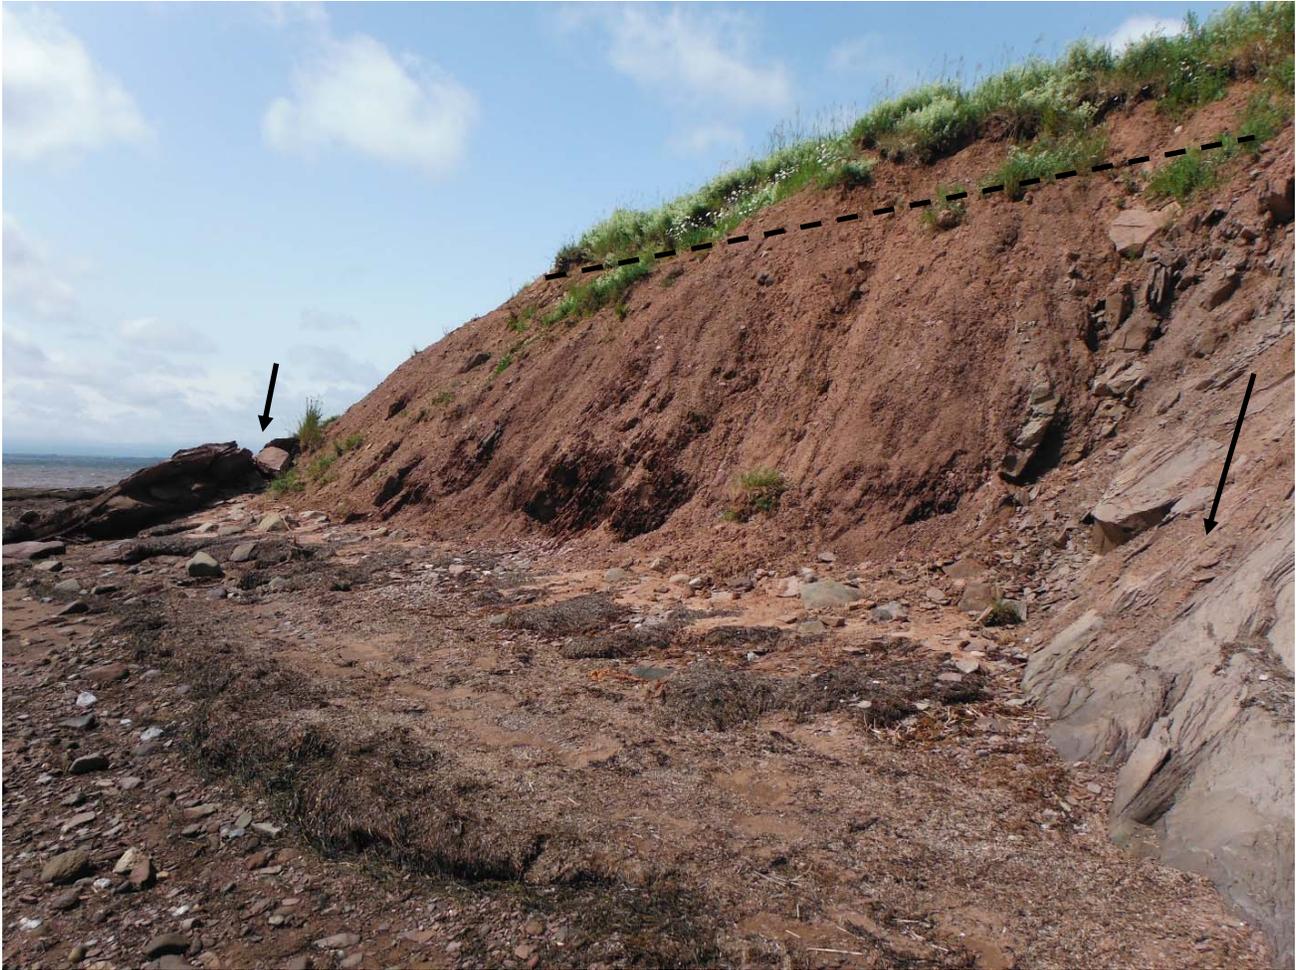
**Figure 2.** A shoreline image taken from the beach at Malagash Point. Note the dipping reddish-brown sedimentary beds between the two grey sandstone beds (black arrows). Only the top ~1 m of the cliff (above dashed line) is till.
