An Overview of Work on the Oxford Sinkhole, 2018-2019

A. Tizzard, G. J. Demont, and D. M. Brushett

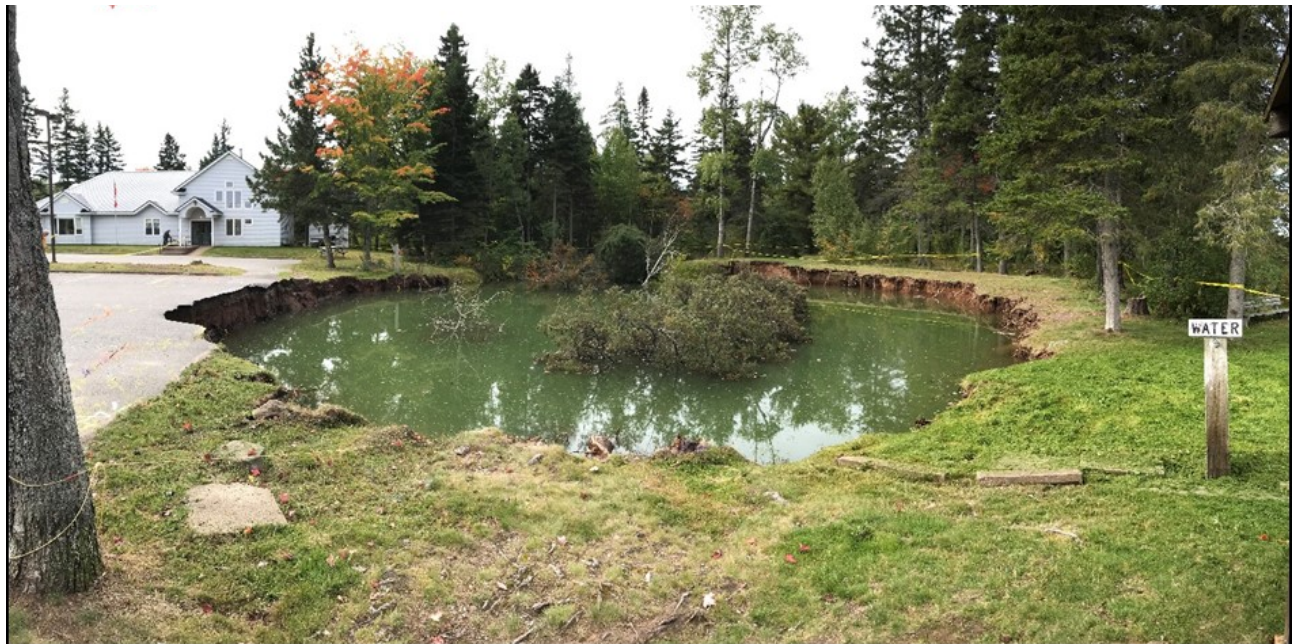
In late July, 2018, a small area of subsidence was observed by members of the Oxford Area Lions Club near the western end of the parking lot in the privately owned Lions Parkland in Oxford, Cumberland County (Fig. 1). The circular depression was described as approximately 60 cm deep by 100 cm wide. On August 9, 2018, approximately 12 tonnes of shale were used to fill the depression back to surface grade. On August 10, the area again subsided, resulting in a square-shaped depression approximately 1.5 m² and 30 cm deep. The area was cordoned off and monitored until August 20, when a witness described the sound of rushing water, a loud “whump” noise and felt the ground shake as a result of sudden collapse, leading to the development of the sinkhole. At that time, emergency responders were called to the scene and the park was closed to the public. From August 20 to early September, 2018, the sinkhole grew rapidly from a few metres to approximately 40 m in diameter (Fig. 2). The underground extent of the collapsed cavern is presently unknown.

Figure 2. Photograph of the sinkhole in September 2018.

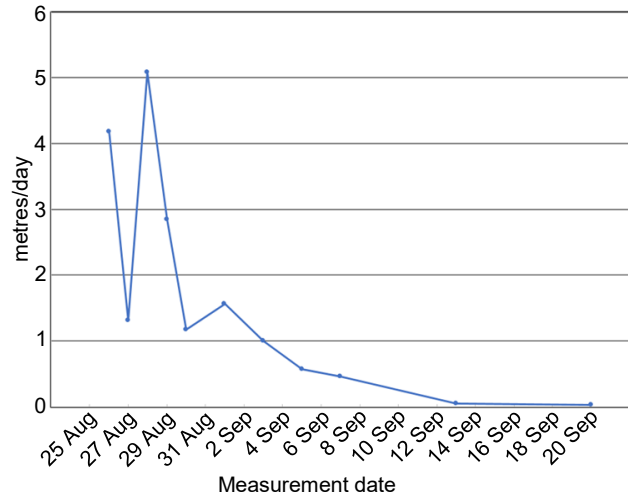
During the course of initial rapid sinkhole development in late August and September, the sinkhole progressed at variable rates predominantly to the northeast toward playground infrastructure and surrounding Salt Lake (Fig. 3). Many cracks grew in width from hairline fractures to tens of millimetres wide to being unsafe to measure or being completely consumed by the sinkhole. The rate of growth of the sinkhole boundary was likely influenced by dense root masses of large trees in an otherwise homogenous sand deposit. The thick sand deposit in the area of the Lions Parkland likely contributed to the rapid growth of the sinkhole, due to the ability of surface and ground water to flow more easily through a permeable medium. Additionally, the steep walls of the sinkhole combined with the low cohesiveness of the sand are conditions favourable to a sudden bank collapse.

Figure 3. Rate of growth of the Oxford sinkhole, 25 August to 20 September 2018.

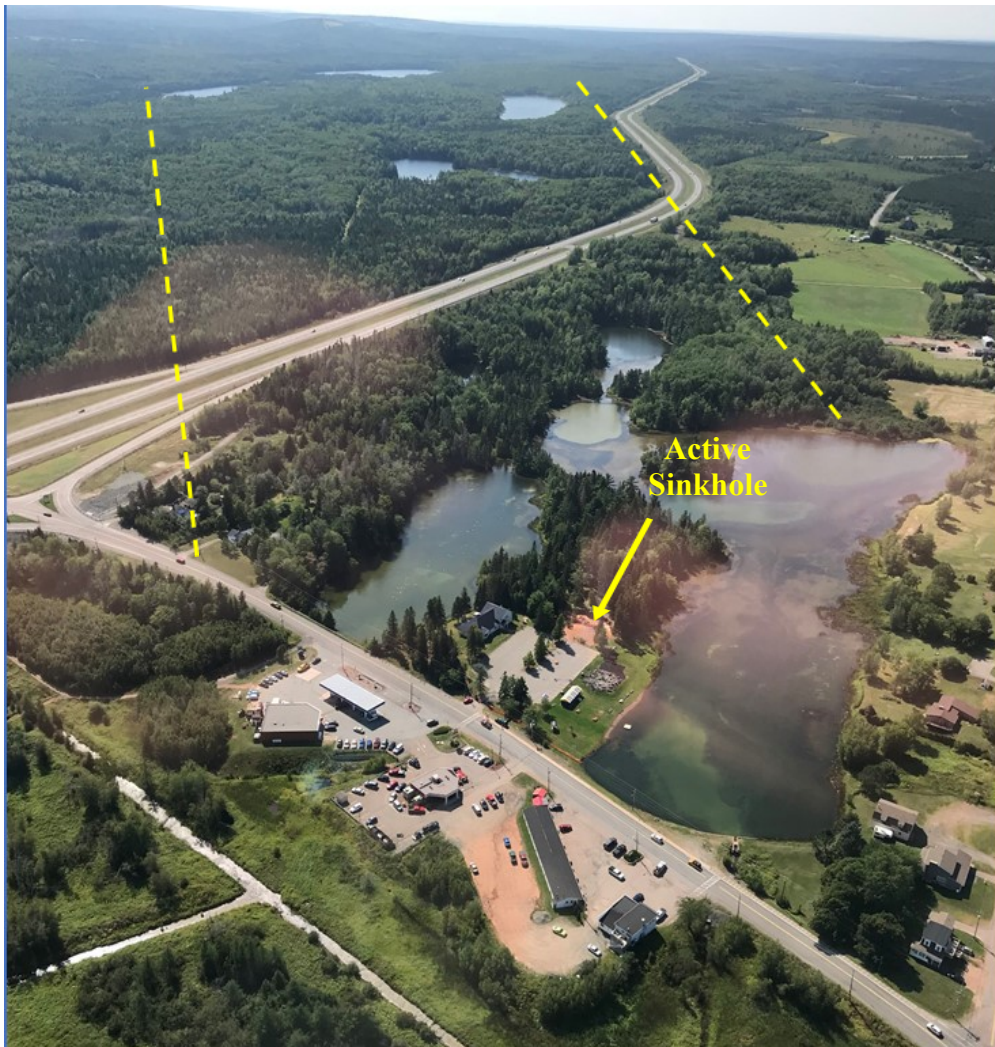
Water in the sinkhole was extremely turbid at the time of its development. Aerial surveillance of the region was undertaken to examine surrounding water bodies for signs of change (Fig. 5). No unexpected turbidity was noted in surrounding water bodies, indicating no apparent immediate connectivity between the Oxford sinkhole and surrounding sinks or River Philip. The underground extent of fractures, fissures or voids beneath the Oxford sinkhole is unknown.

Figure 5. Aerial view of the Oxford sinkhole and regional extent of karstic terrain. View is to the southwest. Photo taken August 29, 2018.
