**APPENDIX 3.**  
**RESTORATION OF HISTORIC BUILDINGS**  
**BY**  
**LES BATTEN**  
**MARITIME CANSTONE INC.**

## RESTORATION OF HISTORIC BUILDINGS

## RESTORATION OF PROVINCE HOUSE, HALIFAX

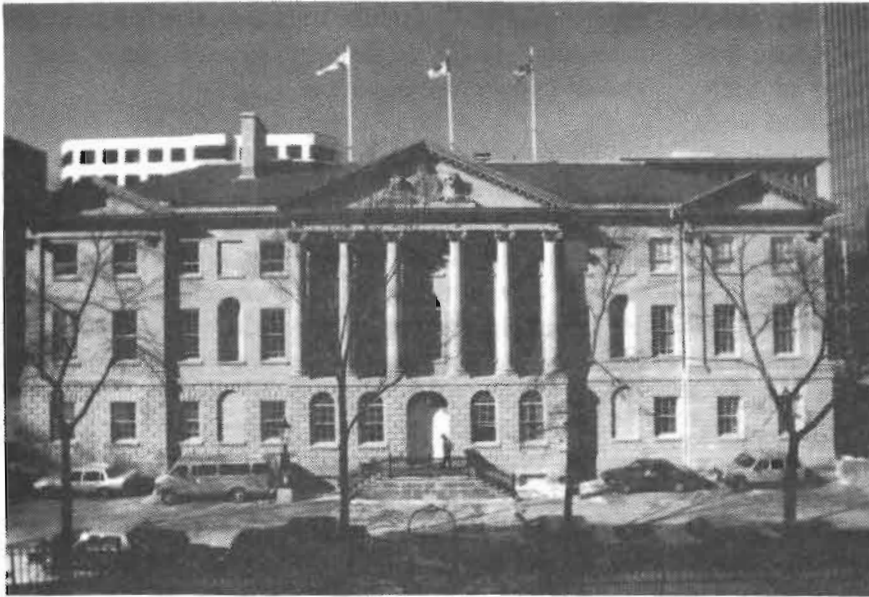
Province House was built over a period of eight years and opened in 1819. Its design is thought to have been influenced by the Adams brothers, the leading exponents of the Palladian (or Georgian) style. It is classic in its dimensions, with its length being twice its width and with the opposite elevations being identical. One of the many outstanding features of this building is the extremely intricate and beautifully carved coat of arms, an outstanding example of the architectural carver's art. It was executed by David Kinnear who is responsible for other fine works in Halifax. Added to its fine architectural value, it has a unique place in both the social and political history of Canada, indeed, a building worthy of restoration (Fig. A3-1).

Figure A3-1. Province House, Halifax, Nova Scotia
