APPENDIX D

PHOTOGRAPHS - No. 1 SHAFT

PROJECT NO. 10903

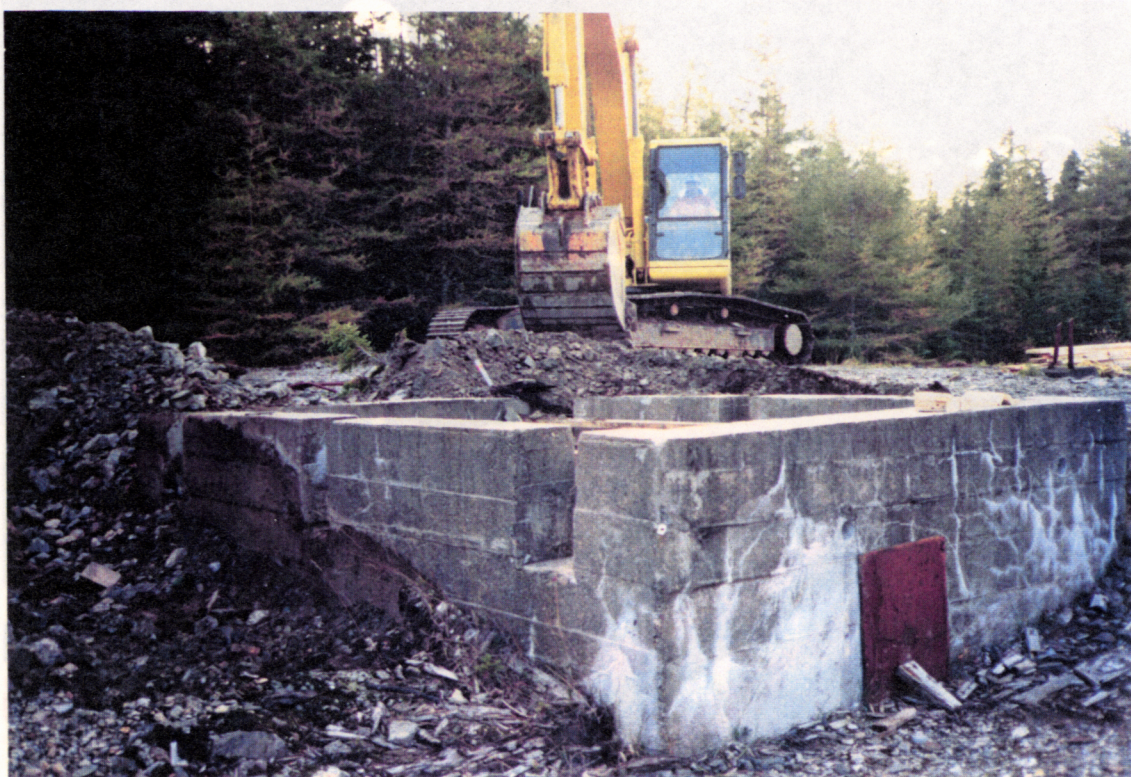
PHOTO NO. D-1: No. 1 Shaft collar showing shaft timber support notches.

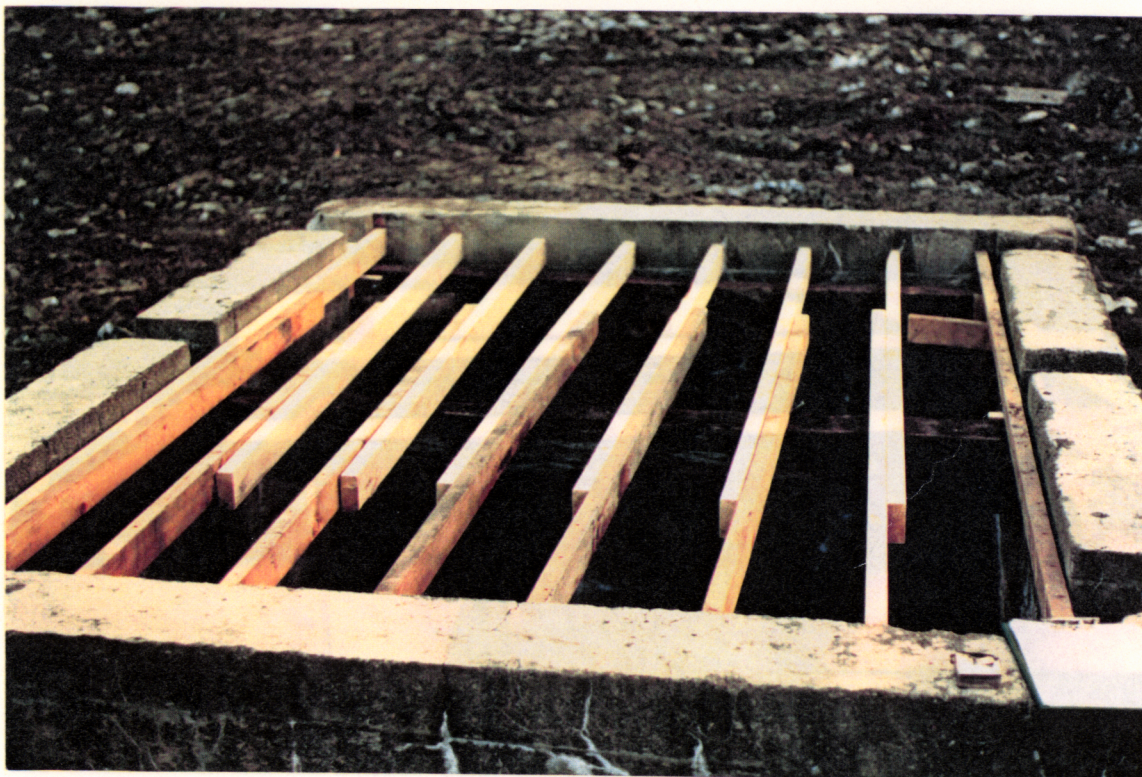
PHOTO NO. D-2: "Two by four" and railway tie timber support formwork for concrete cap.

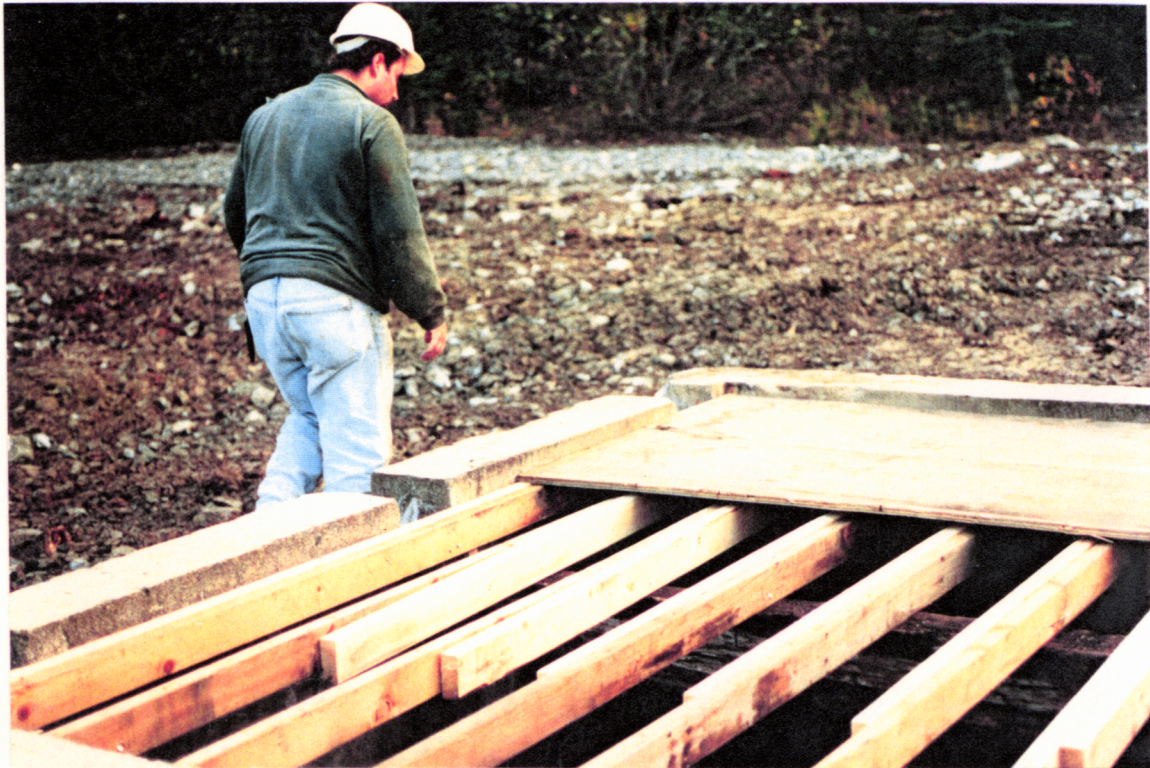
PHOTO NO. D-3: Positioning plywood cover on support formwork leaving 50 mm edge around concrete collar.

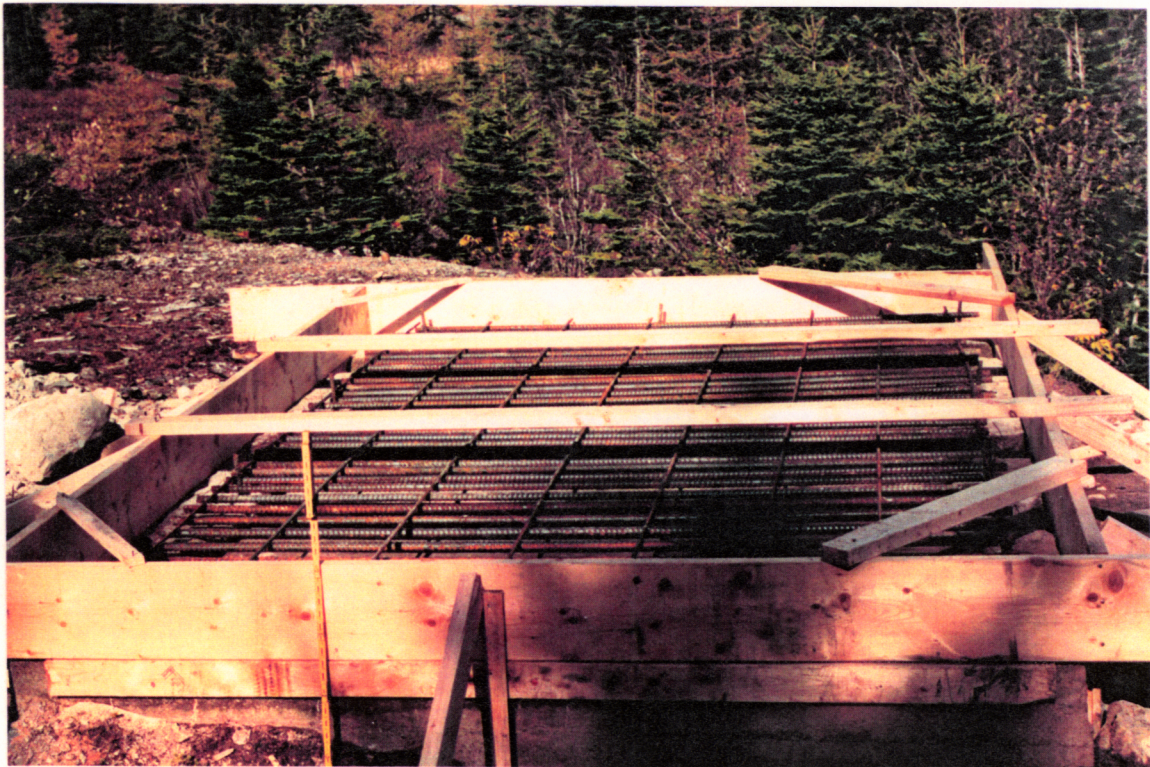
PHOTO NO. D-4: Completed concrete form with rebar reinforcement.

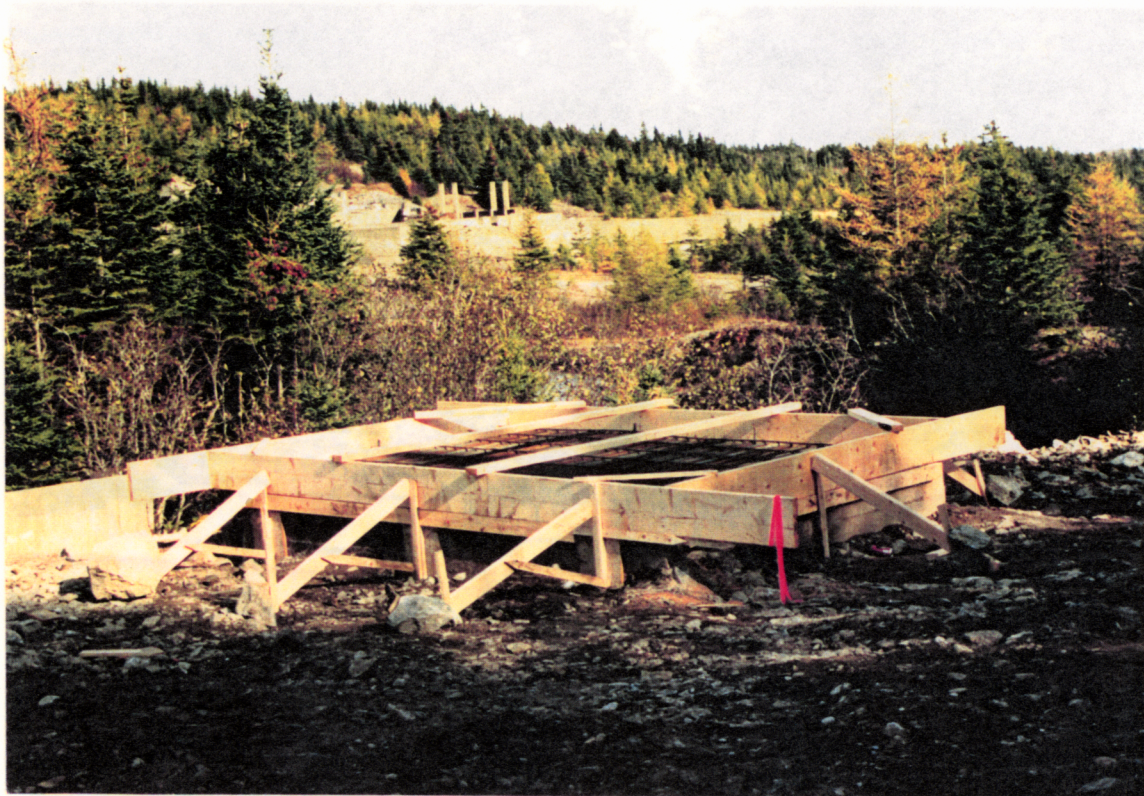
PHOTO NO. D-5: No. 1 Shaft formwork showing supports prior to delivery of concrete.

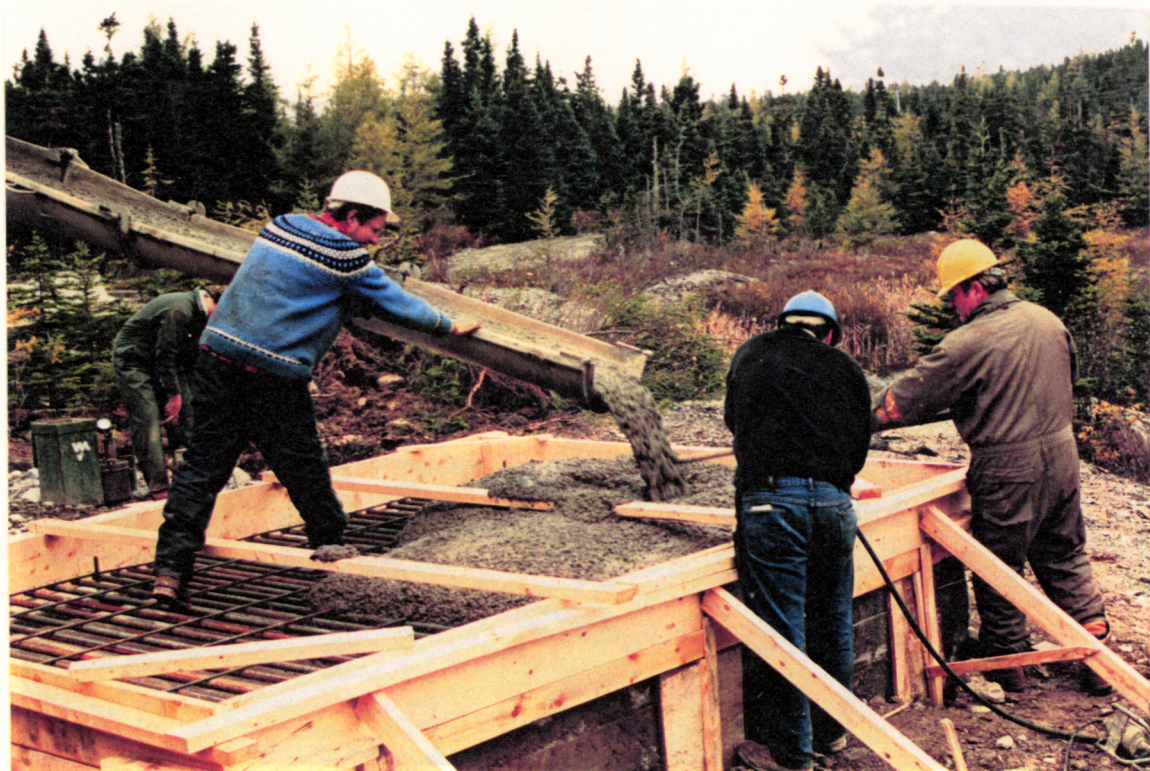
PHOTO NO. D-6: Casting concrete into form work over No. 1 Shaft.

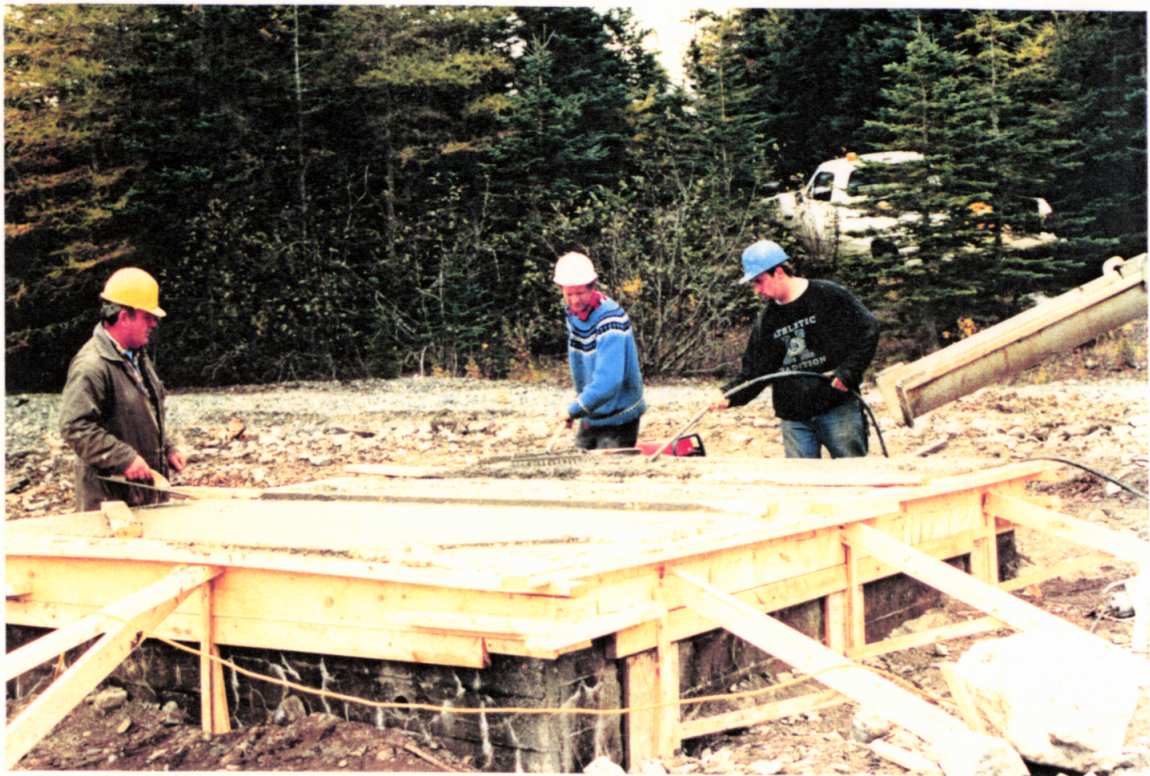
PHOTO NO. D-7: Finishing surface and vibrating concrete around rebar and forms.

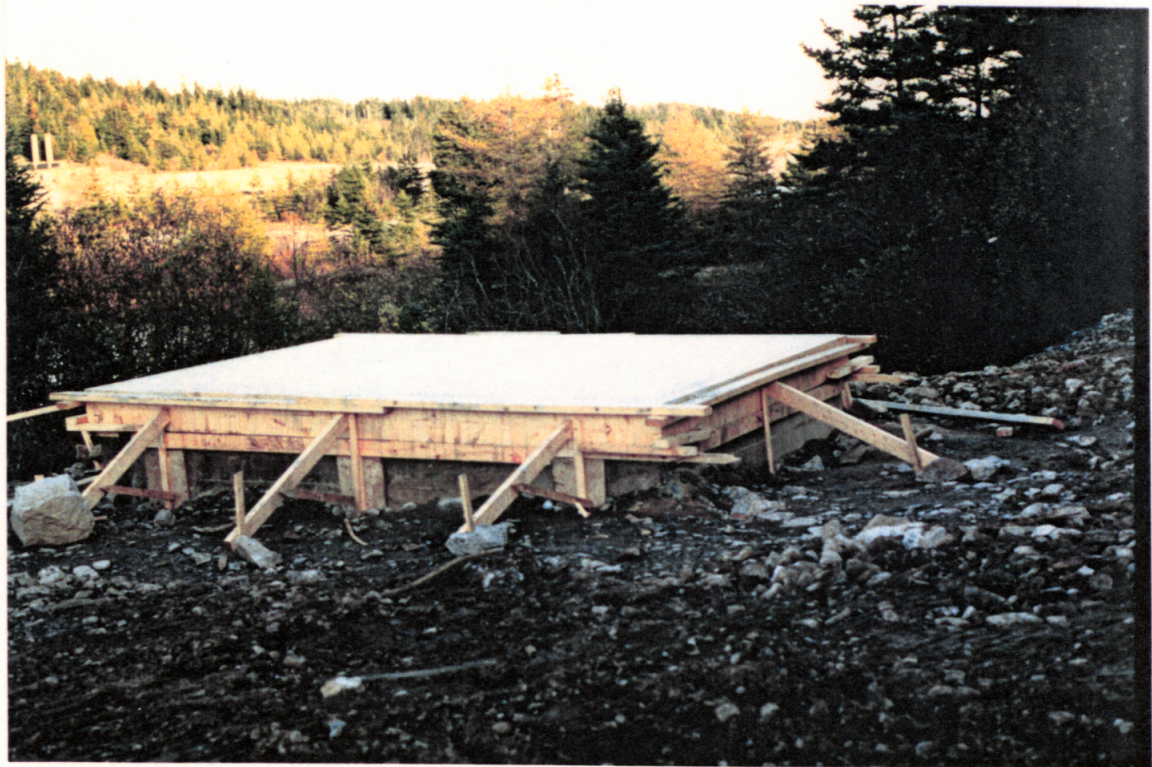
PHOTO NO. D-8: Concrete cast-in-place cap prior to removal of wooden forms.

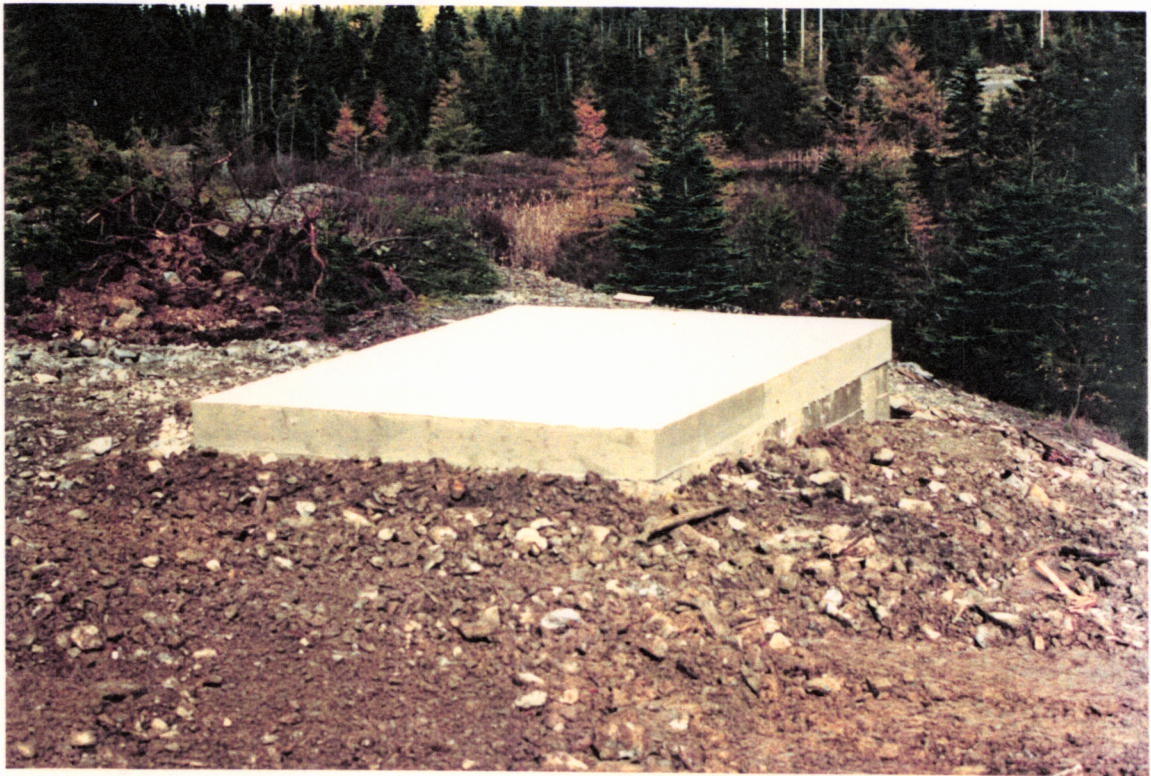
PHOTO NO. D-9: Completed cast-in-place concrete cap over No. 1 Shaft.
