## **APPENDIX F**

### **PHOTOGRAPHS - No. 1 RAISE**

**PROJECT NO. 10903**

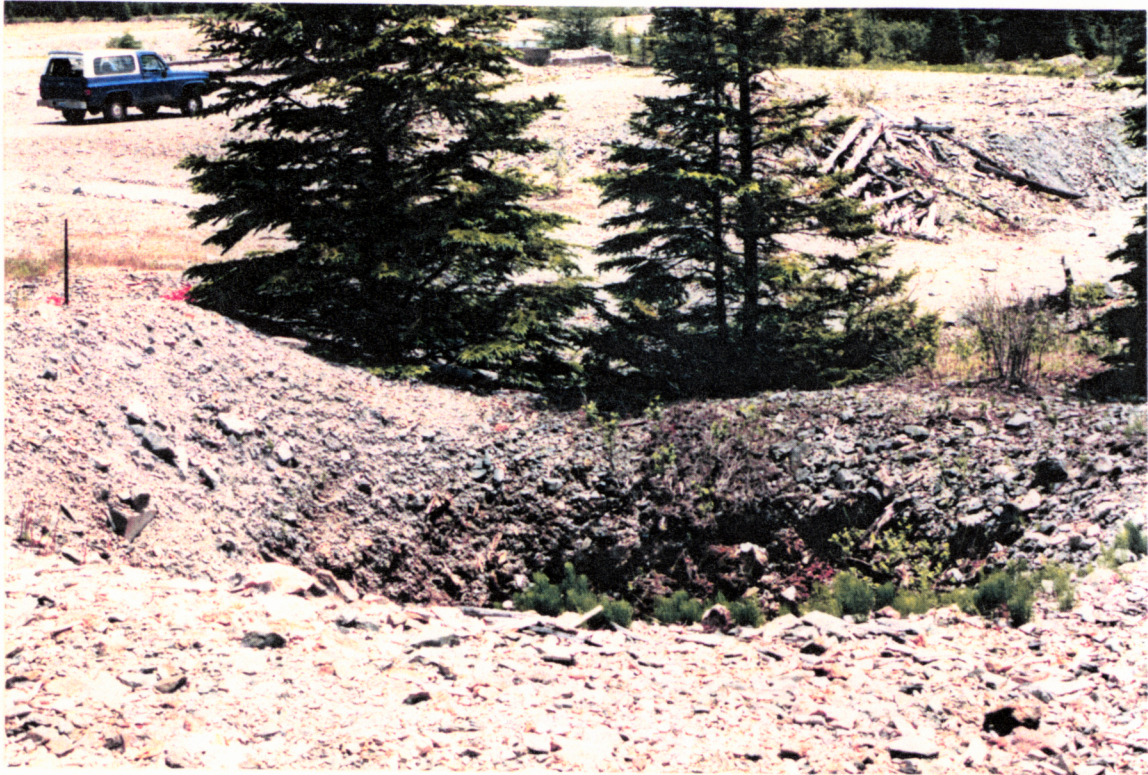
**PHOTO NO. F-1: View of subsidence feature associated with No. 1 Raise.**

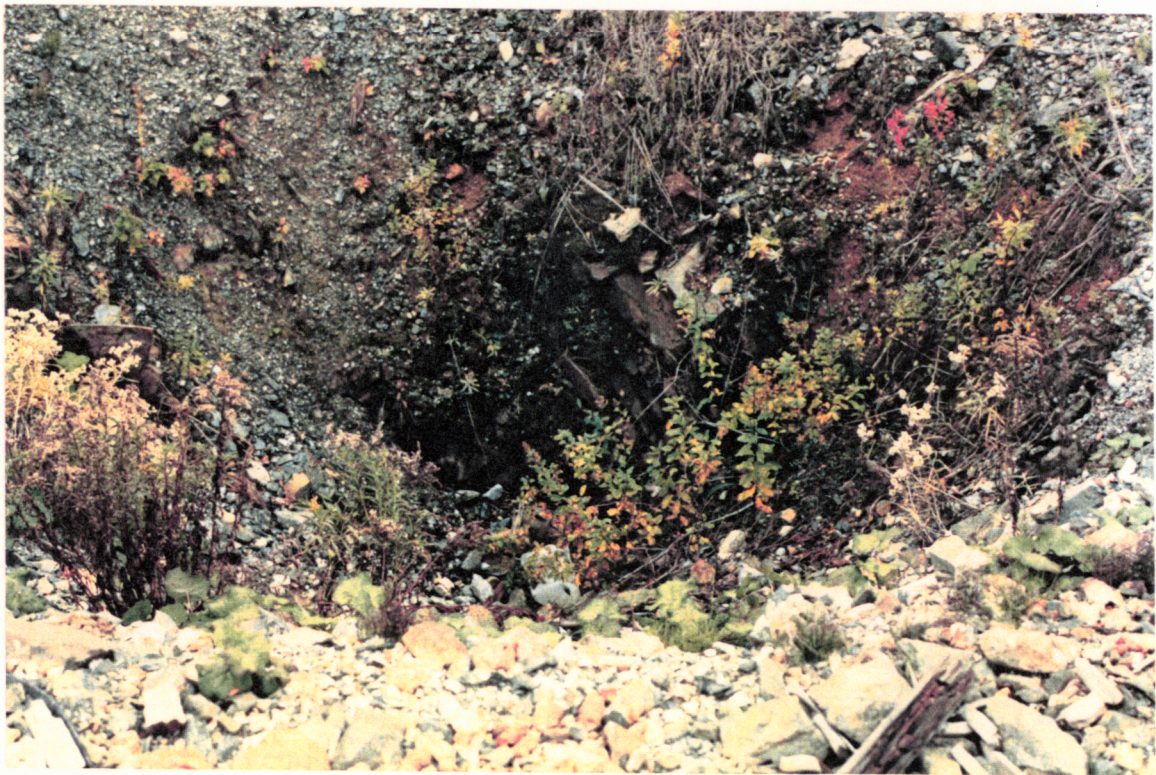
**PHOTO NO. F-2: Looking into No. 1 Raise subsidence feature showing timber debris and vegetation.**

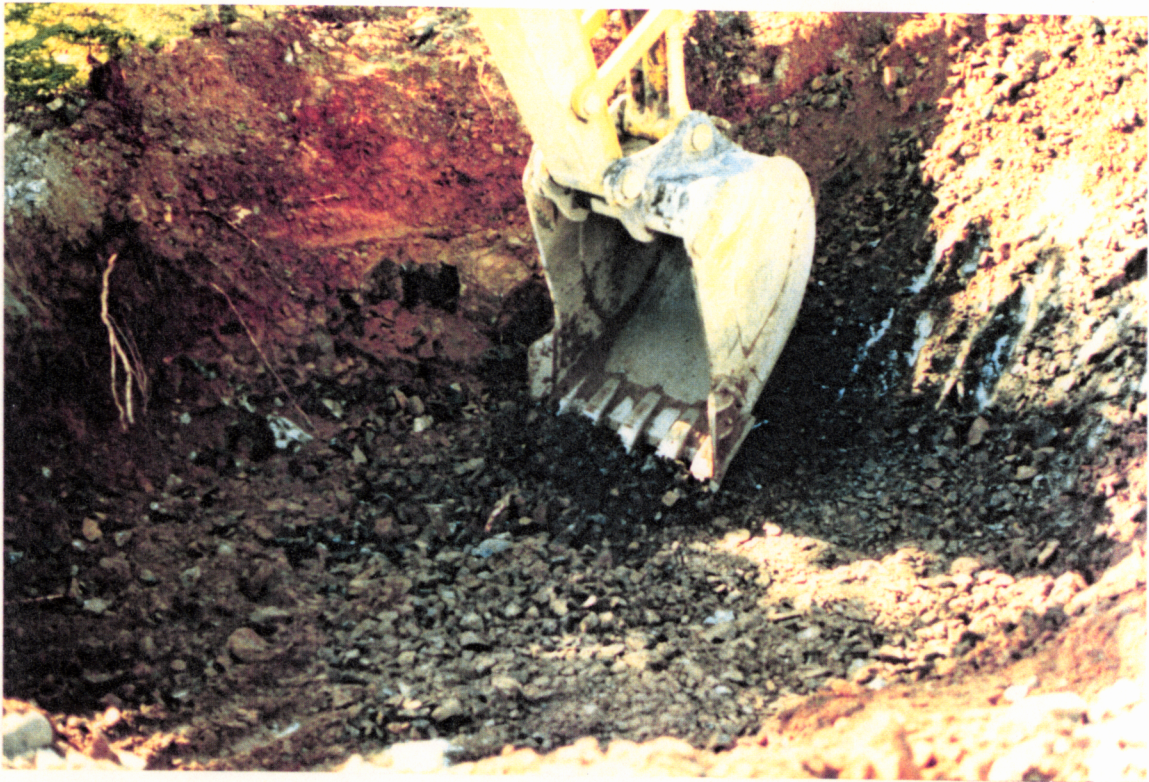
PHOTO NO. F-3: Grooming slopes and levelling base of No. 1 Raise subsidence feature.

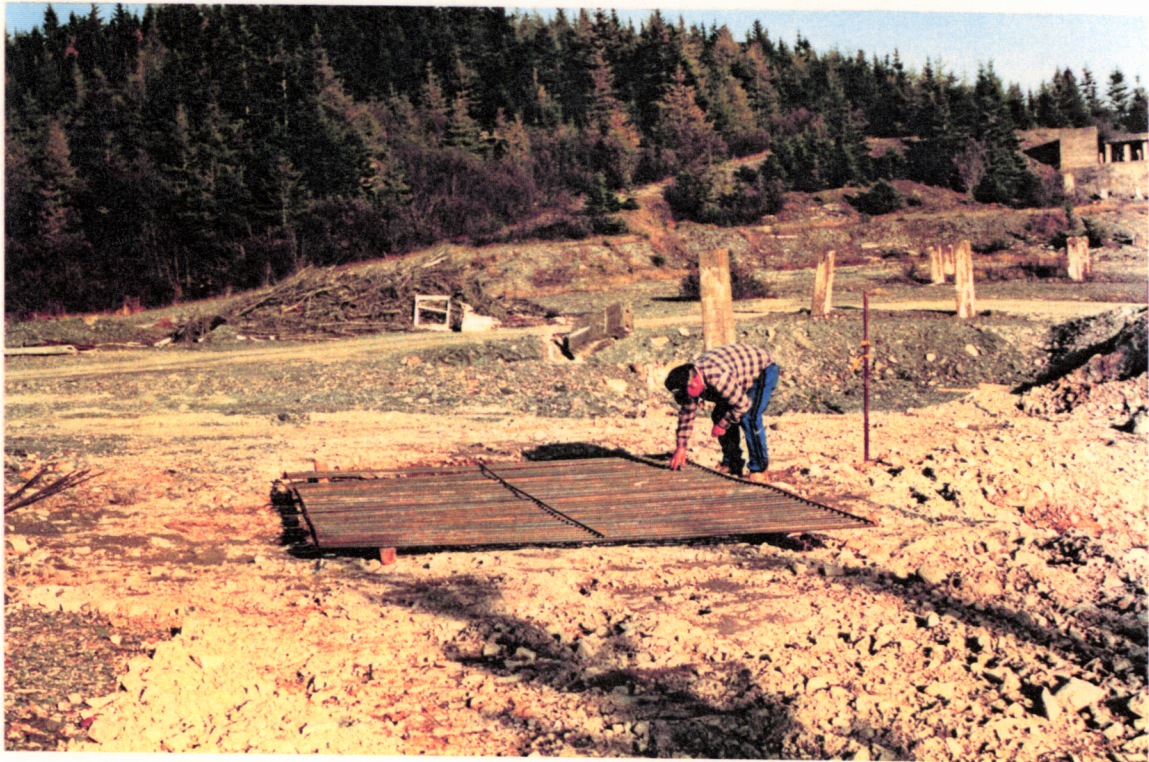
PHOTO NO. F-4: Assembling rebar mat for No. 1 Raise monolithic concrete slab.

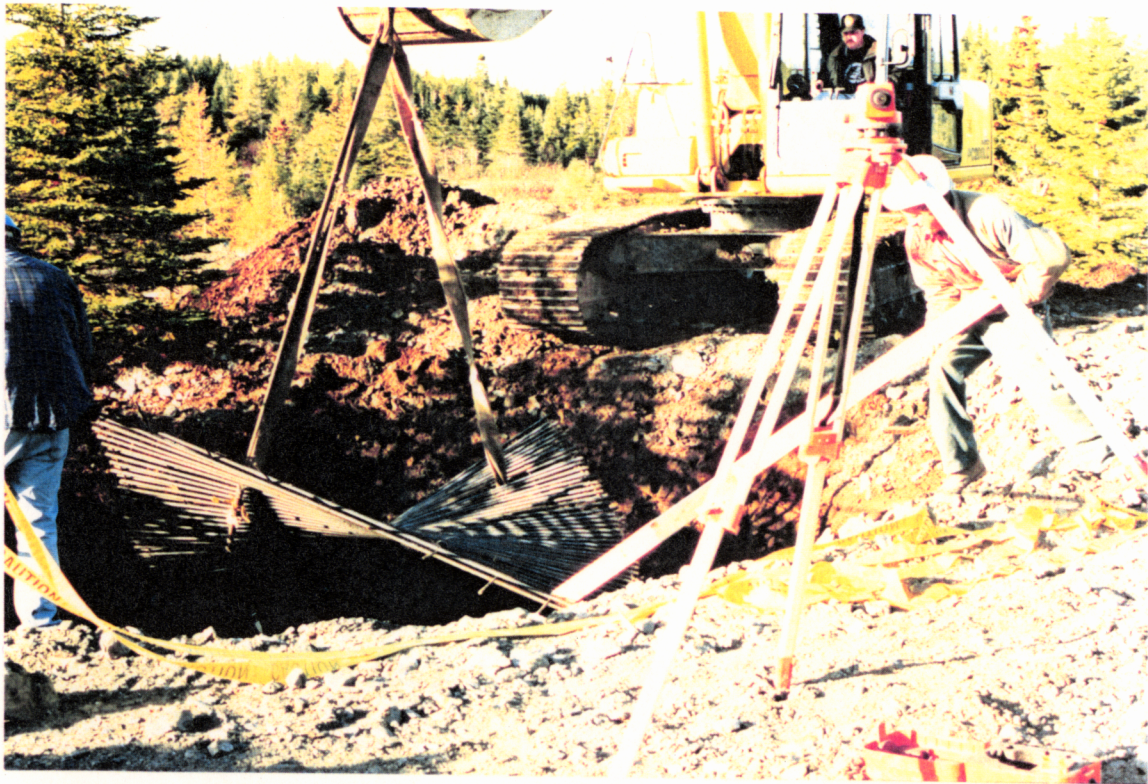
PHOTO NO. F-5: Lowering rebar reinforcing mat into No. 1 Raise excavation.

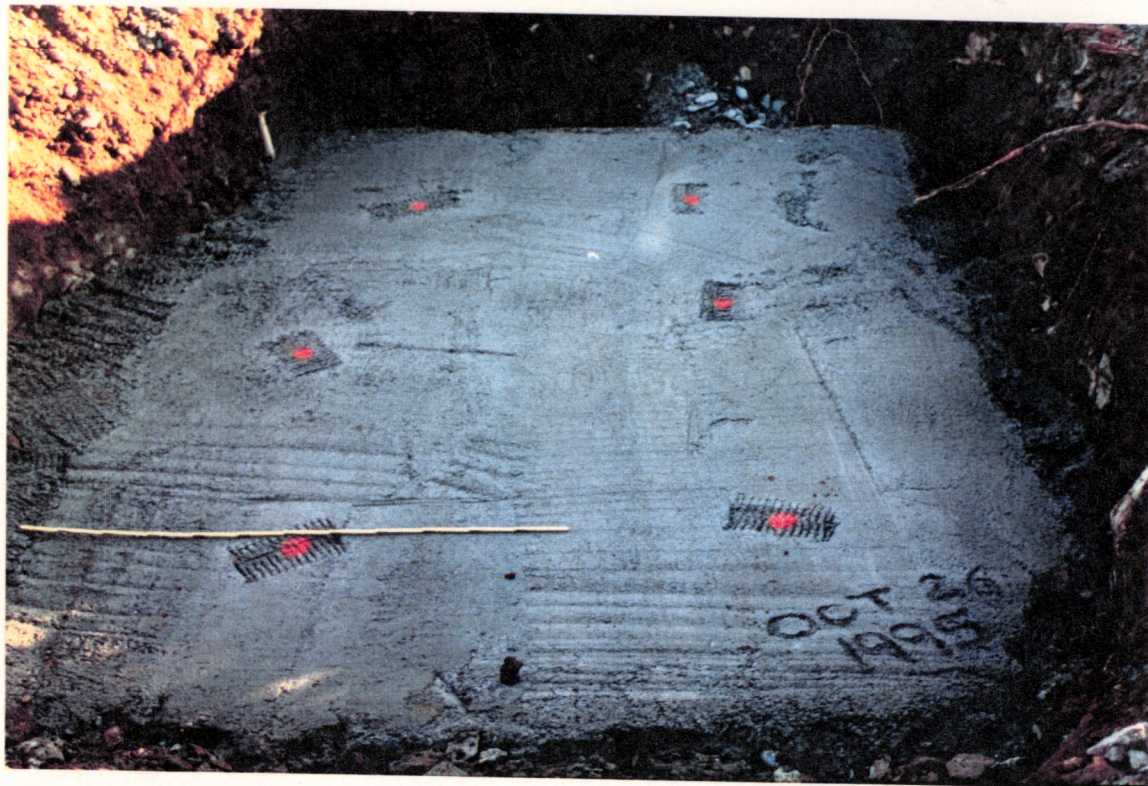
PHOTO NO. F-8: Completed concrete monolithic slab showing locations where thickness was measured.
