APPENDIX G

PHOTOGRAPHS - No.2 RAISE

PROJECT NO. 10903

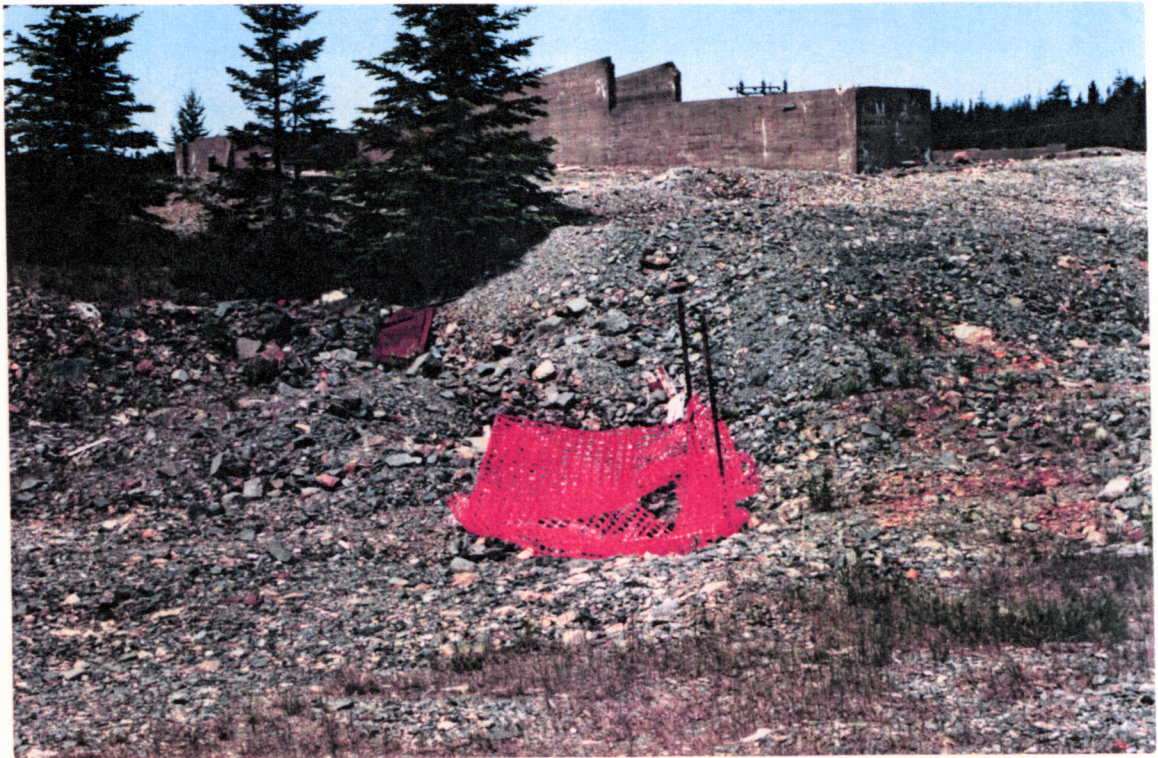
PHOTO NO. G-1: No. 2 Raise with protective barrier prior to closure.

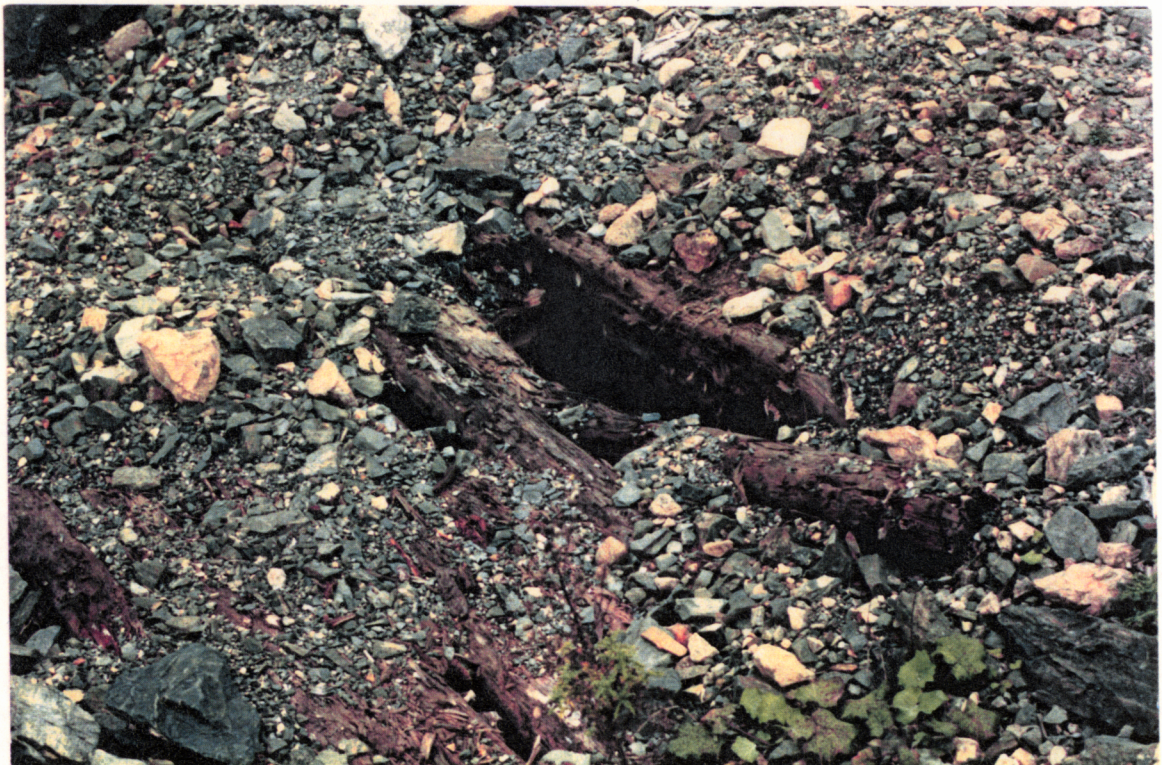
PHOTO NO. G-2: No. 2 Raise showing deteriorating timber cover.

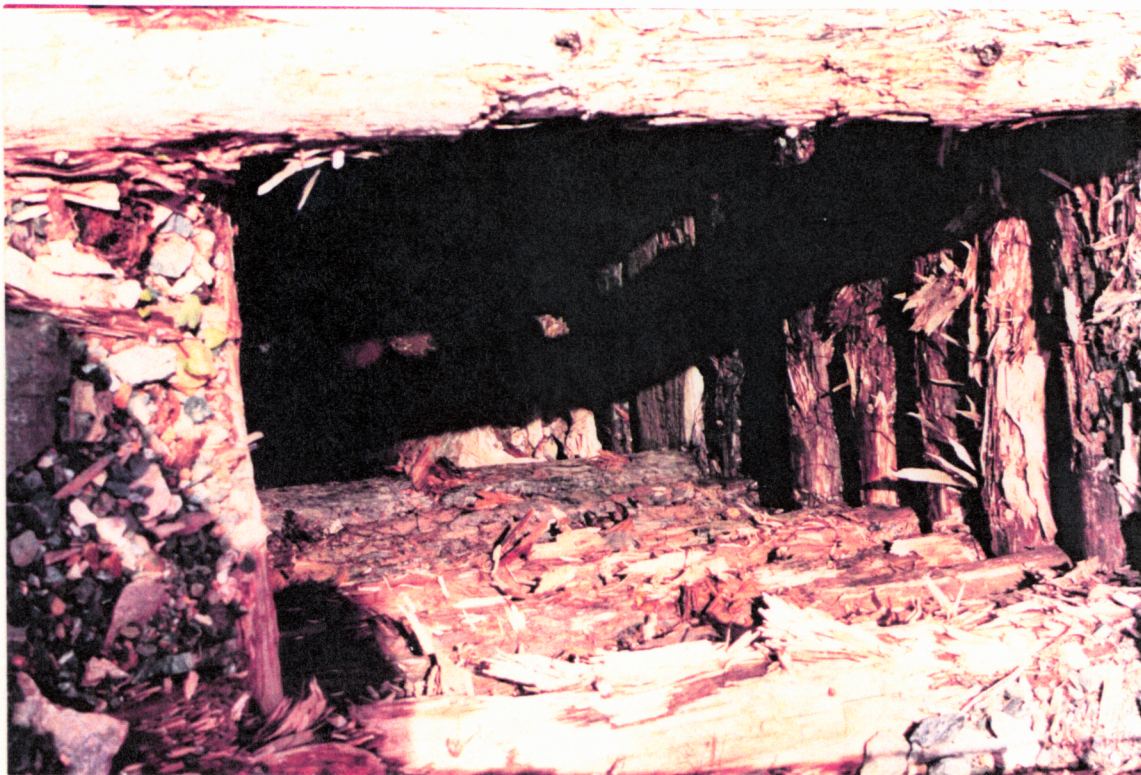
PHOTO NO. G-3: Timber lining in No. 2 Raise extending to bedrock.

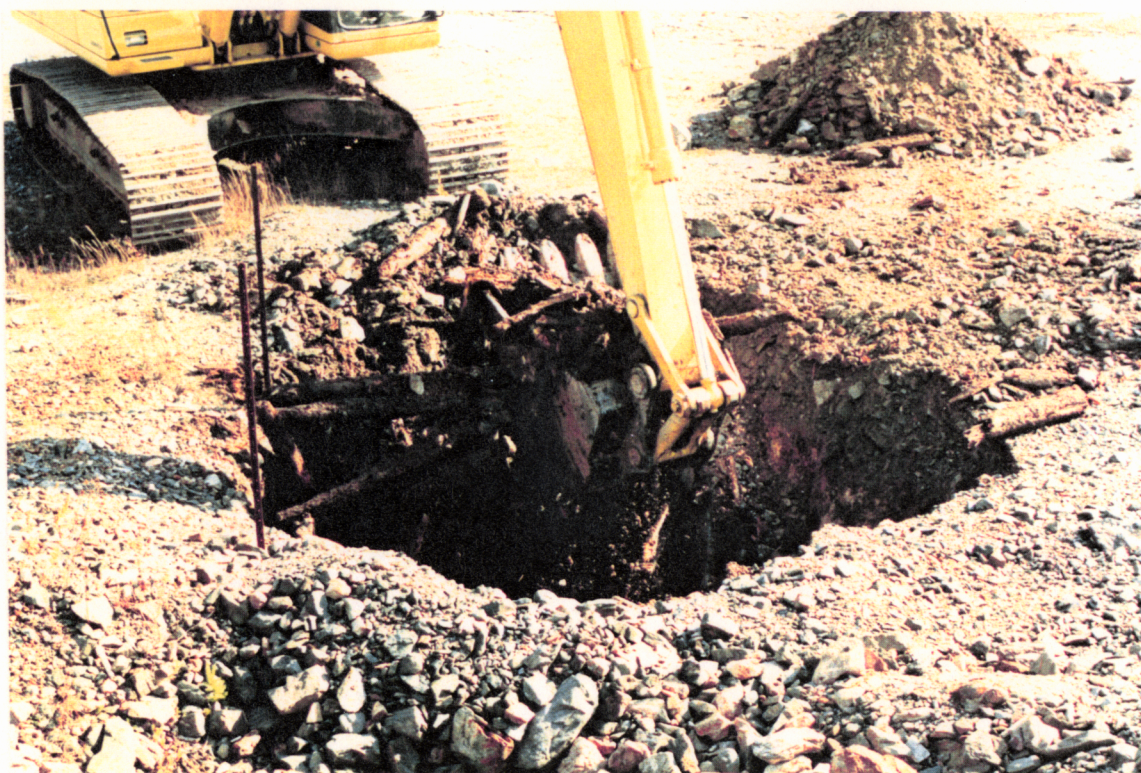
PHOTO NO. G-4: Excavating fill and timber lining around No. 2 Raise.

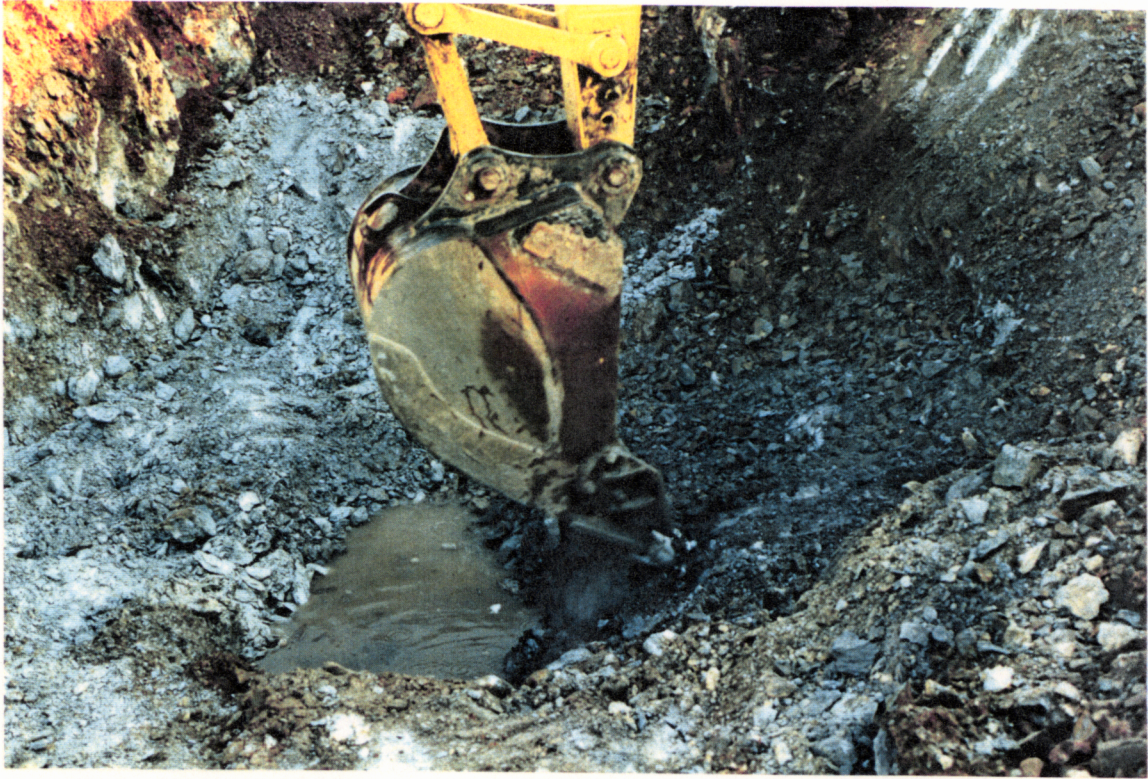
PHOTO NO. G-5: Removing loose and weathered bedrock around perimeter of No. 2 Raise.

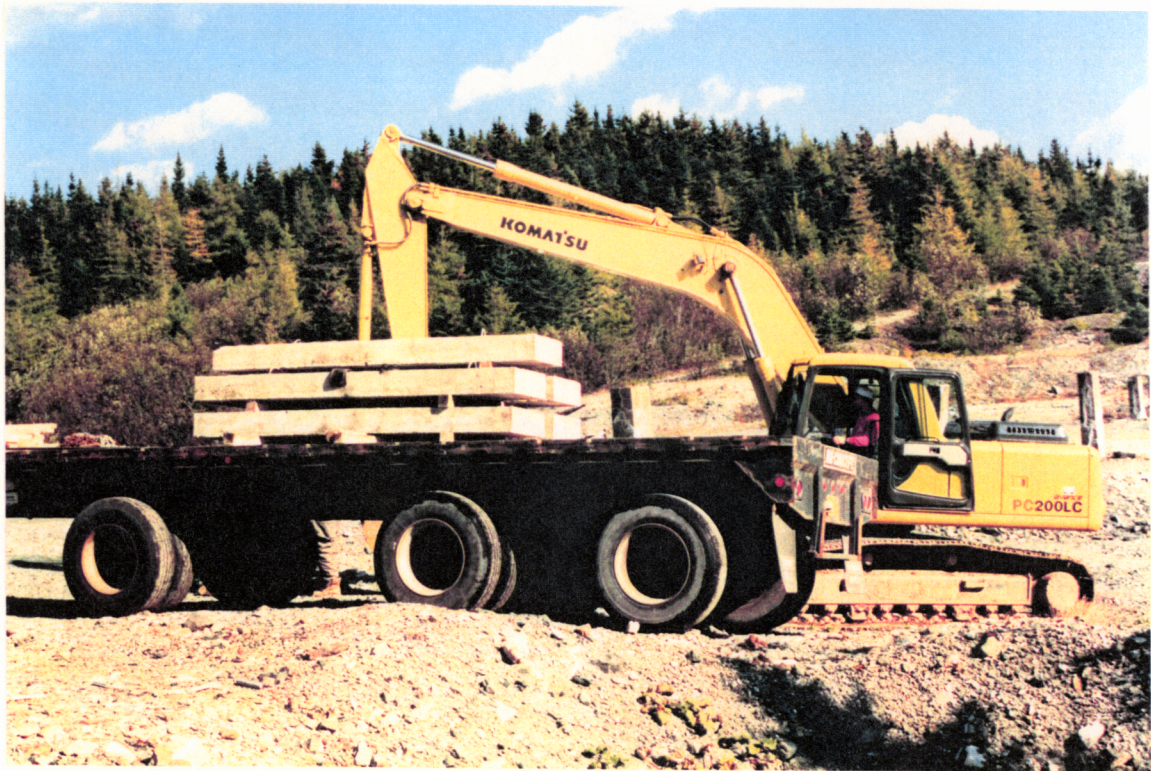
PHOTO NO. G-6: Preparing to unload precast concrete panels from flatbed.

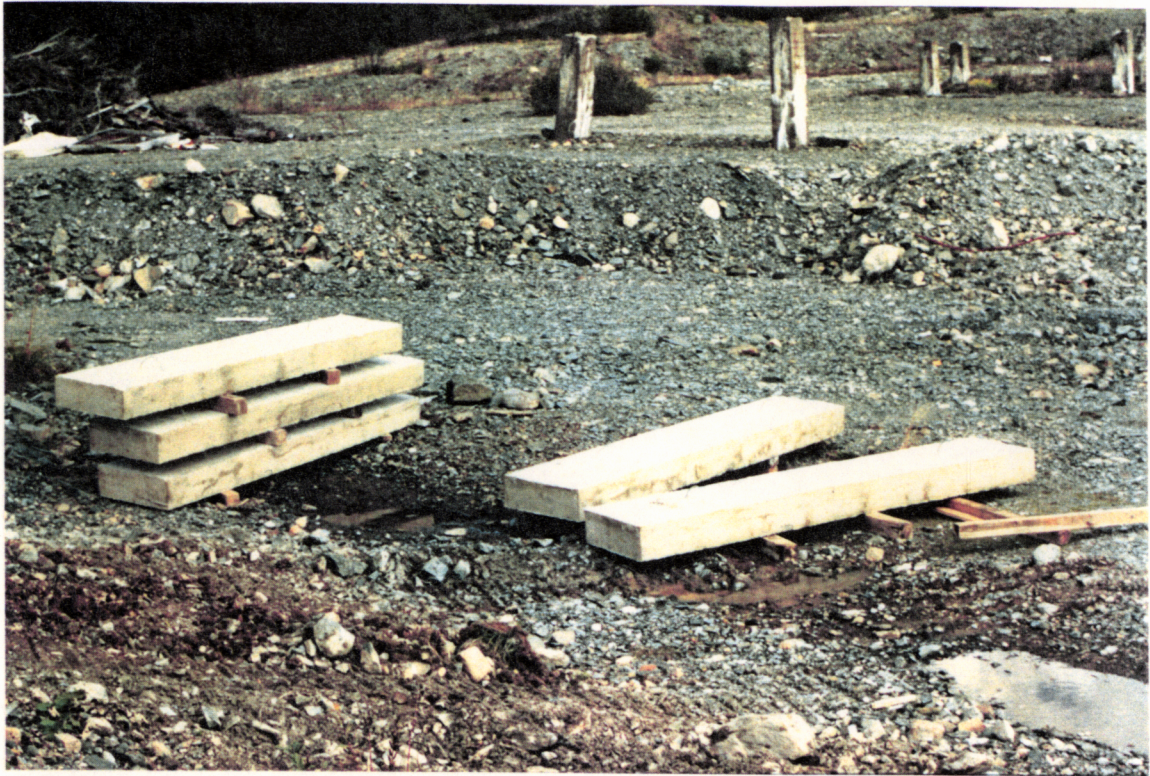
PHOTO NO. G-7: Precast panels awaiting installation with cracked panels on right.

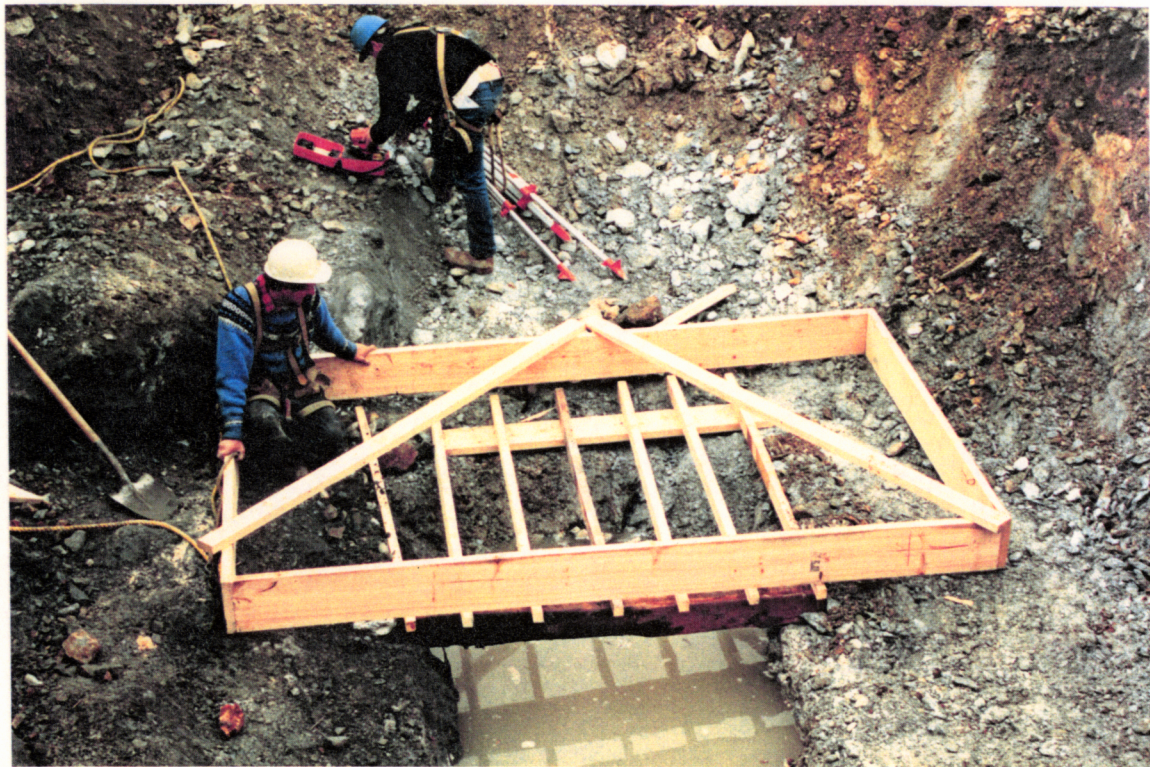
PHOTO NO. G-8: Installing formwork for concrete cast-in-place cap over south half of No. 2 Raise.

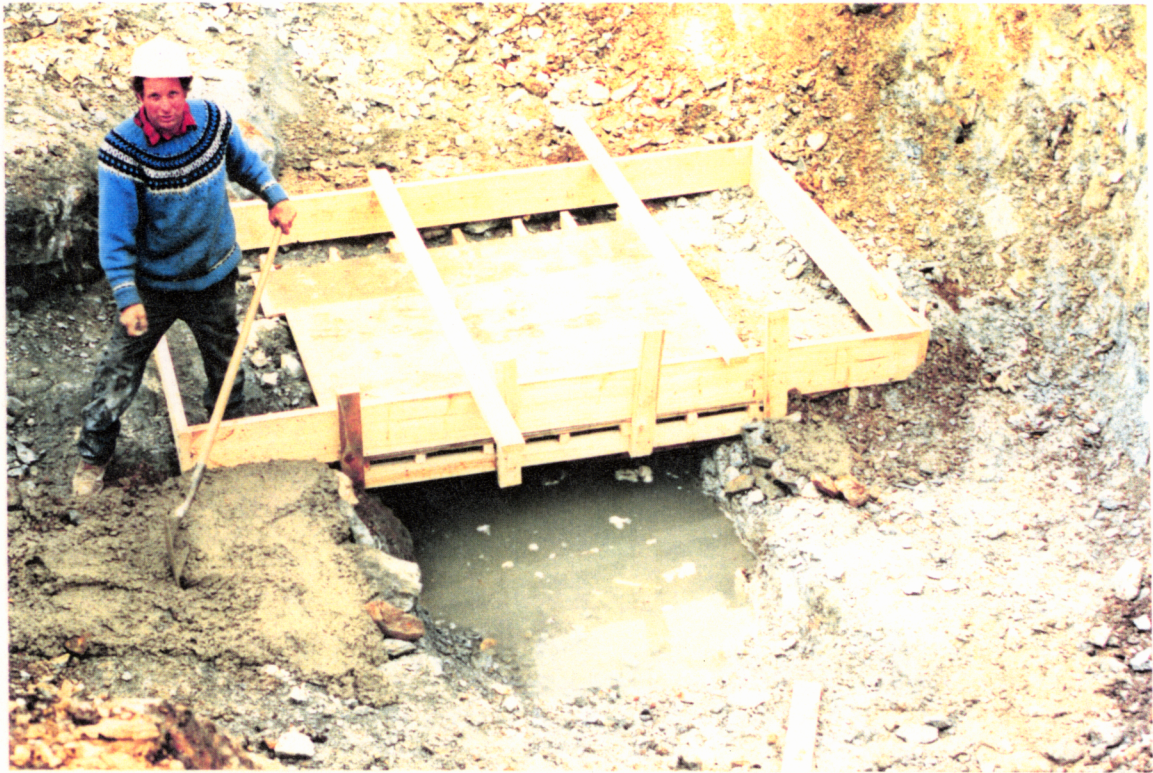
PHOTO NO. G-9: Completed formwork for cast-in-place concrete cap and spreading concrete levelling course for pre-cast panels.

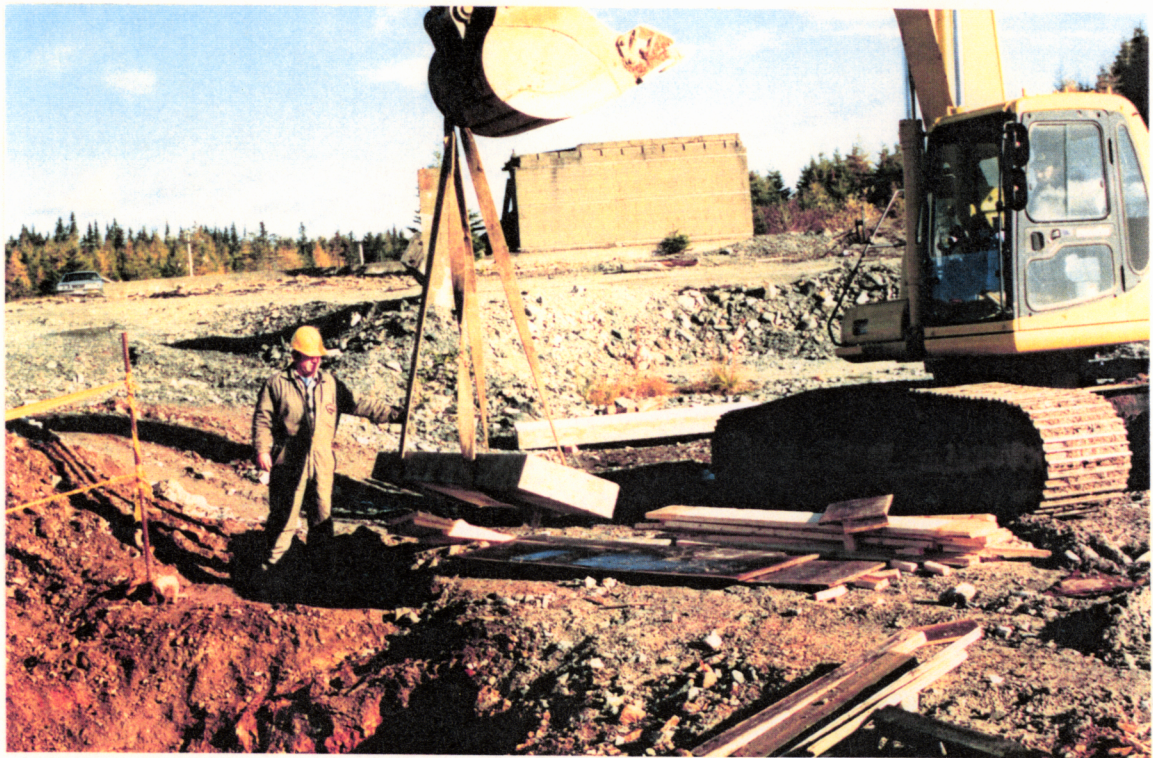
PHOTO NO. G-10: Lowering pre-cast panel into No. 2 Raise excavation.

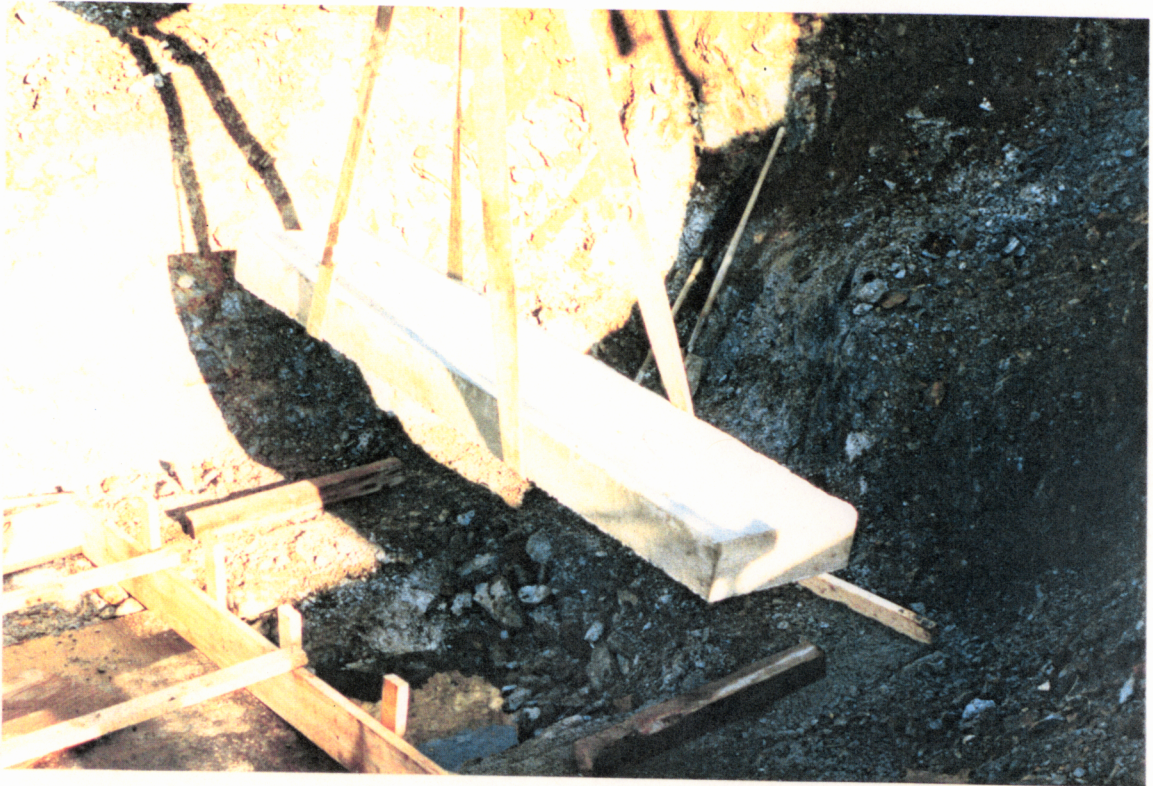
PHOTO NO. G-11: Lowering pre-cast panel onto support timbers prior to final positioning.

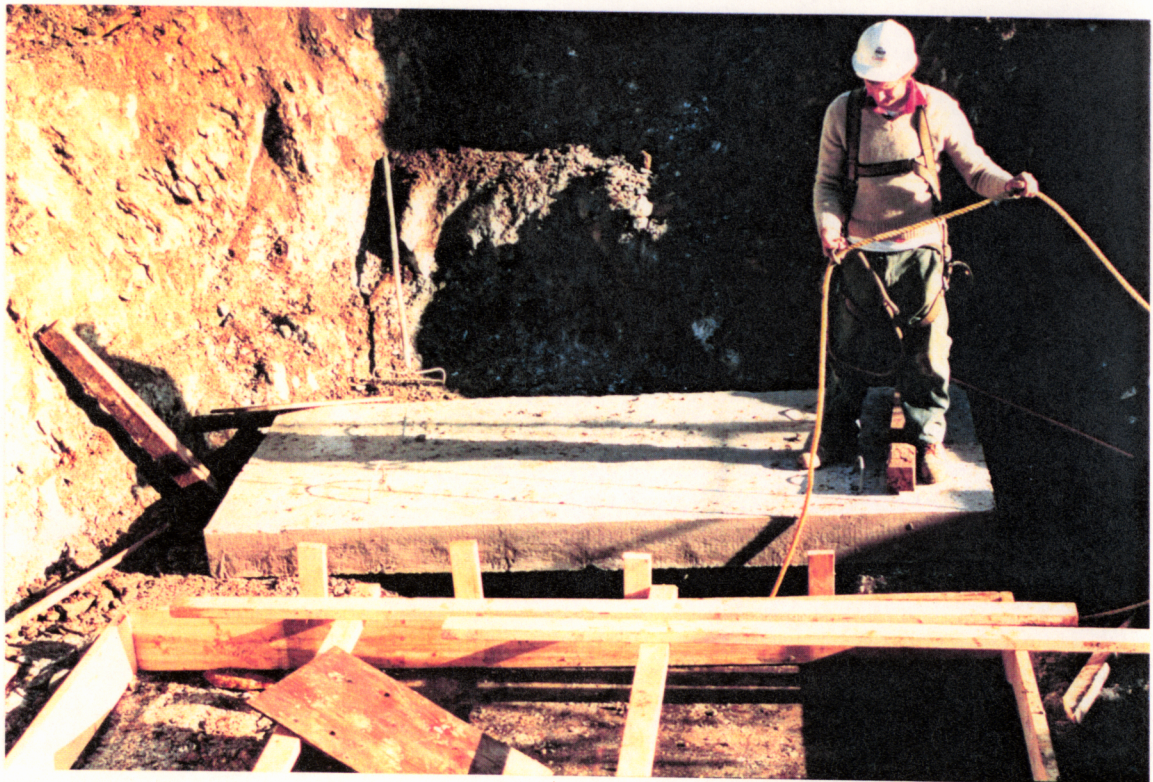
PHOTO NO. G-12: Two pre-cast panels in final location over north half of No. 2 Raise.

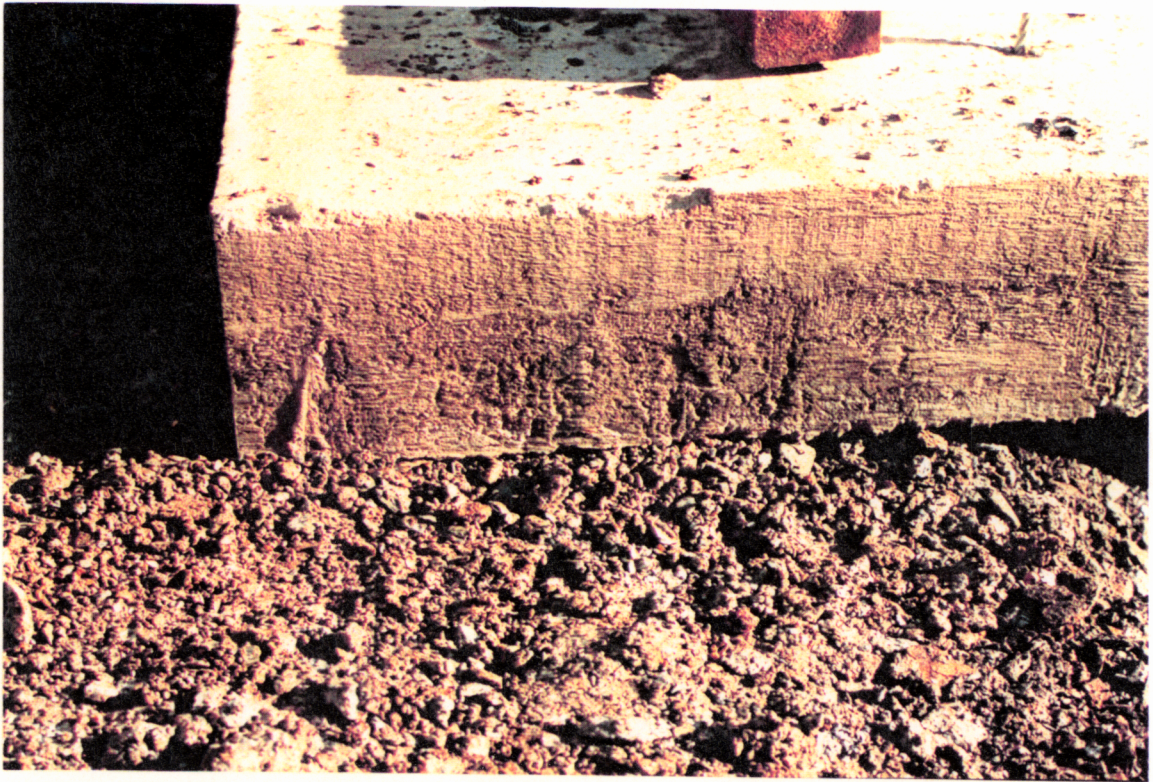
PHOTO NO. G-13: Close-up of fine rock fill levelling course under pre-cast panel.

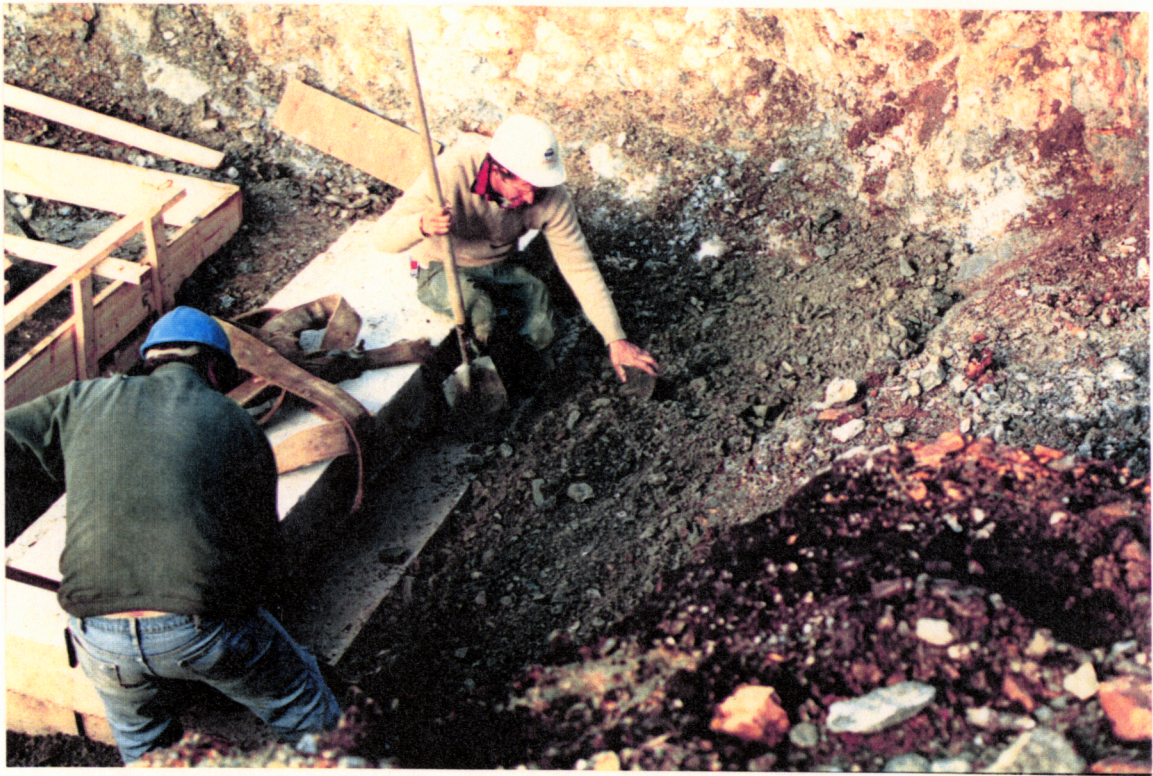
PHOTO NO. G-14: Placing well graded rock fill around pre-cast panels.

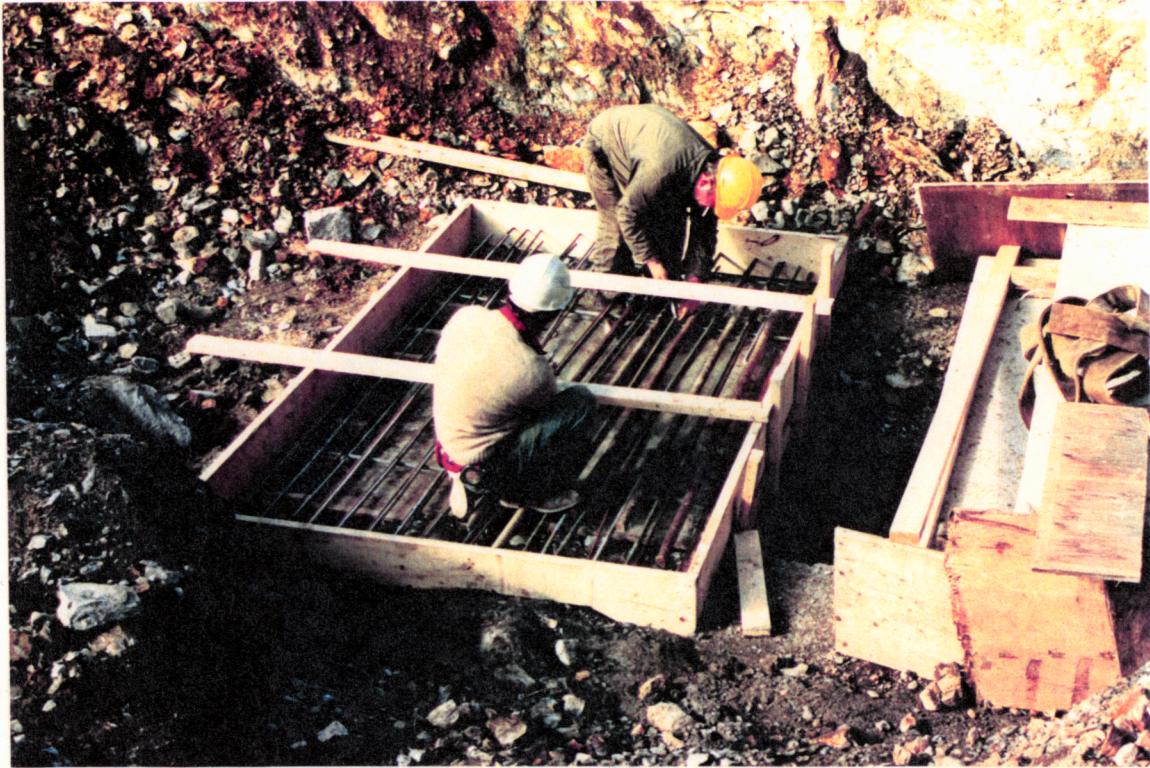
PHOTO NO. G-15: Positioning and tying rebar reinforcement in formwork of cast-in-place concrete cap.

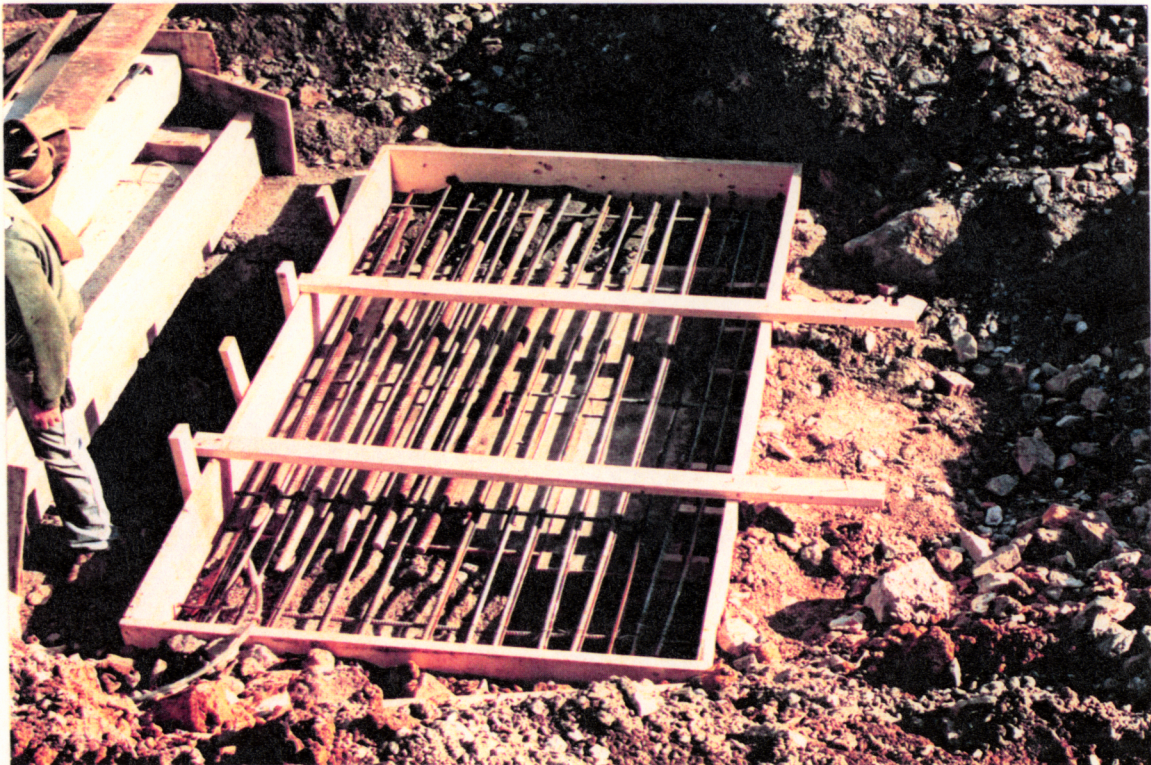
PHOTO NO. G-16: Completed rebar reinforcement prior to delivery of concrete.

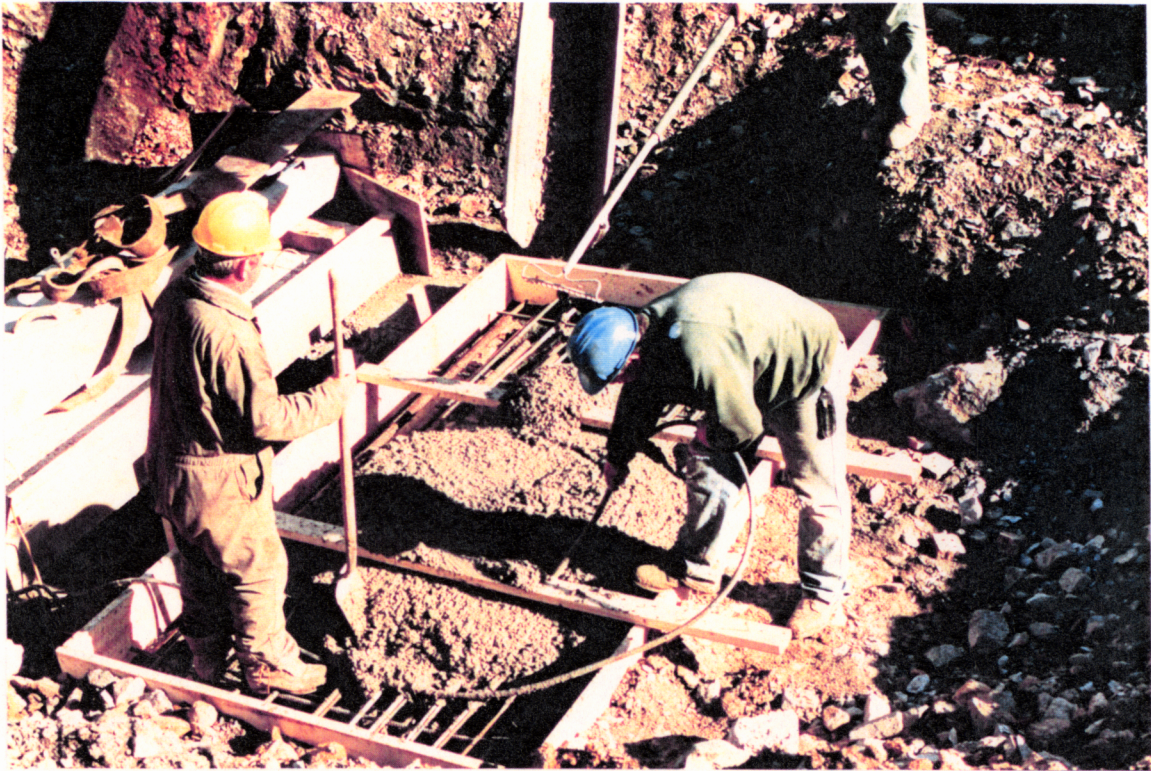
PHOTO NO. G-17: Vibrating concrete under and around rebar reinforcing rods.

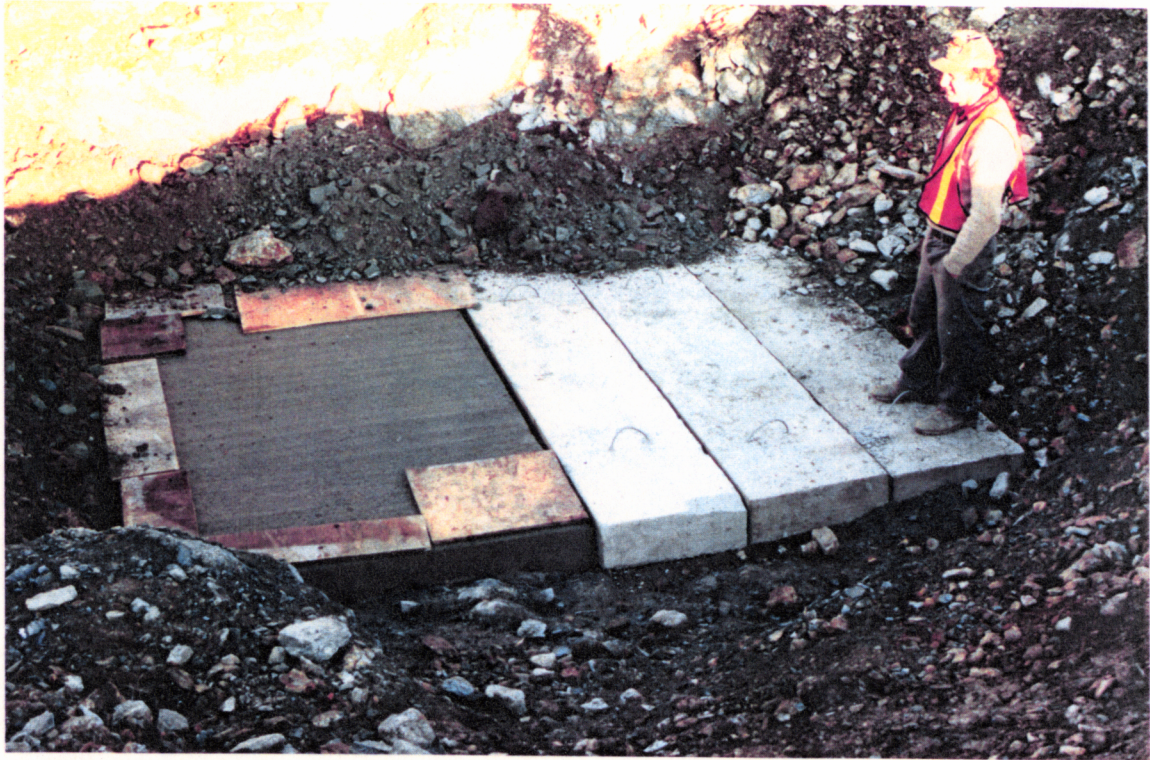
PHOTO NO. G-19: Completed cap with third pre-cast panel in position.

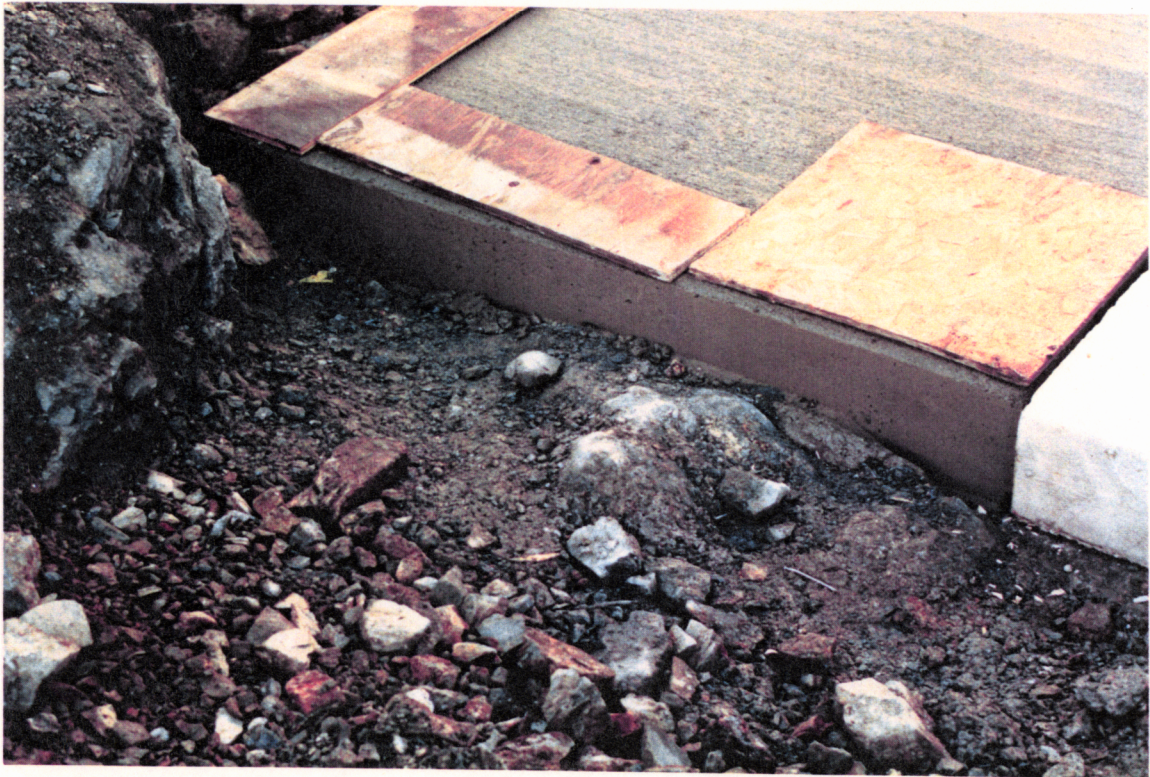
PHOTO NO. G-20: Close-up of cast-in-place concrete cap positioned on bedrock.

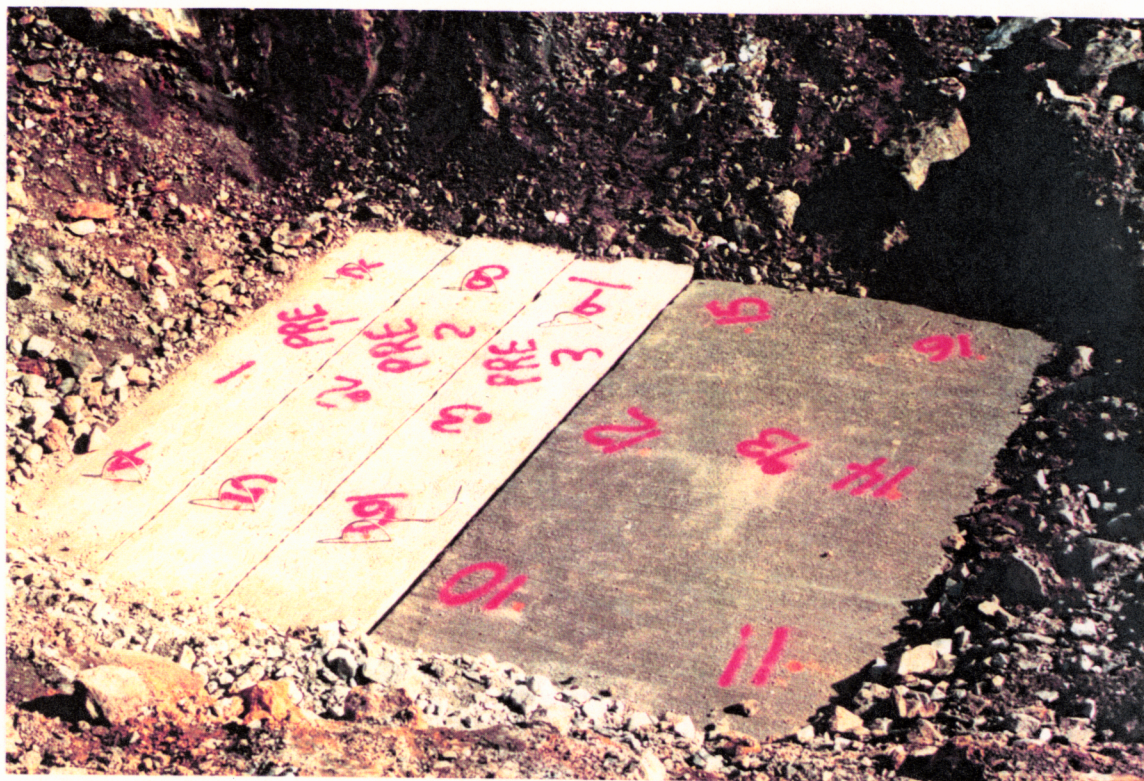
PHOTO NO. G-21: Completed pre-cast and cast-in-place concrete closure cap over No. 2 Raise with survey locations painted on concrete.
