HAZARDS

Unsecured Mine Openings

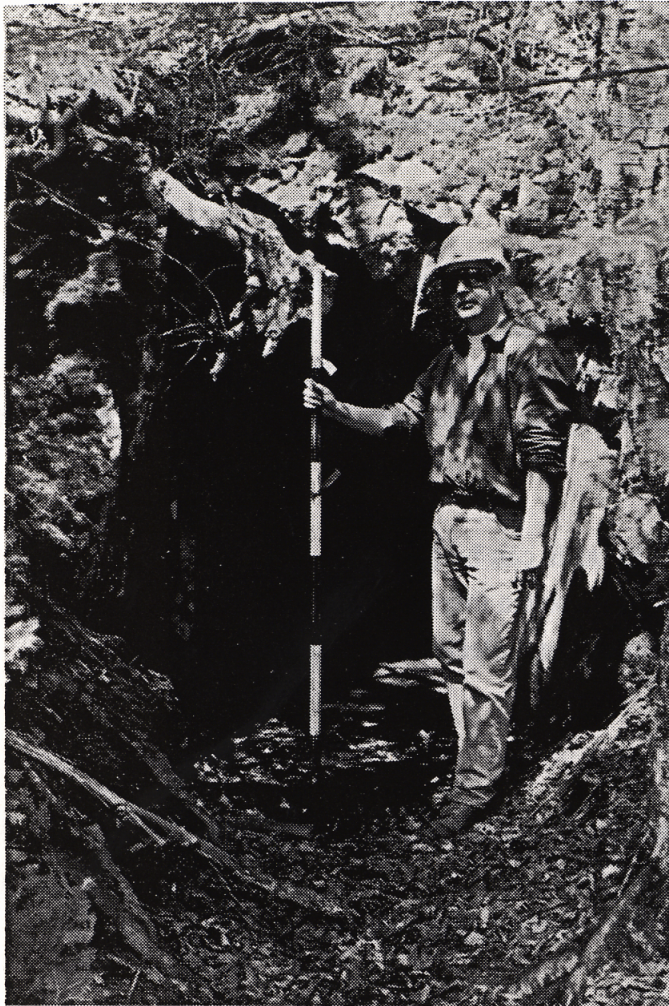
Figure 4: Adit into side of hill showing weakened and fractured rock around entrance of the opening.

Typical examples of unsecured, abandoned mine openings common to Nova Scotia are shown on Figures 4 through 7.

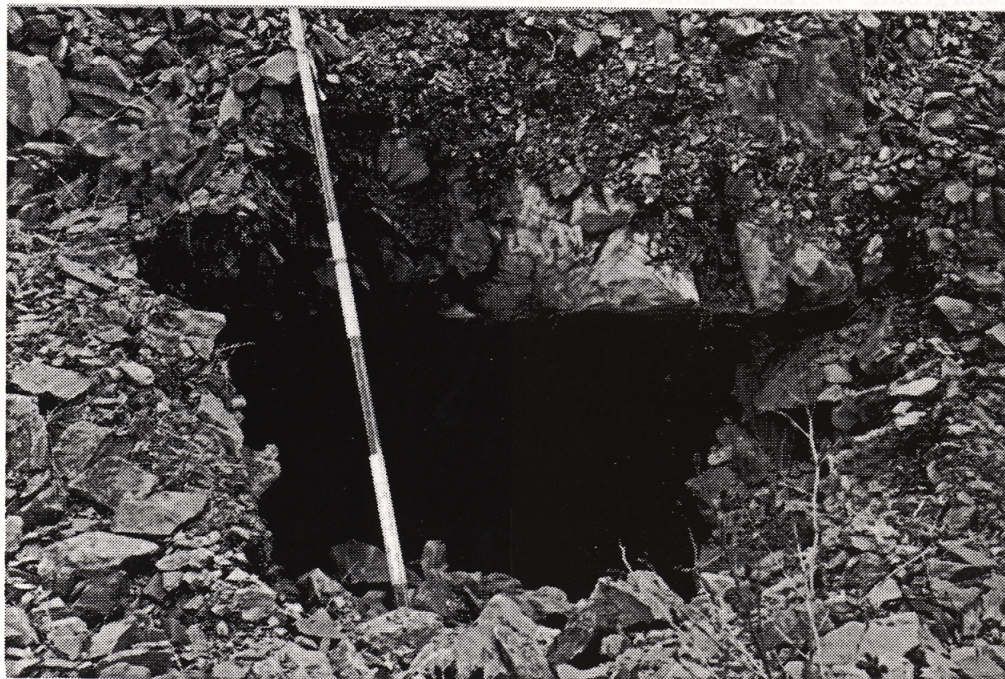
Figure 5: A mine stope extending through to surface with weak, fractured rock around the perimeter of the opening.

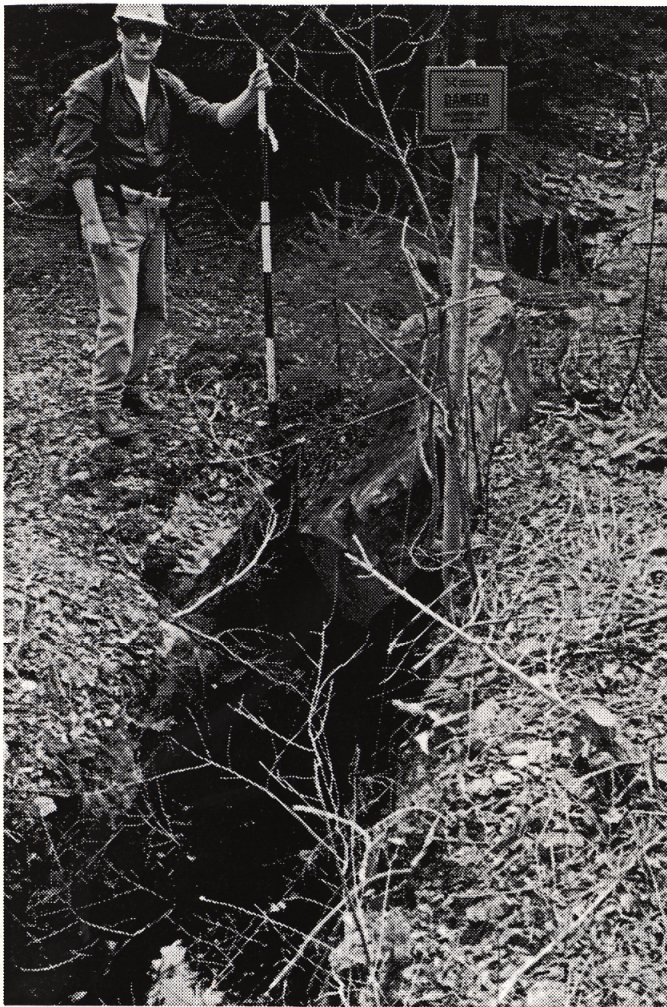
Figure 6: A water filled stope along a gold vein which has partially caved through to surface.

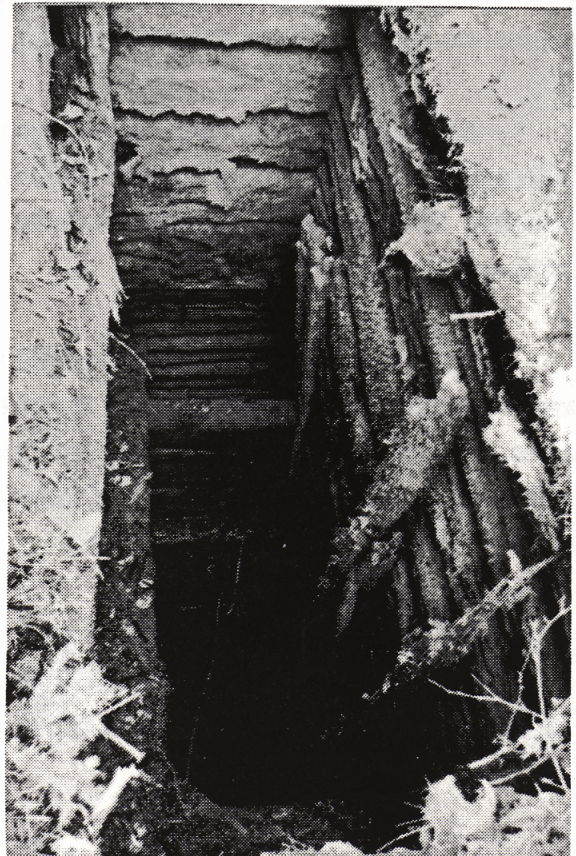
Figure 7: Vertical shaft which is open at surface showing deteriorating and rotting timber.

- Supports and roof spans weaken and deteriorate, and can fall without warning.
- The rock around vertical mine openings can fracture and become unstable.
- Timber supports and covers around and over shafts deteriorate and weaken.
- Underground workings mined close to surface can cave and collapse.

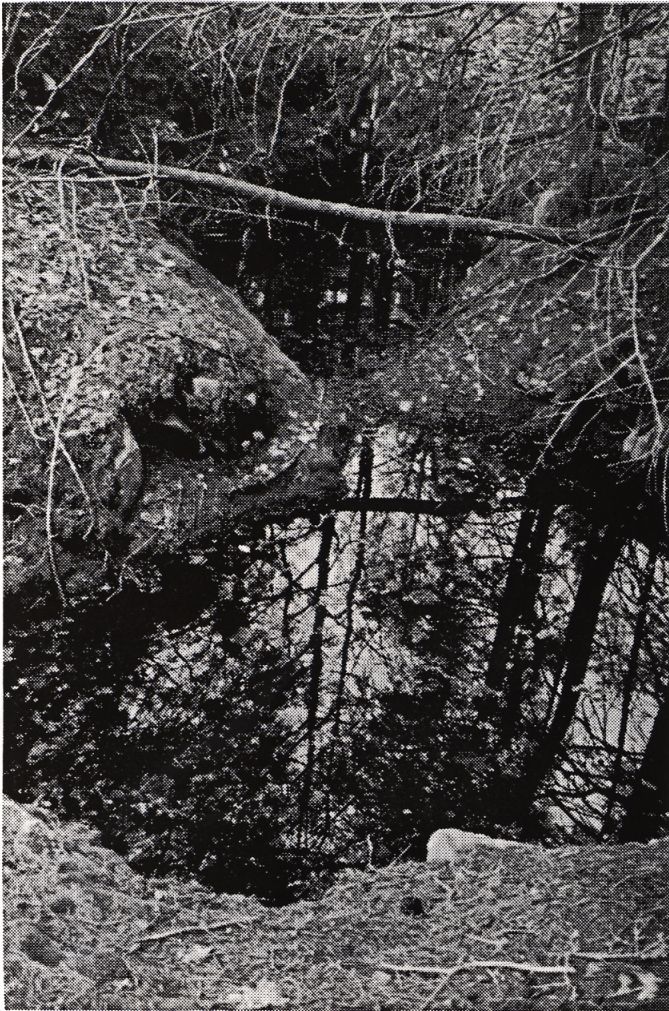
Figure 8: Water filled subsidence features

Subsidence and caving can occur when underground openings collapse. These features are particularly common in areas of shallow mine workings. Failure can be rapid or slow, and can be represented at surface as either an opening or a depression. Figure 8 shows the depth of a caving feature being measured by Nova Scotia Department of Natural Resources staff. A typical subsidence feature, common to Nova Scotia is shown on Figure 9.

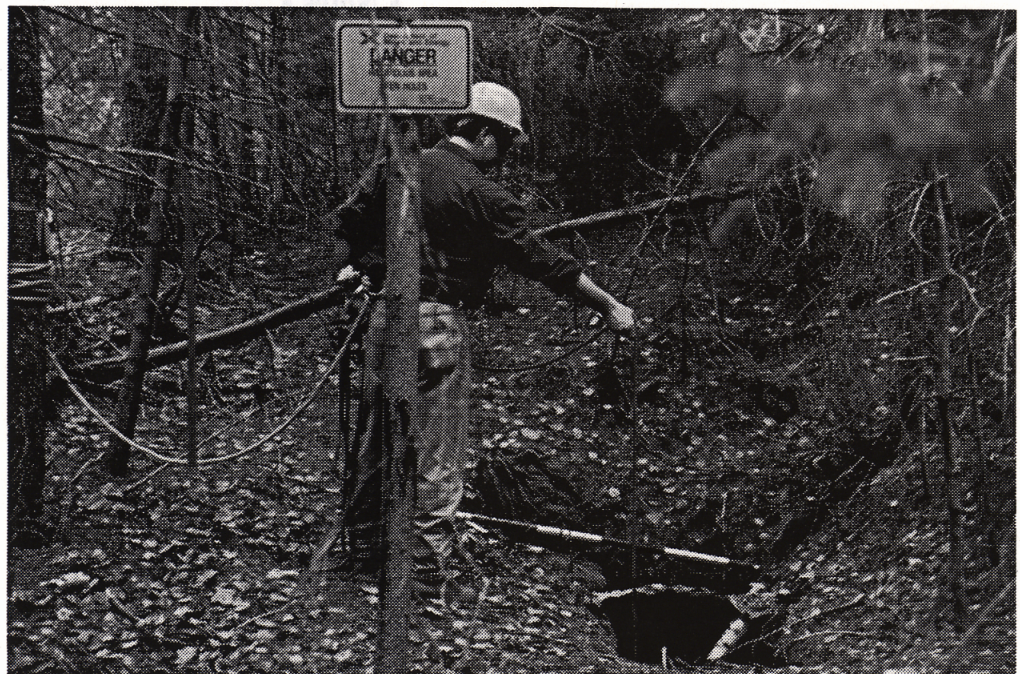
Figure 9: Nova Scotia Department of Natural Resources staff measuring depth of a caving feature.

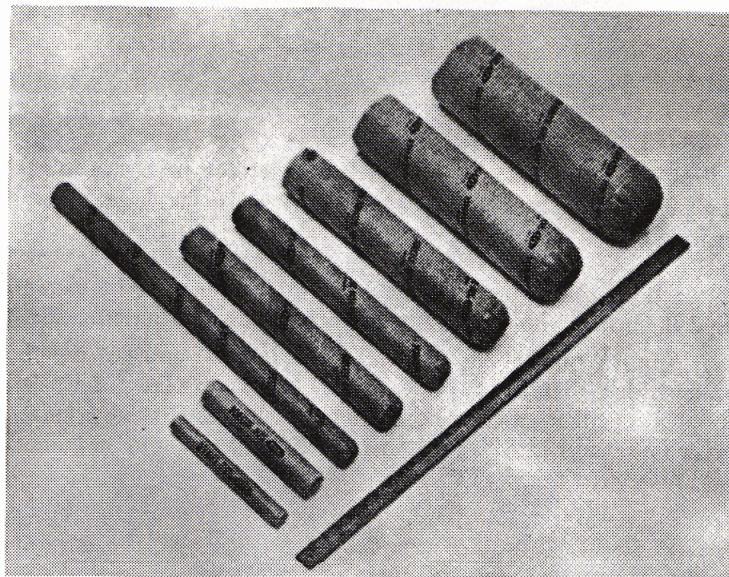
Various sizes of dynamite and cardboard
box packaging
Figure 10

Dynamite is manufactured in round sticks approximately 200 mm long and 25 mm in diameter, and is composed of nitroglycerin and an inert filler wrapped in a paper roll. Initially packaged in wooden cases, more recently cardboard boxes have been used. Over time, nitroglycerine can seep out of the filler and appear as beads on the outside of the sticks or accumulate nearby. The nitroglycerine is extremely unstable and can explode if disturbed.

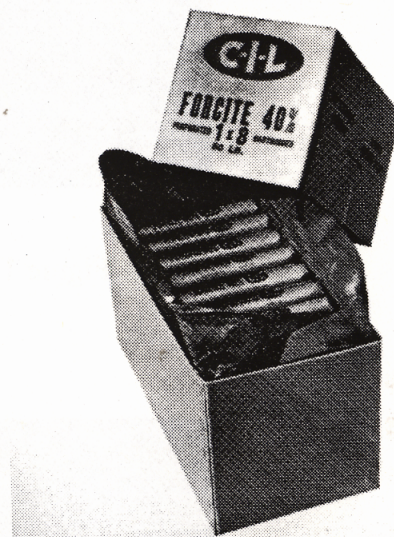
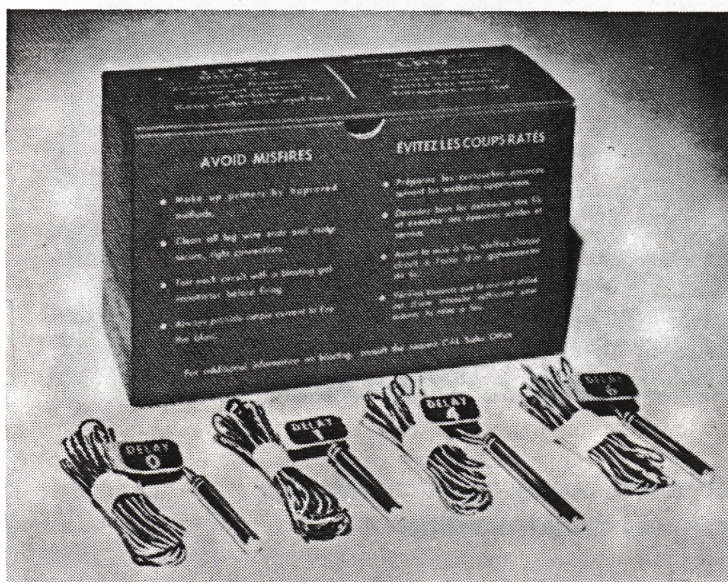
Typical examples of blasting caps
Figure 11

Detonators which may be found on abandoned mine sites consist of electric and non-electric blasting caps. Typically, they are 25 to 50 mm long metal tubes about the diameter of a pencil. Electric blasting caps have two thin wires extending from one end and can be detonated with a very small electrical charge including static electricity. Non-electric blasting caps are attached to a fuse and can be detonated by igniting the fuse. Both types of blasting caps can also be detonated by impact or heat. If explosives or anything resembling explosives are found - **DO NOT HANDLE**. Report your finding immediately to one of the government departments identified in Chapter 8.

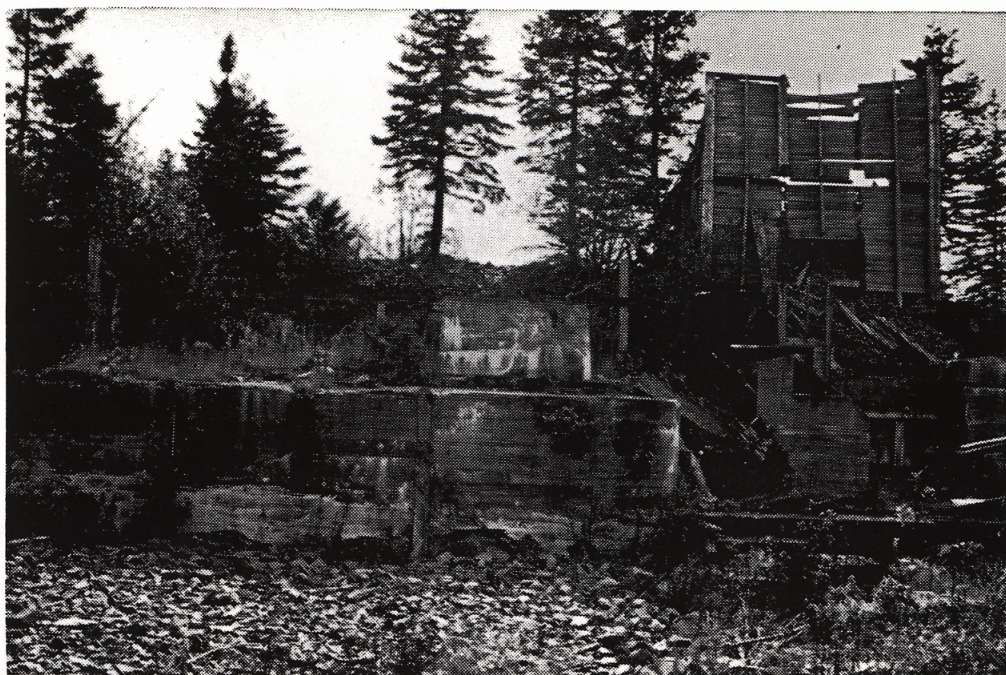
Figure 12: Abandoned mill foundation and structure -
former Forest Hills gold mine

Old buildings and equipment located on abandoned mine sites can present hazards. Through weathering and lack of use, structures become unstable and may collapse. Particular dangers exist in old headframes where a shaft may be covered over with wood.

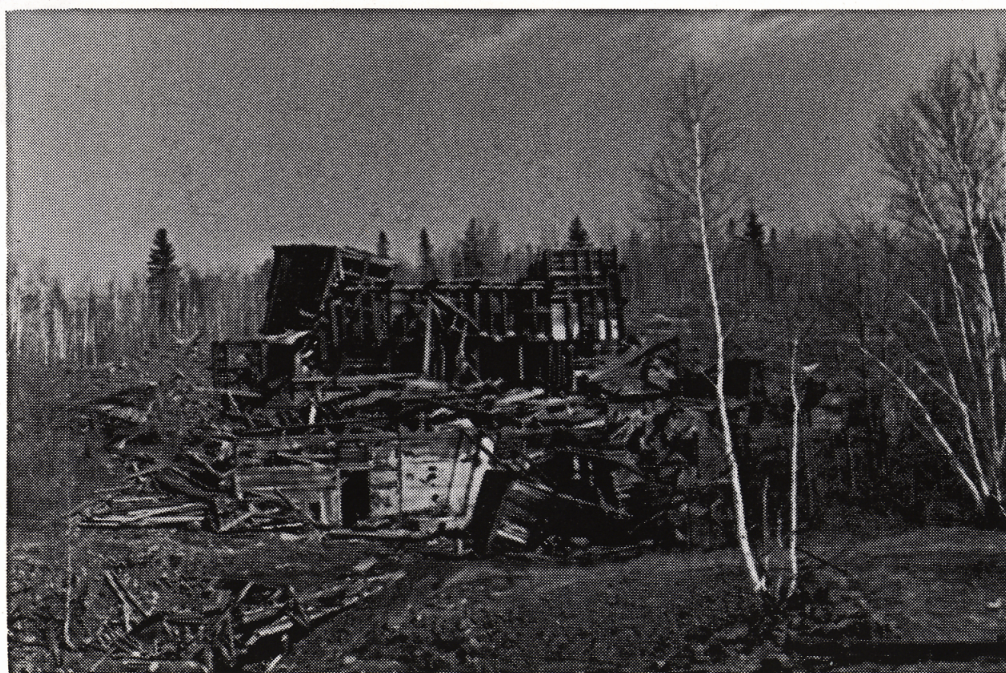
Figure 13: Deteriorated abandoned mine structure -
former gold mining operation
