An Engineering Review of the Existing Steering Arrangement of the Sailing Vessel “Bluenose II”

Prepared for the Minister of Transportation and Infrastructure Renewal of the Province of Nova Scotia
FINAL REPORT – REVISION B – February 15th, 2016

Tom Degremont and Sam Howell,
Langan Design Partners, LLC

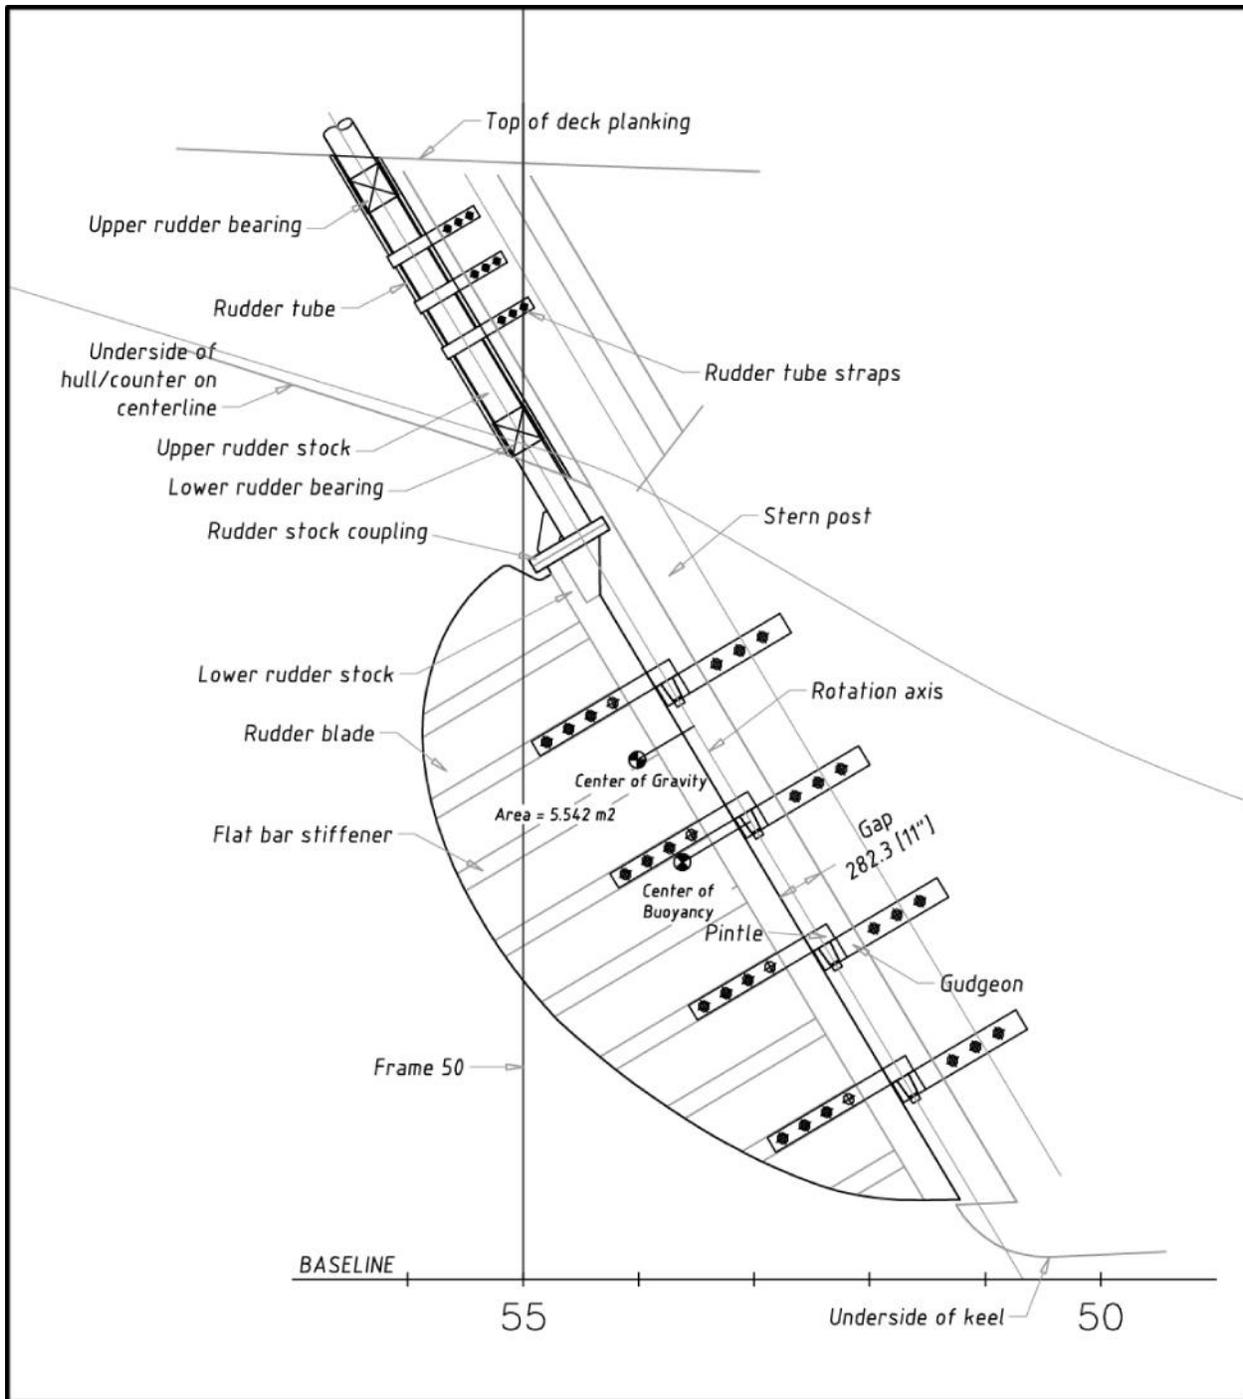
Figure 1 - Rudder Nomenclature

For a description of the terms used in this report please refer to figure 1 below.

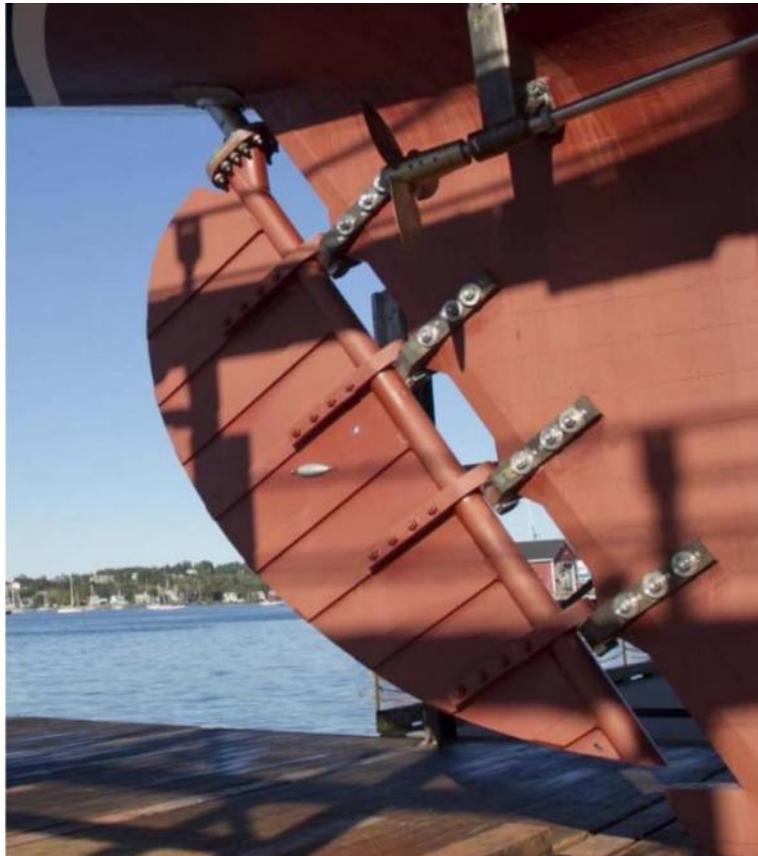
Figure 2:Existing Rudder

The rudder blade is a steel welded fabrication consisting of a solid steel stock (7.5" solid round bar machined to 7.25" diameter) to which a flat 9/16th plate has been welded. The rudder plate is strengthened by 9 pairs of steel flat bar stiffeners (1-1/4" x 4-1/4") that are welded on either side of the blade.

The rudder blade is attached to the upper rudder stock by way of a bolted connection.

The upper stock is a solid stainless steel round bar (7.5" diameter). A flanged connection sits at the lower end of the upper stock. A keyway has been machined at the upper end of the stock to enable a solid mechanical connection to the steering system.

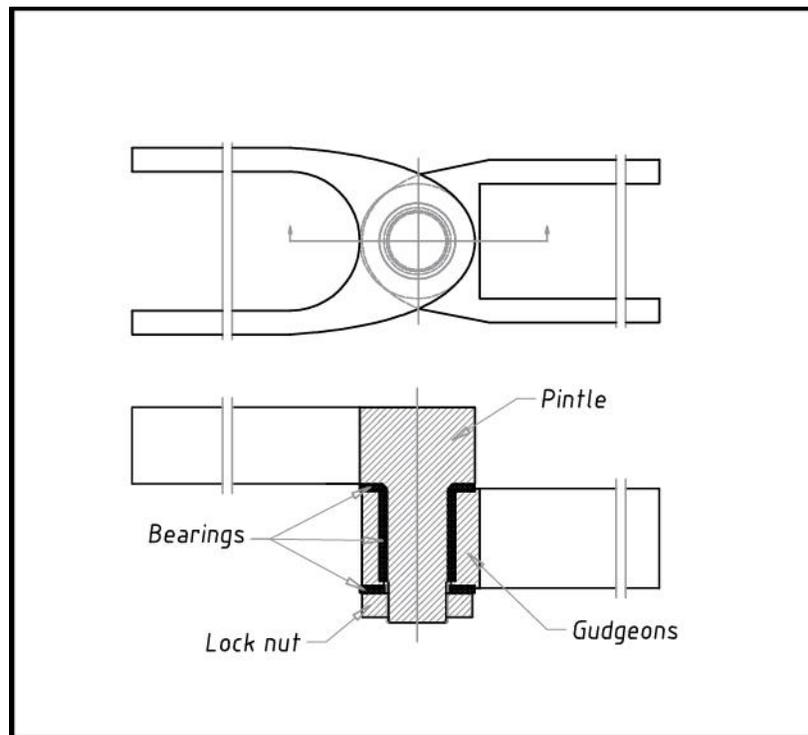
Figure 3: Pintle and Gudgeon Detail

The pintles are affixed to the rudder blade by way of bolts. The gudgeons are similarly bolted to the stern of the vessel. The center of rotation of the hinges is intended to sit on the axis of rotation of the rudder. Note that the hinges sit perpendicular to the axis of rotation of the rudder, and at 31 degrees to the angle of the incoming flow.

The gudgeons are lined with Thordon bearings and the rudder is prevented from vertical motion by way of lock nuts on the lower end of the pintle shafts. These lock nuts were hand-tightened upon installation of the rudder.

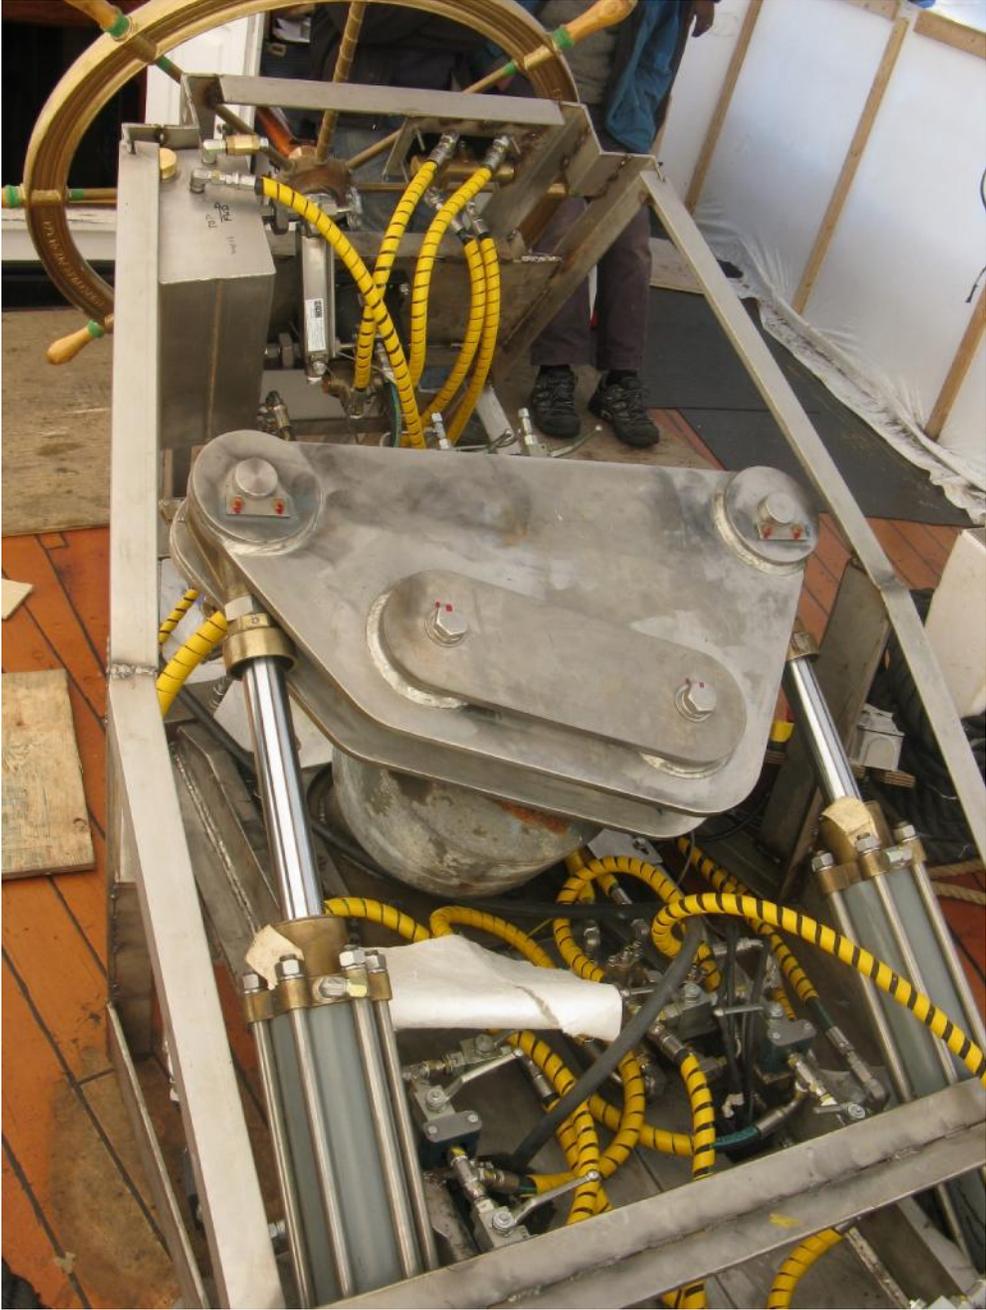
Figure 4: Existing Hydraulic System

The steering system makes use of the rudder stock “head” fabricated for the custom manual steerer that was installed at launch. A pair of dual-acting Kobelt hydraulic cylinders are attached to a base plate itself bolted on to the deck and to a custom tiller arm mechanism on the rudder stock head fitting.

The cylinders are actuated by a hydraulic power unit (HPU) that sits under the deck to port, and which is accessible via a deck hatch also on port.

The wheel is connected to a hydraulic steering pump which is connected to the HPU, thus translating the rotation of the wheel into the rotation of the rudder. The sensitivity of the wheel can be adjusted at the helm station.

The following picture shows the current hydraulic system with the wood-clad enclosure removed.

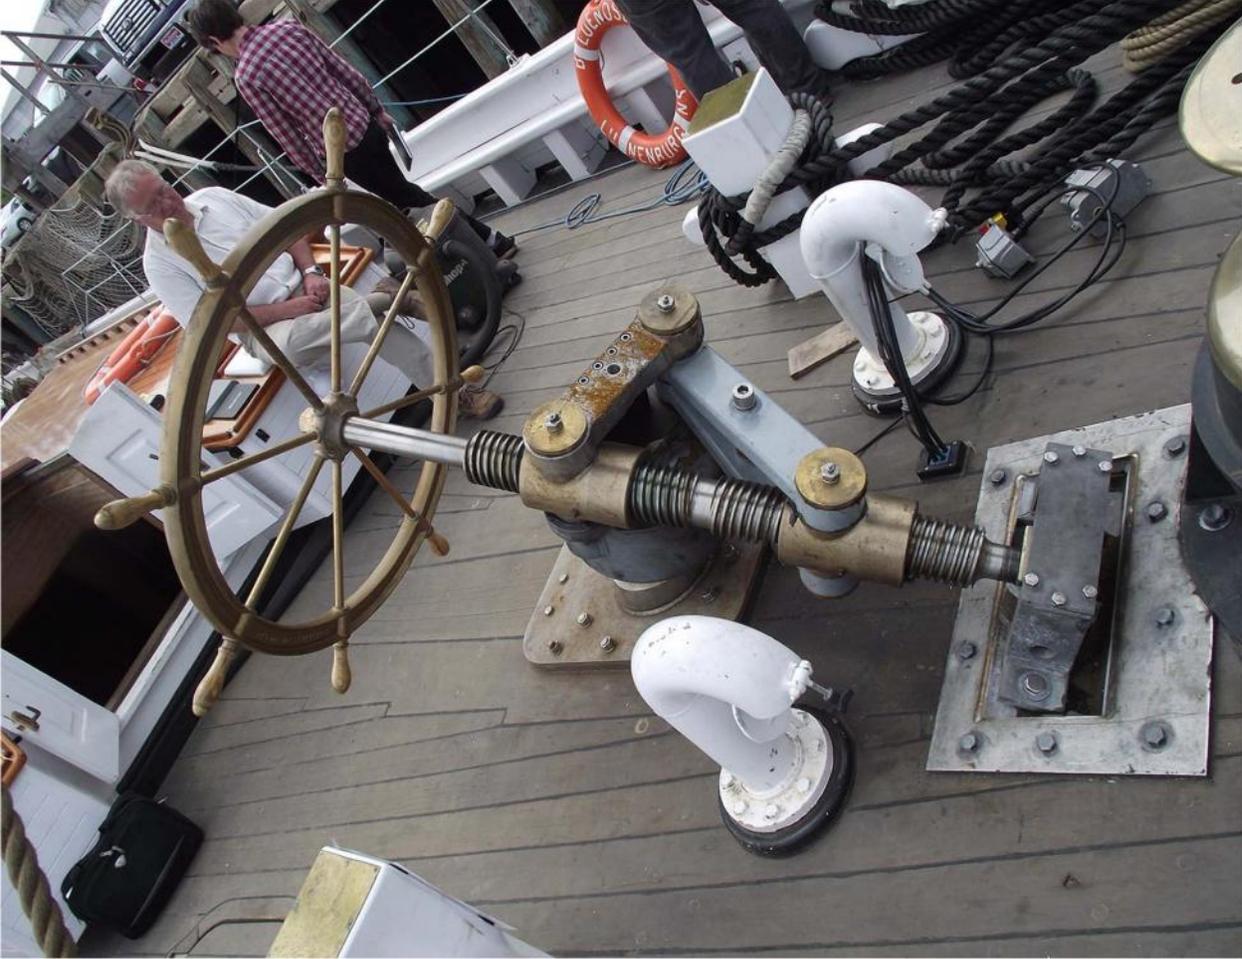
Figure 5: Manual steerer in 2014

As part of the design for the newly rebuilt Bluenose II a new manual steering gear was designed and fabricated. It was installed after the installation of the rudder in late fall 2014. The steering system was an oscillating worm gear of the “Fishermen’s Steerer” style, similar in functionality to the “Edson Oscillating Steerer” found in various reference material. Note that this is called an oscillating steerer because the entire steering wheel shifts slightly from port to starboard as the wheel is turned.

The following picture shows the manual steerer as it was installed on Bluenose II in early 2014.

Although this steering system is functionally identical to what was found on the fishing schooners of the day it is considerably larger and heavier, albeit designed to fit on a smaller diameter stock.

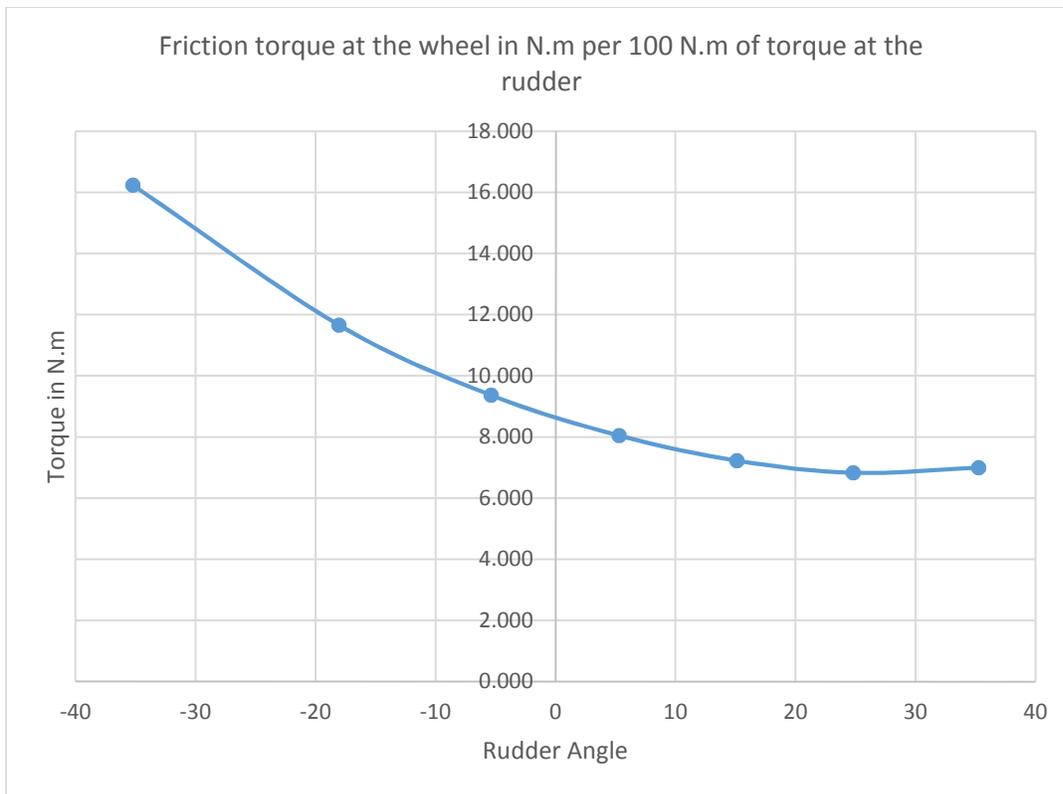
Figure 7: Steerer Friction Torque Per 100 N.m of Rudder Torque

The authors have calculated an approximate friction curve based on the existing steerer geometry and a coefficient of friction of 0.19 (C.O.F assuming steel-brass interface, greased). The graph that follows shows the results.

For 100 N.m of torque at the rudder one would expect to see from 7 to 16 N.m of torque at the wheel shaft depending on the rudder angle.

Although several simplifying assumptions have been made for this calculation this number is surprisingly large. One of the takeaways from doing this quick calculation is that the diameter of the thread on the steerer rod, upon which the two nuts slide back and forth as the wheel is rotated, is a key driver of the friction torque felt at the wheel. The greater the diameter of the screw thread, the larger the torque required to overcome friction.

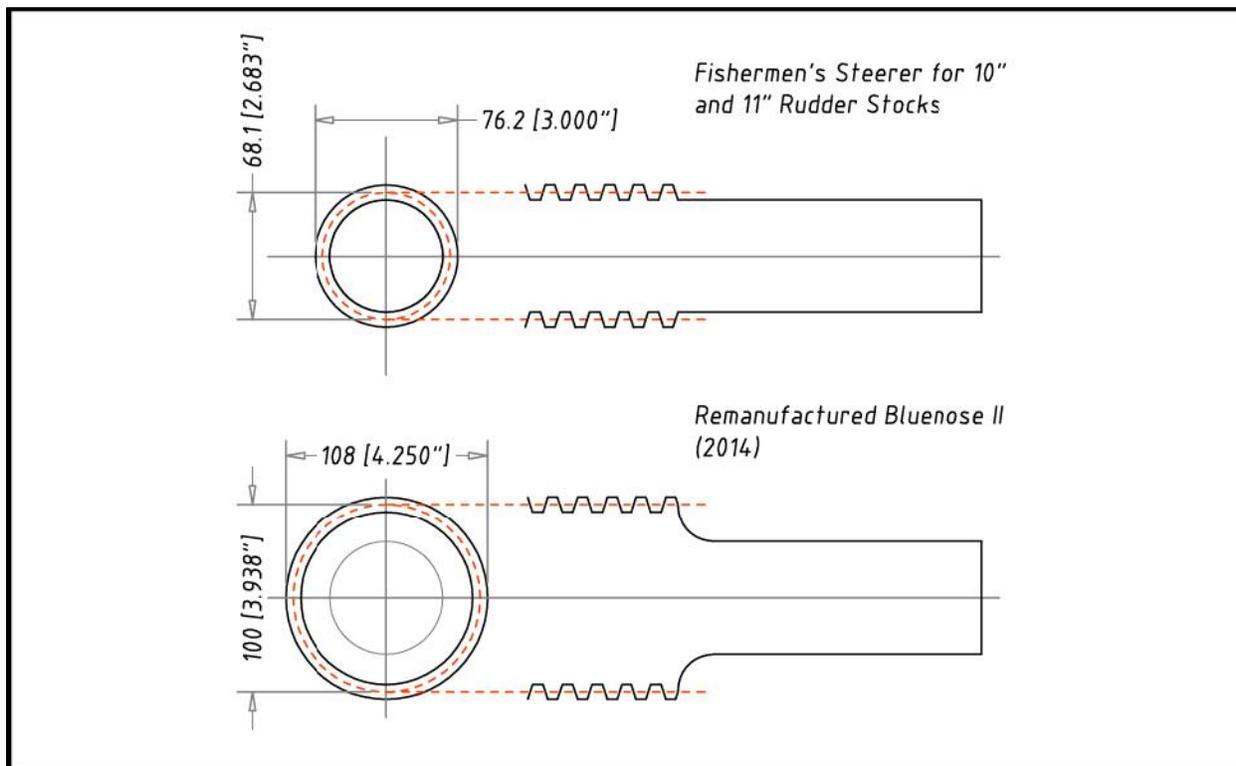
Figure 8: Worm Gear Thread Size Comparison

In the case of the newly remanufactured steerer the diameter of the rod screw is 4.25” to the outside of the thread, with a pitch diameter of approximately 3.938”. In the case of Bluenose II (1963) the thread had an outside diameter of 3”, and a pitch diameter of 2.683”. Based on these dimensions the torque needed to overcome the steerer friction would be 47% greater than using the original steerer.

It is important to note that some friction at the worm gear is normal, and indeed in some cases can be thought of as a feature. In this instance, however, the increased diameter of the screw shaft has a direct impact on the friction at the wheel: an increase of 47% is significant.

The following drawing shows the difference in size between the Bluenose (1963) and the Bluenose (2014) screw rods.

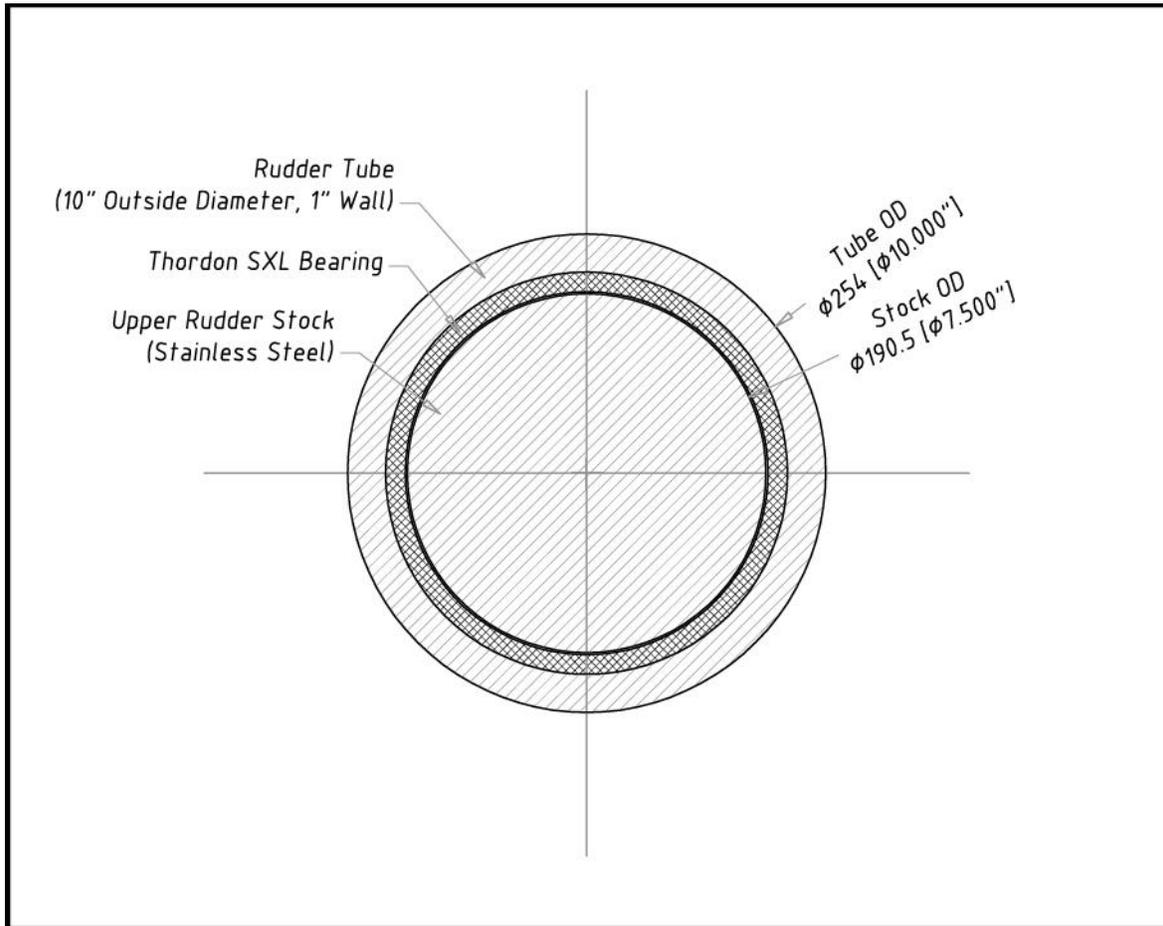
Figure 9: Section through the rudder tube bearing

These bearings are specified as a being Thordon SXL bearings and were fabricated as per the manufacturer's instructions. Specifically, the clearance on the diameter between the bearing and the rotating rudder stock was specified as 60 Mil (0.060 inch, 1.5 mm). After an initial installation in which it was found that the total clearance on the diameter was 0.018" the bearings were removed and machined to a .060" clearance. It should be noted that the ABS rules specify a *minimum* bearing clearance of .060" and a maximum axial alignment of 15 Mil (.015 inch, 0.381 mm).

The illustration below shows a section through one of the rudder tube bearings. For a detail of the pintle/gudgeon arrangement please refer to the illustration found in a previous section.

One possible explanation for the excessive resistance to turning could be attributed to insufficient clearances between the bearings and the rudder stock and pintles. The manufacturer of the bearings (Thorndon) made clear that the 60 Mil clearance required was in part to accommodate for the swelling of the bearings when they are immersed in water. If one assumes some swelling, then the available clearances are further reduced.

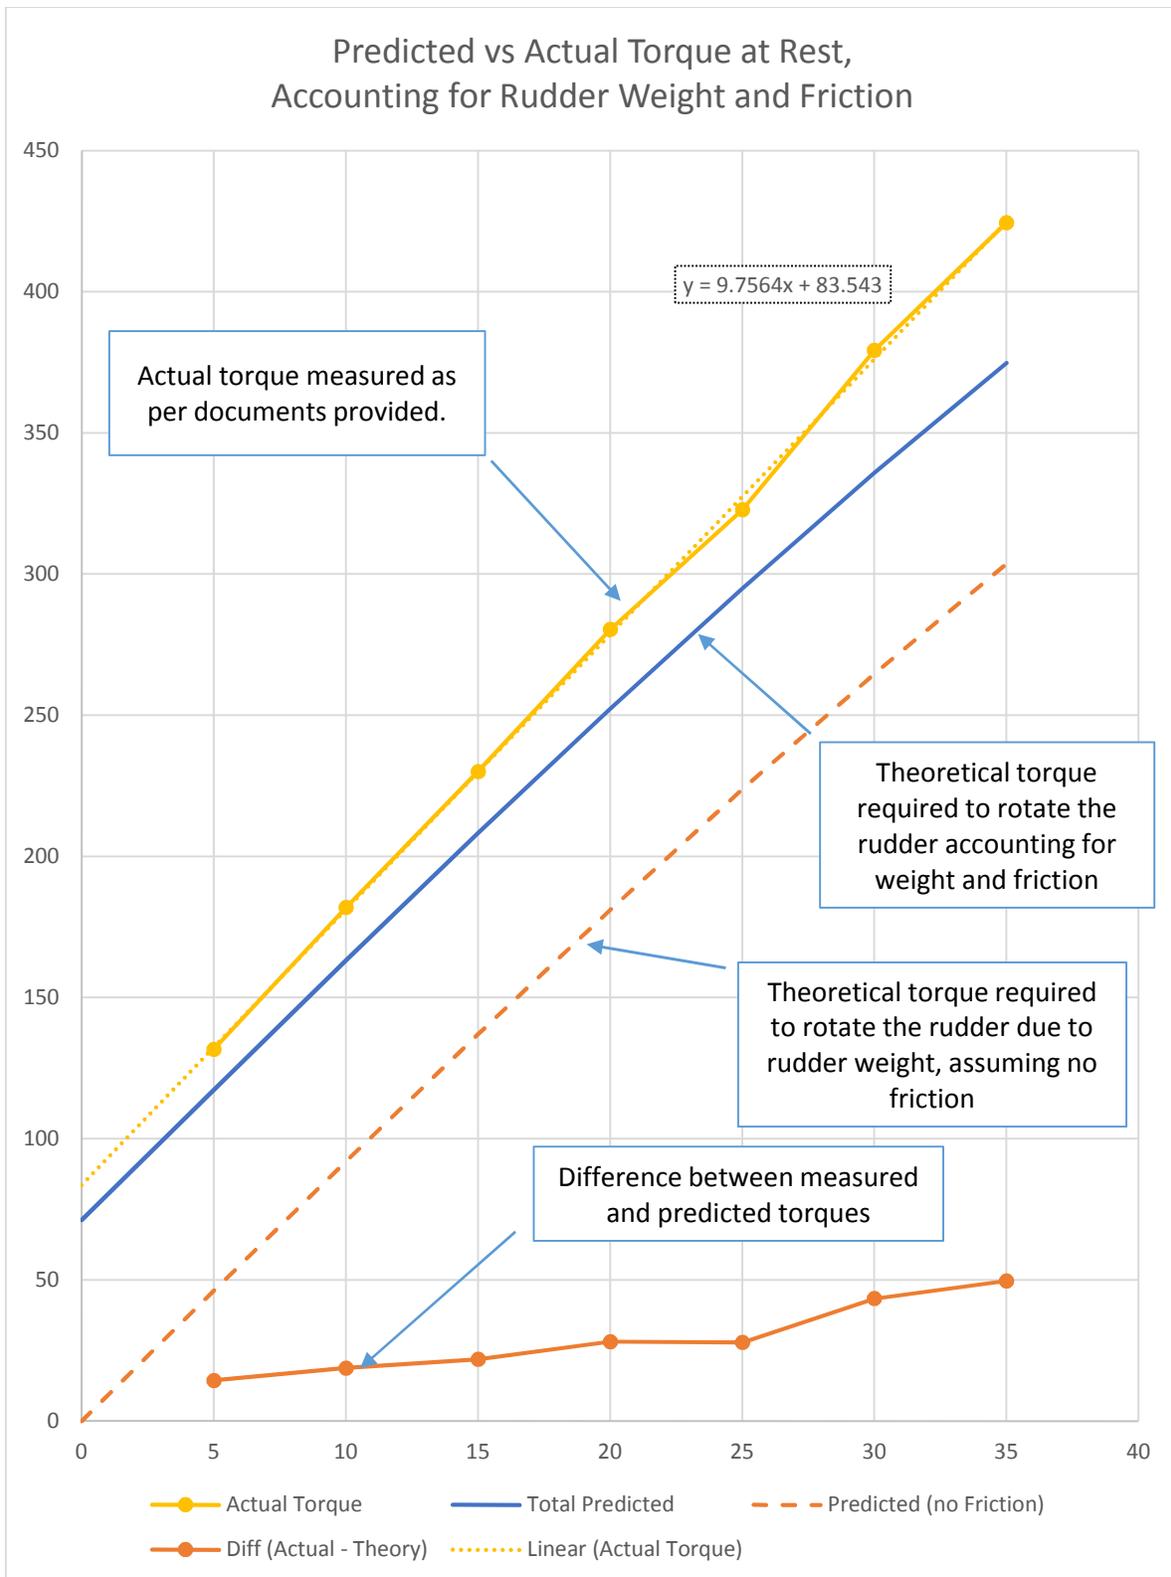
Figure 10: Torque Curves

In fact, given the experimental setup used to record the torque, one can partially explain the discrepancy found between the predicted and measured torques: As a load is applied to the tiller (used to turn the rudder during the test) the net reaction forces increase on the upper bearing. This additional load would result in additional friction and would increase with rudder angle. The authors were not provided with the exact geometry of the tests so quantifying this additional friction was not possible.

- the weight of the rudder which is the cause of substantial friction throughout the range of motion of the rudder
- the lack of buoyancy and weight in the blade which is driving the significant torque required to lift the weight of the rudder as it rotates around the angled shaft.
- The increased diameter of the worm gear screw contributes to approximately 47% more friction under load than was the case for Bluenose II (1963).

The data would suggest that alignment issues did not play a significant role at the time the measurements were taken.

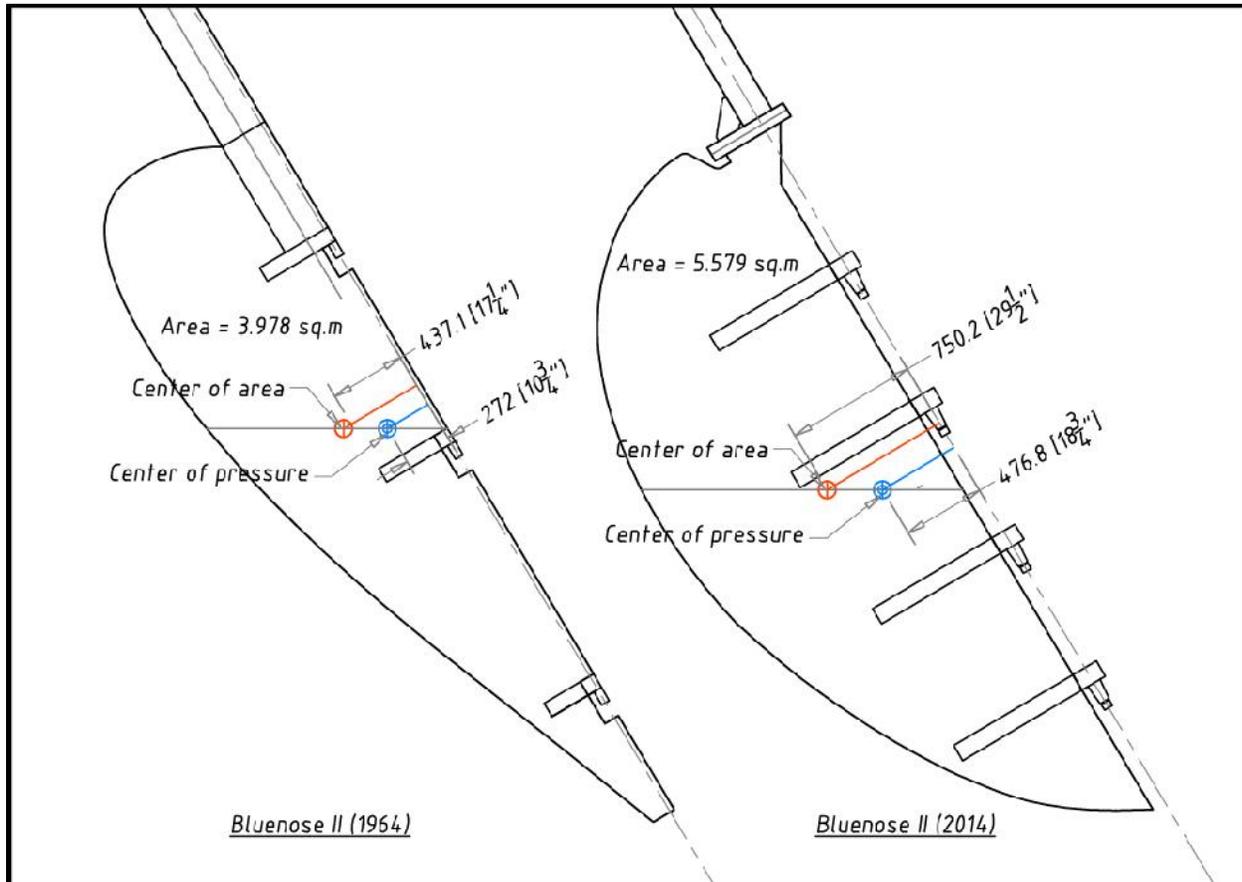
Figure 11: Rudder Shape and Size Comparison

The following drawing shows a comparison between the current metal rudder blade and the Bluenose II (1963) wood rudder.

It is immediately apparent that the new rudder is both substantially larger than the Bluenose II (1963) rudder (+40.3%) and that its center of area sits farther away from the axis of rotation of the rudder (+71.6%).

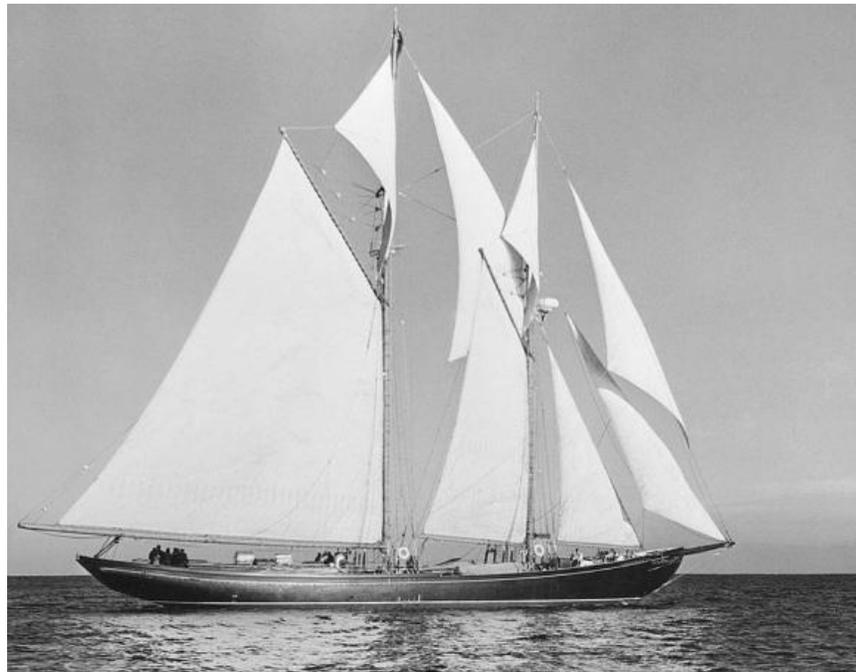
Figure 12: Bluenose II (1963) circa 1964

The two pictures below show the long term effects of the shear forces and bending moments inherent in this type of sailing vessel. The weight of the bow and the stern are not supported by buoyancy. Over time these forces tend to deform the hull.

Note the graceful upward slope of the shear line both in the bow and in the stern of the vessel in the first picture which was presumably taken early in her life. The second picture shows the dramatic effect of age on this shape: the shear line has flattened, most dramatically in the stern.

On the short term the structure of the vessel can easily accommodate these forces. The issues arise over time: the continuous stress on the wood structure means it slowly deforms and "hogs". This condition is typical of older wood vessels. For a dramatic depiction of hogging on the original Bluenose II please refer to Appendix B.

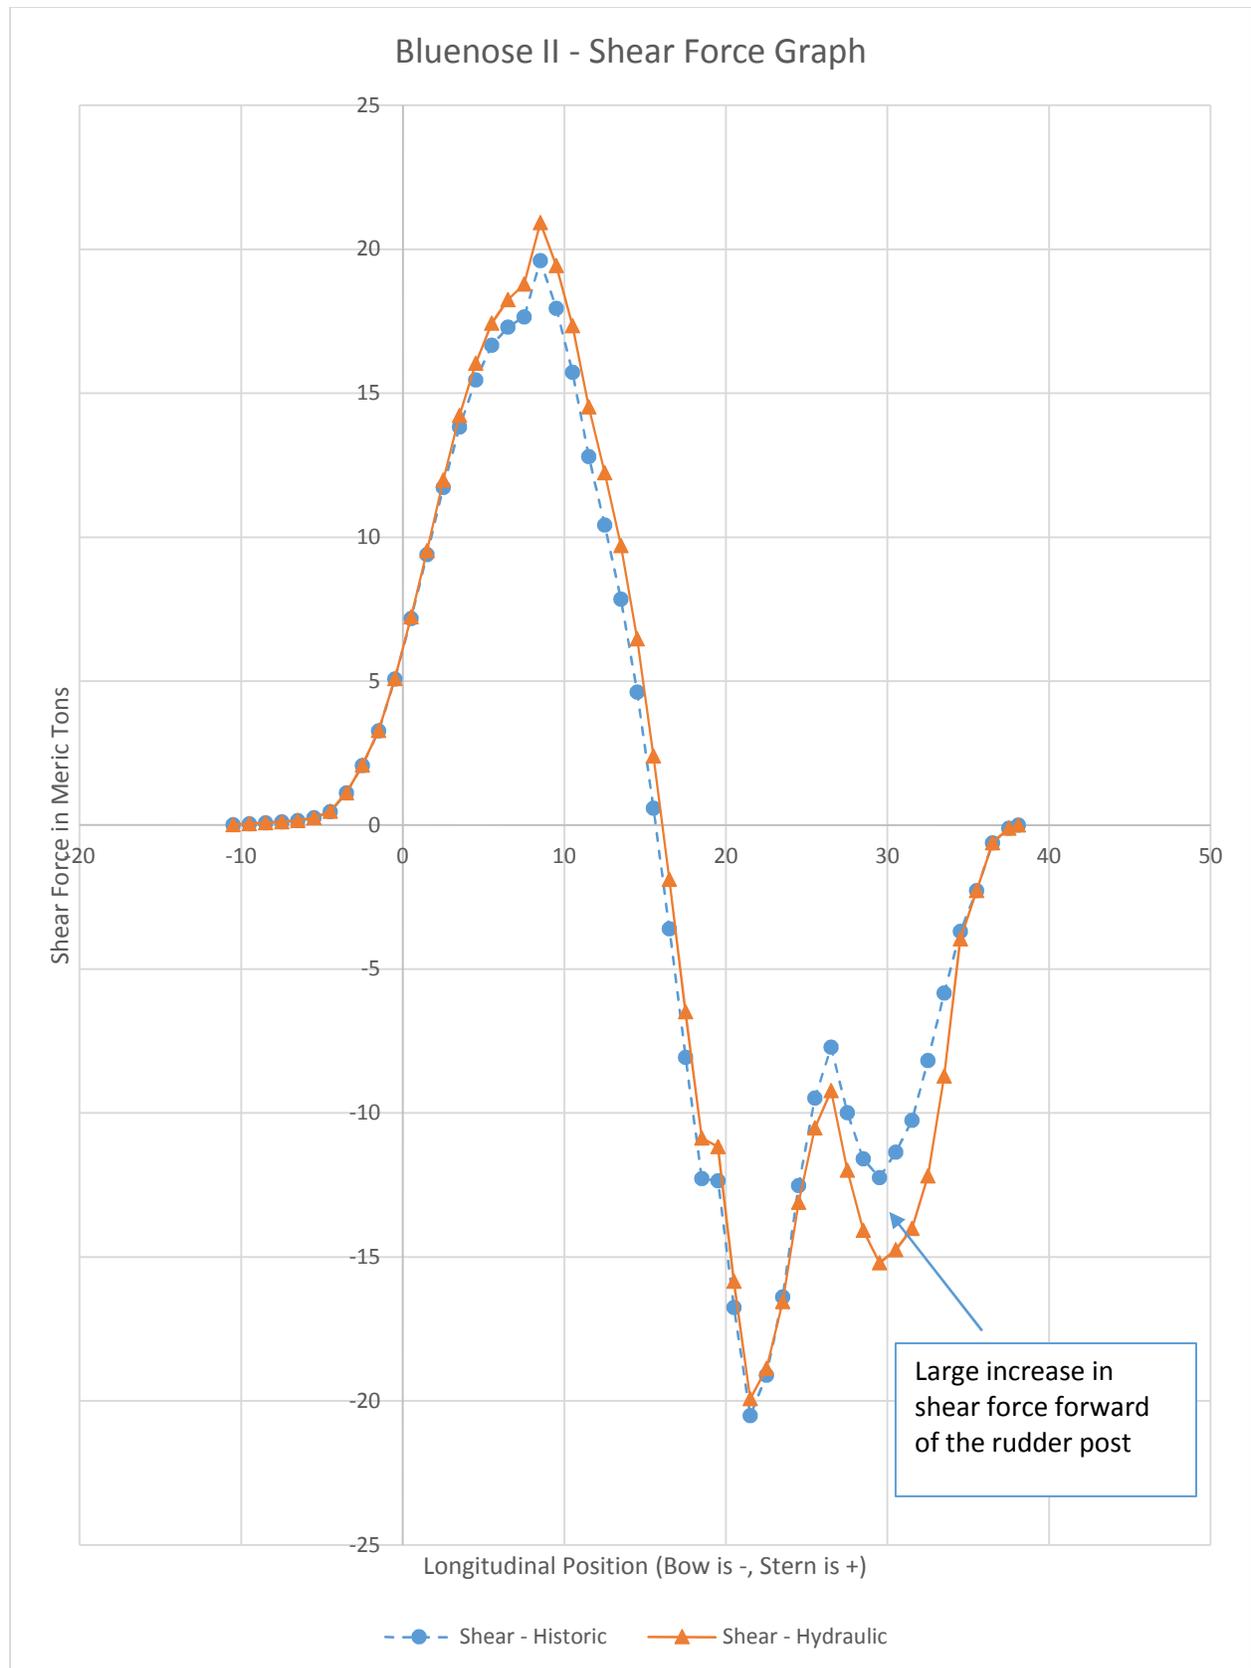
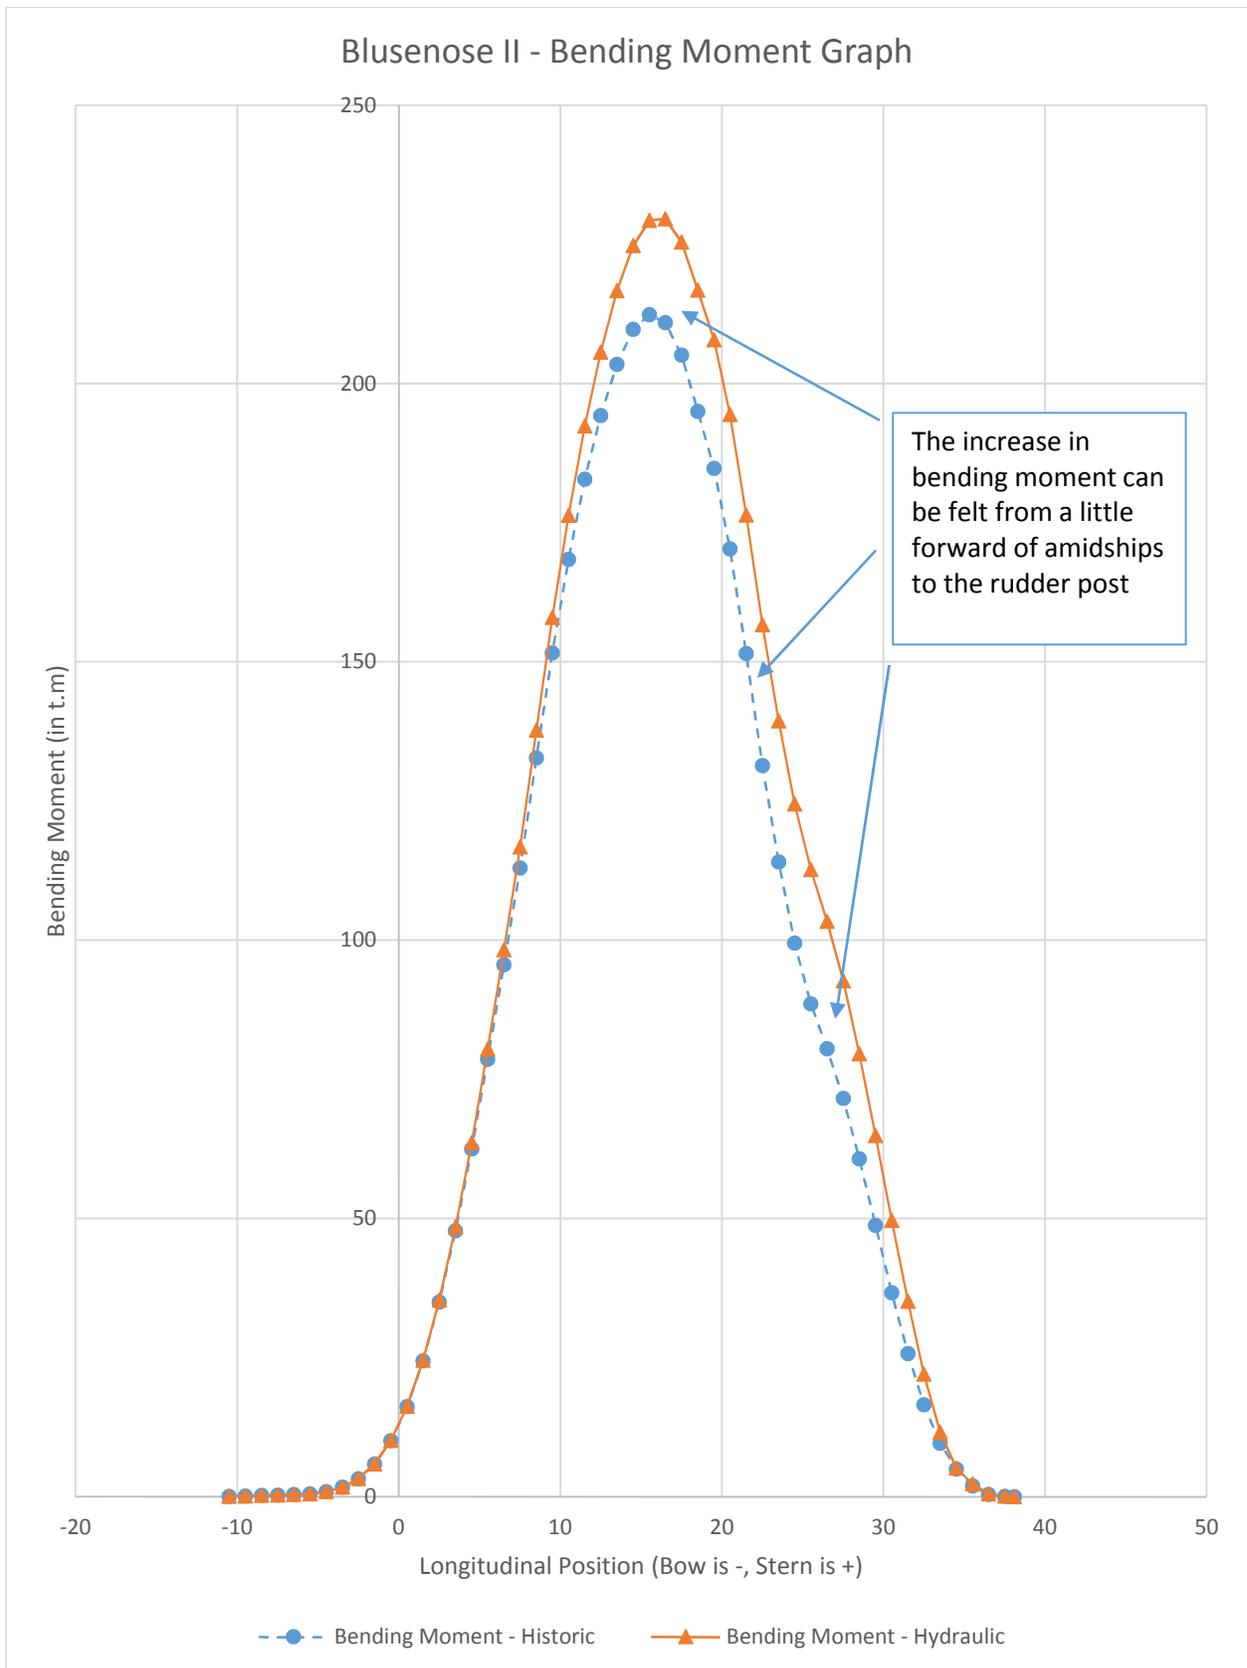
The two graphs that follow show the longitudinal distribution of shear force and bending moments for Bluenose II when at rest, in her lightship condition.

Note that only the aft portion of the vessel is shown in the following table. For the development of these graphs the authors have assumed the weight of the vessel, minus the major weight items, was distributed proportionally to the section area at each station. The major weight items considered included: the ballast, engines, generators, masts, booms and the bowsprit.
