APPENDIX C – COMPREHENSIVE WATER QUALITY MONITORING PROGRAM – 2022

COMPREHENSIVE WATER QUALITY MONITORING—WESTCHESTER QUARRY

Suspended Sediment and Conductivity Monitoring of
Streams Adjacent to the
Chapman Brothers Westchester Quarry,
2327 Westchester Road
Rose, Nova Scotia

NOVEMBER, 2022

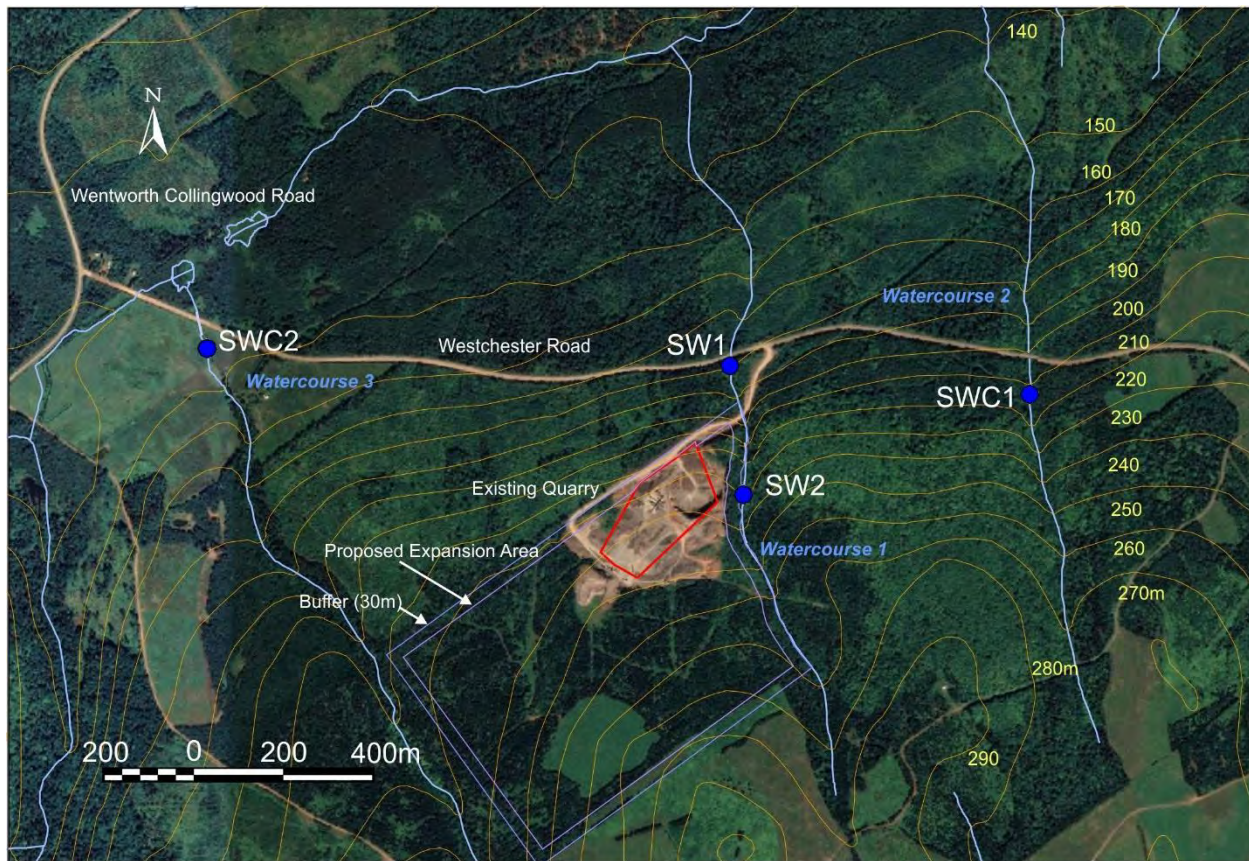
Figure 1. Location of Site Features and proposed sampling locations, Chapman Bros. Construction Ltd., Westchester Quarry. .

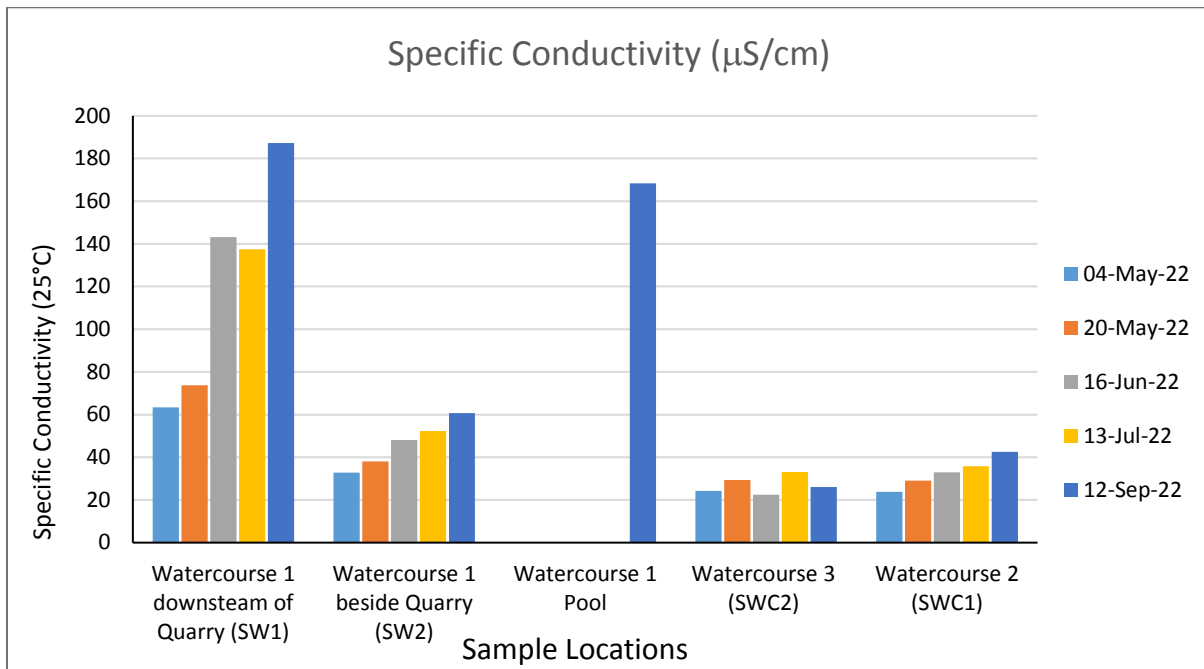
Specific Conductivity at SW1 on Watercourse 1 was highest of all sites and the differences with the other locations were statistically significant (Kruskal Wallance (KW) One-Way Analysis of Variance, $n=5$)⁴, with SW1 greater than SW2 ($p<0.01$); SW1 greater than SWC1 ($p<0.01$); and SW1 greater than SWC2, ($p<0.05$). Specific Conductivity at the upstream site on Watercourse 1 (SW2) was in turn significantly higher than Watercourse 3 (SWC2) (KW One-Way Analysis of Variance, $n=5$, $p<0.05$), but was not significantly different from that observed in Watercourse 2 (SWC1).

Figure 2. Specific Conductivity ($\mu\text{S}/\text{cm}$) in watercourses sampled in the vicinity of the Westchester Quarry, May to September 2022. Sampling locations are shown in Figure 1.

Presence of the access road itself may be contributing to the elevated conductivity / specific conductivity. Use of the road leads to the generation of dust which can settle nearby; the road bed is slightly permeable and water percolating through it is exposed to minerals which can potentially dissolve; precipitation running off the outer road slopes can introduce fine particulates into the watershed below; the damaged and partially blocked culvert, assists in retaining (slowing the movement of) water, allowing potential for greater dissolution of solids, which would limit the occurrence of high concentrations of TSS in downstream areas.

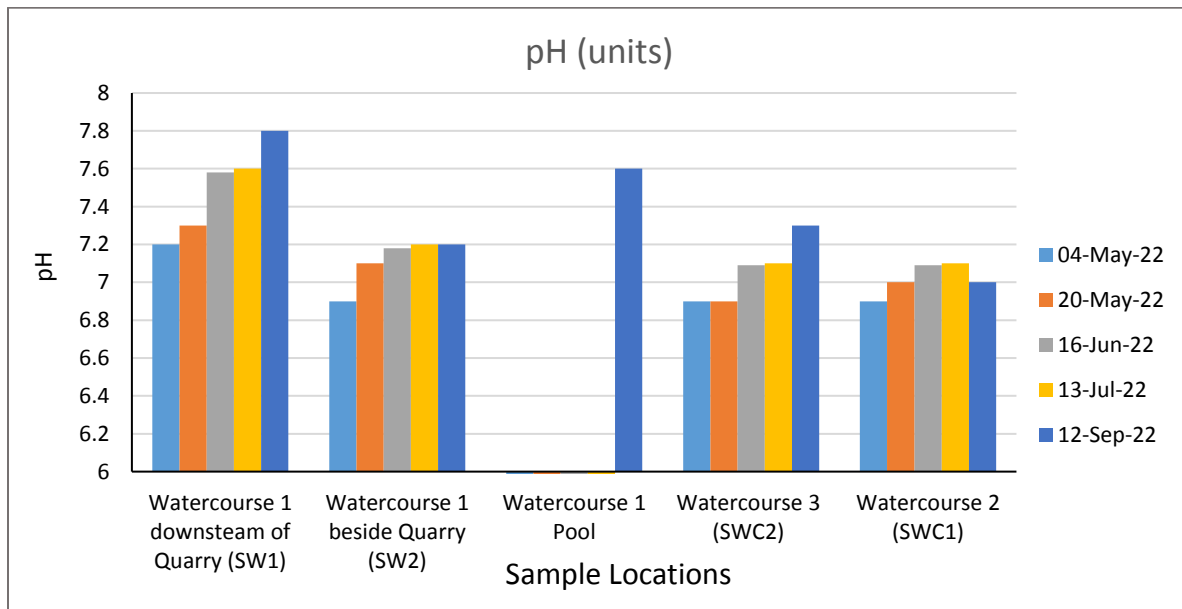
pH as an indicator of water quality was monitored in parallel to TSS and Specific Conductivity. pH at SW1 was highest of all sites and the differences from the other sites were statistically significant (KW One-Way Analysis of Variance, $n=5$)(SW1 greater than SW2, $p<0.05$); SW1 greater than SWC1, $p<0.01$); and SW1 greater than SWC2, $p<0.05$). pH at the upstream site on Watercourse 1 (SW2) and sampling locations in the other watercourses were similar (i.e. not statistically significantly different). All sites showed a general gradual increase in pH through the year. The pH of 7.6 observed in the pool on Watercourse 1 in September 2022 (immediately upstream of the quarry access road) was comparable to the pH of 7.8 observed further downstream at SW1.

Figure 3. pH in watercourses sampled in the vicinity of the Westchester Quarry, May to September 2022. Sampling locations are shown in Figure 1.

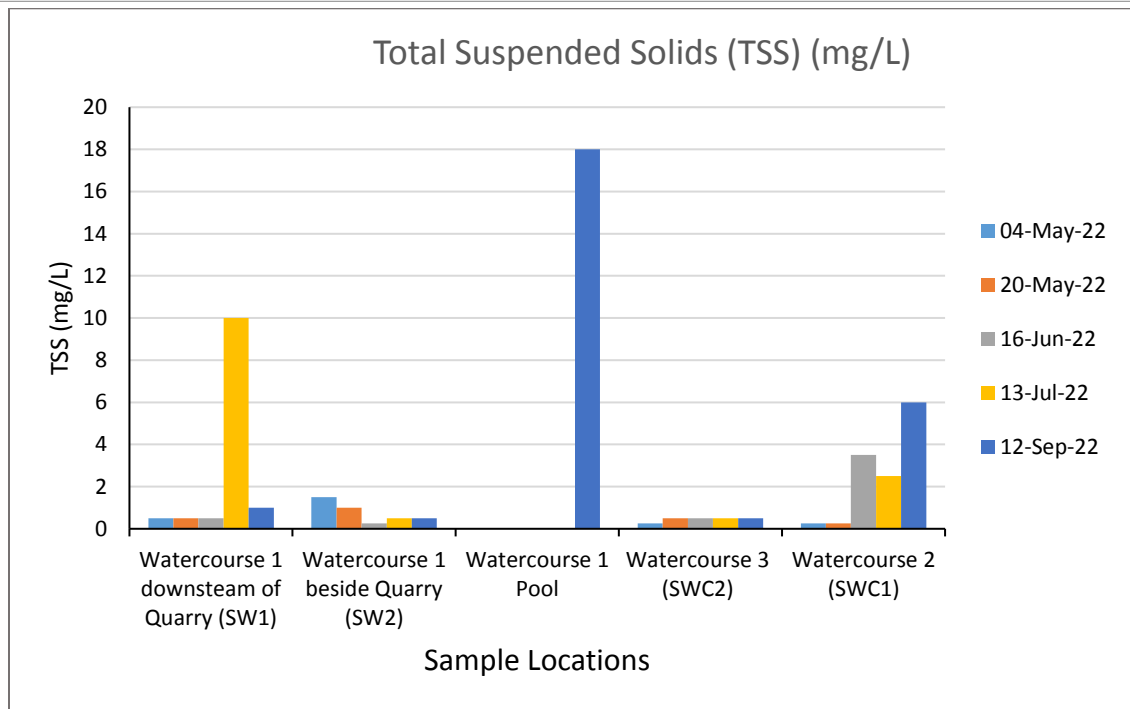
Total Suspended Solids None of the water sampling sites showed particularly elevated concentrations of Total Suspended Solids (TSS), with 10 mg/L being the highest in Watercourse 1 (SW1) and 6 mg/L on Watercourse 2 (SWC2). The highest TSS measured in the present study was 18 mg/L, observed in the pool on Watercourse 1 upstream of the access road (Table 1) but was not accompanied at the time by an elevated level of TSS in the sampling location (SW1) further downstream. All levels of TSS observed were below the level of 46 mg/L measured at in Watercourse 1 immediately above Westchester Road in 2017 which in part resulted in the request for additional information which triggered this study.

Figure 4. Total Suspended Solids (TSS) (mg/L) in watercourses sampled in the vicinity of the Westchester Quarry, May to September 2022. Sampling locations are shown in Figure 1.

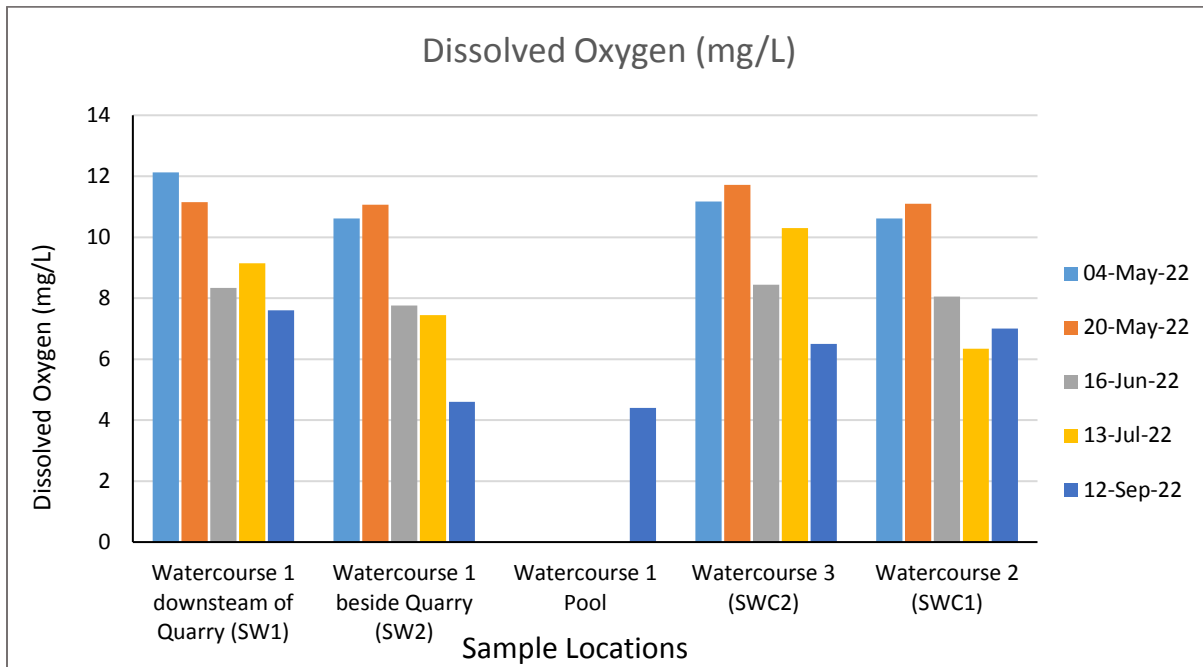
Overall, levels of all parameters reflected normal ranges for flowing upper-watershed streams in Nova Scotia (Table 1). Dissolved Oxygen was measured at all water sampling locations (Table 1, Figure 5). Dissolved Oxygen was at or above the CCME Freshwater Aquatic Life (FAL) Guideline of 6.5 (coldwater fish) except at two locations—the upstream site (SW2) on Watercourse 1 in September (4.6 mg/L) and Watercourse 2 (SWC1) in July (6.34 mg/L). A level of 4.4 mg/L was observed in the pool which occurs on Watercourse 1 immediately upstream of the access road. Low levels of dissolved oxygen are attributable to low flows immediately upstream of the sampling location, as both are flowing water environments albeit at low flow, and oxygen concentration is dependent on flows to mix the water and expose it to air. A spring can cause locally low oxygen levels; however they are usually accompanied by a lower temperature, and temperatures at both the sites were not depressed. A relatively high dissolved oxygen level was observed at the downstream location on Watercourse 1 (SW1) in September (7.6 mg/L) when levels were comparable to those in Watercourses 2 and 3 (7.0 and 6.5 mg/L respectively).

Figure 5. Dissolved Oxygen (mg/L) in watercourses sampled in the vicinity of the Westchester Quarry, May to September 2022. Sampling locations are shown in Figure 1.

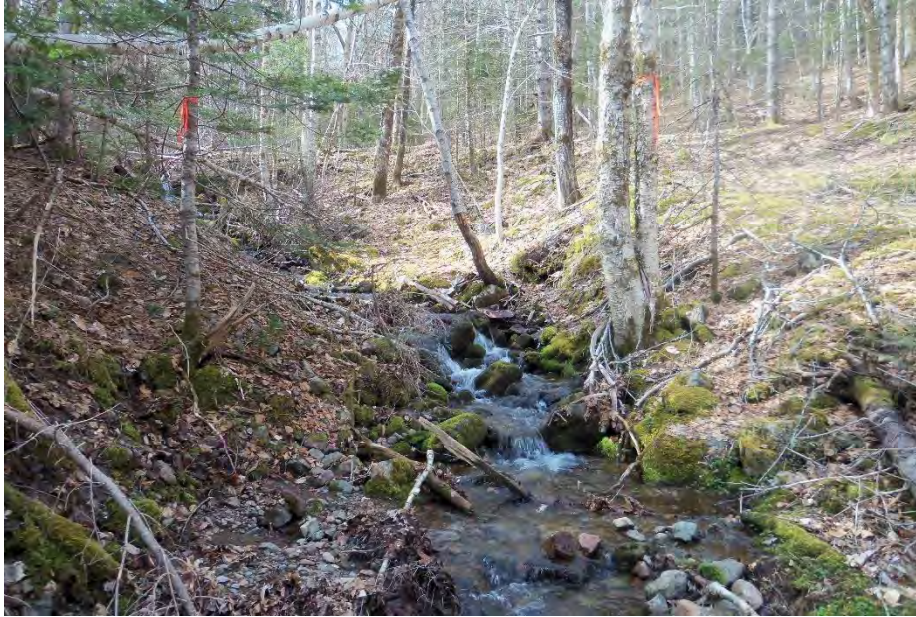
Photo 1. Watercourse 1 (Site SW1) downstream of the Westchester Quarry, May 4, 2022.

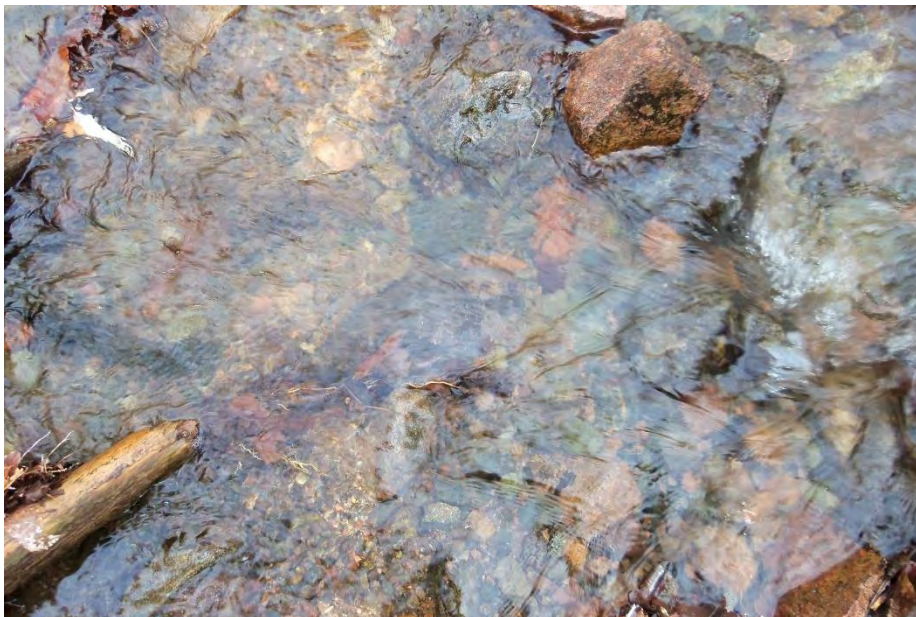
Photo 2. Substrate in Watercourse 1 (Site SW1) downstream of the Westchester Quarry, May 4, 2022.

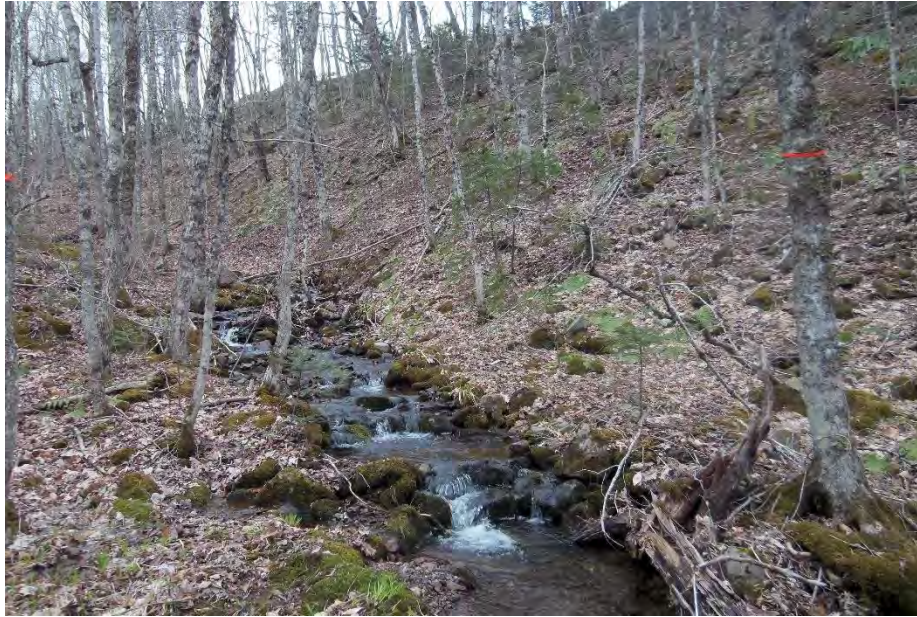
Photo 3. Watercourse 1 (Site SW2) 165 m upstream of the Westchester Quarry access road, May 4, 2022.

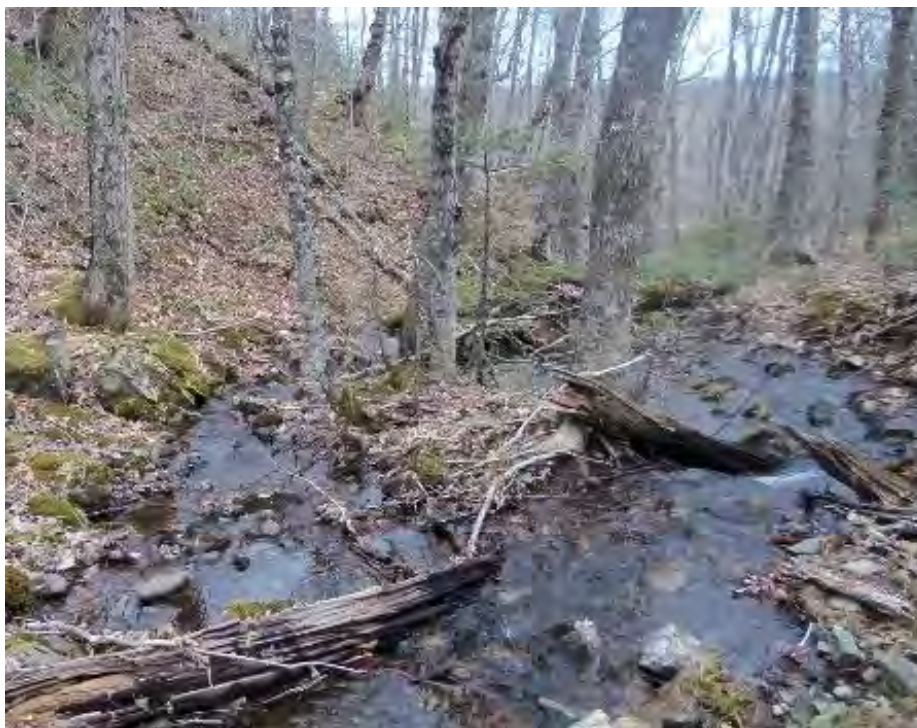
*Photo 4. Watercourse 1 (Site SW2) 165 m upstream of the Westchester Quarry access road, May 4, 2022. Downstream view.
Access road visible in extreme background.*

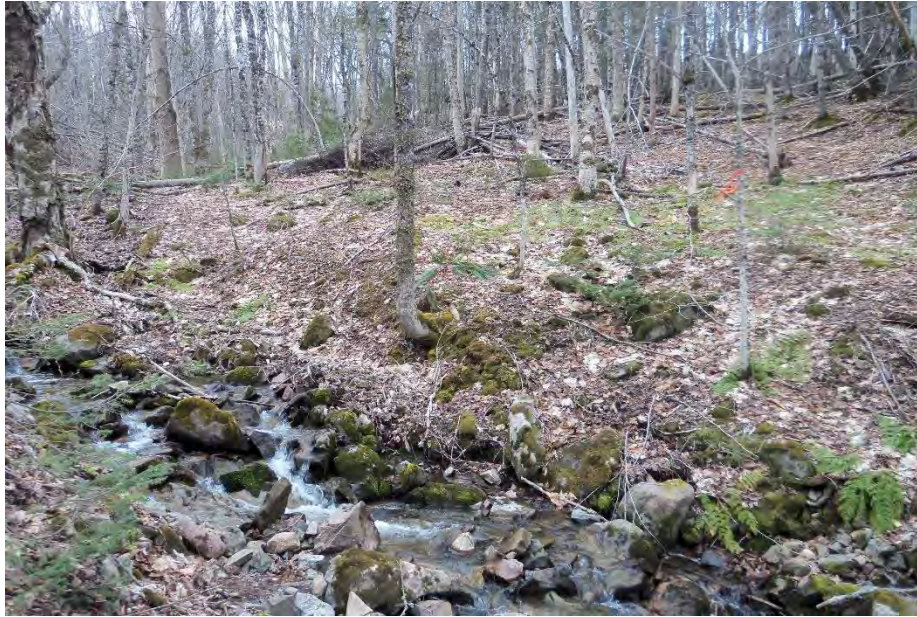
Photo 5. Watercourse 2 (Site SWC1) upstream of Westchester Road, May 4, 2022.

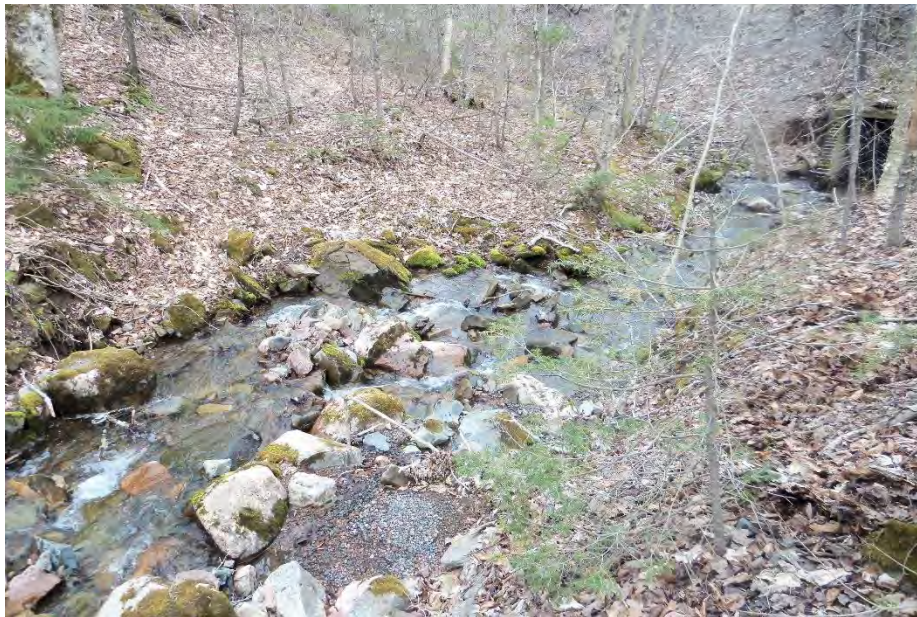
Photo 6. Watercourse 2 (Site SWC1) downstream and showing culvert under Westchester Road, May 4, 2022.

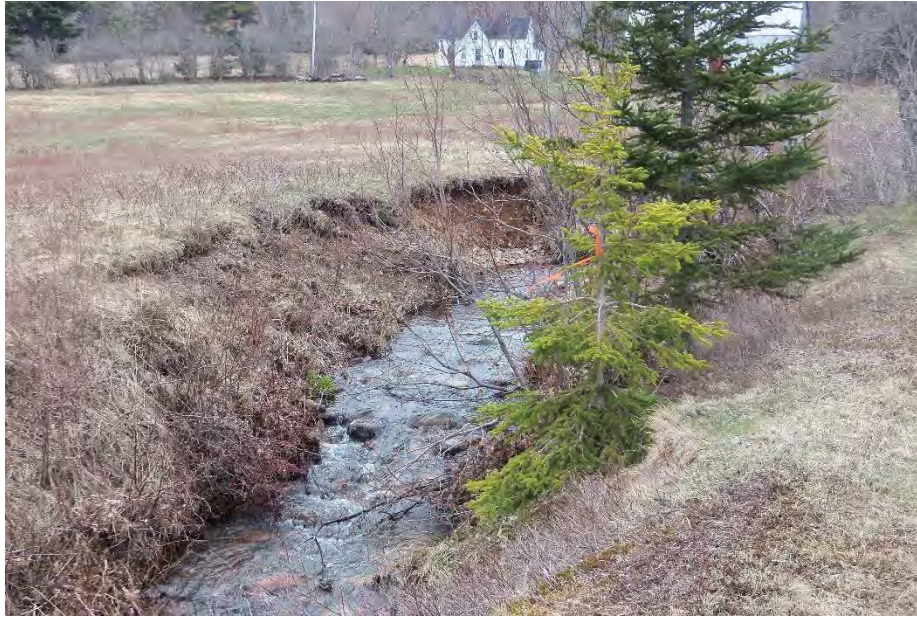
Photo 7. Watercourse 3 (Site SWC2) upstream of Westchester Road, May 4, 2022.

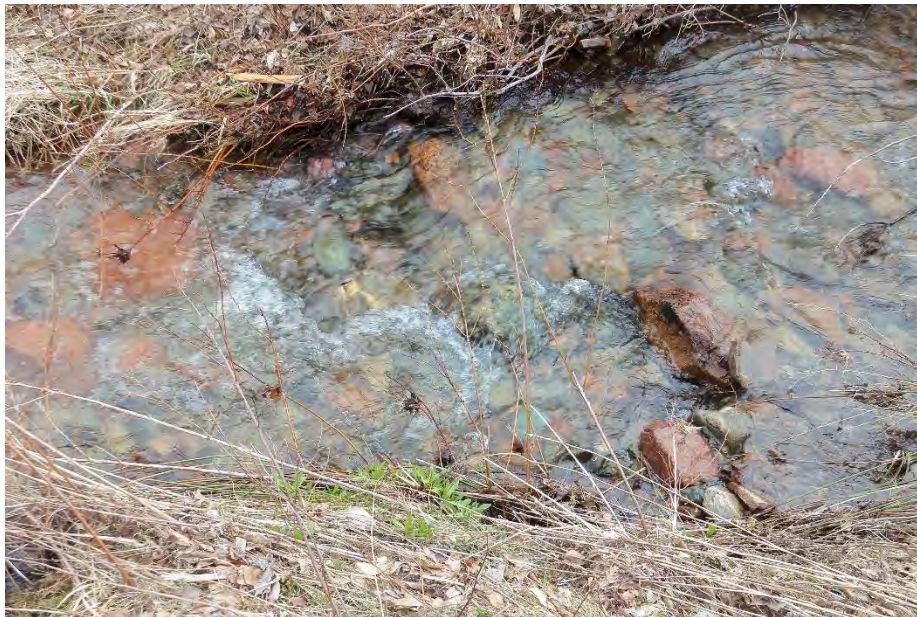
Photo 8. Watercourse 3 (Site SWC2) upstream of Westchester Road, showing substrate, May 4, 2022.

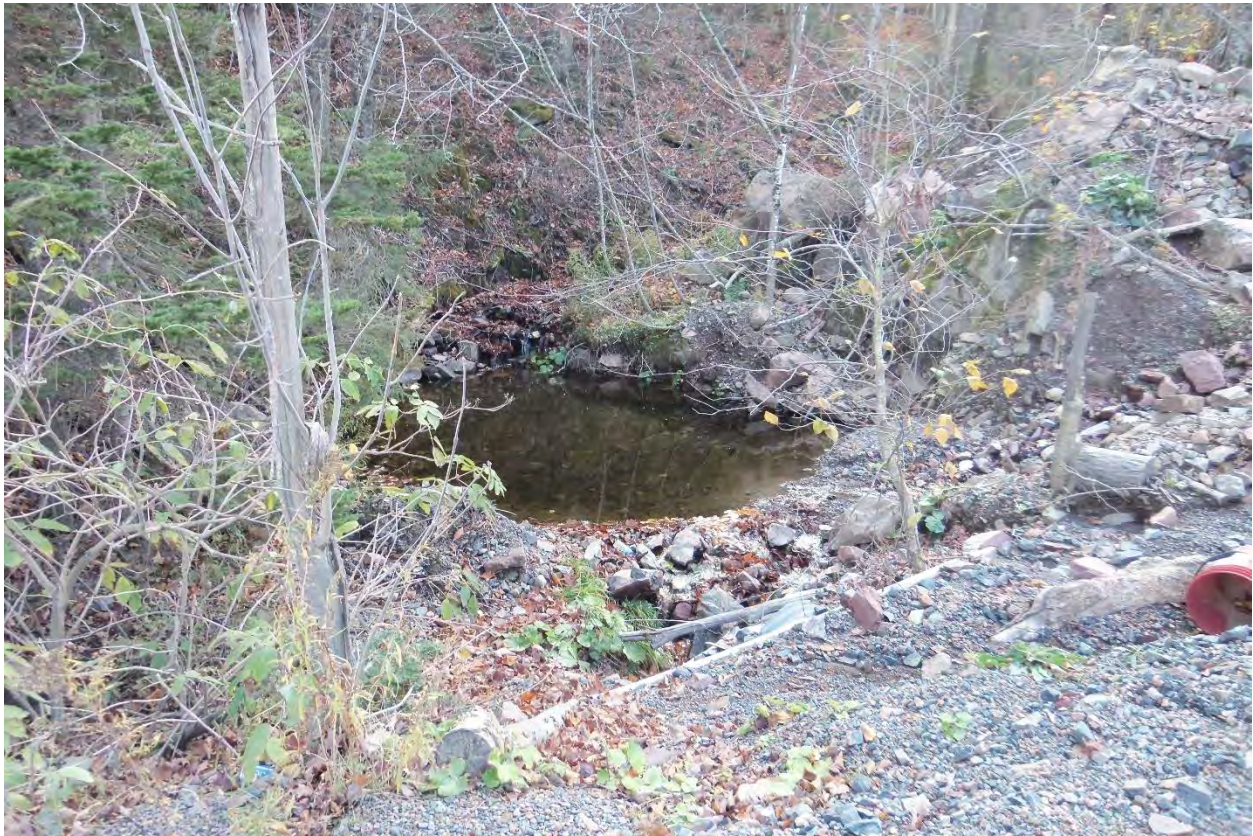
It originates in a headwater area adjacent to blueberry fields. After passing the Quarry, it flows under the quarry access road in a subsurface flow where an existing culvert is partially blocked. A small pool/pond is located immediately upstream of the access road (Photo 9) upstream of the partially blocked culvert. The Quarry floor is largely level or slightly sloping to the northwest. Precipitation entering the quarry leaves the site primarily through percolation into fractures in the bedrock to enter the water table; however excess runoff is channeled off site to the northwest². The access road leaves the level floor of the quarry on the northeast side and has a downhill slope towards and past Watercourse 1, eventually reaching Westchester Road.

Photo 9. Pool/Pond in Watercourse 1 upstream of access road, showing encroachment by road, October 30, 2021. Photo is taken from the road surface looking upstream.

No changes to the existing Quarry access road which crosses the subject watercourse are required. The addition of a berm on the southeast side to separate the road from the upstream watercourse edge would prevent surface water from the road from entering the watercourse, and may lead to a reduction in conductivity levels in the water further downstream in the watercourse.

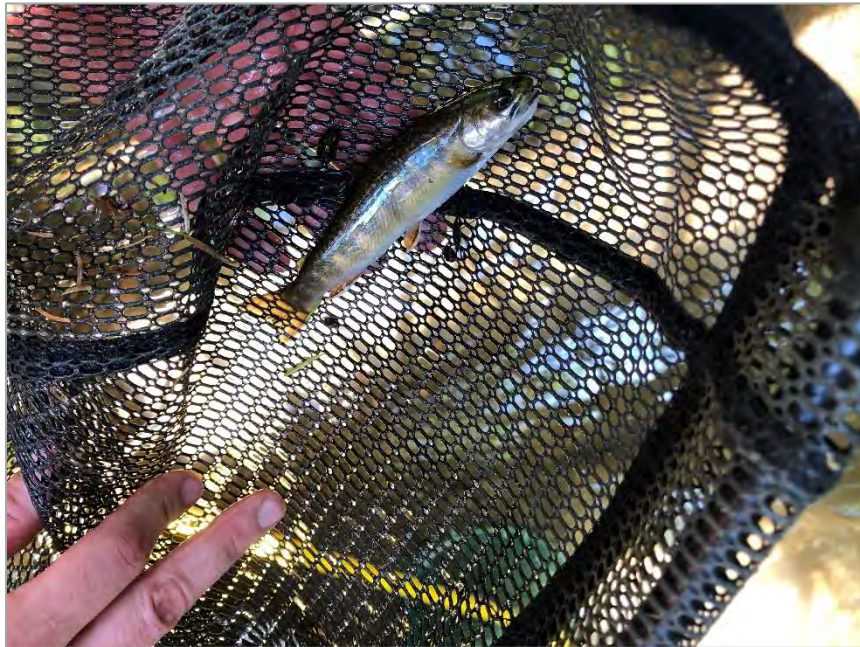
Figure 3. Brook trout netted below Westchester Road in unnamed stream 1, during the fish survey. July 13, 2022.

Electro-fishing was carried out along unnamed streams 1 and 2 (Figure 2) on both survey days. Both lower and upper reaches (below and above Westchester Road) were surveyed in July and upper reaches only in September⁶. Three (3) brook trout and four (4) unidentified fish (likely trout but they escaped before identification could be determined) were observed at sites below Westchester Road, along unnamed stream 1 (Table 1, Figure 2 and Figure 3). One (1) brook trout was caught below Westchester Road, along unnamed stream 2 (Figure 2) and others were periodically seen as well. No fish were caught in streams above Westchester Road, on either survey day. No species at risk (i.e., Atlantic Salmon) were observed during the surveys.

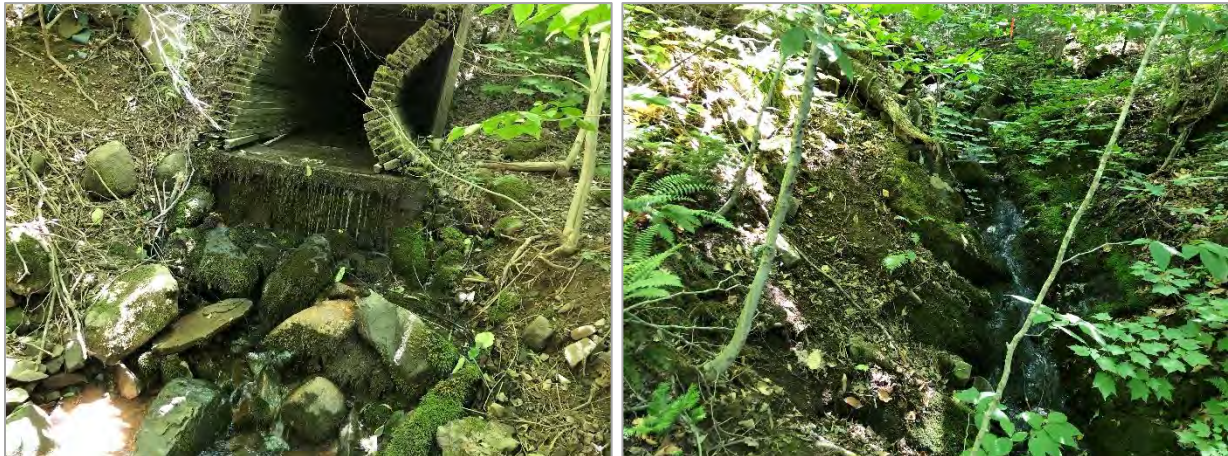
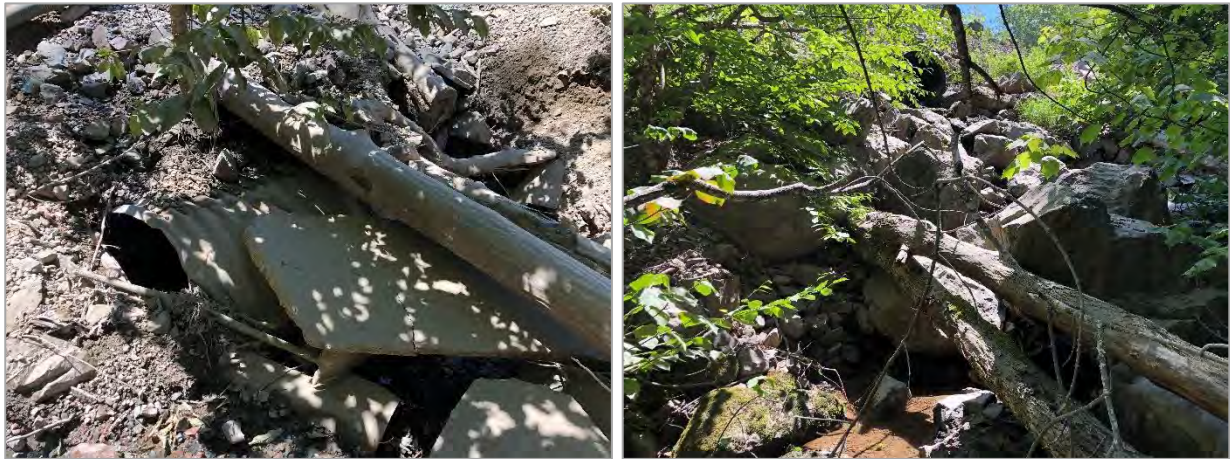
Along unnamed stream 1, numerous barriers to fish passage were observed (hanging culverts, steeply sloped rock waterfall, etc.) (Figures 2 and 4). In unnamed stream 2, a hanging culvert with a drop of 1.5 m was also present (Figure 5). Therefore, the upper reaches of both streams (above Westchester Road) were determined not accessible to fish due to the type and size of barriers present.

Figure 4. Fish barriers along unnamed stream 1. *Top left photo*, downstream end of culvert below Westchester Road, a hanging culvert 1+ m above the streambed. *Top right photo*, a steeply sloped rock waterfall in upper reaches of unnamed stream 1 (above Westchester Road). *Bottom left photo*, upstream end of the hanging culvert positioned under the Westchester quarry access road; it was partially blocked by sediment during both survey days. *Bottom right photo*, downstream end of the quarry access road culvert, which was 2+ m above the streambed. July 13, 2022.

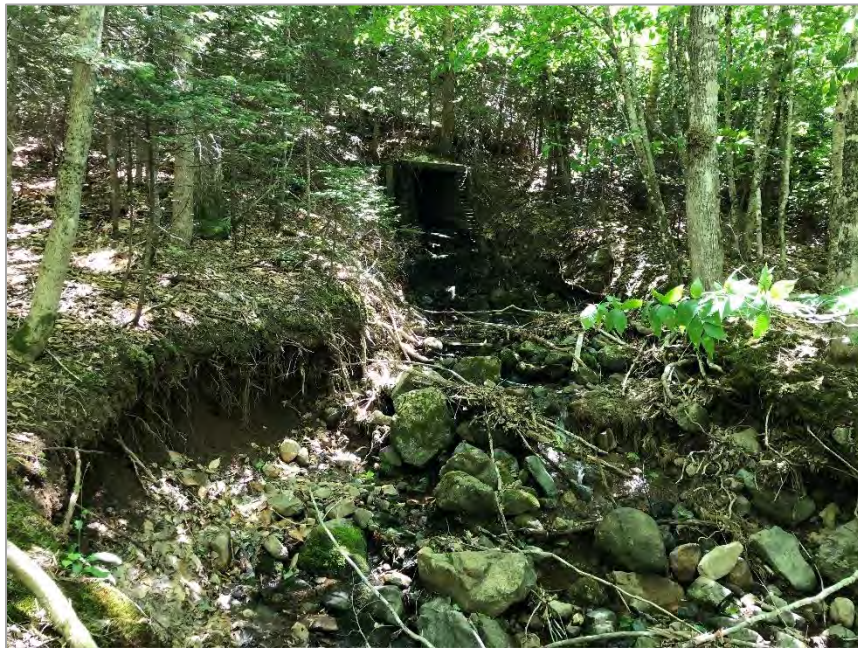
Figure 5. Downstream end of culvert below Westchester Road; a hanging culvert along unnamed stream 2, situated approximately 1.5 m above the streambed creating a barrier to fish. July 13, 2022.

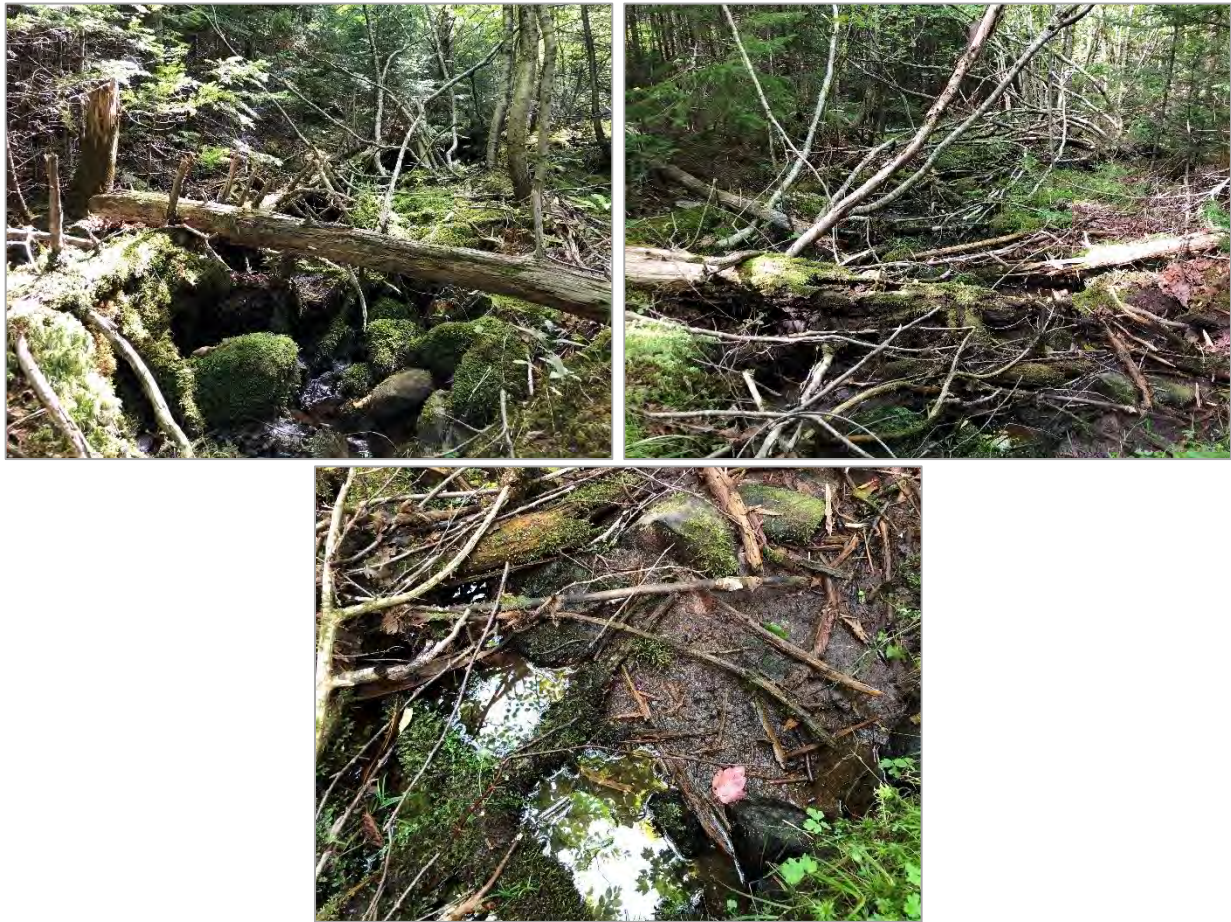
**Photo 1. Site US1 on unnamed stream 1; upstream, downstream and substrate views (top left, top right and bottom photos).
September 12, 2022.**

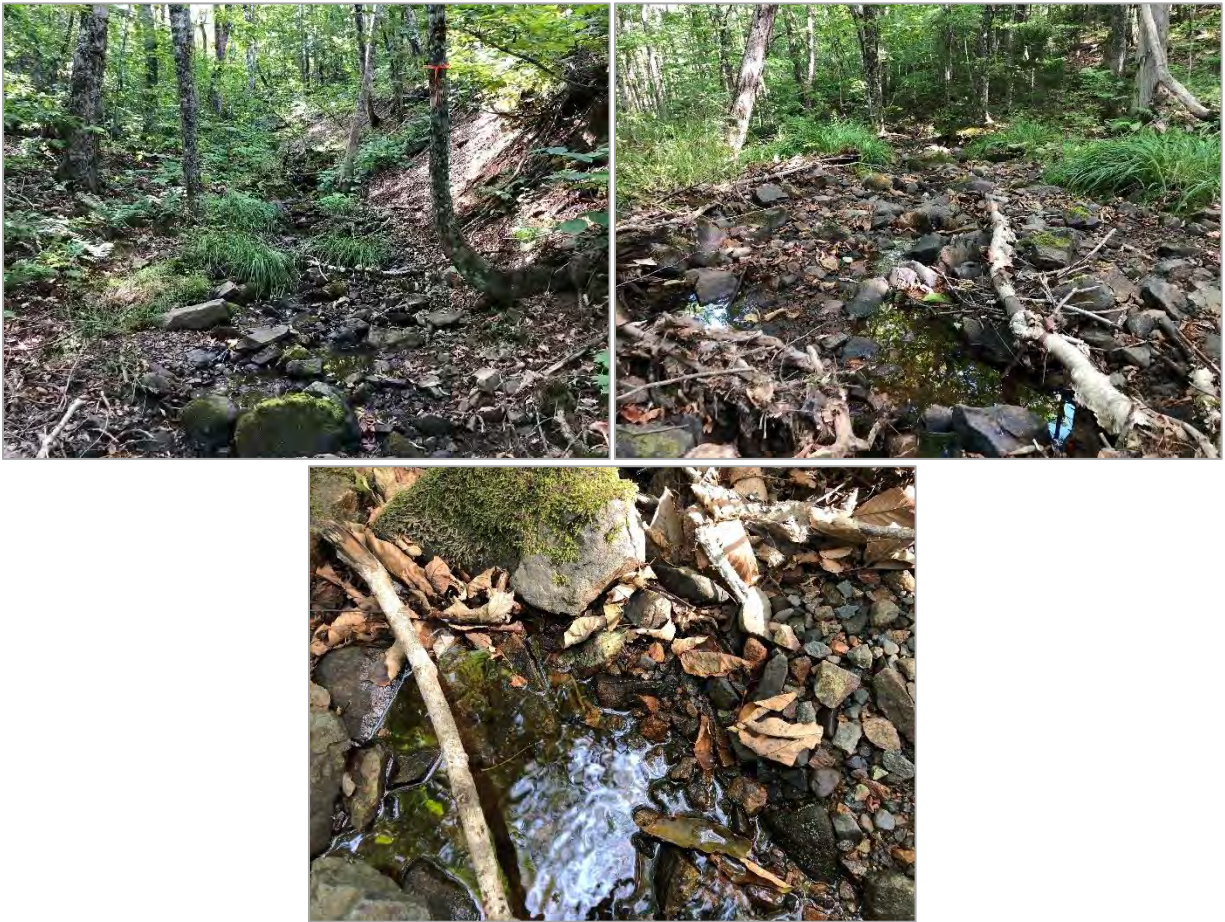
**Photo 2. Site US2 on unnamed stream 1; upstream, downstream and substrate views (top left, top right and bottom photos).
September 12, 2022.**

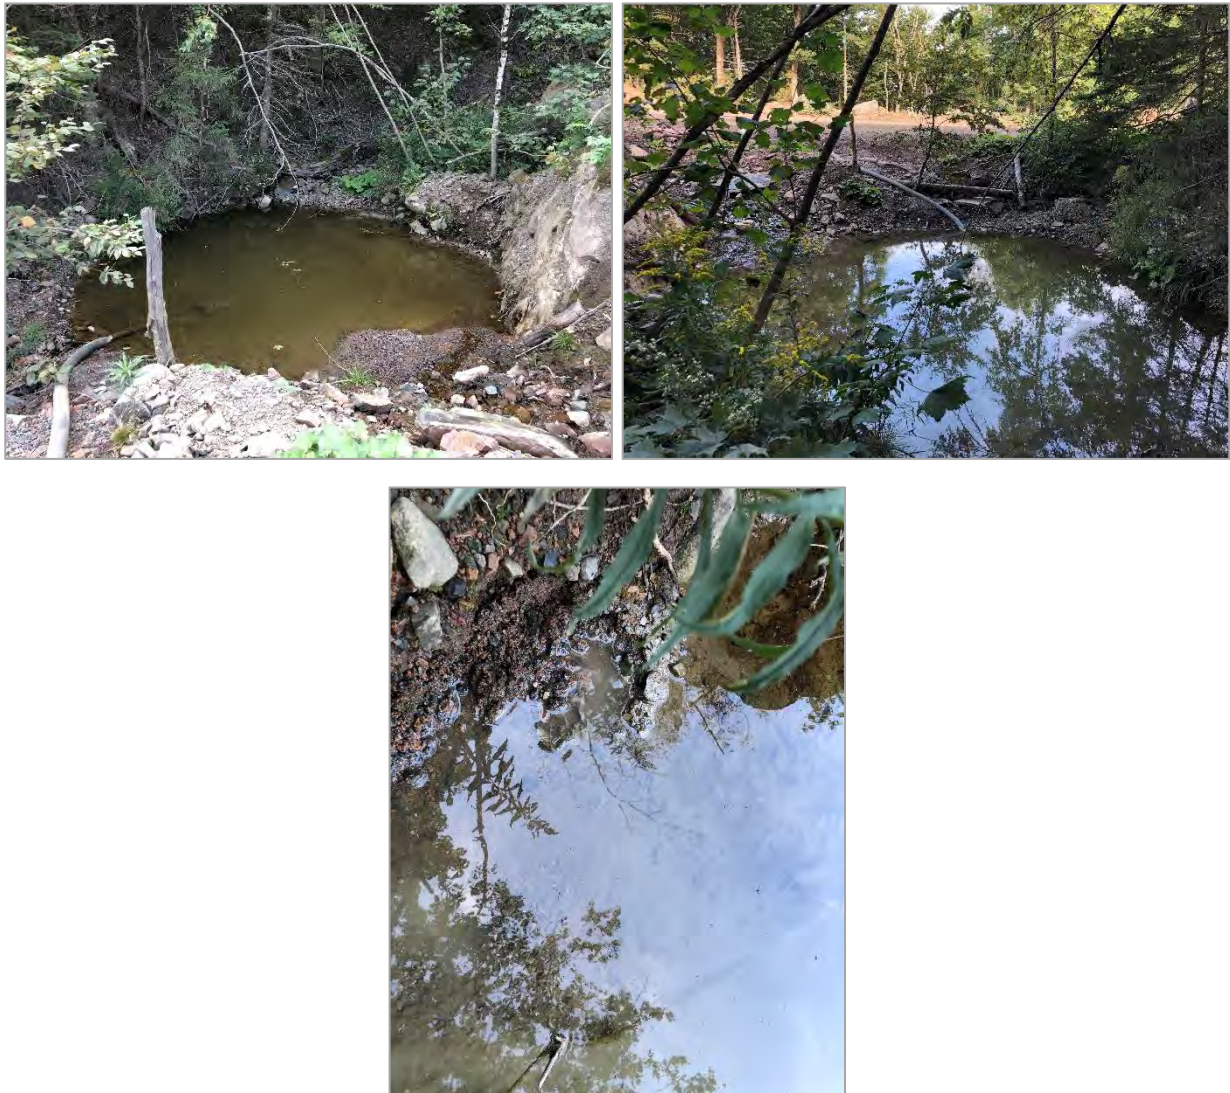
Photo 3. Site US Pond on unnamed stream 1; upstream, downstream and substrate views (top left, top right and bottom photos). September 12, 2022.

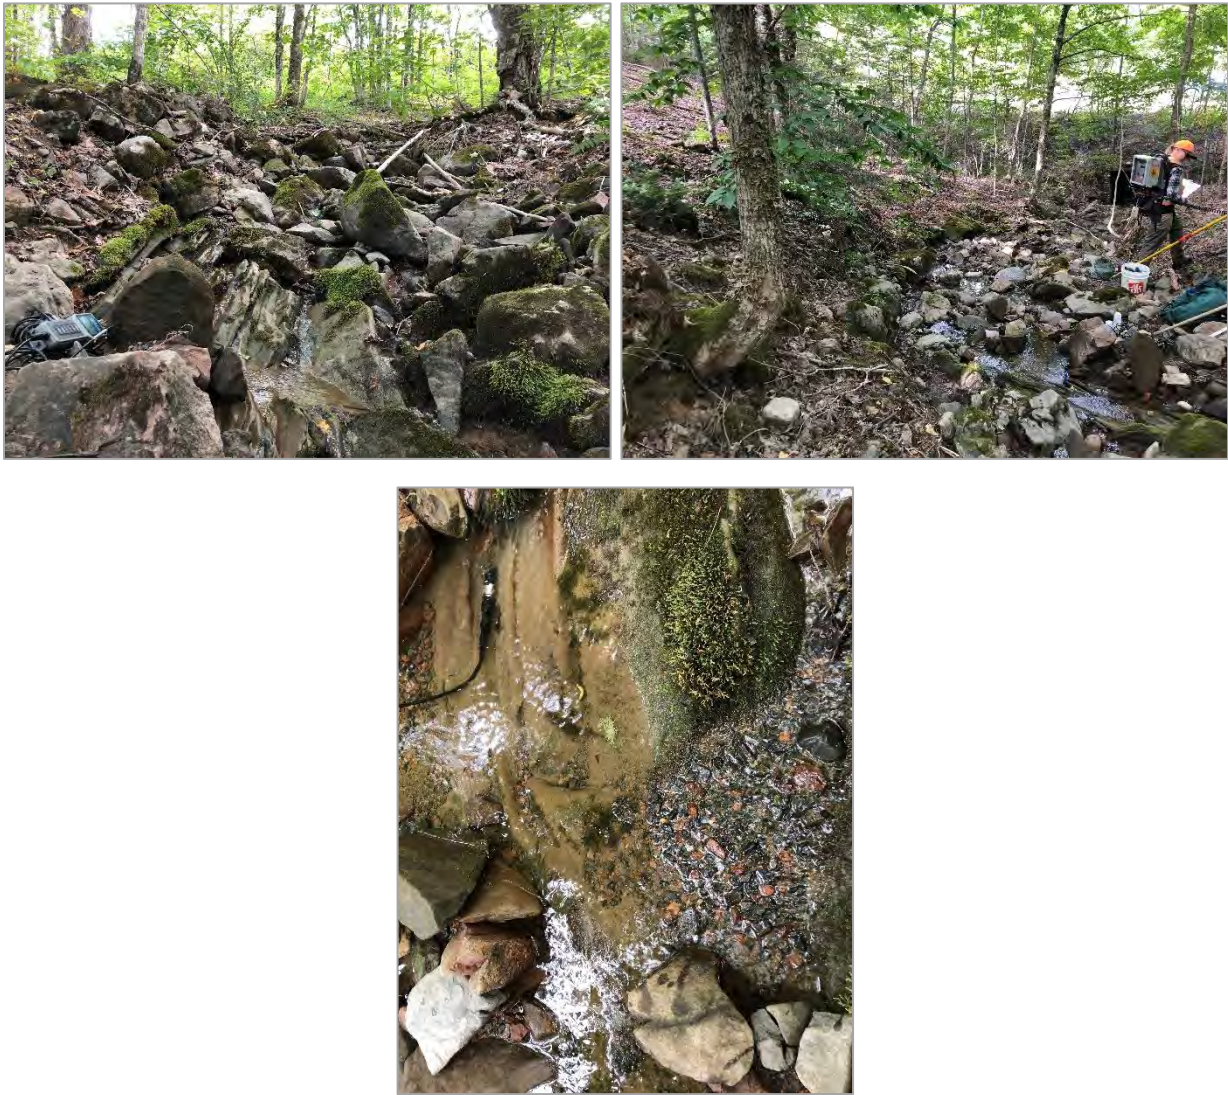
**Photo 4. Site DS1 on unnamed stream 1; upstream, downstream and substrate views (top left, top right and bottom photos).
September 12, 2022.**

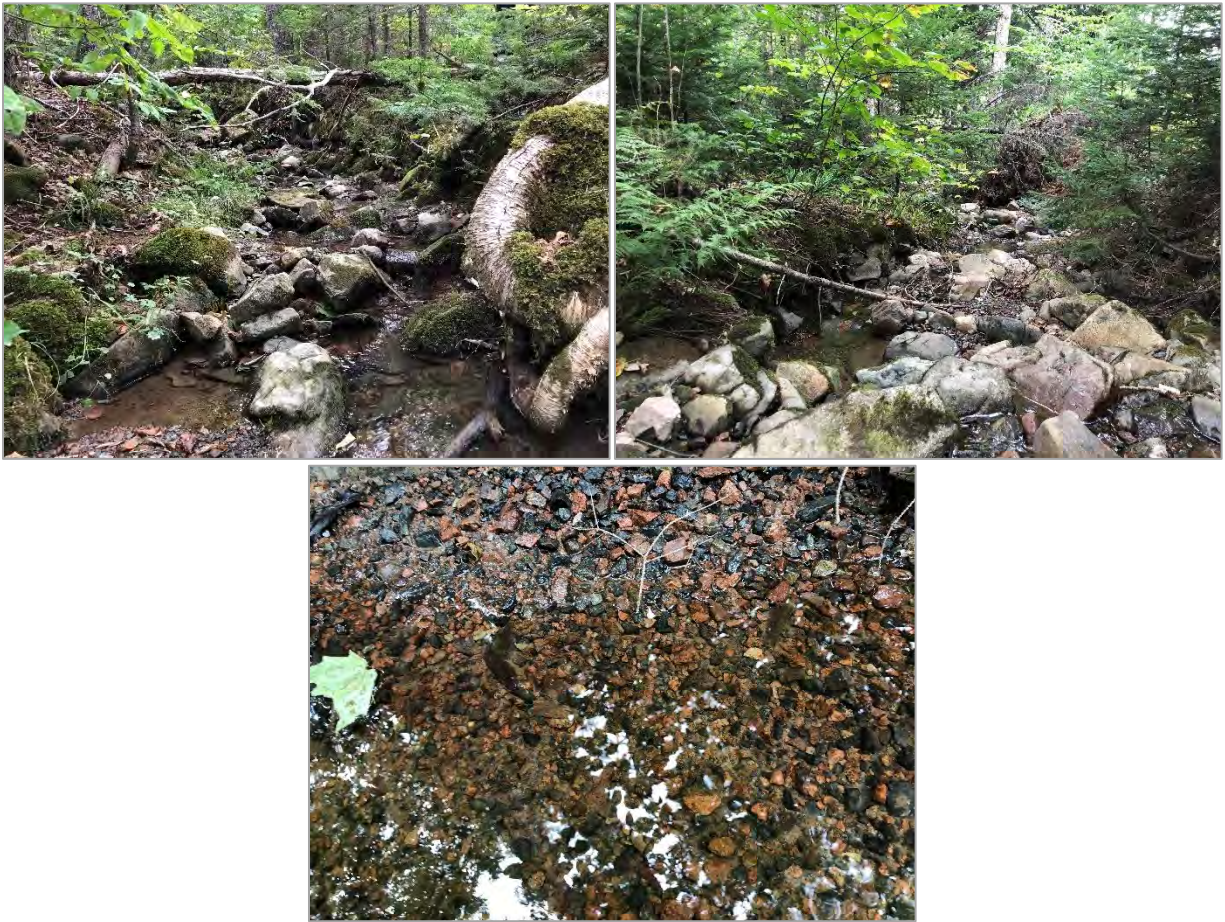
**Photo 5. Site DS2 on unnamed stream 1; upstream, downstream and substrate views (top left, top right and bottom photos).
September 12, 2022.**

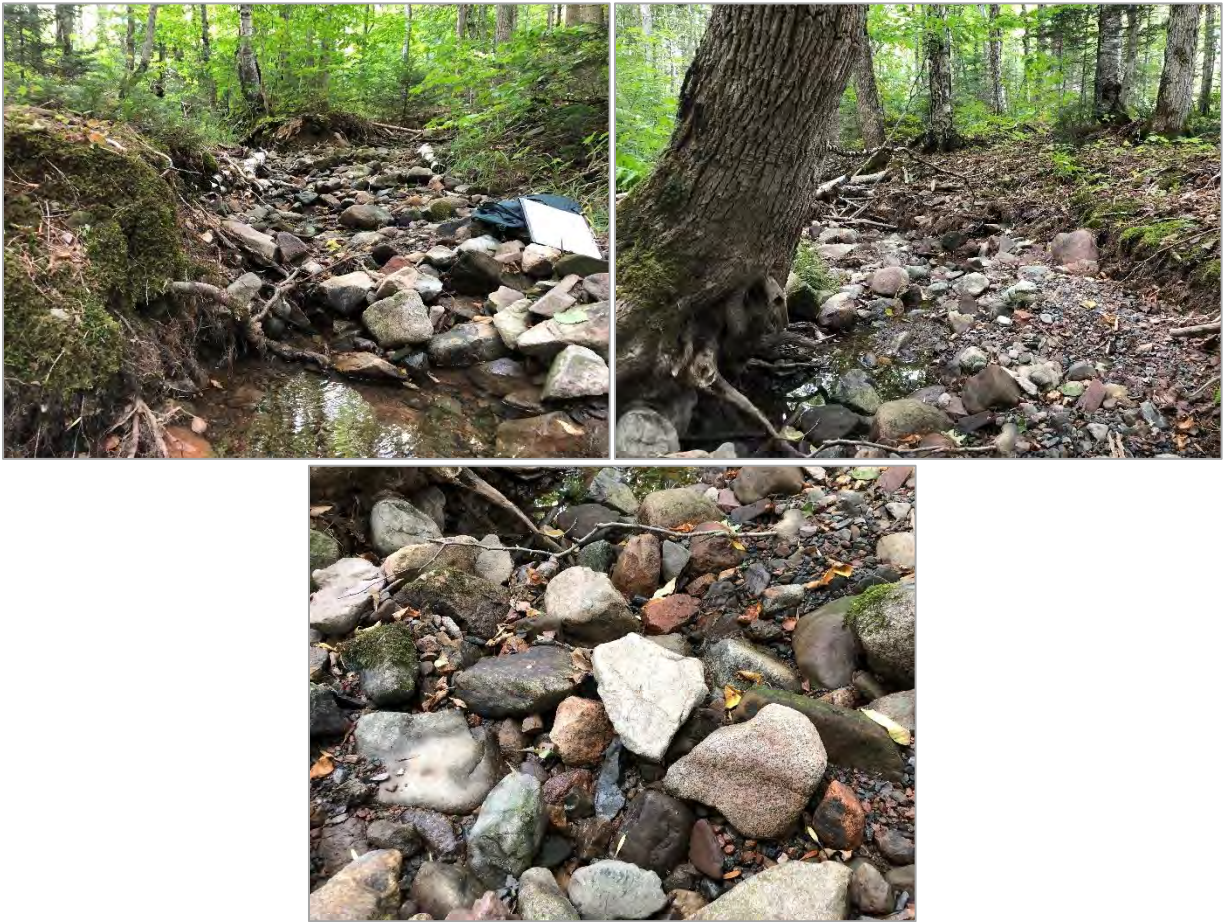
Photo 6. Site DS3 on unnamed stream 1; upstream, downstream and substrate views (top left, top right and bottom photos).
September 12, 2022.

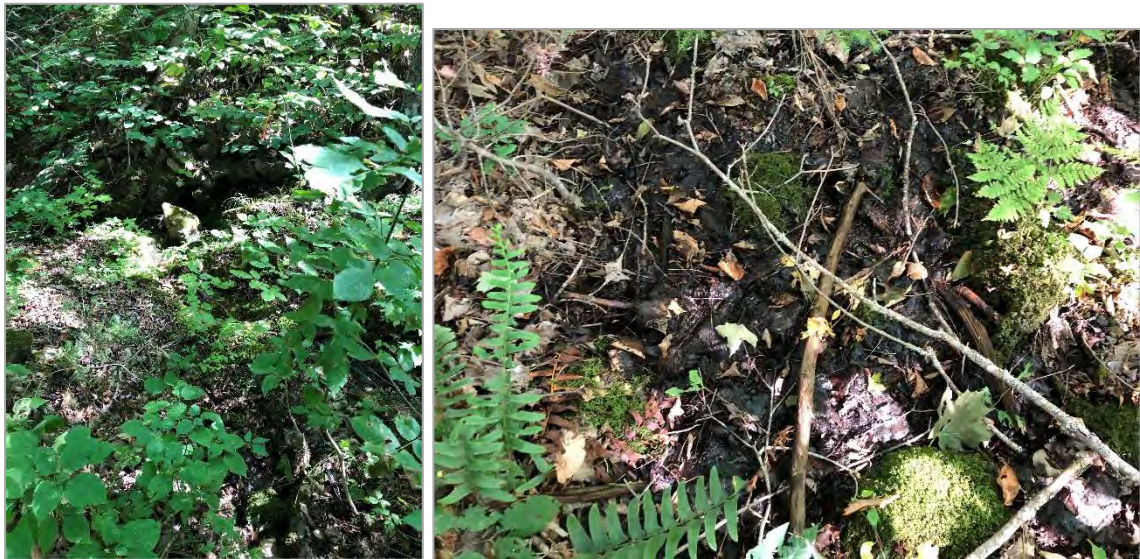
Flow channels leading to the stream and wet areas along stream embankments were observed in upper and lower reaches, which would provide sources of water and nutrients to the stream during higher flow periods. See Figure 1 for locations and Appendix A for photos.

Photo 7. *Left photo:* Evidence of flowage down embankment leading to the streambed of unnamed stream 1. *Right photo:*
wet patch on embankment. Area above site US2 adjacent to the Quarry. September 12, 2022.
