APPENDIX C – COMPREHENSIVE WATER QUALITY MONITORING PROGRAM – 2022

COMPREHENSIVE WATER QUALITY MONITORING—WESTCHESTER QUARRY

Suspended Sediment and Conductivity Monitoring of
Streams Adjacent to the
Chapman Brothers Westchester Quarry,
2327 Westchester Road
Rose, Nova Scotia

NOVEMBER, 2022

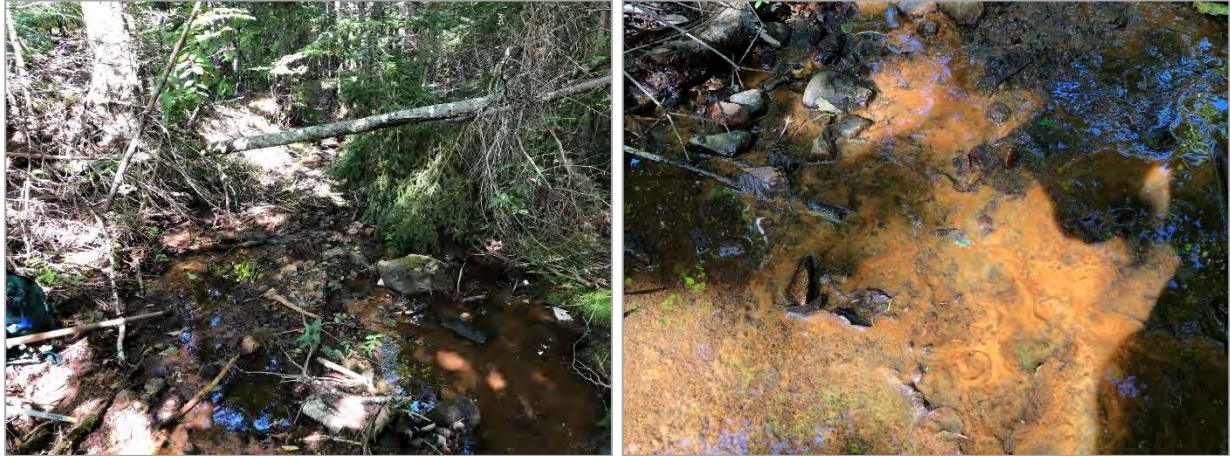
At site US1, oxygen levels were high and temperatures were cool despite low flows at the time of September sampling indicating potential groundwater influence and mixing of ground water (spring water) and surface water. In the stream below the road/trail crossing [noted earlier as having caused flooding because of a partially blocked or damaged culvert which had restricted downstream flow], there was minimal water present in the stream and iron flocculant and a manganese sheen were observed on the stream bottom, indicating groundwater influence.

Photo 8. Flocculated iron and manganese seen on bottom substrate of unnamed stream 1 (below old road/trail), indicating groundwater influence. September 12, 2022.

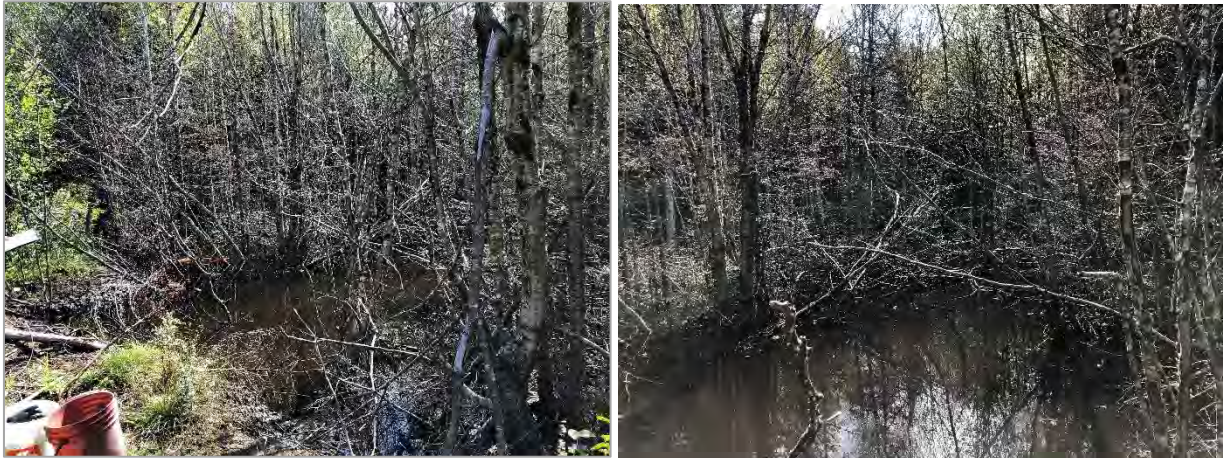
A short distance downstream of US1, an area upstream of an old road/trail crossing the stream, was flooded due to partial blockage of a culvert (Figure 2). Low flow and evidence of sedimentation was present immediately downstream of the road/trail. Further downstream was litter (tarps, plastics and geotextile fabrics in the stream), which caused additional unnatural blockage, leading to accumulation of fine sediment.

Photo 9. Flooding immediately above old road/trail, below site US1. September 12, 2022.

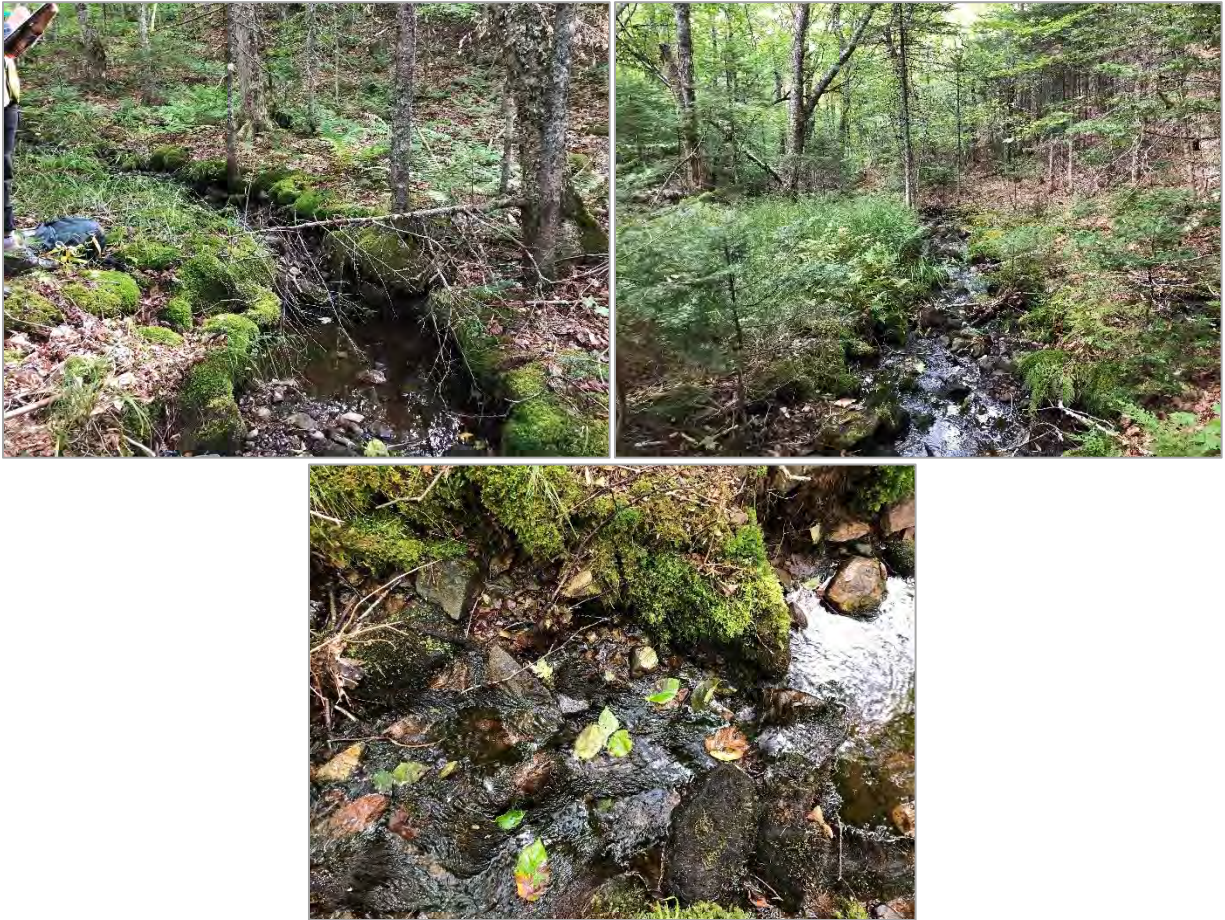
Photo 10. Site 2-US1 on unnamed stream 2; upstream, downstream and substrate views (top left, top right and bottom photos). September 12, 2022.

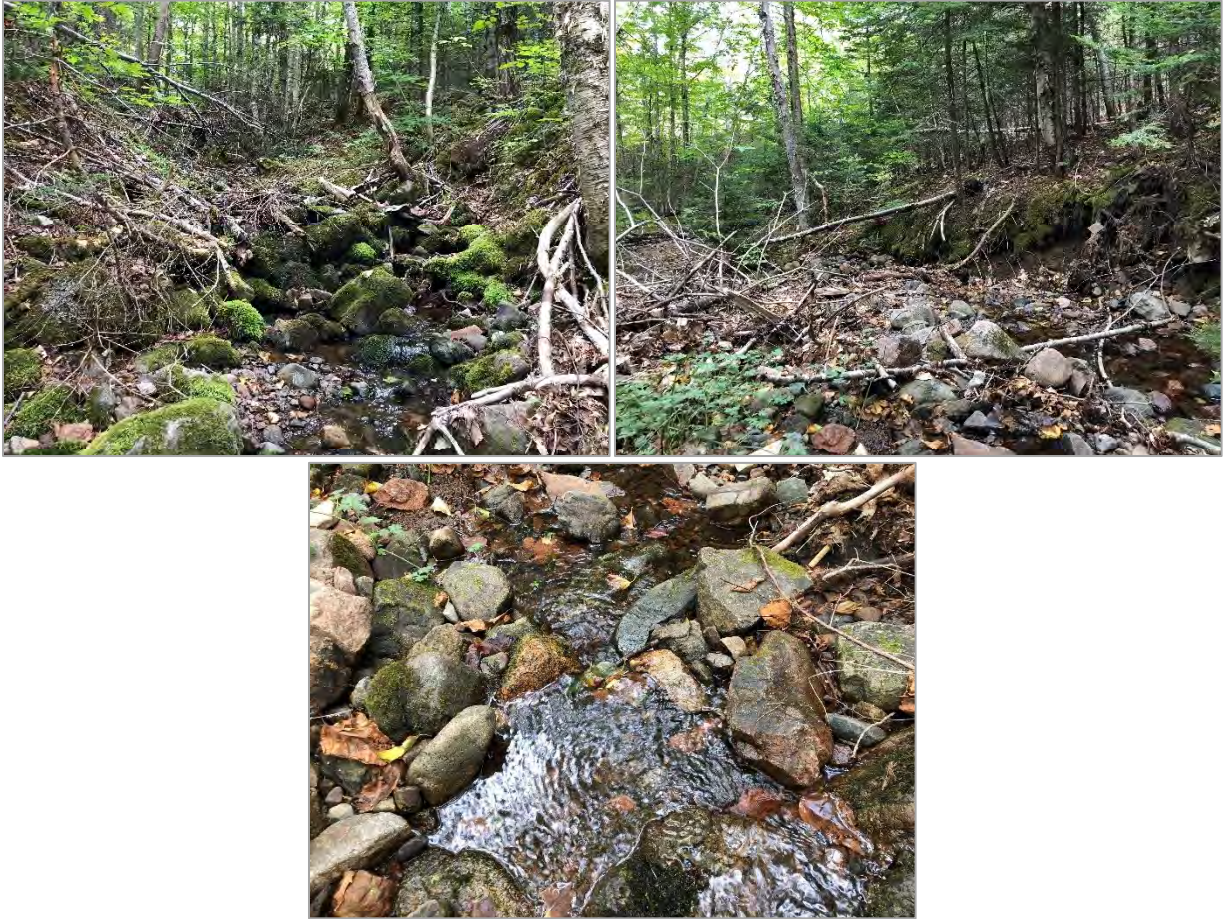
Photo 11. Site 2-DS1 on unnamed stream 2; upstream, downstream and substrate views (top left, top right and bottom photos). September 12, 2022.

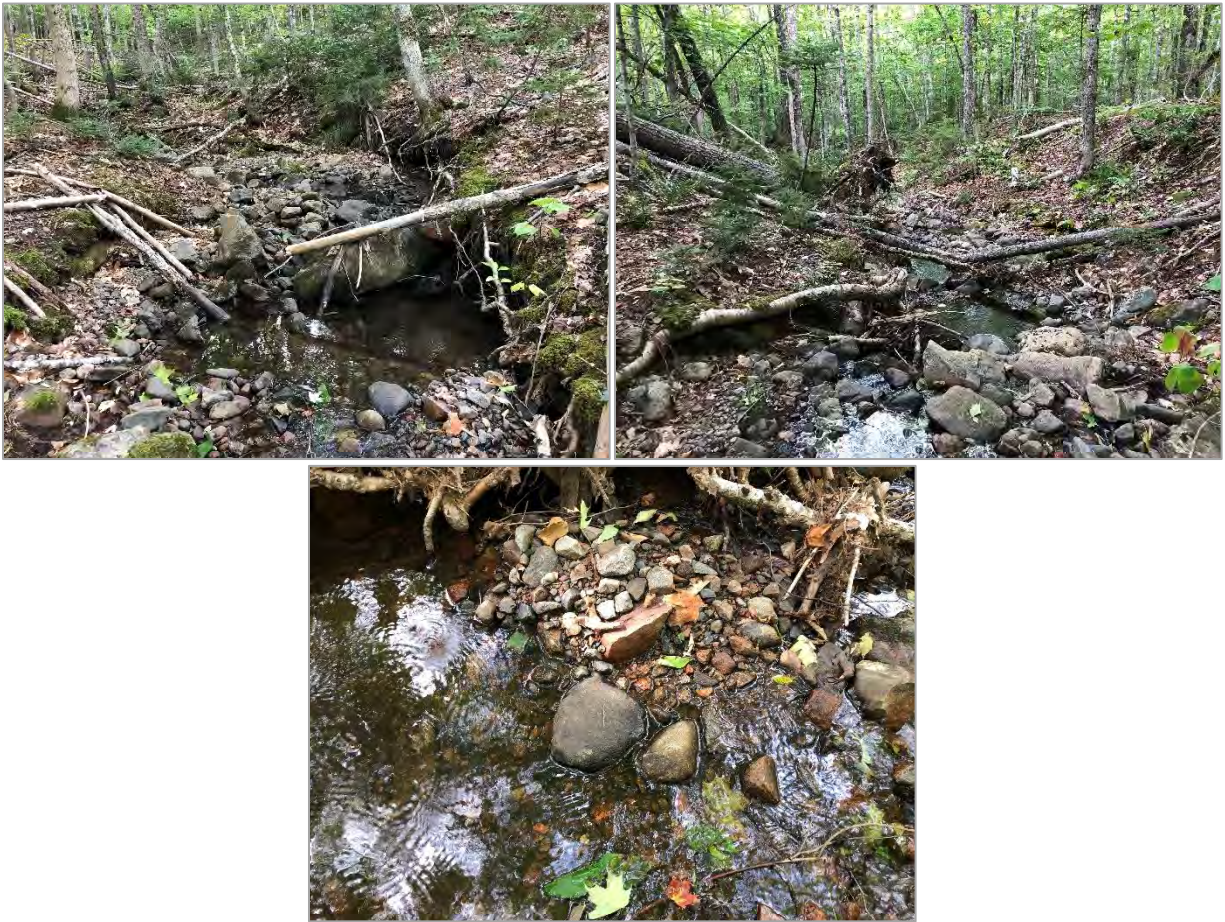
Photo 12. Site 2-DS2 on unnamed stream 2; upstream, downstream and substrate views (top left, top right and bottom photos). September 12, 2022.

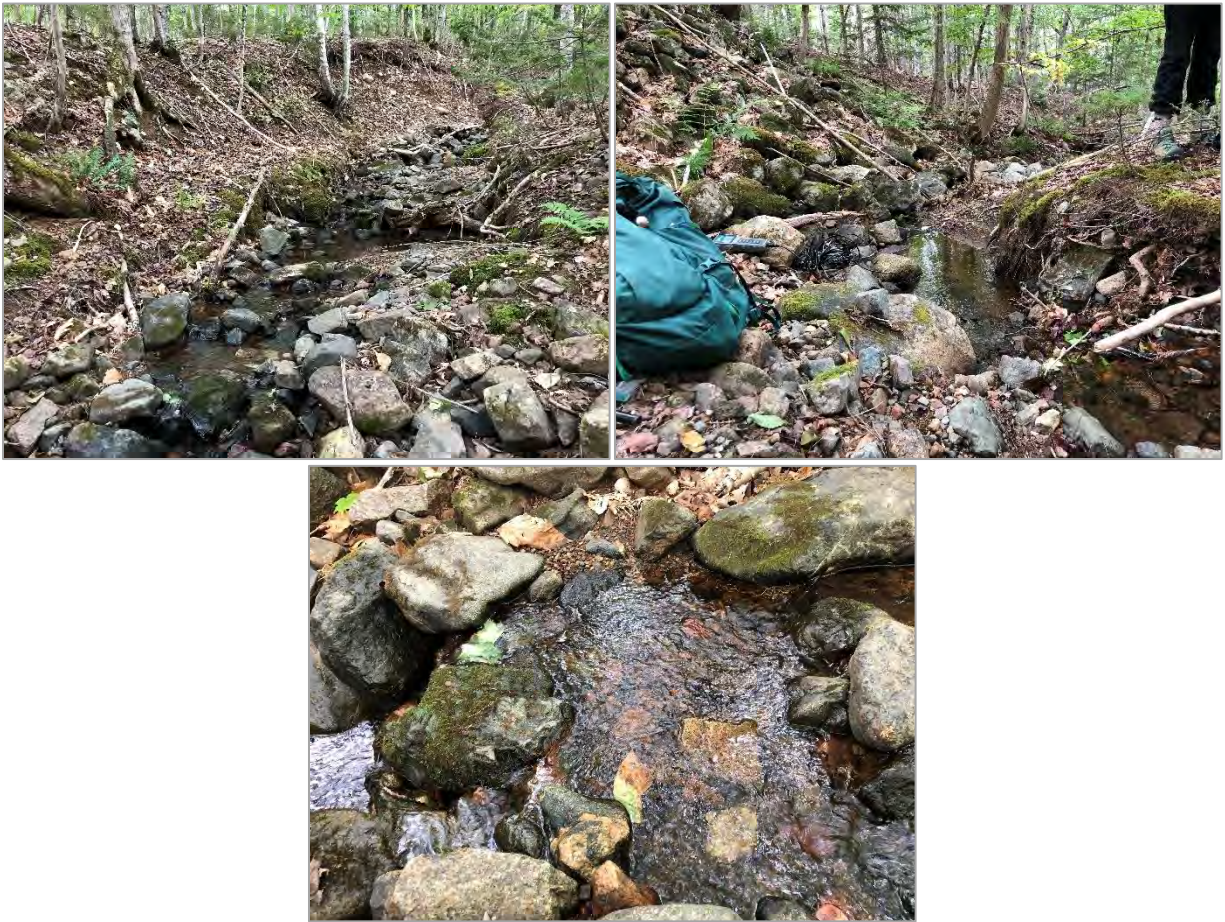
Photo 13. Site 2-DS2B on unnamed stream 2; upstream, downstream and substrate views (top left, top right and bottom photos). September 12, 2022.

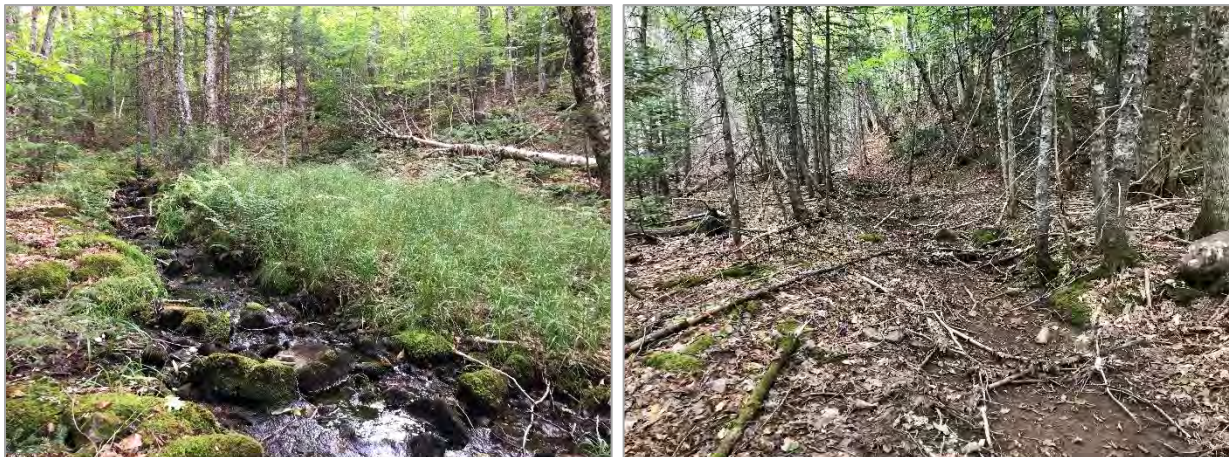
Photo 14. *Left photo*: small wetland in riparian area at the toe of the slope. *Right photo*: Dried channel adjacent to unnamed stream 2; evidence of flow off slope during higher flow times. September 12, 2022.
