Environmental Assessment Home Hardware Stores Limited Warehouse & Distribution Centre Expansion

Debert Air Industrial Park

Nova Scotia Environment

September 2011

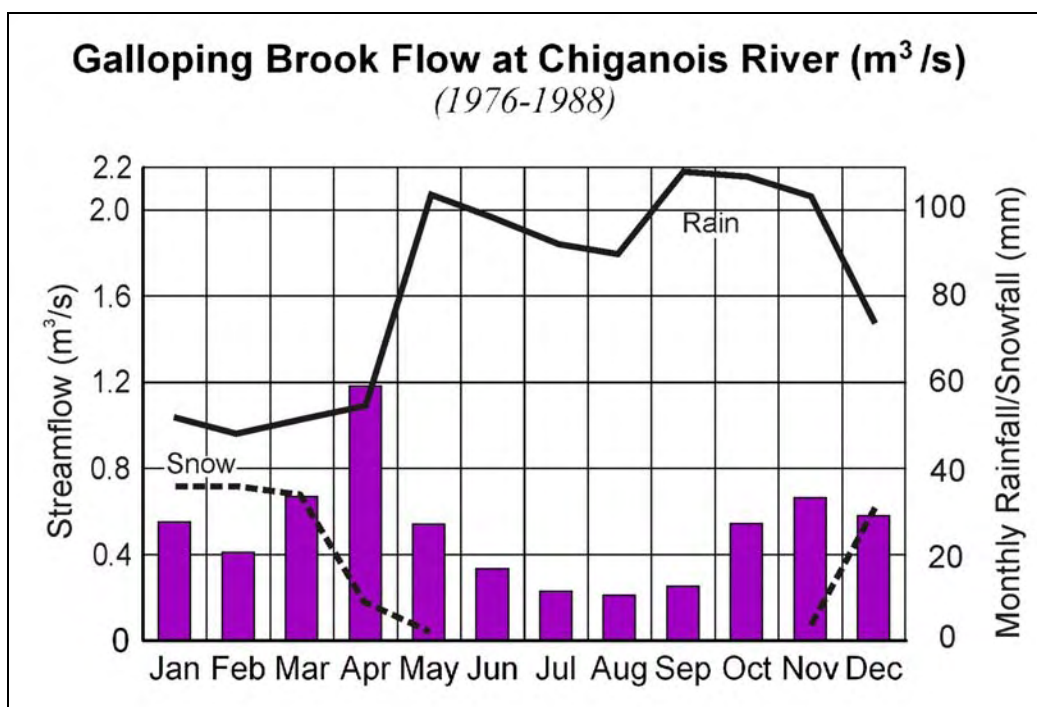
Figure 3. Estimated average monthly flow (m^3/s) of Galloping Brook, at Chiganois River, 1976-1988 and monthly precipitation. Based on watershed area of 16.2 km^2 and flows in North River, Colchester County (Environment Canada 1989 & Water Survey of Canada, www.ec.gc.ca/rhc-wsc). Precipitation from www.climate.weatheroffice.gc.ca/climate_normals/.

The Minas Lowland in which the project is located is drained by several rivers including the Debert and the Chiganois which originate in the Cobequid Uplands to the north, flowing through the area to discharge in Cobequid Bay of Minas Basin. The project site is at the head of the watershed of the Chiganois River, draining through an intermittent stream into Galloping Brook which flows into MacElmon's Pond and thence into the Chiganois River. Peak runoff occurs in the March-May period with secondary peaks in the winter (October-January) period (Figure 3).

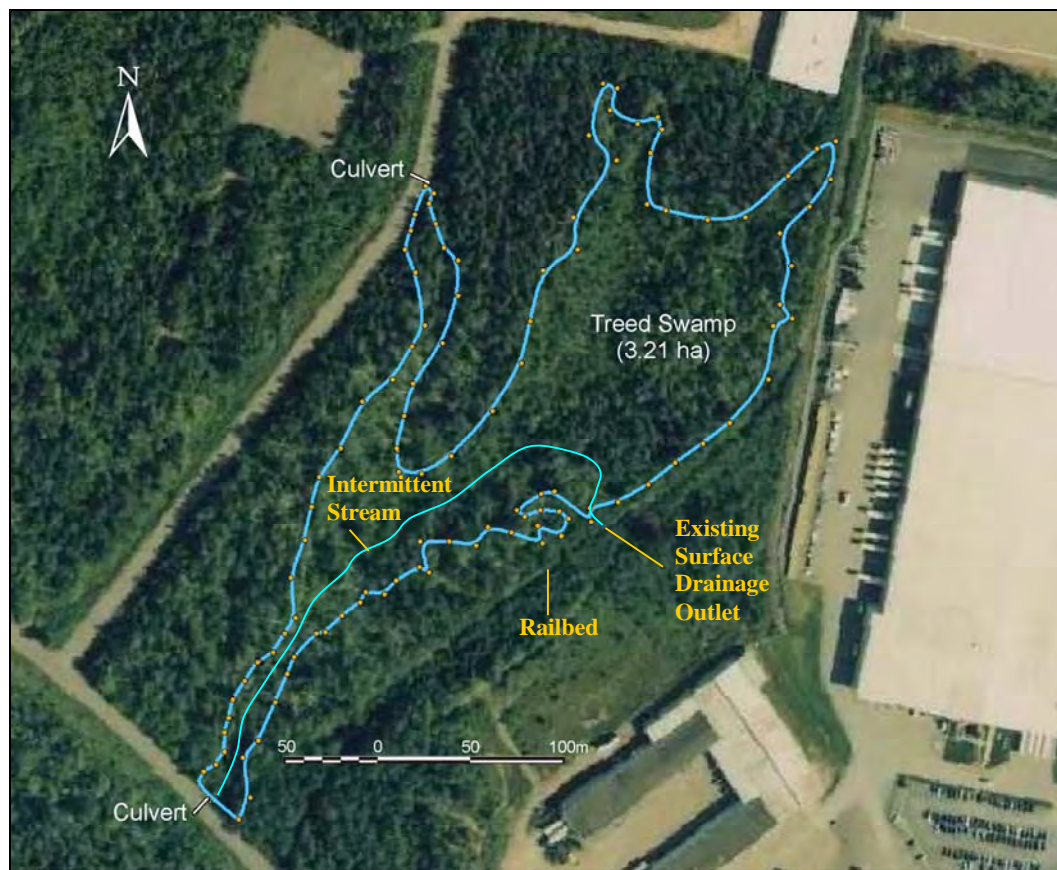
Figure 4. Wetland and surface water features on project site.

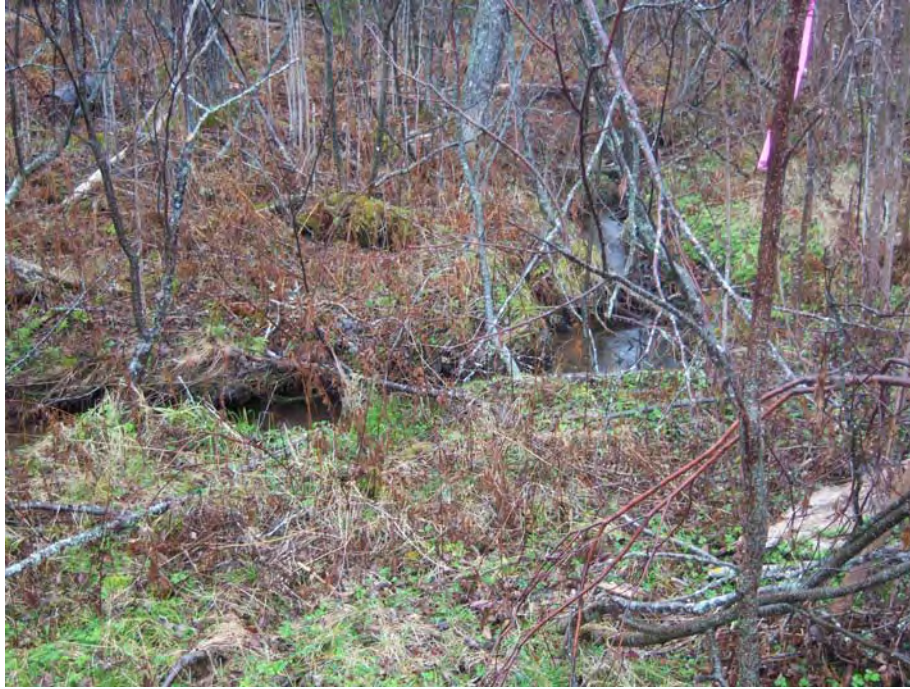
Figure 7. Intermittent stream at Plains Road, November 16, 2010.

Table 1. Water quality measurements of intermittent stream upstream and downstream of Plains Road at study site, November 16, 2010.		
Site Location	Upstream	Downstream
Temperature °C	6.7	6.6
Saturation %	82.2	80.2
Dissolved Oxygen (mg/L)	9.9	9.9
Conductivity (µs)	227.2	218.6
Specific Conductivity (25° C) (µs)	348.6	336.8
TSS (mg/L)	11.0	3.0
pH	7.9	7.3

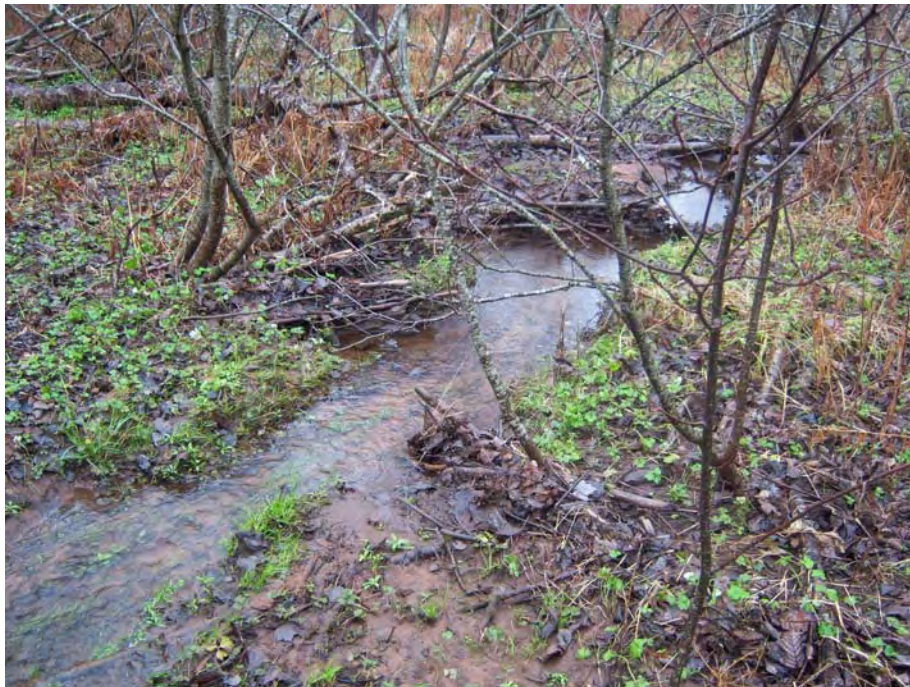
Figure 8. Intermittent stream and alder swamp below Plains Road, looking south, November 16, 2010.
