**Underwater Benthic Habitat
Survey of Caribou Harbour and
Pictou Harbour Pipeline Corridors**
Final Report

July 18, 2019
File: 121621877

Northern Pulp Nova Scotia Corporation
260 Granton Abercrombie Branch Rd.
New Glasgow, NS B2H 5C6

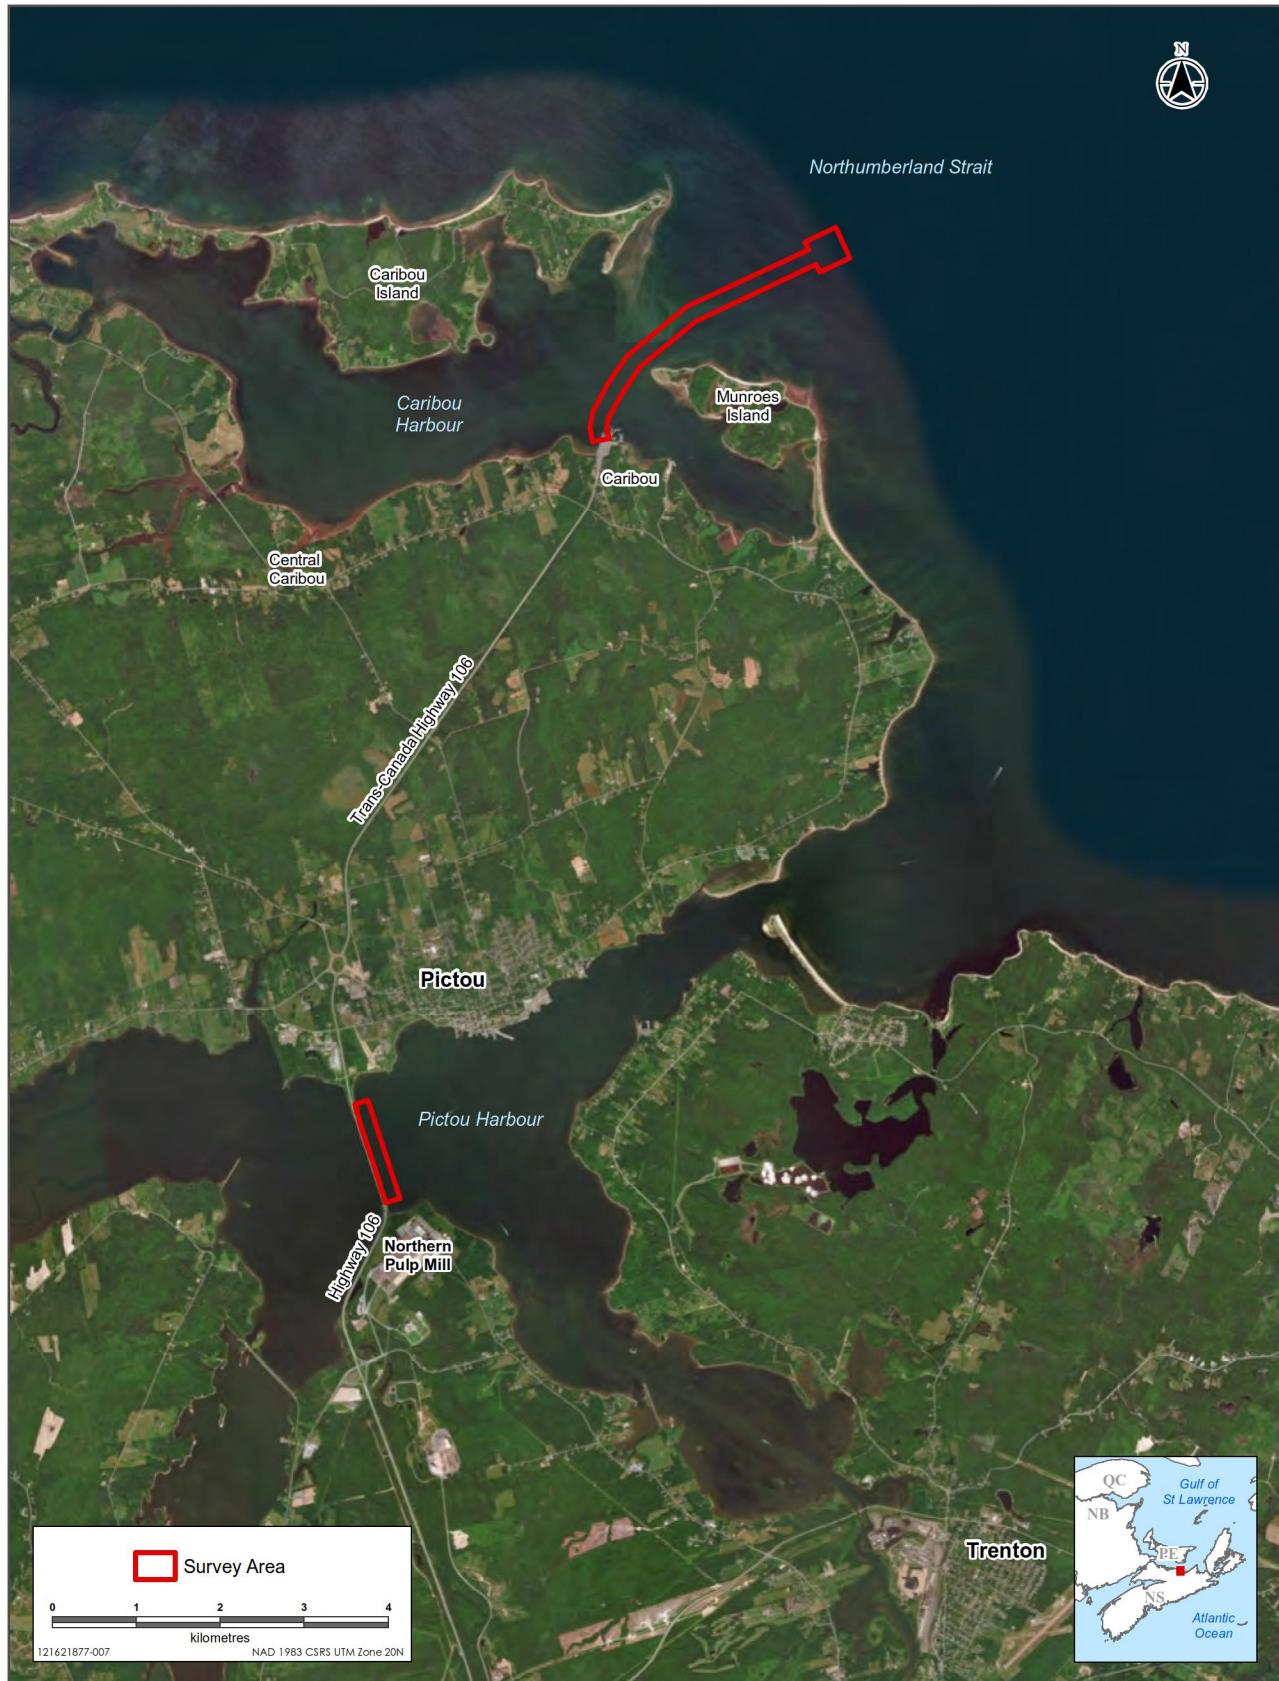
Underwater Benthic Habitat Survey Area in Caribou Harbour and Pictou Harbour

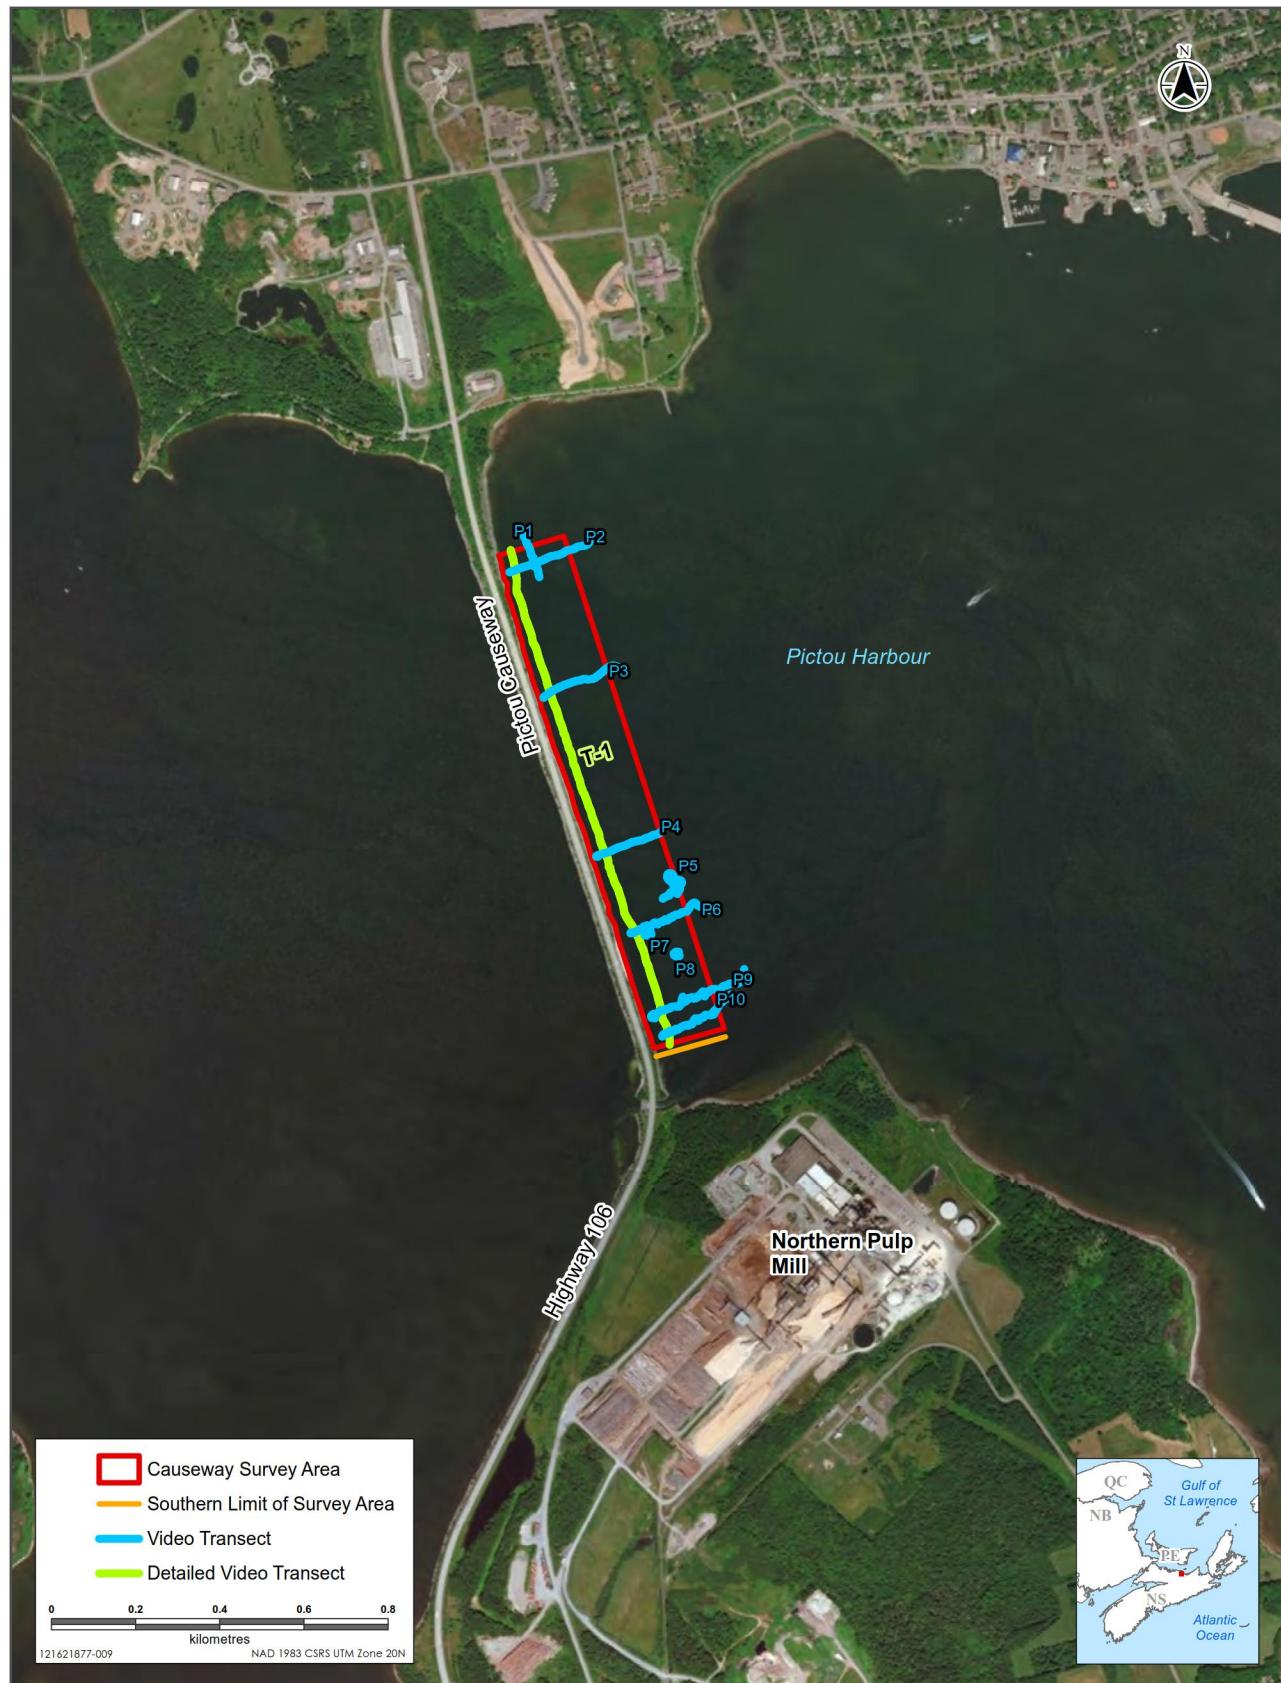
Location of Video Transects in Pictou Harbour

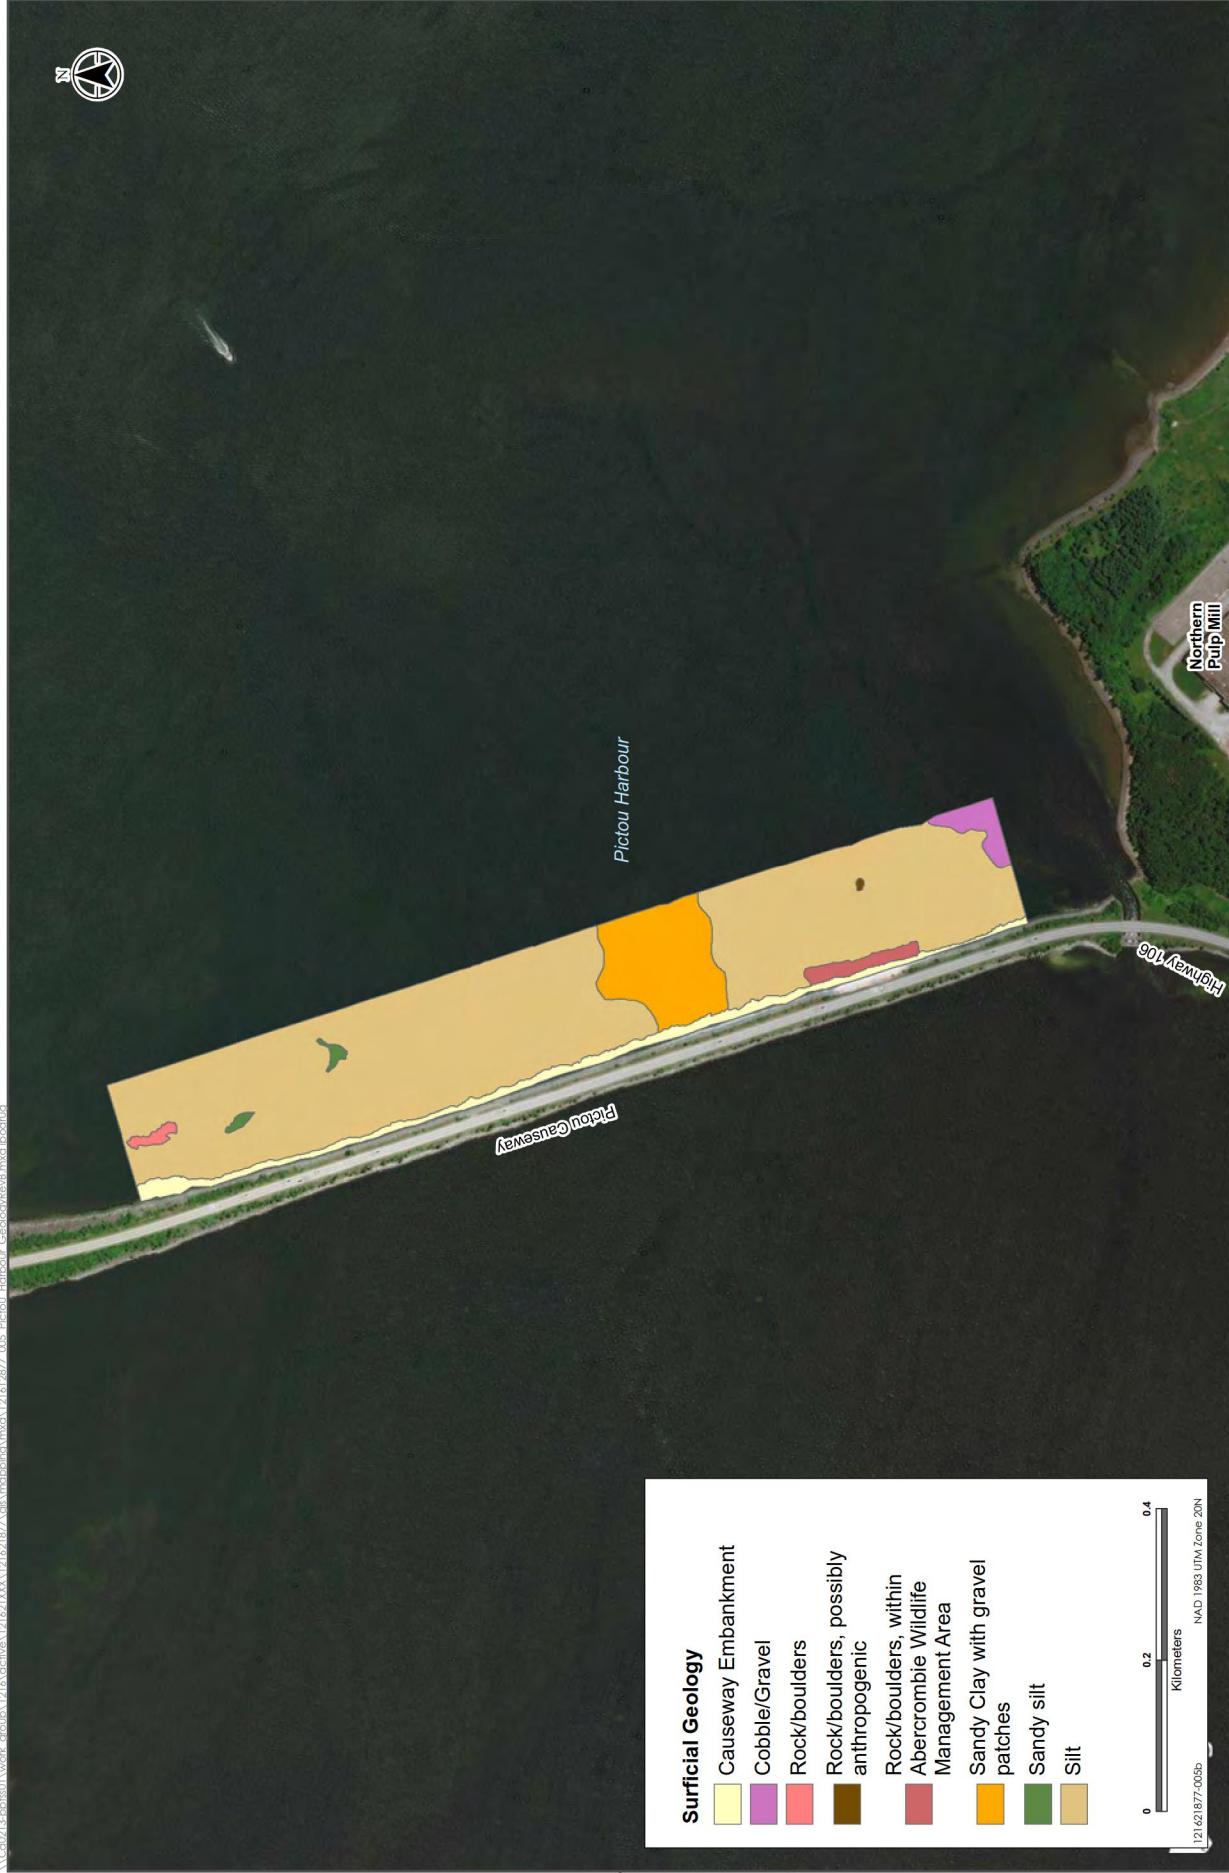
Figure 4

Surficial Geology of Pictou Harbour Pipeline Corridor from Side-scan Data

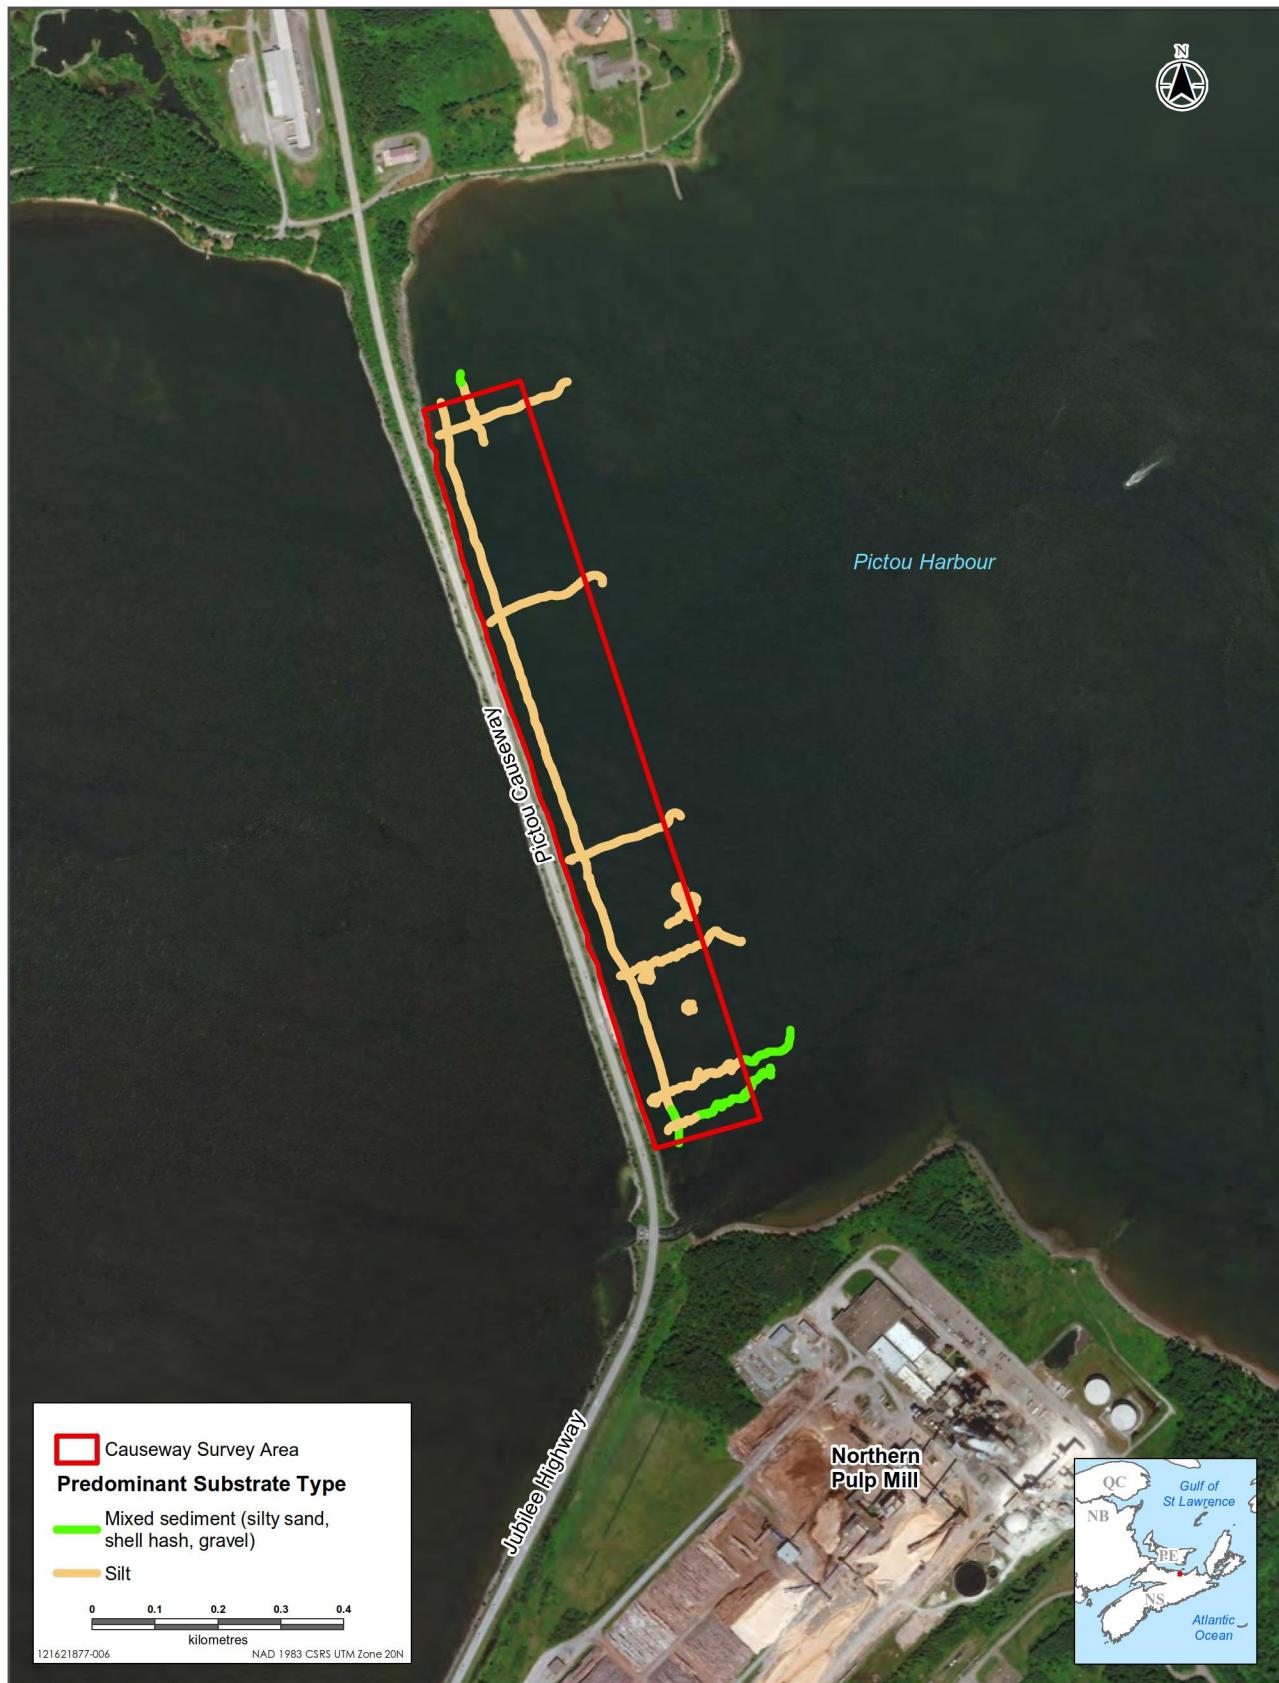
Video was collected in Pictou Harbour along the causeway within the area where side-scan data was collected. One long transect ran parallel to the causeway and additional video transects ran perpendicular to the causeway. Water depths in the surveyed area ranged from 3 to 9 m, with most of video collected in less than 5 m water depth (Figure 4). Interpretation of surficial geology from side-scan sonar data identified eight substrate types in the surveyed portion of Pictou Harbour (Figure 5). The predominant substrate types identified from the high-level video analysis in Pictou Harbour were silt and mixed sediment (silty sand, shell hash and gravel) (Figure 6). In general, the area surveyed in Pictou Harbour is a silty habitat. Benthic communities along the silty sections were composed primarily of sea stars (*Asterias forbesi*) and rock crabs (*Cancer irroratus*), which were the most commonly observed macrofaunal species. Plumose anemones (*Metridium senile*) were present on hard structures (i.e., occasional boulder or wooden structure). At the southern end of the causeway there is an opening for water to pass which also contains the fastest moving water. As a result, benthic habitat closer to this opening had less silt due to the higher water velocities. In this area with less silt, blue mussel (*Mytilus edulis*) beds were observed. Elsewhere, macroflora was covered in silt and it was not possible to determine what substrate was present under the heavy silt layer. In areas with heavy silt, holes of different sizes in the sea floor for infauna were commonly observed.

Predominant Substrate Types Surveyed Within the Pictou Harbour Pipeline Corridor

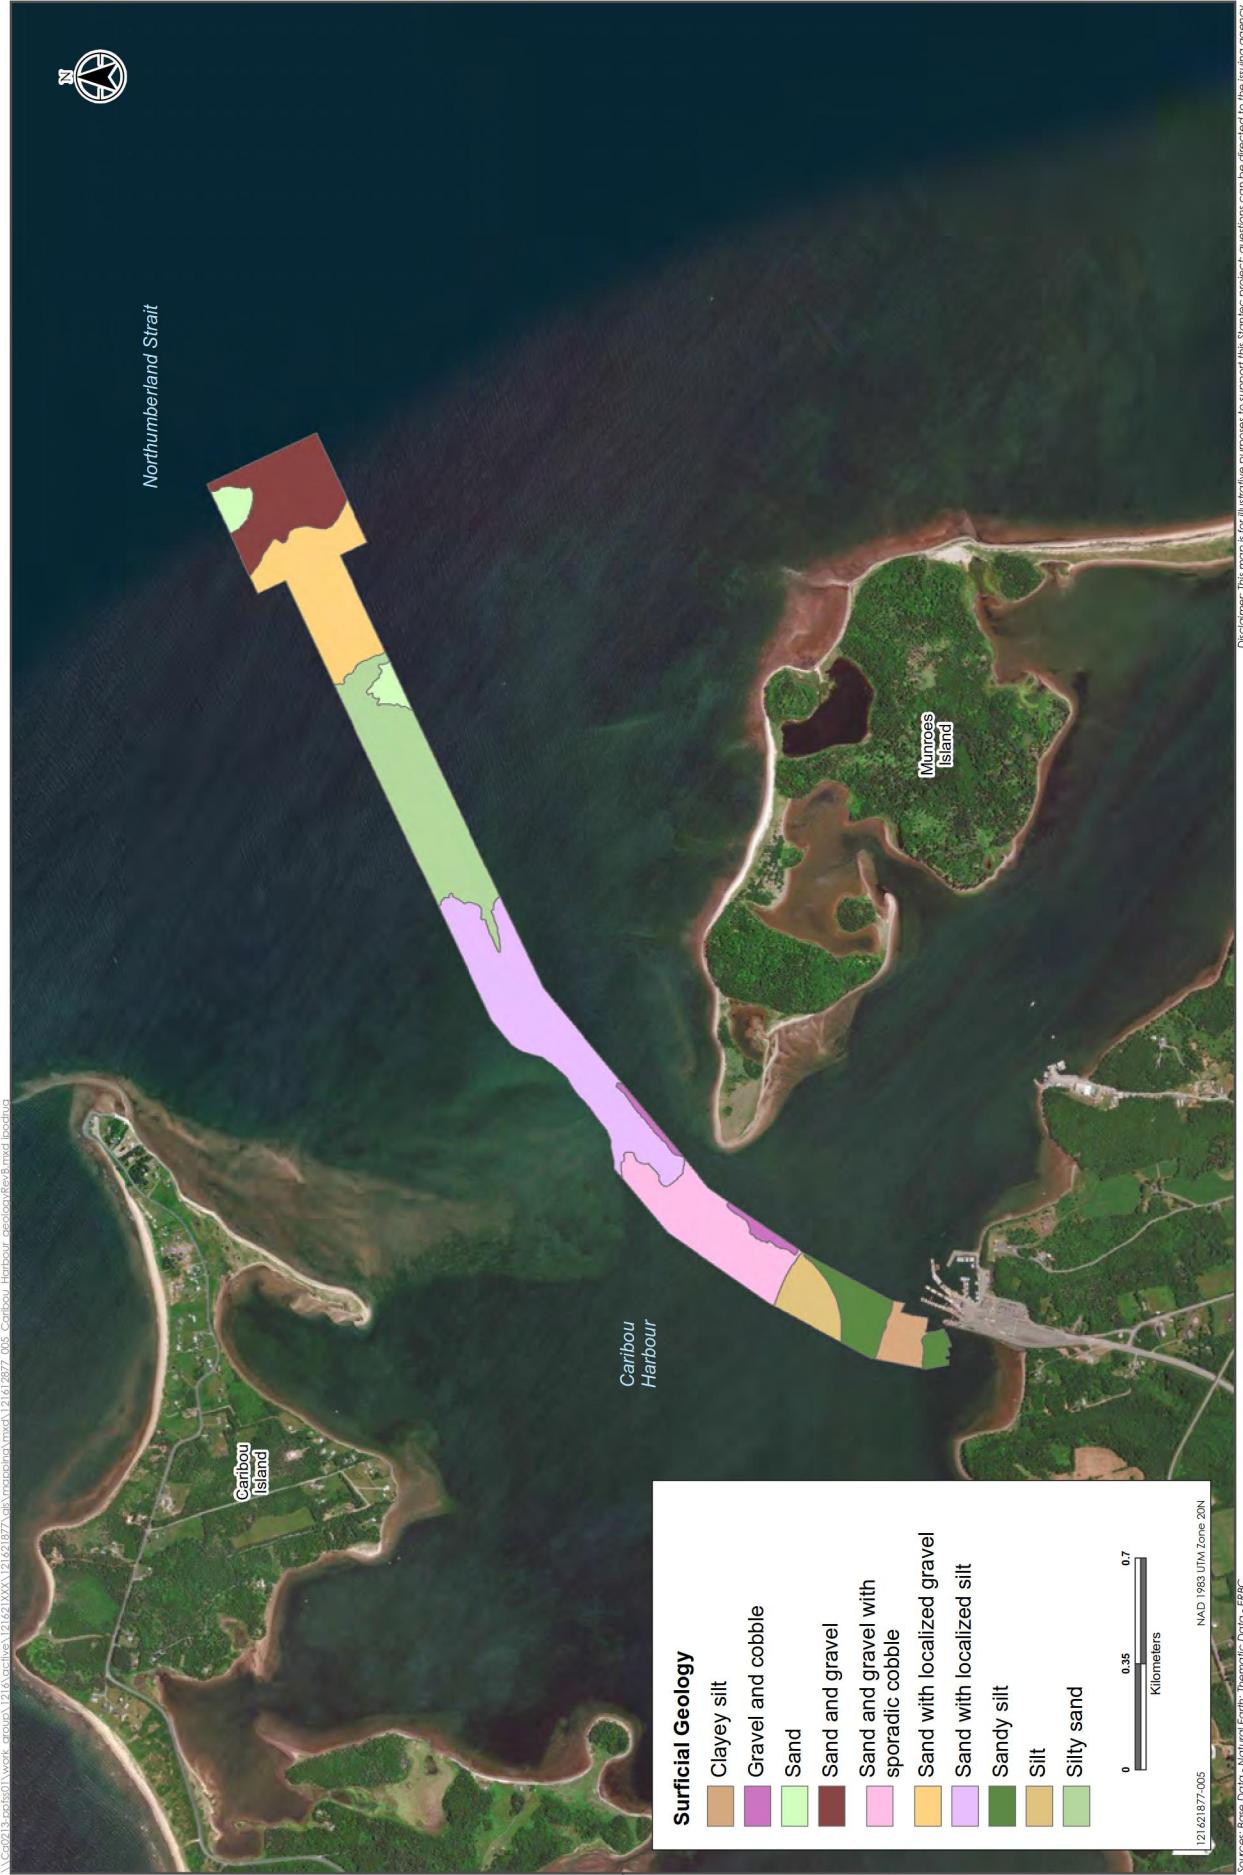
Figure 8

Interpretation of surficial geology from side-scan sonar data identified ten substrate types in the surveyed portion of Caribou Harbour (Figure 8). Four predominant substrate types were identified from the high-level video analysis in Caribou Harbour. These included silt, silty sand, sand, and mixed sediment (sand, shell hash and gravel) (Figure 9). In general, the pipeline corridor is composed primarily of sand. Closer to shore, the habitat was silty with eelgrass; eelgrass beds were thickest near shore. Moving seawards from shore, the habitat transitions into silty sand, also with eelgrass and eelgrass beds. Silty sand transitions into sand near the mouth of Caribou Harbour and continues out to the diffuser area where it transitions into mixed sediment (sand with gravel and shell hash).

Surficial Geology of Caribou Harbour Pipeline Corridor from Side-scan Data

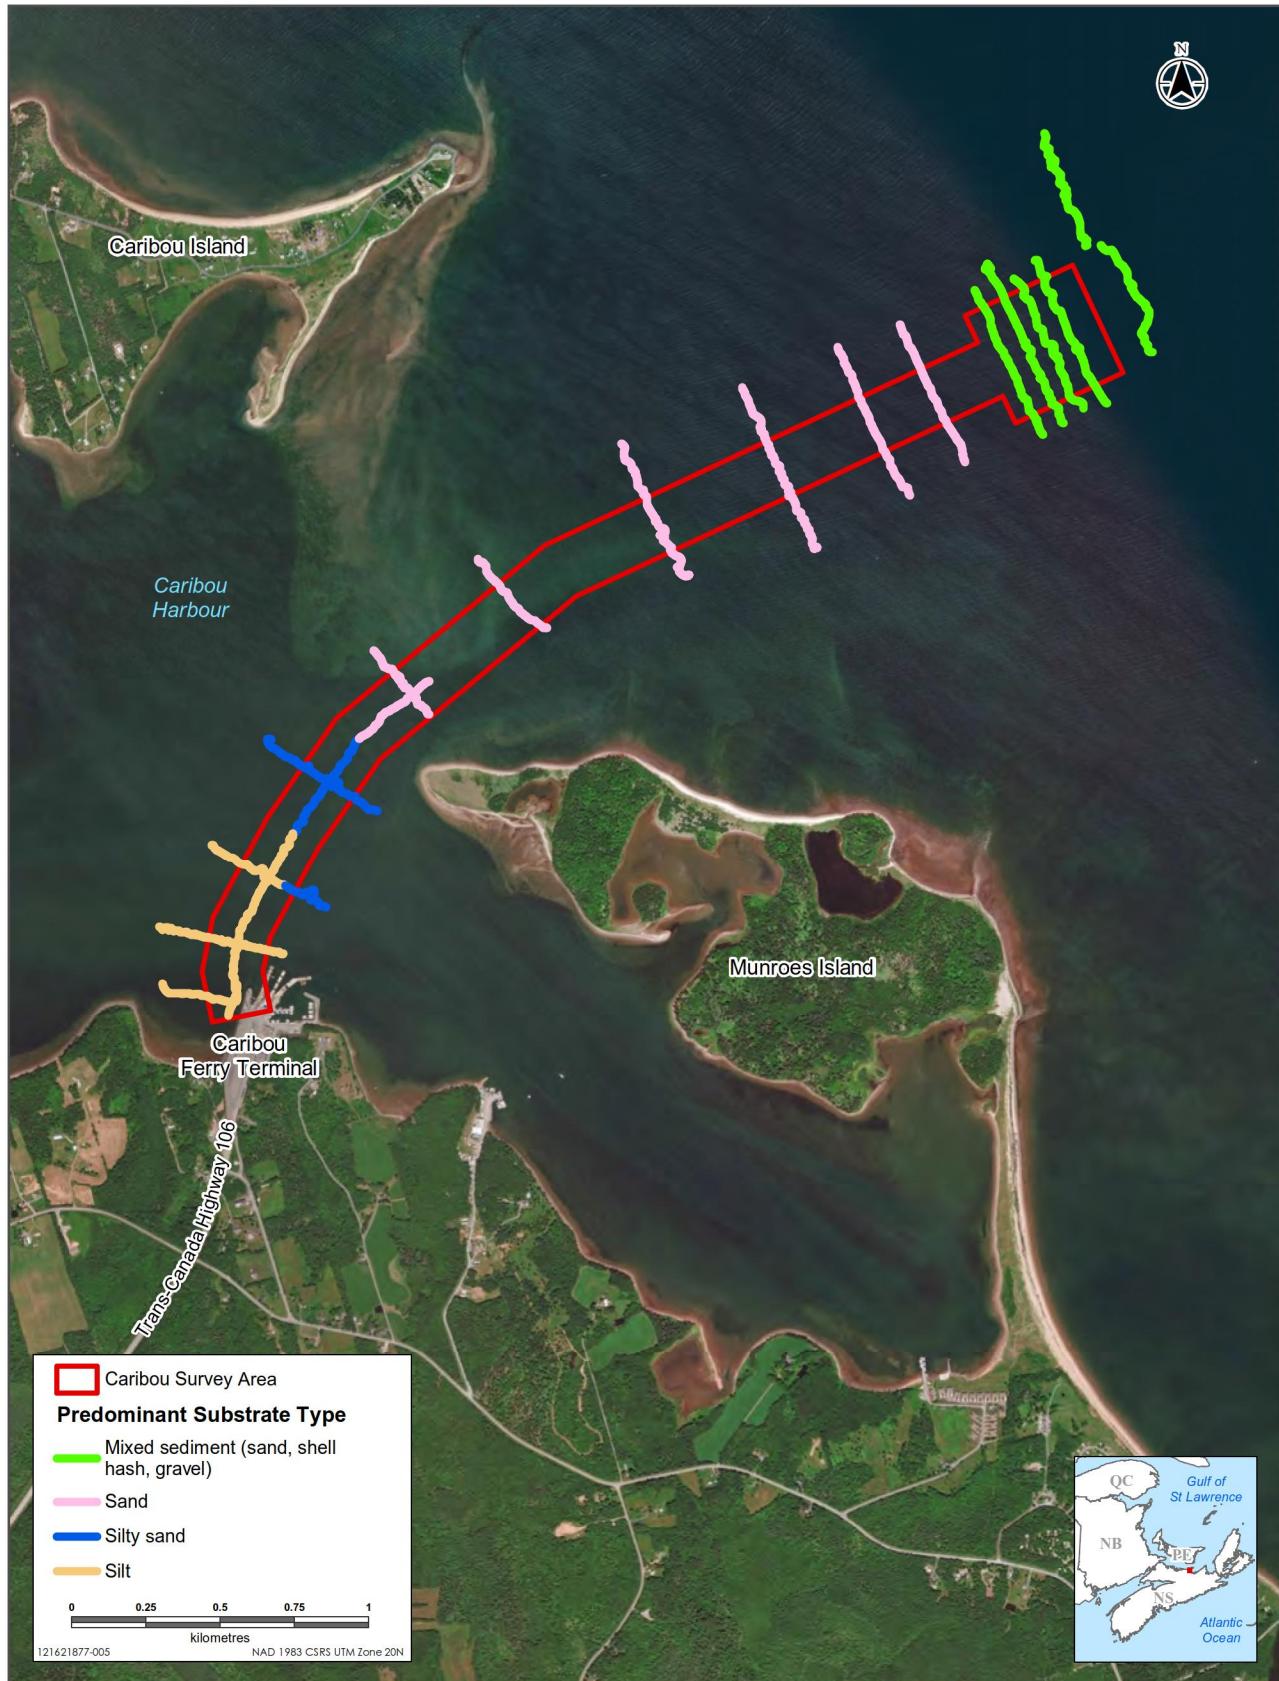
Predominant Substrate Types Surveyed Within the Caribou Harbour Pipeline Corridor

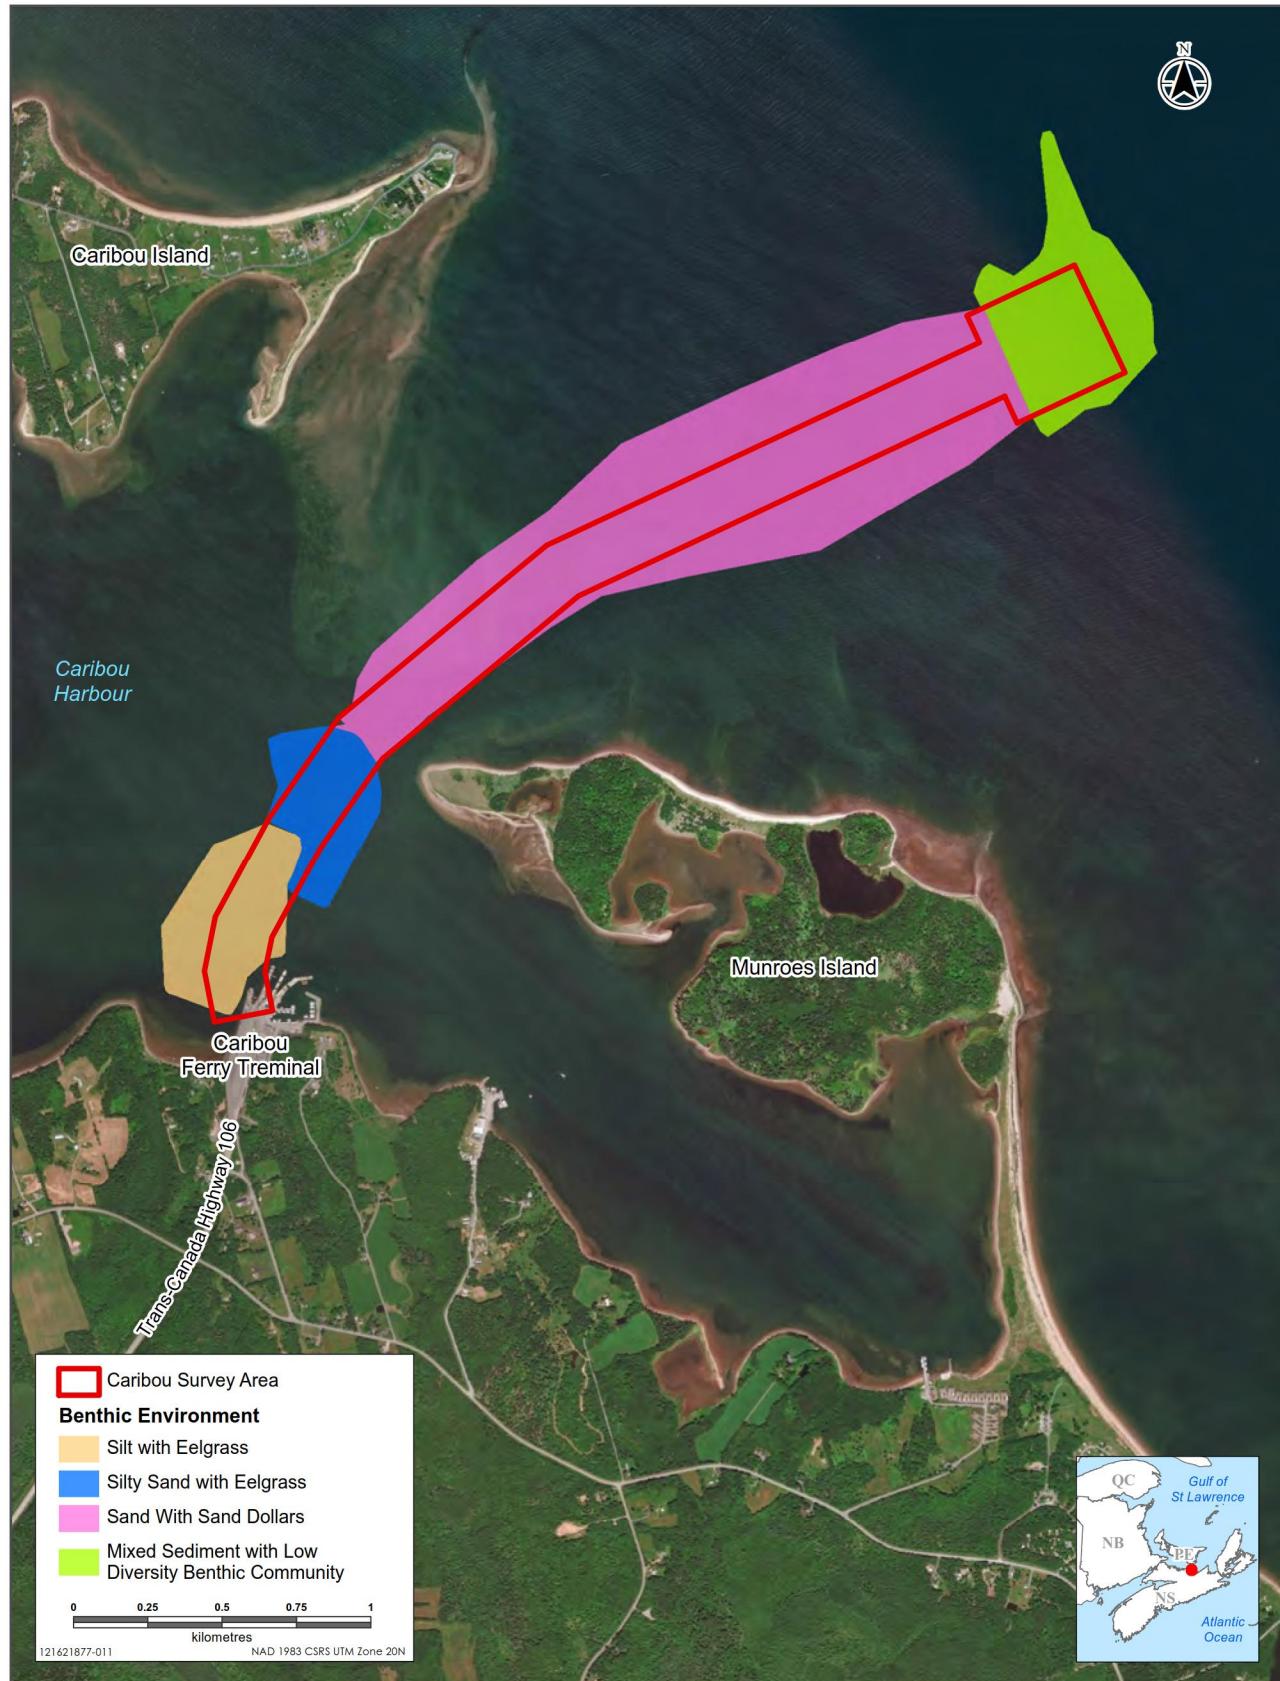
In shallower areas within Caribou Harbour, eelgrass was the most common macroflora and was present in different densities. As water depths increased, there was less eelgrass; where it transitioned into sand habitat there was very little macroflora. Rock crabs (*Cancer irroratus*) were observed in all habitat types. In the sand habitat, sand dollars (*Echinarachnius parma*) were abundant and moon snails (*Euspira heros*) were also observed. At the diffuser area there were fewer sand dollars than in the sand habitat closer to shore. The overall benthic communities observed included silt with eelgrass, silty sand with eelgrass, sand with sand dollars and mixed sediment with lower biological diversity compared to the other areas (Figure 10). Figure 10 also illustrates the extent of eelgrass in Caribou Harbour based on available video in the survey area.

Benthic Communities Surveyed Within the Caribou Harbour Pipeline Corridor

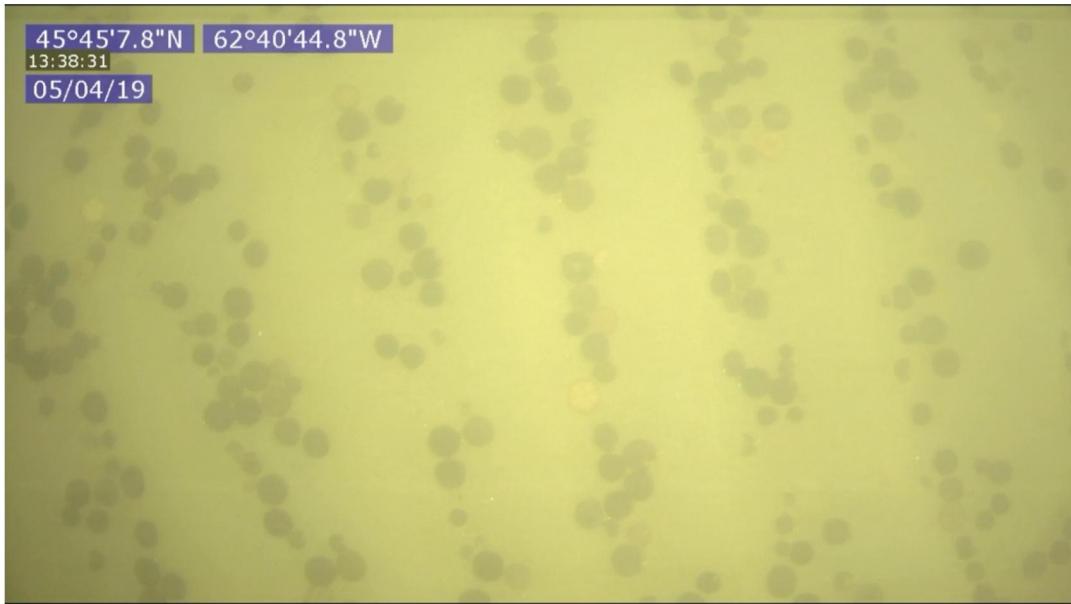
Two of the more interesting things observed during the high-level video analysis in Caribou Harbour were sand dollar formations and the sponge *Haliclona oculata*. In some areas with sand waves, sand dollars were observed in striped formation on the seabed (Photo 1). *Haliclona oculata* was only observed in one location in Caribou Harbour (Photo 2).

Photo 1 Sand waves with sand dollars in striped formation in Caribou Harbour

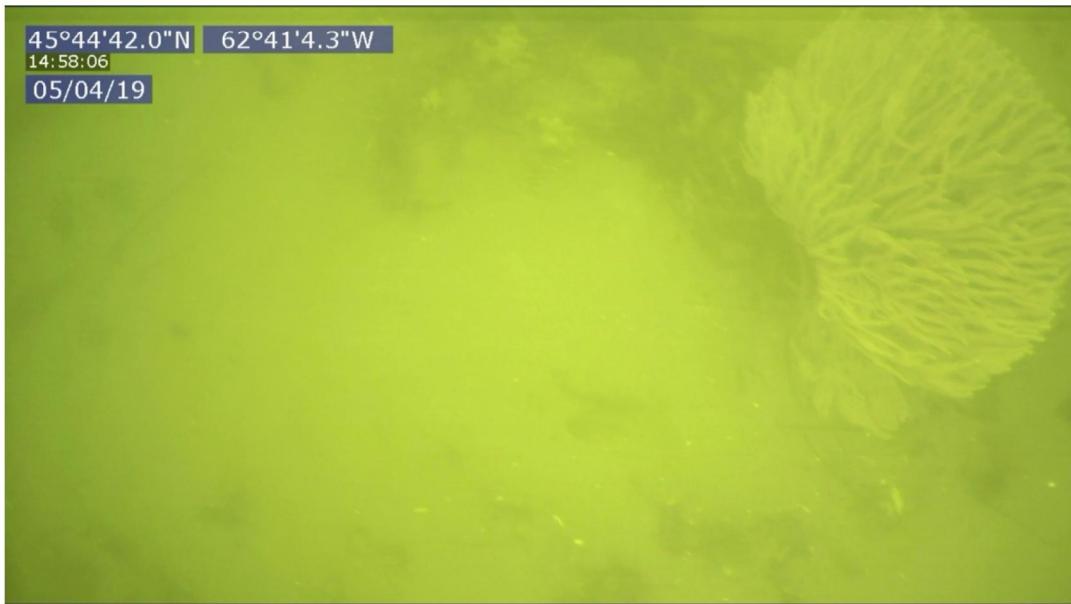
Photo 2 Sponge (*Haliclona oculata*) in Caribou Harbour

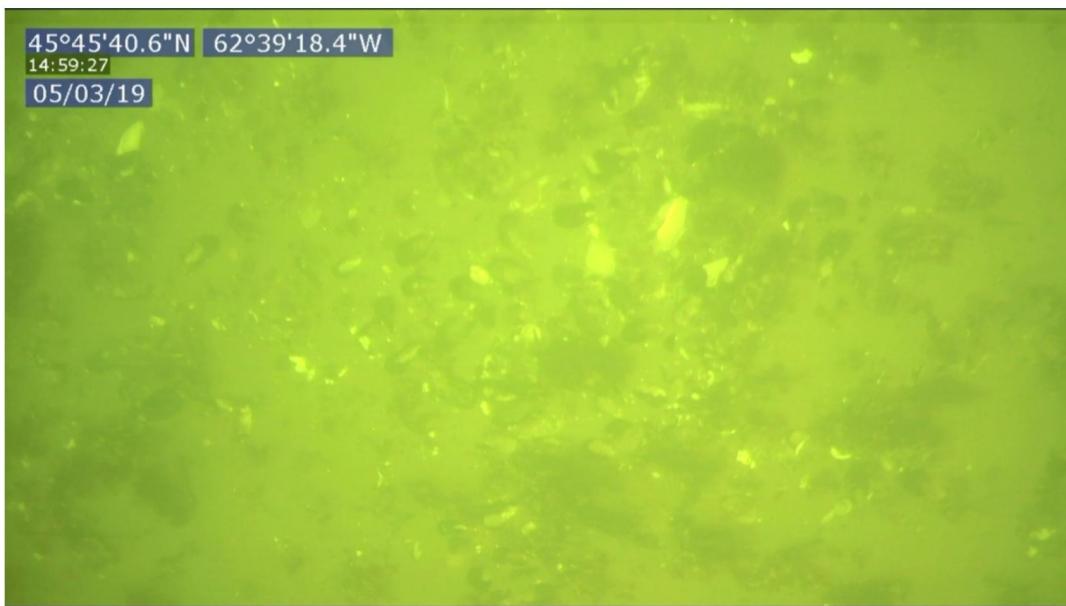
Within the diffuser area, the predominant substrate type was mixed sediment (sand, gravel and shell hash) (Photos 3 and 4). Macroflora observed included *Laminaria* sp., *Rhodophyta* sp., *Cladophora rupestris* and other brown algae. Macrofauna observed included rock crab (*Cancer irroratus*), sand dollar (*Echinorachnius parma*) and blue mussel (*Mytilus edulis*).

Photo 3 Mixed bottom (predominantly sand) with blue mussels in diffuser area

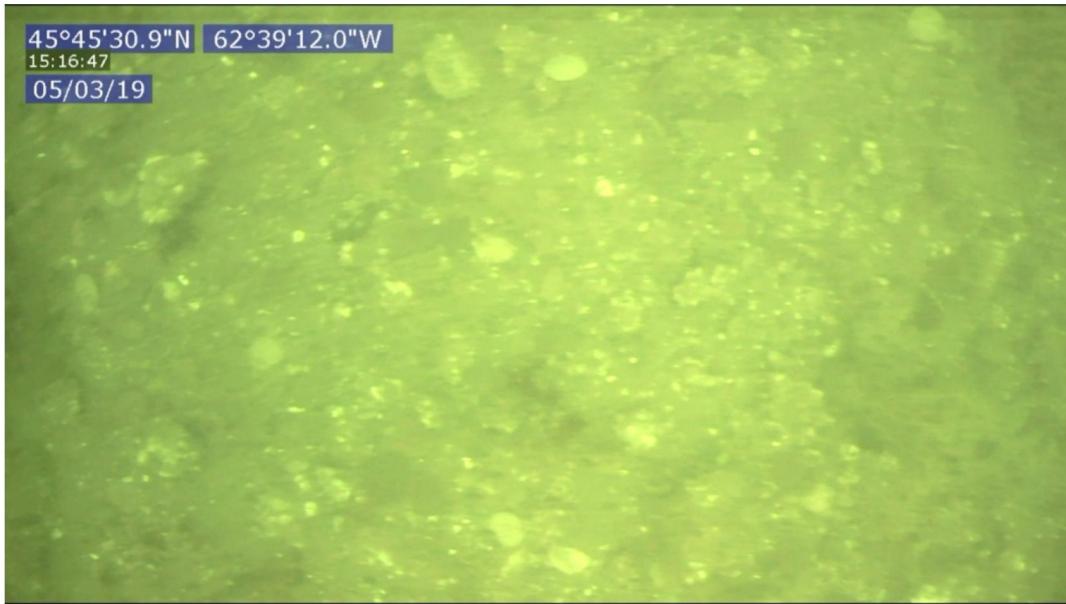
Photo 4 Mixed bottom (predominantly gravel) in diffuser area

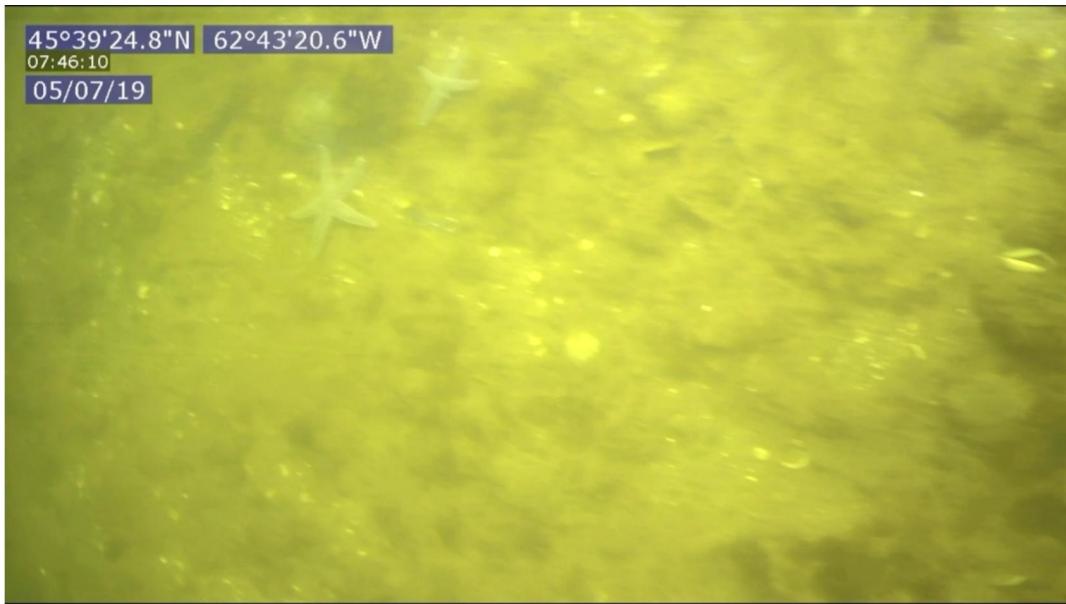
Transect 1 had a total length of 1.25 km. The majority of Transect 1 was in less than 5 m water depth, with one small section that was 8 m deep. The substrate along Transect 1 consisted predominantly of silt. The first 50-75 m of the transect was composed of silty sand (50-95% coverage) with lesser amounts of gravel, shell hash and cobble (Photo 5). Silty sand transitioned into silt (100% coverage) for the remainder of the transect (Photo 6).

Photo 5 Mixed sediment (silty sand, gravel shell hash) with brown algae and sea stars (0-50 m on Transect 1)

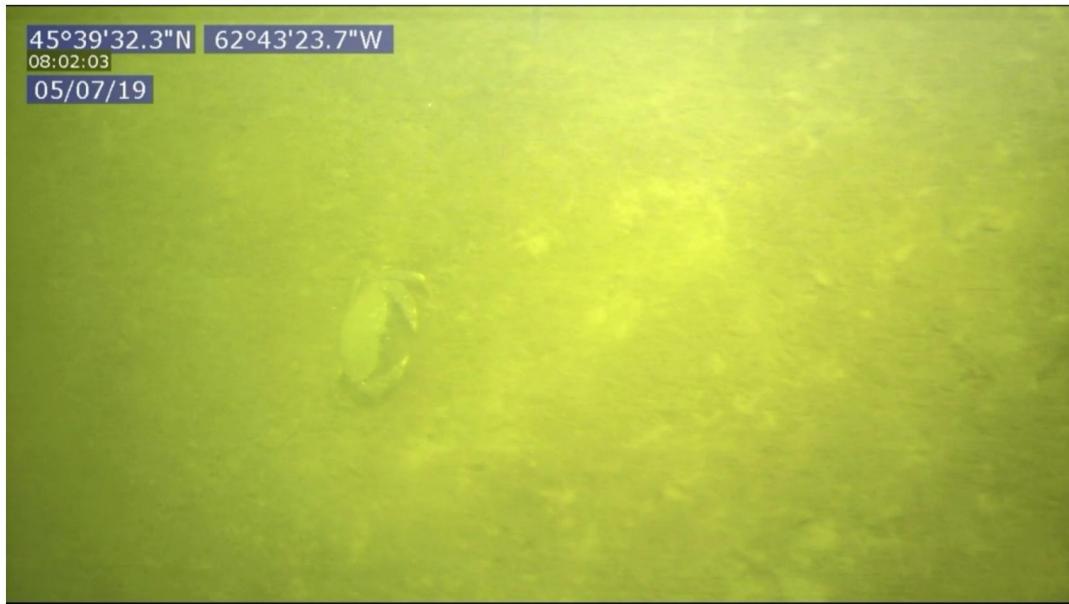
Photo 6 Silty habitat with rock crab (250-300 m on Transect 1)

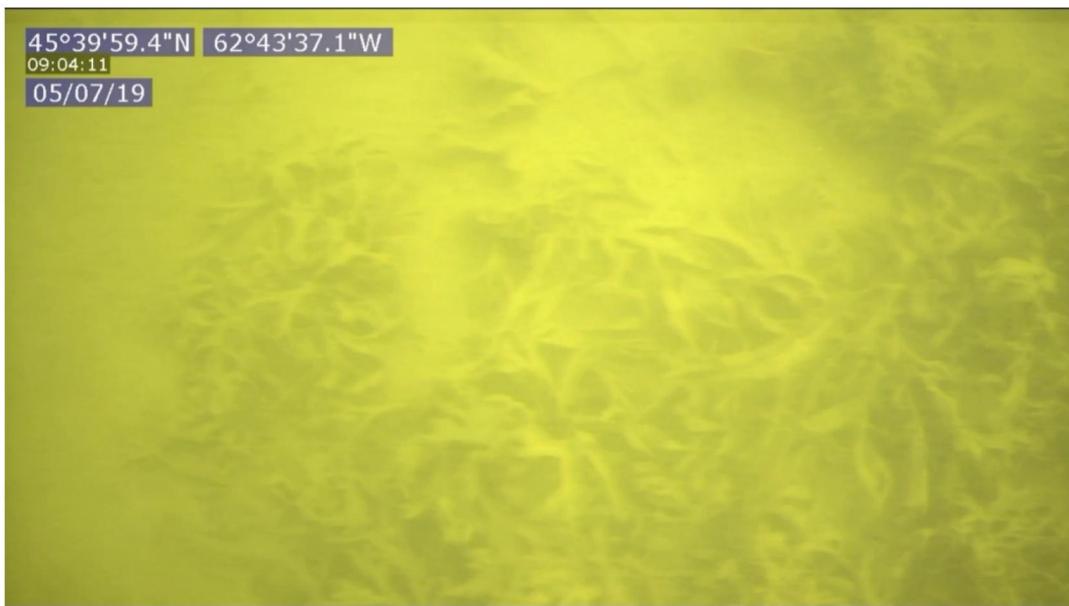
Macrofloral species observed in Transect 1 included unidentified brown algae (<1% to 5% cover), *Cystoseira* sp. (<1% coverage), *Chorda filum* (<1% coverage), *Fucus vesiculosus* (<1% coverage), *Laminaria longicuris* (<1% coverage) and *Ascophyllum nodosum* (<1% coverage). Macroflora cover was greater in the first 50 m of the transect in the northern end. Thereafter, macroflora was sparse and was generally covered in silt making identification difficult (Photo 7).

Photo 7 Silty habitat with brown algae covered in silt (1150-1200 m on Transect 1)

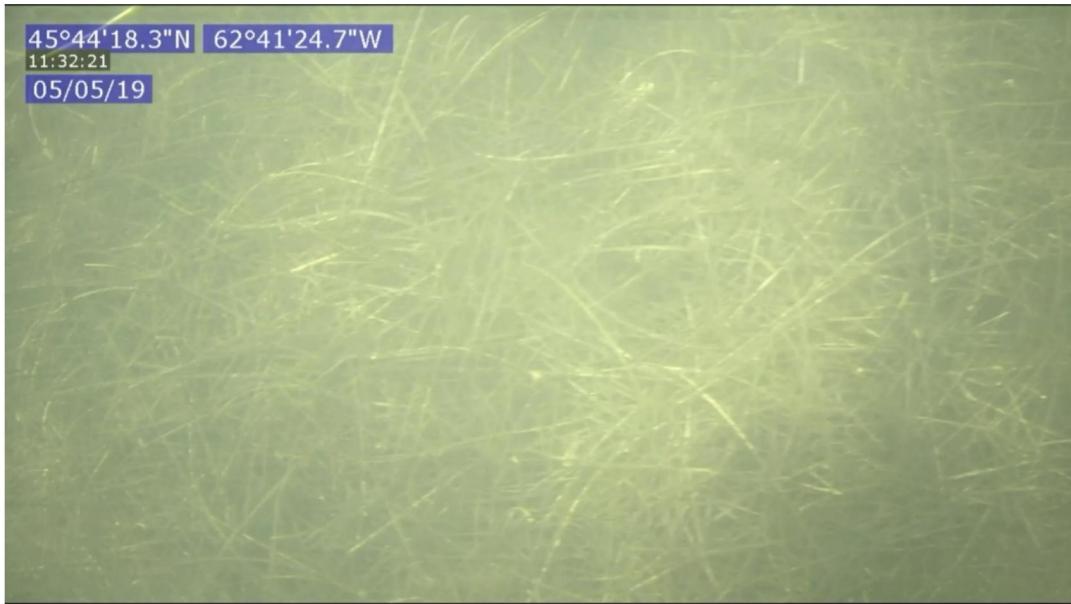
Macroflora observed along Transect 2 was predominantly eelgrass (*Zostera marina*). Eelgrass cover was thickest at the start of the transect near shore at the beginning of the pipeline corridor. There was nearly 100% coverage in the first 50 m (Photo 8) and cover ranged from 10-90% in the first 500 m of the transect (Photo 9). Identification of other macroflora was difficult as they were generally covered in silt. These included unidentified brown algae (<1% coverage), *Fucus* sp. (<1% coverage), *Fucus spiralis* (<1% coverage), and *Fucus vesiculosus* (<1% coverage). Towards the end of the transect, there were sections with no eelgrass, just silt (Photo 10).

Photo 8 Thick eelgrass bed (0 m on Transect 2)
