**Underwater Benthic Habitat
Survey of Caribou Harbour and
Pictou Harbour Pipeline Corridors**
Final Report

July 18, 2019
File: 121621877

Northern Pulp Nova Scotia Corporation
260 Granton Abercrombie Branch Rd.
New Glasgow, NS B2H 5C6

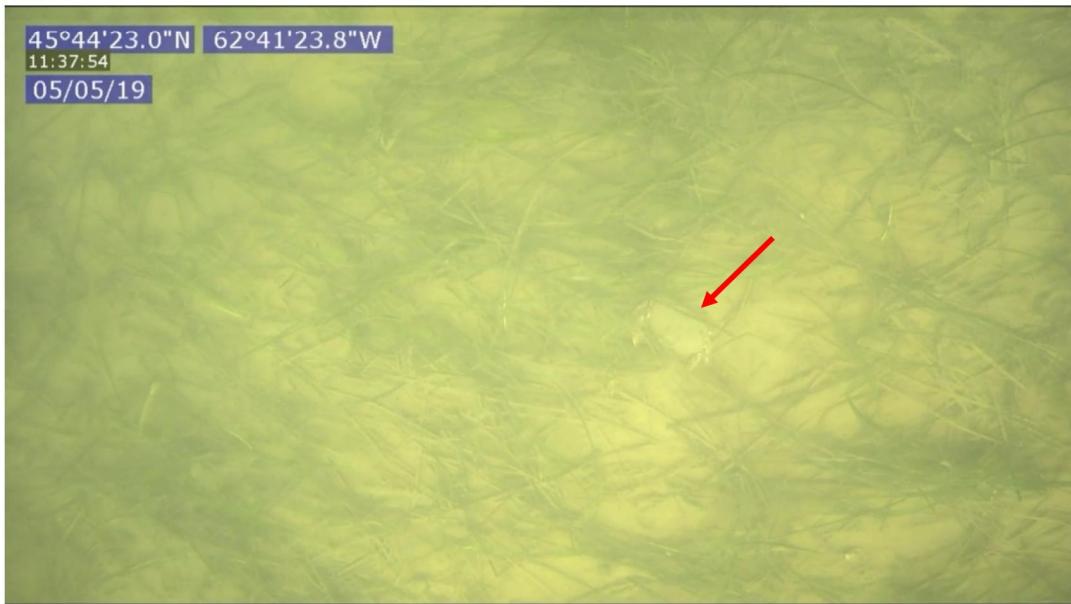
Macroflora observed along Transect 2 was predominantly eelgrass (*Zostera marina*). Eelgrass cover was thickest at the start of the transect near shore at the beginning of the pipeline corridor. There was nearly 100% coverage in the first 50 m (Photo 8) and cover ranged from 10-90% in the first 500 m of the transect (Photo 9). Identification of other macroflora was difficult as they were generally covered in silt. These included unidentified brown algae (<1% coverage), *Fucus* sp. (<1% coverage), *Fucus spiralis* (<1% coverage), and *Fucus vesiculosus* (<1% coverage). Towards the end of the transect, there were sections with no eelgrass, just silt (Photo 10).

Photo 9 Silty habitat with eelgrass and rock crab (150-200 m on Transect 2)

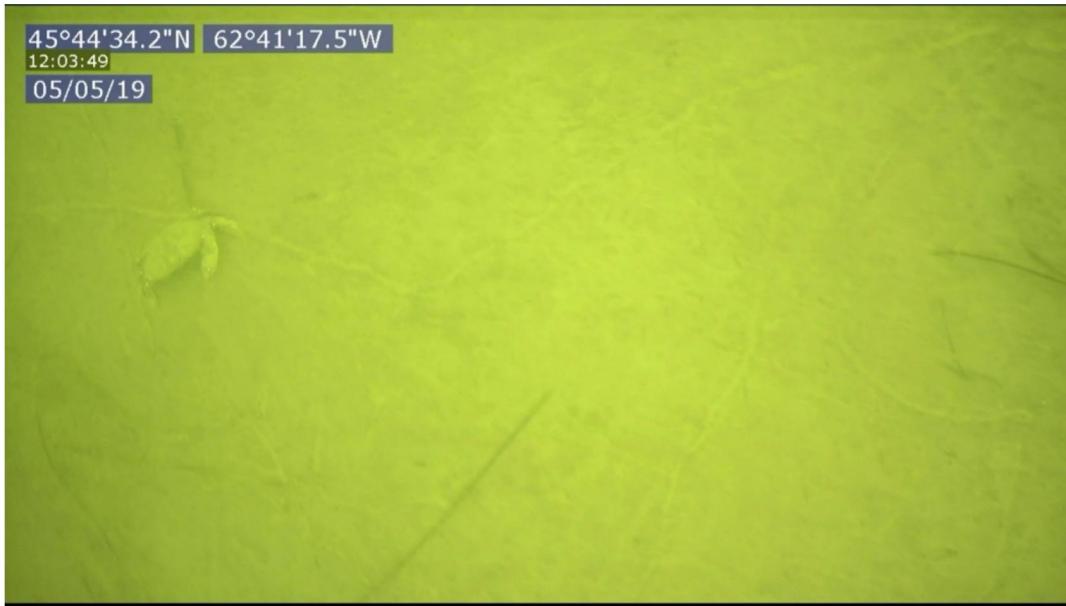
Photo 10 Silty habitat with rock crab (550-600 m on Transect 2)

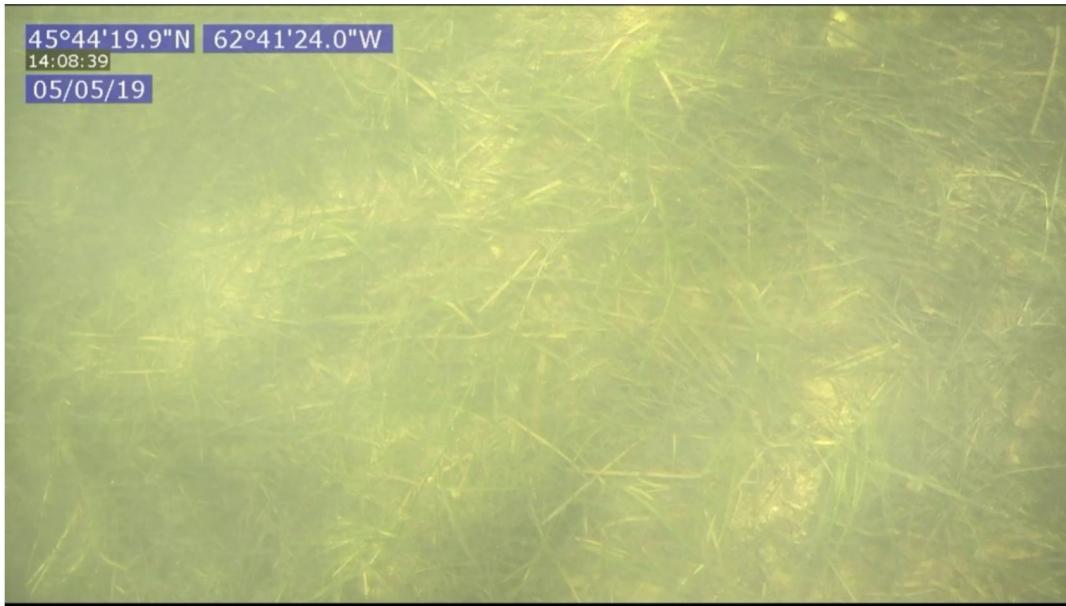
Eelgrass was the most common macroflora observed and was present in high densities (60-70% coverage) (Photo 11). Other macrofloral species observed included *Fucus spiralis*, *Fucus vesiculosus* and unidentified brown algae; these were present in low densities (<1% coverage) and generally covered in silt.

Photo 11 Silty habitat with eelgrass (250-300 m on Transect 3)

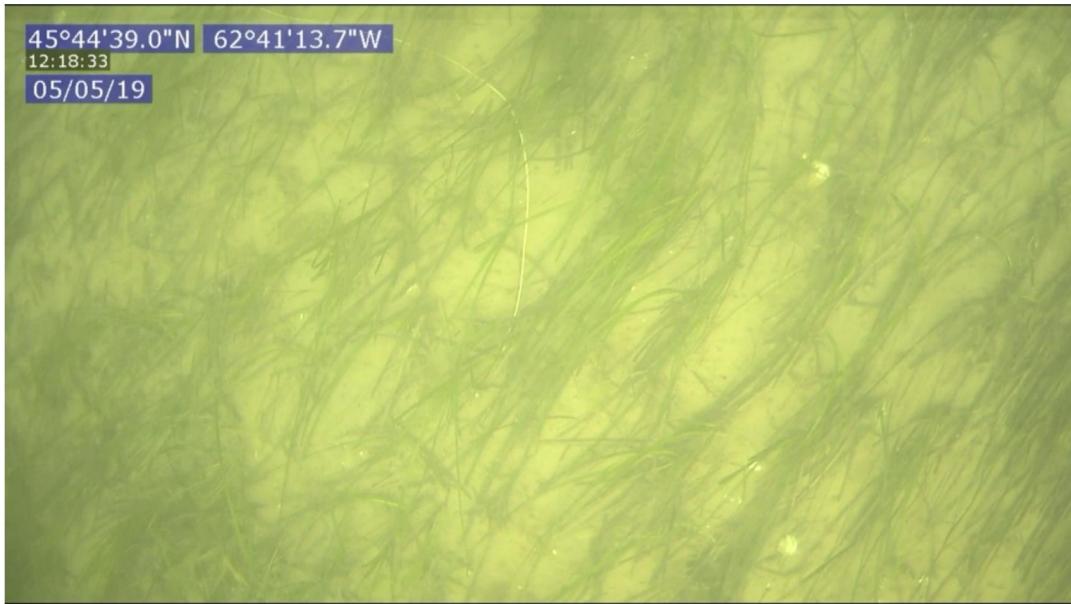
Transect 4 had a total length of 450 m. Water depths along Transect 4 ranged from 3 to 5 m. The substrate along Transect 4 consisted predominantly of silty sand (100% coverage) and small amounts of shell hash (<1% coverage) (Photo 12). At the northern end of the transect (400-450 m) the substrate transitions to sand (Photo 13).

Photo 12 Silty sand habitat with eelgrass (0-50 m on Transect 4)

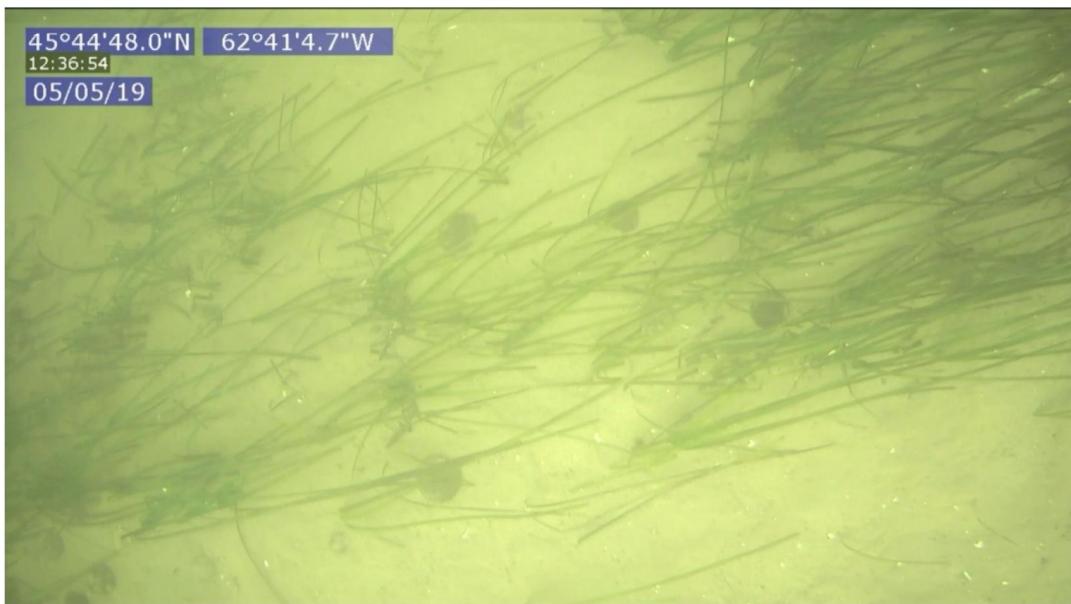
Photo 13 Transition from silty sand to sand with eelgrass and sand dollars at end of transect (400-450 m on Transect 4)

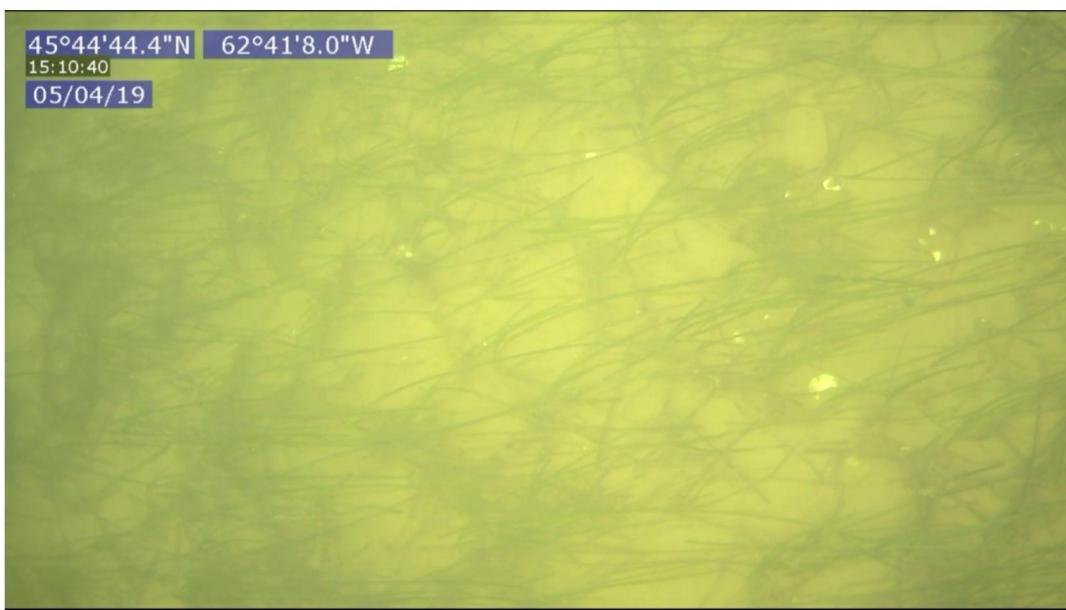
Eelgrass was the most common macroflora observed where coverage ranged from 10-60% (Photo 14). There were some small areas along the transect with no eelgrass, as well as areas with thick patches of eelgrass (Photo 15). Other macroflora observed include *Fucus spiralis* (<1% coverage), *Fucus vesiculosus* (<1% coverage) Rhodophyta sp. (<1% coverage), *Laminaria* sp. (<1% coverage), unidentified green algae (<1% coverage) and unidentified brown algae (<1% coverage).

Photo 14 Silty sand habitat with eelgrass (100-150 m on Transect 5)

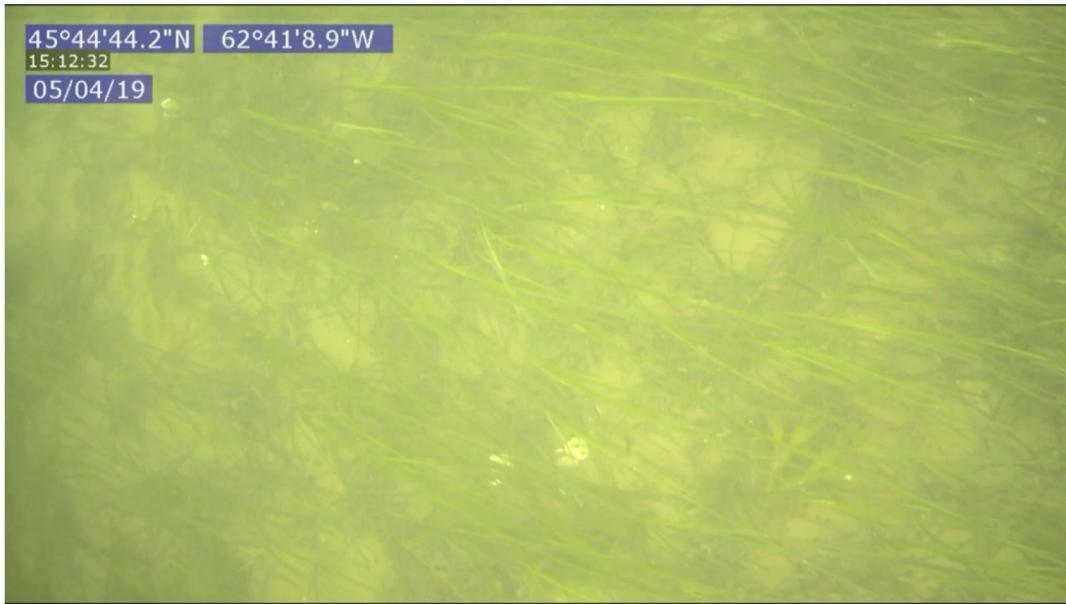
Photo 15 Silty sand habitat with thick eelgrass (150-200 m on Transect 5)

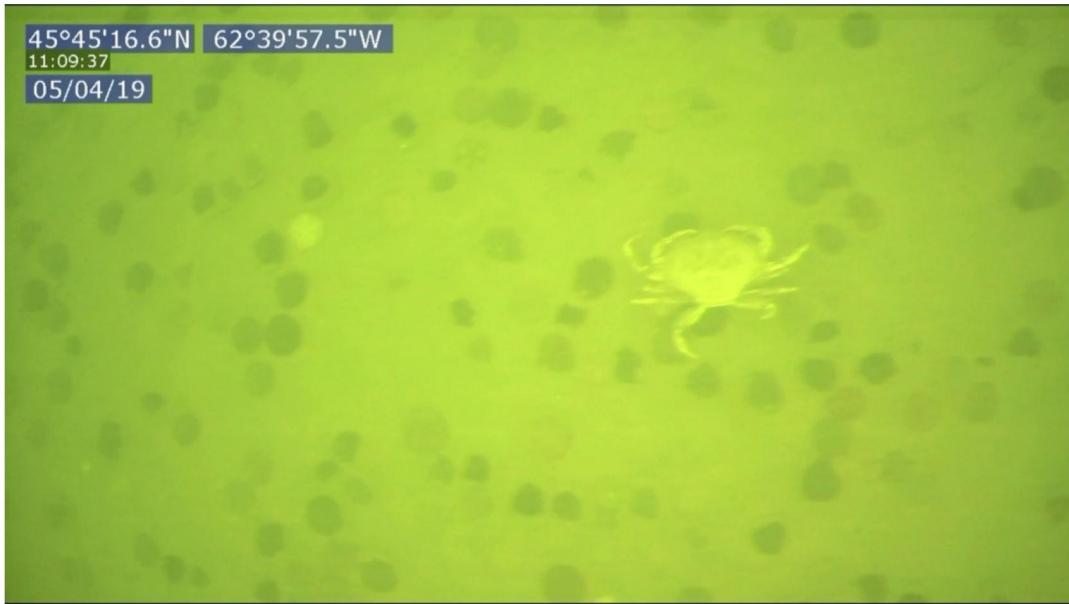
Sand dollars (*Echinarachnius parma*) (abundant) were abundant along the whole transect (Photo 16). There were sections with dense aggregations of sand dollars (Photo 17). Rock crab (*Cancer irroratus*) were also observed in two of the 50 m sections.

Photo 16 Sandy habitat with sand dollars and rock crab (250-300 m on Transect 6)

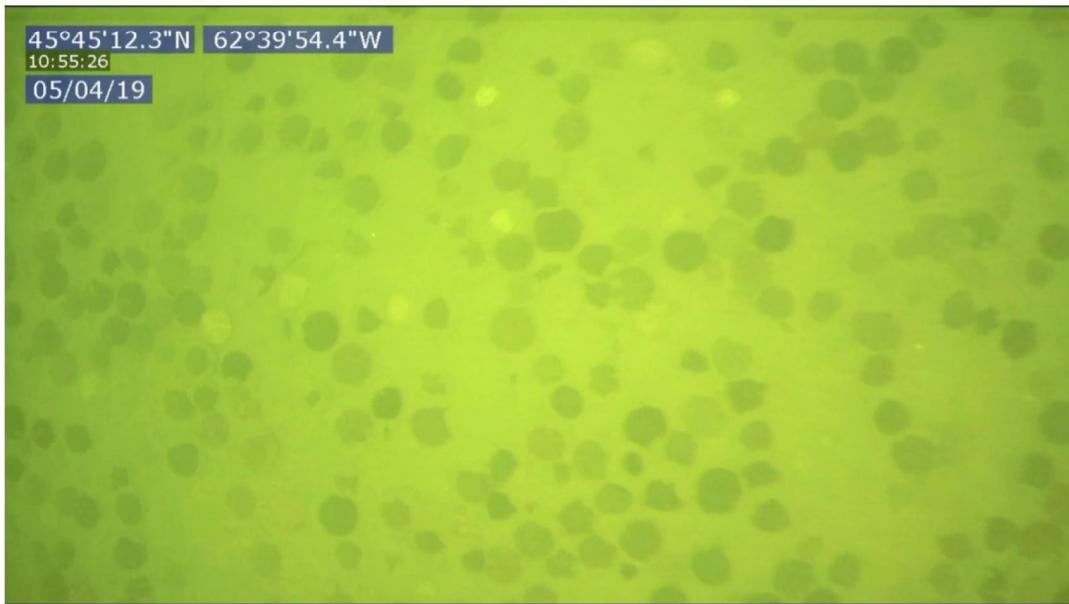
Photo 17 Sandy habitat with dense aggregations of sand dollars (50-100 m on Transect 6)

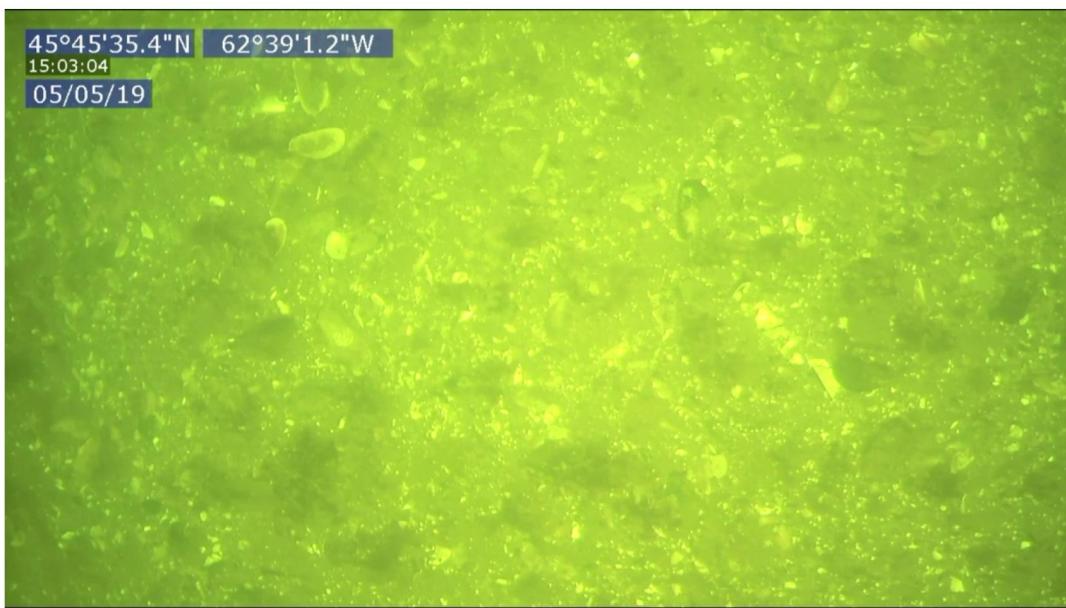
Transect 7 had a total length of 500 m. Water depths along Transect 7 ranged from 10 m to 20 m. The substrate along Transect 7 was composed of mixed sediment (sand, shell hash and gravel). From the video it appeared to be approximately 60% sand, 30% gravel and 10% shell hash (Photo 18)

Photo 18 Mixed sediment (sand, shell hash and gravel) with blue mussels (250-300 m on Transect 7)

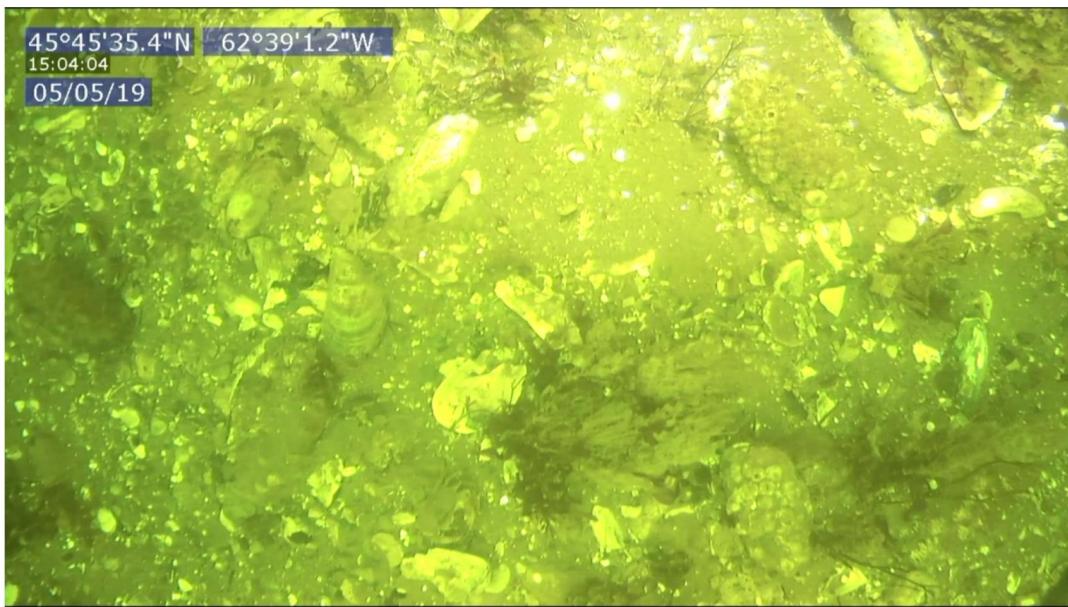
Macrofauna observed included blue mussels (*Mytilus edulis*) (common), rock crabs (*Cancer irroratus*) (uncommon), sand dollars (*Echinorachnius parma*) (occasional) and acorn barnacles (*Semibalanus balanoides*) (uncommon). Blue mussels were the most common species observed. Acorn barnacles were observed on rocks when the camera dipped close to the seabed (Photo 19).

Photo 19 Mixed sediment (sand, shell hash and gravel) with acorn barnacles and blue mussels (250-300 m on Transect 7)
