**AVIAN STUDY  
AULD'S COVE**

**March 2, 2016**

**Re: Avian Study, Auld's Cove, NS**

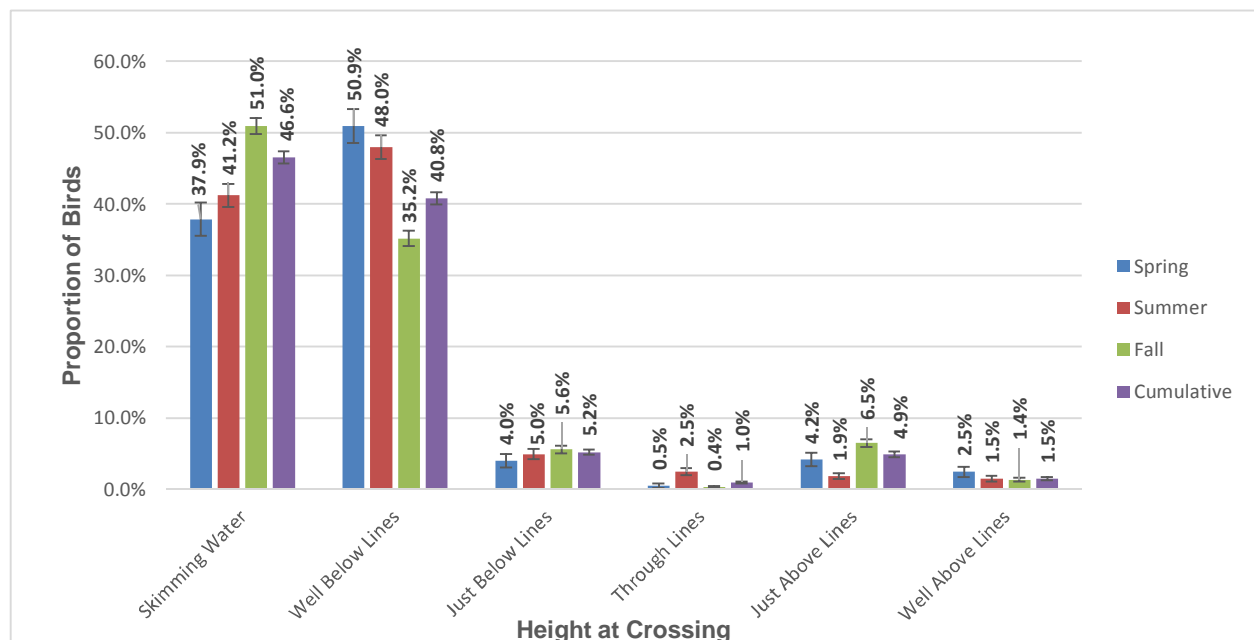
Figure 2. Height at crossing at the Auld's Cove power lines with 95% confidence intervals

- skimming the water;
- well below lines;
- just below lines;
- through lines;
- just above lines; and
- well above lines.

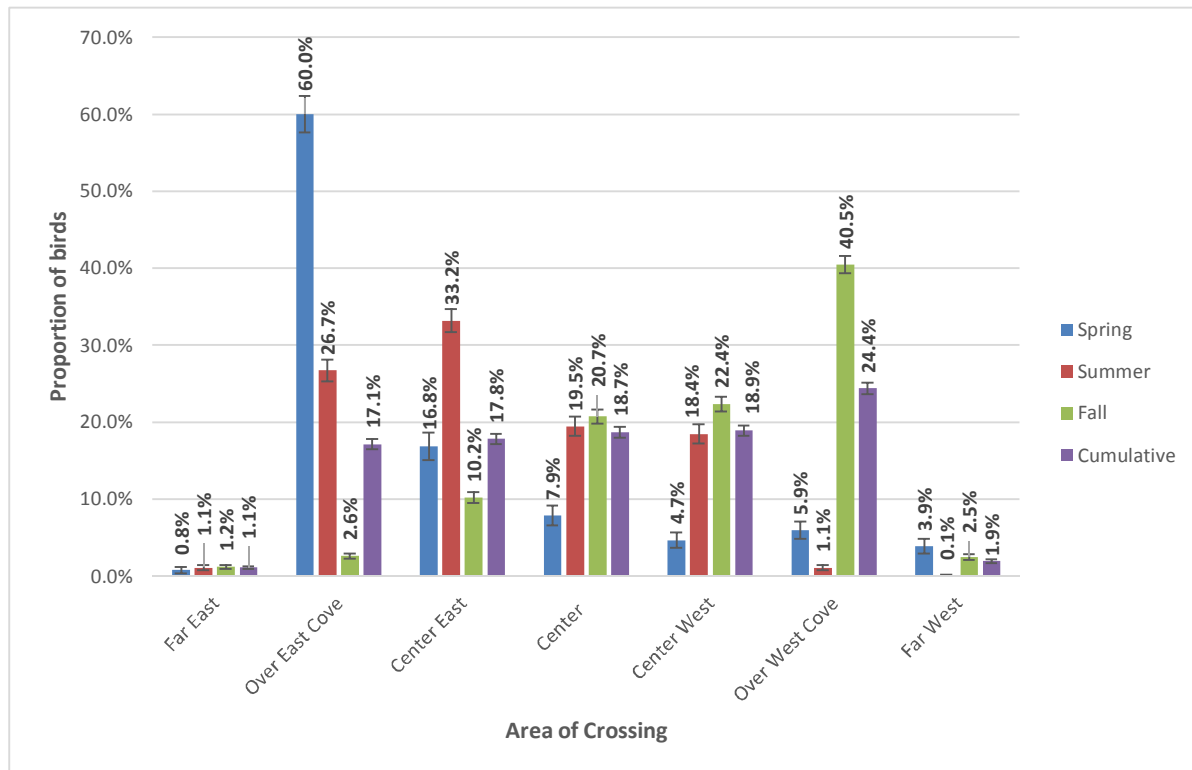
**Figure 3. Area of Crossing at the Auld's Cove power lines with 95% confidence intervals**

Figure 3 indicates the areas where birds crossed the Auld's Cove power lines, throughout each season and cumulatively. Seven areas of crossing were evenly distributed across the Strait of Canso in the vicinity of NSPI infrastructure. Drawing 4 (Appendix A) illustrates the approximate delineations of each crossing location relative to the Auld's Cove diurnal surveys.

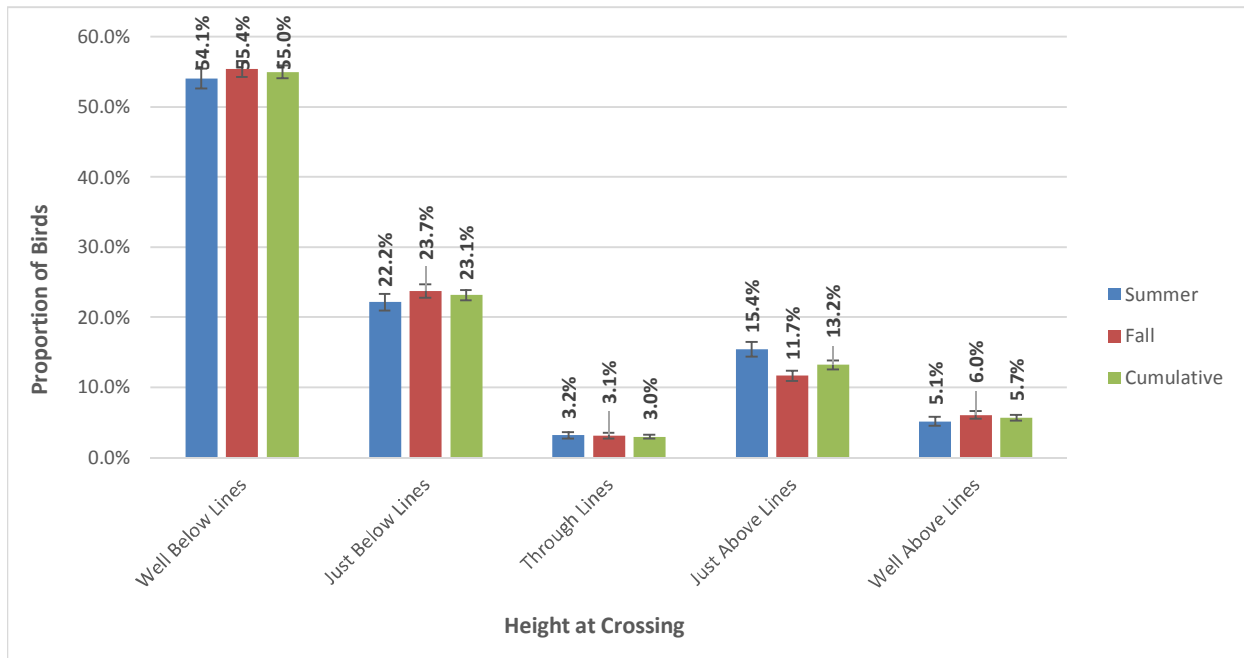
**Figure 5. Height of birds at crossing of power lines at Canso Causeway with 95% confidence intervals**

at this location. As discussed in Section 5.1, instances in which the bird was observed to have passed 'just below', 'through', or 'just above' the power lines are considered high risk interactions.

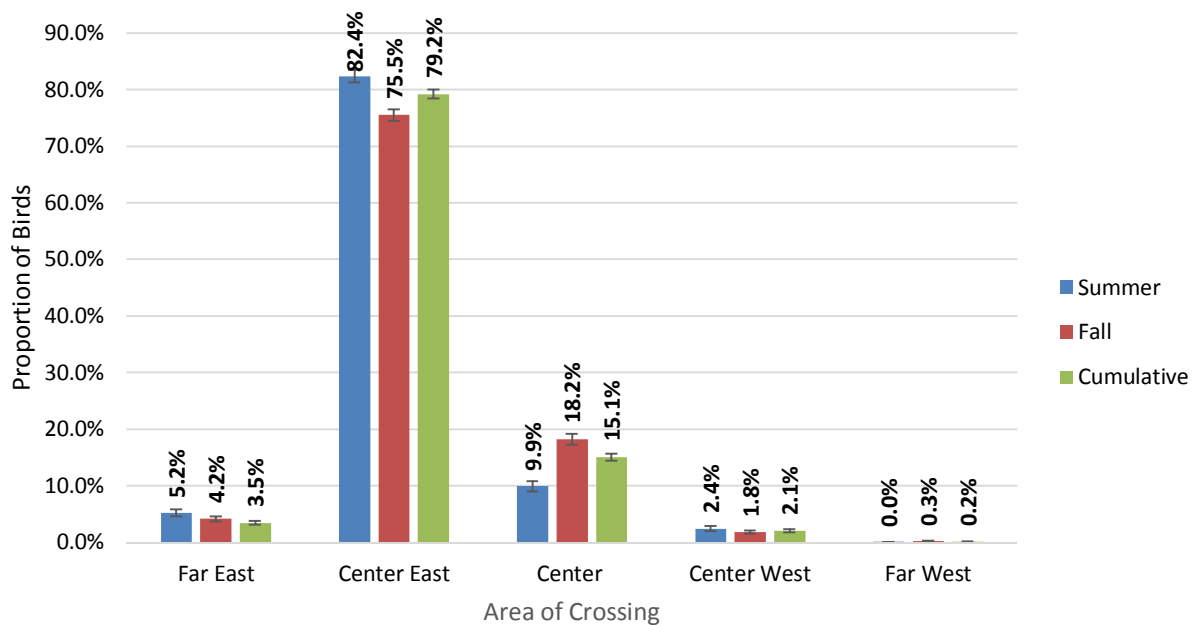
**Figure 6. Area of crossing at Canso Causeway with 95% confidence intervals**

Causeway in the vicinity of NSPI infrastructure. Drawing 4 (Appendix A) illustrates the approximate delineations of each crossing location relative to the Canso Causeway diurnal surveys.

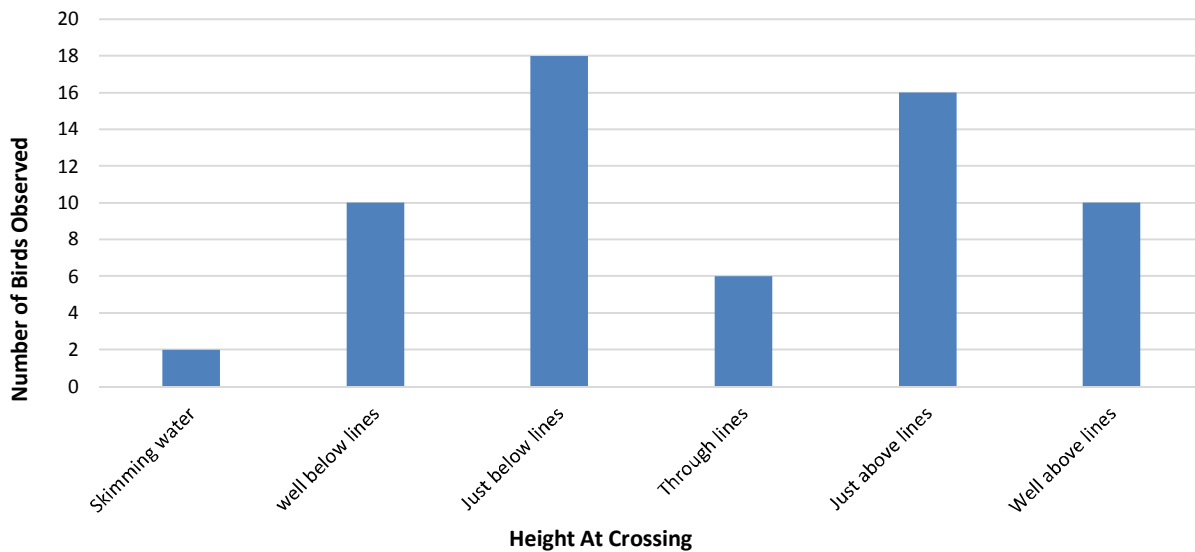
Figure 16. Height at crossing of birds observed during nocturnal surveys at Auld's Cove

A total of 76 birds were observed during nocturnal surveys, of which many were unidentifiable to species level (Table 8). The most abundantly observed were gulls, followed by unidentified species. Most of the observed birds crossed the lines at center east or center (Figure 15 and Drawing 4, Appendix A) just beneath the lines, or just above the lines hence categorizing them as high risk interactions (Figure 16).

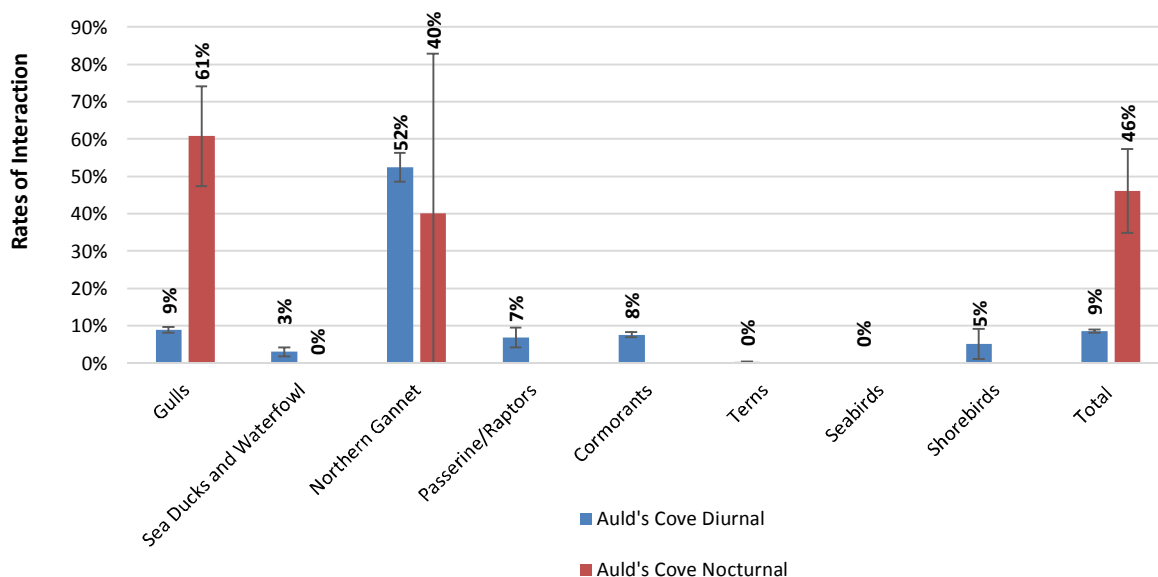
**Figure 17. Rates of interaction per guild for diurnal and nocturnal surveys at Auld's Cove with 95% confidence intervals**

46 % ( $\pm 11\%$ , 95% CI) of the total birds observed during nocturnal surveys interacted with the power lines at Auld's Cove (Figure 17). This indicates that on average, nocturnal interaction rates appear to be higher than diurnal interaction rates. However, it should also be noted that visual limitations of the scope did not allow for a full viewscape as experienced during the day and, therefore, nocturnal observations may be biased towards those birds directly in line with the scope which was oriented at the lines. It is possible that birds skimming the water or flying well above the lines were not captured with the scope and the results are thus skewed towards a higher proportion of interactions. Additionally, the number of nocturnal visual observations is limited by a small sample size (only 76 individual birds observed). Caution is urged in relying on the nocturnal visual survey data as confidence in it is somewhat low, and the nocturnal visual survey approach is inherent with limitations. No collisions or mortalities were observed during the nocturnal surveys.

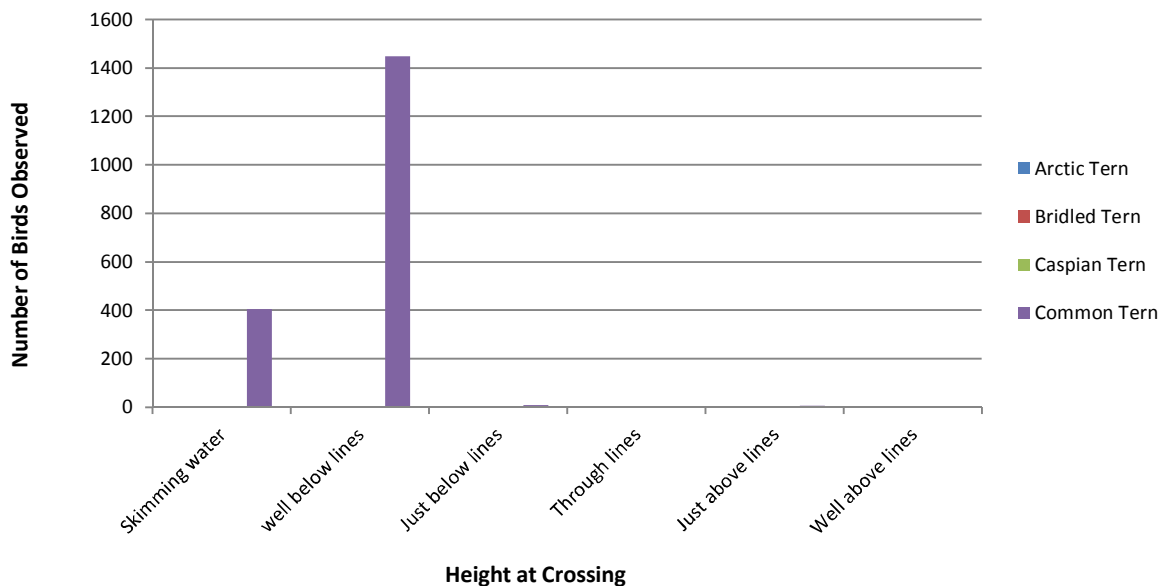
Figure 21. Height at crossing of terns observed at Auld's Cove during Diurnal Bird Surveys

Despite their abundance in the area, terns do not behave in a way that puts them at risk of interacting with the existing Auld's Cove power lines.

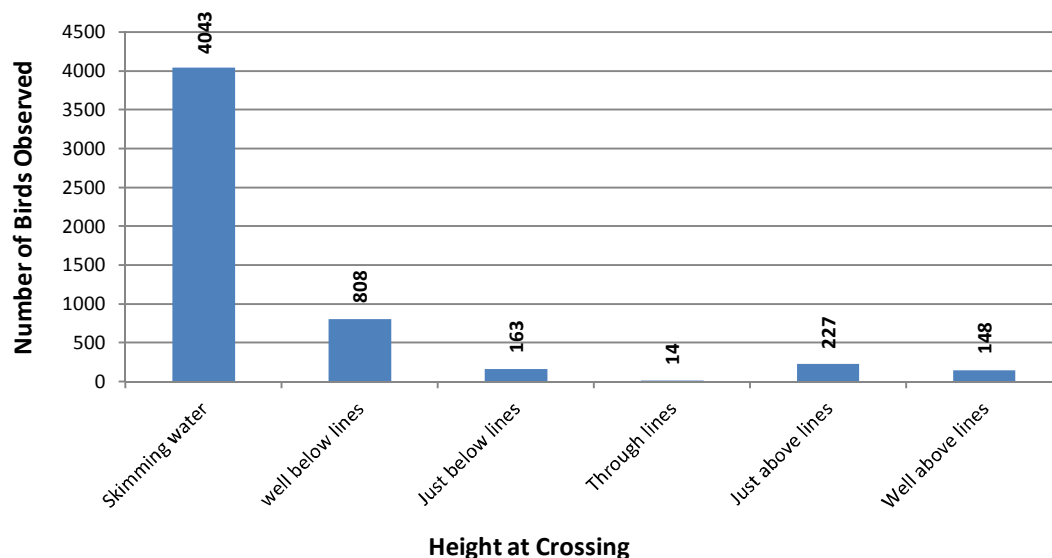
Figure 23. Height at crossing of cormorants at Auld's Cove during Diurnal Bird Surveys

Most cormorants were observed to be skimming the water as they crossed the Auld's Cove power lines (Figure 23). Just over 400 cormorants were observed to cross the Auld's Cove power lines in high risk areas (just below, through, or just above the power lines). Instances in which cormorants were flying higher than just a few metres above the water level (skimming the water) tended to correlate to weather events, in which the water was rough as a result of high winds, or when the Strait of Canso was ice covered.
