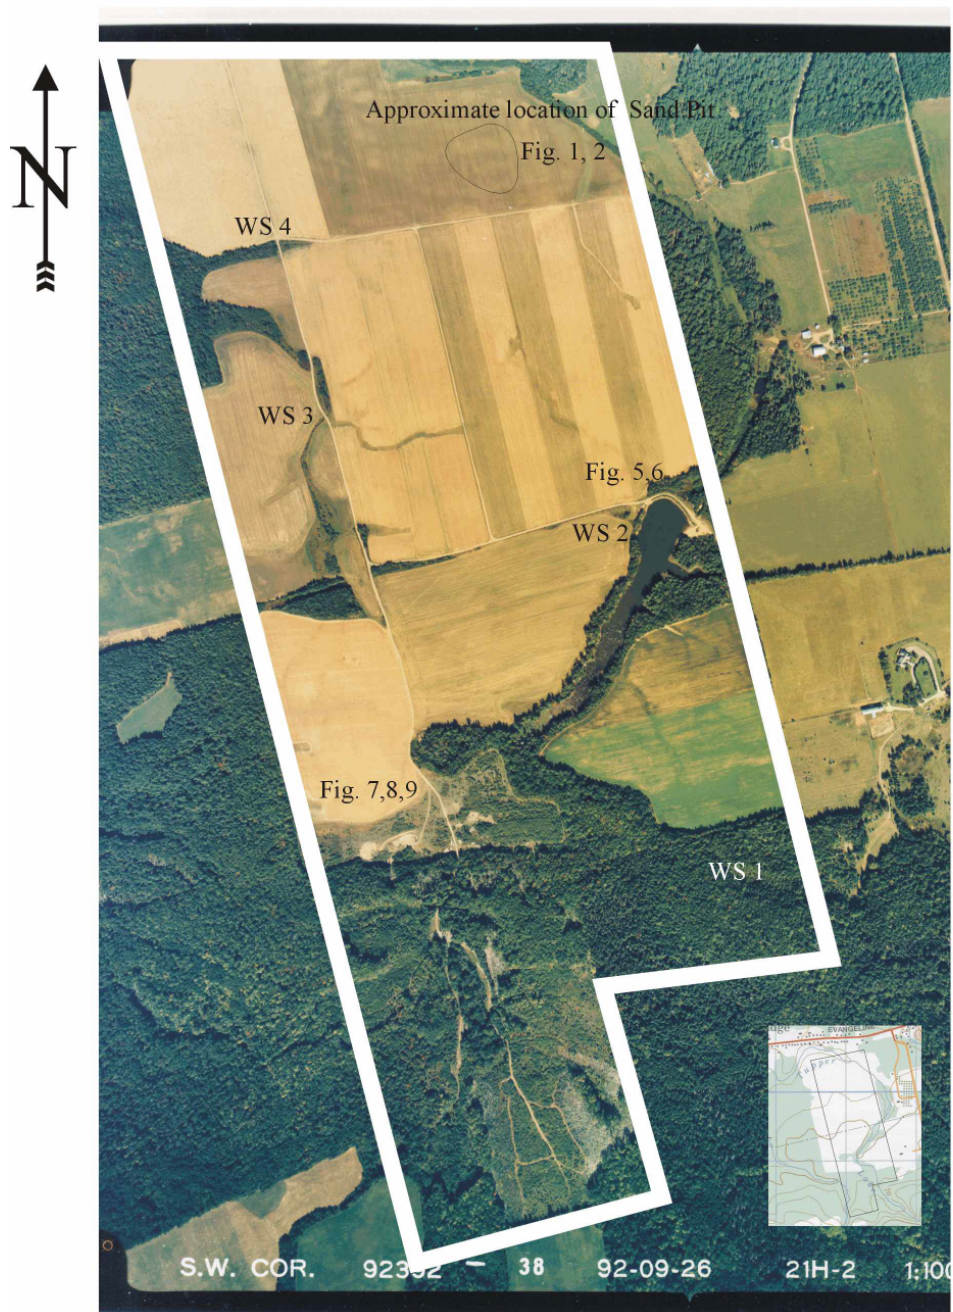
Figure 1: Approximate boundaries of Cambridge Aggregate site. Locations of some of the accompanying figures are noted, location of water quality samples denoted as WS-#. The property is primarily low gradient and low relief however gradients increase in the southern $\frac{1}{4}$ of the property where the north facing slope of the South Mountain is encountered (see inset topographic map of area).

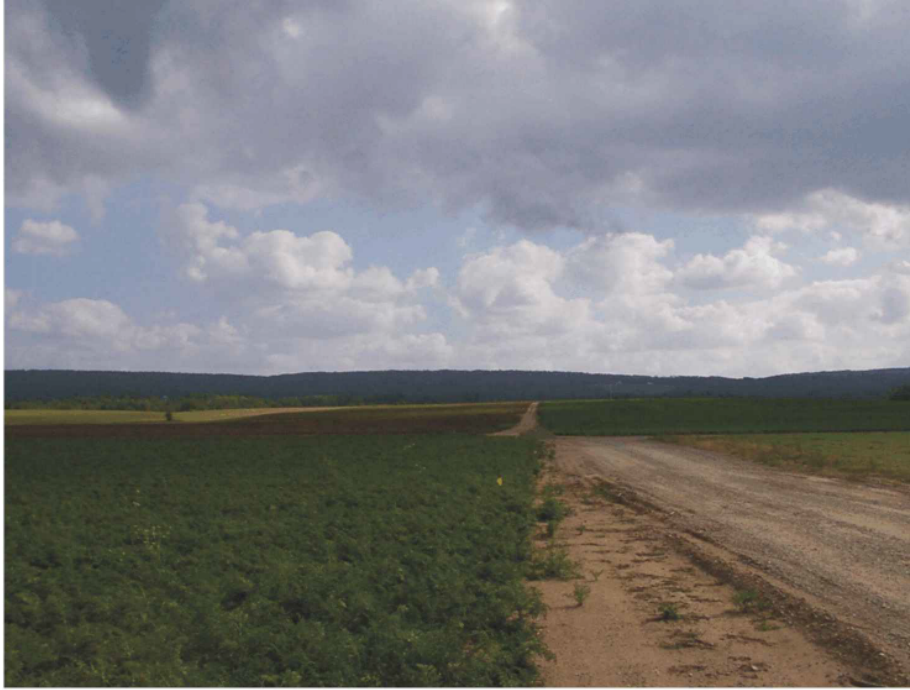
Figure 2. View south from center of property. Note the gently undulating hills typical of the outwash deposits that are common on the south side of Annapolis Valley floor. Highland in the distance is the South Mountain.

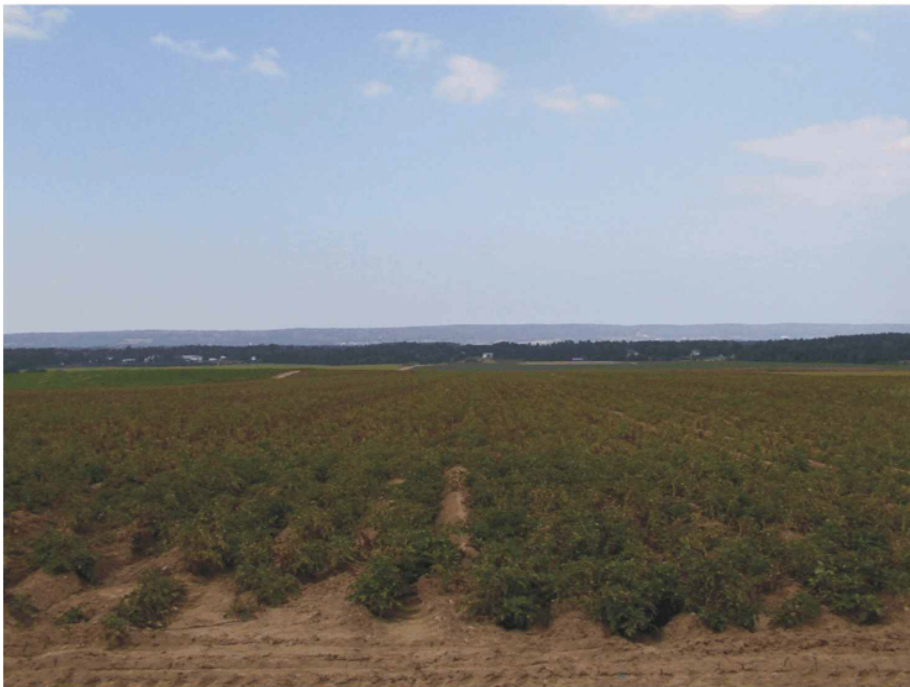
Figure 3. View north from center of the property. Land use is primarily agricultural and takes advantage of the sandy, well drained soils (Cambridge/Berwick soils). Irrigation is commonly employed.

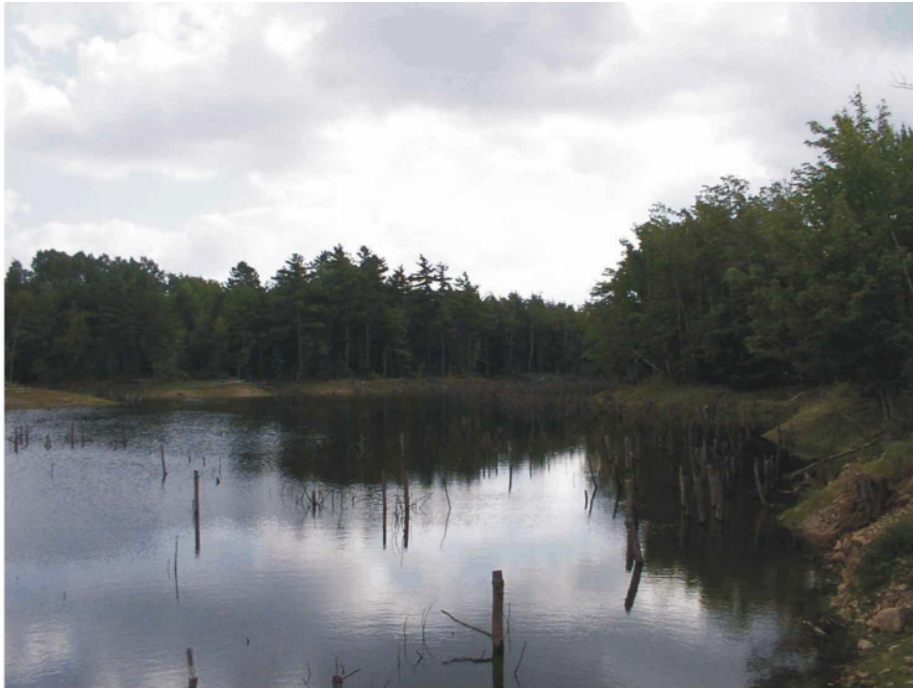
Figure 4. View of reservoir looking south. The reservoir appeared to be stagnant with little circulation.

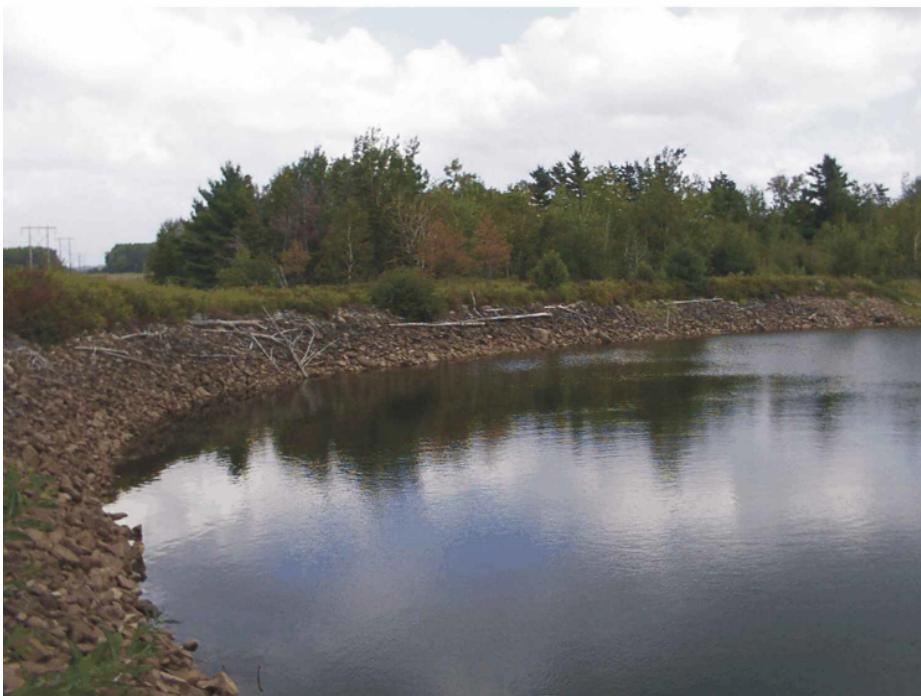
Figure 5. View of reservoir dam. The location of the outlet for this dam is unclear.

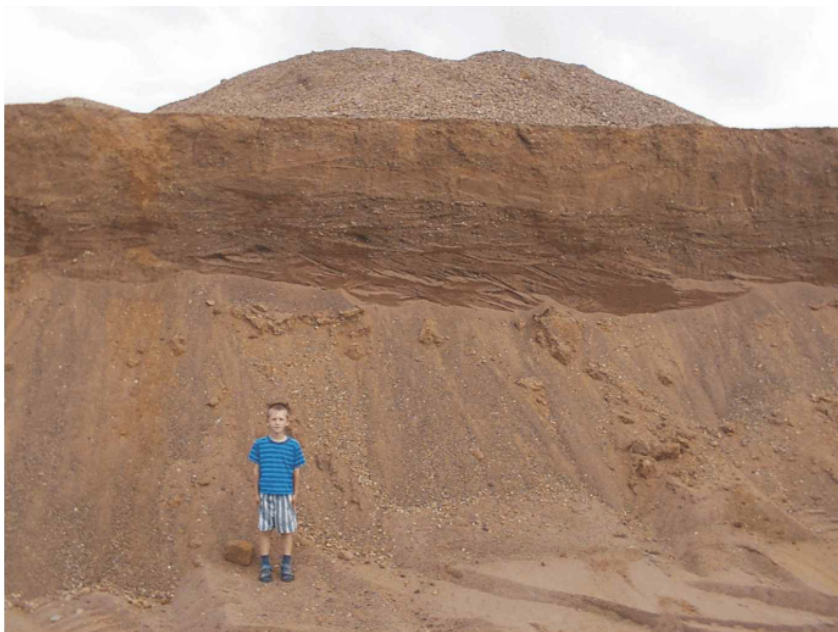
Figure 6. Pit exposure in northwest quarter of the property. The sediment is glacio-fluvial outwash and is moderately to well-sorted with high conductivity. These deposits tend to be rarely thicker than 10 m and laterally continuity can be highly variable. Lodgement till and/or glaciolacustrine sediment (both with low conductivities) most often underlies these deposits.

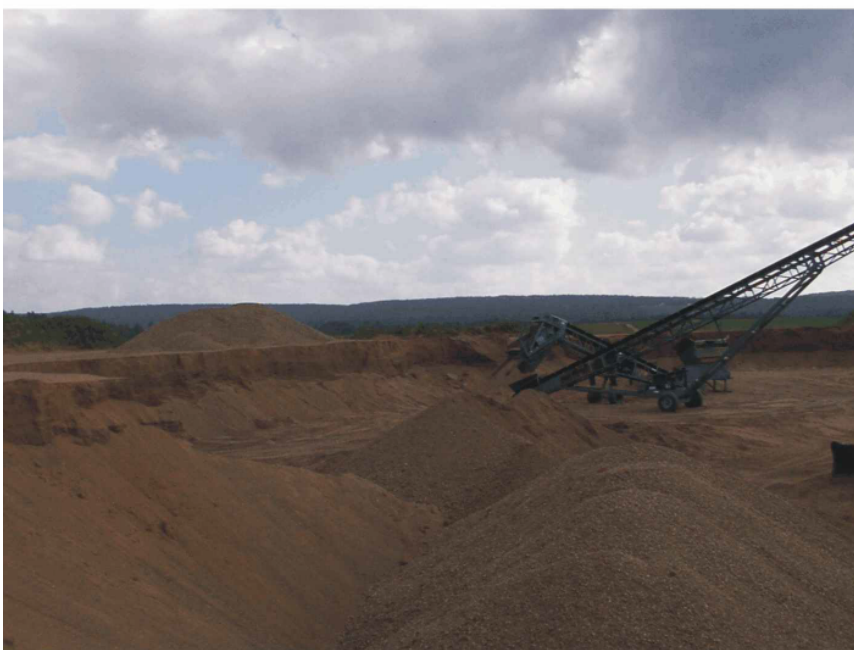
Figure 7. View of sand pit looking south. Note uniform thickness and flat top, characteristic of outwash. Soils developed on top of these deposits are generally thin and nutrient poor.
