**Proposed Nuttby Ridge Wind Farm
Technical Summary Report**
Fish and Fish Habitat, Water Quality, Aquatics, and
Turtle Habitat Assessments

FINAL Report

221265.01 • May 19, 2023

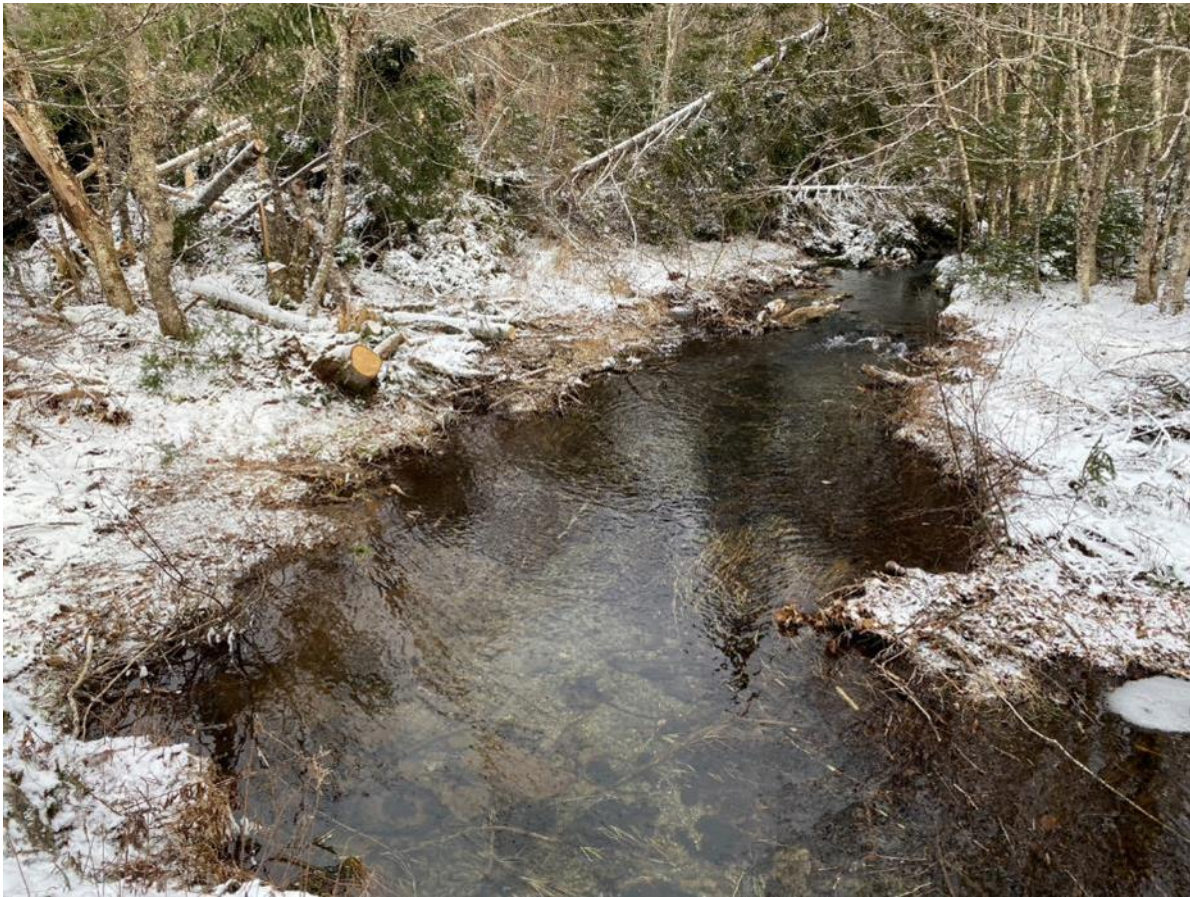
Photo 3-1 Looking upstream from crossing at watercourse channel.

Watercourse NR-WC0121a204, or the Middle Branch of the North River, is a small permanent watercourse that is a tributary to the North River. At the time of assessment, the watercourse was flowing north to south through a culvert located under an access road for the existing wind turbines. The average channel and wetted widths were 2.9 m and 2.88 m, respectively. The dominant substrates were cobbles and gravels with deep pool being the dominant cover available. Water quality was considered good and within recommended CCME guidelines for the protection of Aquatic Life (CCME, 2017). Water quality details are provided in Table 3.3 below.

Watercourse NR-WC0121a204 meandered irregularly along its assessed length, which was bounded by impassable barriers. A 4 m high waterfall was located approximately 80 m upstream from the existing road crossing and at the approximate location of the proposed access road for the Project. The plunge pool below the waterfall could provide good overwintering habitat, as it was greater than 0.5 m deep. An additional unobserved waterfall is known to exist on the watercourse approximately 1 km downstream of the existing road crossing. Mapping, as well as anecdotal information from a local forester, indicates that this waterfall exists downstream on the watercourse. This downstream waterfall was indicated to be taller than 4 m; however, no observations or measurements were taken since the location of the falls was significantly outside of the existing Study Area. Additionally, a cascade barrier was observed between approximately 150 m and 200 m downstream of centreline. The cascade (Photo 3-1) was approximately 6 m high and 20 m in length with a number of 1 to 1.5 m drops over boulders and large woody debris. Despite the known barriers downstream of the crossing suitable habitat and water quality for all life stages of fish was observed in the Study Area.

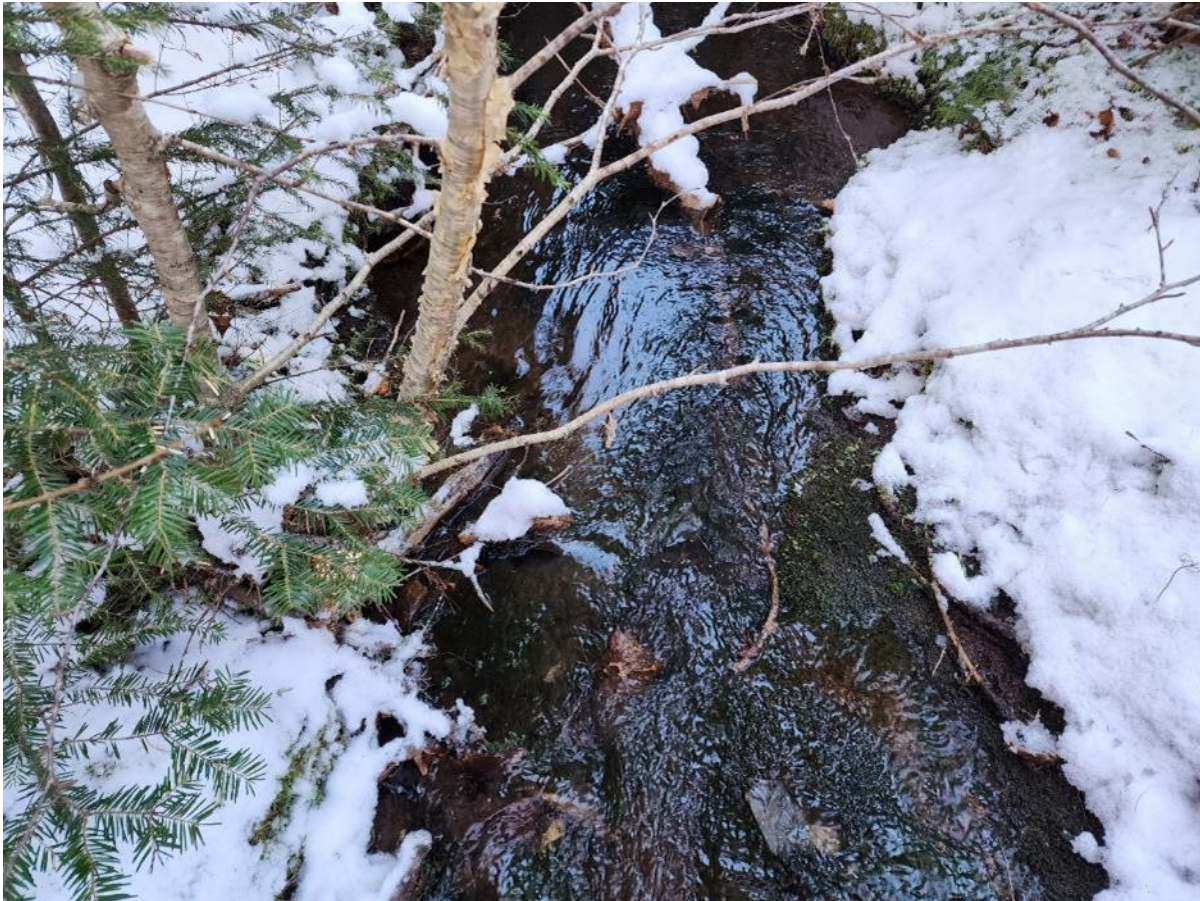
Photo 3-2 Looking downstream, from crossing, at channel.

Watercourse NR-WC-121b244 (tributary to the North River; Photo 3-2) was a small permanent watercourse that generally had poor conditions for fish. The average channel width was 1.48 m, with an average wetted width of 0.97 m. Water depth was on average less than 0.1 m with few deep pools. The dominant substrates were cobbles and gravels, with large and small woody debris providing the main form of cover. Riparian areas were

young mixed forest with stable banks. Water quality was suitable for fish (Table 3.3), with pH of 5.27 and dissolved oxygen of 10.9 mg/L. No barriers were observed within the Study Area. No fish were observed and, overall, the potential for fish in this section of the watercourse was determined to be low.

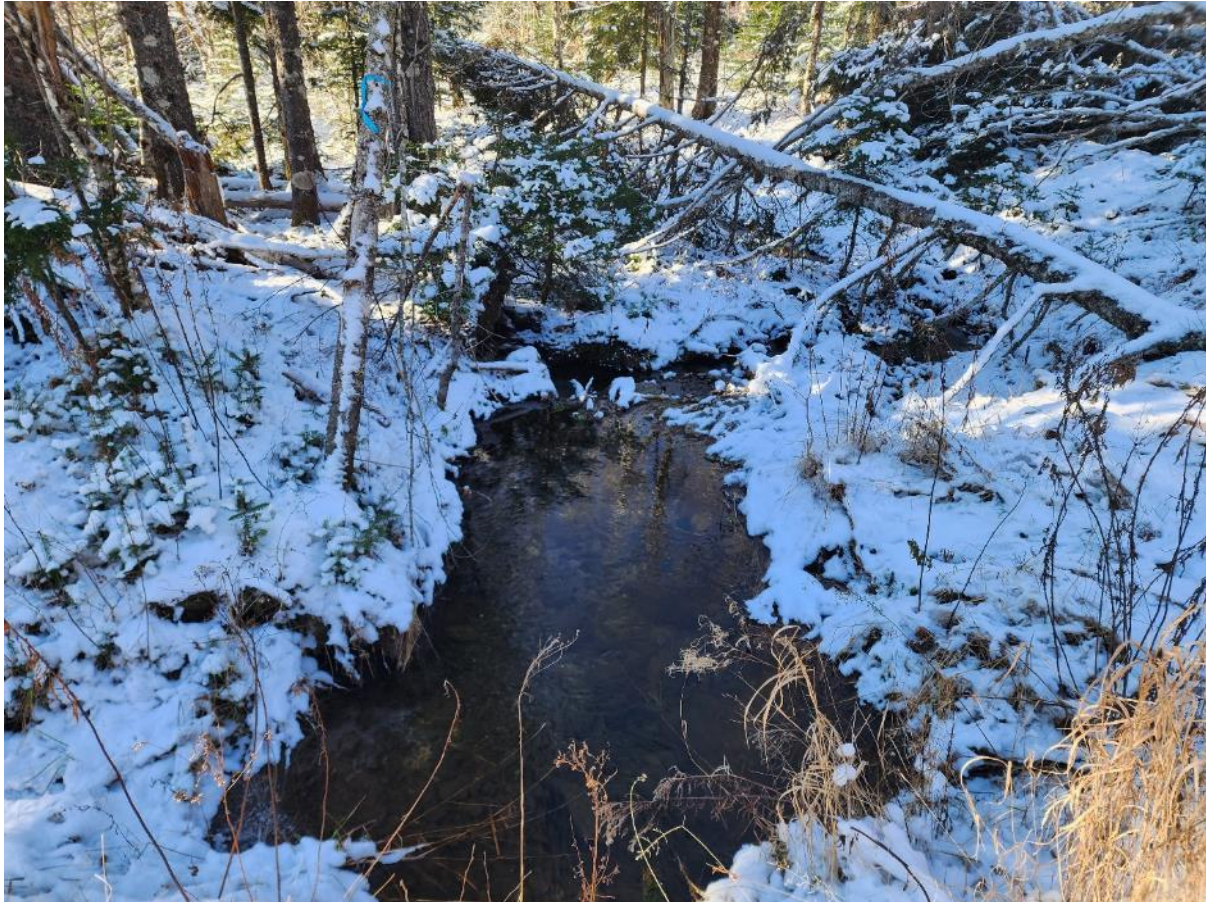
Photo 3-3 Looking downstream, from crossing at watercourse.

Watercourse NR-WC-122h34 was a small permanent watercourse that had an average channel width of 1.48 m and an average wetted width of 0.97 (see Photo 3-3). Average

depth of the channel was less than 0.1 m. Dominant substrates were cobbles and gravels, with undercut banks being the dominant cover type observed. Overall likelihood for fish was determined to be low and fish habitat quality was poor, except for moderate quality rearing habitat. Water quality was suitable for fish (see Table 3.3), with a pH of 5.67 and dissolved oxygen of 7.78 mg/L.

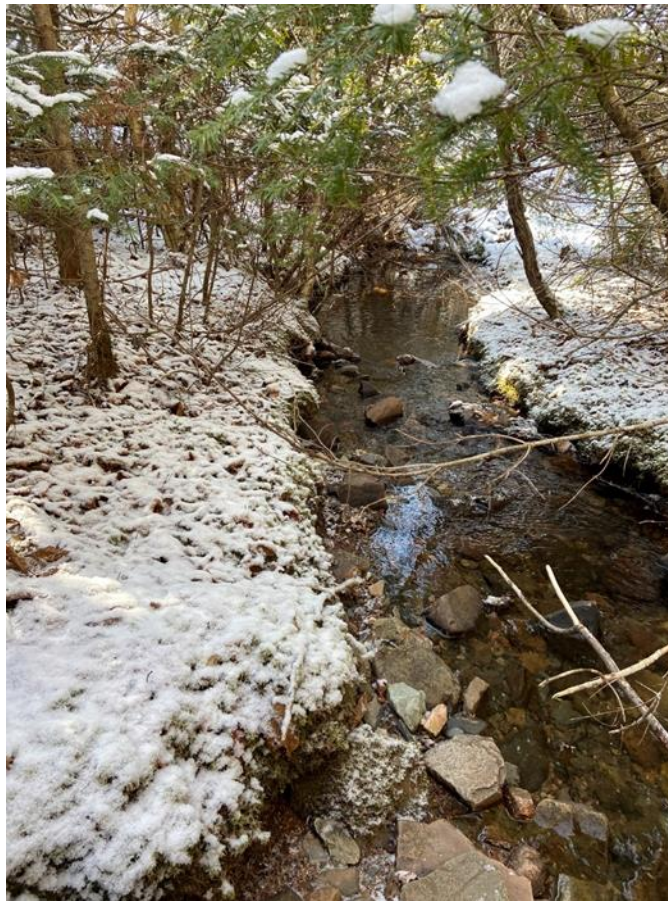
Photo 3-4 Looking upstream at the watercourse from the crossing location.

Watercourse NR-WC-122h26 was a small, unconfined, permanent watercourse with riffle-pool morphology (Photo 3-4). Average channel and wetted widths were 2.62 m and 1.22 m, respectively. Average channel and pool depths were 0.10 m and 0.34 m, respectively. Dominant substrates were gravels and fines, with overhanging vegetation as the dominant instream cover type. Watercourse banks were stable and vegetated with pole-sapling stage forest. Water quality was within acceptable limits for fish (see Table 3.3). Overall, habitat quality within the assessed watercourse was poor, despite moderate quality rearing, foraging, and overwintering habitat. The likelihood for fish presence was determined to be low. A perched culvert was noted at the centreline, where the watercourse crossed under an existing access road, which may limit or prevent fish access upstream.

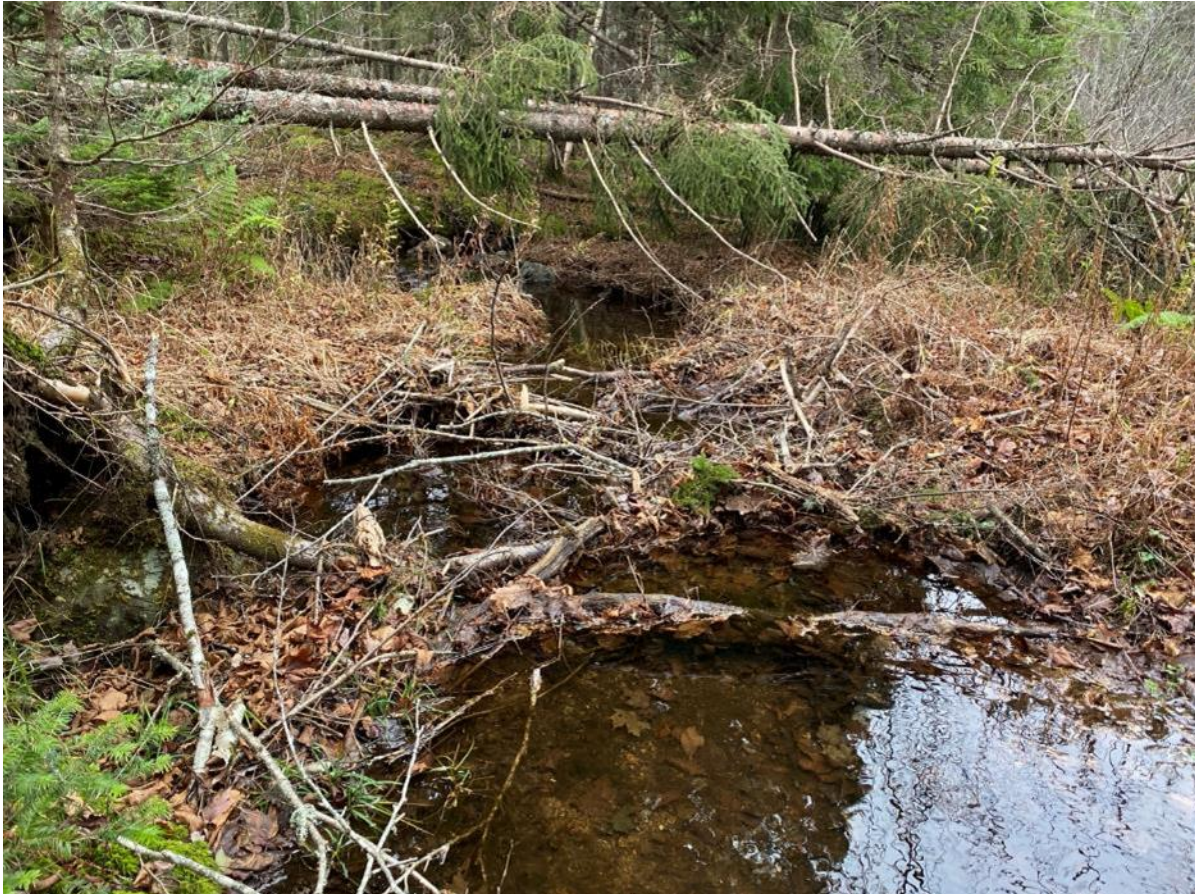
Photo 3-5 Looking downstream at watercourse channel section.

Watercourse NR-WC-122b89 was a small permanent watercourse with intermittent characteristics that appeared to have been formed due to the works for the existing wind turbine access road (see Photo 3-5). The watercourse had an average channel and wetted width of 0.68 m and an average pool depth of 0.13 m. Watercourse morphology was riffle-pool with unconfined irregular meandering. Dominant substrates were organics and fines, with small and large woody debris as the dominant instream cover types. Water quality was within acceptable ranges (see Table 3.3). A small stickleback was observed within the

watercourse at the proposed Project crossing centreline. Although fish-bearing, with moderate to good habitat for fish, the watercourse disappears 100 m upstream of the crossing location and after flowing through the culvert under the current access road, goes subsurface. The connectivity issues are considered a partial barrier to fish movement and access.

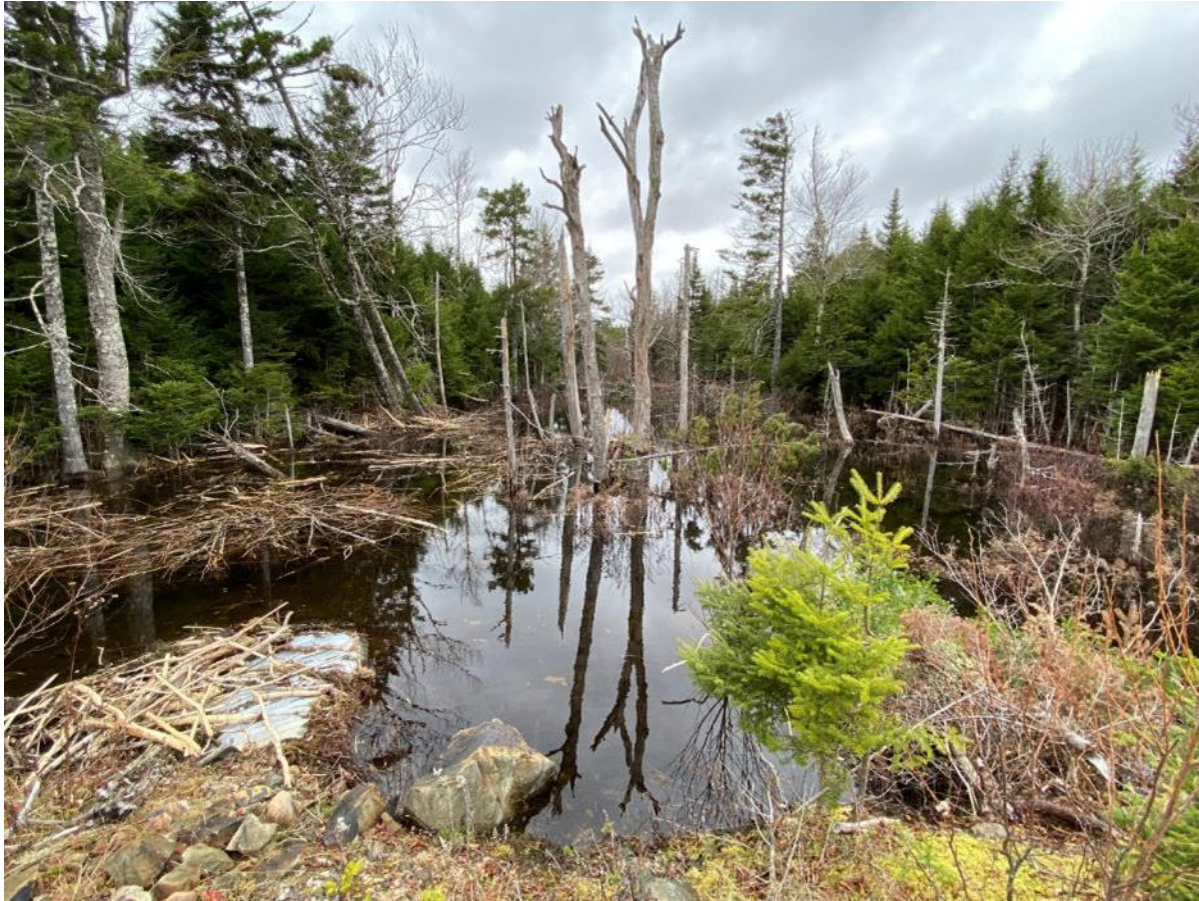
Photo 3-6 Looking upstream at beaver impacted area, near centreline.

Watercourse NR-WC-122f157 was a small permanent watercourse with intermittent characteristics (see Photo 3-6). The watercourse meandered irregularly through an unconfined area with average channel and wetted widths of 1.91 m and 1.87 m, respectively. Average pool depth for the watercourse was 0.42, and overall, the

watercourse had good overwintering habitat due to the presence of deep pools greater than 0.5 m; however, migration habitat quality was poor due to beaver activity. No spawning habitat was observed within the assessed reach due to presence of beaver activity and organics in the channel. Dominant substrates were organics, with deep pools being the dominant type of cover present. Water quality was acceptable for fish (see Table 3.3). Beaver dams were observed at 300 m downstream of the proposed crossing location as well as at 50 m upstream. A culvert under the existing access road, at the proposed centreline, was plugged and likely would prevent fish passage.

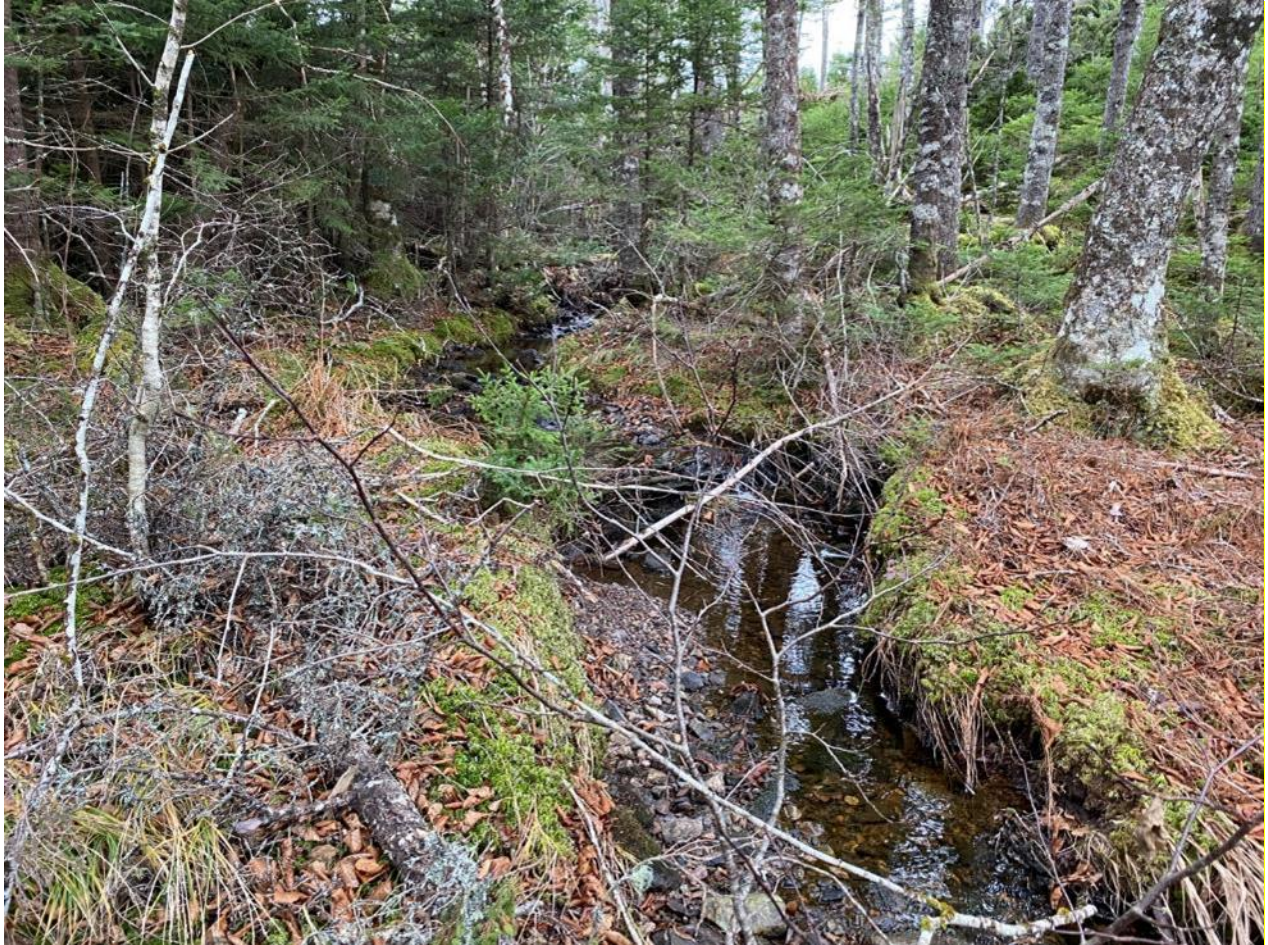
Photo 3-7 Looking upstream, near centreline.

Watercourse NR-WC-122f147 was a small permanent watercourse with intermittent characteristics (Photo 3-7). The watercourse was unconfined with an irregular meandering pattern. Average channel and wetted widths were 1.14 m and 1.08 m, respectively. Average pool depth was shallow at 0.19 m, which is insufficient for overwintering habitat. Dominant substrates were organics and fines, with undercut banks being the dominant cover type. Sections of the watercourse downstream of the centreline had more suitable habitat for fish compared to the upper watershed of this watercourse; however, overall fish habitat quality was considered poor and the likelihood for fish was low. Spawning habitat was

absent due to the presence of organics and fines. Water quality was within acceptable limits for fish, except for low dissolved oxygen of 4.47 mg/L (see Table 3.3).

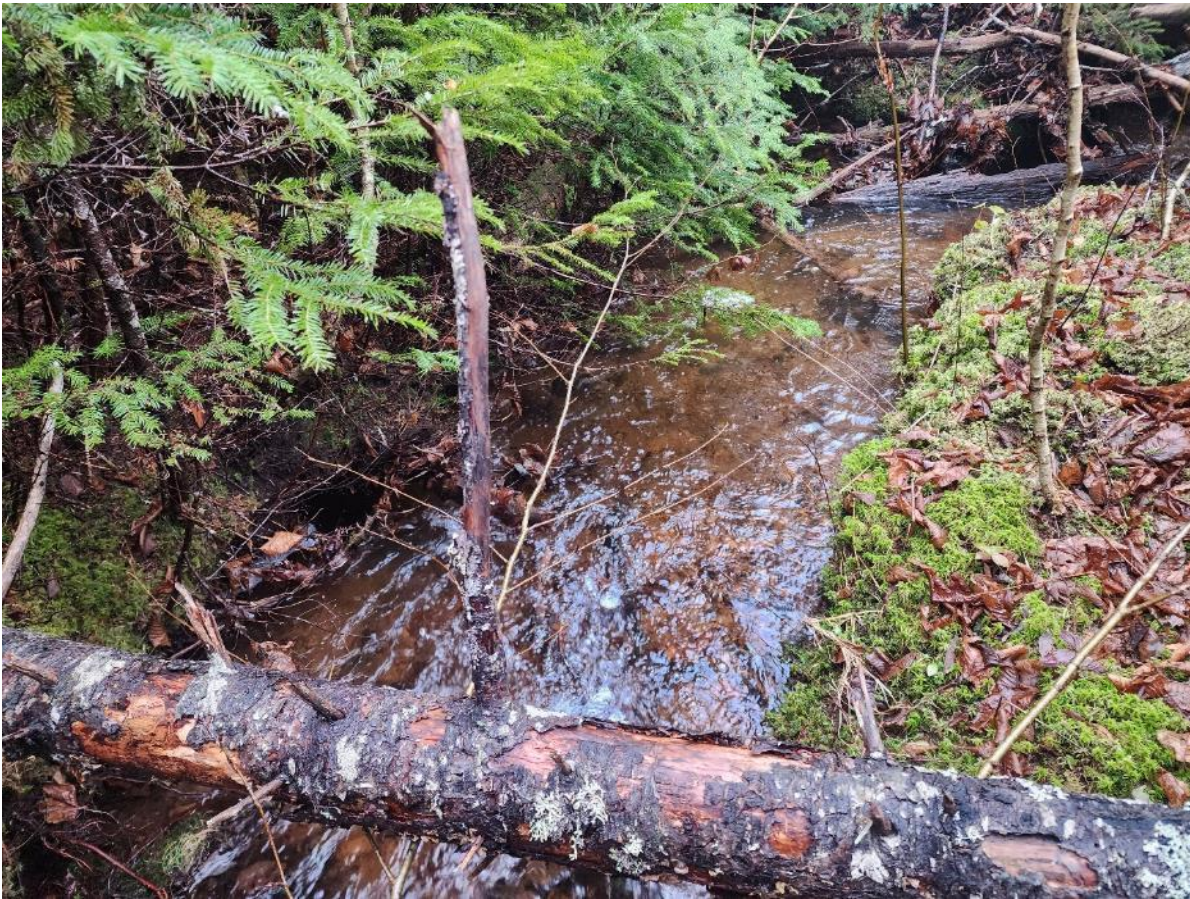
Photo 3-8 Looking upstream, near centreline.

Watercourse NR-WC-122f162 was a small permanent watercourse that was frequently confined along its assessed length (Photo 3-8). The morphology of the watercourse was run, with a sinuous pattern. Average channel and wetted widths were 1.78 m and 1.53 m, respectively. Average pool depth was 0.39 m. Dominant substrates were gravel and cobble, with overhanging vegetation as the dominant cover type. Overall habitat quality was considered as moderate, with low likelihood for fish presence. Good rearing and foraging habitat were observed in the watercourse; however, migration and overwintering habitat were both considered poor. Water quality was within acceptable limits for fish (see Table 3.3).

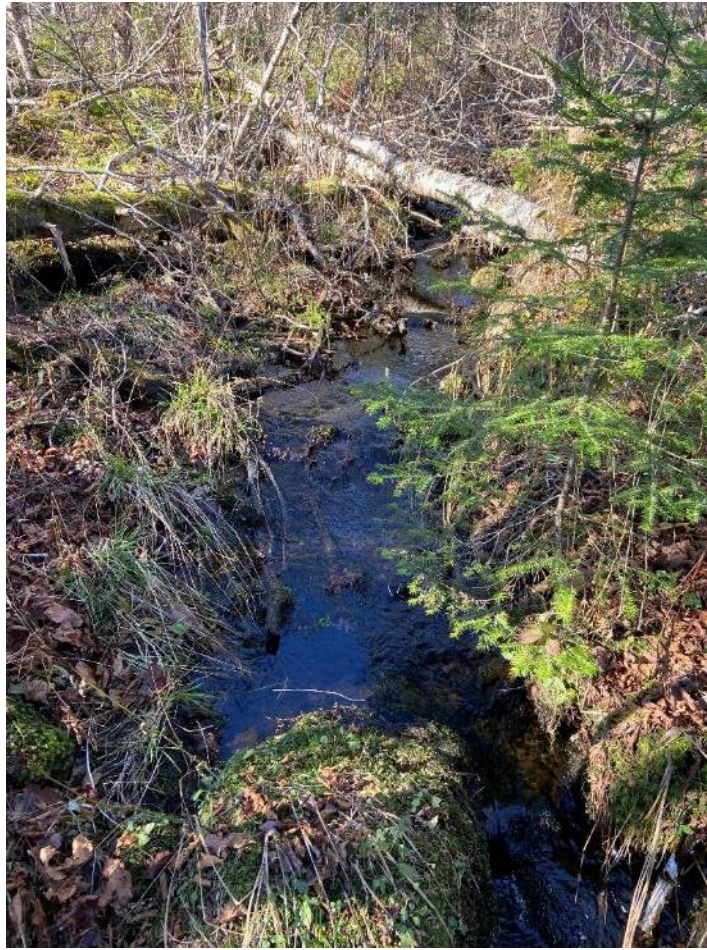
Photo 3-9 Looking upstream, near centreline.

Watercourse NR-WC-122d116, a tributary to the West Branch of the North River, was field identified as a small permanent watercourse with riffle pool morphology (Photo 3-9). Average channel and wetted widths were 2.32 m and 1.89 m, respectively. Average pool depth was 0.31 m. Dominant substrates were gravels and fines, with small woody debris, overhanging vegetation, and large woody debris as co-dominant habitat types. Overall fish habitat quality was moderate, with moderate rearing and foraging habitat, but poor spawning, migration, and overwintering habitat. Water quality was good and well within the acceptable ranges for fish (see Table 3.3).

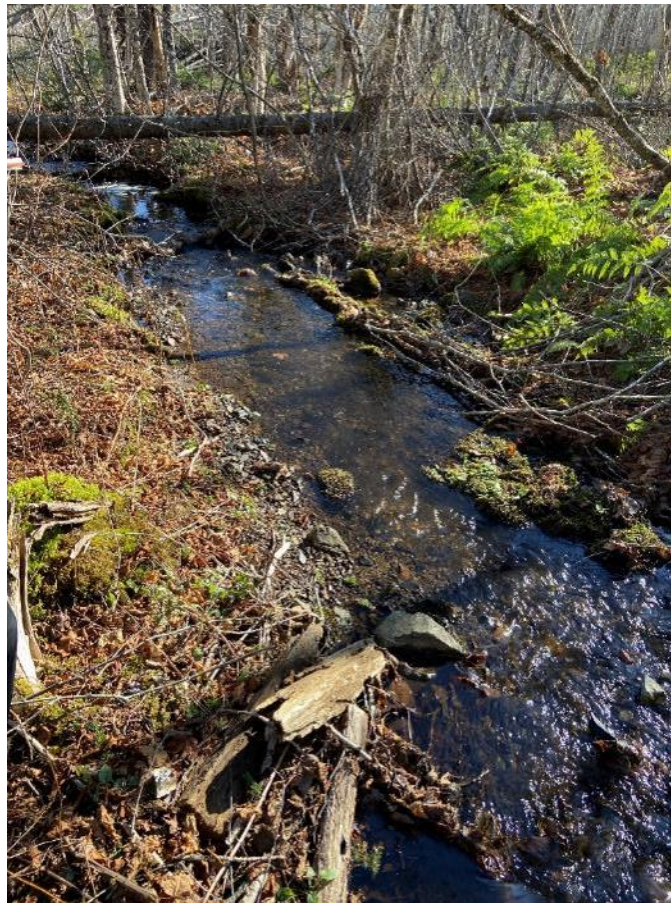
Photo 3-10 Looking upstream, near centreline.

Watercourse NR-WC-122d113 (Unnamed Tributary to West Branch North River) was a small permanent riffle-pool watercourse (Photo 3-10). Average channel and wetted widths were 2.32 m and 1.89 m, respectively. Average pool depth was 0.31 m. The dominant instream substrate was gravels, with large woody debris being the dominant cover type. Water quality was good and within the acceptable range for fish (see Table 3.3). Overall, fish habitat quality in the assessed section of the watercourse was poor; however, rearing, foraging, and overwintering habitats were of moderate quality. The likelihood of fish presence was high; one fish, possibly a salmonid, was observed within the assessment area. No barriers to fish passage were noted.

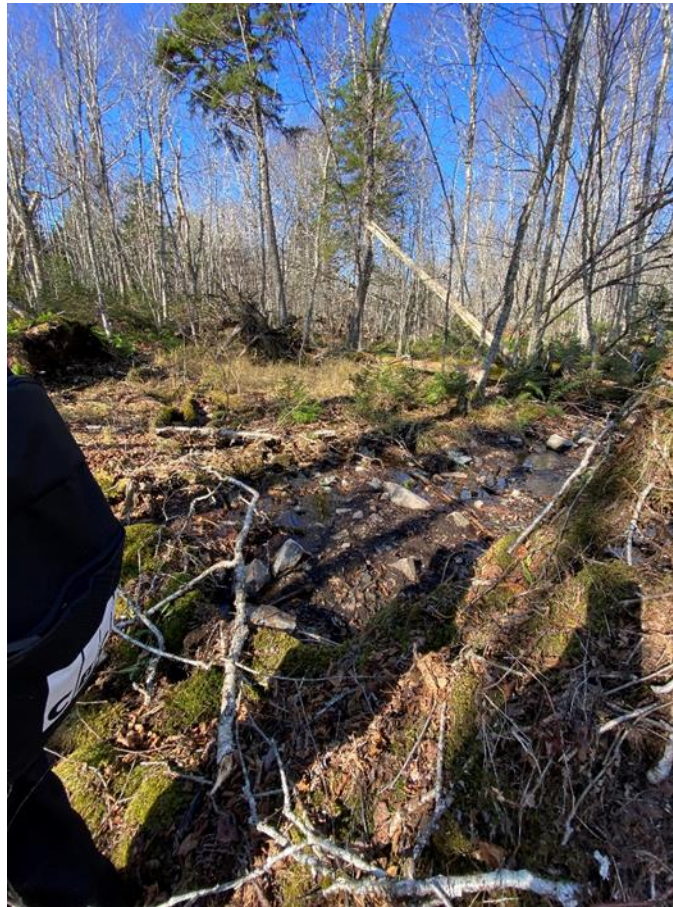
Photo 3-11 Looking upstream at channel, near centreline.

Watercourse NR-WC-122d111 (Unnamed Tributary 1 to West Branch North River) was an intermittent, unconfined, riffle-pool watercourse adjacent to an existing access road (Photo 3-11). The average channel and wetted widths were 2.74 m and 2.36 m, respectively. The watercourse was shallow with an average depth of 0.09 m. The dominant substrate type was cobble, followed by gravel; dominant cover was instream vegetation. No water quality samples were taken at this location; however, based on the proximity to NR-WC-122d113, similar water quality is probable. Overall, fish habitat quality in this watercourse was classified as moderate, but with pool spawning and overwintering habitat quality. Overall fish presence likelihood was moderate; one fish was observed, which was likely a Brook Trout. No permanent barriers to fish passage were noted.

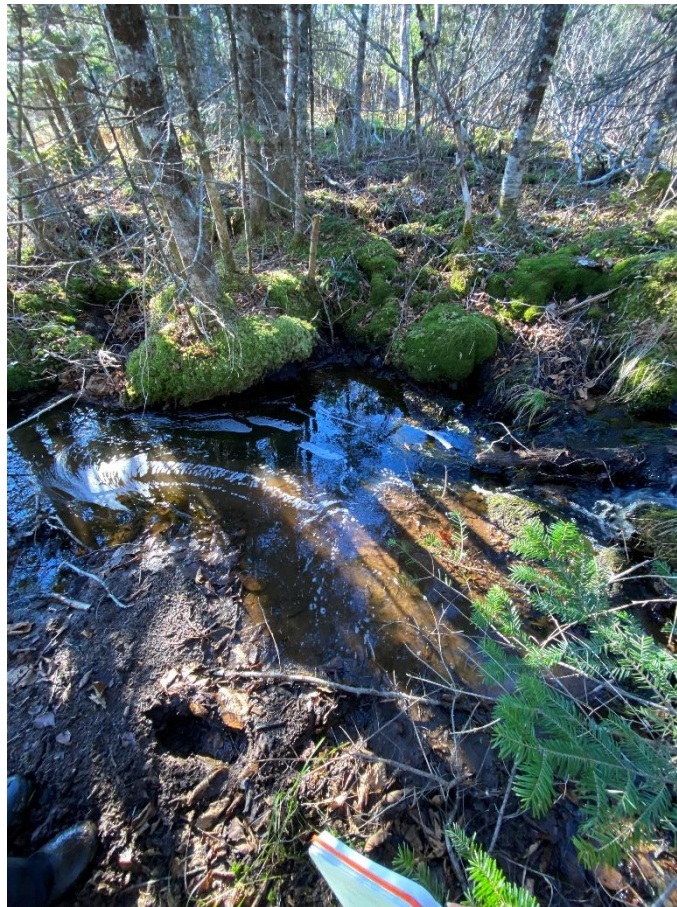
Photo 3-12 Near centreline, looking at main channel.

Watercourse NR-WC-122d101 (Unnamed Tributary to West Branch North River) was a shallow, intermittent, unconfined, riffle-pool watercourse that passed under the existing access road (Photo 3-12). Average channel and wetted widths were 2.25 m and 2.13 m, respectively. Dominant substrates were boulders, while dominant habitat types were small woody debris and boulders. Water quality was good and within the acceptable range for fish (see Table 3.3). Overall, habitat quality was moderate, despite poor spawning and migration habitat as well as an absence of overwintering habitat. Overall fish presence likelihood was moderate; one fish, likely a Brook Trout, was observed in the watercourse. No permanent barriers were observed within the assessed section; however, the culvert under the access road appeared to be blocked.

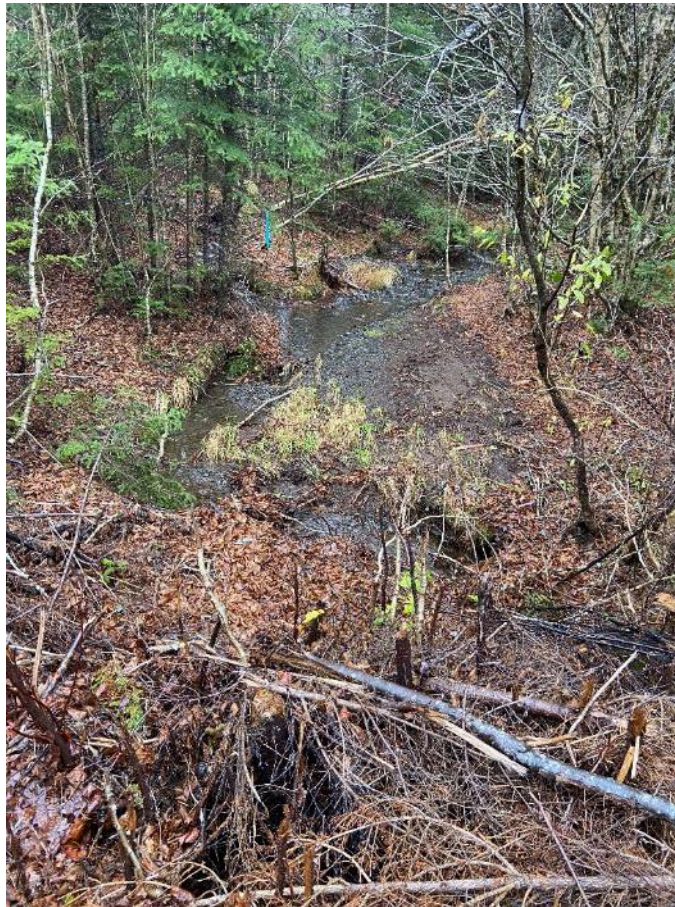
Photo 3-13 Looking upstream at channel and riparian vegetation.

Watercourse NR-WC-122d34 (Unnamed Tributary to West Branch North River) was a shallow, unconfined, small permanent, riffle-pool watercourse that flowed alongside the existing access road before going through a culvert under the road and flowing downstream through the forest (Photo 3-12). The average channel and wetted widths were 0.86 m and 0.72 m, respectively. Average pool depth was 0.21 m at mid-stage. Dominant instream substrates were gravels and fines, while the dominant cover type was overhanging vegetation, followed by a subdominant cover type of small woody debris. Water quality was good and within the acceptable range for fish (see Table 3.3). Overall, habitat quality for fish was determined to be poor, despite moderate rearing and foraging habitat observed in the assessed area. Overall likelihood for fish presence was moderate. No permanent barriers were observed; however, a blocked culvert under the access road was noted.

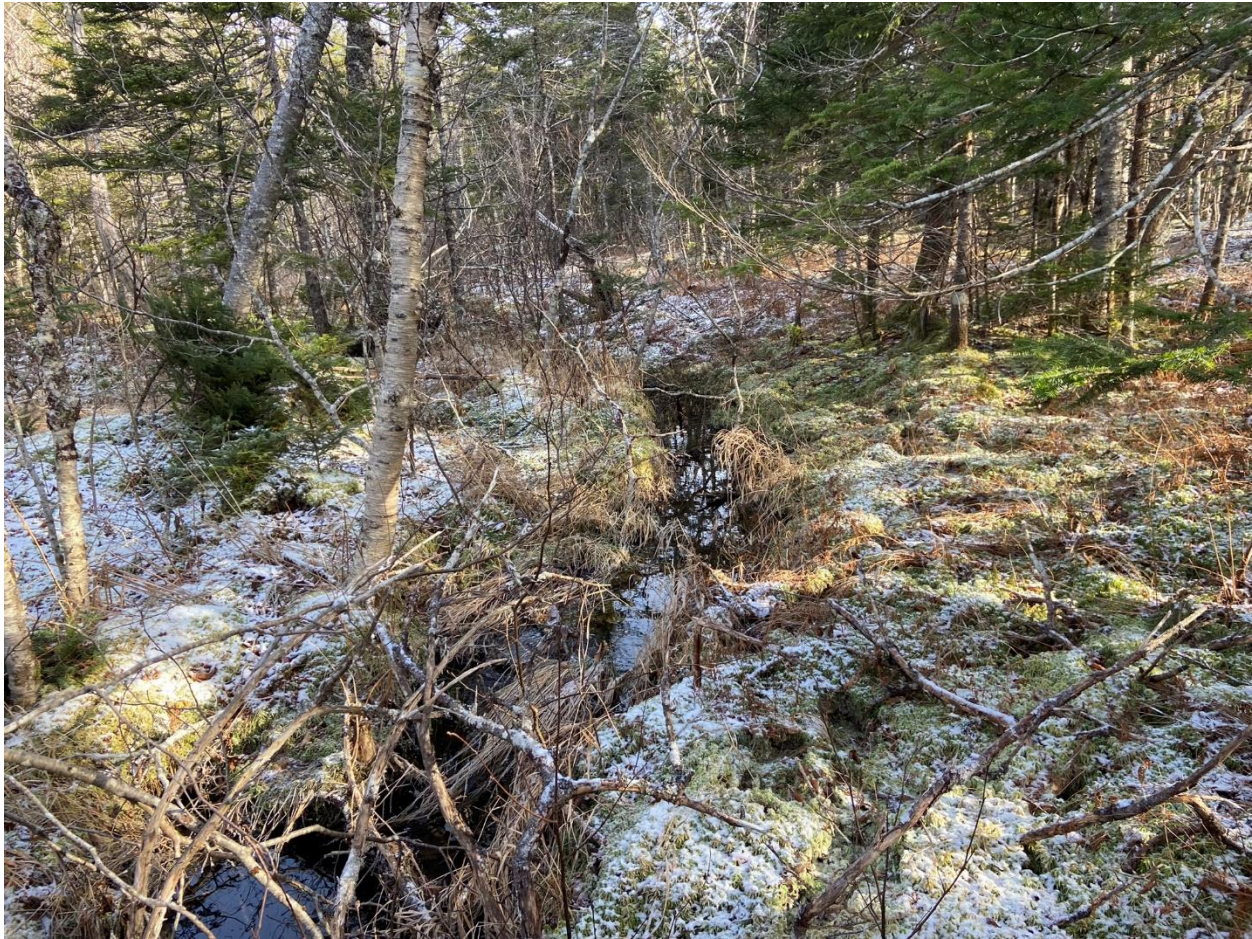
Photo 3-14 Looking upstream at channel upstream of crossing location.

Watercourse NR-WC-122a339 (downstream on Coal Mine Brook) was a small permanent, riffle-pool, watercourse with intermittent characteristics (Photo 3-14). The watercourse had a sinuous morphology and was occasionally confined within the assessed area. Average channel and wetted widths were 1.48 m and 1.33 m, respectively. Average channel and pool depths were 0.11 m and 0.34 m, respectively. Dominant substrates were fines, with subdominant boulders. The dominant instream cover type was small woody debris. Watercourse banks were stable and vegetated with mixed, mature forest, with mosses and ferns. Water quality was within acceptable limits for fish (see Table 3.3). Overall, habitat quality was poor within the assessed area, despite moderate habitat quality noted for rearing and foraging habitat. The likelihood for fish presence was moderate. No barriers were noted within the assessed area. Abundant blowdown and upturned tree roots, likely

from the post-tropical storm in fall 2022, were observed throughout the assessment area, including adjacent to and over the stream.

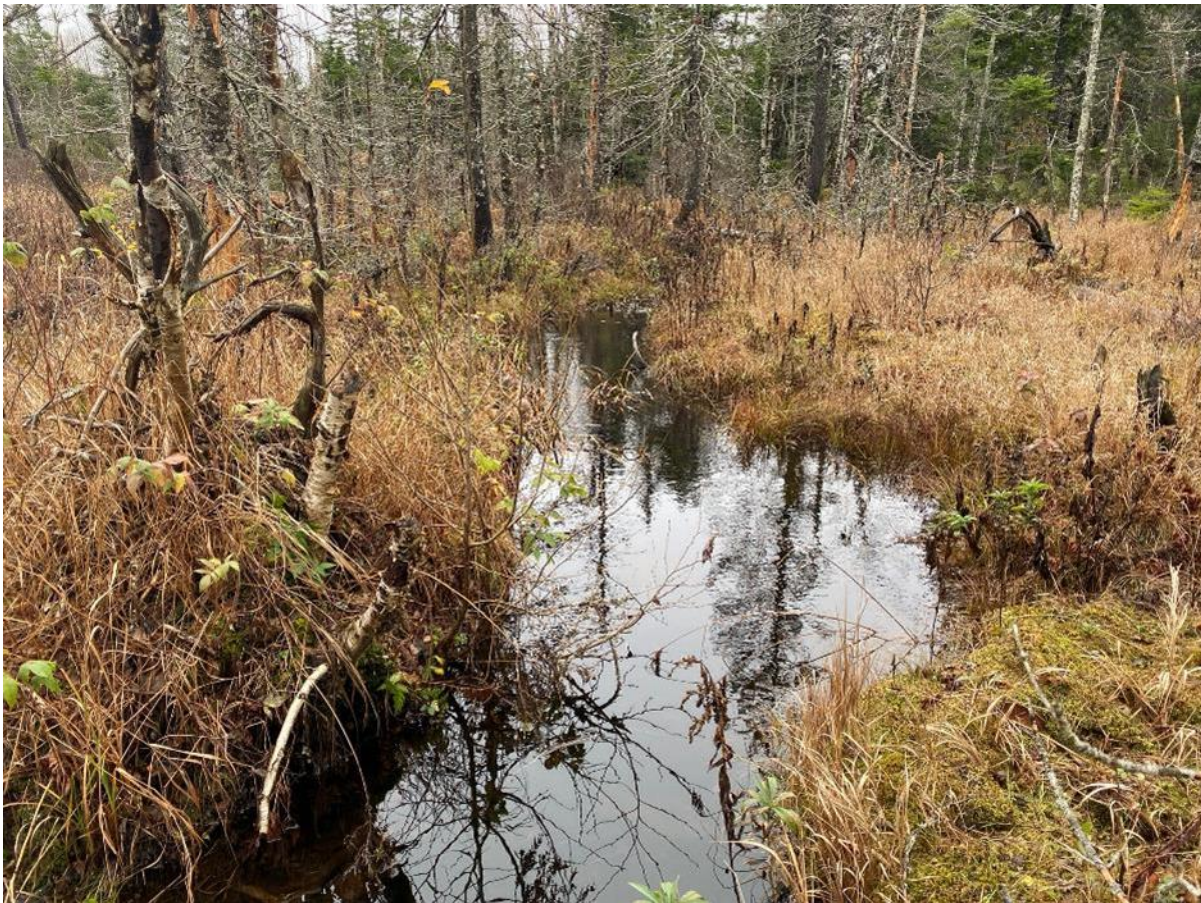
Photo 3-15 Looking upstream at centreline at a section of the watercourse that flowed through an existing wetland.

Watercourse NR-WC-122a374 (upstream of NR-WC-122a339 – Coal Mine Brook) was a small permanent watercourse with intermittent characteristics (Photo 3-15). The watercourse morphology was run with regular meanders and was unconfined through the assessment area. The average channel and wetted widths were 1.58 m and 1.61 m, respectively. Dominant substrates were fines and organics, with undercut banks as the dominant habitat type. Shallow, stable banks with mixed mature forest were found in the riparian areas. Overall habitat quality was good, except for an absence of spawning habitat, due to the dominance of organics and fines. Although average pool depth was recorded as 0.24 m, overall overwintering habitat was considered as good. Water quality was within the acceptable range for fish (see Table 3.3). No barriers were observed within the assessed section of the watercourse, although a small boulder-dominated riffle-pool section was observed approximately 270 m downstream of the centreline.

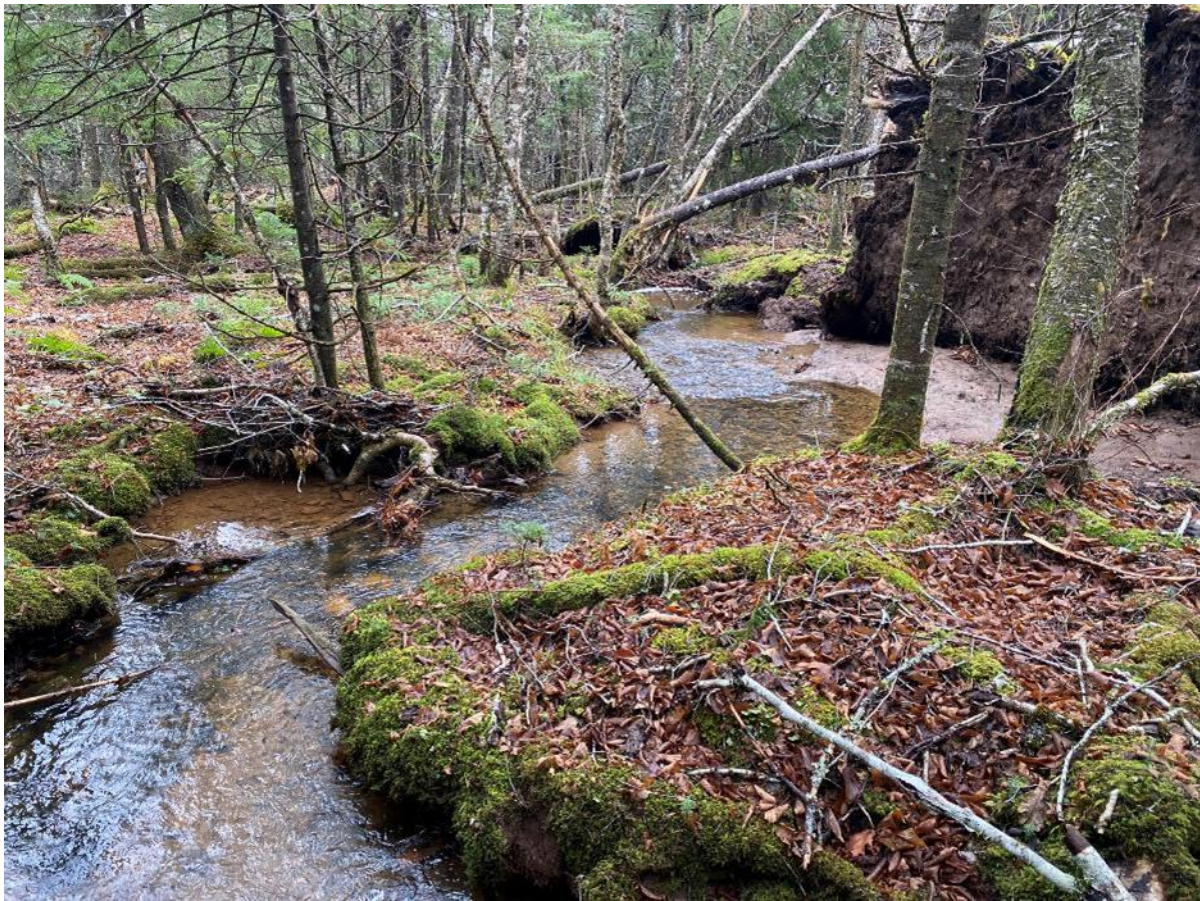
Photo 3-16 Looking downstream, near centreline, at upturned tree and root system.

Watercourse NR-WC-122a367 was a small permanent watercourse with intermittent characteristics (Photo 3-16). The watercourse was located outside of the updated alignment but was within the originally proposed Study Area and, as such, it is included in this report. The watercourse had average channel and wetted widths of 1.22 m and 1.32 m, respectively, with an average pool depth of 0.27 m. The watercourse was unconfined with riffle-pool morphology and irregular meanders. Overall habitat quality was good, except for overwintering, which was considered as moderate due to few pools with a depth of 0.5 m or more. Fines were the dominant substrate, followed by gravels, and undercut banks were the dominant cover type. Banks were shallow and moderately stable, with mixed forest. Numerous upturned trees, likely a result of the post-tropical storm in the fall of 2022, with exposed rootballs were observed along the assessed watercourse. Water quality was within acceptable limits (see Table 3.3), although with a pH of 4.46, is on the lower end of the acceptable range for most fish species. Overall, the likelihood for fish presence was determined to be moderate. No barriers were observed within the assessed length of the watercourse.

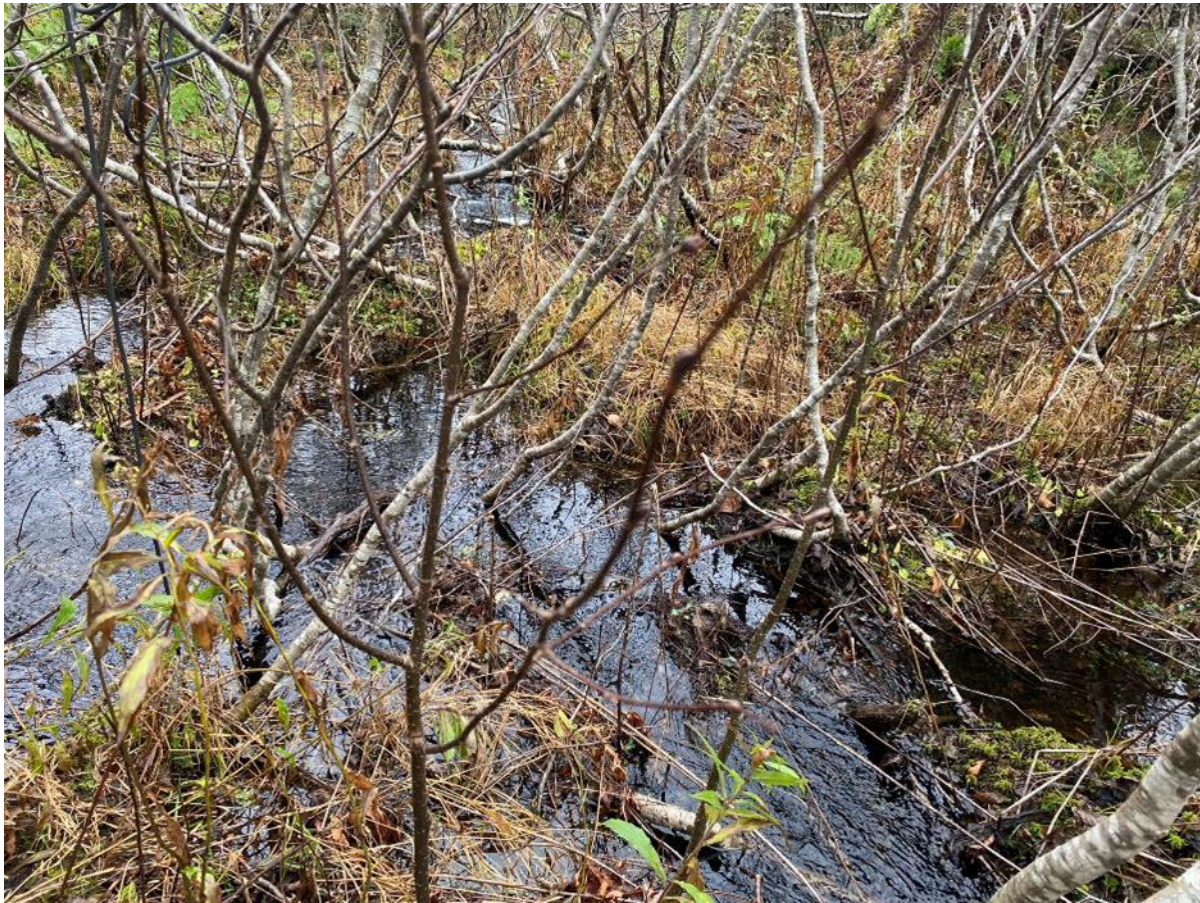
Photo 3-17 Looking upstream at centreline channel and riparian vegetation.

Watercourse NR-WC-122a319, Coal Mine Brook, was a small permanent watercourse with intermittent characteristics (Photo 3-17). The watercourse morphology was riffle-pool, sinuous, and unconfined within the assessment area. Dominant substrate type was organics, followed by fines, with overhanging vegetation as the dominant habitat type. The average channel and wetted widths were almost identical at 1.24 m and 1.25 m, respectively. Average pool depth was 0.22 m. Watercourse banks were moderately stable and vegetated with shrubs and grasses. Water quality was within acceptable limits (see Table 3.3). Overall habitat quality was evaluated as poor, with no spawning habitat observed; moderate quality rearing and migration habitat was present. Overall, likelihood for fish was moderate.

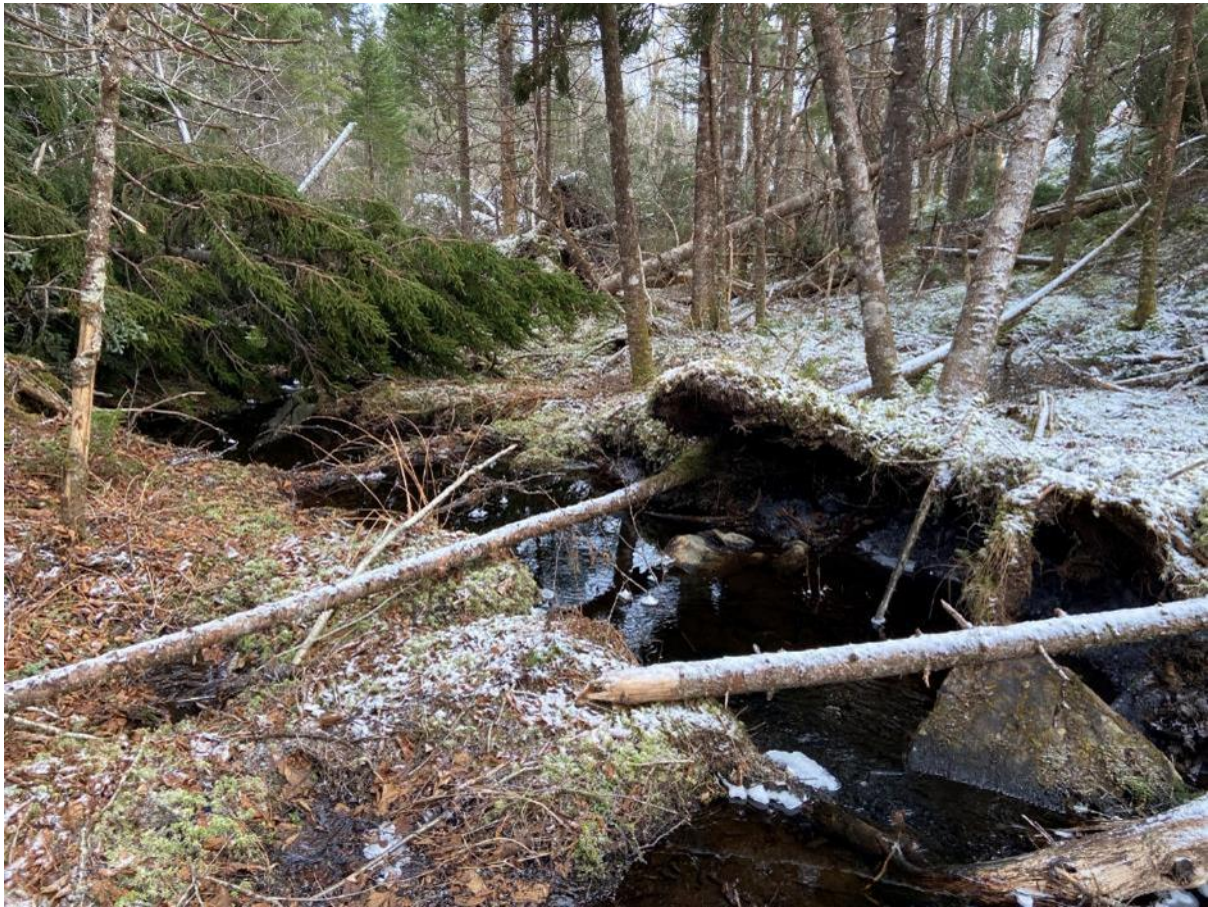
Photo 3-18 Looking upstream at channel with downed trees and upturned tree roots.

Watercourse NR-WC-111a137 (Chiganois River Unnamed Tributary 1a) was a shallow, small permanent watercourse with intermittent characteristics (Photo 3-18). The watercourse was an occasionally confined, riffle-pool watercourse that had an irregular wandering (i.e., meandering) morphology. The average channel and wetted widths were 1.29 m and 1.07 m, respectively. The dominant substrate type was fines and the dominant instream cover was small woody debris. The banks were stable and vegetated with a mixed, mature forest. Water quality was within the acceptable range for fish (see Table 3.3). Overall, fish habitat quality was poor, except for moderate rearing and foraging habitat. The watercourse had a moderate likelihood for fish presence and no barriers were noted. Abundant blow-down was noted along the length of the assessed watercourse, likely from the post-tropical storm in fall 2022.

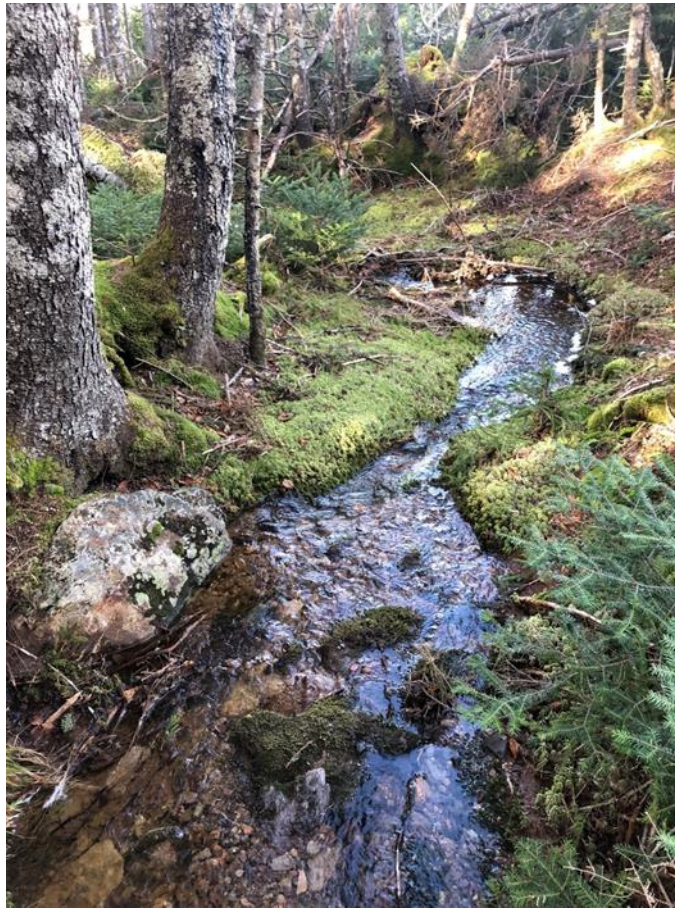
Photo 3-19 Downstream from centreline on NR-WC-122L26.

Watercourse NR-WC-122L26 (Unnamed Tributary 9 of the West Branch North River) was a shallow, small permanent, sinuous, riffle-pool watercourse with intermittent characteristics (Photo 3-19). The watercourse was frequently confined along the assessed length. Average channel and wetted widths were 0.55 m and 0.45 m, respectively. Average water depth was 0.10 m. Dominant substrates were cobbles and co-dominant instream cover types were undercut banks, small woody debris, and boulders. Watercourse banks were stable and vegetated with mature, mixed forest. Overall, likelihood for fish presence was assessed as moderate. Neither water quality measurements nor habitat quality assessments were completed for this watercourse.
