**Proposed Nuttby Ridge Wind Farm
Technical Summary Report**
Fish and Fish Habitat, Water Quality, Aquatics, and
Turtle Habitat Assessments

FINAL Report

221265.01 • May 19, 2023

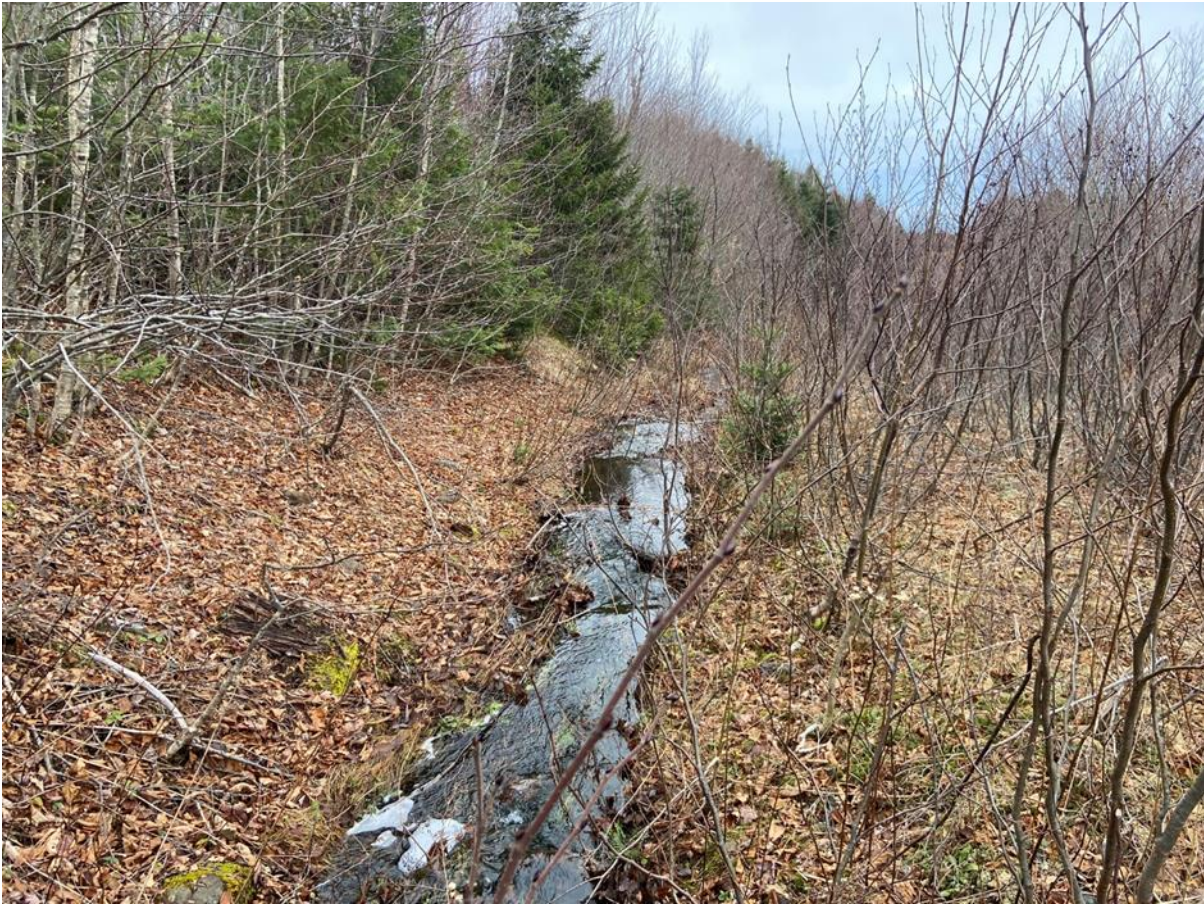
Photo 3-20 Looking upstream at channelized watercourse, near centreline.

Watercourse NR-WC-200b297, Tributary to Cavanagh Brook, was a shallow, unconfined, intermittent watercourse with ephemeral characteristics (Photo 3-20). The watercourse was sinuous with run morphology. Average channel and wetted widths were 0.99 m and 0.82 m, respectively, with an average pool depth of 0.37 m. Dominant instream substrates were fines and gravels, with overhanging vegetation as the dominant instream cover type. Watercourse banks were stable and vegetated with mixed forest. Water quality was within the acceptable range for fish (see Table 3.3). Overall, fish habitat quality was classified as poor, with no noted habitat due to the ephemeral nature of parts of the stream, including a section that went into a roadside drainage feature. A waterfall was noted downstream as a complete barrier to fish passage within the assessed area of the watercourse.

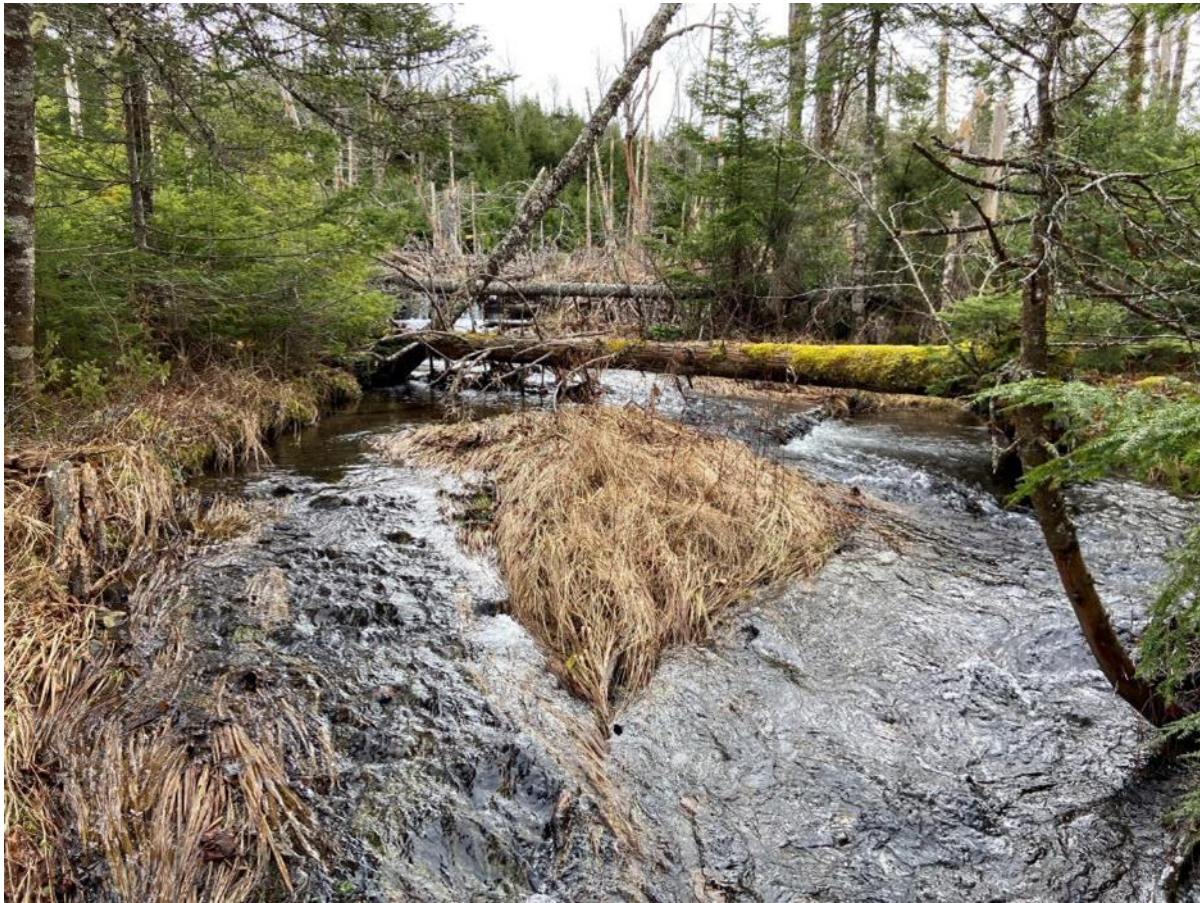
Photo 3-21 Looking upstream at riffle and island, near centreline.

Watercourse NR-WC-200b473 (Cavanagh Brook) was an unconfined, intermittent, riffle-pool watercourse (Photo 3-21). Average channel and wetted widths were 4.57 m and 3.73 m, respectively. Average channel and pool depths were 0.20 m and 0.37 m, respectively. Dominant substrates were cobbles and gravels, while the dominant instream cover type was uprooted tree area, followed by boulder and woody debris (small and large). Water quality was good and within the acceptable range for fish (see Table 3.3). Overall, fish habitat quality was classified as good, except for moderate overwintering habitat. Potential spawning redds were observed within the assessed section of watercourse, along with an observation of a fish, possibly Brook Trout. The likelihood for presence of fish was considered as high. A possible barrier was observed, as a boulder dominated cascade was present in the stream.

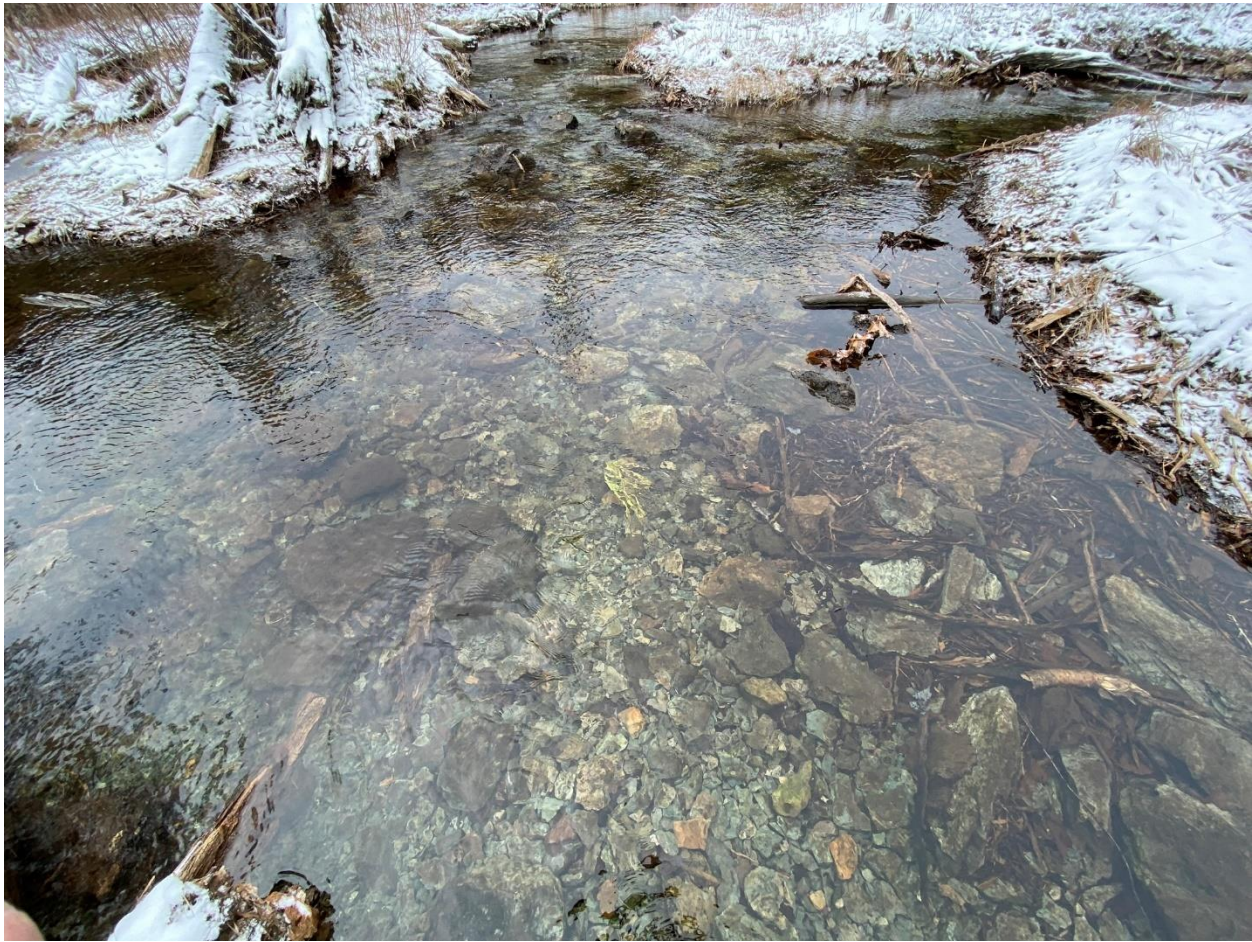
Photo 3-22 Typical habitat with high abundance of aquatic invertebrates (Watercourse: NR-WC 121a204).

Aquatic invertebrates were investigated at the centreline / crossing location for each of the detailed watercourse assessment locations. The presence of aquatic invertebrates was noted throughout the detailed assessment area and varied in abundance from none or trace to abundant. Generally, aquatic invertebrates were present at most sites where there was good cobble and/or boulder substrates (Photo 3-22). Abundance of aquatic invertebrates was used in determining classification of fish habitat, including foraging habitat.
