From:  
To: [Environment Assessment Web Account](#); [Hunter, Tanya](#); [Van Lunen, Erik](#)  
Cc: [Premier](#); [Minister, Env](#); [Brad Johns \(mlabradjohns@gmail.com\)](#)  
Subject: NCCI Mount Uniacke Quarry - Apparent Non-Compliances 30-Oct-2025  
Date: October 31, 2025 4:38:55 PM  
Attachments: [Quarry Violations - 2025-10-31 - Flat - BSP.pdf](#)

**Apparent Quarry Violations**

Prepared: 31-Oct-2025 - BSP  
Image: Quarry,1  
Image Date: 30-Oct-2025

Mount Uniacke, NS - NCCI Quarry - Apparent Violations Identified by the Community  
Photo Taken: 13-May-2022

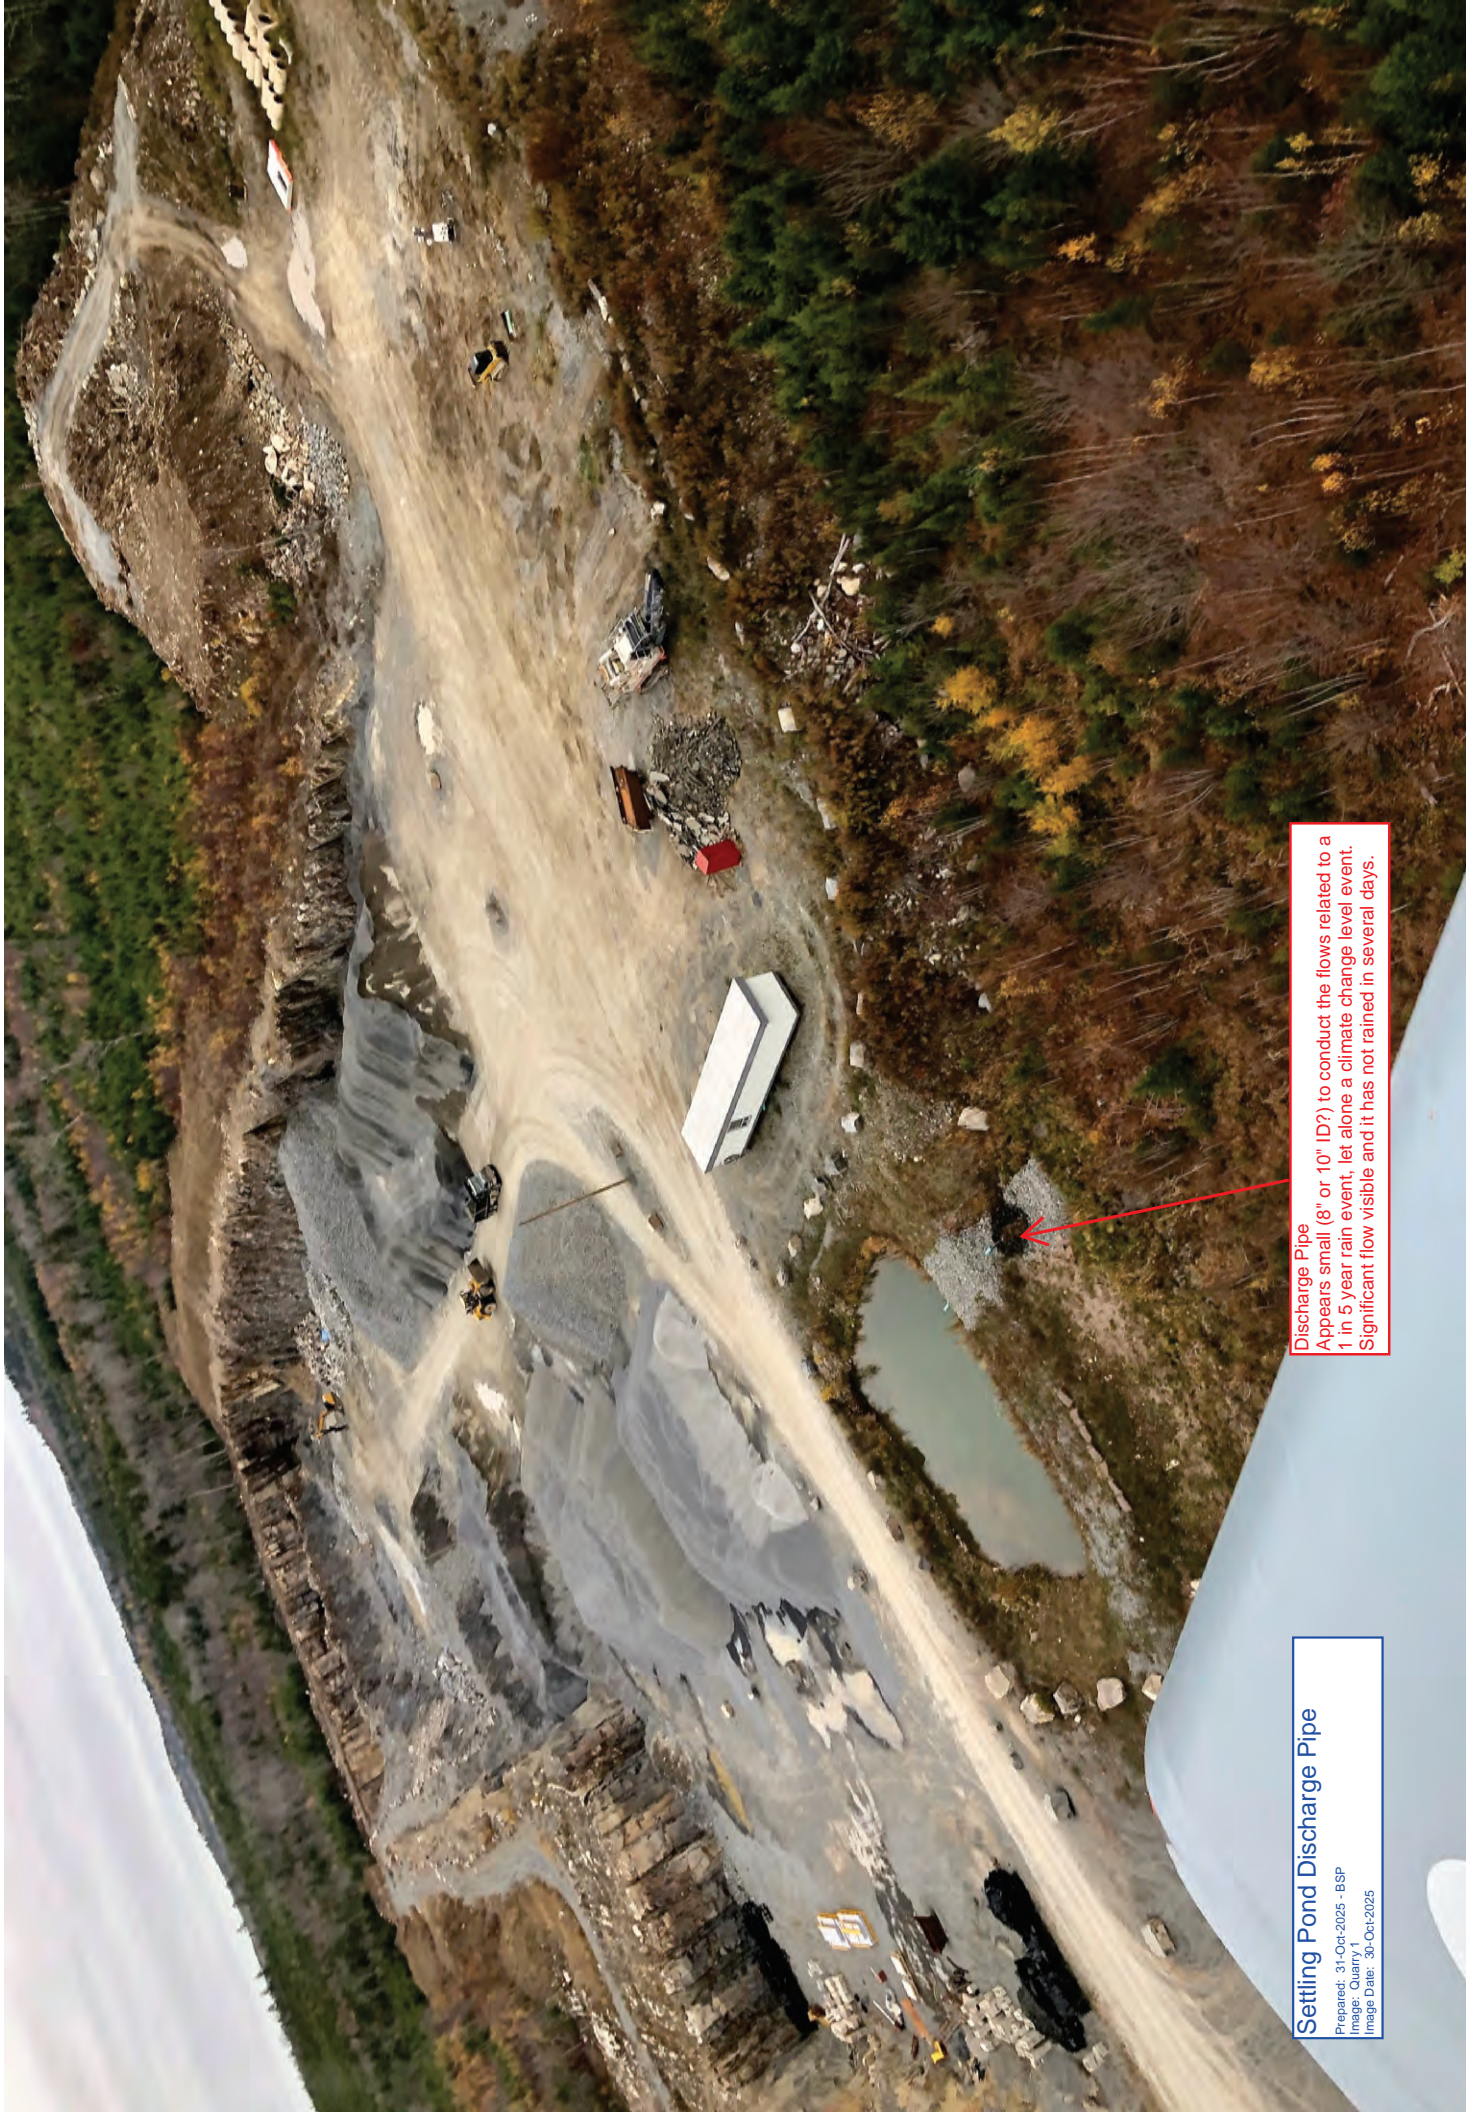
Settling Pond Discharge Pipe  
Prepared: 31-Oct-2025 - BSP  
Image: Quarry,1  
Image Date: 30-Oct-2025

The attached photo shows the NCCI Quarry discharge pipe, I would estimate it is 8" or 10" ID. The pipe appears to be flowing at ~30% capacity, the ground is dry except for ponding areas, this area has seen extreme drought since June, and it has not rained in several days. Based on regulations and NCCI written information, the quarry area slopes to the settling pond. I doubt this pipe has the capacity to handle a 1 in 5 year rain event, let alone a climate change level event such as 2023. The expected outcome of a significant rain event would be for the pond to backup and overflow into the wetlands south of the quarry boundary.

Discharge Pipe  
Appears small (8" or 10" ID?) to conduct the flows related to a  
1 in 5 year rain event, let alone a climate change level event.  
Significant flow visible and it has not rained in several days.

Recommended path for verification:

1. Attend the site during a significant rain event, or shortly thereafter. Do not show up early in the event, the system will need time to fill and backup. Observe flow behaviors on around the entire site.
2. Collect real data. Install flow and level monitoring in the inlet of the settling pond discharge pipe. Flowmetrix Technical Services (<https://flowmetrix.ca/can>) can provide this service.

3. Conduct topographic survey, including a drone-based Lidar scan of the site, to determine surface elevations.
4. Consult an independent, experience professional to analyze and interpret the data and provide recommendations.

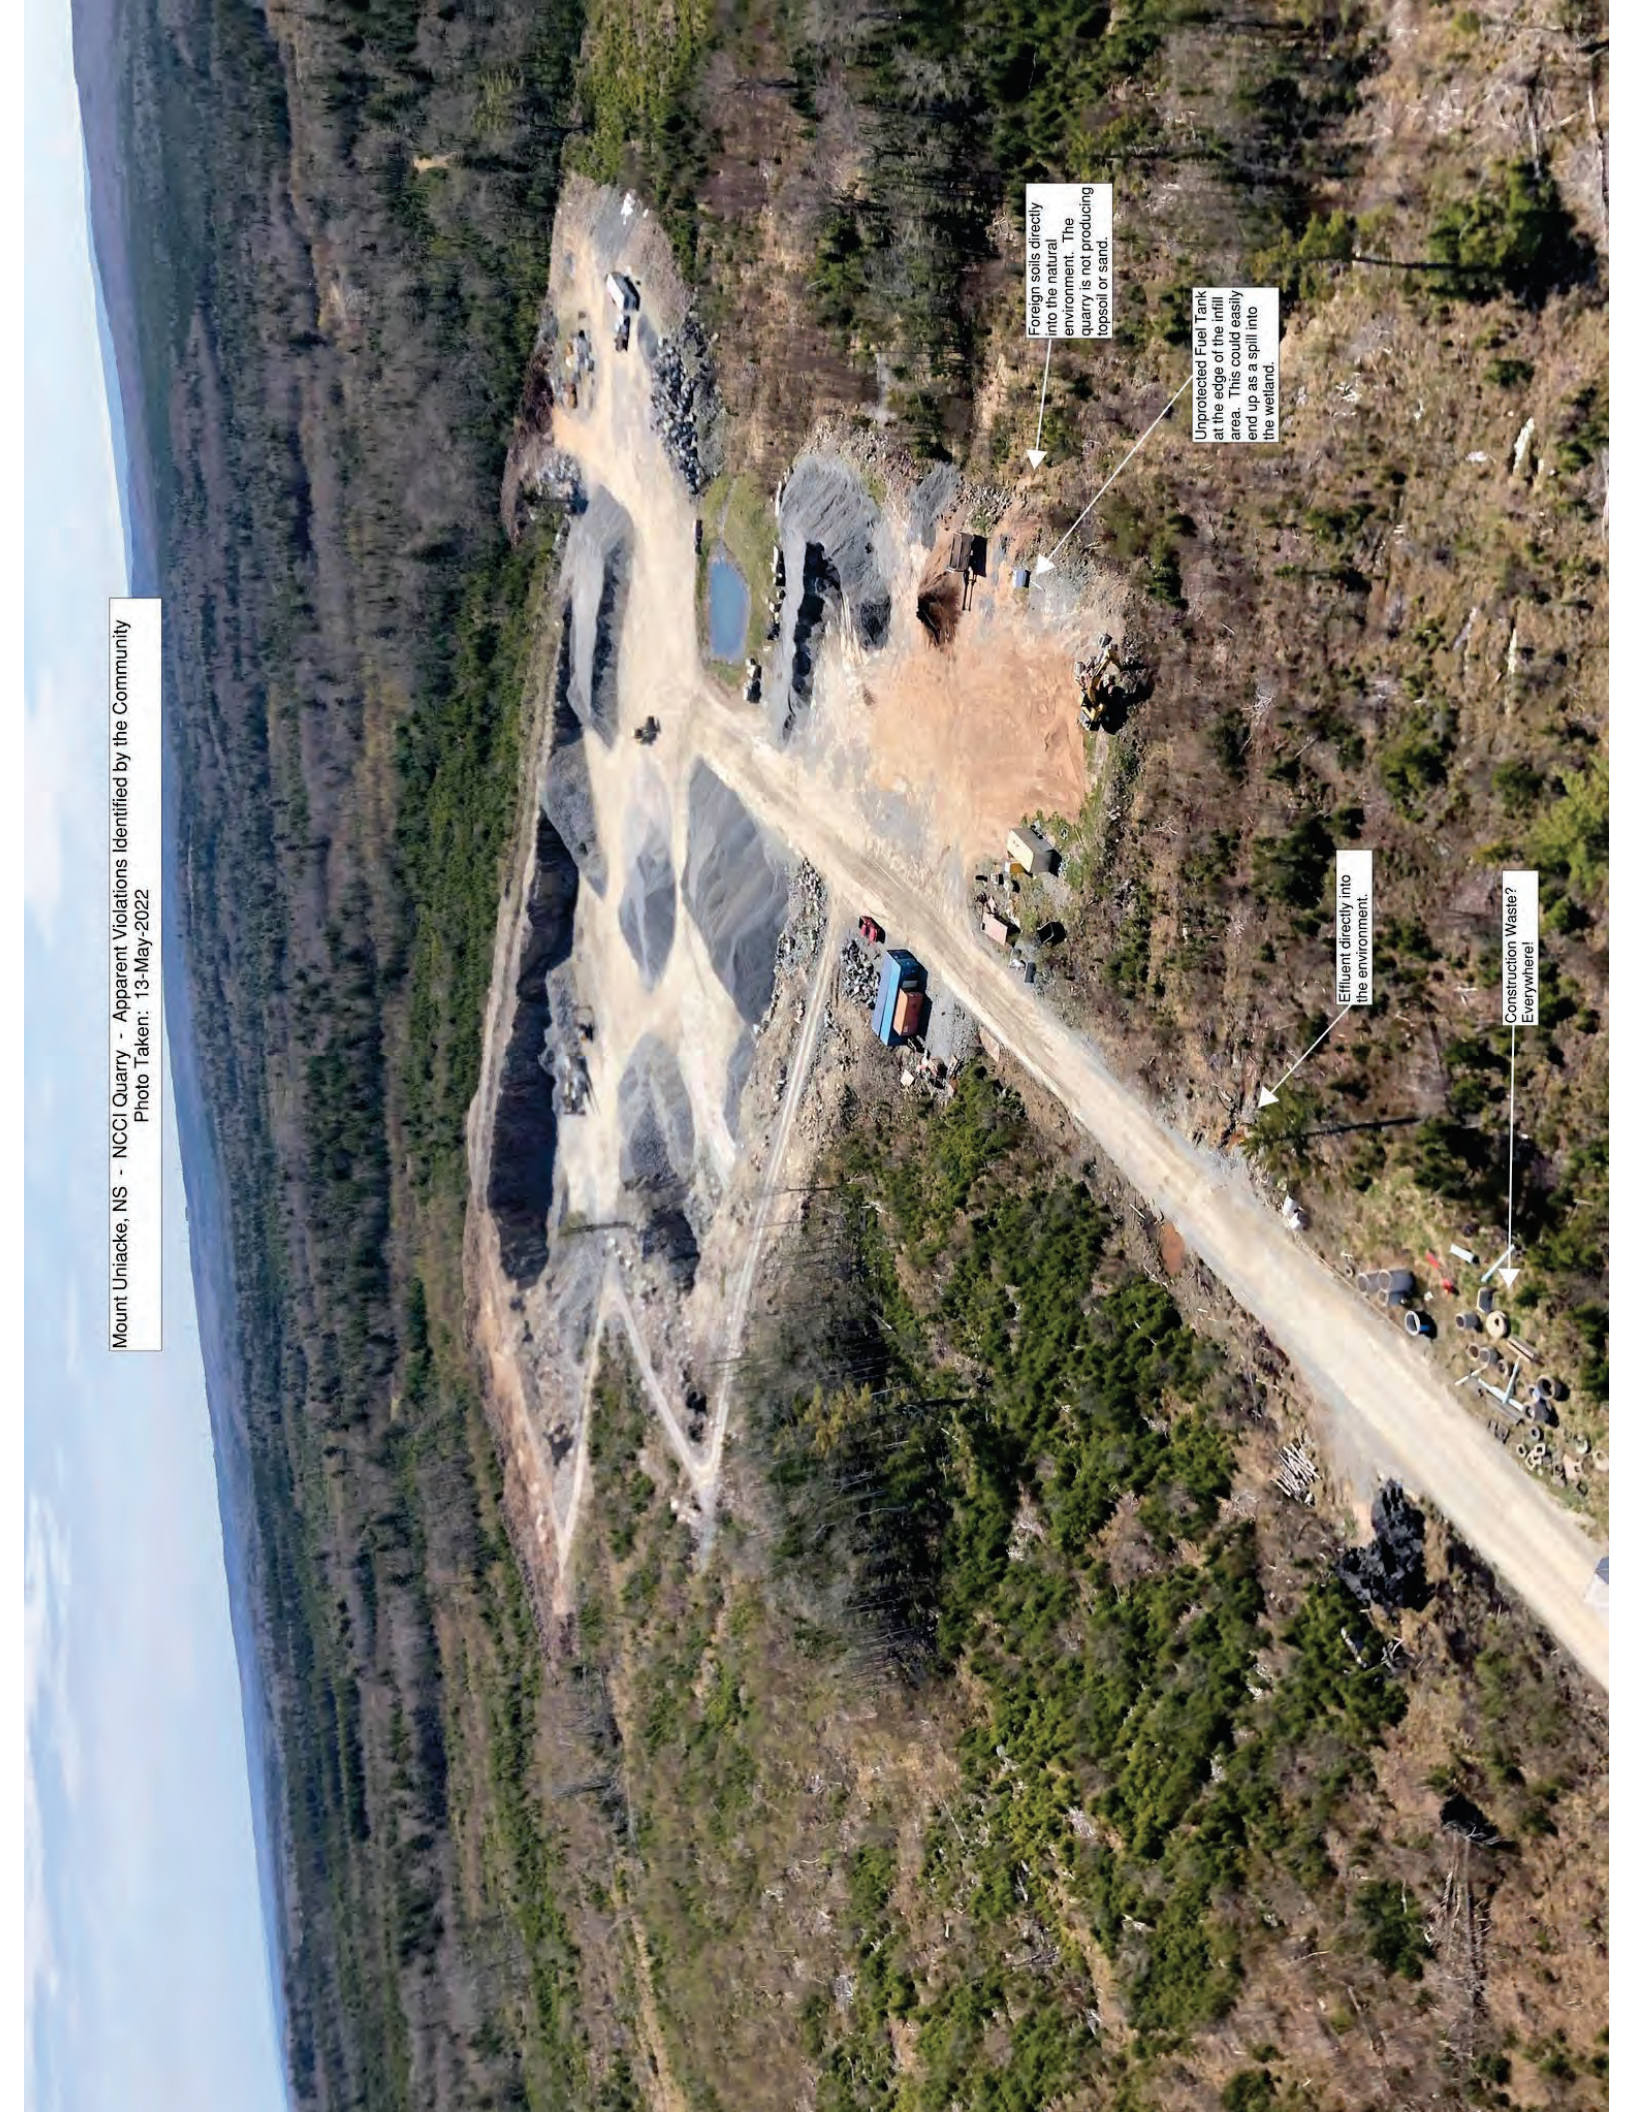
Foreign soils directly into the natural environment. The quarry is not producing topsoil or sand.

Unprotected Fuel Tank at the edge of the infill area. This could easily end up as a spill into the wetland.

Effluent directly into the environment

Construction Waste? Everywhere!

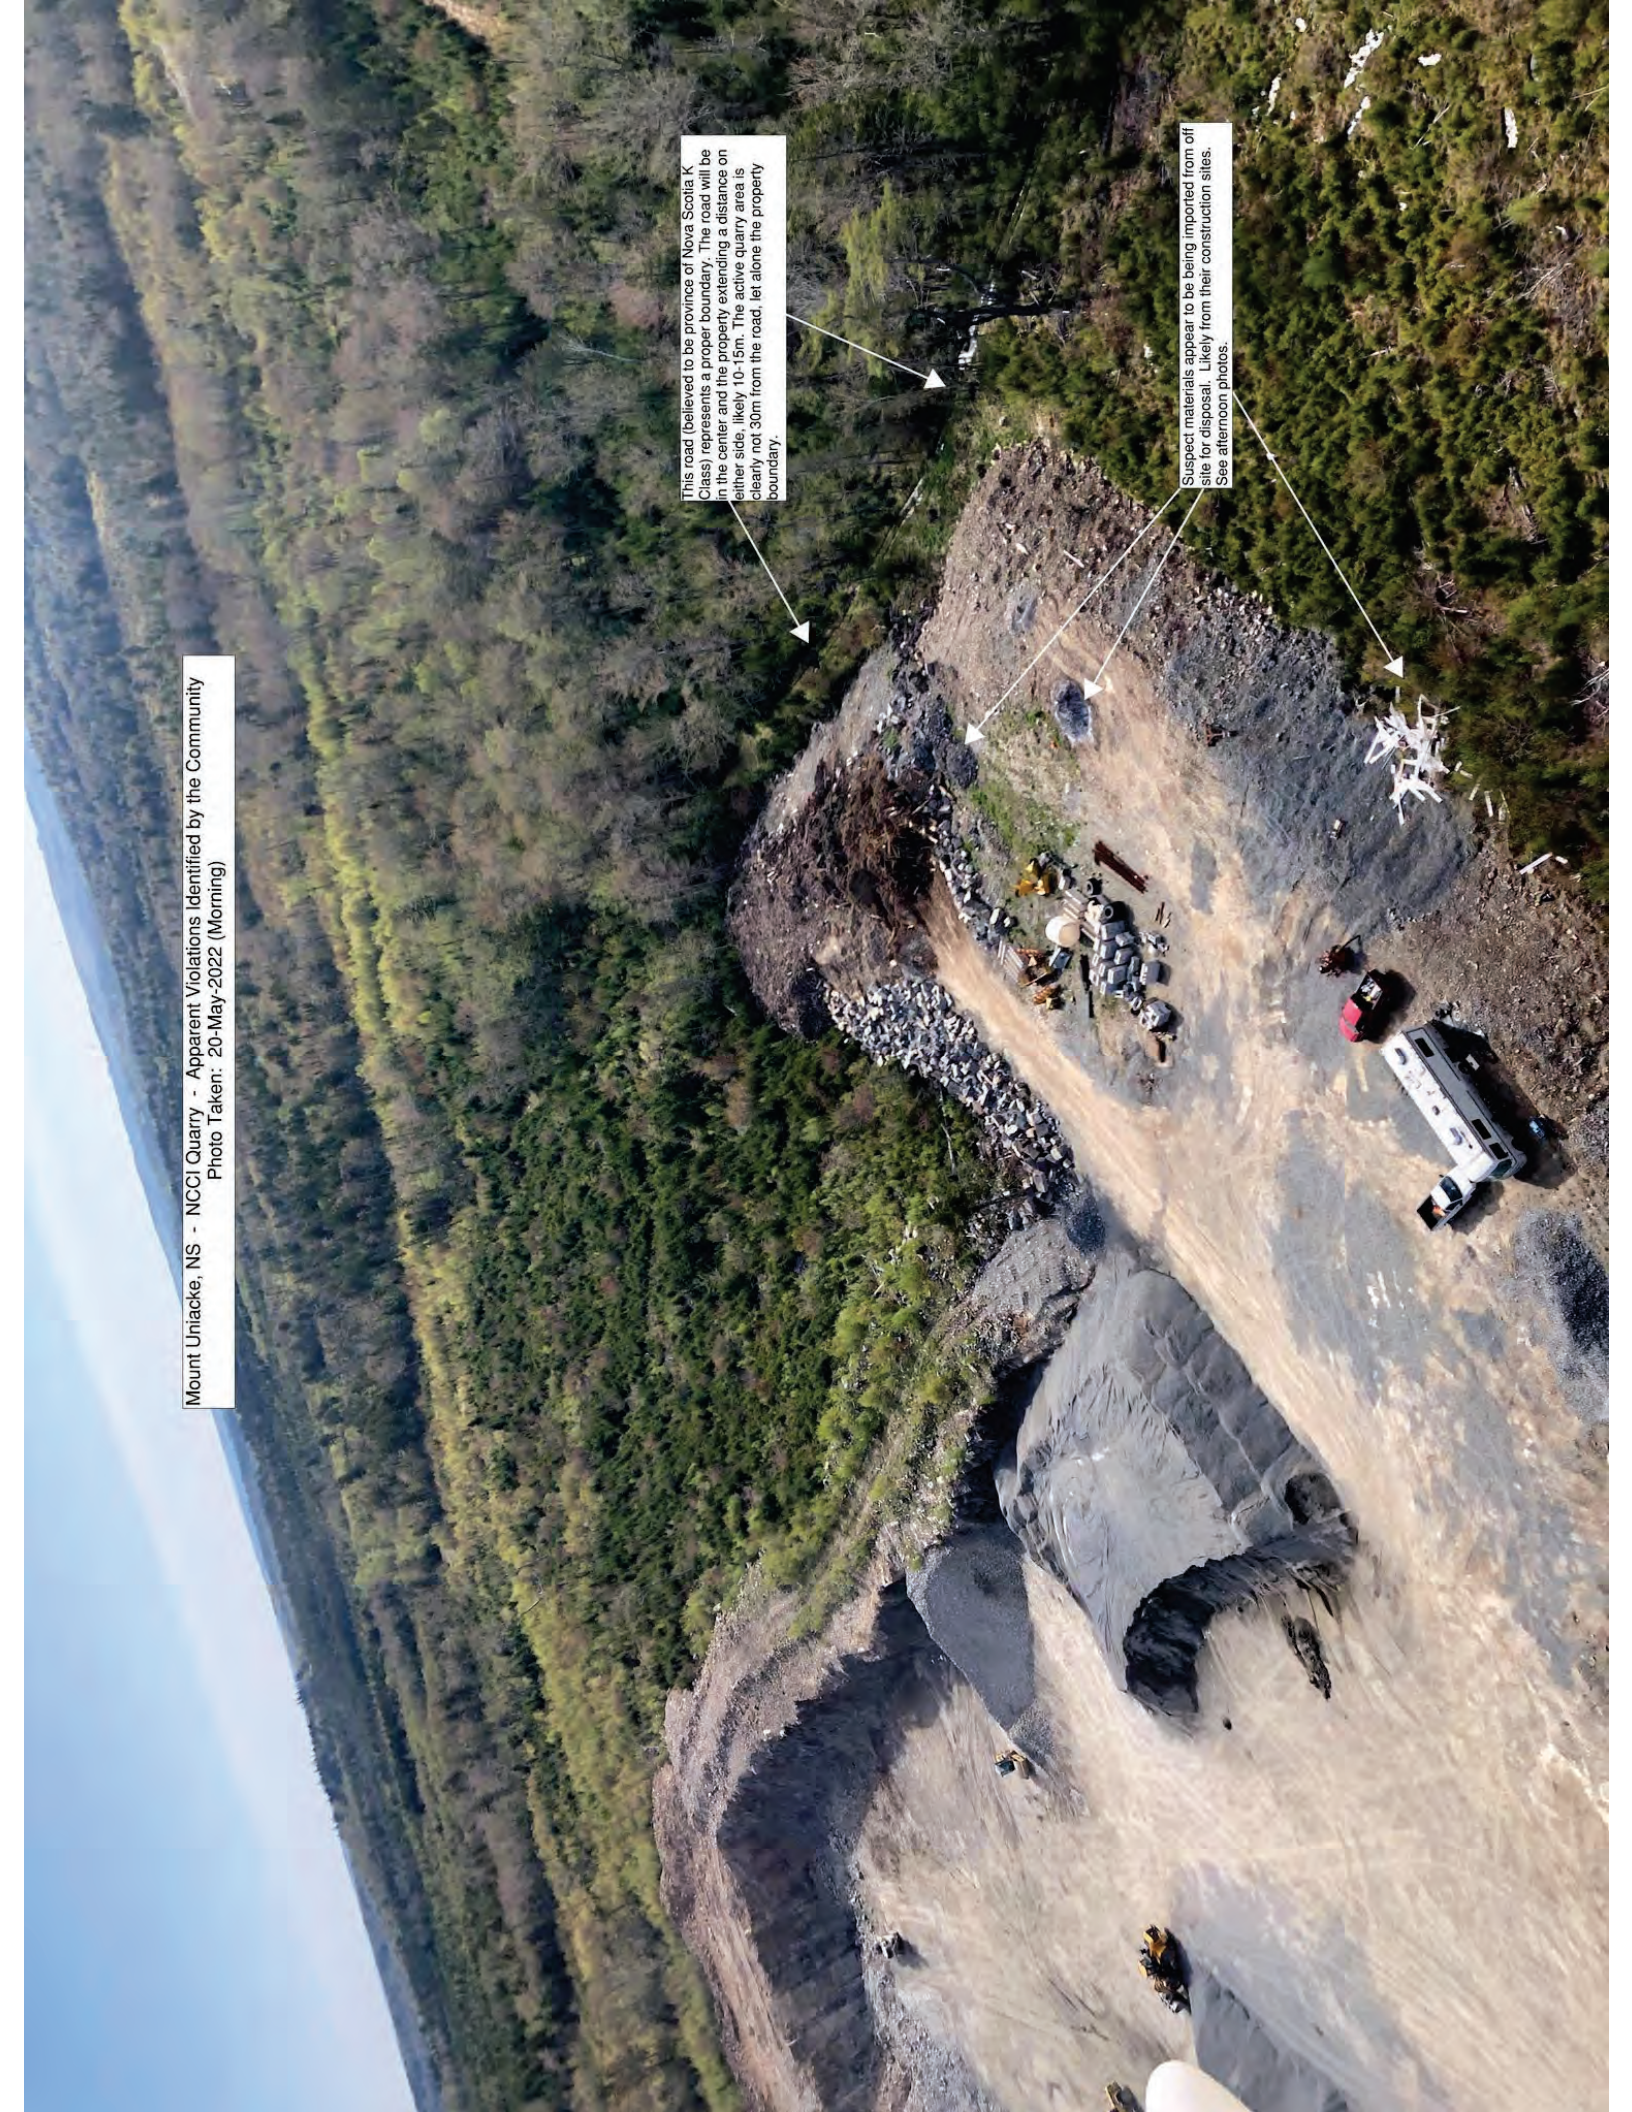
Mount Uniacke, NS - NCCI Quarry - Apparent Violations Identified by the Community  
Photo Taken: 20-May-2022 (Morning)

This road (believed to be province of Nova Scotia K Class) represents a property boundary. The road will be in the center and the property extending a distance on either side, likely 10-15m. The active quarry area is clearly not 30m from the road, let alone the property boundary.

Suspect materials appear to be being imported from off site for disposal. Likely from their construction sites. See afternoon photos.

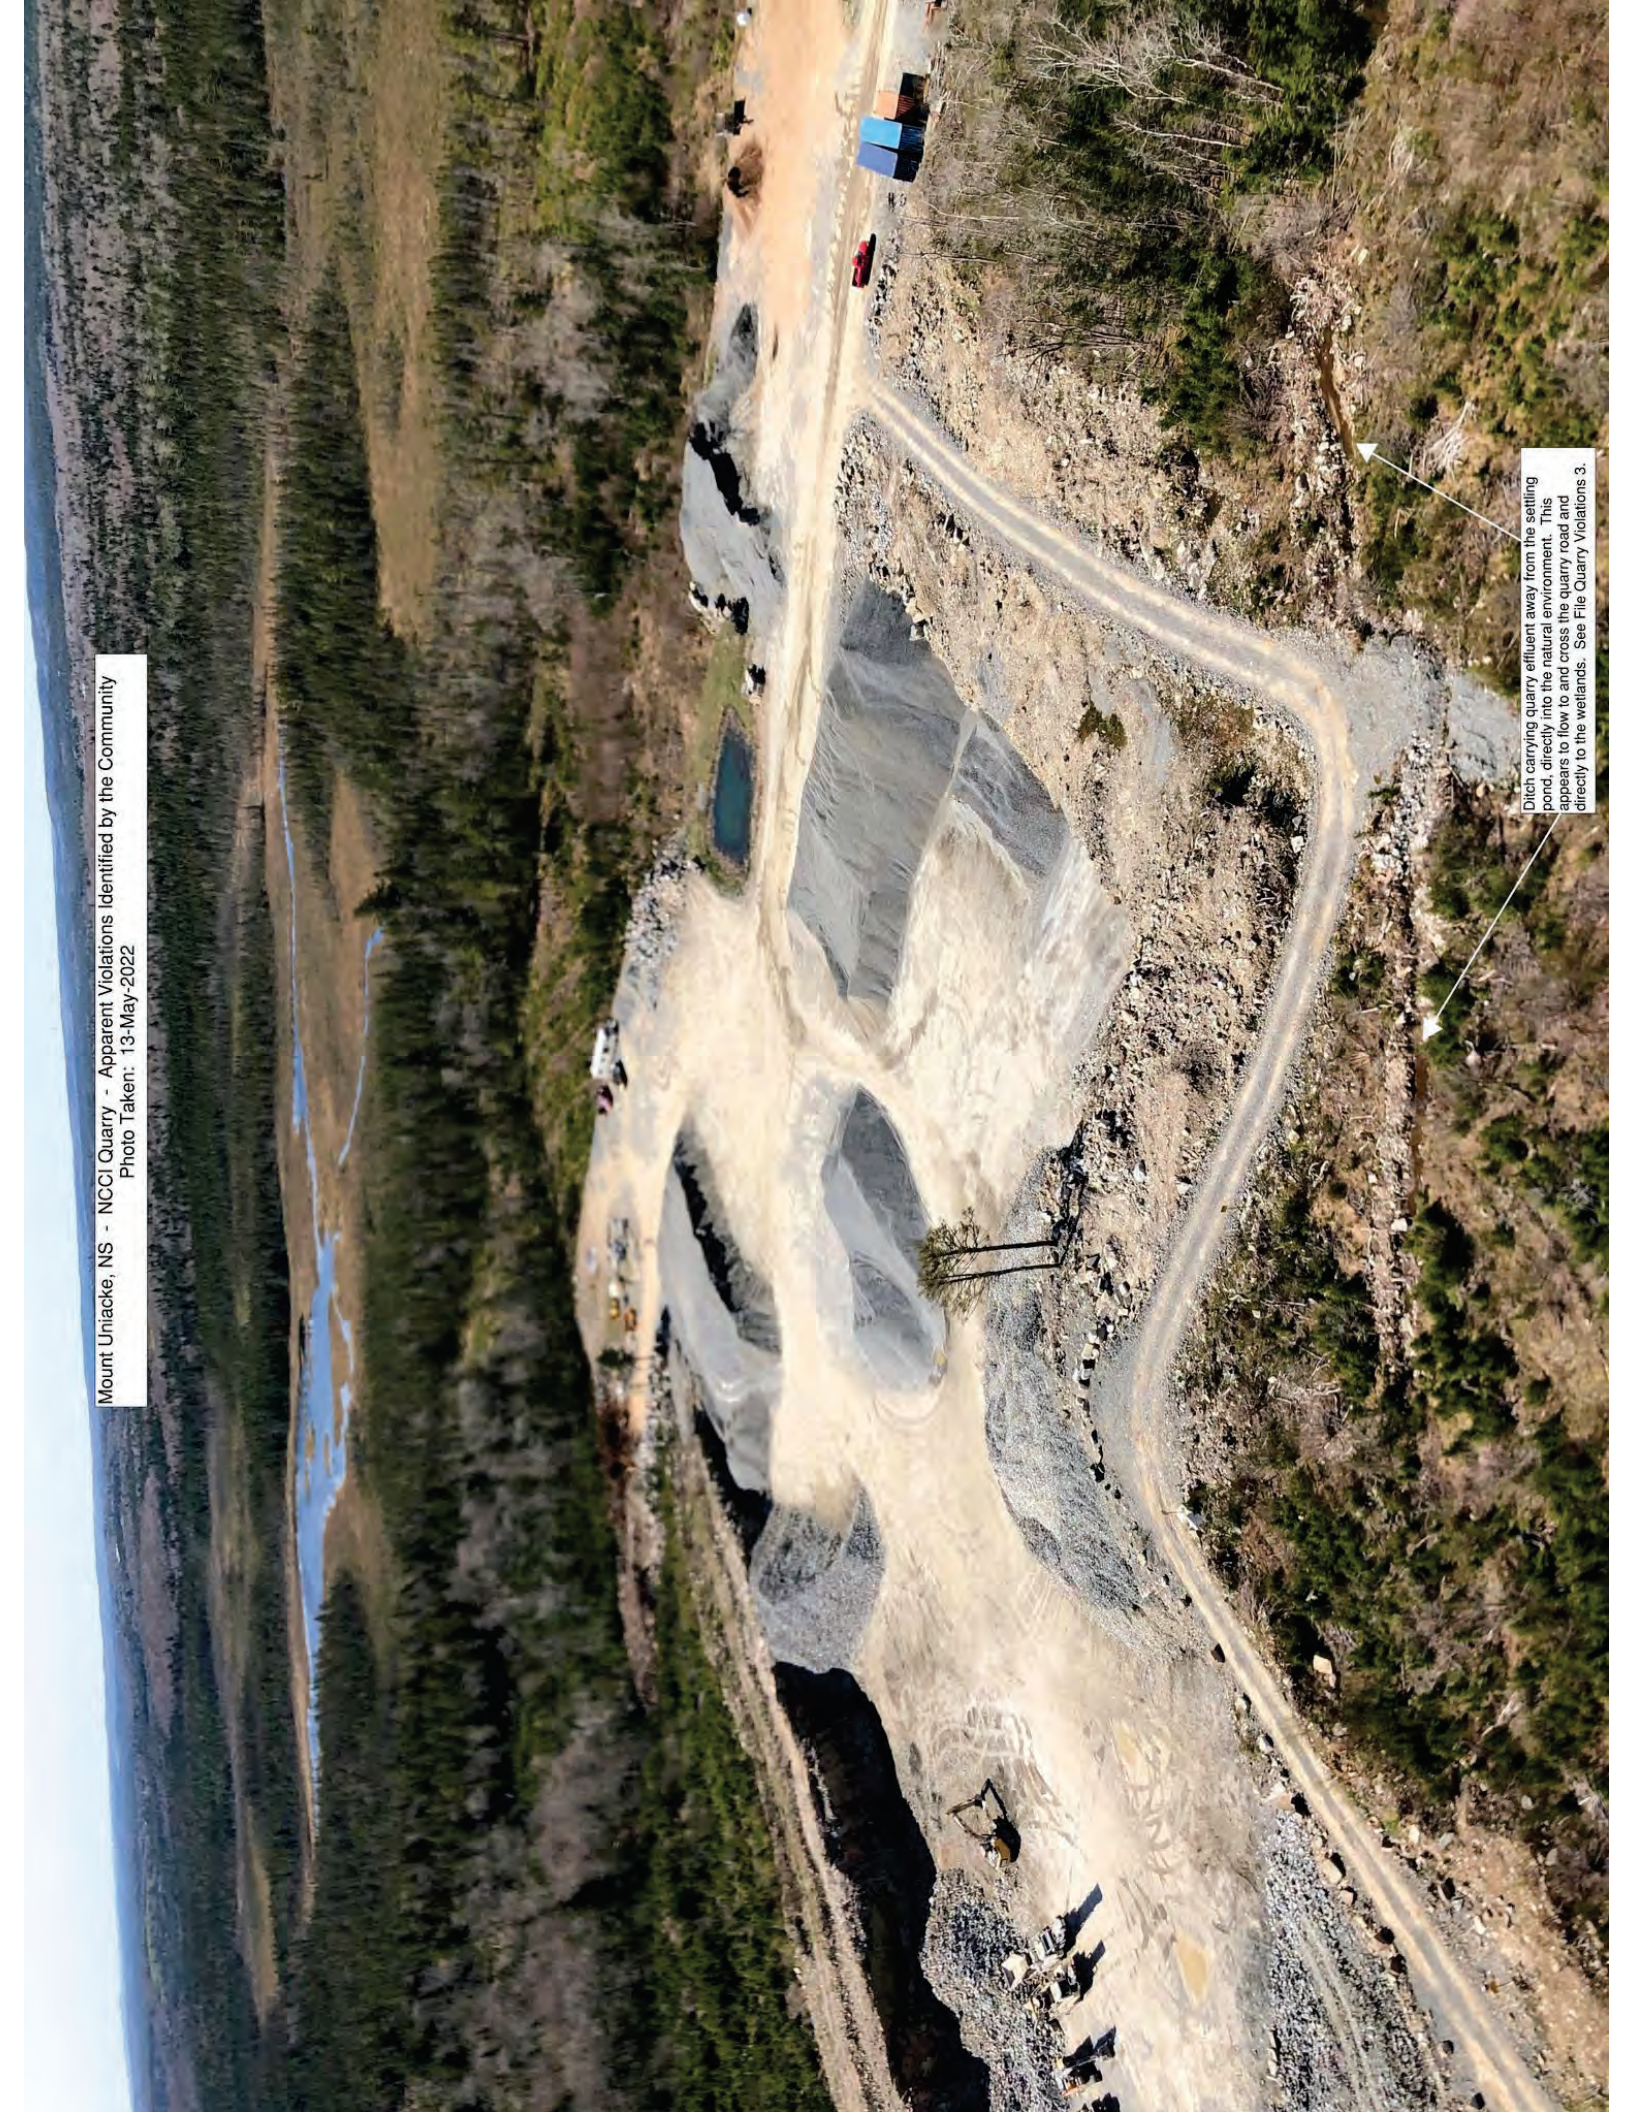
Mount Uniacke, NS - NCCI Quarry - Apparent Violations Identified by the Community  
Photo Taken: 13-May-2022

Ditch carrying quarry effluent away from the settling pond, directly into the natural environment. This appears to flow to and cross the quarry road and directly to the wetlands. See File Quarry Violations 3.

Construction waste dumped over the bank, presumably soon to be buried. What else is buried in the infill areas?

Rainwater collecting silt from gravel piles and depositing directly into the natural environment

All the gray / is silt deposited from quarry effluent.

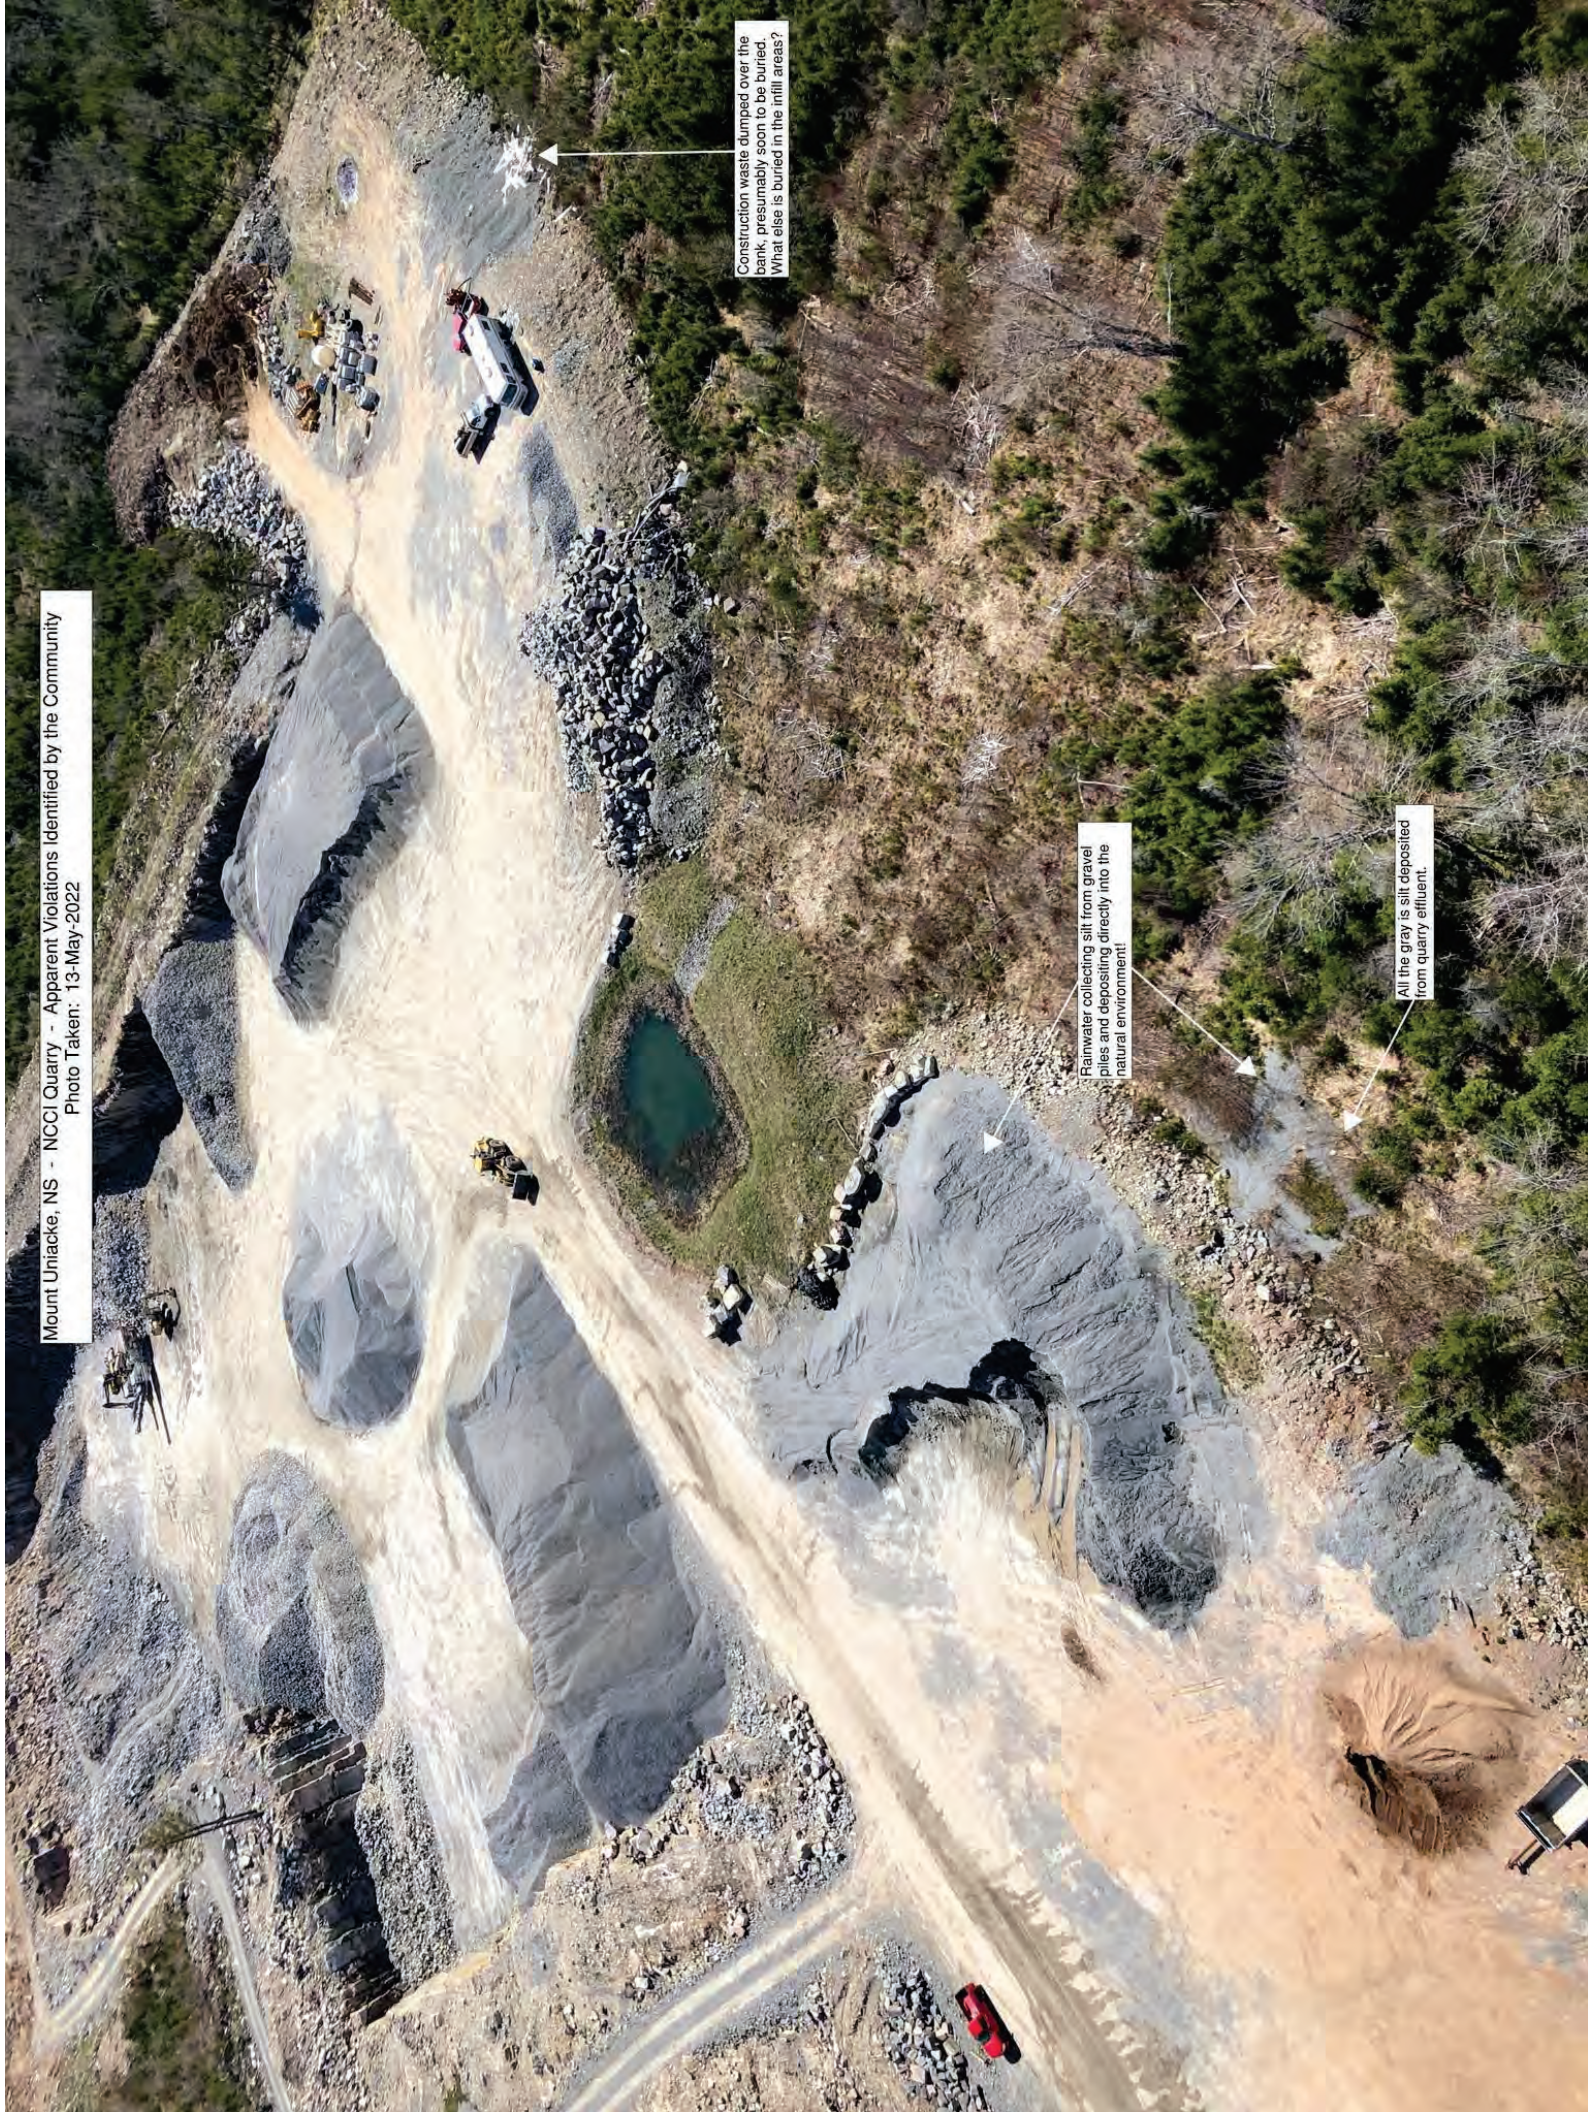
Mount Uniacke, NS - NCCI Quarry - Apparent Violations Identified by the Community  
Photo Taken: 20-May-2022 (Afternoon)

Materials appear to be being brought in from off site for disposal. No grubbing work is evident on site. This pile appeared over the course of 20-May. We have photos from the am and pm.

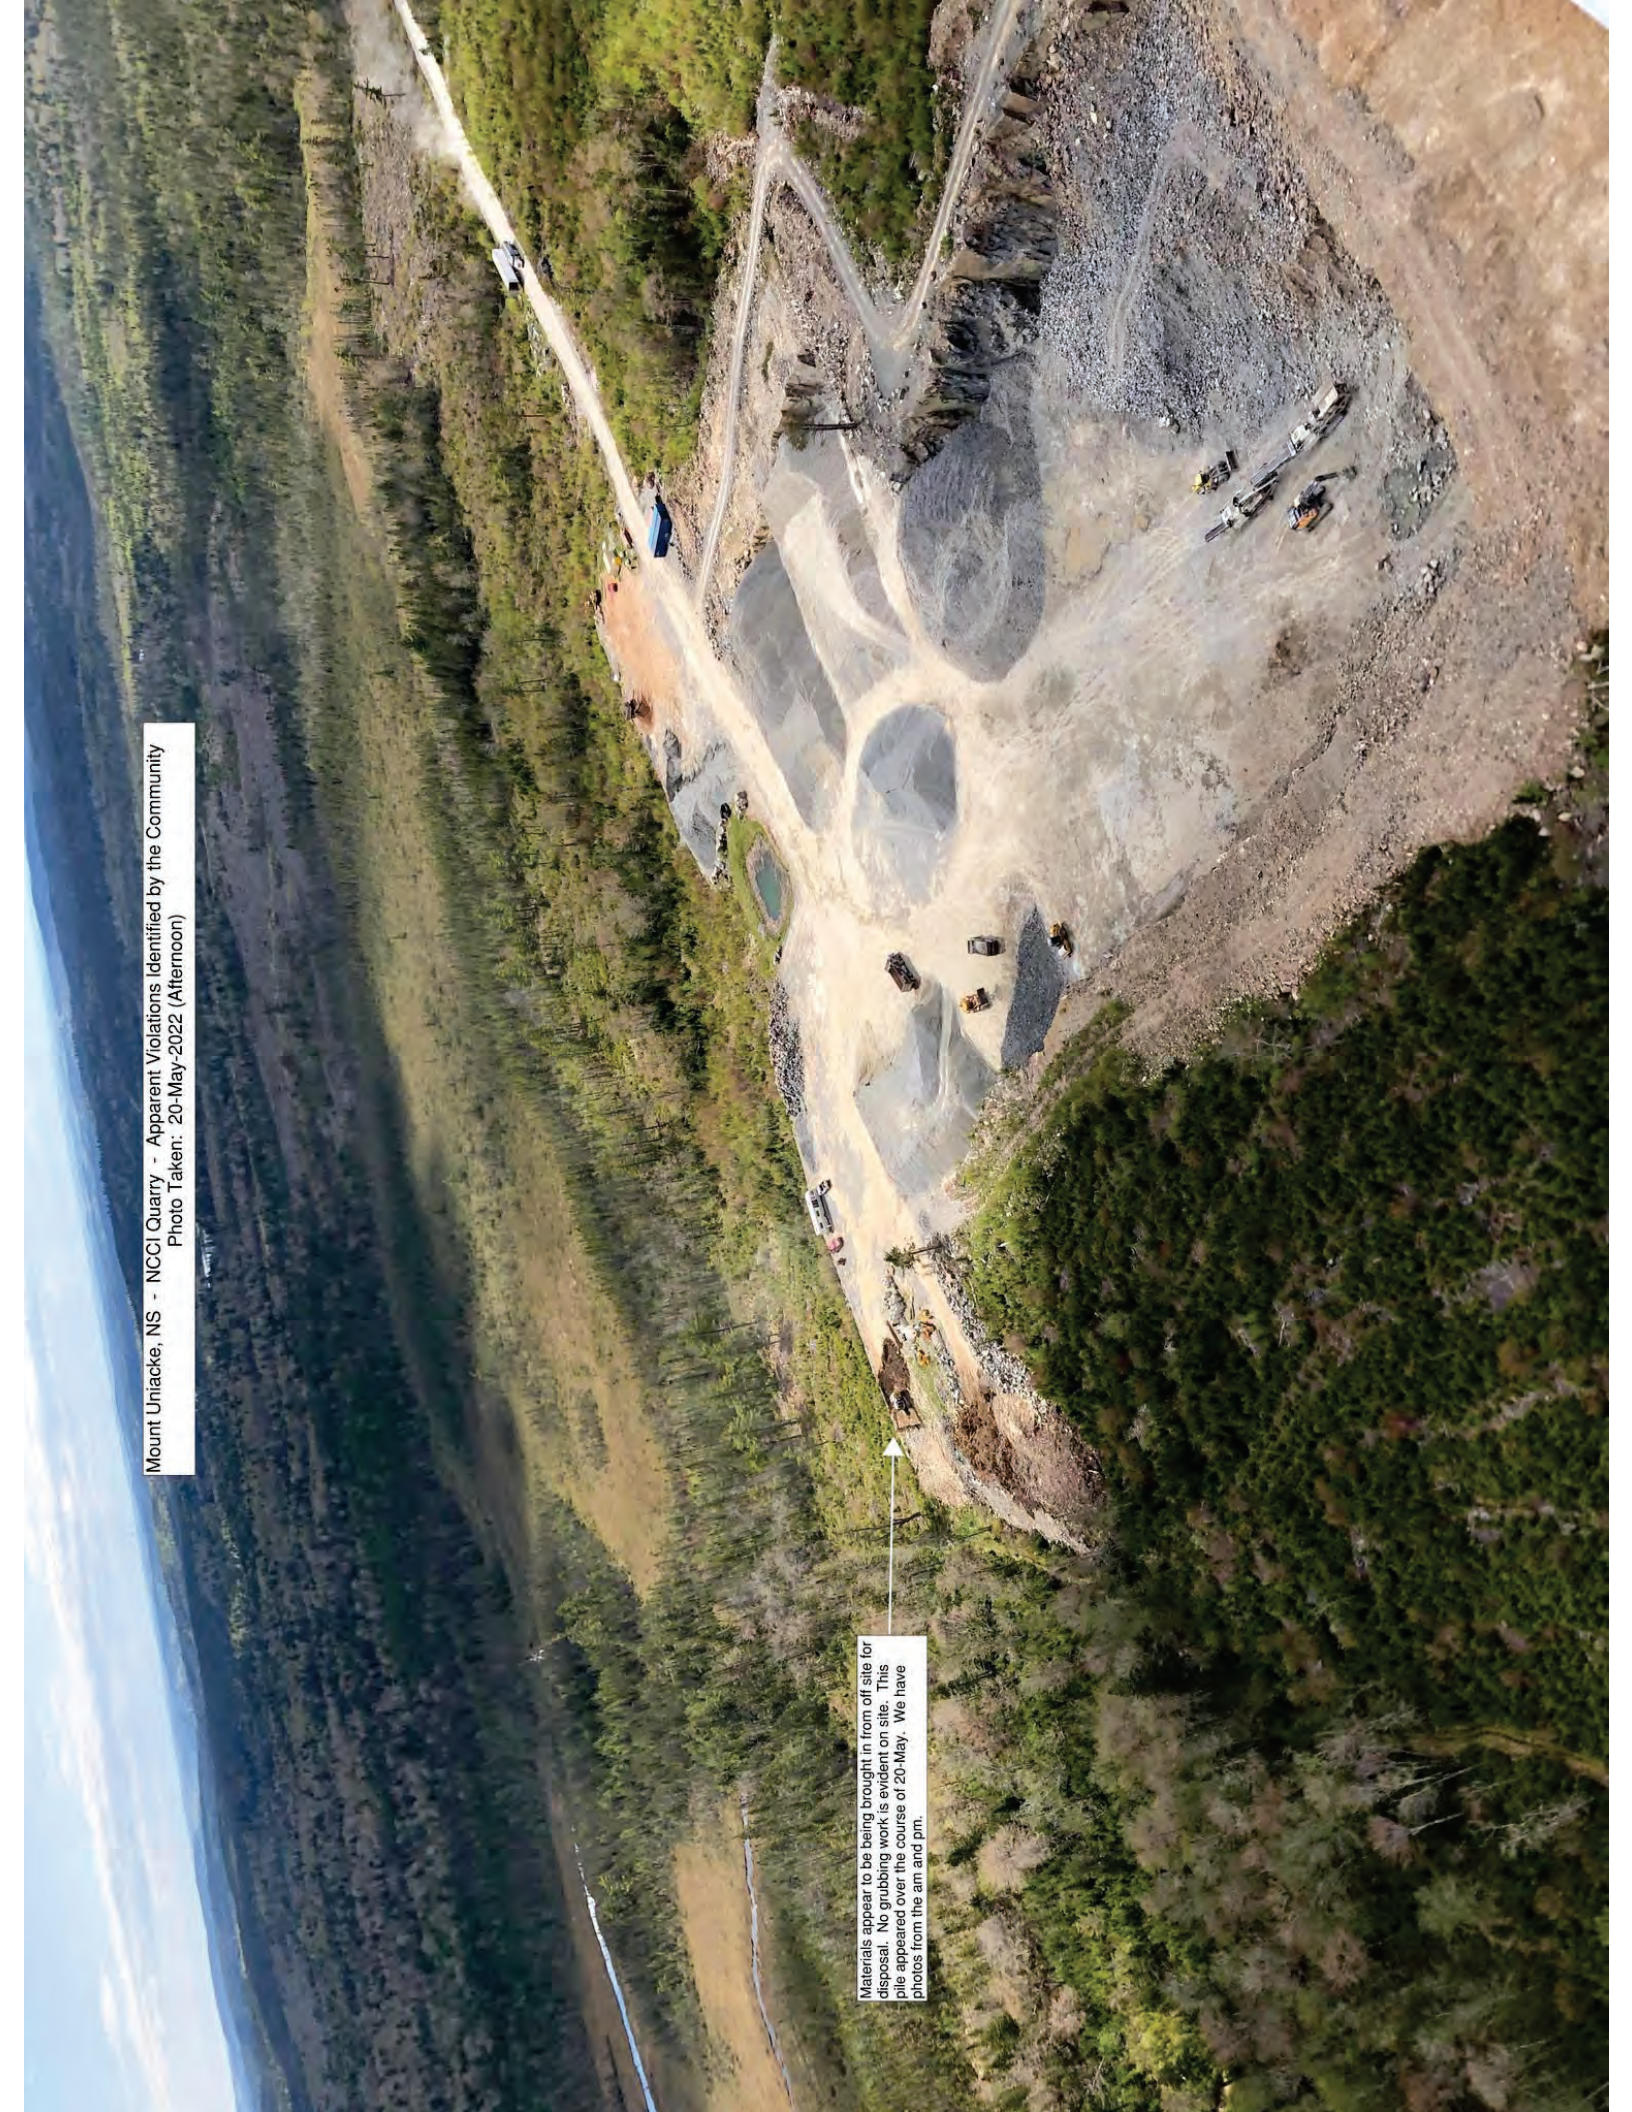
Mount Uniacke, NS - NCCI Quarry - Apparent Violations Identified by the Community  
Photo Taken: 20-May-2022 (Afternoon)

Dumping construction  
waste?
