From:  
To: [Environment Assessment Web Account](#); [Hunter, Tanya](#); [Van Lunen, Erik](#)  
Cc: [Premier](#); [Minister, Env](#); [Brad Johns \(mlabradjohns@gmail.com\)](#)  
Subject: NCCI Mount Uniacke Quarry - Apparent Non-Compliances 30-Oct-2025  
Date: October 31, 2025 4:38:55 PM  
Attachments: [Quarry Violations - 2025-10-31 - Flat - BSP.pdf](#)

**Apparent Quarry Violations**

Prepared: 31-Oct-2025 - BSP  
Image: Quarry,1  
Image Date: 30-Oct-2025

Mount Uniacke, NS - NCCI Quarry - Apparent Violations Identified by the Community  
Photo Taken: 13-May-2022

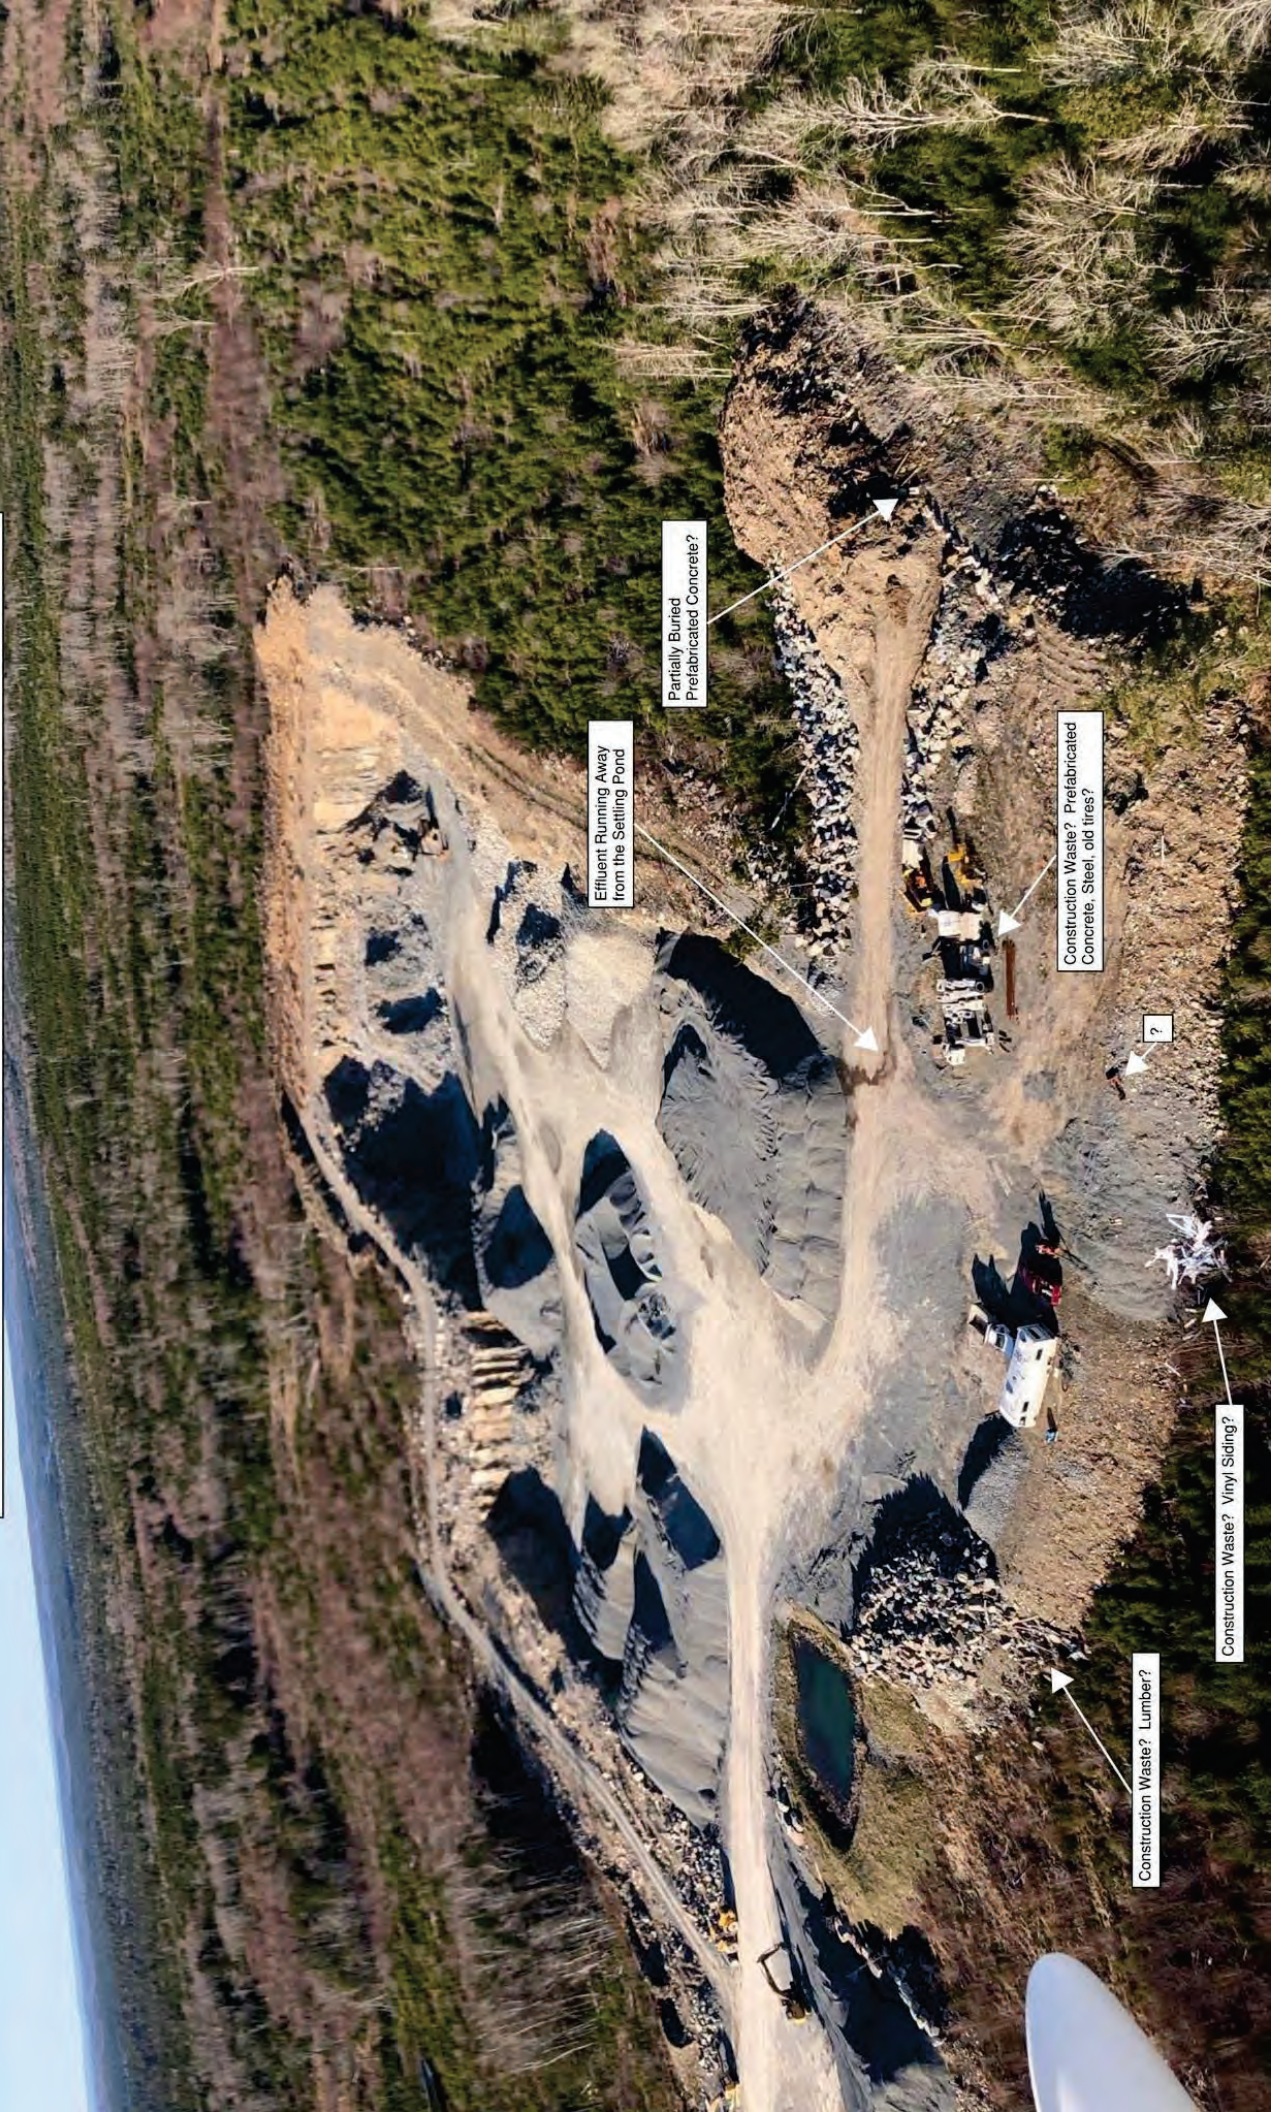
Mount Uniacke, NS - NCCI Quarry - Apparent Violations Identified by the Community  
Photo Taken: 3-May-2022

Disturbed Wetland that has a 50m buffer identified in approval documents.

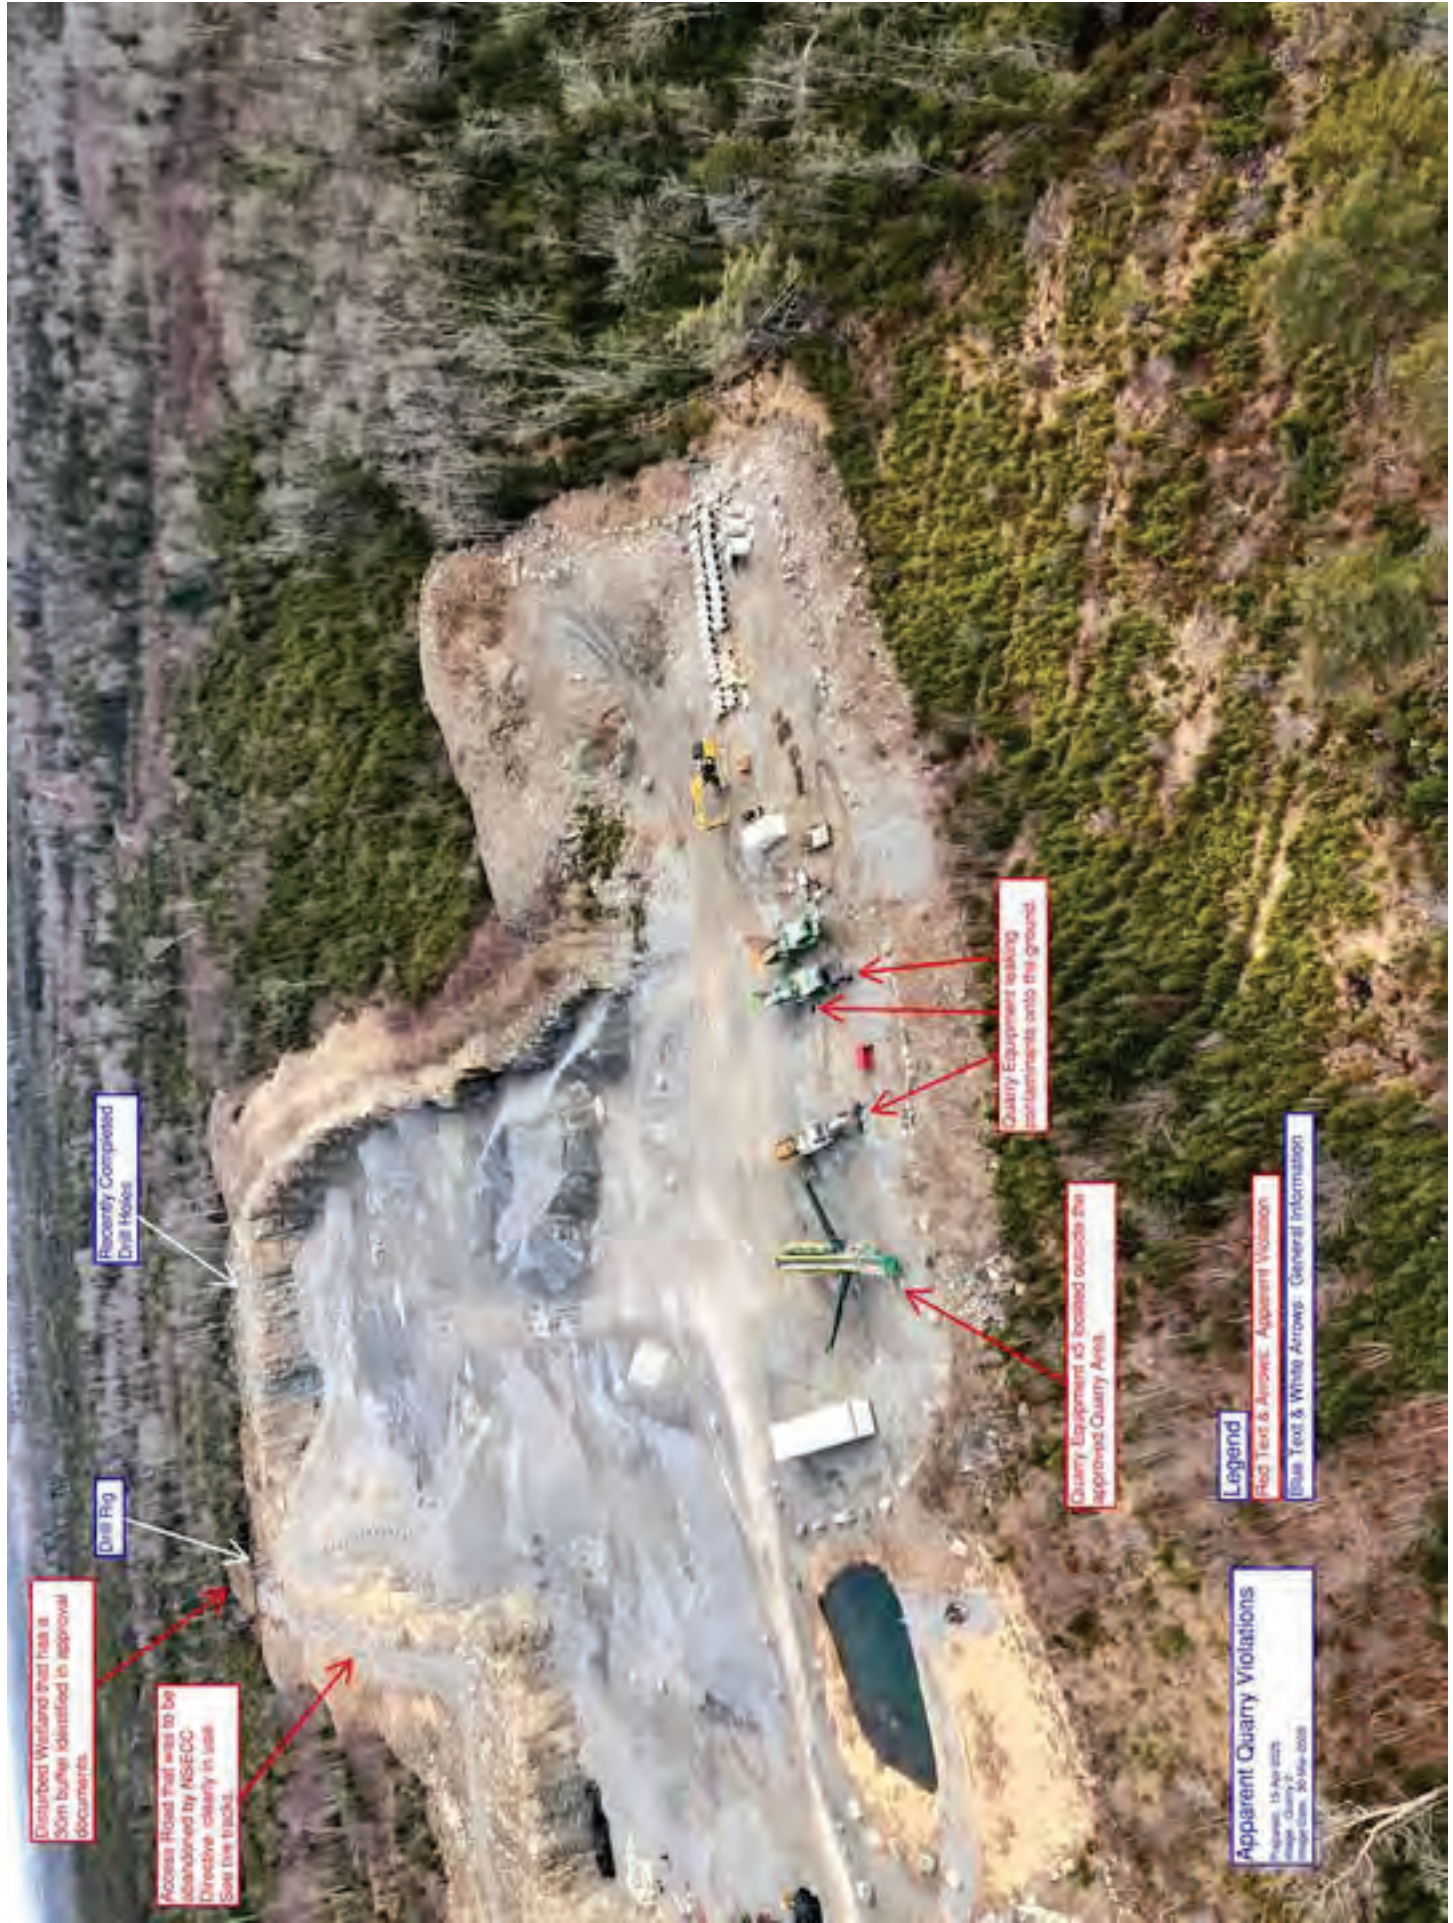
Apparent Quarry Violations

Access Road that was to be abandoned by NSECC Directive clearly in use. Soil tire tracks.

Recently Completed Drill Holes

Quarry Equipment taking contaminants onto the ground

Quarry Equipment located outside the approved Quarry Area

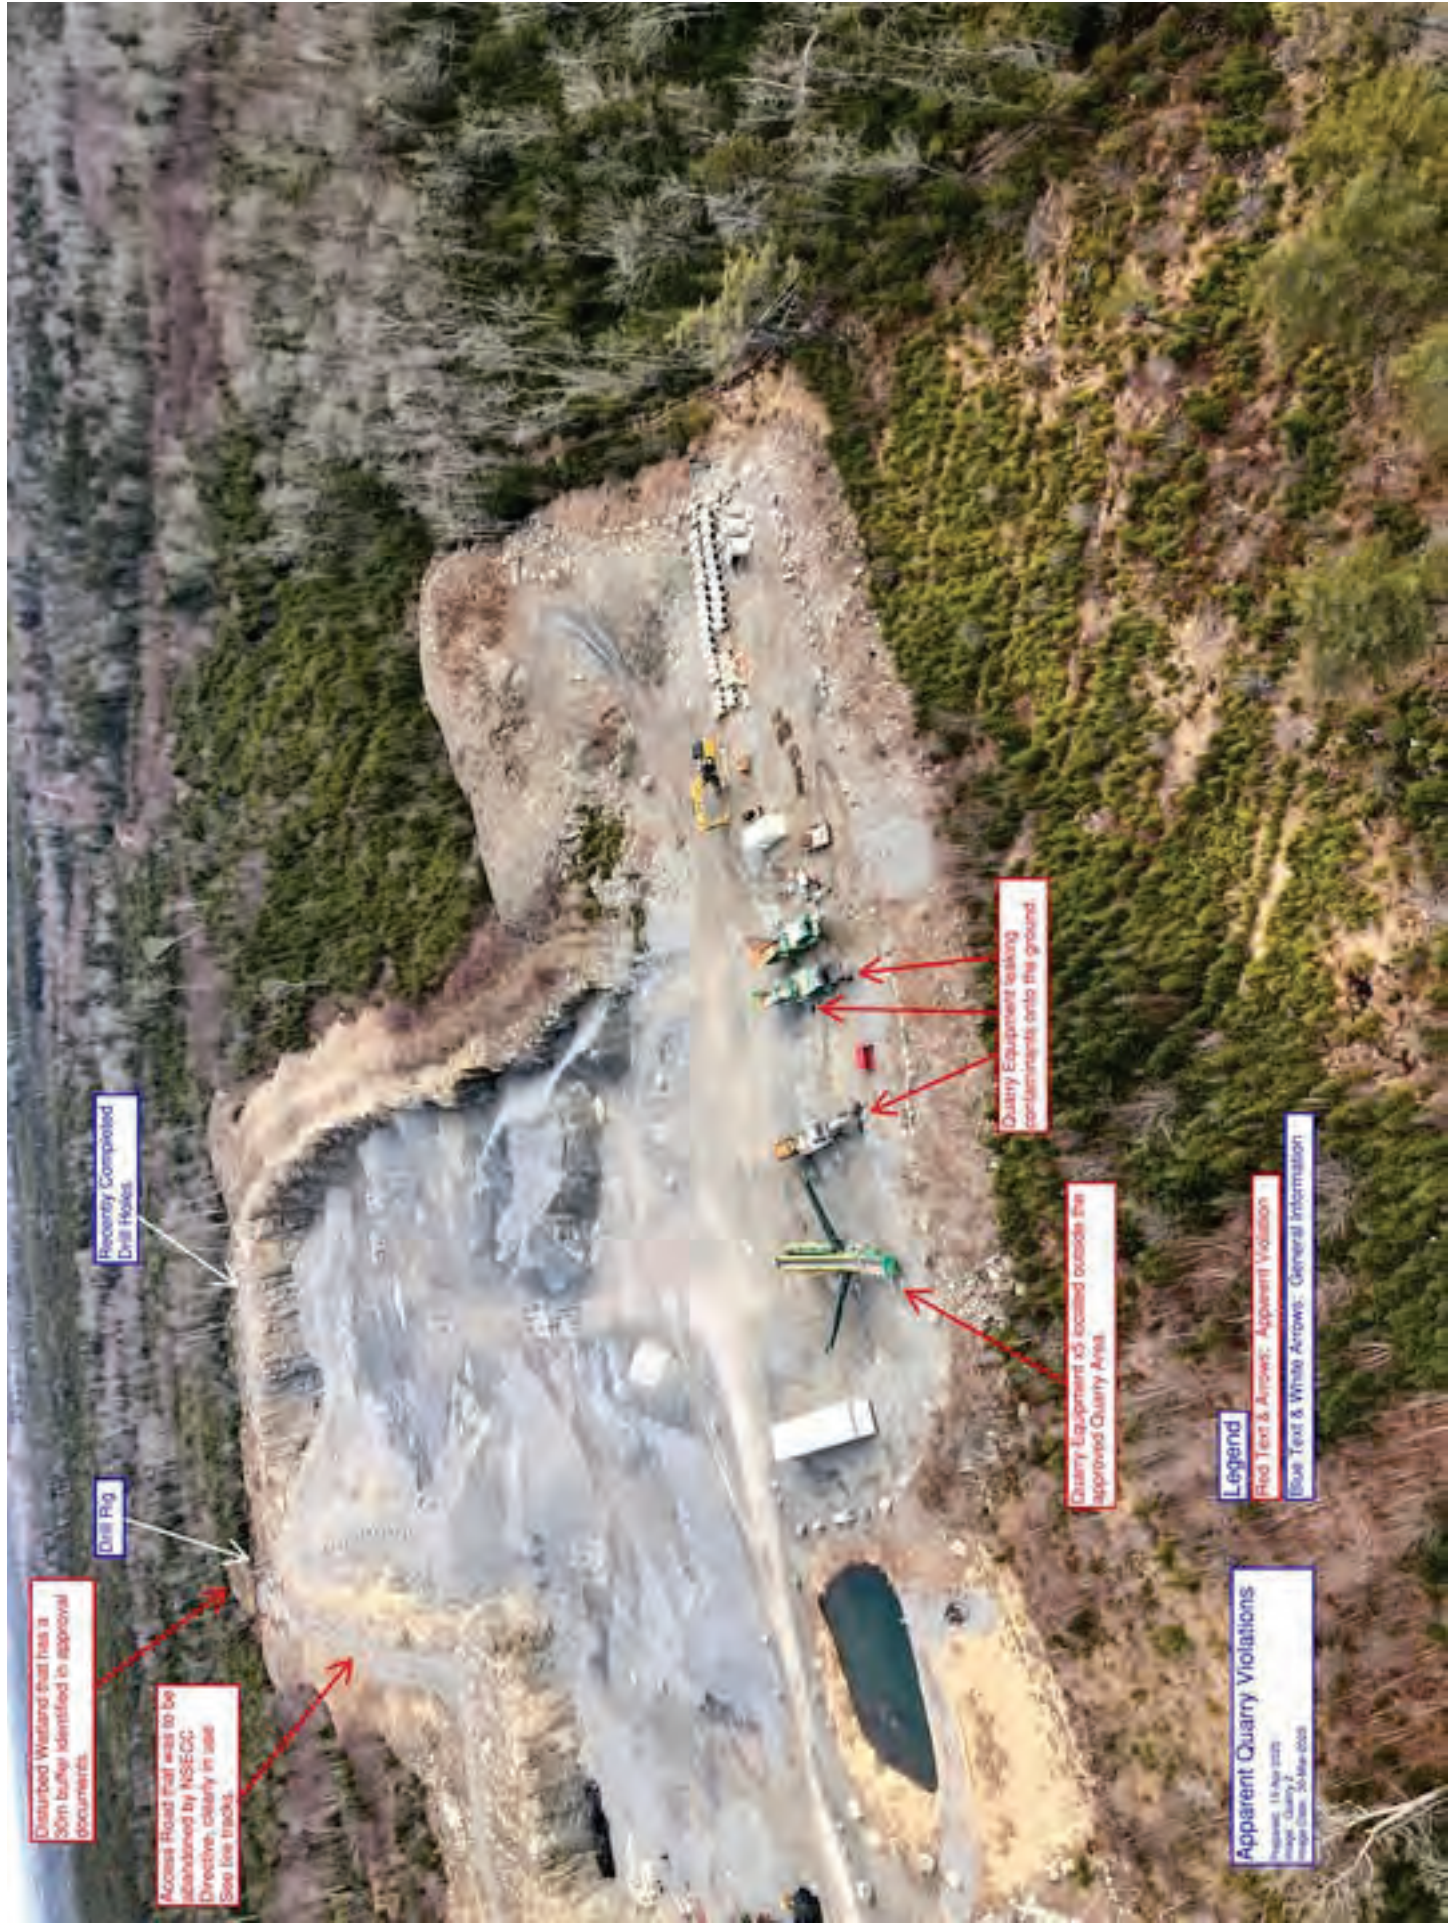
**Apparent Quarry Violations**  
Prepared: 14-Apr-2025  
Image: Quarry, 20-Mar-2025  
by: [illegible]

Disturbed Wetland that has a 30m buffer identified in approval documents.

Access Road that was to be abandoned by NSECC Directive, clearly in use. See fire tracks.

Recently Completed Drill Hoses

Quarry Equipment taking sediment into the ground

Quarry Equipment 45 located outside the approved Quarry Area

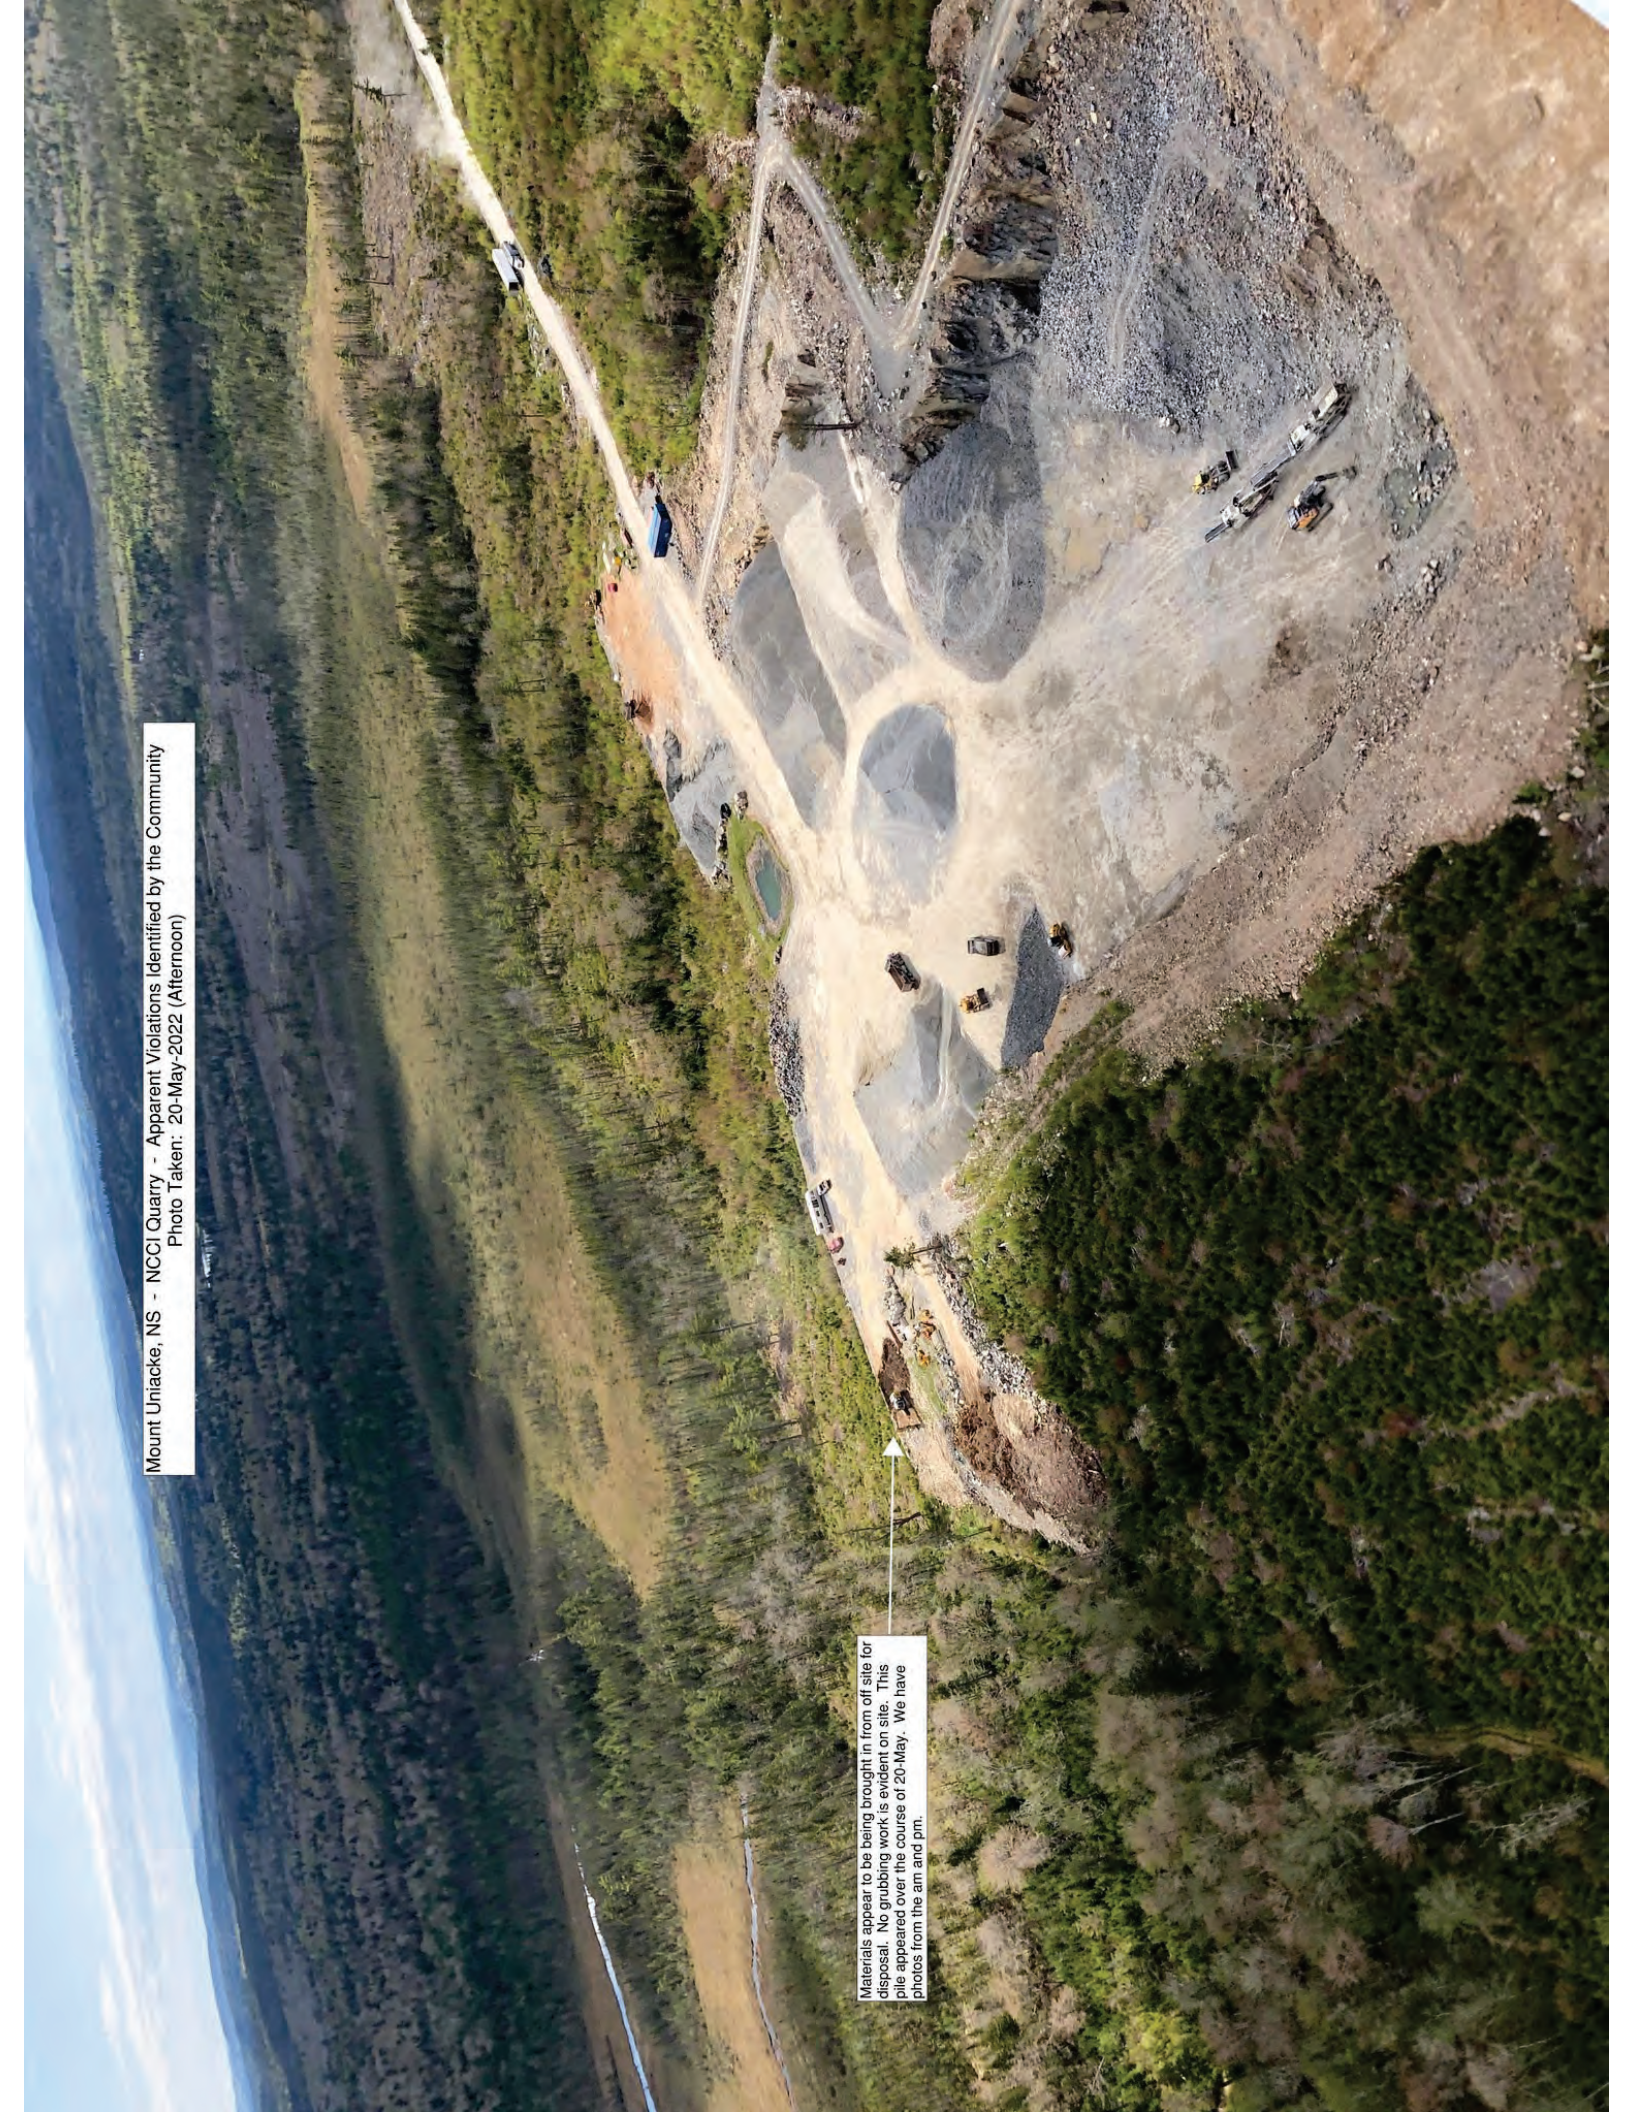
Mount Uniacke, NS - NCCI Quarry - Apparent Violations Identified by the Community  
Photo Taken: 20-May-2022 (Morning)

This road (believed to be province of Nova Scotia K Class) represents a property boundary. The road will be in the center and the property extending a distance on either side, likely 10-15m. The active quarry area is clearly not 30m from the road, let alone the property boundary.

Suspect materials appear to be being imported from off site for disposal. Likely from their construction sites. See afternoon photos.

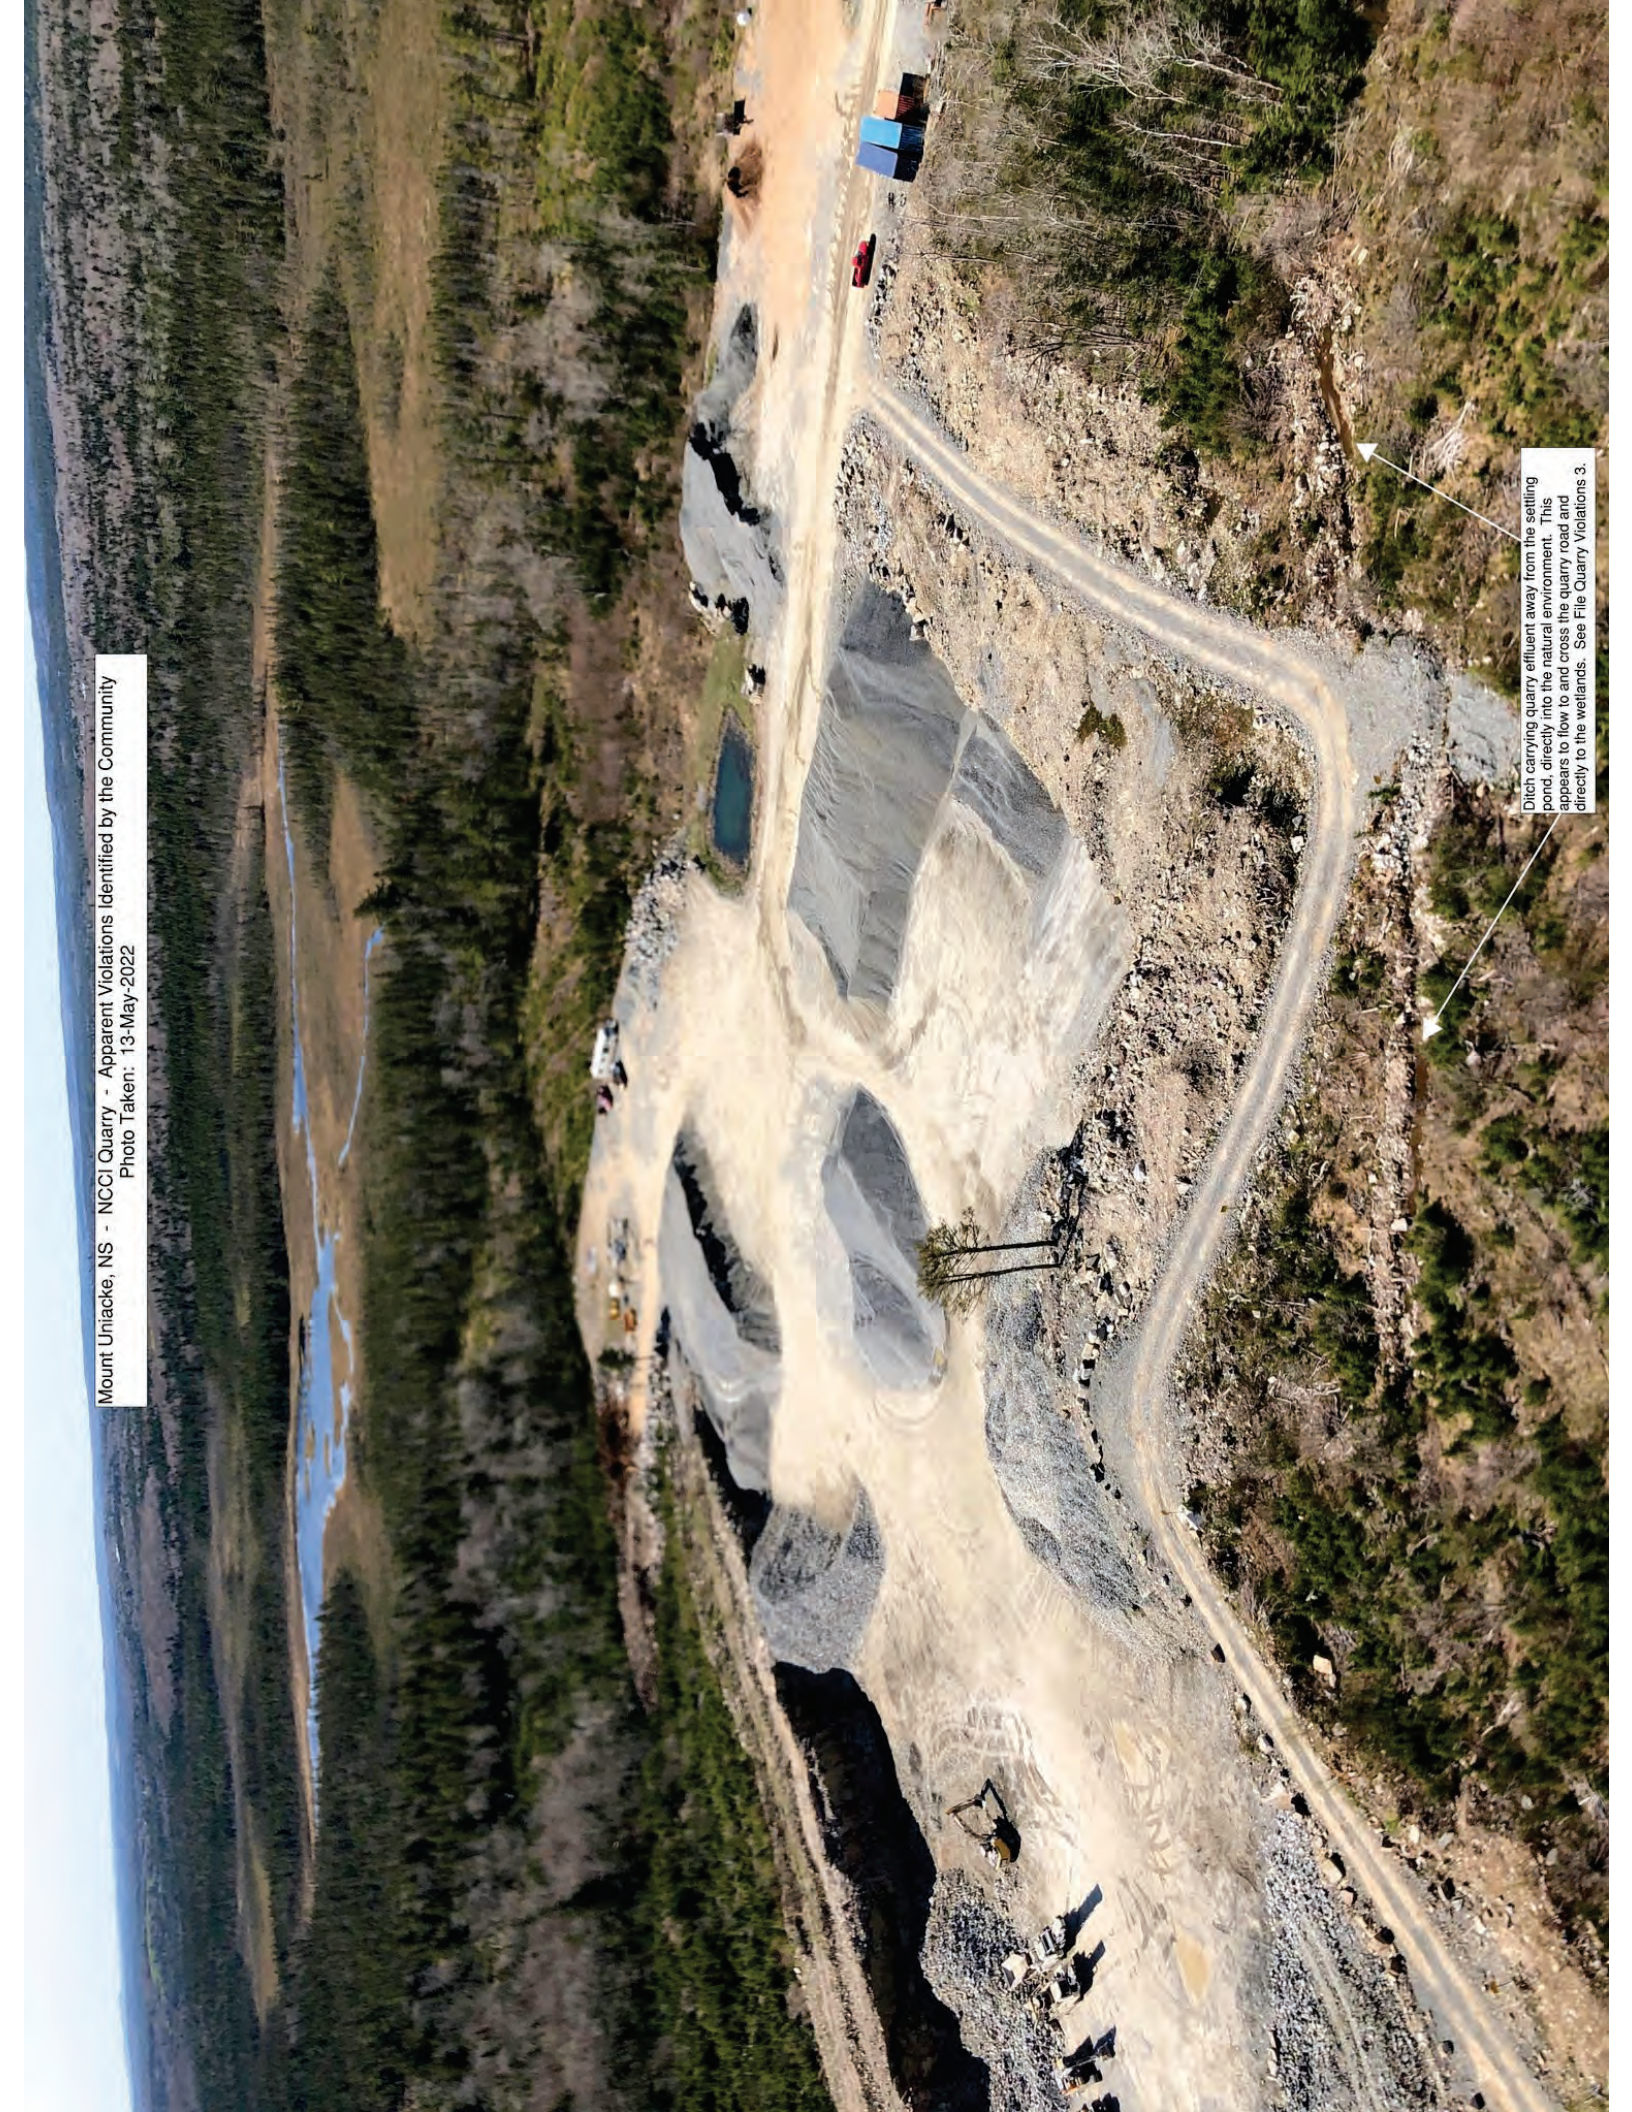
Mount Uniacke, NS - NCCI Quarry - Apparent Violations Identified by the Community  
Photo Taken: 13-May-2022

Ditch carrying quarry effluent away from the settling pond, directly into the natural environment. This appears to flow to and cross the quarry road and directly to the wetlands. See File Quarry Violations 3.

Construction waste dumped over the bank, presumably soon to be buried. What else is buried in the infill areas?

Rainwater collecting silt from gravel piles and depositing directly into the natural environment

All the gray silt deposited from quarry effluent.

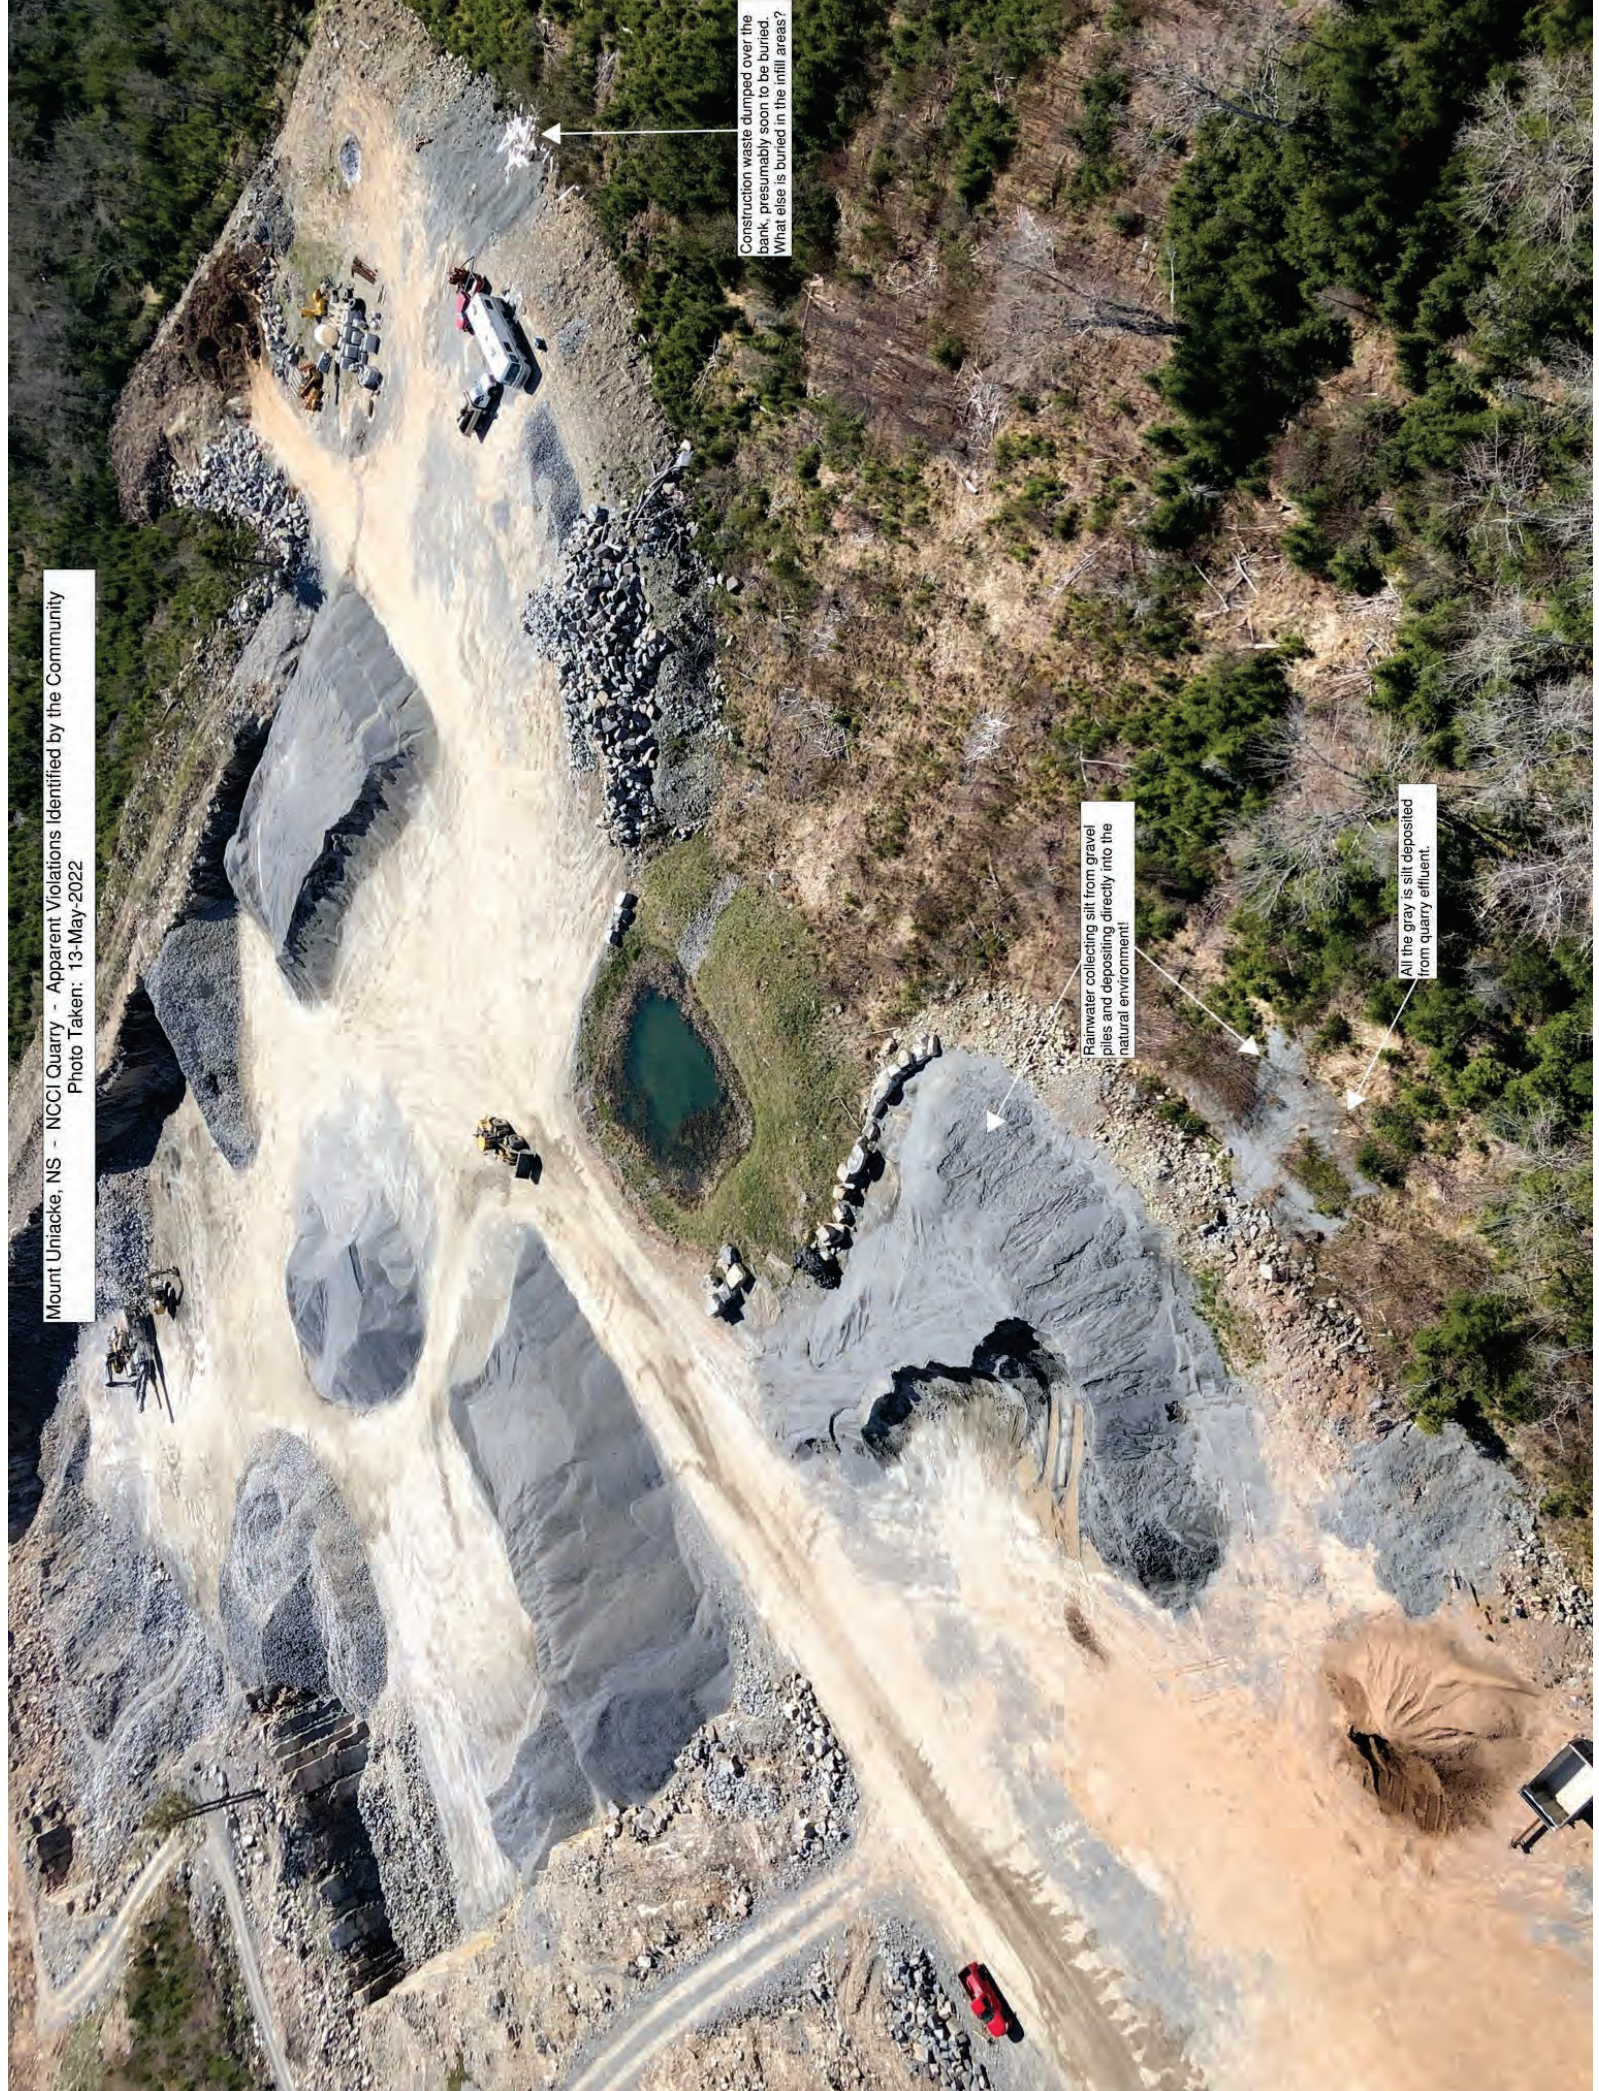
Foreign soils directly  
into the natural  
environment. The  
quarry is not producing  
topsoil or sand.

Unprotected Fuel Tank  
at the edge of the infill  
area. This could easily  
end up as a spill into  
the wetland.

Effluent directly into  
the environment

Construction Waste?  
Everywhere!

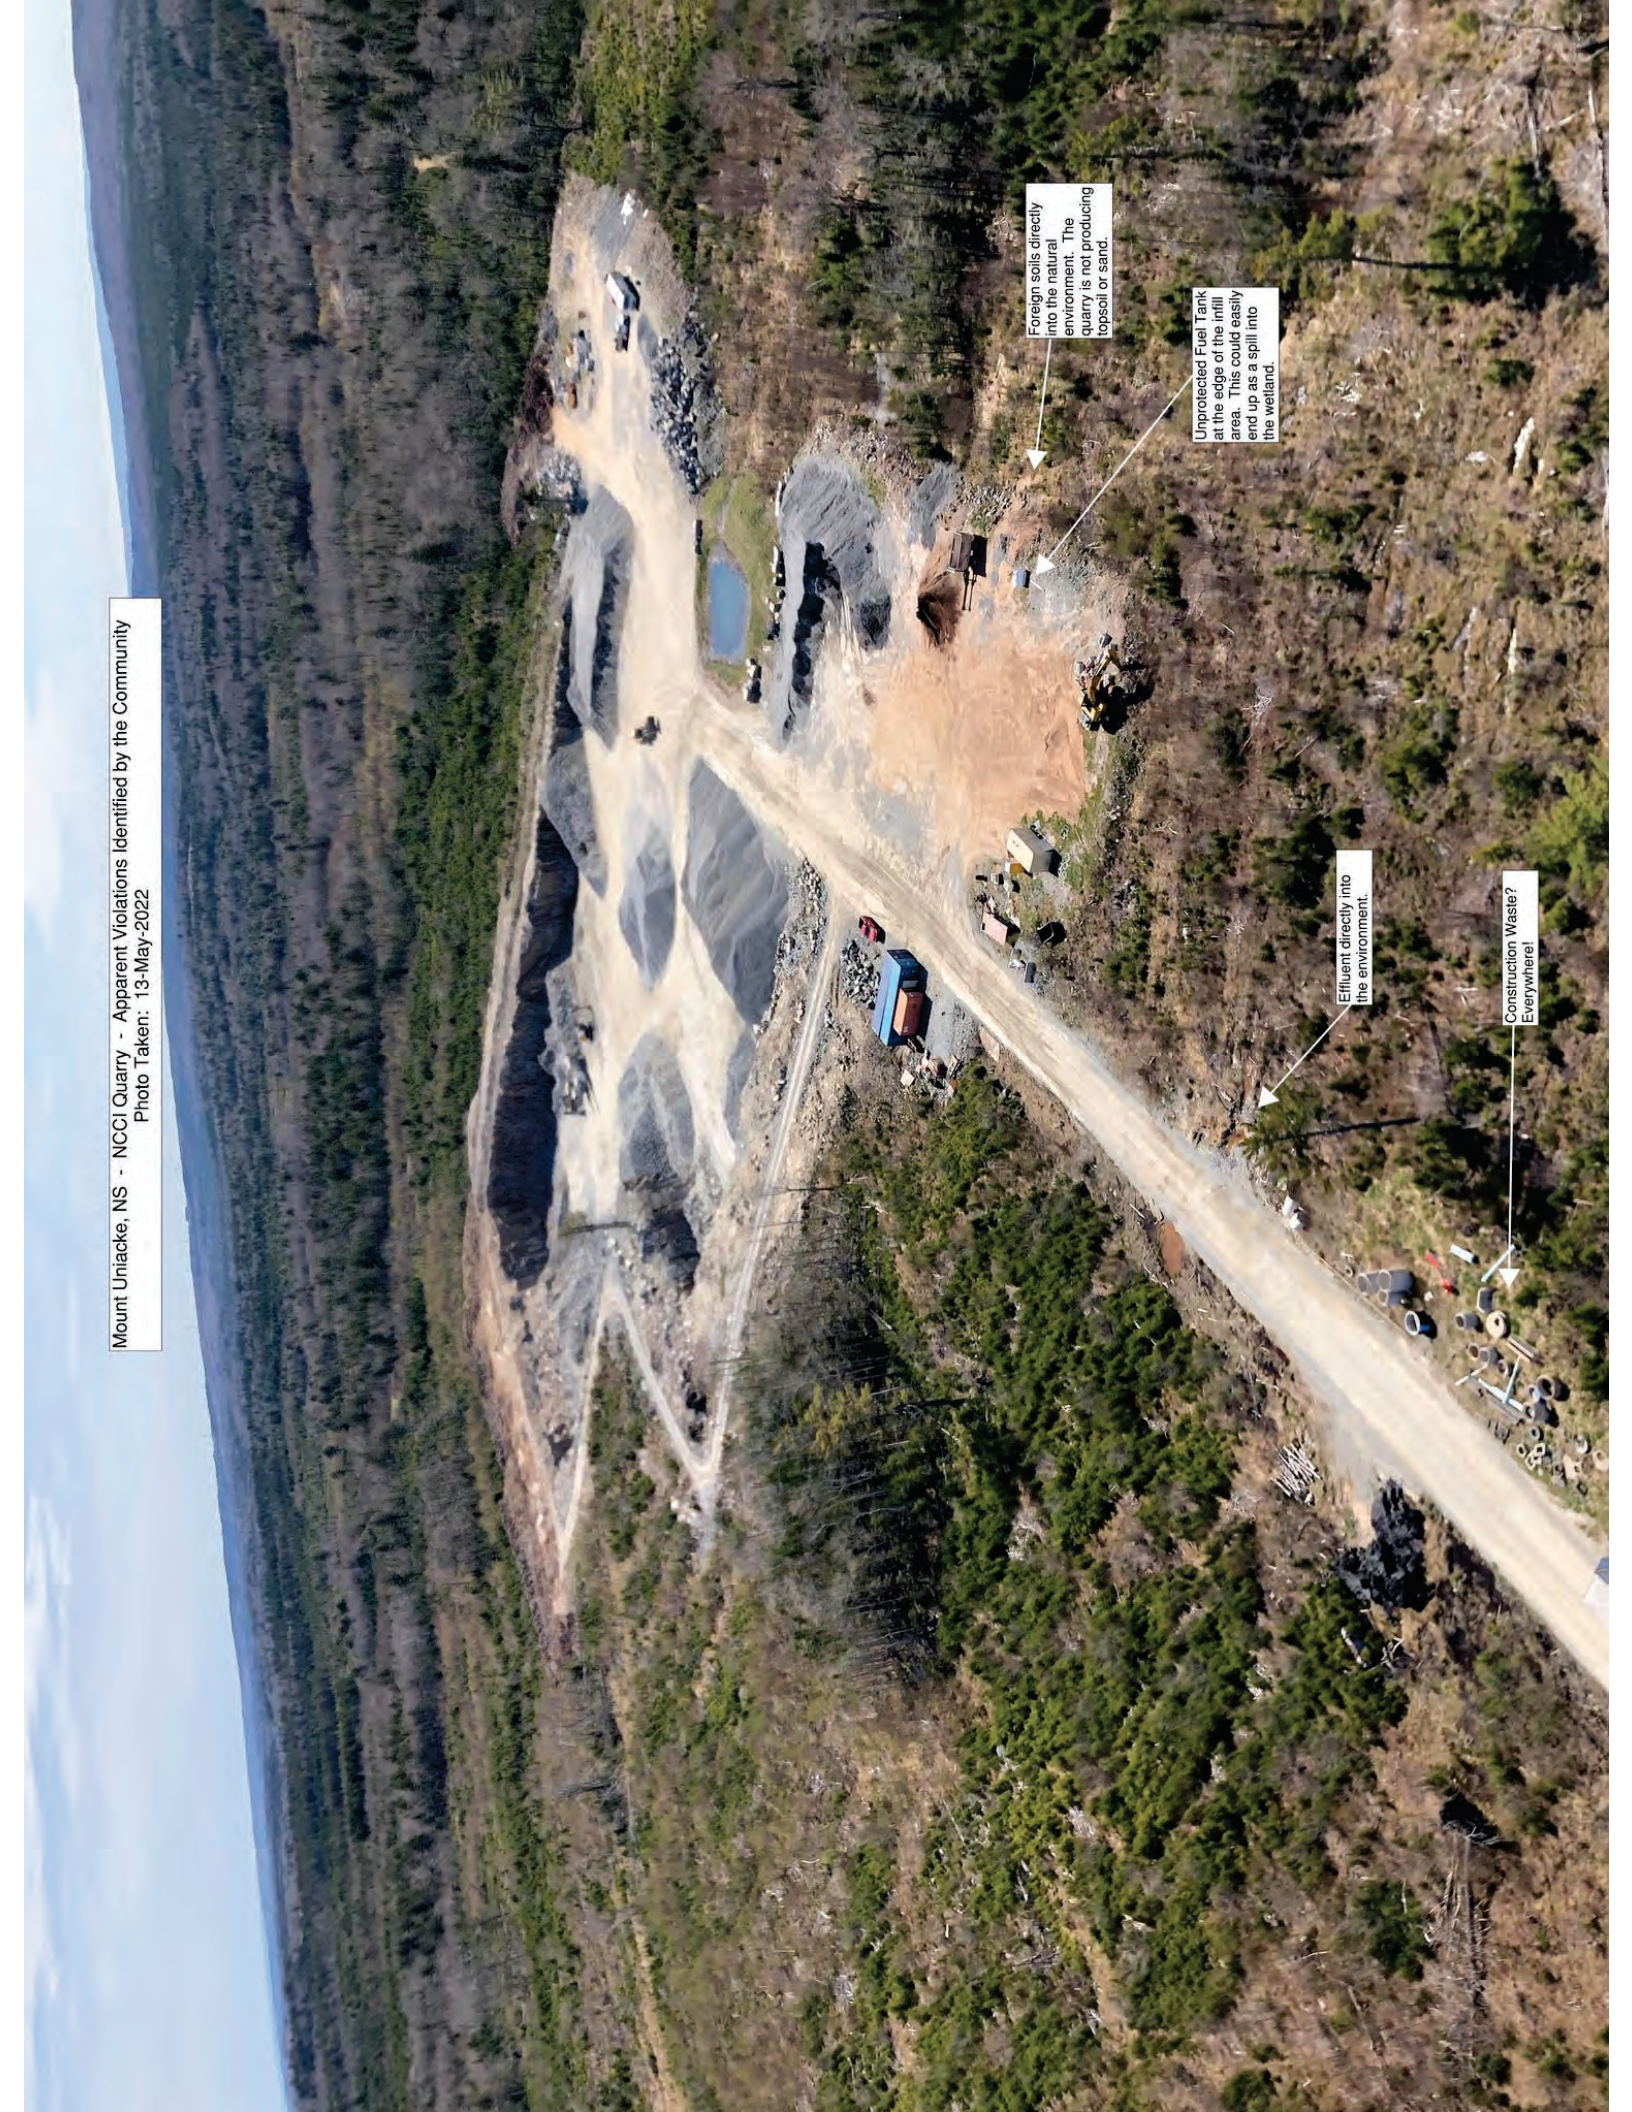
Mount Uniacke, NS - NCCI Quarry - Apparent Violations Identified by the Community  
Photo Taken: 20-May-2022 (Afternoon)

Dumping construction  
waste?
