From:  
To: [Environment Assessment Web Account](#); [Hunter, Tanya](#); [Van Lunen, Erik](#)  
Cc: [Premier](#); [Minister, Env](#); [Brad Johns \(mlabradjohns@gmail.com\)](#)  
Subject: NCCI Mount Uniacke Quarry - Apparent Non-Compliances 30-Oct-2025  
Date: October 31, 2025 4:38:55 PM  
Attachments: [Quarry Violations - 2025-10-31 - Flat - BSP.pdf](#)

**Apparent Quarry Violations**

Prepared: 31-Oct-2025 - BSP  
Image: Quarry,1  
Image Date: 30-Oct-2025

Mount Uniacke, NS - NCCI Quarry - Apparent Violations Identified by the Community  
Photo Taken: 13-May-2022

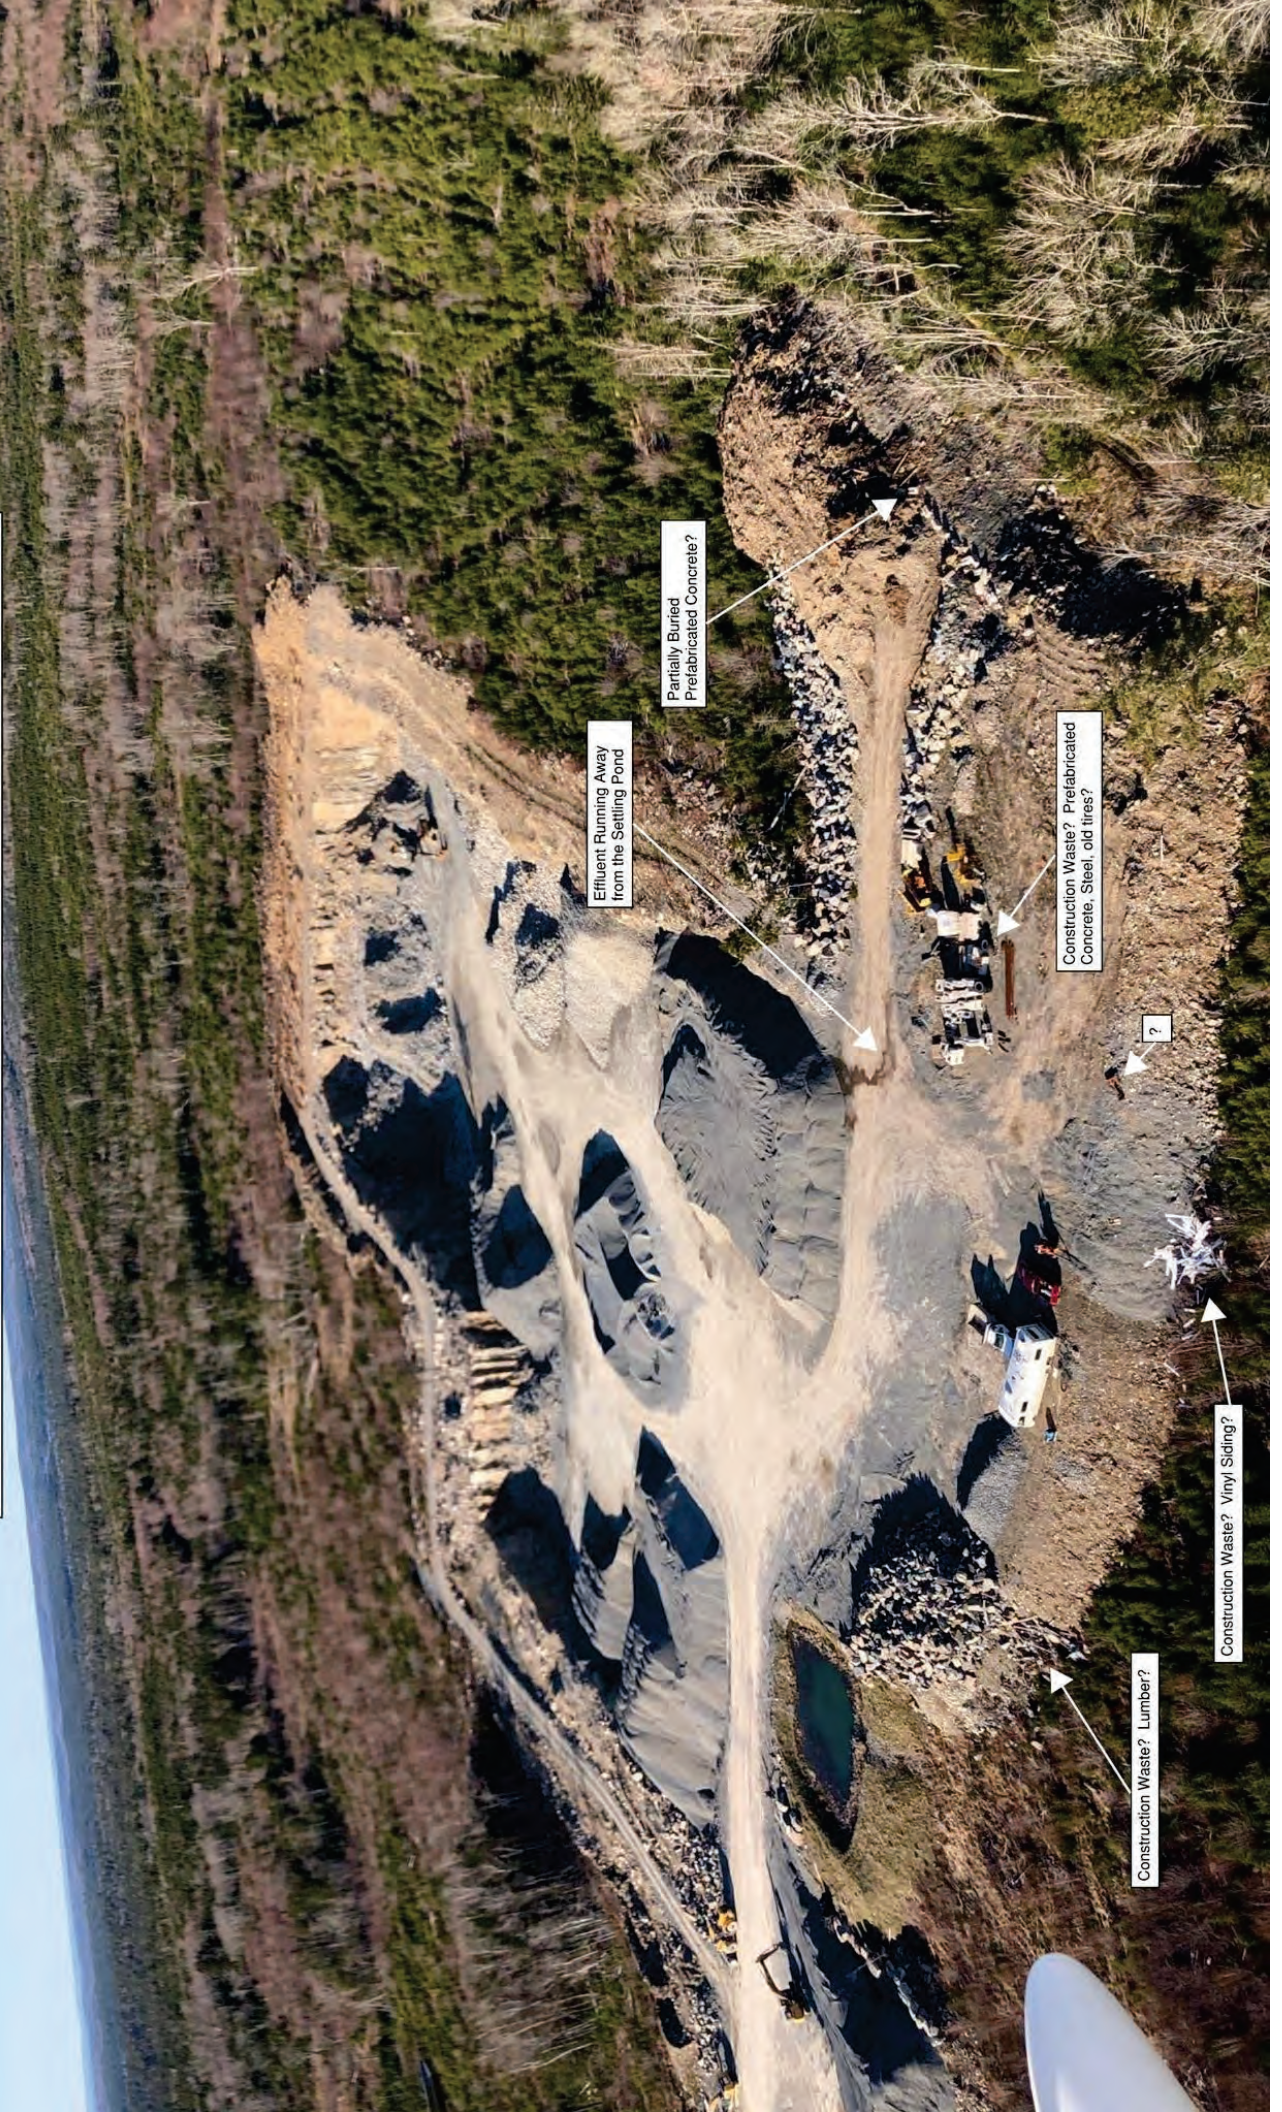
Mount Uniacke, NS - NCCI Quarry - Apparent Violations Identified by the Community  
Photo Taken: 3-May-2022

Effluent Running Away from the Settling Pond

Partially Buried Prefabricated Concrete?

Construction Waste? Prefabricated Concrete, Steel, old tires?

Construction Waste? Lumber?

Construction Waste? Vinyl Siding?

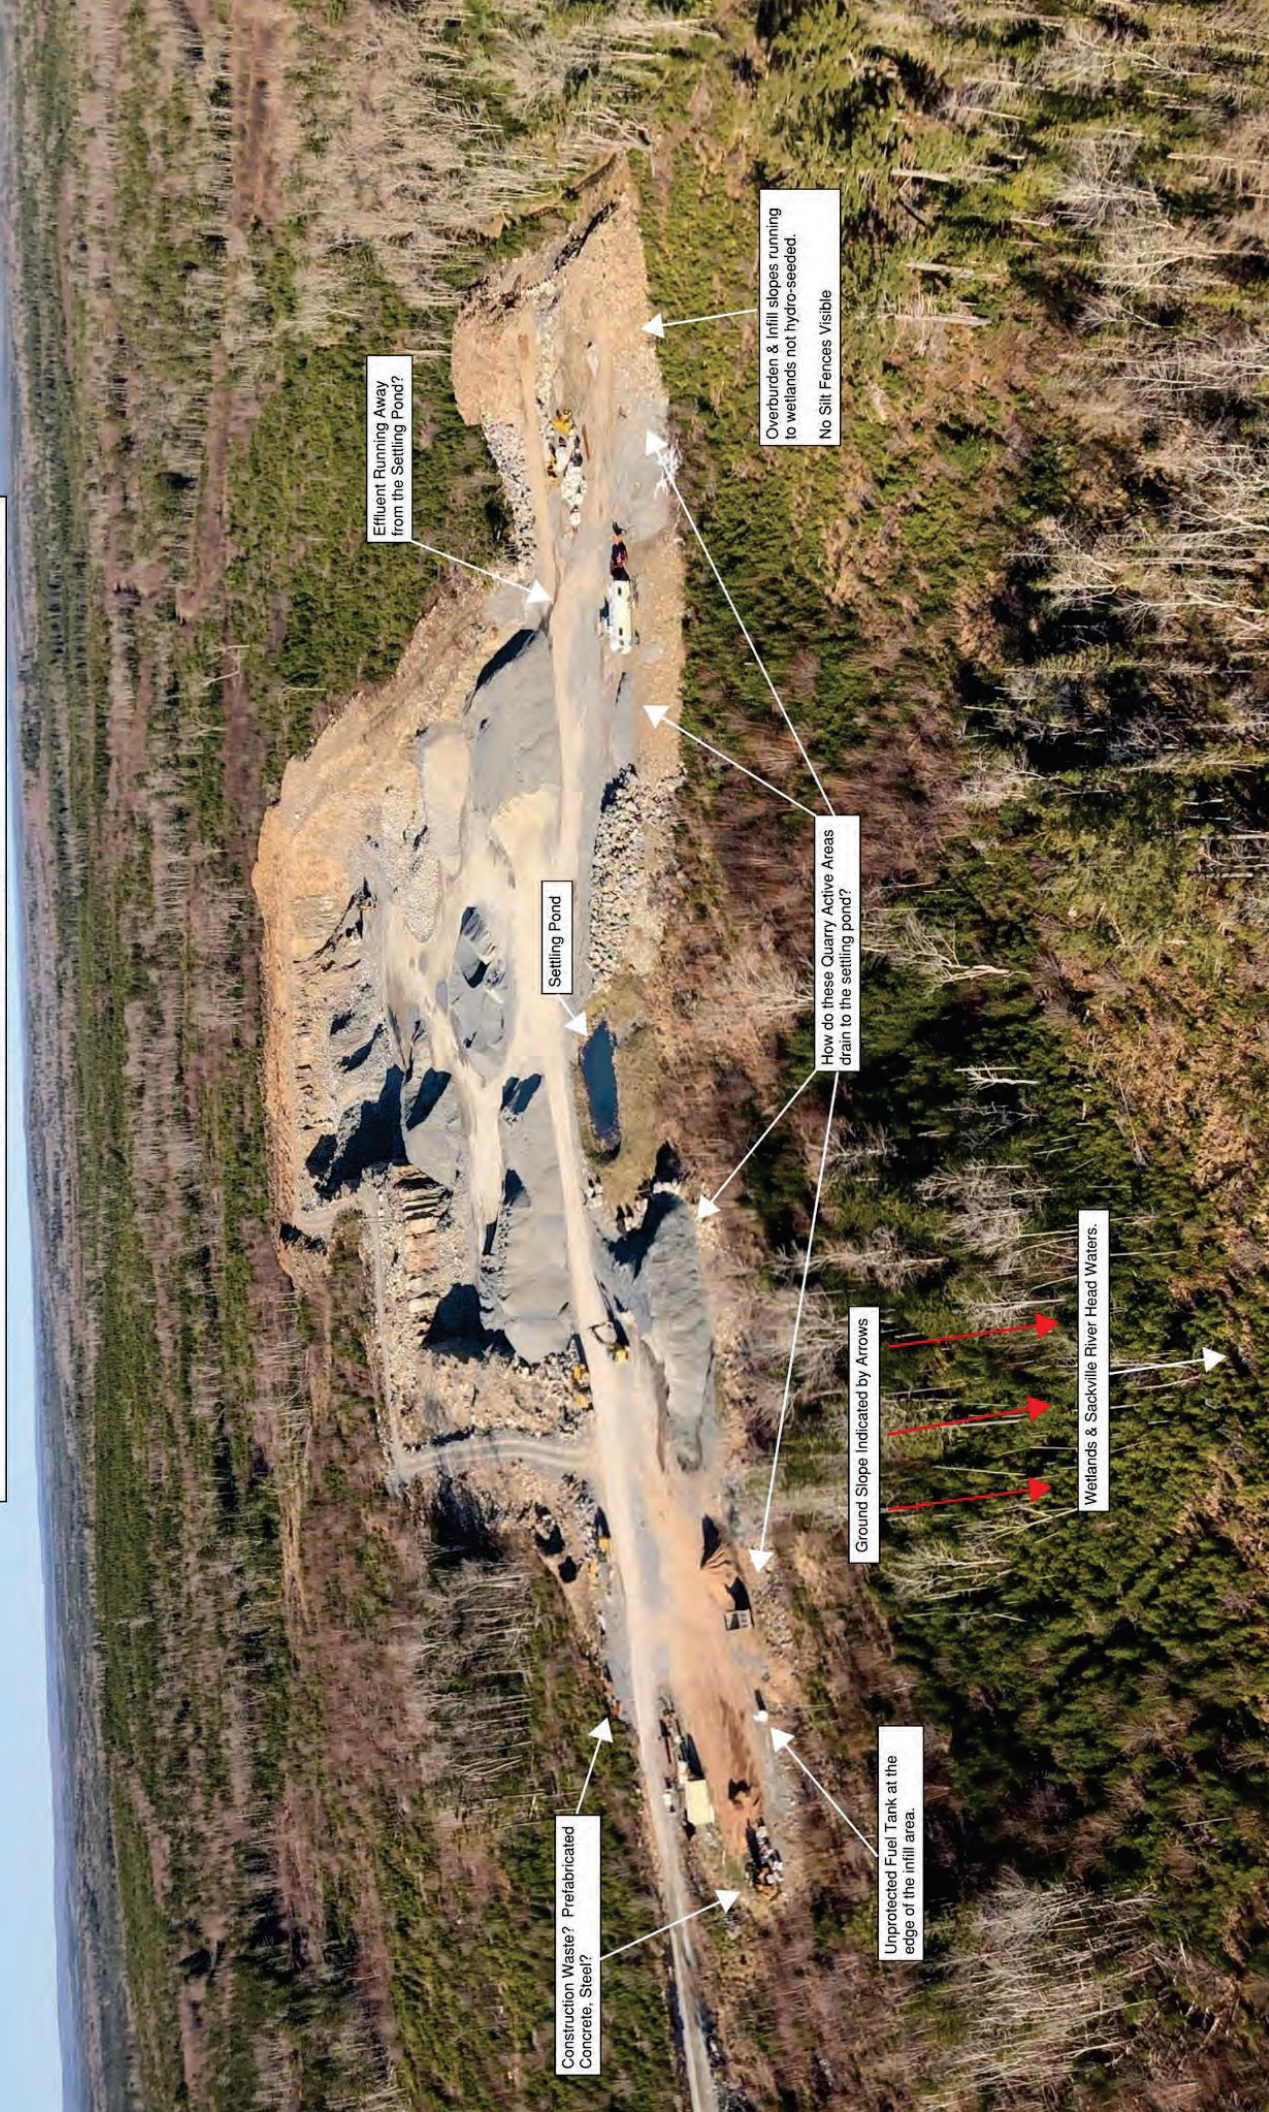
Effluent Running Away from the Settling Pond?

Settling Pond

Overburden & Infill slopes running to wetlands not hydro-seeded.  
No Silt Fences Visible

How do these Quarry Active Areas drain to the settling pond?

Ground Slope Indicated by Arrows

Wetlands & Sackville River Head Waters.

Unprotected Fuel Tank at the edge of the infill area.

Construction Waste? Prefabricated Concrete, Steel?

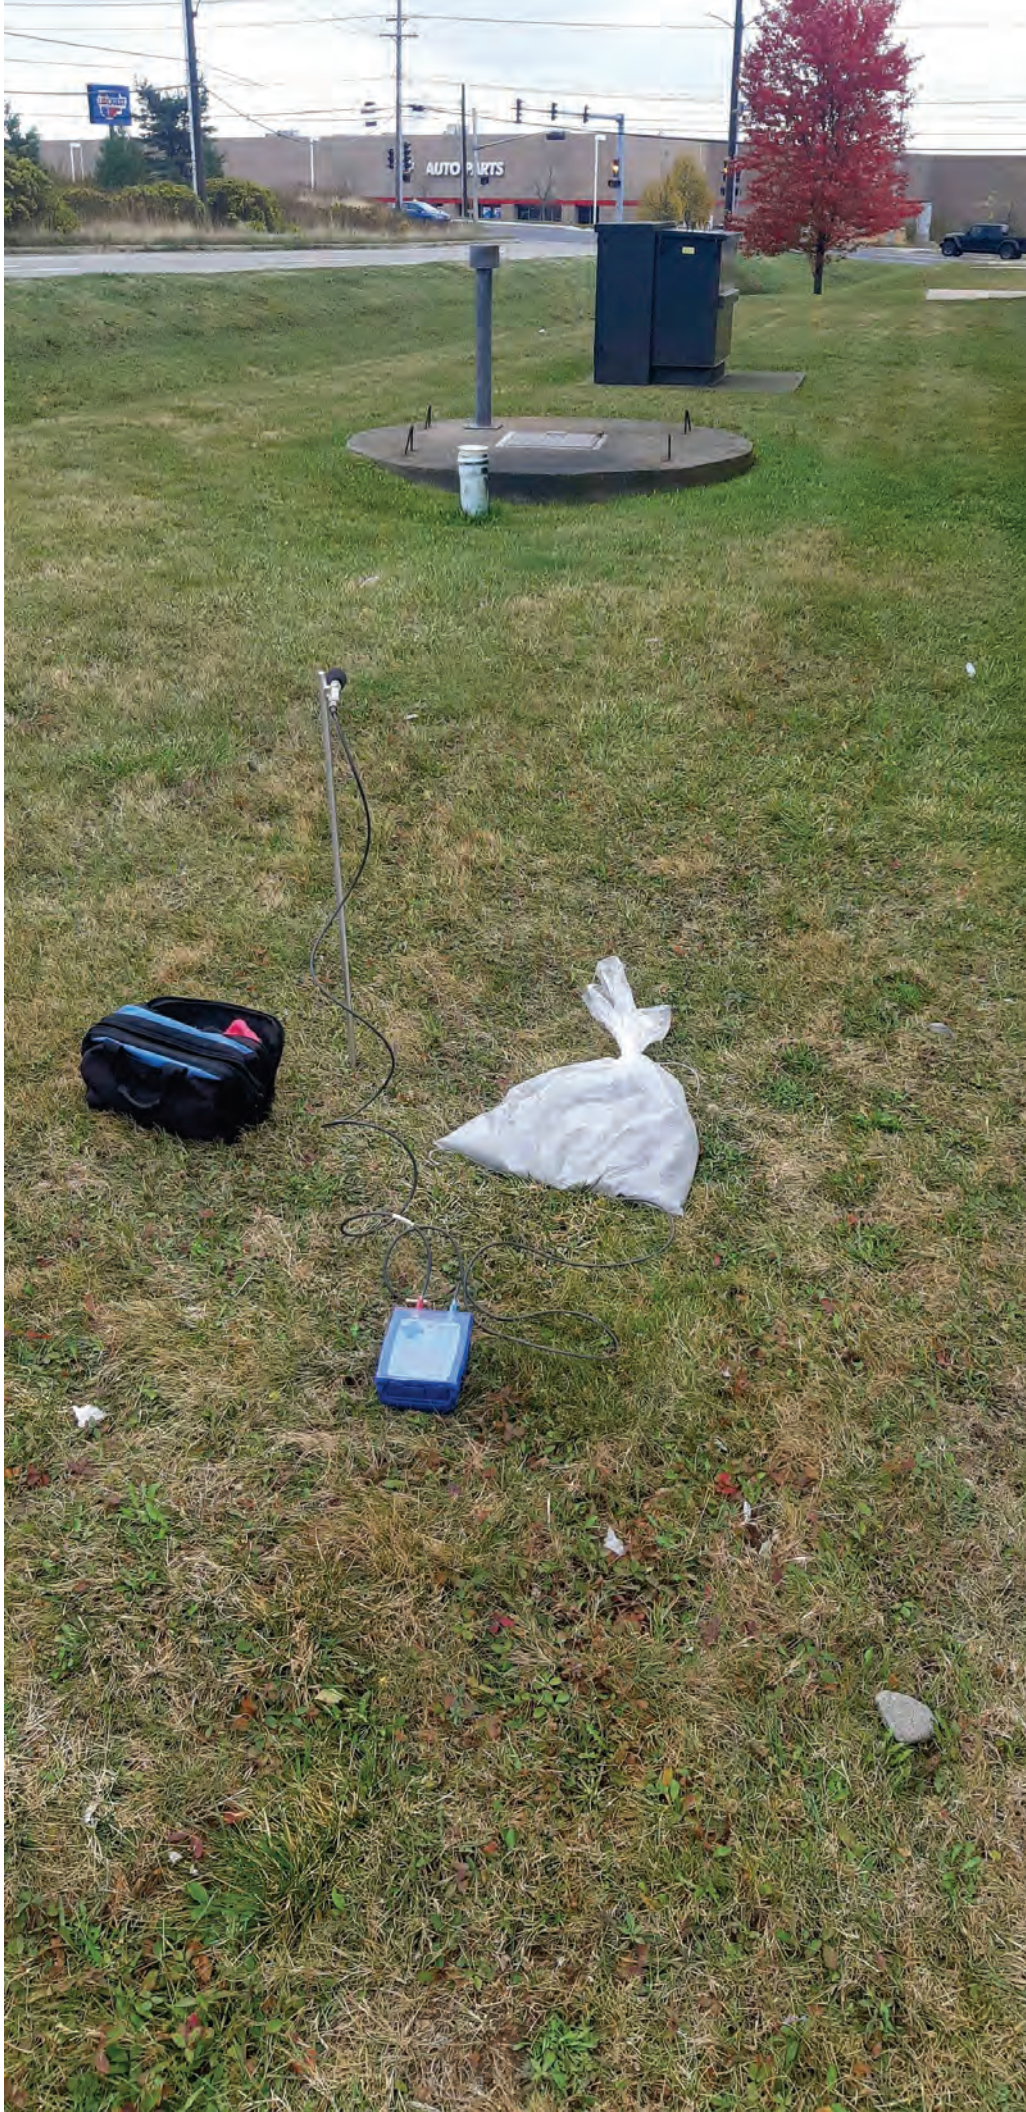
**Image 01:** NCCI's blast monitoring setup on Partridge Lane. This arrangement violates regulations, industry standards, and the manufacturer's instructions. The equipment placement — inside a plastic tote and not coupled to the ground — **masks the true intensity of blasts**, resulting in misleading data reported to NSECC.

NCCI's setup **does not meet Industrial Approval requirements**, which specify that geophones must be **anchored to a foundation at or below grade**. The flawed setup explains why official reports understate the blast impacts residents

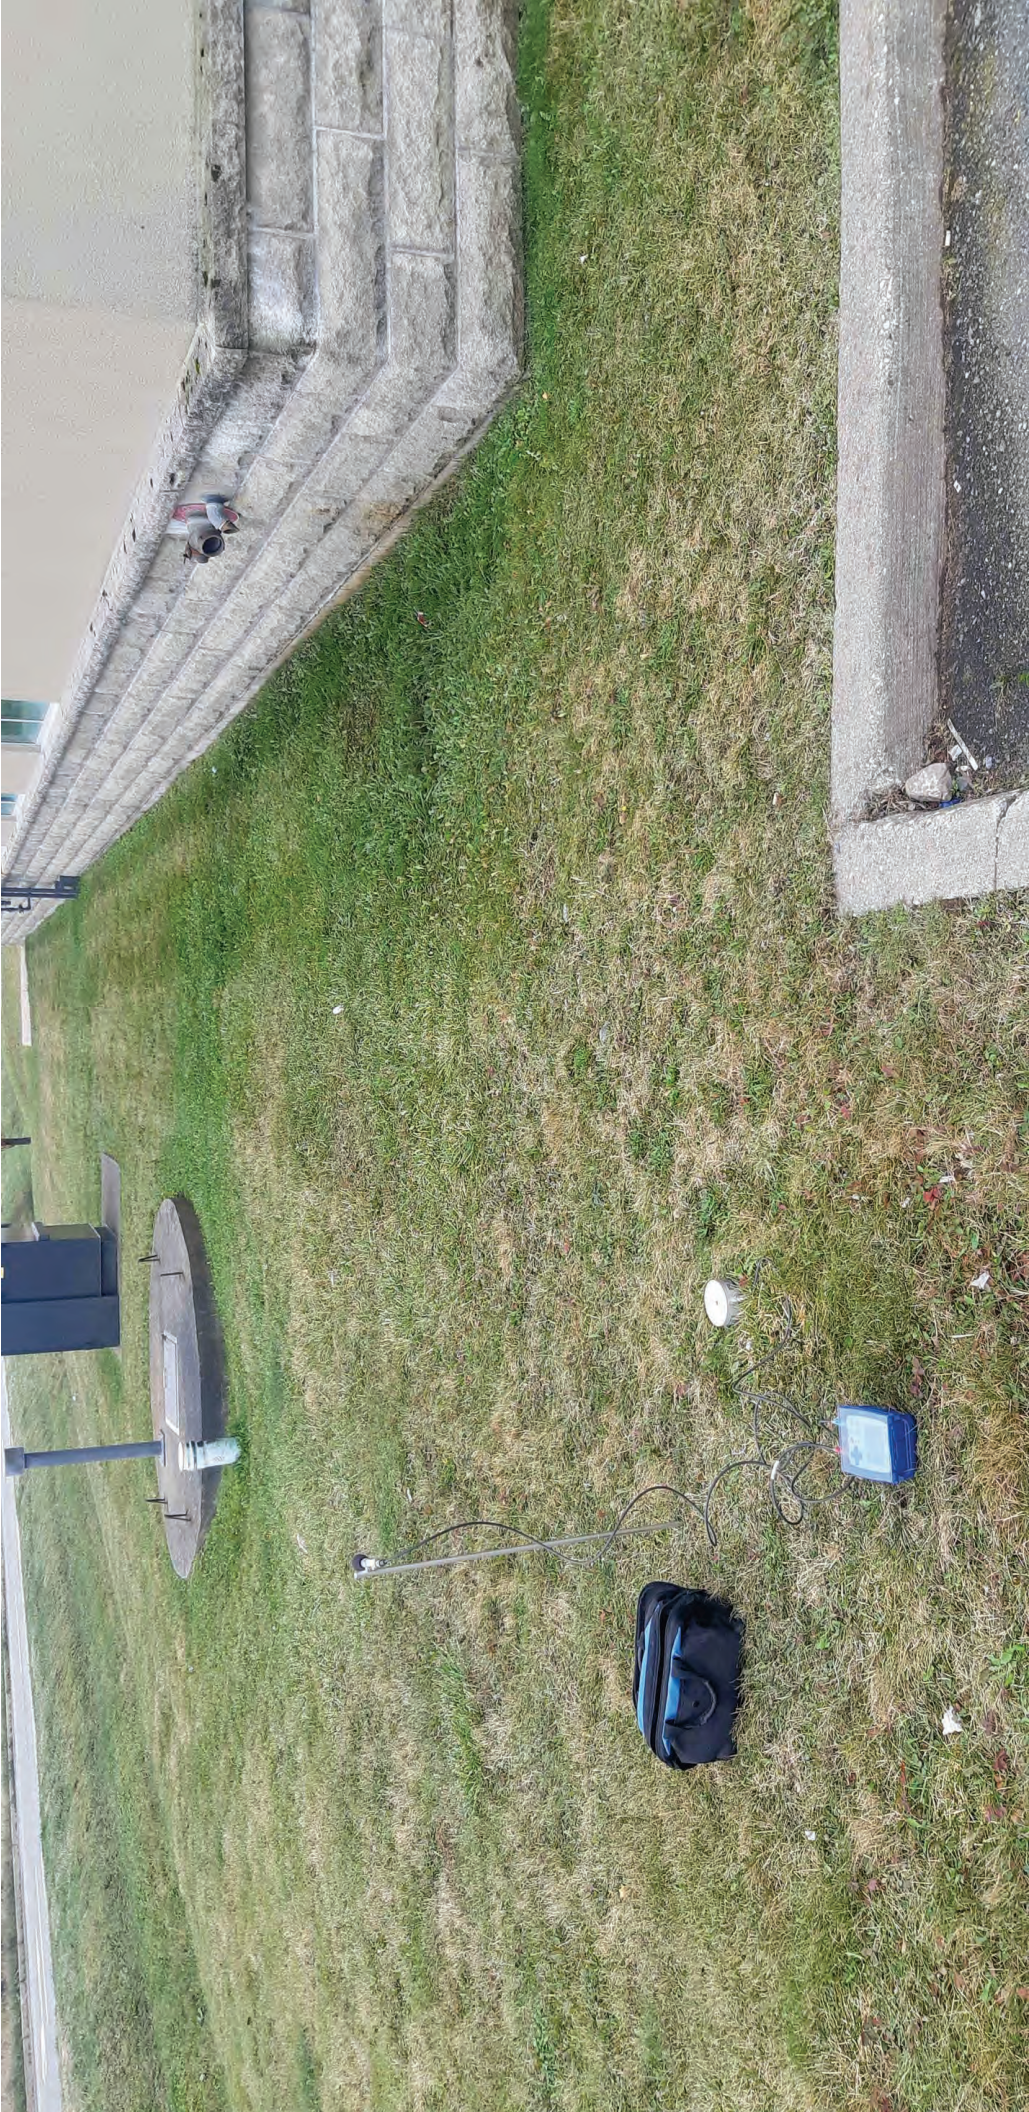
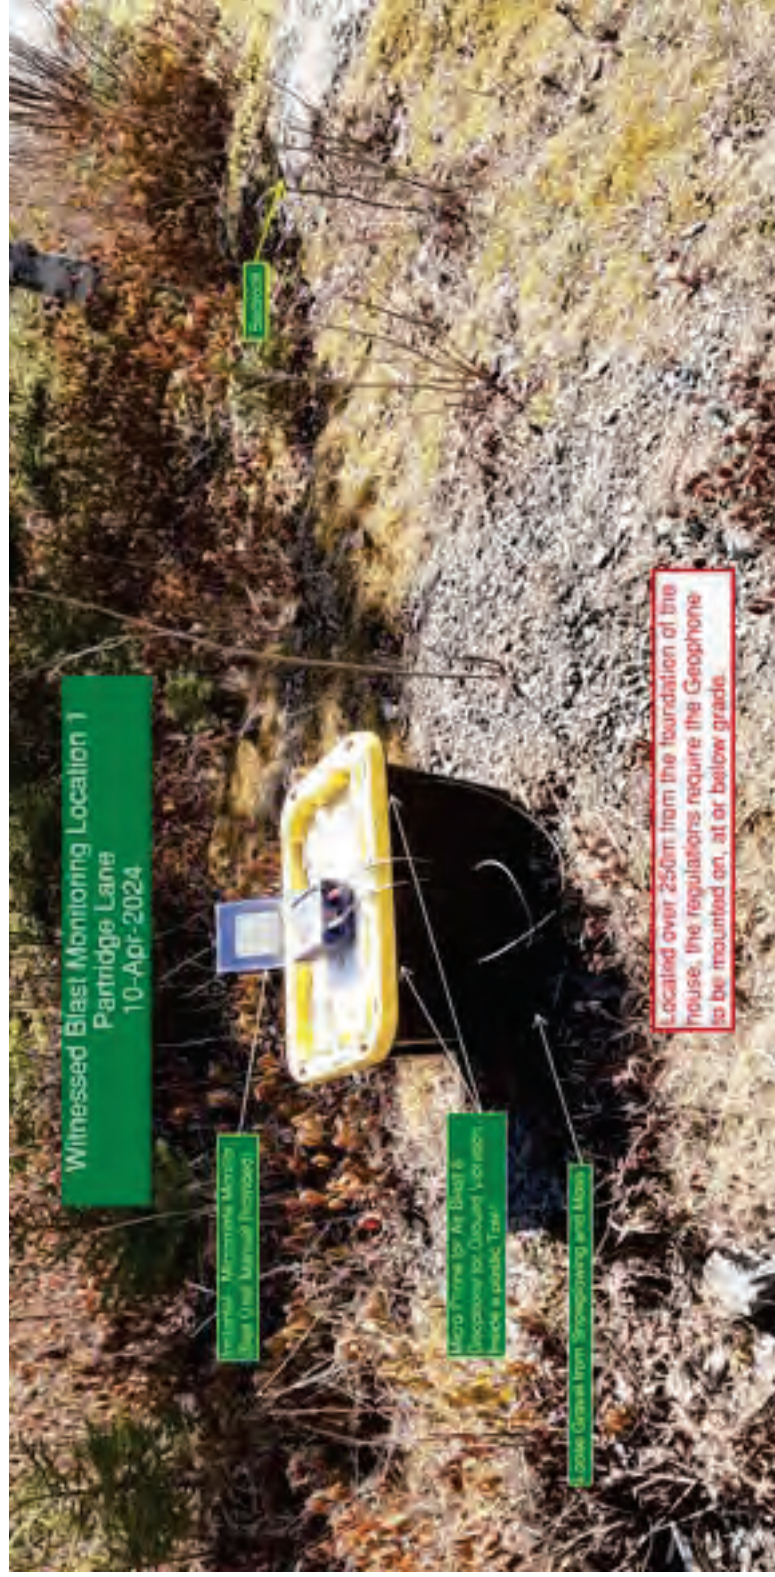
**Images 02 & 04:** Examples of **proper industry-standard setups**, using the same equipment. The geophone is securely placed in soil, fully coupled to the ground to record accurate vibration data.

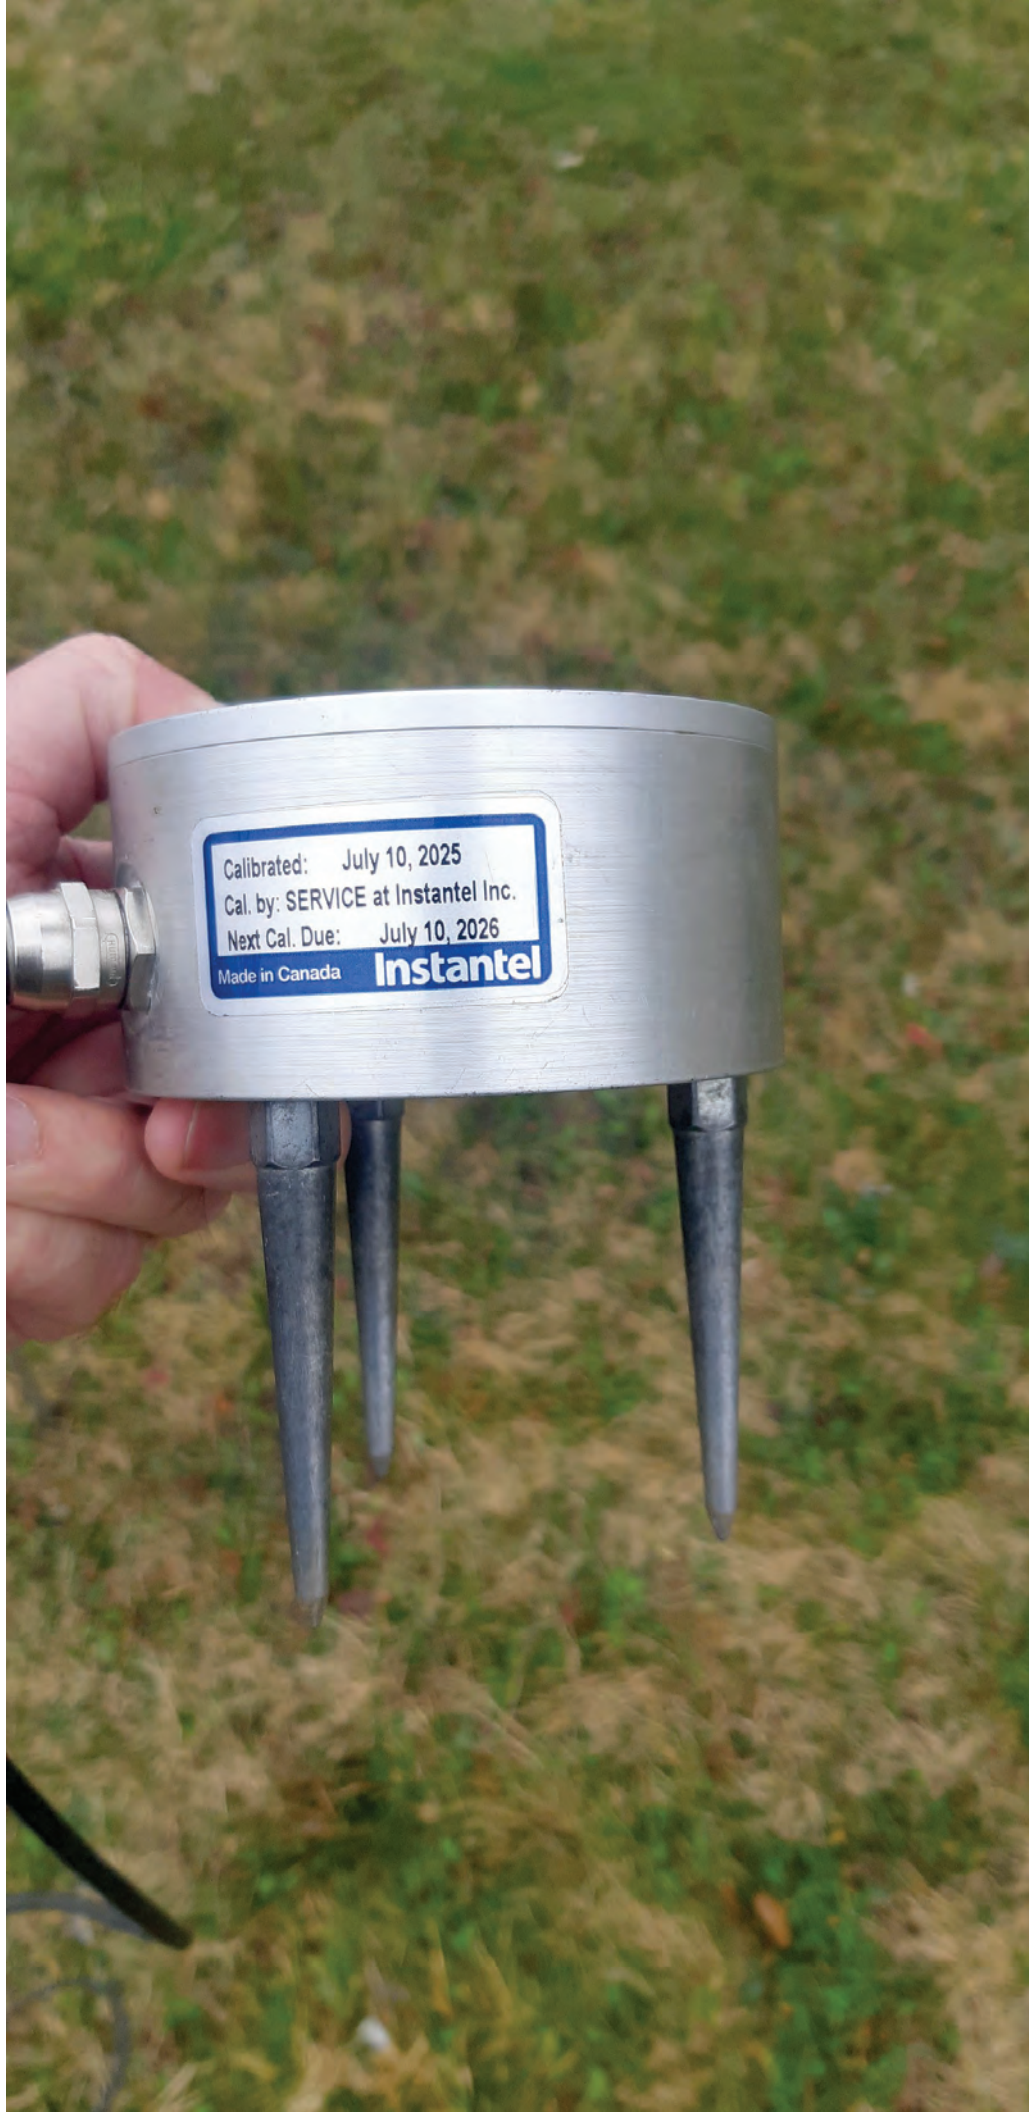
**Image 03:** Close-up of a correctly installed **geophone sensor**. The spikes anchor it into the soil, ensuring accurate ground motion readings.
