## Intertidal Morphodynamics of the Avon River Estuary

Final report submitted to the  
Nova Scotia Department of Transportation and Public Works (NSTPW)

Prepared by  
Dr. Danika van Proosdij, Department of Geography, Saint Mary's University  
& Greg Baker, MP\_SpARC, Saint Mary's University  
923 Robie, St. Halifax, N.S., B3H 3C3

September 30, 2007

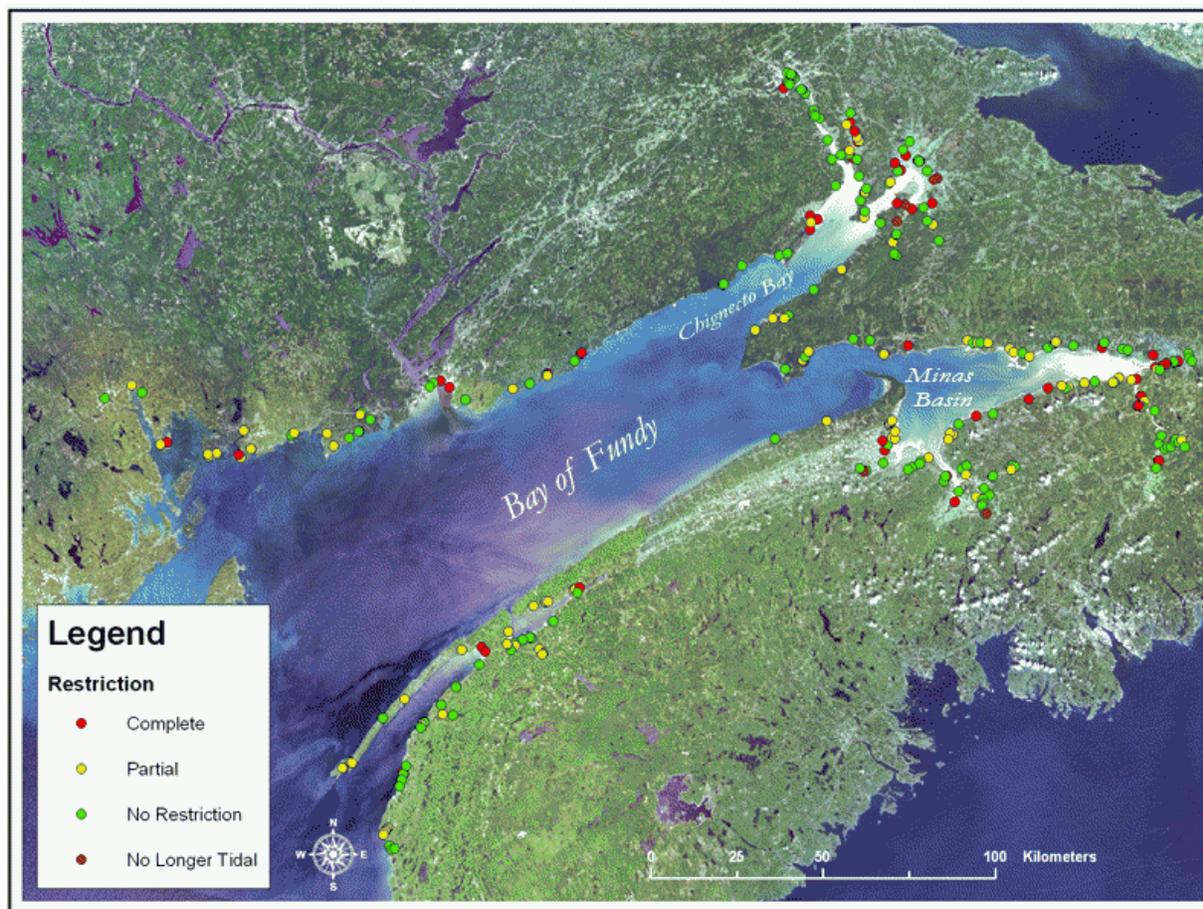
Figure 1.1: Location and categories of tidal barriers in the Bay of Fundy derived from the tidal barrier audits conducted by the Ecology Action Center and the Conservation Council of New Brunswick (van Proosdij & Dobek, 2005).

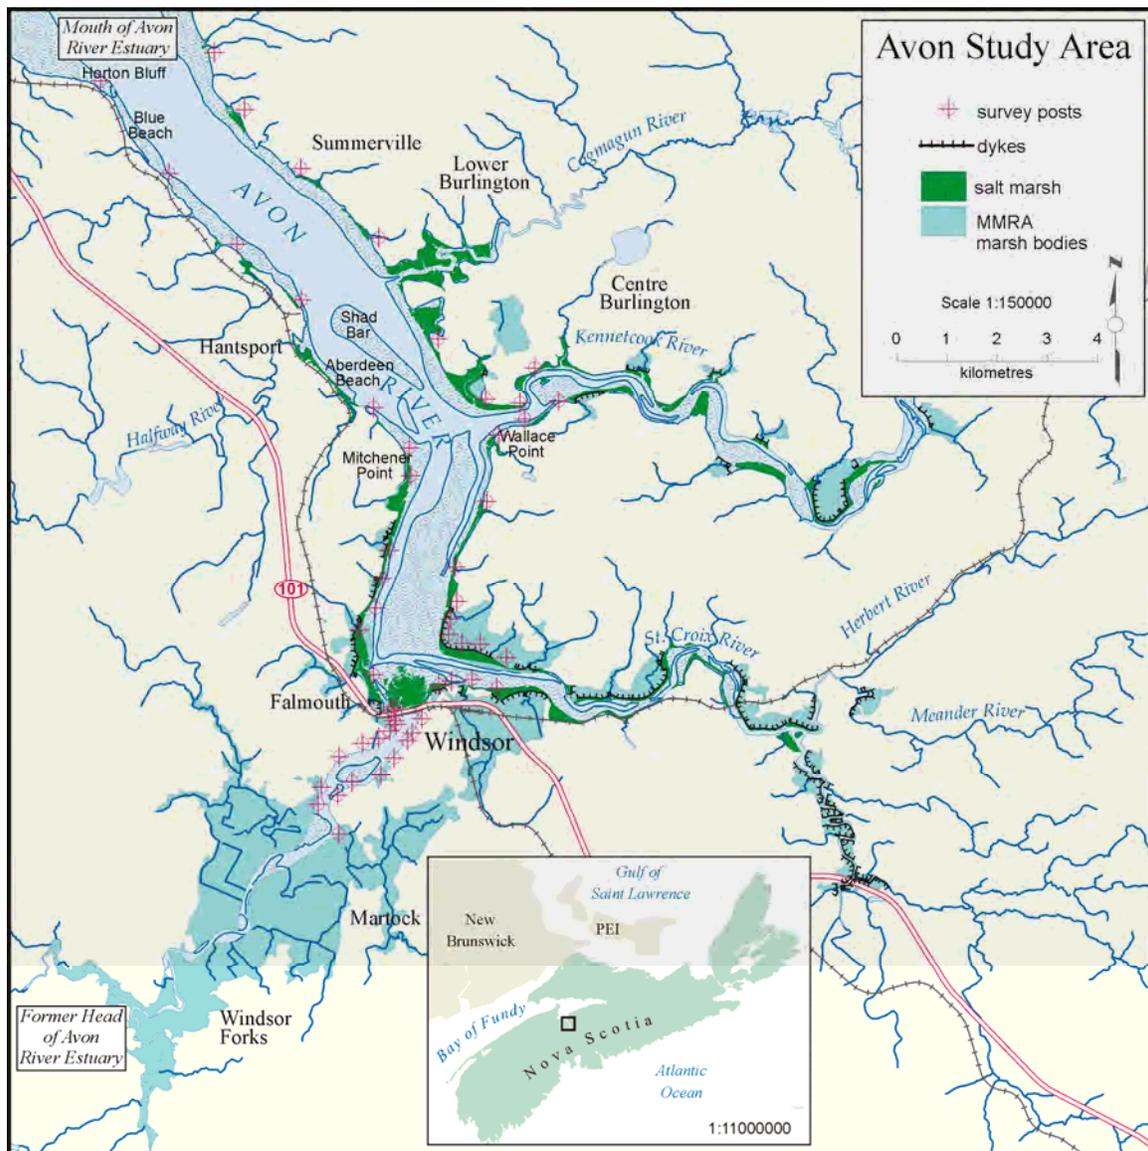
Figure 1.2: Location of the Avon study area. MMRA marsh bodies represent areas of former salt marsh that are now primarily agricultural land that is protected by dykes. Figure created by C. Probst, 2007.

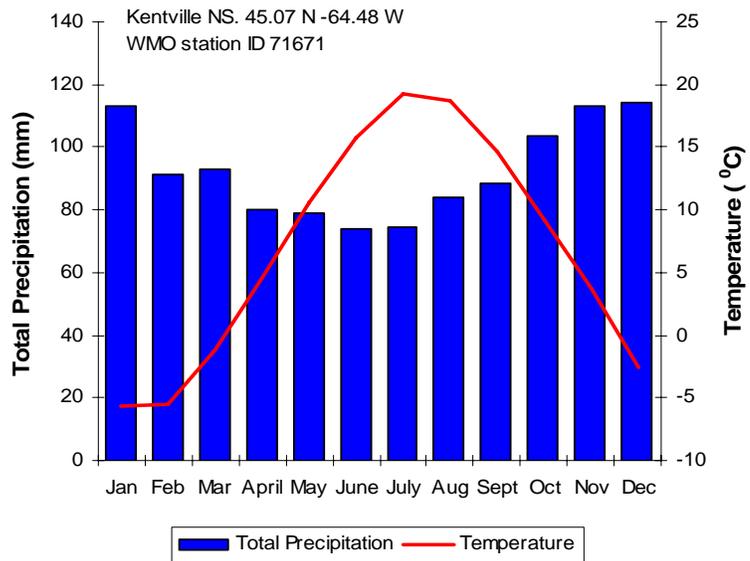
Figure 2.1: Climatograph for Kentville, NS. based on data from 1913-2006

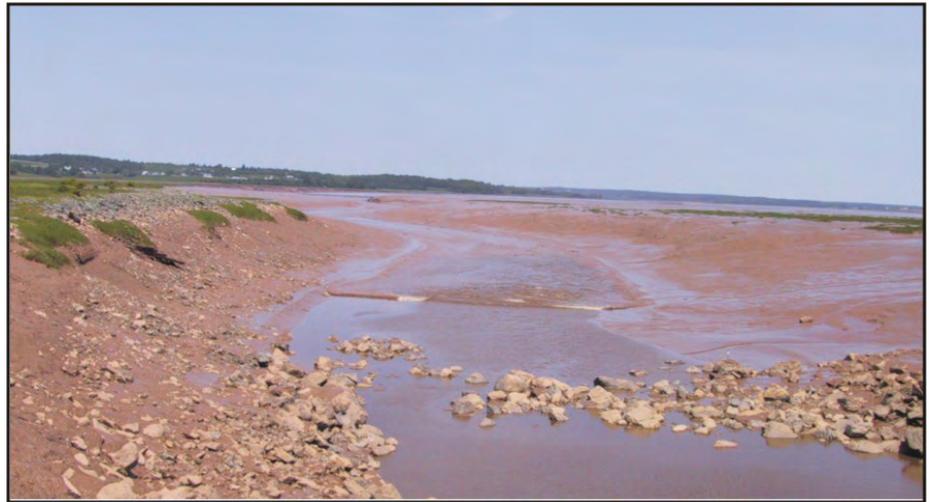
Figure 2.4. Tidal bore at Windsor Tide Gate at 12:36 pm on June 17, 2003 (photo by K. Carroll, 2003)

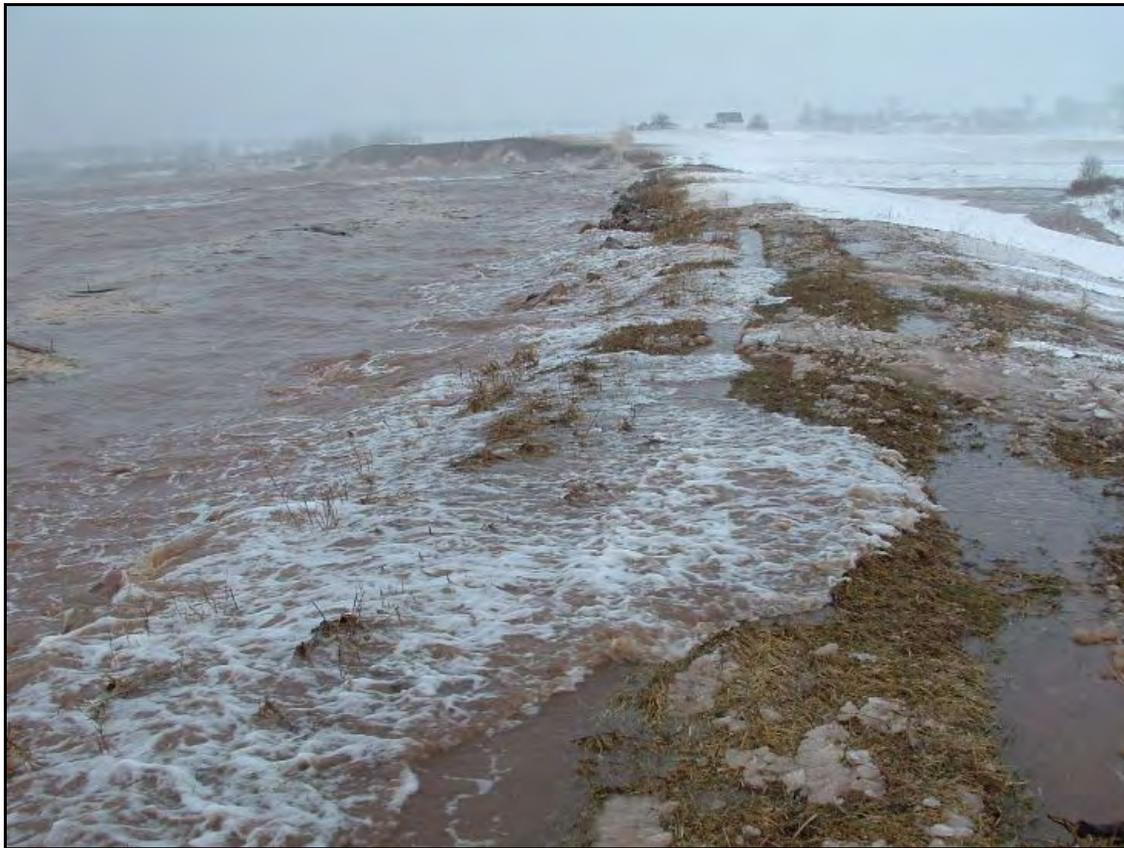
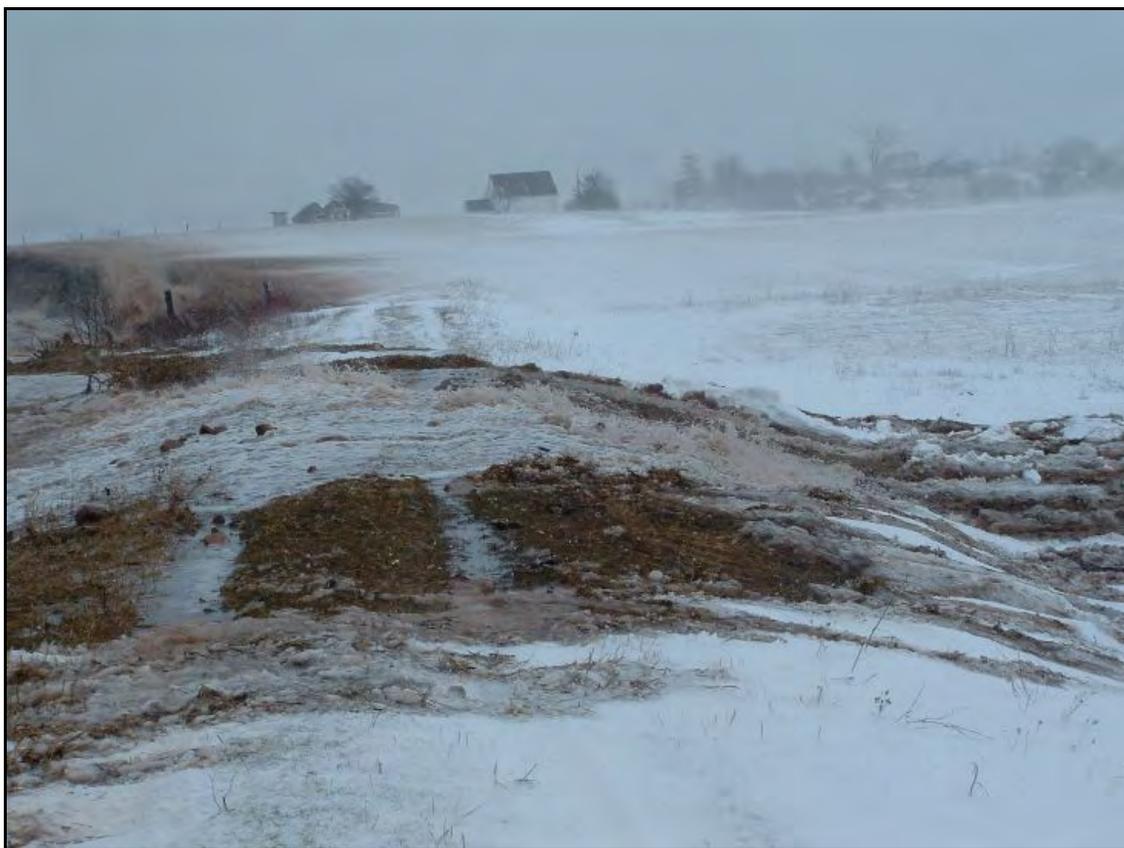
*Figure 2.6: Storm impacts on Feb 1, 2006 at the Avonport Dyke. a) storm waves battering marsh; b) storm surge reached upper limits of dyke and dyke overtopped. Photo by T. Hamilton, 2006.*

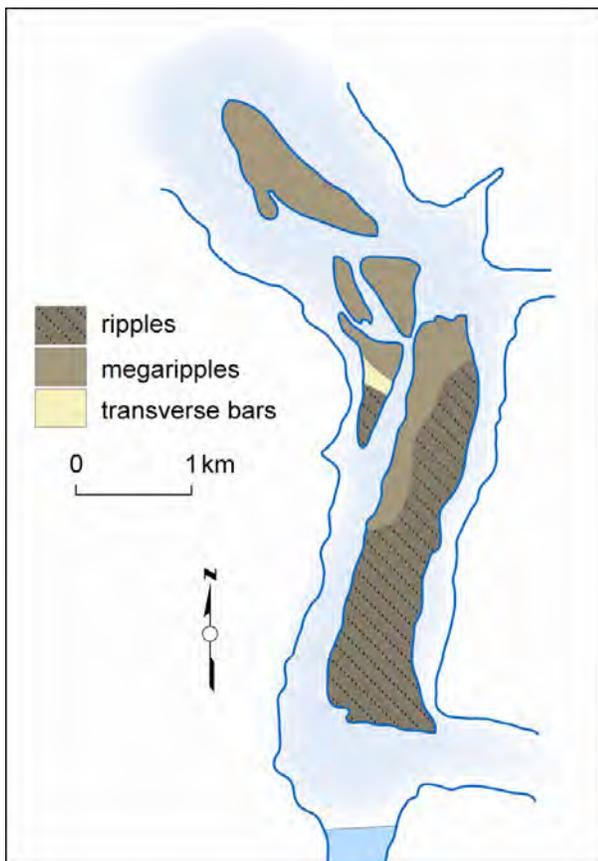
Figure 2.7: Bedform distribution at the head of the Avon River estuary. Modified from Lambiase, 1980.

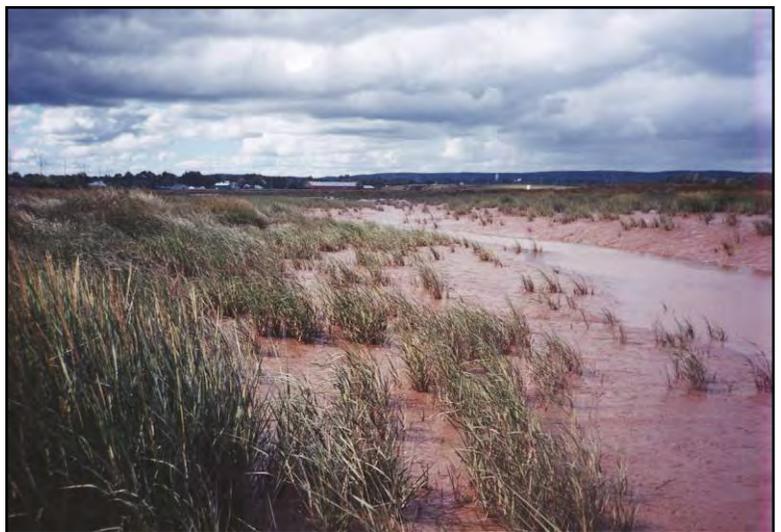
Figure 2.9: *Spartina alterniflora* on Windsor salt marsh August, 2001.

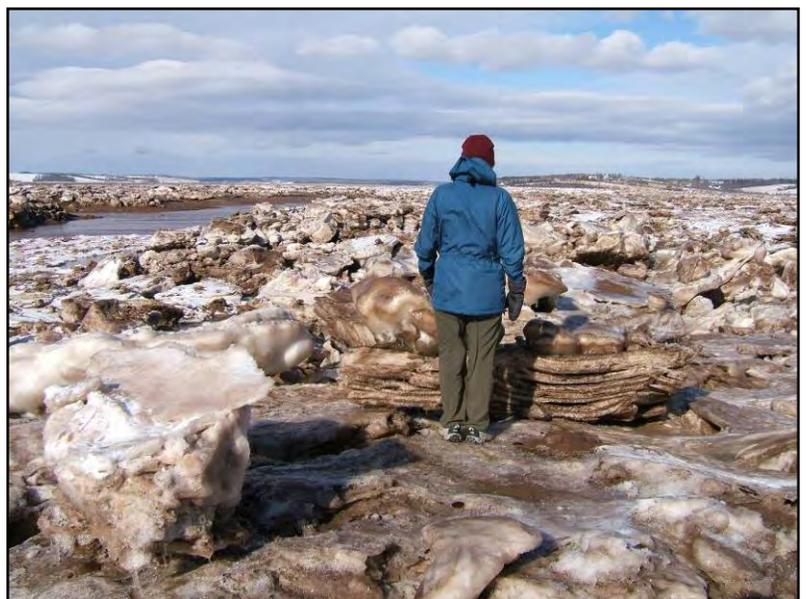
Figure 2.10: Ice blocks stranded on the Windsor saltmarsh close to the Windsor Tourist Bureau on Feb 17, 2007. Photo by D. van Proosdij, 2007

During the winter months, intertidal areas are covered with snow and ice that is rafted in with the tides and stranded on the marsh surface and within the tidal creek channels (Figures 2.10 and 2.11-a). This ice is quite ephemeral in nature, and can appear and disappear within only a few tides (van Proosdij, 2005). However, it can also build up within the tidal creeks, altering patterns of flow and erosion/deposition of sediments (Figure 2.12). These ice blocks contain high concentrations of both sediment and plant rhizome material which are important inputs to the salt marsh system (Ollerhead et al., 1999; van Proosdij et al., 2006). This material, including very coarse sediments, can be deposited on the marsh surface in the Spring. Standing vegetation in the Spring is quite sparse, having been sheared off in most years by ice and wave action. Significant amounts of marsh wrack material will then accumulate along the edge of the causeway and dykes. This material will be exported into the estuary in areas exposed to wave action (e.g. Windsor mudflats). Marshes in more sheltered areas will retain more of their dead material and it will decompose *in situ* (Gordon and Cranford, 1994). This is

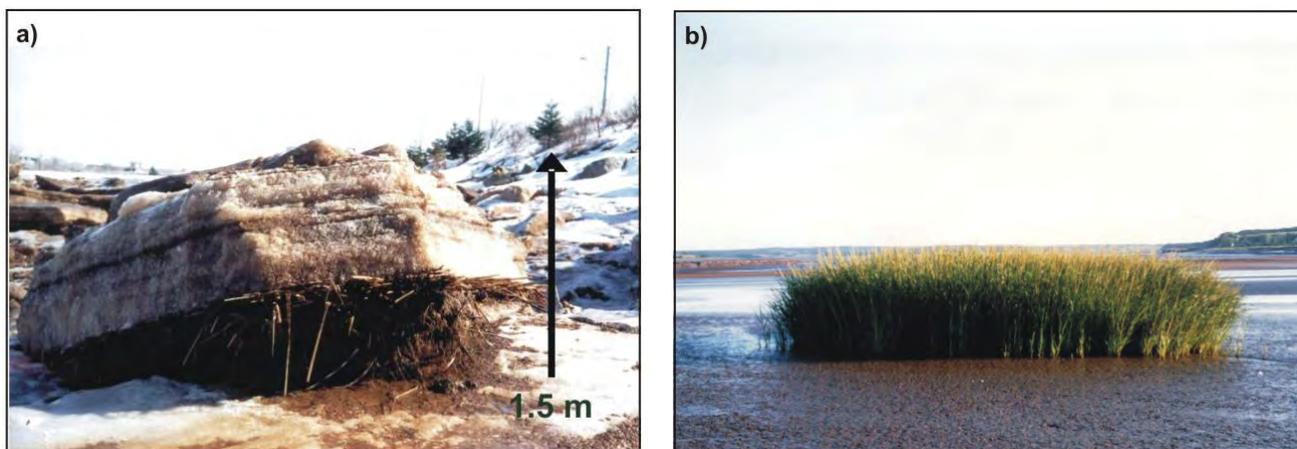
Figure 2.11: a) Rafted ice block (Feb, 2002) adjacent to the Windsor Causeway and b) *Spartina alterniflora* colony on the north-east edge of the Windsor marsh/mudflat ecosystem (Aug, 2003).

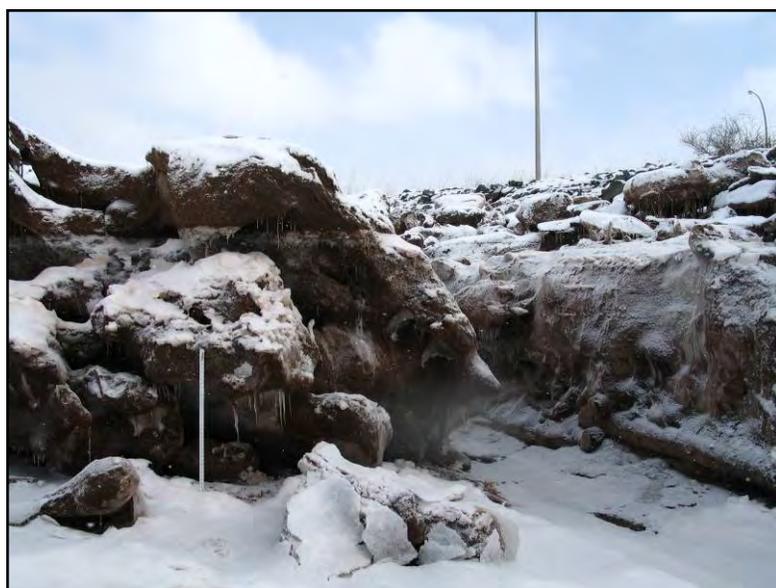
Figure 2.12: Approximately 2.5 m high by 4 m block of ice blocking creek channel near southeast corner of marsh adjacent to causeway. Metre stick for scale. Photo by D. van Proosdij, Feb 25, 2005.

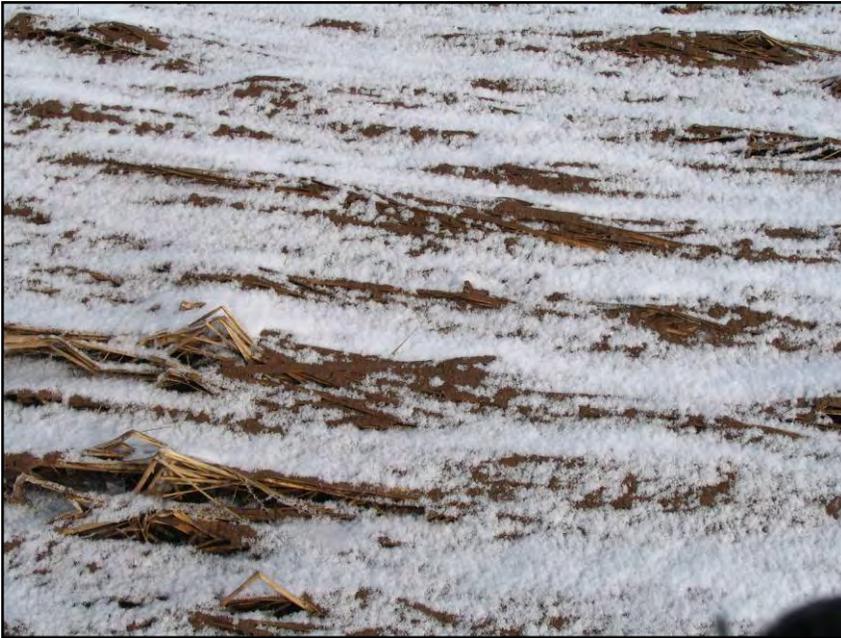
*Figure 2.13: Sediment deposited on spartina alterniflora in sheltered areas on the Windsor marsh. Over time, the vegetation will decompose and be incorporated within the soil matrix. Photo by D. van Proosdij on Feb 25, 2005*

also evident at the Windsor site with dead *Spartina alterniflora* lying flat on the marsh surface in more sheltered areas (Figure 2.13).

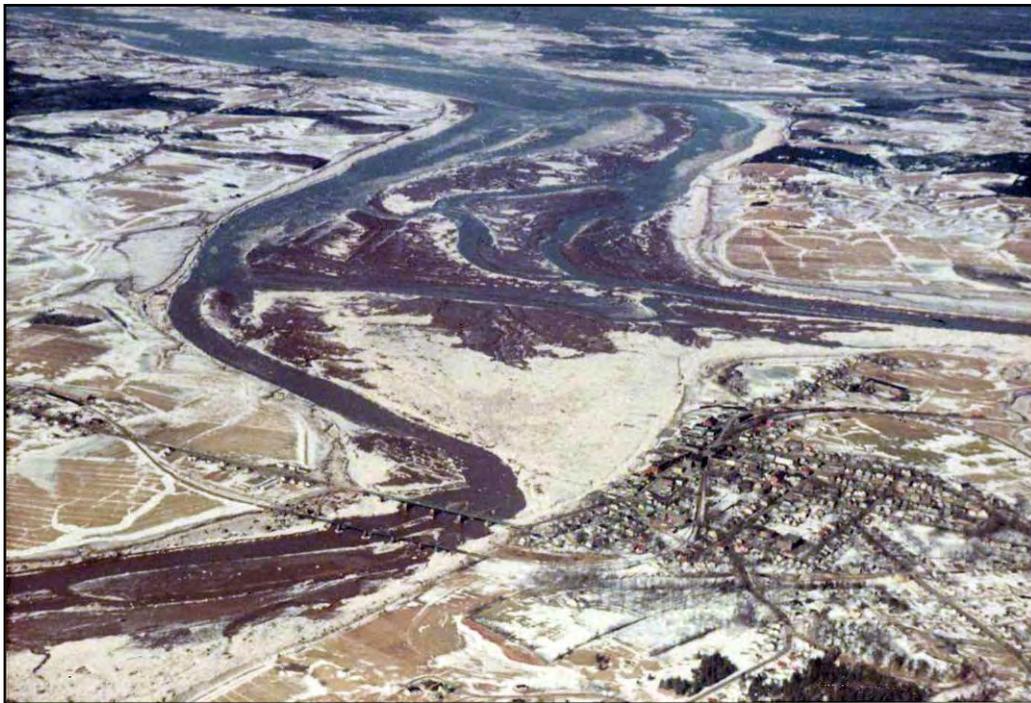
*Figure 2.14: Extensive intertidal flats evident at low tide on the Avon River near the Town of Windsor during the Winter of 1963. This aerial photo demonstrates evidence of natural bar formation in the location of the future causeway. Photo by C.A. Banks, 1968.*

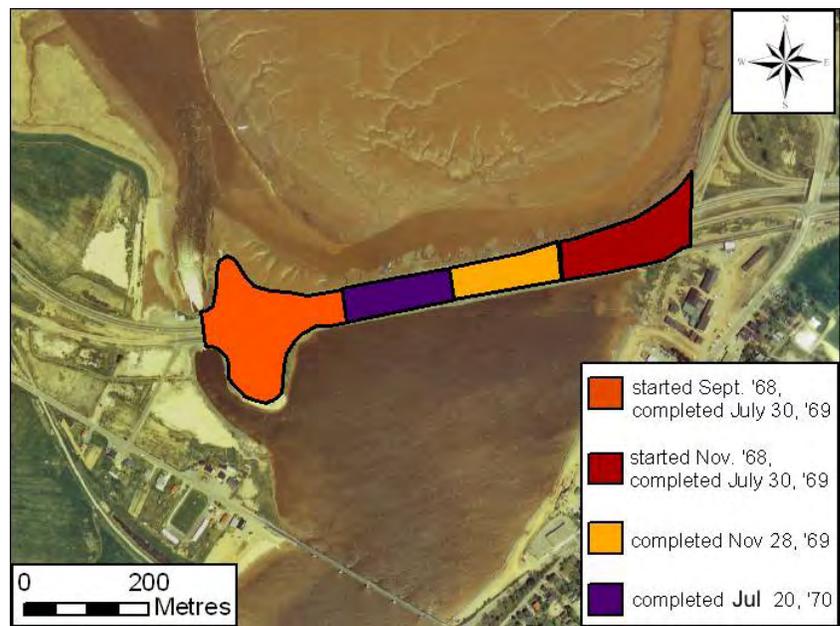
Figure 2.15: Sequence of closure during the construction of the Windsor Causeway superimposed on 1973 aerial photo mosaic. Data obtained from MMRA architectural drawing of proposed causeway, 1967.

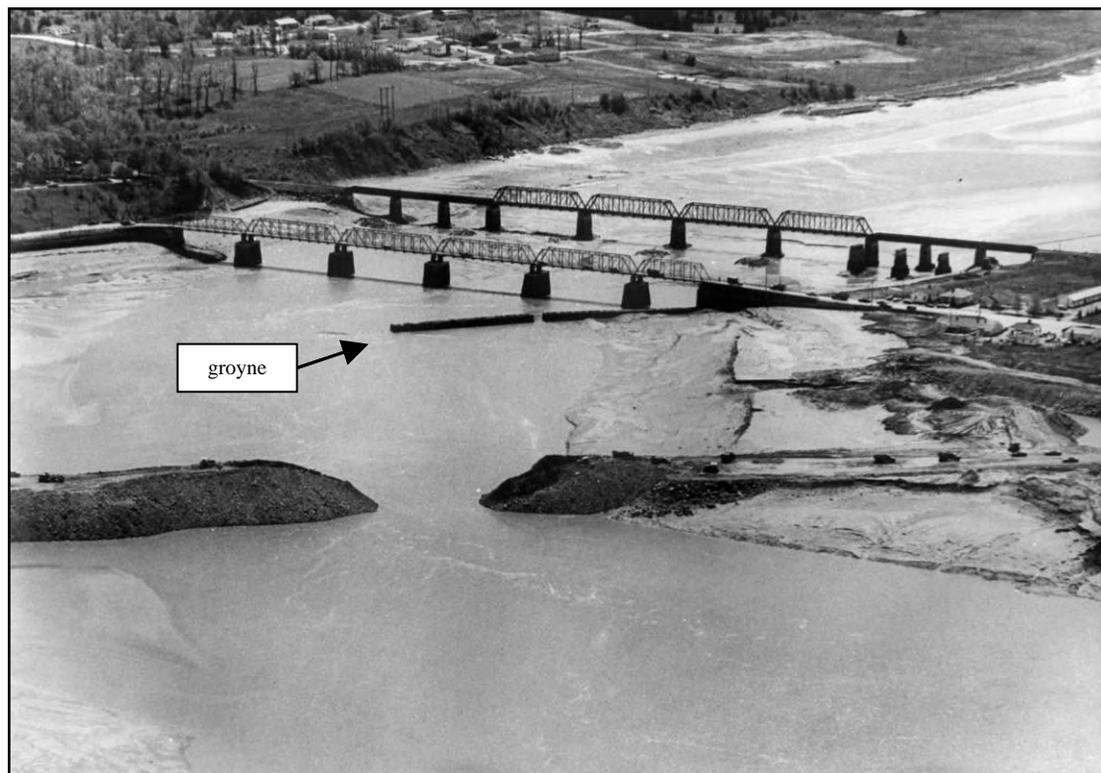
Figure 2.16: Final phase of the construction of the Windsor Causeway, around November, 1969. Photo from NSDA archives. Note the presence of a groyne seaward of the bridge. This groyne is indicative of earlier efforts by Public Works to keep sediment from accumulating and closing the shipping channel near the Wharf at Windsor.

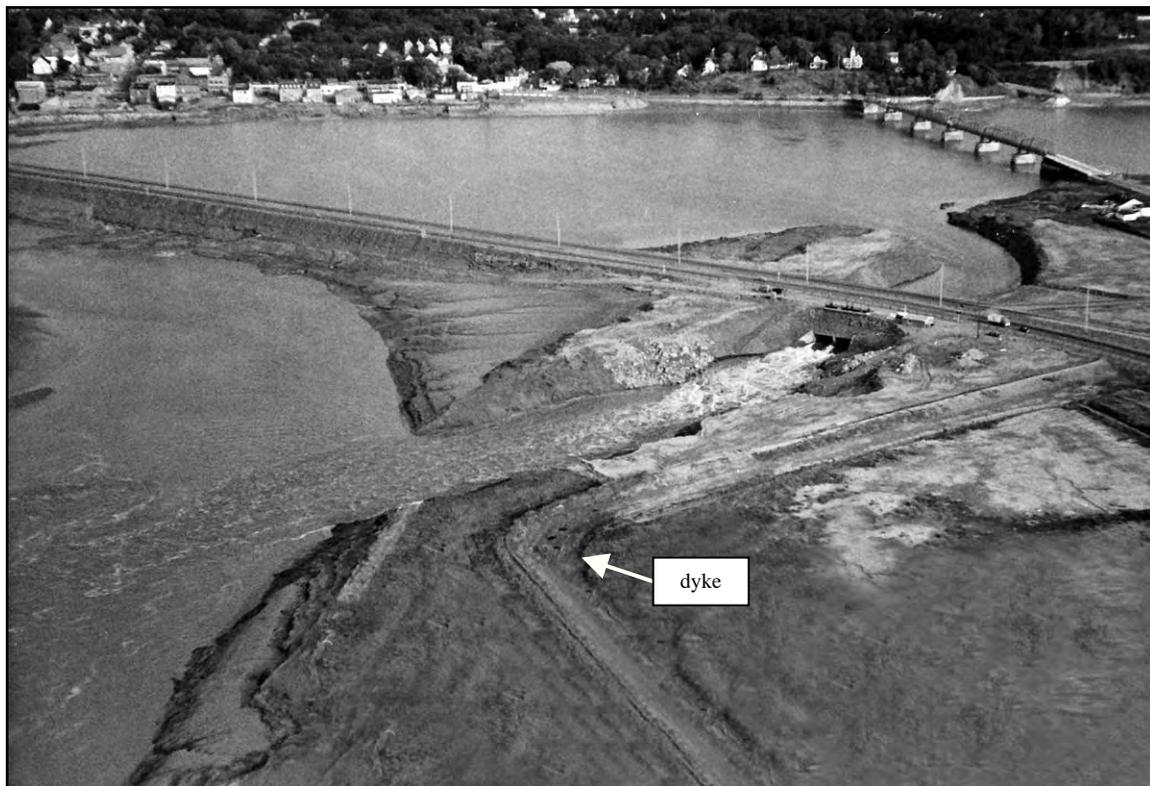
*Figure 2.17: Location of the new tide gate constructed on old salt marsh. Note presence of dyke and strength of downstream flow (photo from MMRA Archives Aug 1971).*

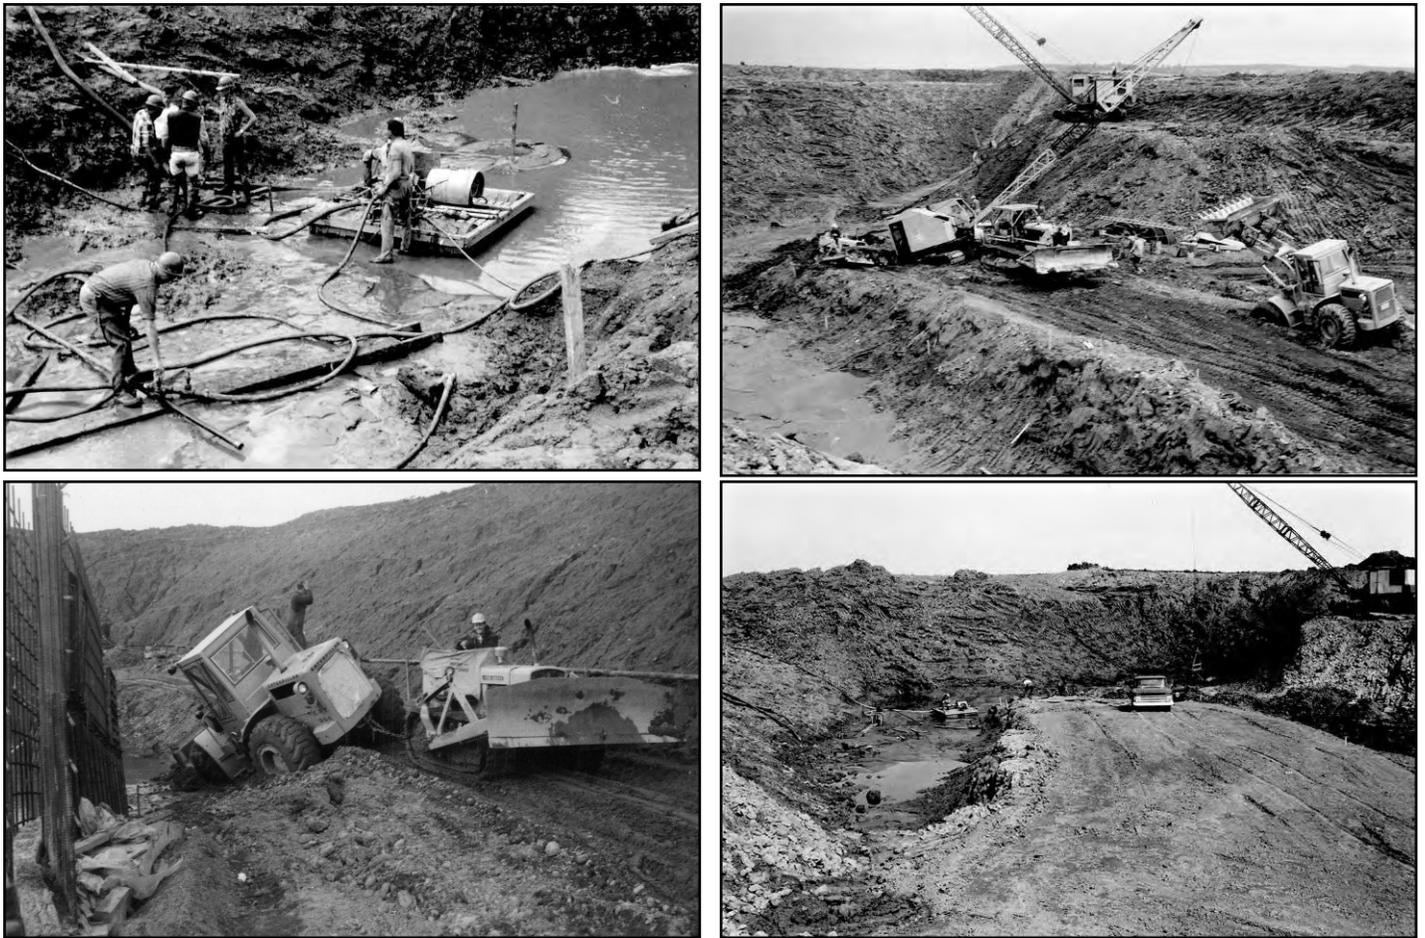
*Figure 2.19: Soft sediments caused numerous challenges during the construction of the tide gate channel.*

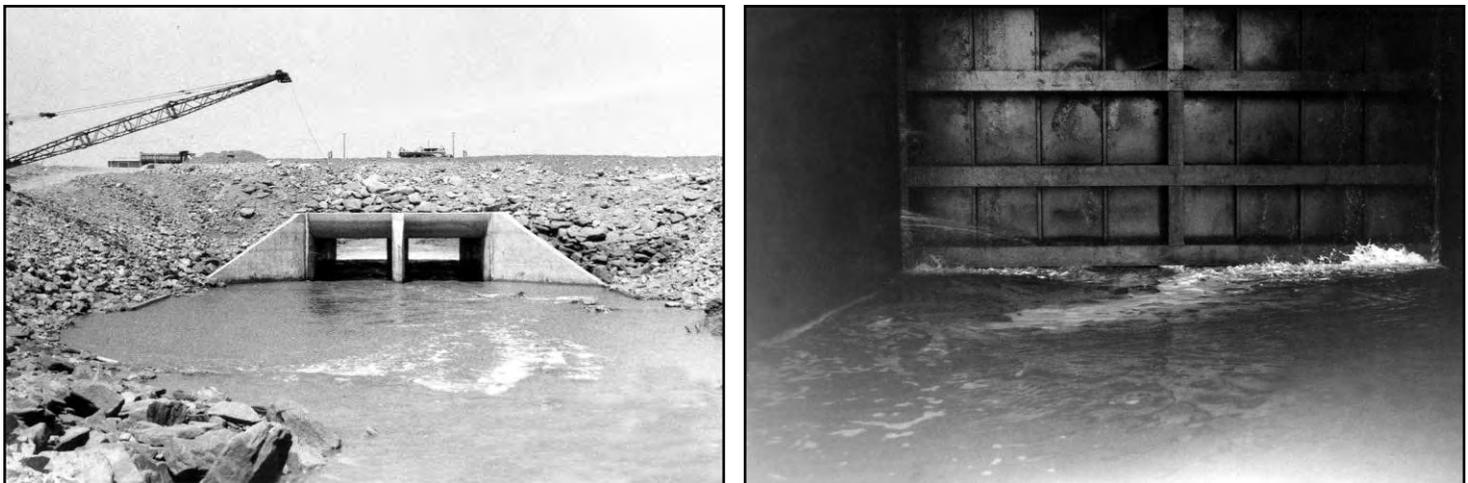
*Figure 2.20: Completion of the sluice gates and opening of gates (MMRA archives Aug 1970).*

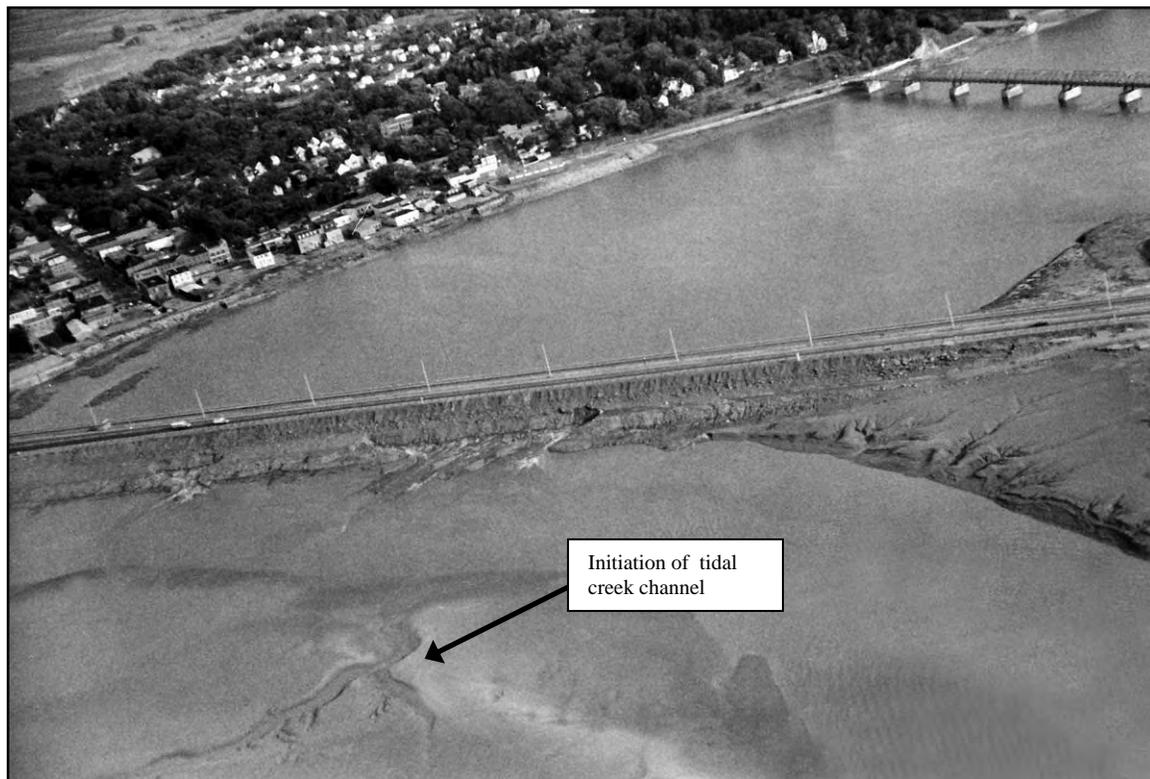
Figure 2.21: Once the causeway was completed, freshwater continued to seep through the structure almost one year later (MMRA archives Aug 1971). Note formation of tidal creek at southern section of the photo. This will become one of the main drainage channels for the new marsh.

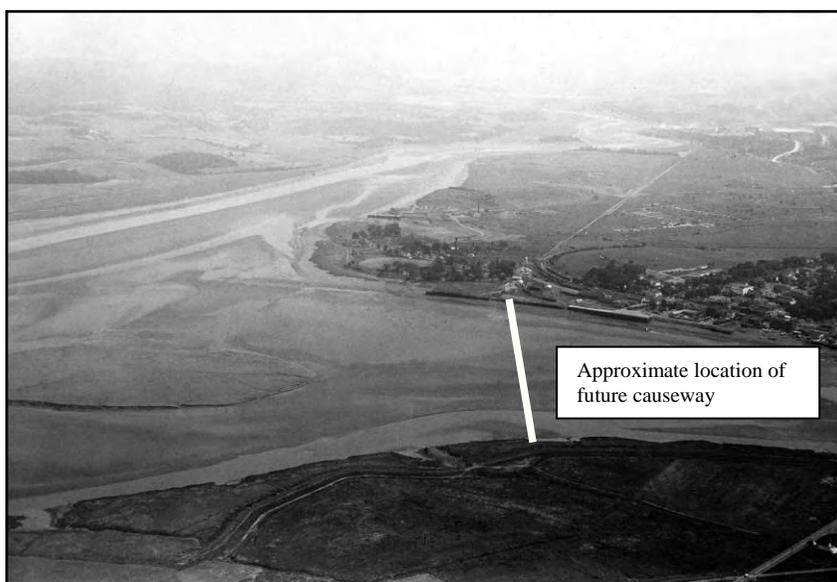
Figure 2.22: Aerial view of intertidal zone near future causeway in July 1963, prior to the construction of the causeway (MMRA, 1963)

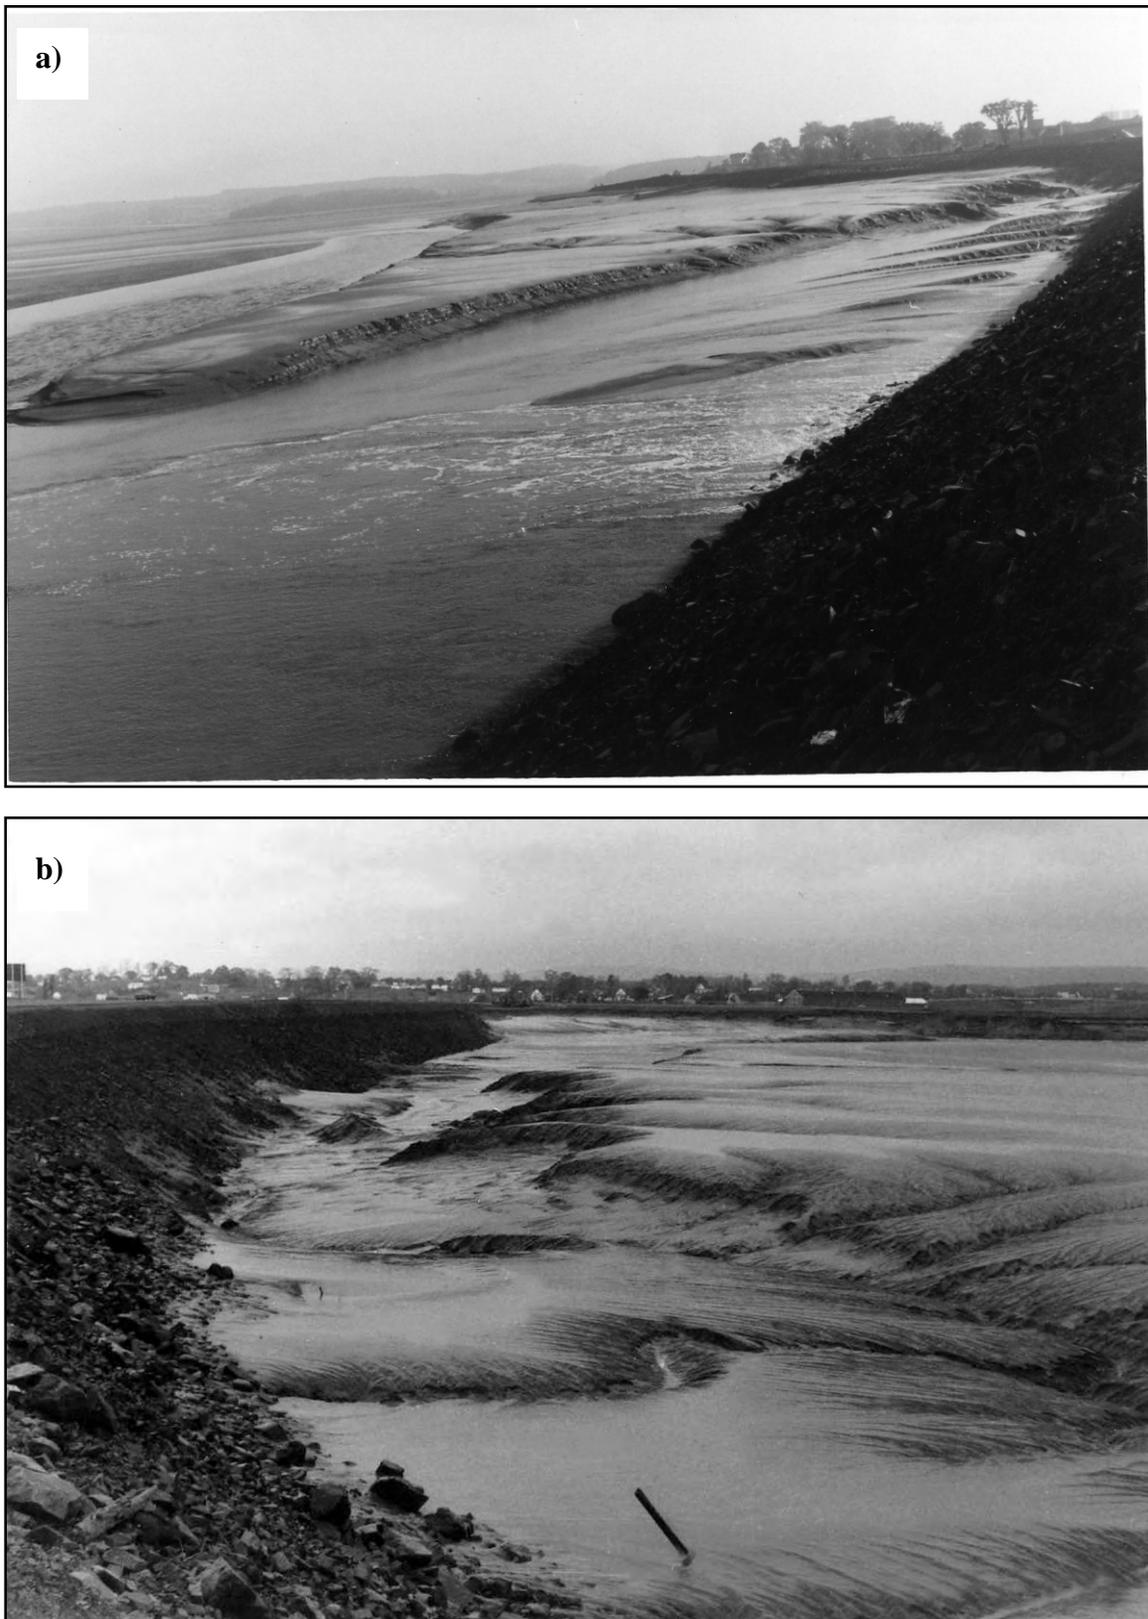
Figure 2.23: Rapid accumulation of unconsolidated sediment close to the causeway. a) Development of what appears to be a mud point bar in Oct 1970 near eastern end of causeway, 3 months after the construction was completed and b) infilling of channel parallel to the causeway in Nov 1970. The future 'causeway' channel is likely the one visible in photo 'a' top left (photos from MMRA, 1970).

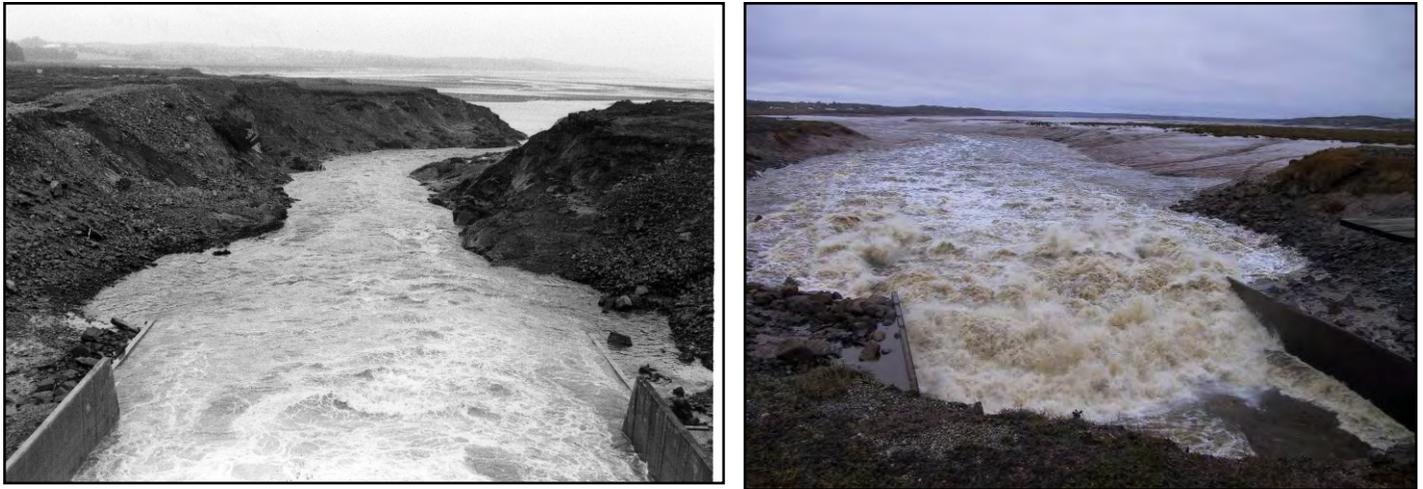
*Figure 2.24: View downstream from tide gate at the Windsor causeway in a) July 1970 when construction was completed (photo from MMRA, 1970) and in November 2002 following heavy rainfall (photo by K. Carroll, 2002).*

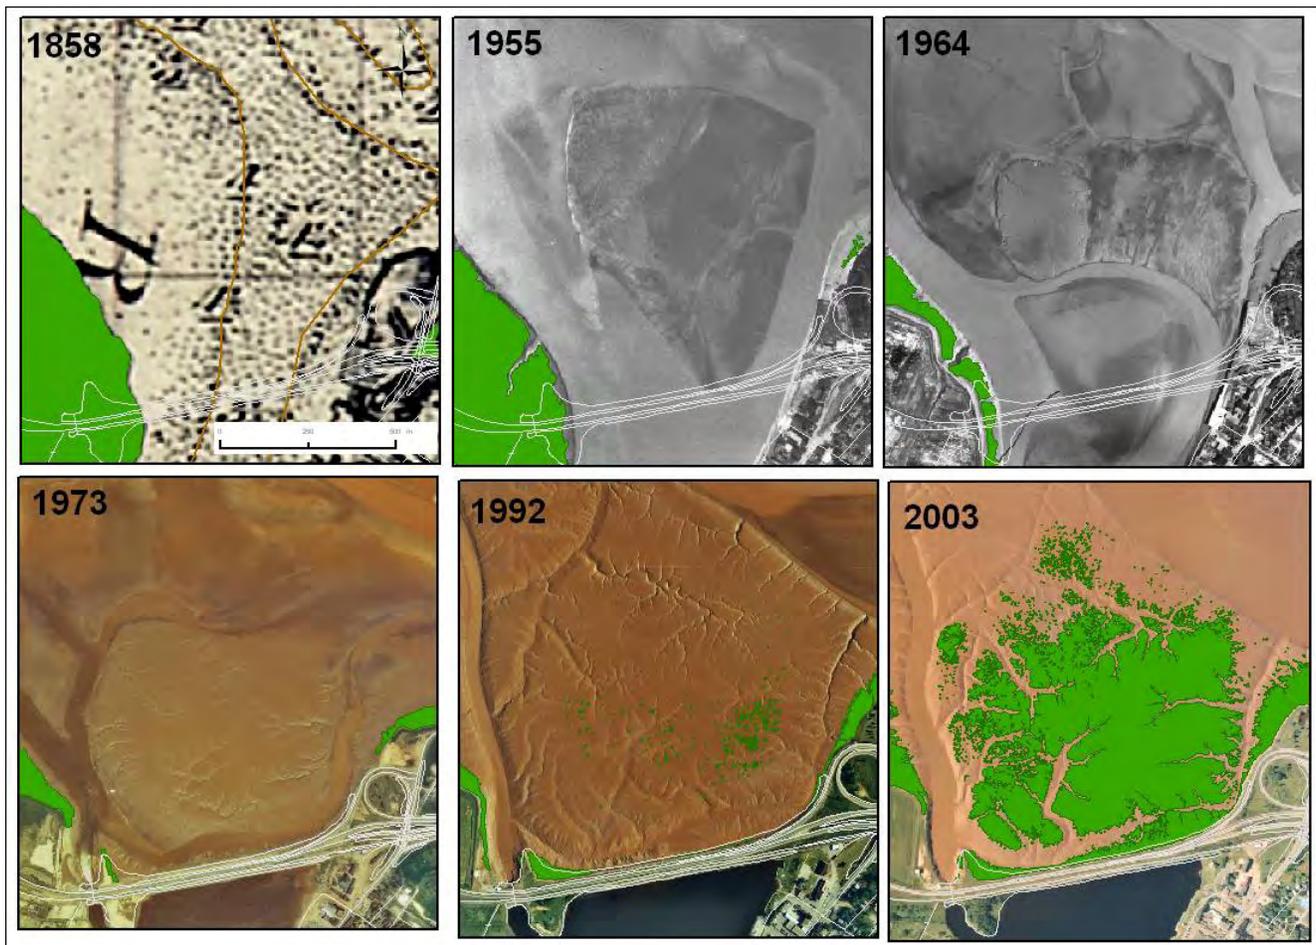
*Figure 2.25: Sequence of evolution of the Windsor mudflat from 1858 to 2003. Position of the future causeway is provided on each aerial photograph used in the GIS analysis. Salt marsh areas indicated in green.*

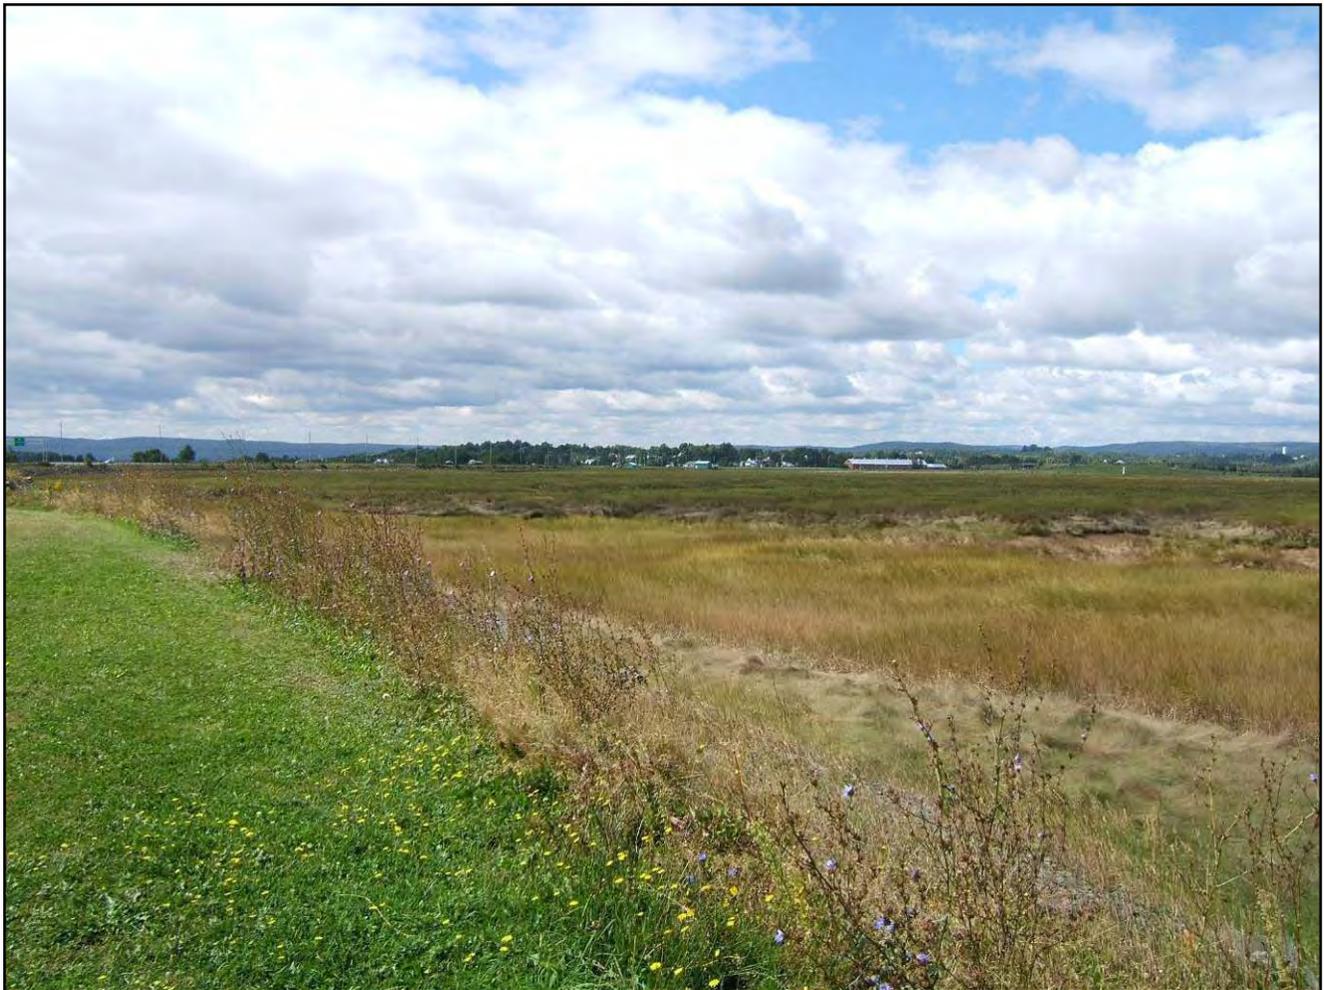
Figure 2.26: View towards Falmouth exit from dyke adjacent to the tourist bureau in August 2006. Note the development of *Spartina patens*, a high marsh species adjacent to the causeway and complete coverage by *Spartina alterniflora* in the remainder of the original mudflat area (photo by D. van Proosdij, 2006).

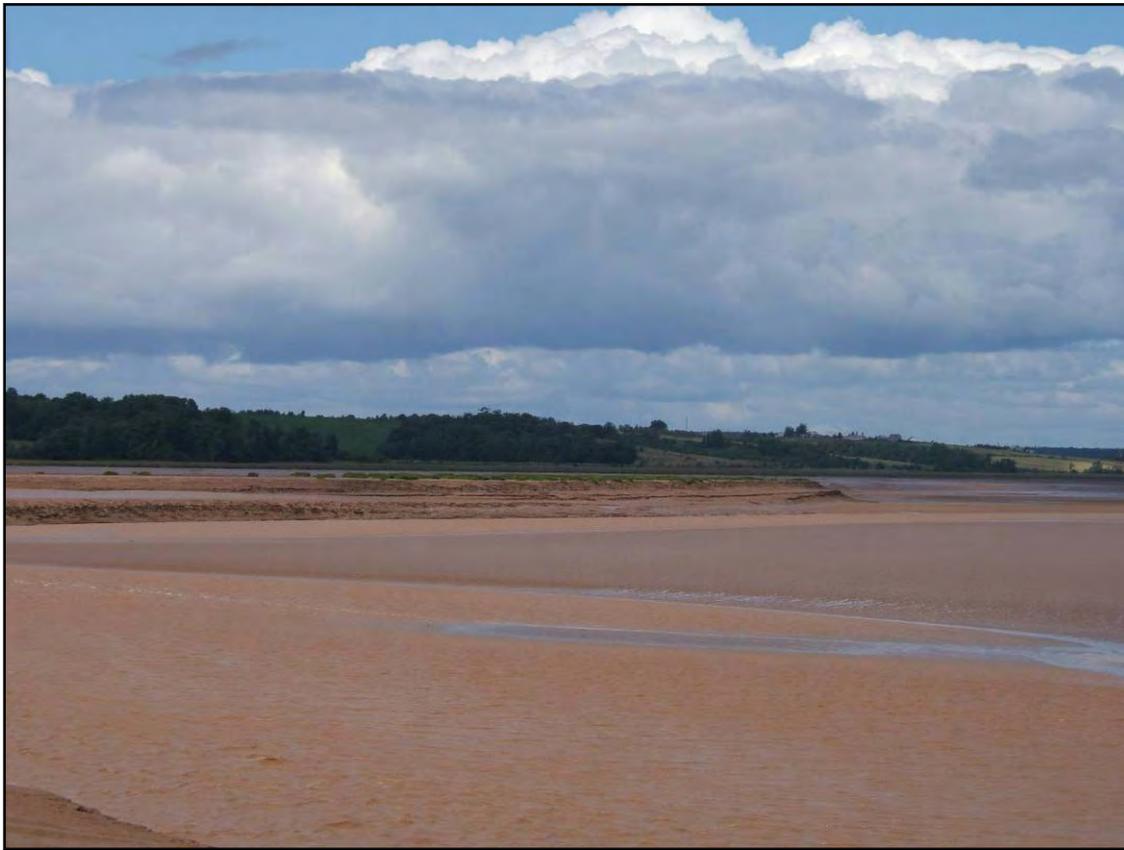
*Figure 2.27: View towards the Newport bar and colonies of *spartina alterniflora* that were established on it in August 2006 (photo by D. van Proosdij, 2006).*
