## Intertidal Morphodynamics of the Avon River Estuary

Final report submitted to the  
Nova Scotia Department of Transportation and Public Works (NSTPW)

Prepared by  
Dr. Danika van Proosdij, Department of Geography, Saint Mary's University  
& Greg Baker, MP\_SpARC, Saint Mary's University  
923 Robie, St. Halifax, N.S., B3H 3C3

September 30, 2007

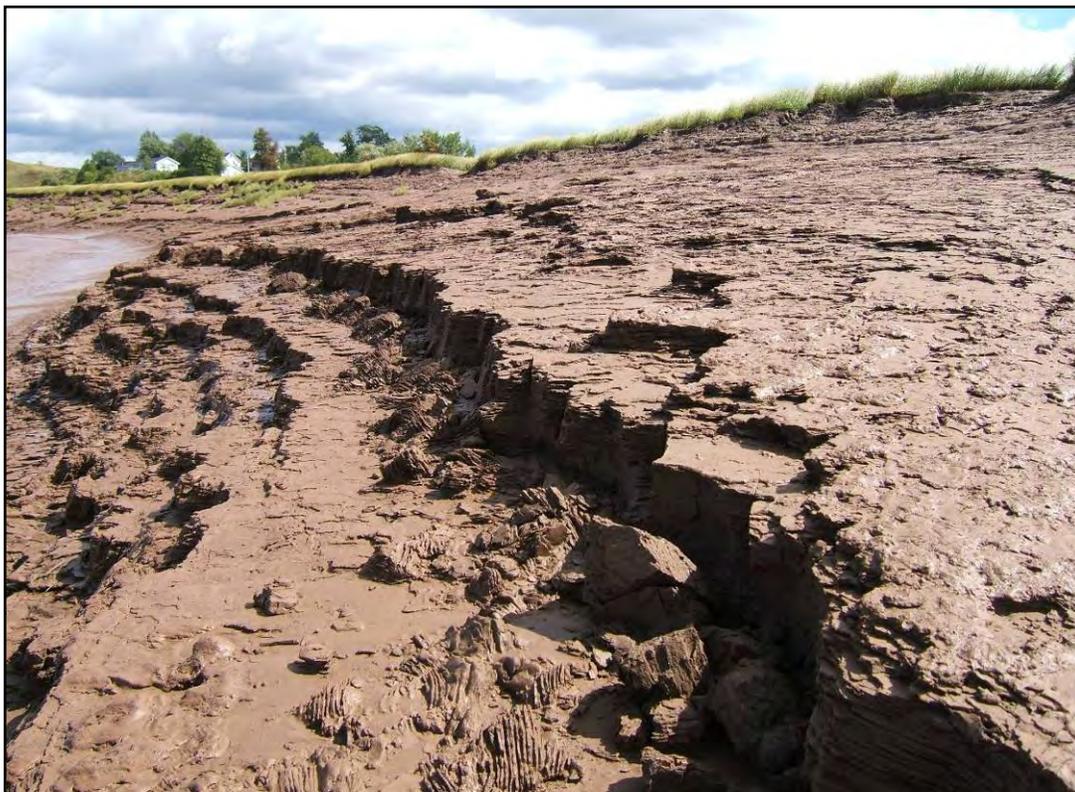
*Figure 2.28: Erosion of north eastern edge of Windsor mudflat/saltmarsh by the main St. Croix channel currents in August 2006 (photo by D. van Proosdij, 2006).*

Salt marsh vegetation began to appear on the exposed mudflat surface around 1981, likely introduced by rafted ice (van Proosdij and Townsend, 2006). After 1992 the rate of colonization by *Spartina alterniflora* increased exponentially as the vegetation became firmly established on the mudflat surface, expanding in size from ~41,000 m<sup>2</sup> to >390,000 m<sup>2</sup> by 2001 (Figure 2.25). By the summer of 2005 almost the entire suitable mudflat surface had been colonized (Figure 2.26). Colonies of marsh vegetation are now appearing on the Newport Bar (Daborn and Brylinsky, 2004), downstream of the Windsor marsh/mudflat (Figure 2.27). The northeast edge of the Windsor marsh/mudflat is being eroded by tens of meters per year by the main channel of the St. Croix river (Figure 2.28).

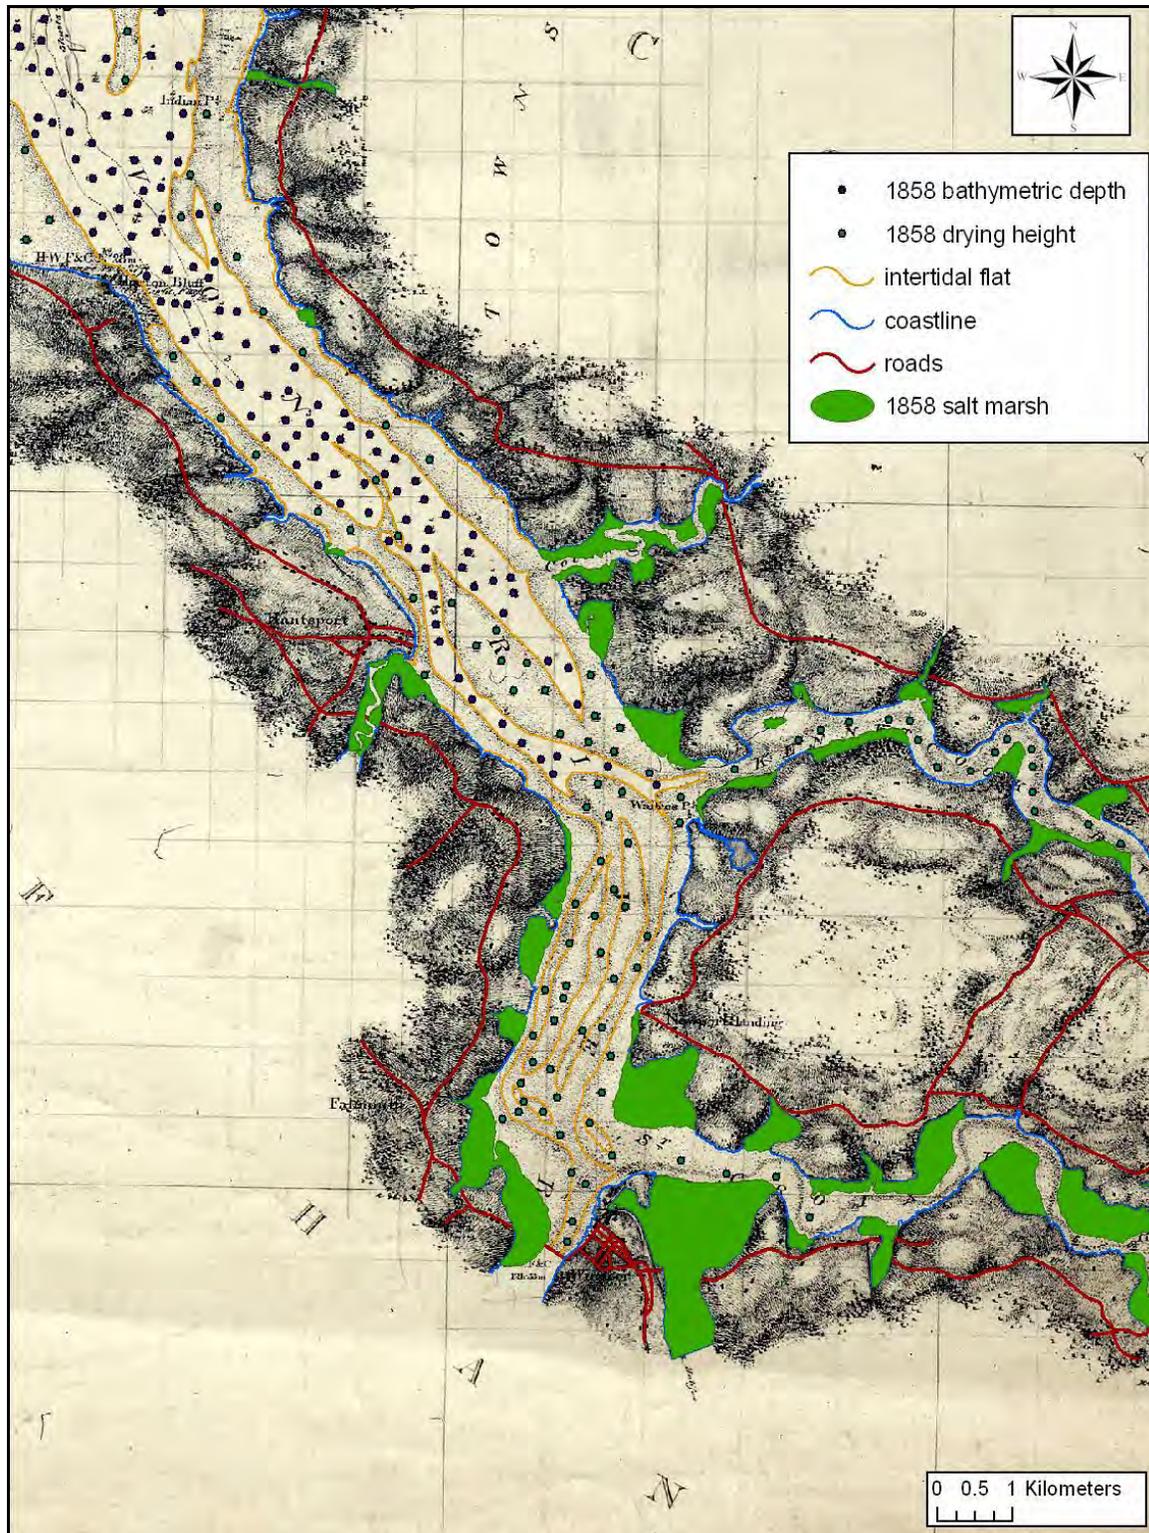
*Figure 3.1: Digitized features on 1858 British Admiralty Field Sheet D4801 from the United Kingdom Hydrographic Office.*

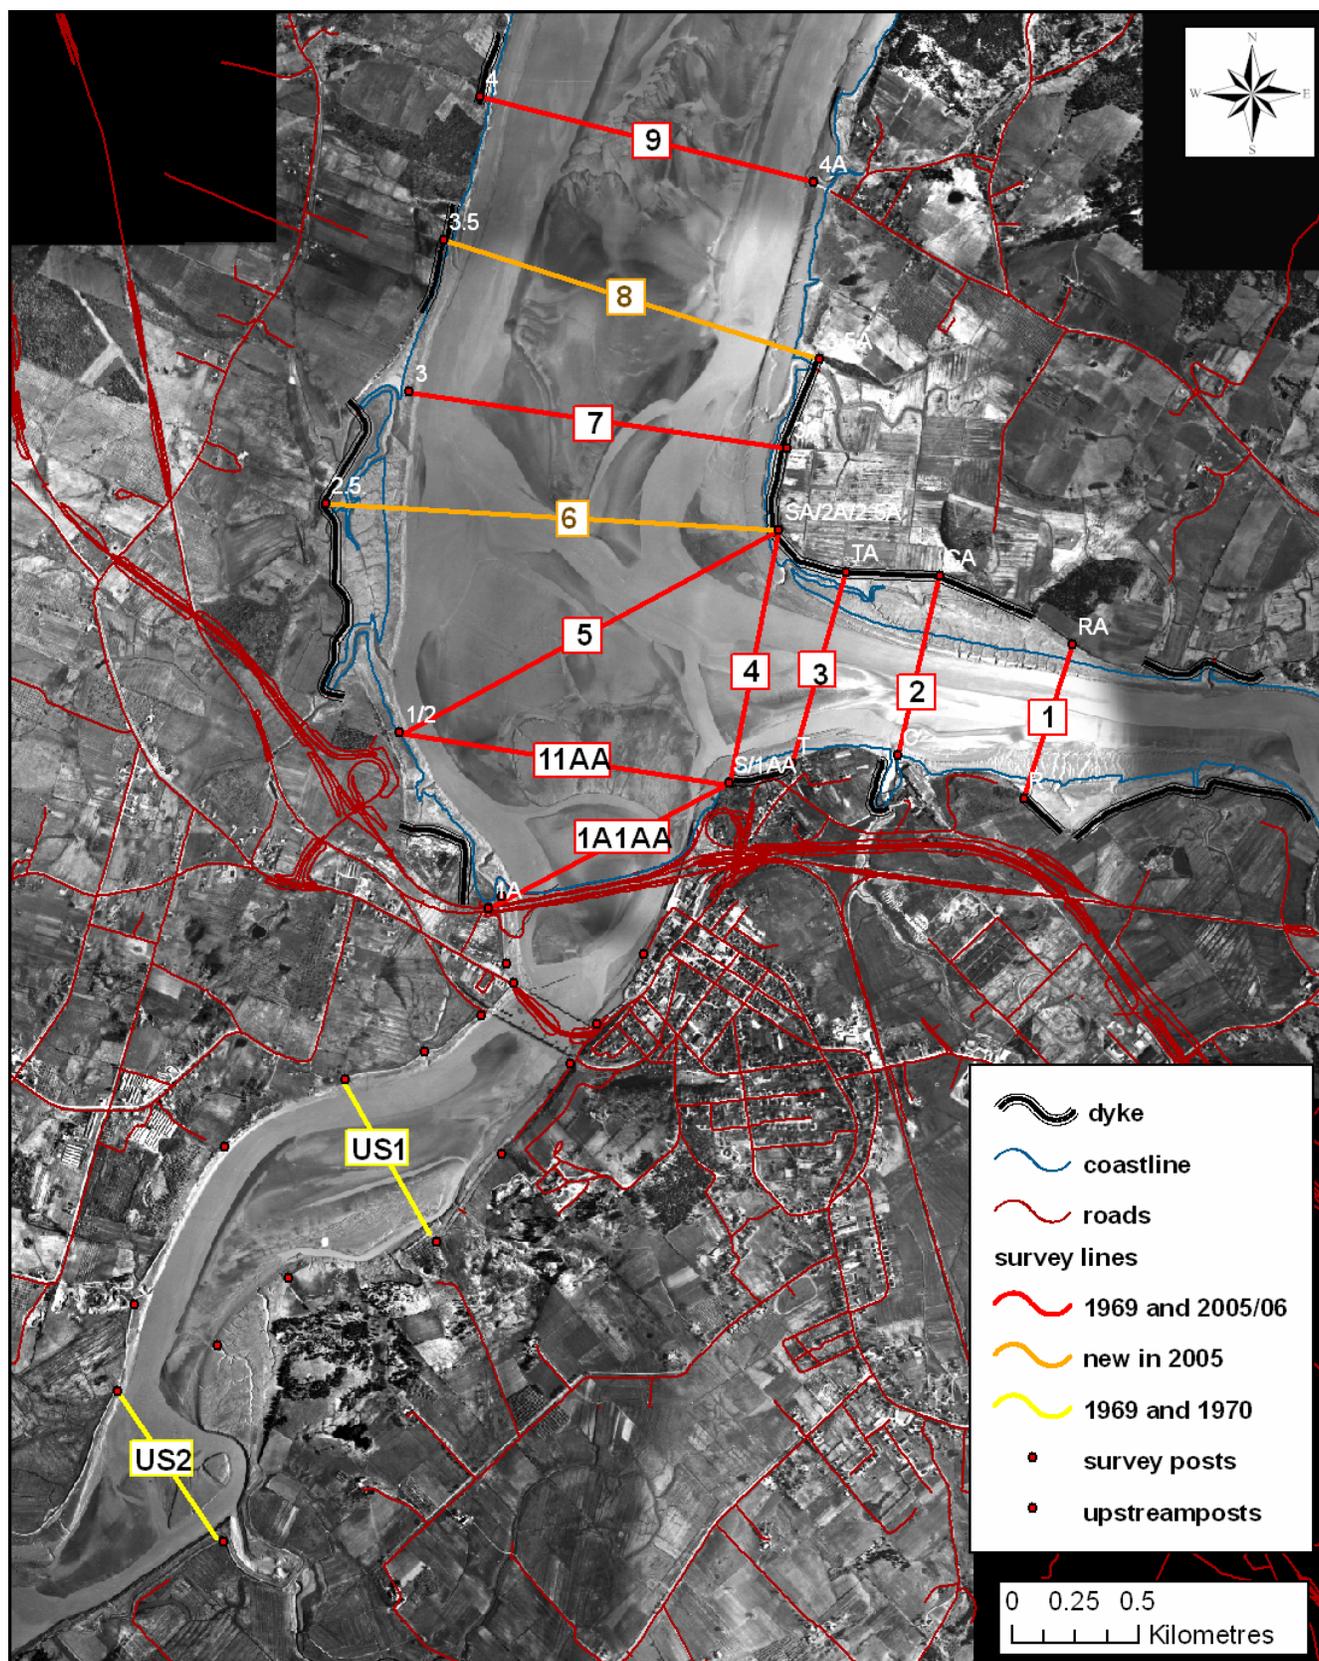
Figure 3.2 a) Location of historical and contemporary survey lines closest to the Windsor causeway. Although additional upstream surveys were conducted as indicated by the survey posts, those data were only collected in Nov 1970, after the causeway was completed and no comparable data are available. Note the road and coast vector layers are based on data from 1986 to 1996 (Service NS Municipal Relations) overlain onto a 1964 digital photo mosaic.

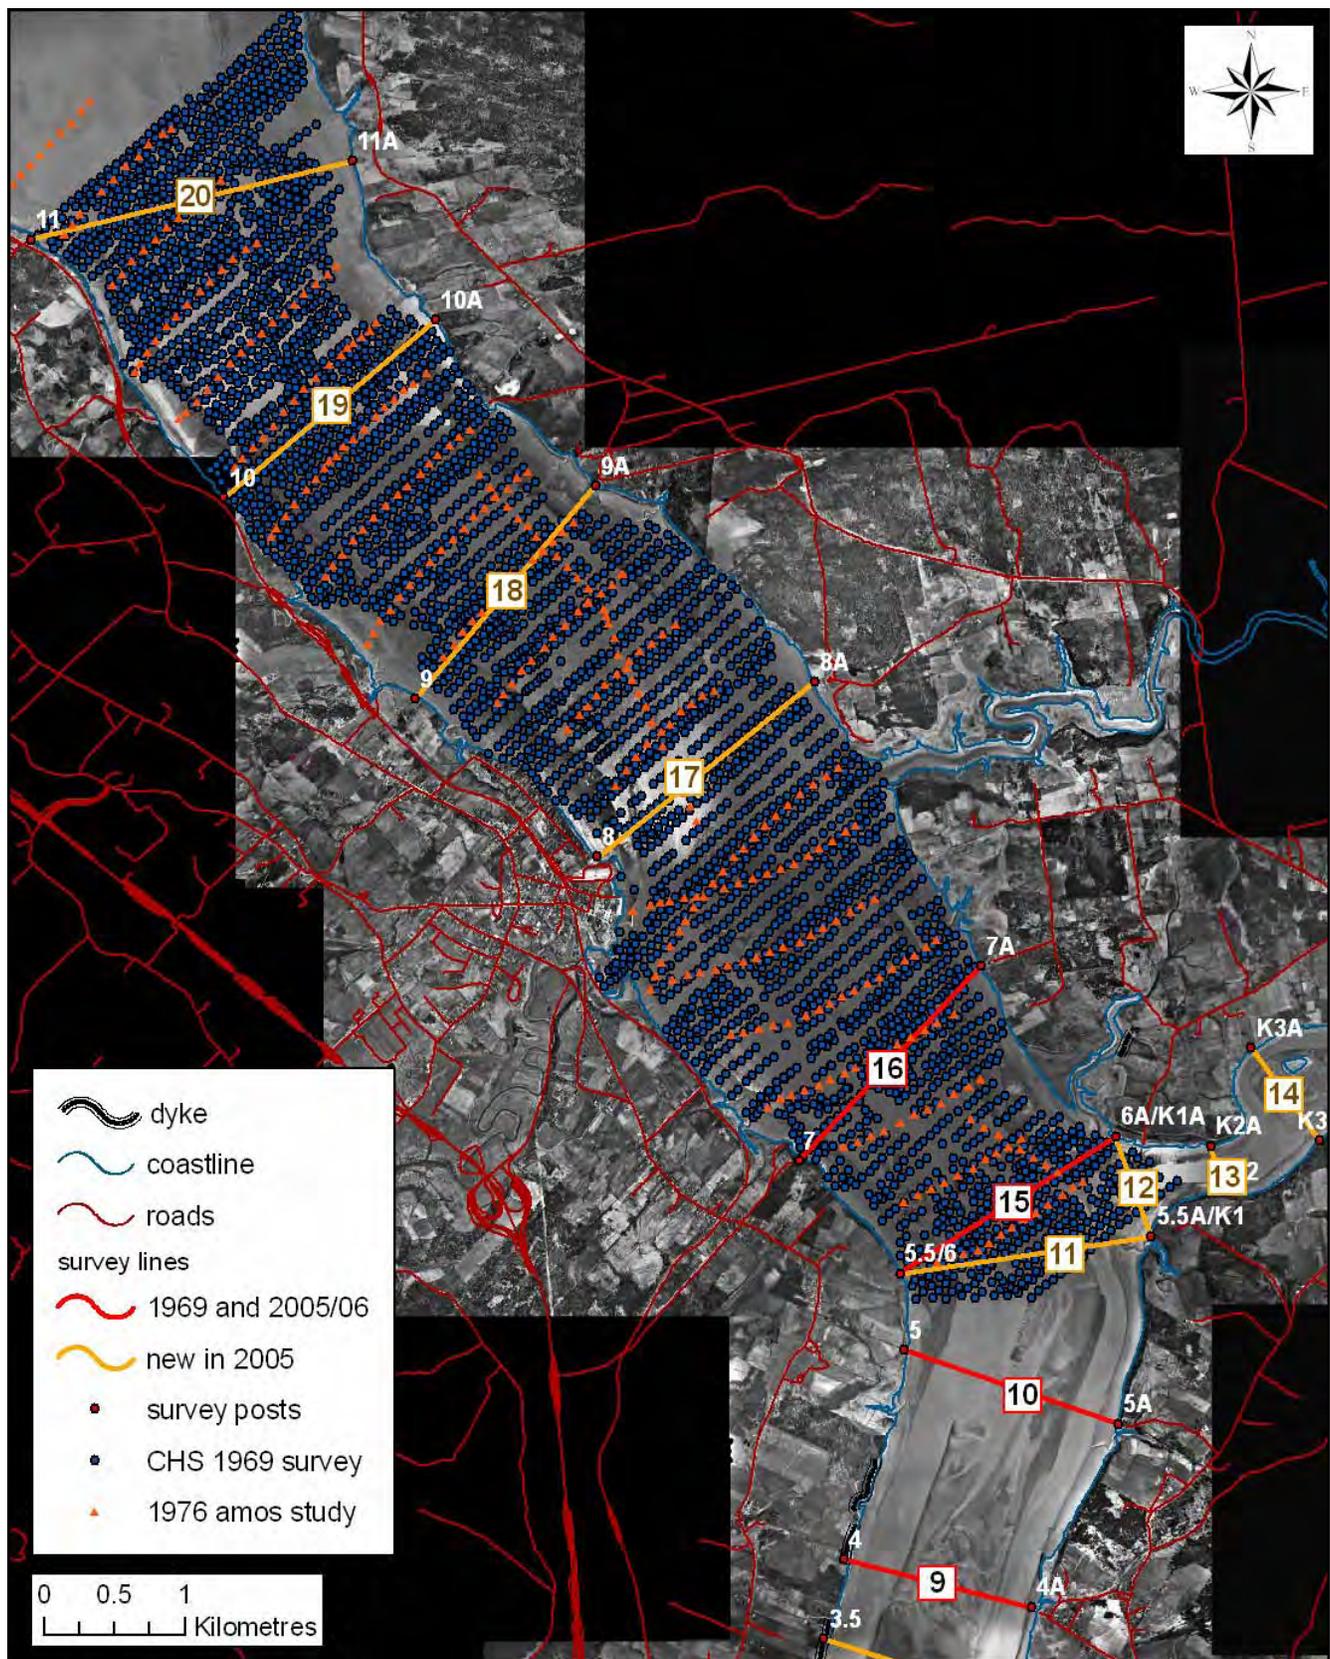
Figure 3.2 b) Location of historical and contemporary survey lines near the mouth of the Avon River. Note the road and coast vector layers are based on data from 1986 to 1996 (Service NS Municipal Relations) overlain onto a 1964 digital photo mosaic.

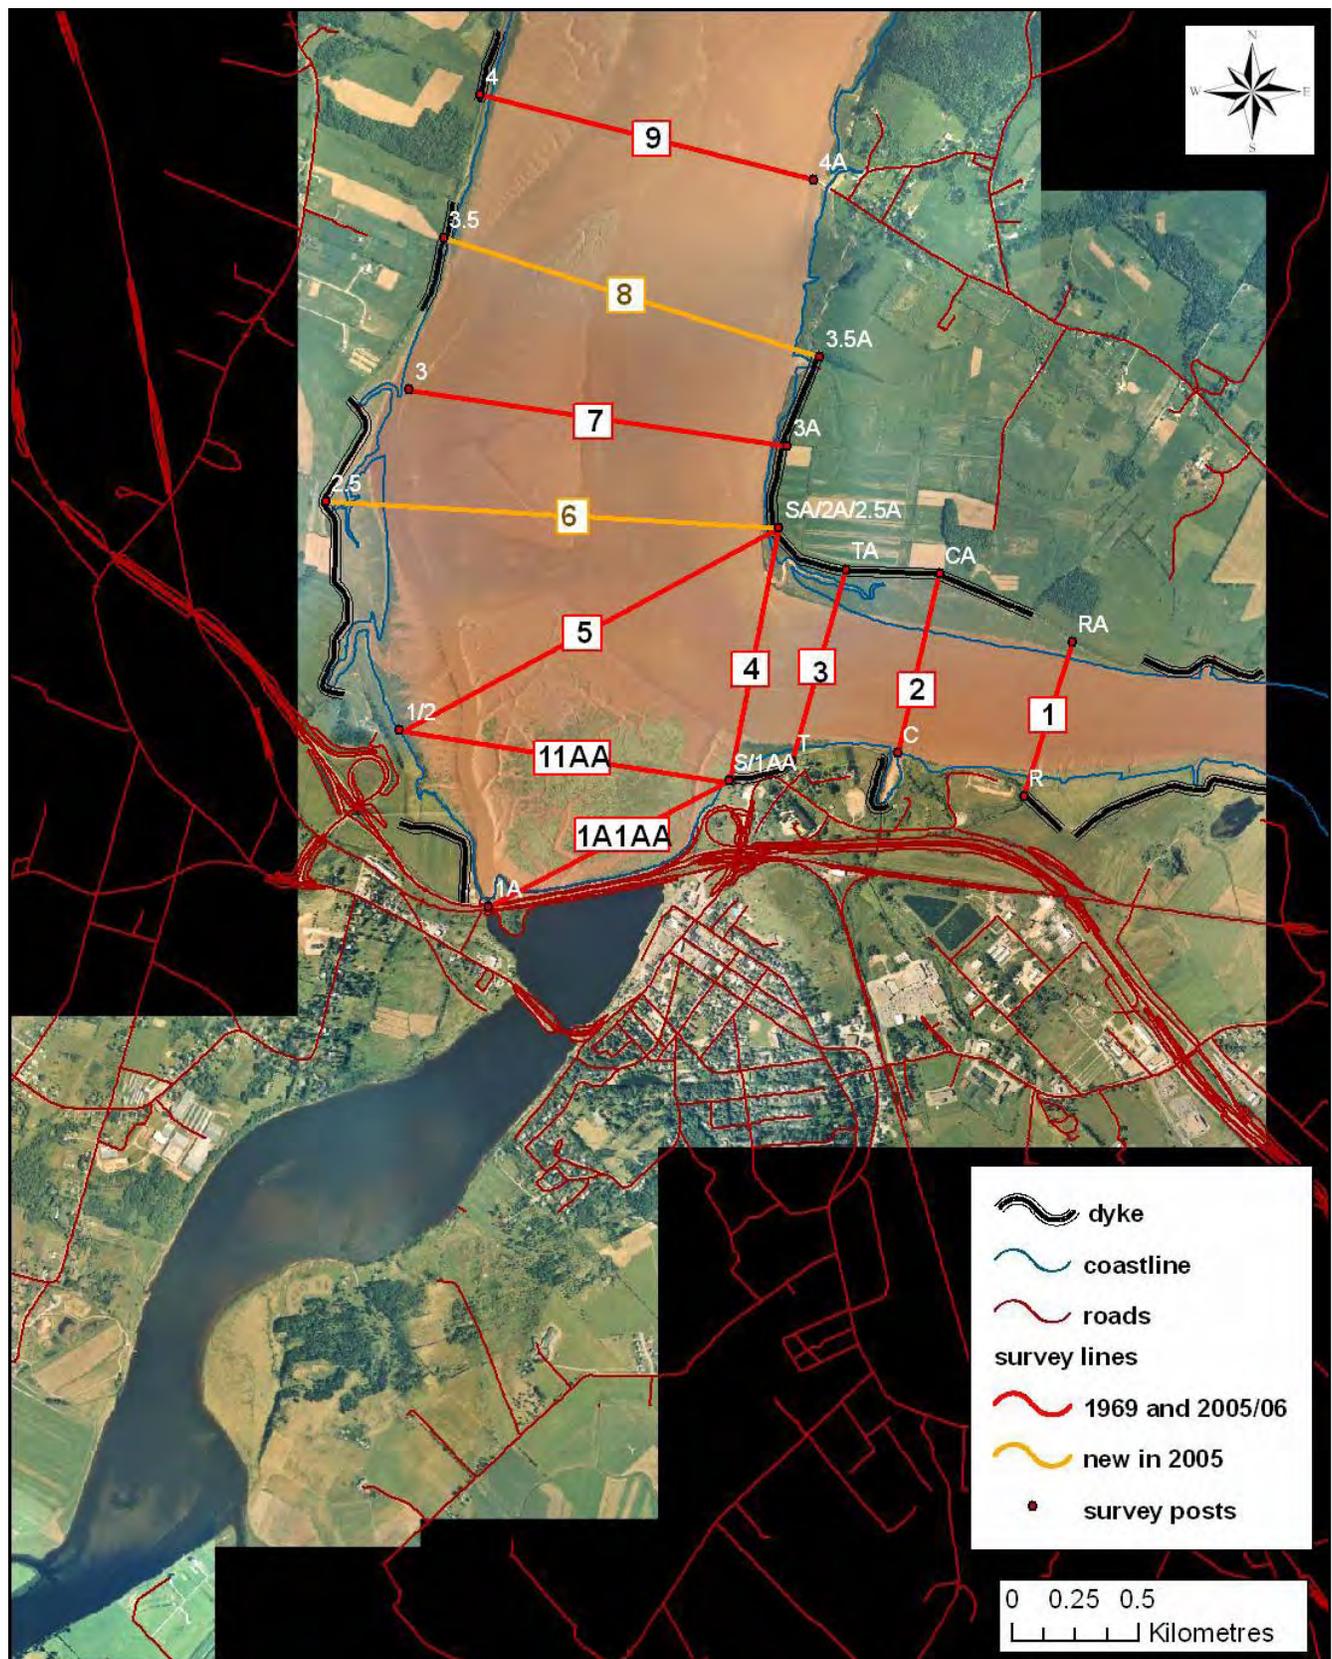
Figure 3.3 a) Location of historical MMRA and contemporary survey lines near the Windsor causeway overlain onto a 2003 digital air photo mosaic.

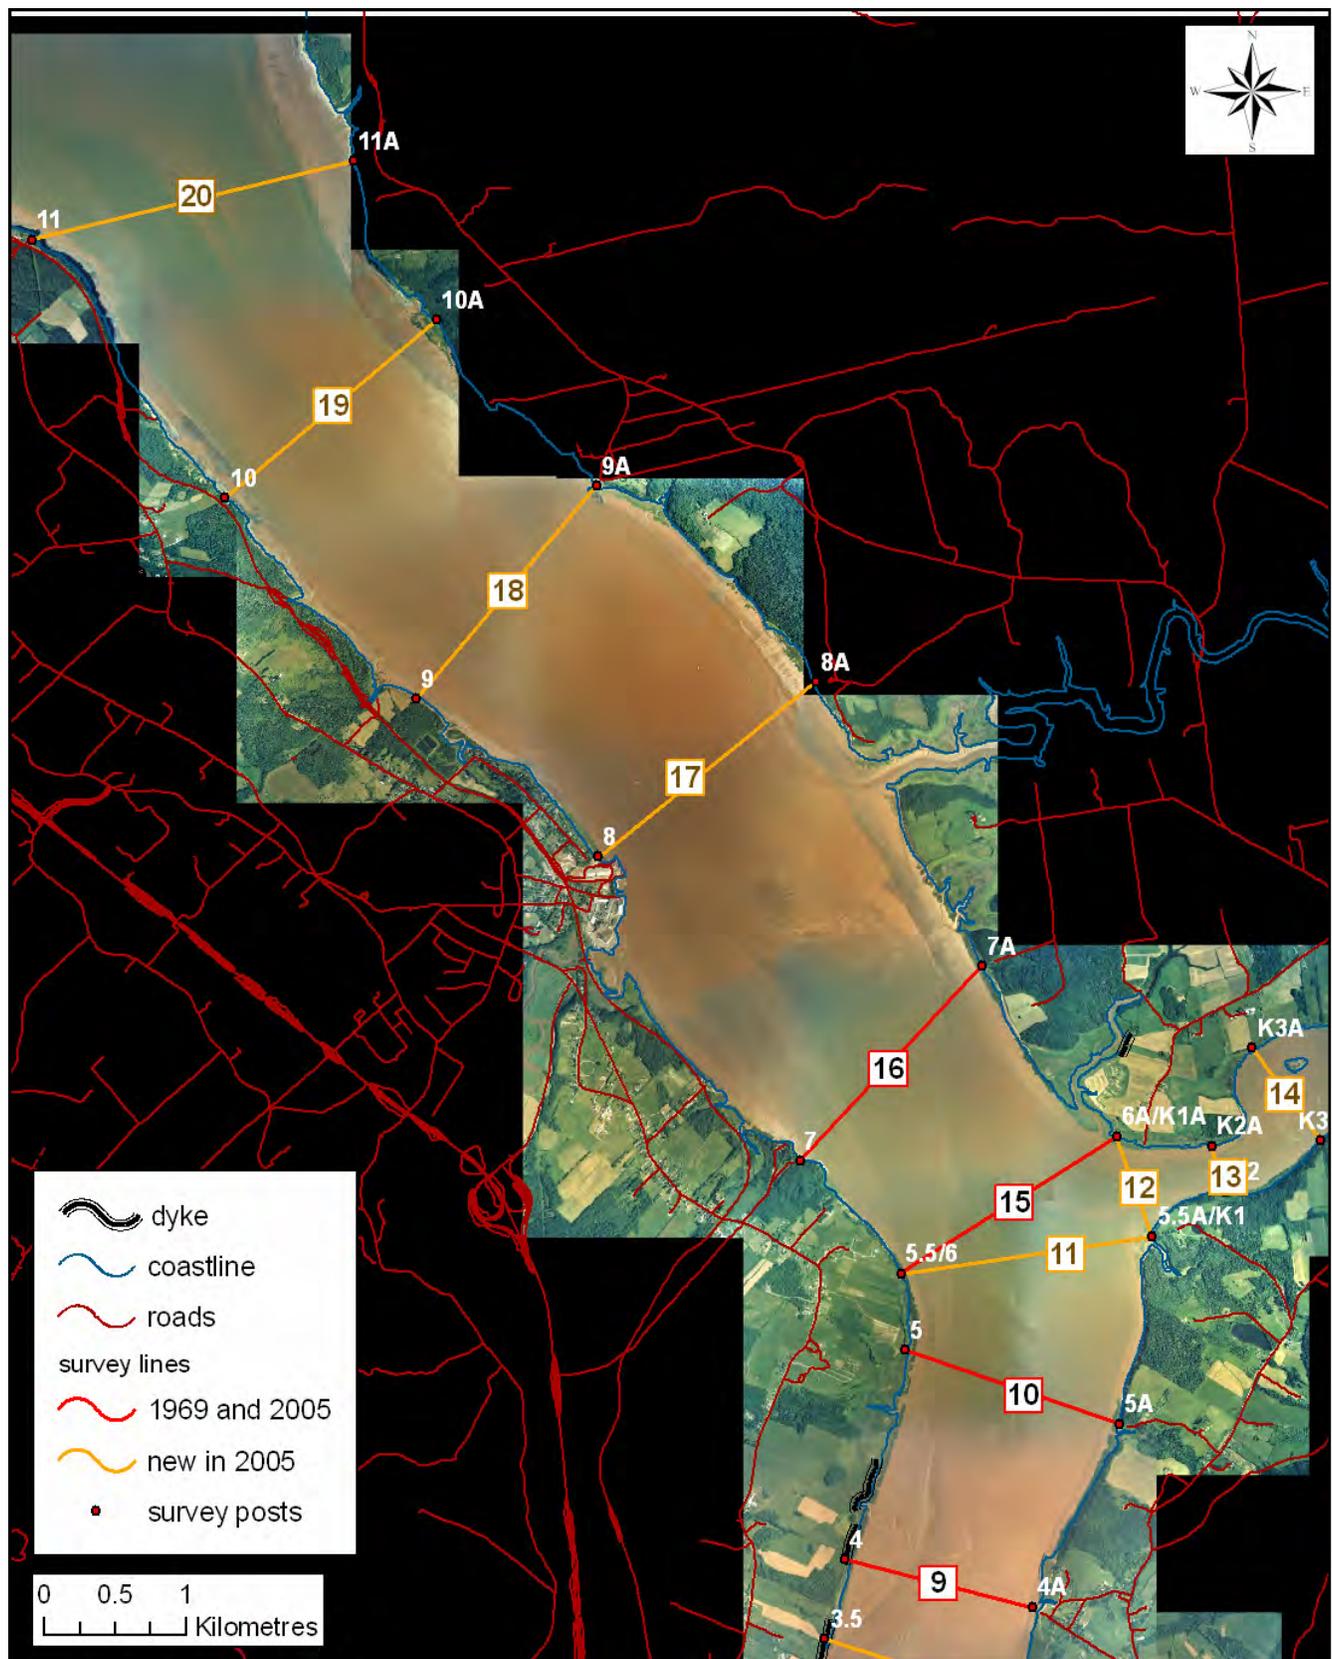
Figure 3.3 b) Location of historical and contemporary survey lines closest to the mouth of the Avon River overlain onto a 2003 digital air photo mosaic. The June 2006 survey ended at line 16 whereas all of the lines were surveyed in August 2006.

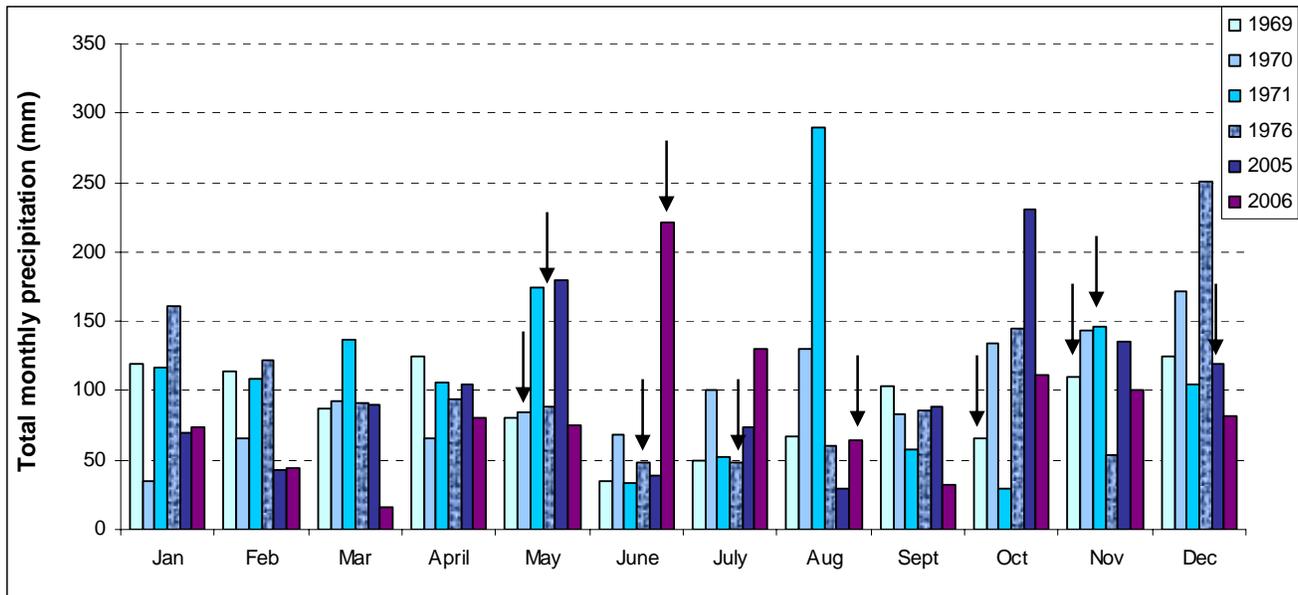
Figure 3.4: Total monthly precipitation at Kentville (45.07 N, -64.43 W). Months during which surveys were conducted indicated by an arrow.

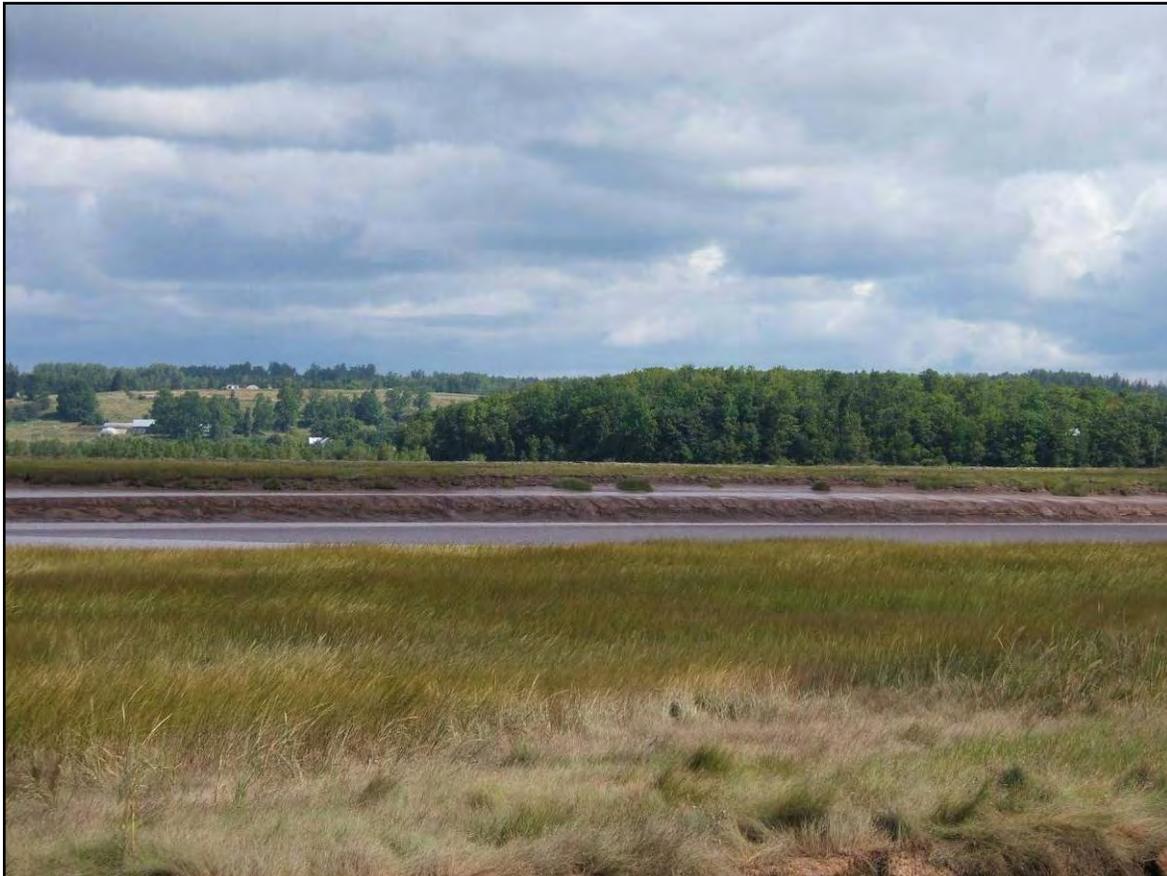
Figure 4.1: New growth of *Spartina alterniflora* along north shore of St. Croix along lines 2 and 3 on new mudflat developing. Photo by D. van Proosdij in August 2006.

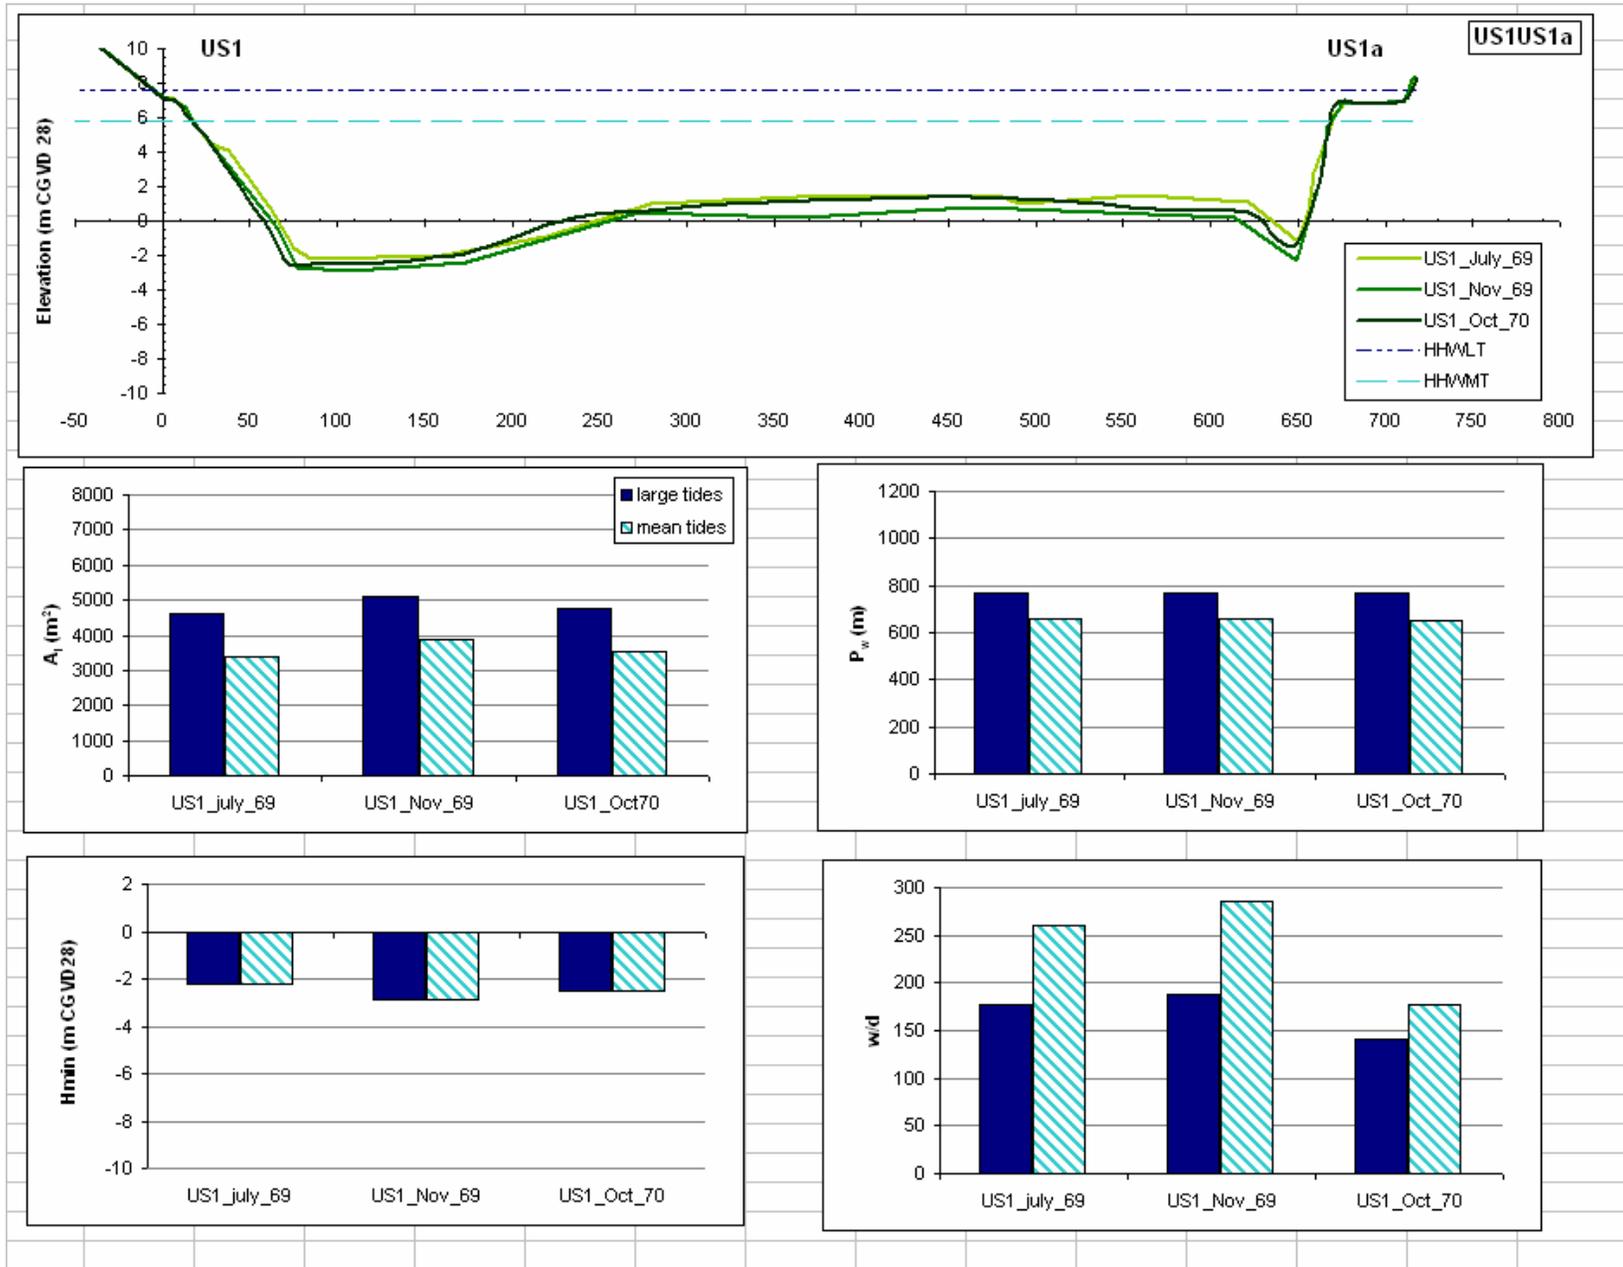
Figure 4.3a: Cross sectional profile for Line US1US1a and associated hydraulic geometry parameters upstream of the Windsor Causeway on the Avon River. Vertical exaggeration on cross sectional profiles = 42.5 X. Distance on cross sectional profile in metres.

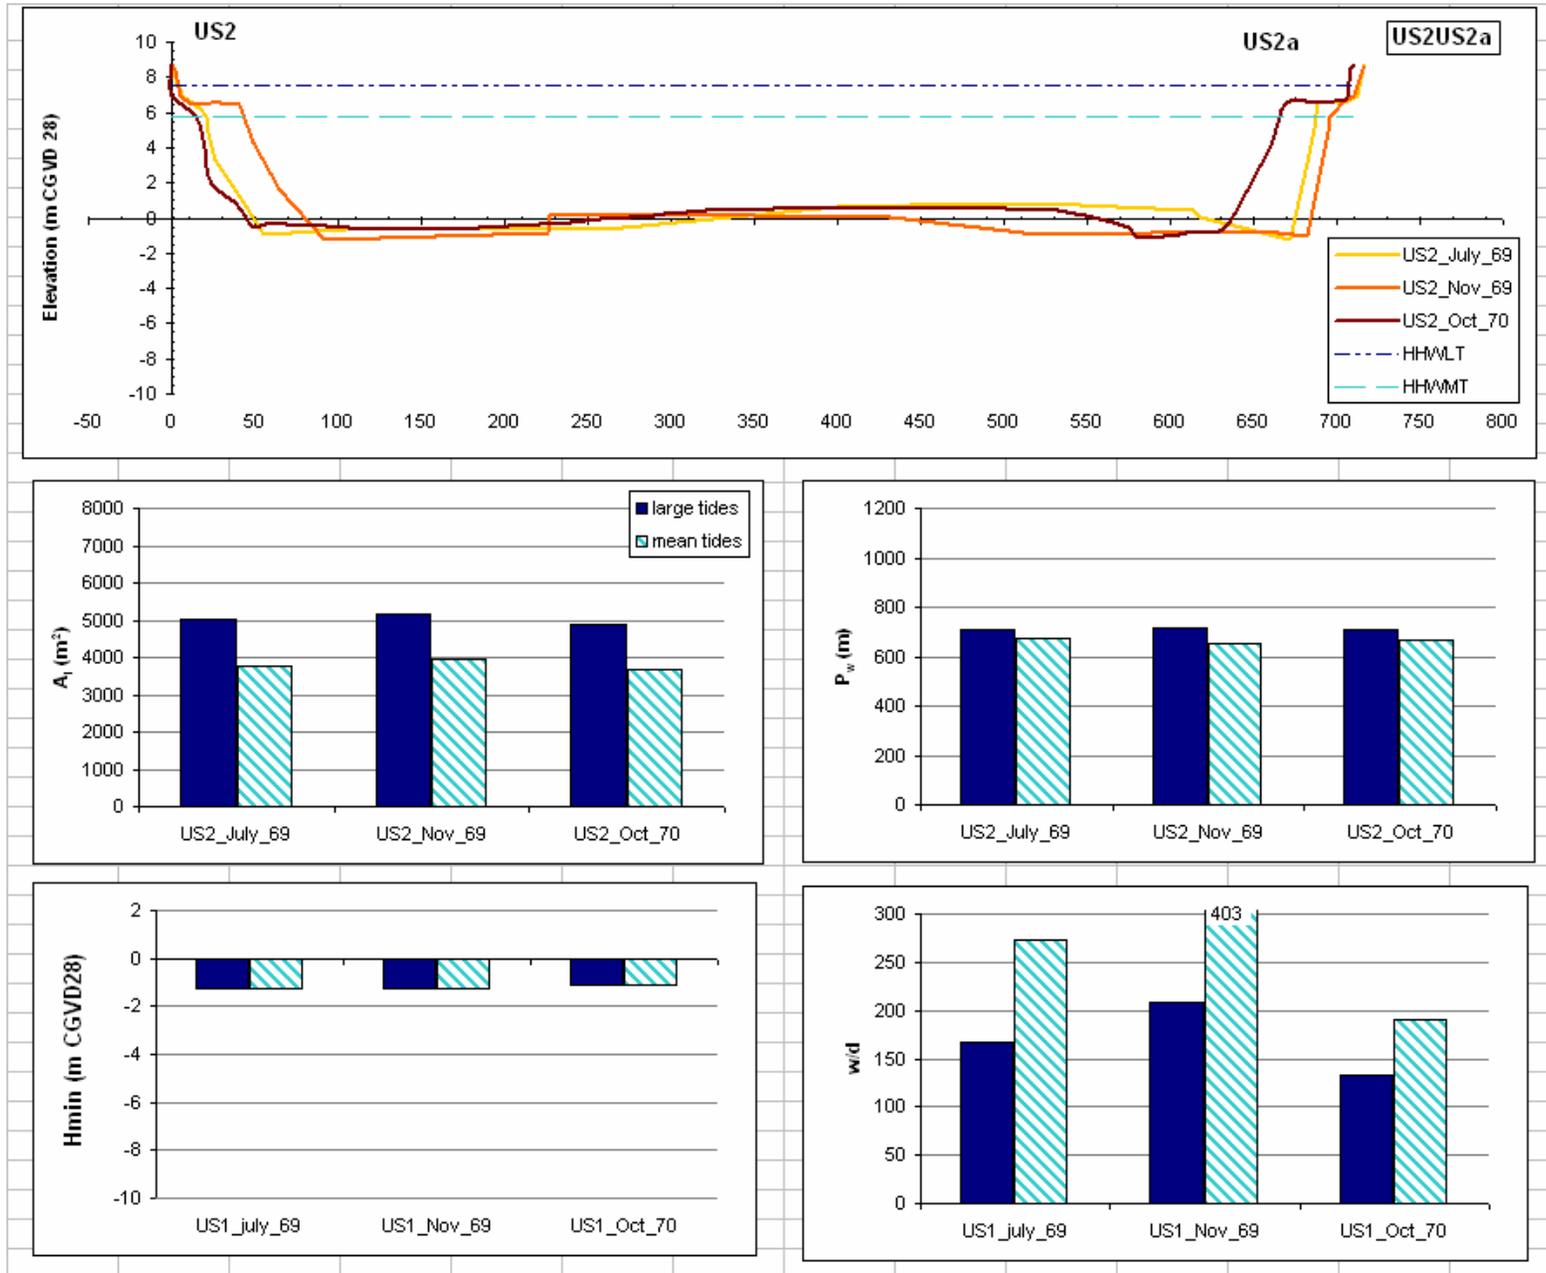
Figure 4.3b: Cross sectional profile for Line US2US2a and associated hydraulic geometry parameters upstream of the Windsor Causeway on the Avon River. Vertical exaggeration on cross sectional profiles = 42.5 X. Distance on cross sectional profile in metres.

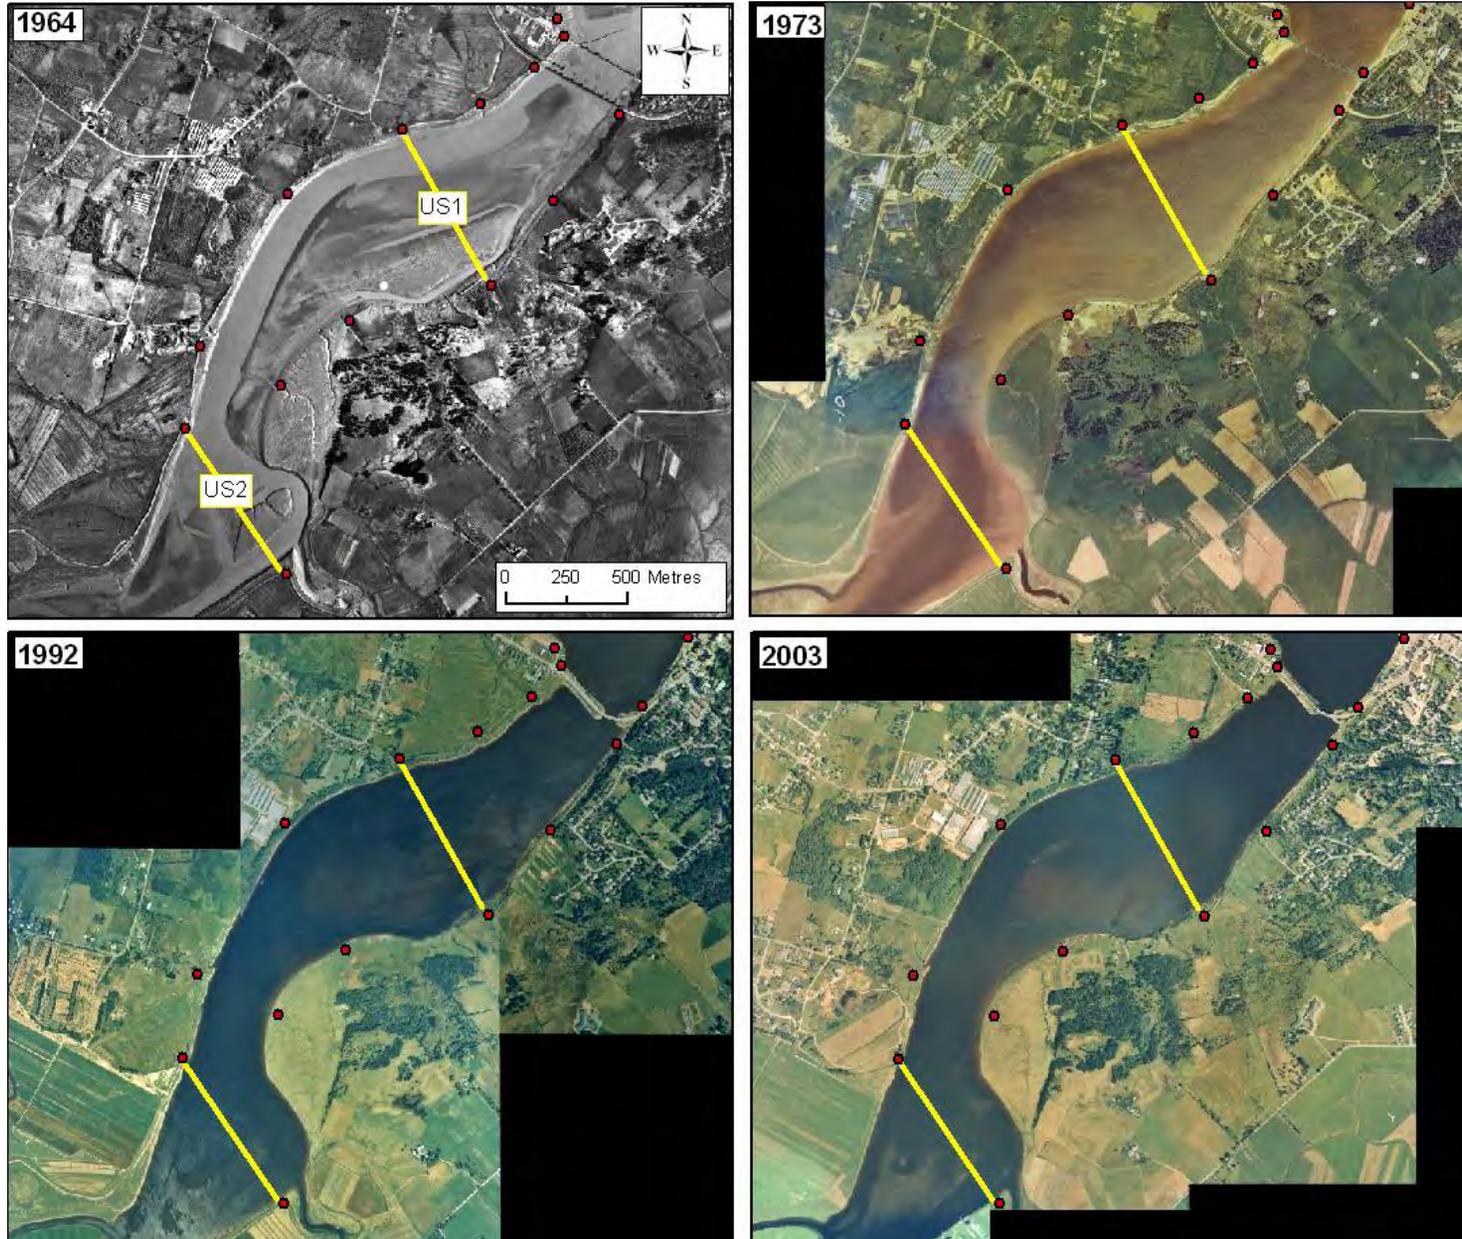
Figure 4.3c: Location of upstream cross section lines US1 and US2. Full tidal flow blocked in July 1970. Note growth of vegetation on original mudflat/low marsh.

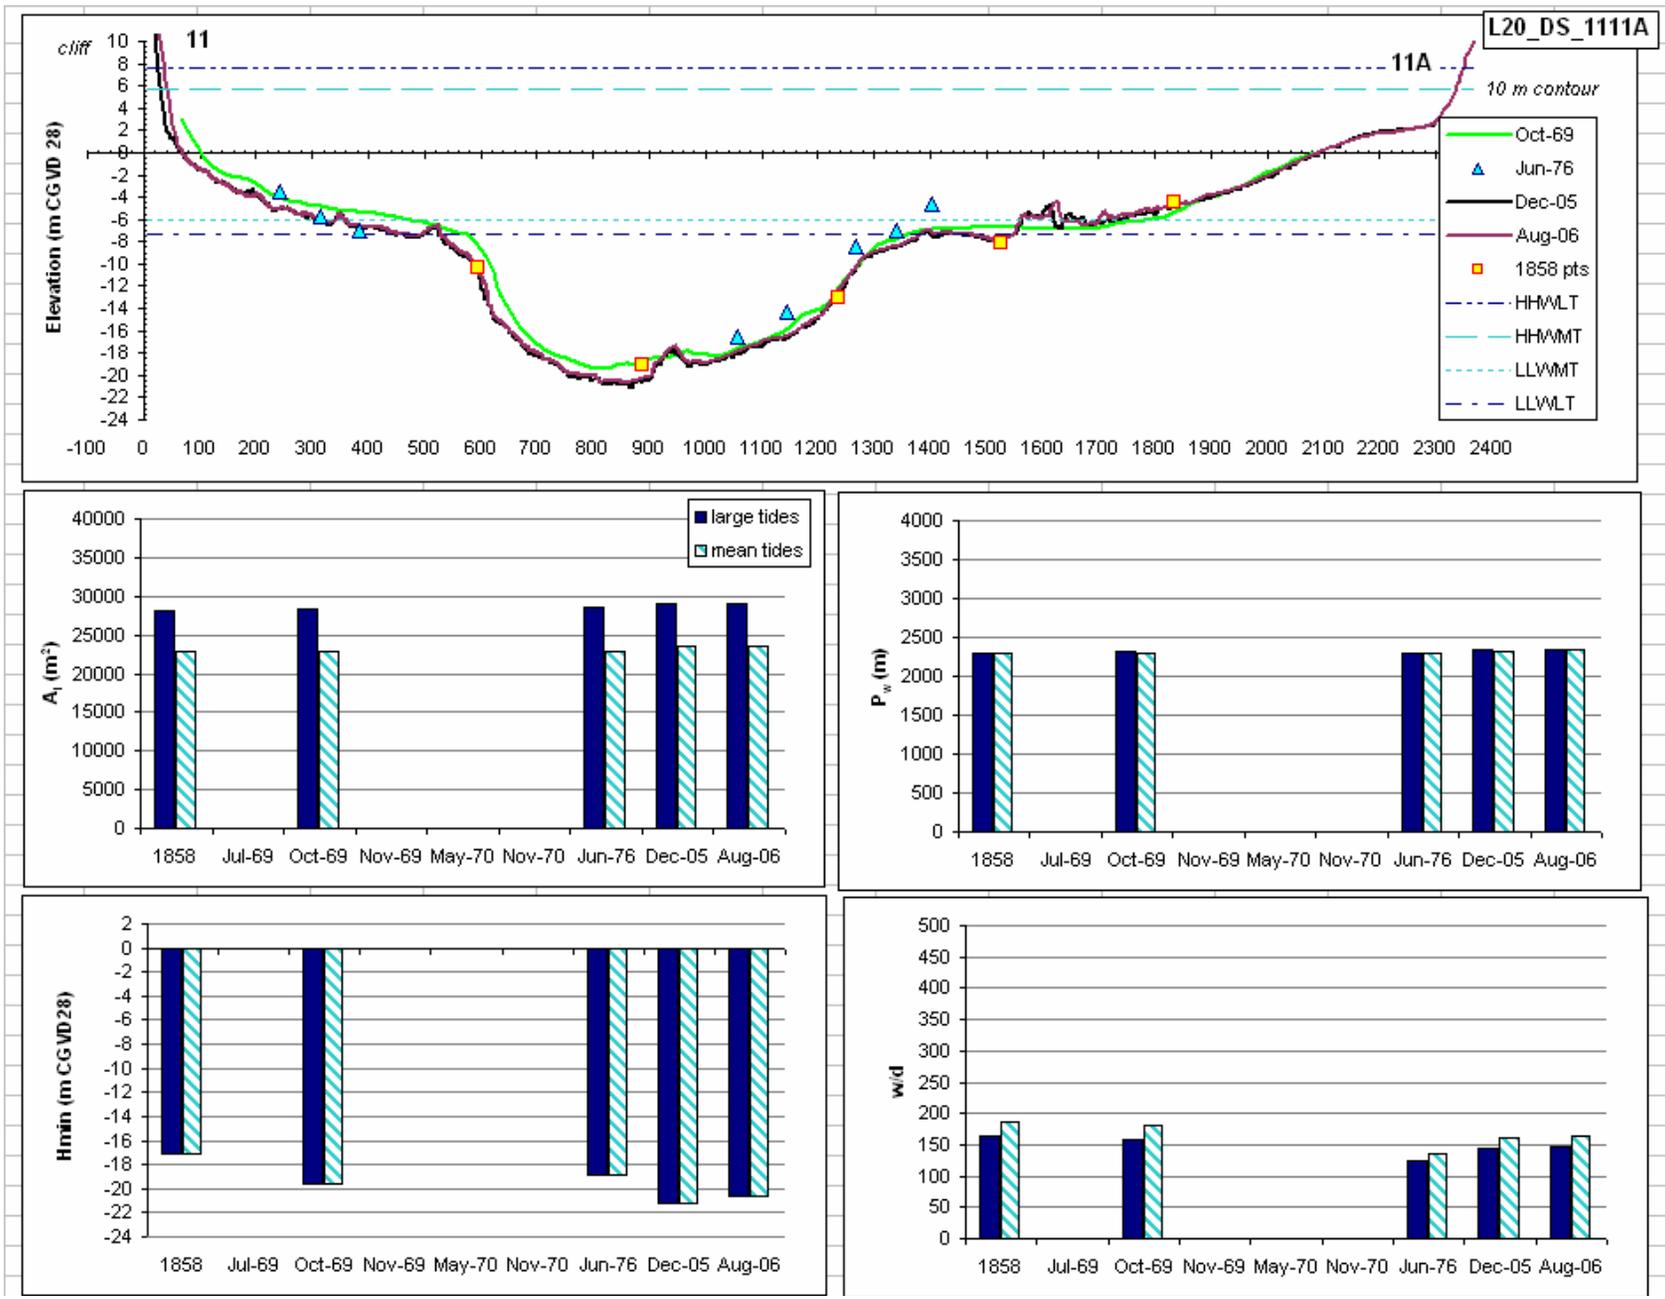
Figure 4.3w: Cross sectional profile for Line20\_DS\_1111A and associated hydraulic geometry parameters on the Avon River. Vertical exaggeration on cross sectional profiles = 73 X. Distance on cross sectional profile in metres.
